**Monthly Site  
Environmental Audit**

**Glanmire Flood Relief Scheme**

29/01/24 To 28/02/24

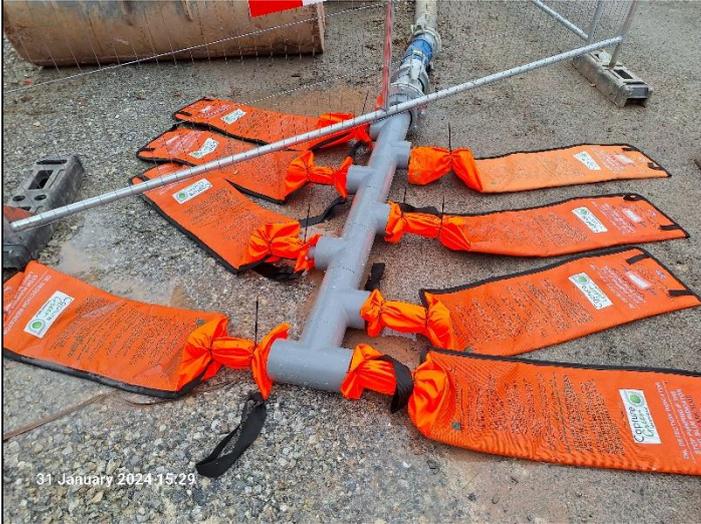
**Photo 1**

- Environmental Tour 005 (29/01/24) – Key findings:
  - Erosion protection required at F.Home riverbank (installed 03/02/24),
  - Pumping at Meadowbrook not in line with RAMS, manifold system not in use due to connection issue (manifold pipe & discharge hose both ‘male’ connection points) – adapter acquired and set up amended 31/01/24. (Photo 1)
  - Improved biosecurity infrastructure at Area 1 JK exclusion zone (wooden fencing improved and hut installed to house sign-in sheets)
- Good use of nappies/spill trays throughout all site areas. (Photos 8, 9 & 10)
- Sallybrook attenuation area altered during installation of septic tank – drainage stone placed as filtration measure, silt curtain installation improved.

<b>Caption 1</b>	<b>Section</b>	<b>W/C 29/01/24</b>
Silt mitigation manifold system set up at Meadowbrook pumping station.

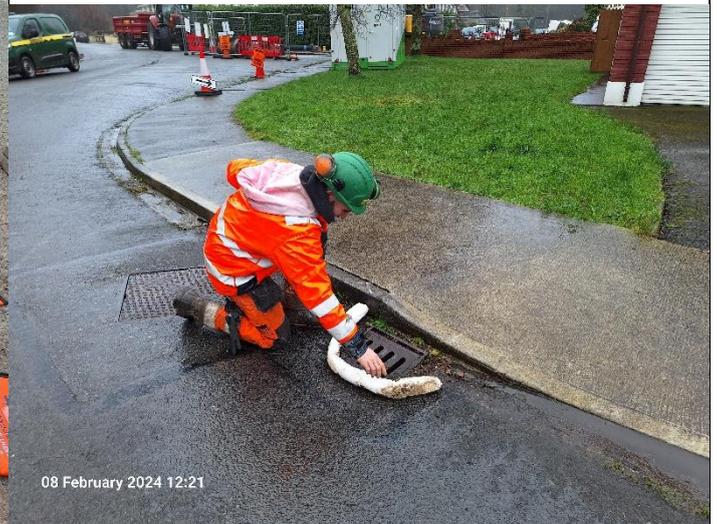
**Photo 2**

- Fuel spill Meadowbrook from overflow of Powers Group tractor – Oil booms and pads deployed around gullies immediately. Area treated with Bioversal HC cleaning product. TBT on Spill response Training scheduled for last week of Feb. (Photo 2 & 3)

<b>Caption 2</b>	<b>Section</b>	<b>W/C 05/02/24</b>
Gully in the process of being bunded with oil boom after fuel spill (Meadowbrook)

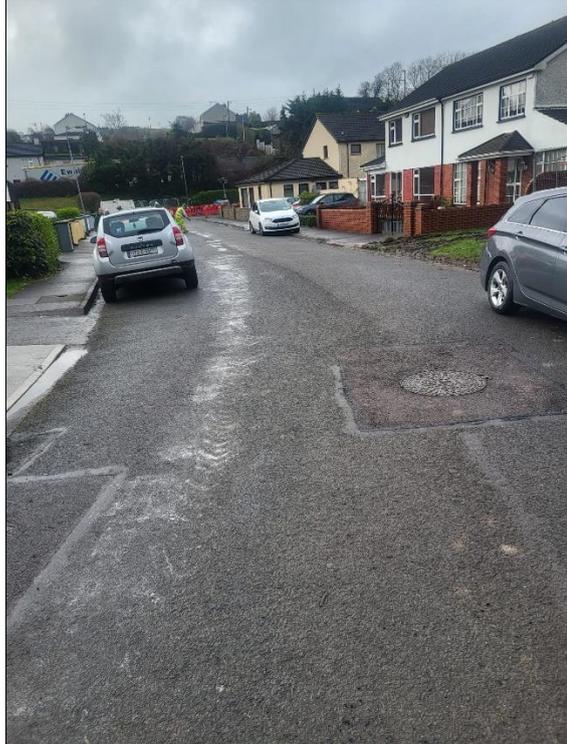
**Photo 3**

<b>Caption 3</b>	<b>Section</b>	<b>W/C 05/02/24</b>
Road sprayed with Bioversal HC after fuel spill (Meadowbrook)

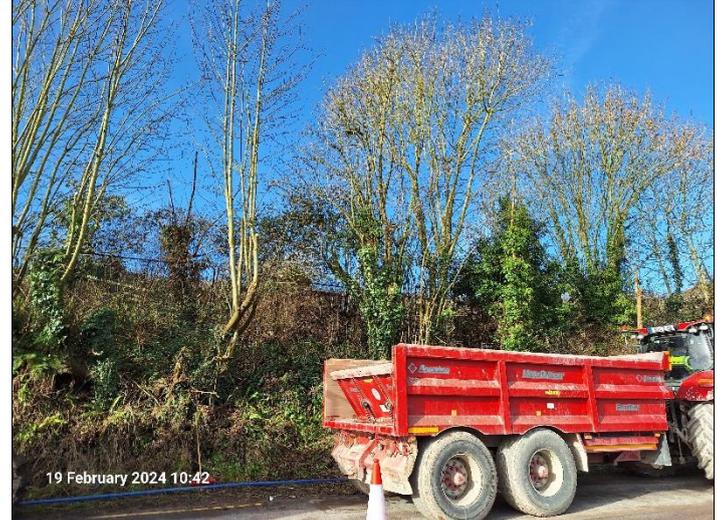
**Photo 4**

- Environmental Tour 006 (09/02/24) – Key findings:
  - Drainage works R639 – plant arm hitting tree branches when turning. SCE unable to swing arm over the road due to risk of injury to pedestrians and vehicle users, tree branches cut back (14/02/24) to prevent plant arm impacting them. (Photo 4)

<b>Caption 4</b>	<b>Section</b>	<b>W/C 05/02/24</b>
Branches cut back – R639

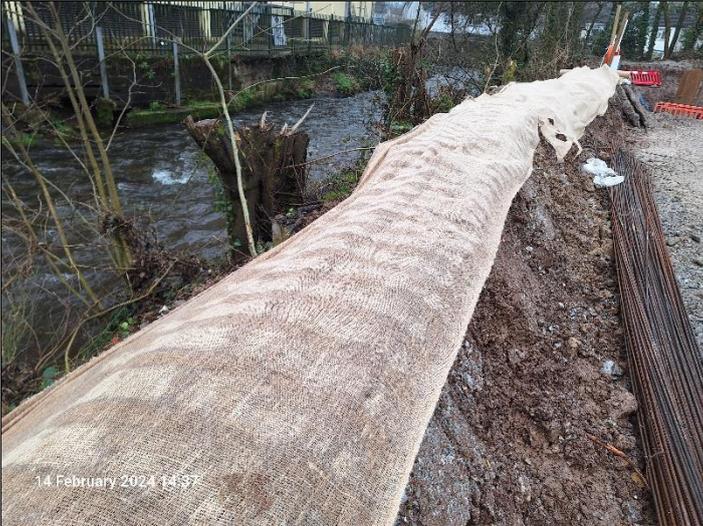
**Photo 5**

- Erosion protection to be extended F.Home riverbank – completed 14/02/24 (Photo 5)
  - Shutter oil visible in water at intake point of pump (back of F.Home) oil and sediment sock on discharge hose for the purpose of removing pollutant from water, however, sock required maintenance (emptying of sediment) for effective control of shutter oil. Pumping was ceased and sock actioned for maintenance, action completed within 30 mins and pumping allowed to recommence. (Photo 6)

Erosion control mesh extended – F. Home

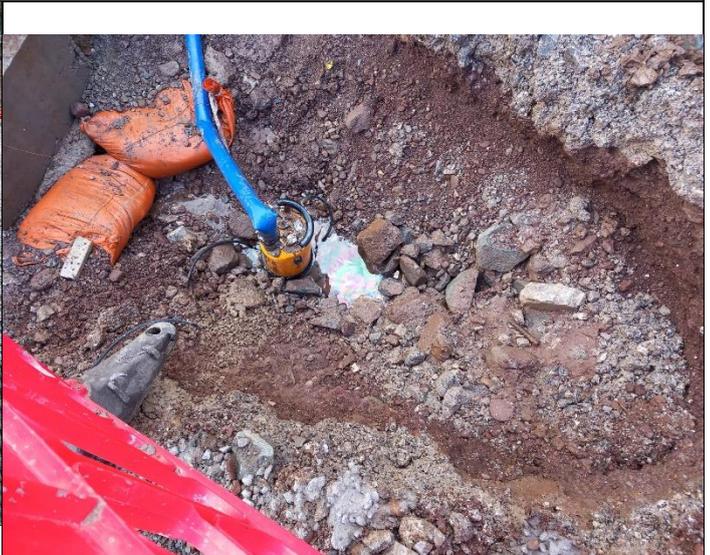
**Photo 6**

Shutter oil visible in water being pumped at F. home.

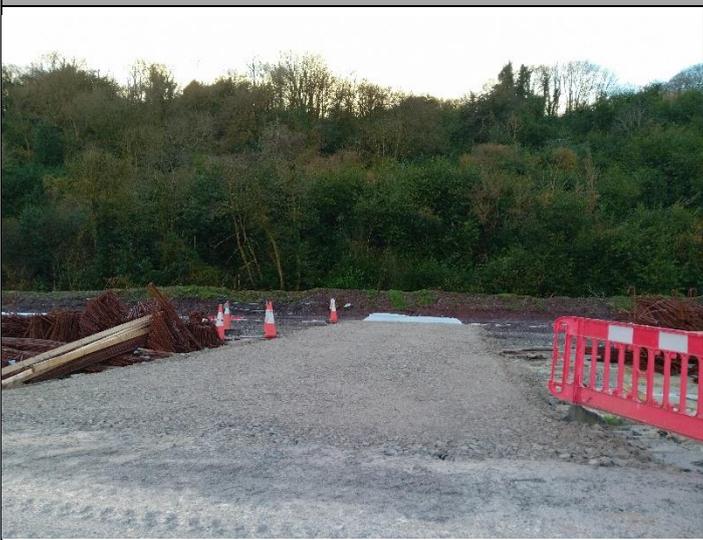
**Photo 7**

- Erosion control matting extended along riverbank at back of Funeral Home.
- Updated Biosecurity Management Plan Rev.02 issued to ARUP 15/02/24.
- Terram and stone placed in JK exclusion zone (Area 1) for access of materials for embankment works – prevents delivery vehicles coming into contact with infested ground. Biosecurity Management Plan Rev 02 abided by at all times. (Photo 7)

Terram and stone access point to embankment – Area 1

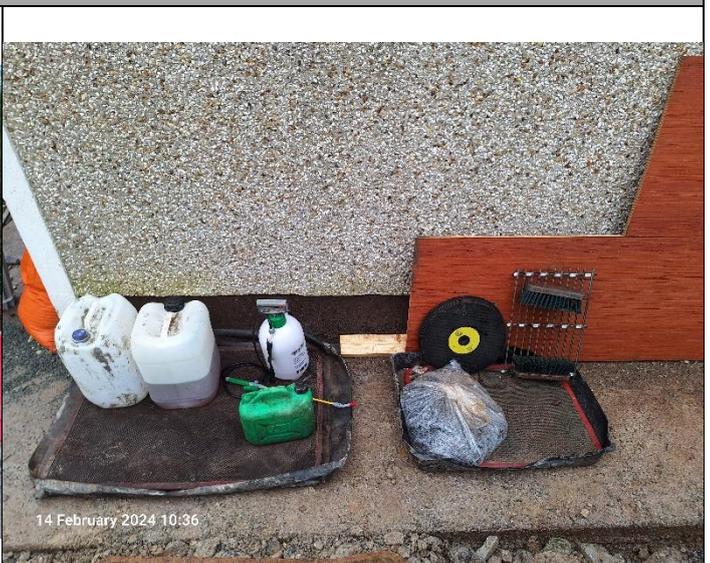
**Photo 8**

Spill trays in use – F. Home

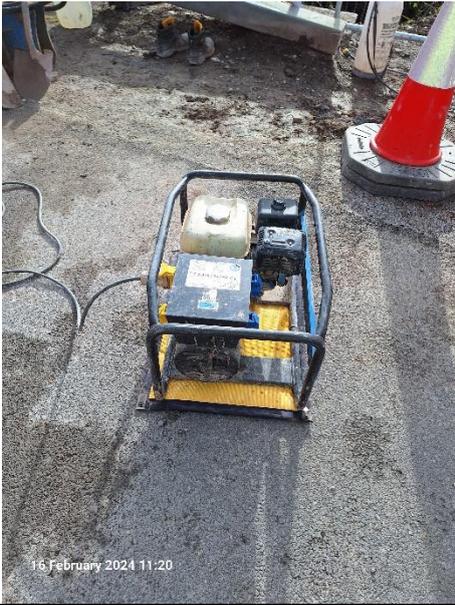
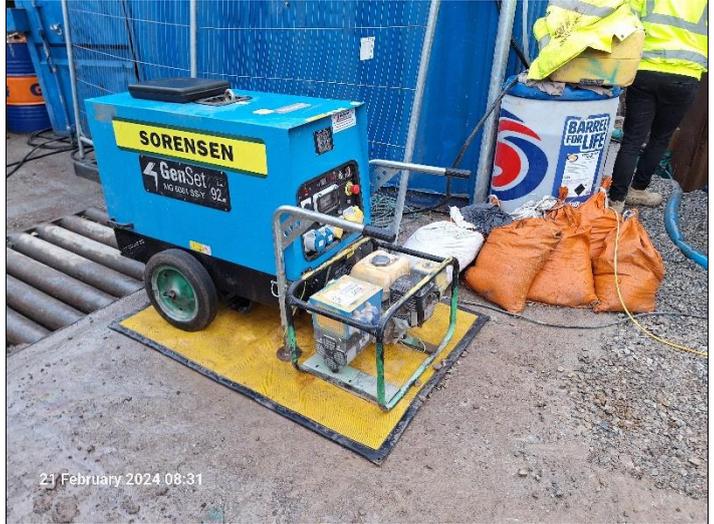
<b>Caption 9</b>	<b>Section</b>	<b>N/A</b>	<b>Caption 10</b>	<b>Section</b>	<b>N/A</b>
Nappy in use – Copper Valley			Spill nappy in use - PODs

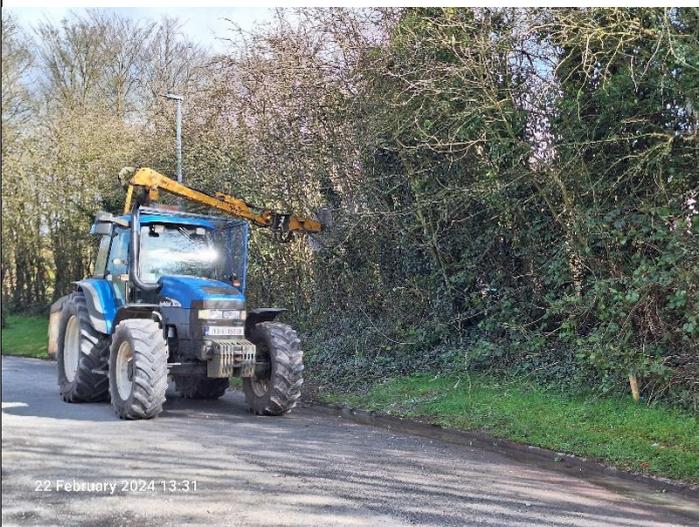
Photo 11

- Tree branches trimmed back in Meadowbrook in preparation of flood defence structure work. (Photo 11)
- Mobile Welfare Unit placed in Circus Field temporarily alongside river (~3m) until permanent unit installation is completed in site compound. Weather monitoring ongoing – Unit will be removed if there is a risk of flood.

<b>Caption 11</b>	<b>Section</b>	<b>W/C 15/01/24</b>	<b>Caption 12</b>	<b>Section</b>	<b>WC 26/02/24</b>
Trees cut back - Meadowbrook			TBT – Spill Response Training sheet

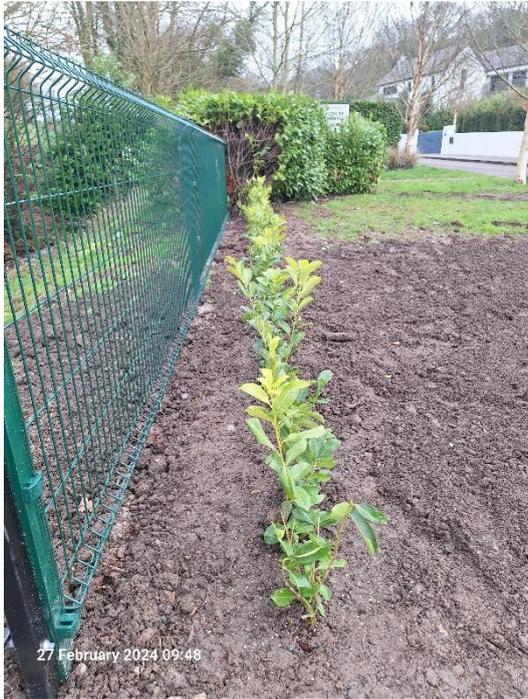
**Photo 13**

Topsoiling and planting completed – Cuil Chluthair

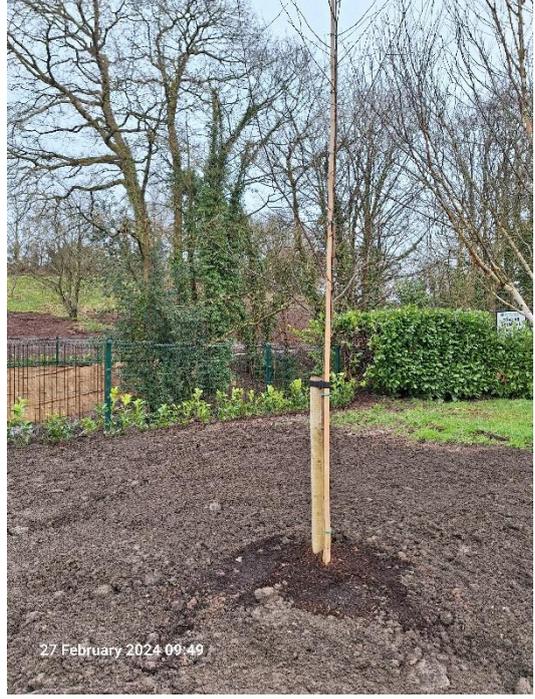
**Photo 14**

Topsoiling and planting completed – Cuil Chluthair

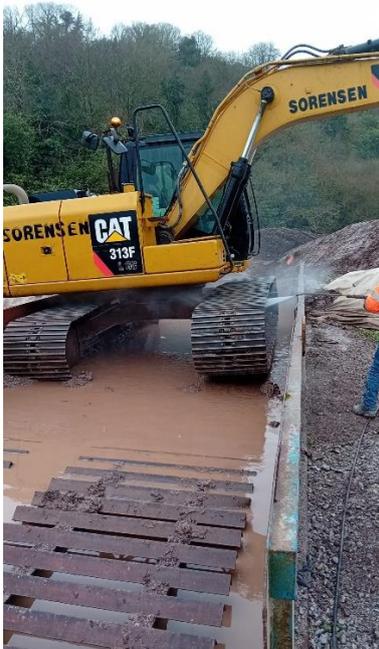
**Photo 15**

Machine wash down upon exiting JK area

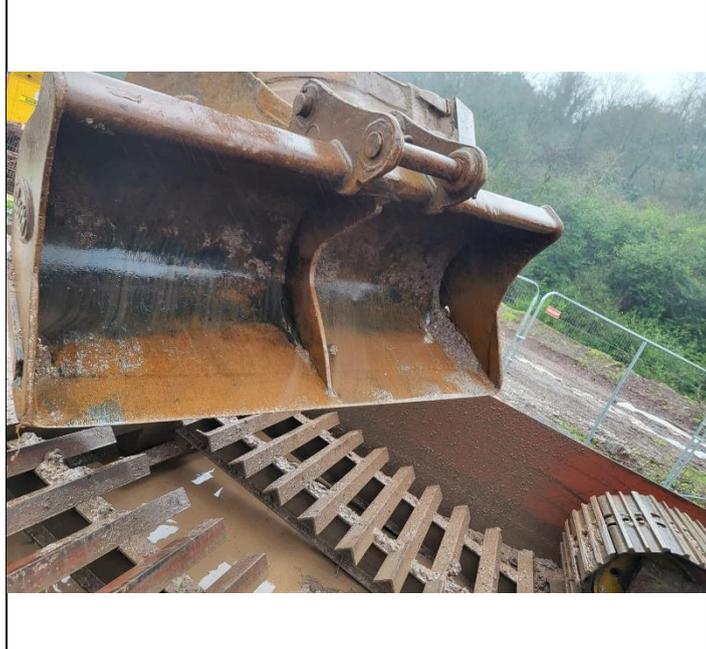
**Photo 16**

Machine wash down upon exiting JK area
