## Monthly Site Environmental Audit

## Glanmire Flood Relief Scheme

01/05/24 To 31/05/24

Details			
<b>Project:</b>	Glanmire Flood Relief Scheme		
<b>Auditor:</b>	SD/LD	<b>Audit Period:</b>	April
<b>Locations Audited:</b>	All sites.

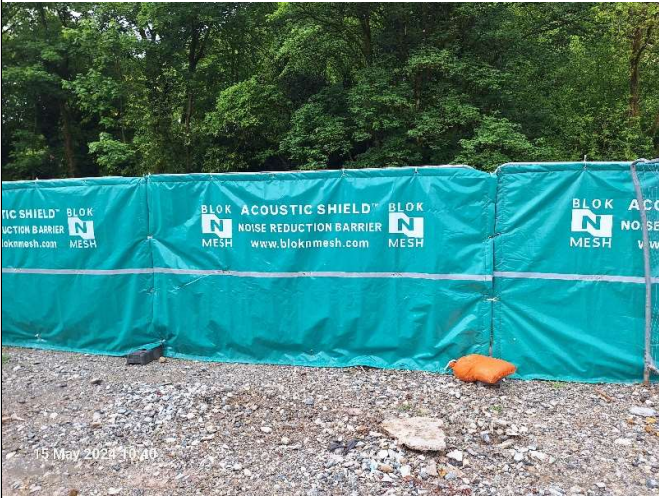
<b>Caption 1</b>			<b>Caption 2</b>		
Acoustic shield installed at holt N2			Fish guard installed at Cois na Gleann overpumping discharge point to prevent kick up of silt from the river bed and bank.

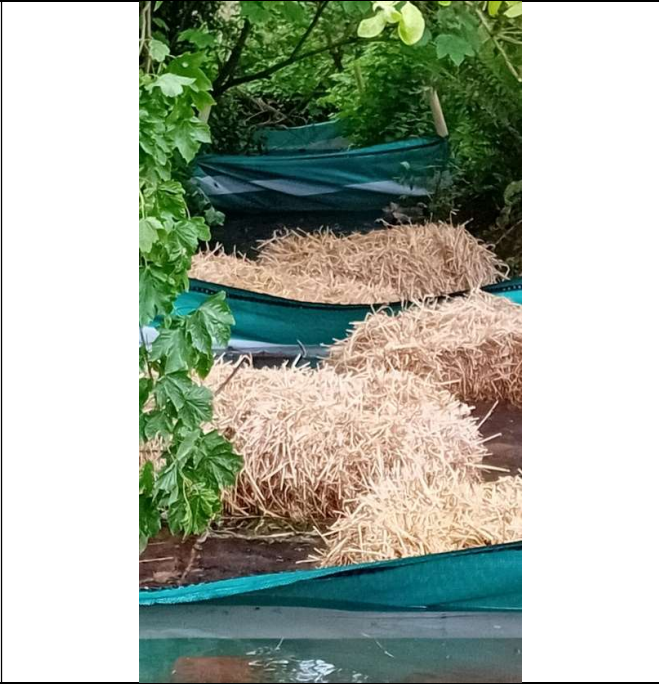
<b>Caption 3</b>			<b>Caption 4</b>		
Silt fencing and straw bales deployed at Cois na Gleann to aid in the catchment and settlement of silt.			Fish and debris guard installed upstream of pump intake hose to prevent fish passage and blockage of pumps.

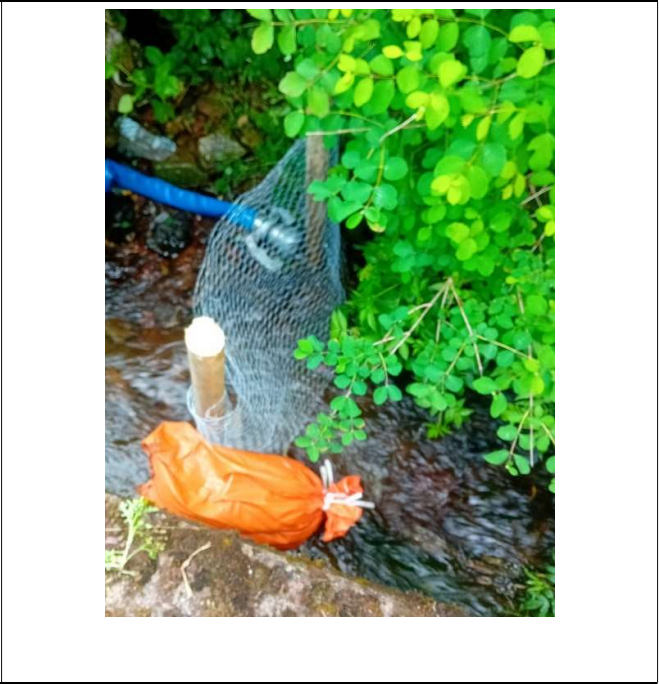
- Fish/debris guard installed upstream of pumps – Cois Na Gleann.
- Further silt control installed at Sallybrook temporary SPW prior to permanent sheet pile wall installation.
- Pump failure upstream of Cois na Gleann and heavy rainfall resulted in the work site flooding
- 13<sup>th</sup> – 19<sup>th</sup> May: No Otter sightings on cameras monitoring N2, C2, N6C and N6D.
  - Mammal sightings: Holt N6D – Cat 16<sup>th</sup> and 19<sup>th</sup> May

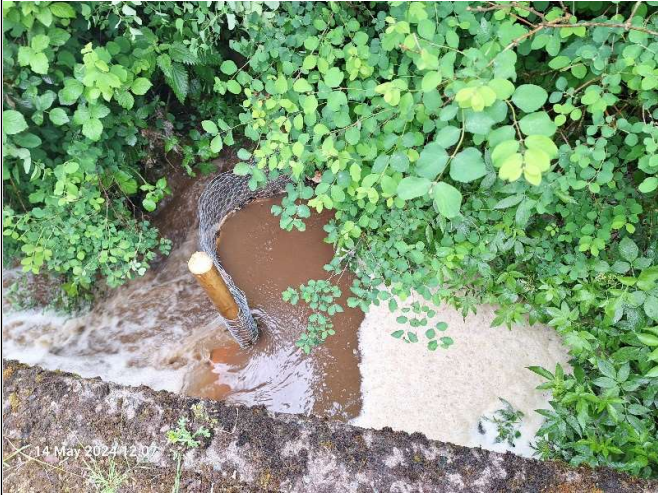
<b>Caption 7</b>			<b>Caption 8</b>		
High turbidity observed in Cois na Gleann stream (upstream)			Overtopping (Cois na Gleann) 14/05/24. High turbidity both up and downstream.

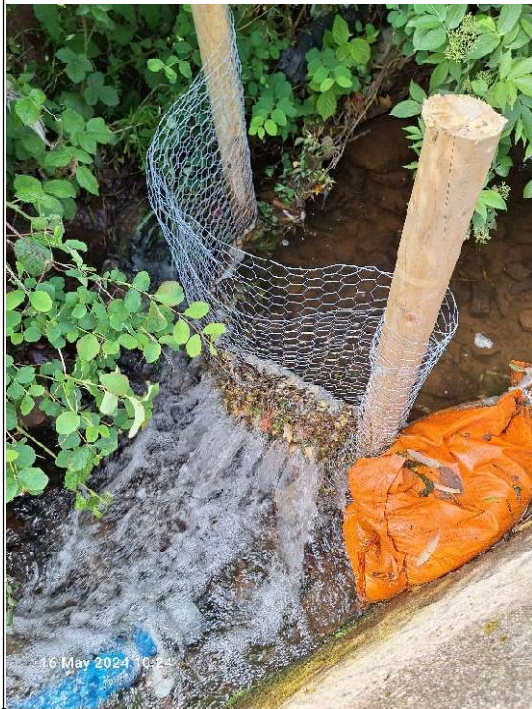
**Caption 9**

Wire fence effectively catching leaf litter/debris, preventing it entering the pumps (Cois na Gleann)

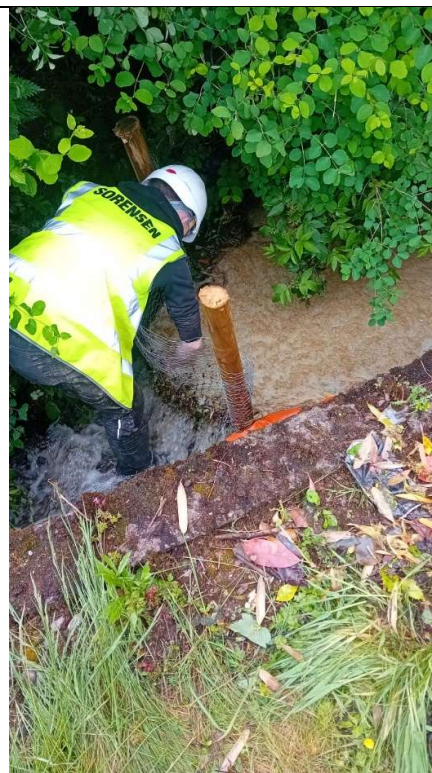
**Caption 10**

Cois na Gleann – Upstream wire fence cleared of debris daily to prevent overtopping.

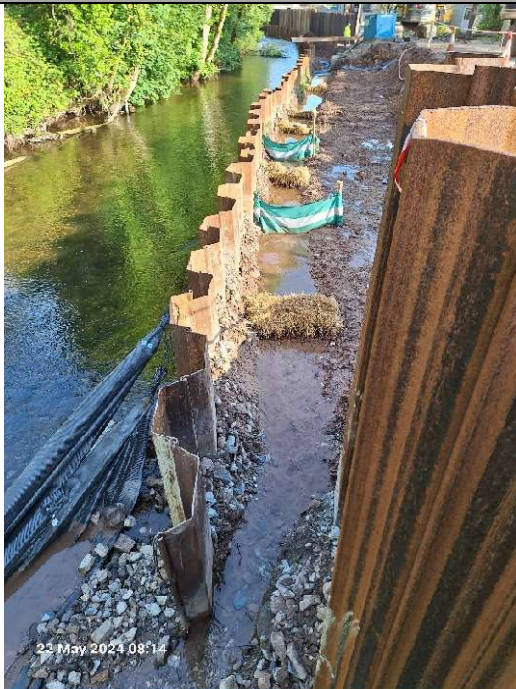
**Caption 11**

Silt fencing, curtains and straw bales installed at Sallybrook/Eurofins prior to sheet piling activity.

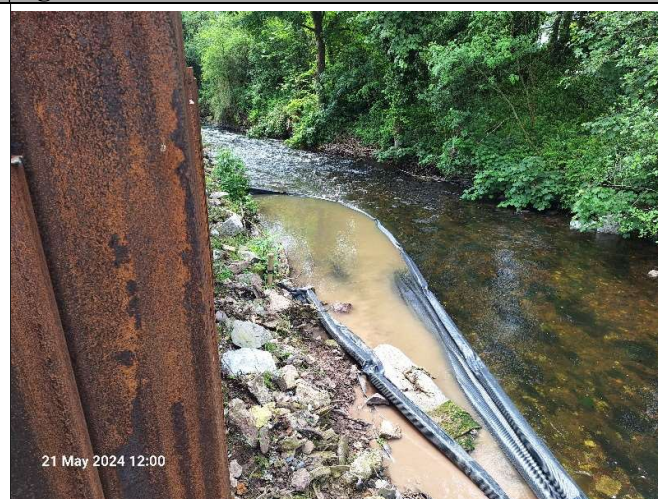
**Caption 12**

Silt curtains – Sallybrook/Eurofins during piling activity.
