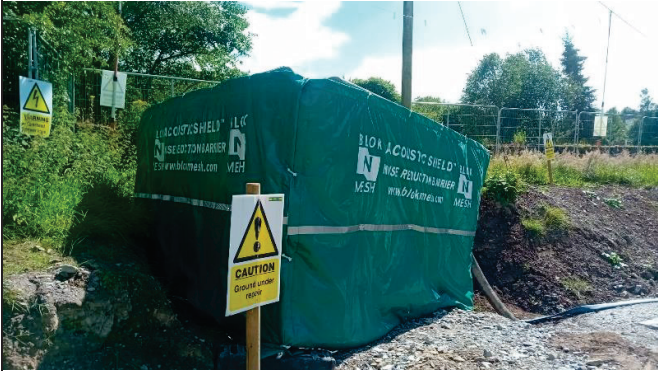
Figure 21			Figure 22

<b>Caption 21</b>			<b>Caption 22</b>		
Noise absorbant panels erected around pump at Area 2 Meadowbrook.			Silt event on Glenmore Stream 25/06/24 – not related to Sorensen works. Followed silt upstream 750m could not trace the source.

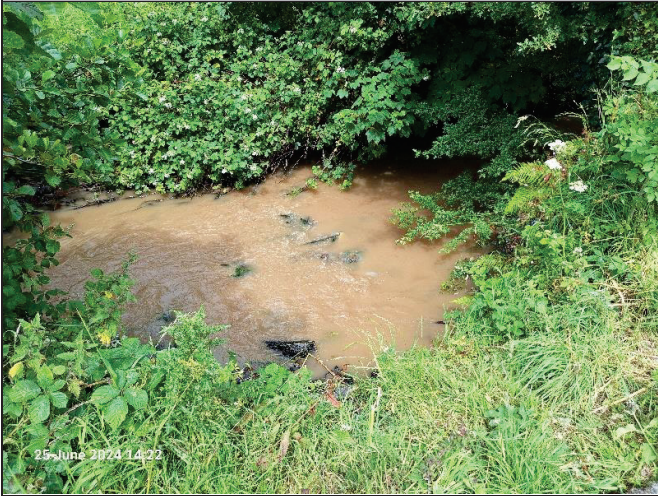
Figure 23			Figure 24

<b>Caption 23</b>			<b>Caption 24</b>		
Silt event on Glenmore Stream 25/06/24 – not related to Sorensen works. Followed silt upstream 750m could not trace the source.			Himalayan Balsam pulled – Area 3 Meadowbrook

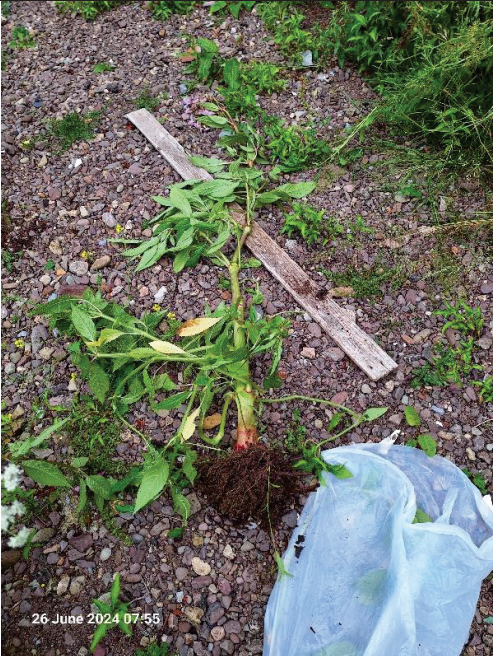
Figure 25			Figure 26

Caption 25			Caption 26		
Himalayan Balsam pulled – Area 3 Meadowbrook			Knotweed infested area demarcated – Area 3 Meadowbrook
