Monthly Site Environmental Audit

Glanmire Flood Relief Scheme

27/08/24 To 30/09/24

Details			
Project:	Glanmire Flood Relief Scheme		
Auditor:	SD/LD	Audit Period:	September
Locations Audited:	All sites

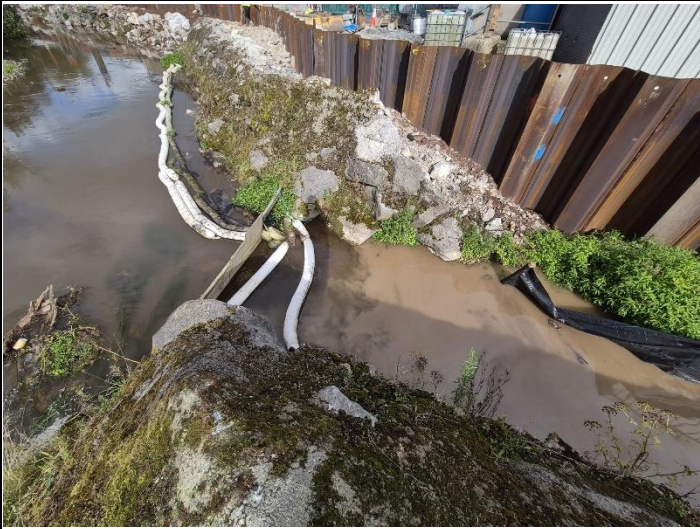
Figure 3			Figure 4

Caption 3			Caption 4		
Sorensen oil booms installed at the Mill Race to aid in the prevention of contamination entering the main Glashaboy channel.			Efishing of the dammed area at Riverstown Bridge

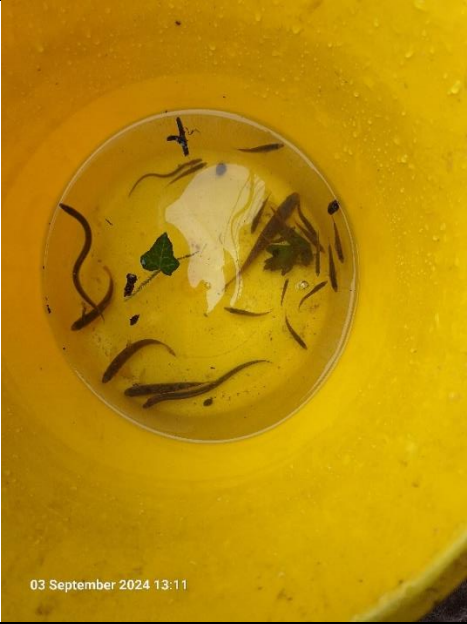
Figure 5			Figure 6

Caption 5			Caption 6		
Sample bucket of fish recovered during efishing activity at Riverstown Bridge.			Silt curtain installed downstream of Riverstown Bridge for dredging of the bridge eye. Works supervised by IAPS Specialist due to the presence of Japanese knotweed.

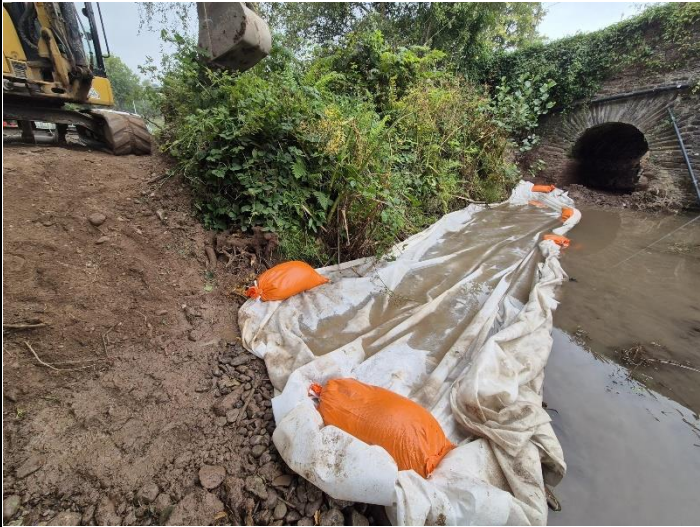
Figure 7			Figure 8

Caption 7			Caption 8		
Biosecurity measures at Hazelwood Bridge for Japanese knotweed recovery works			Grass seeding and laying of coir mesh at Riverstown Bridge.

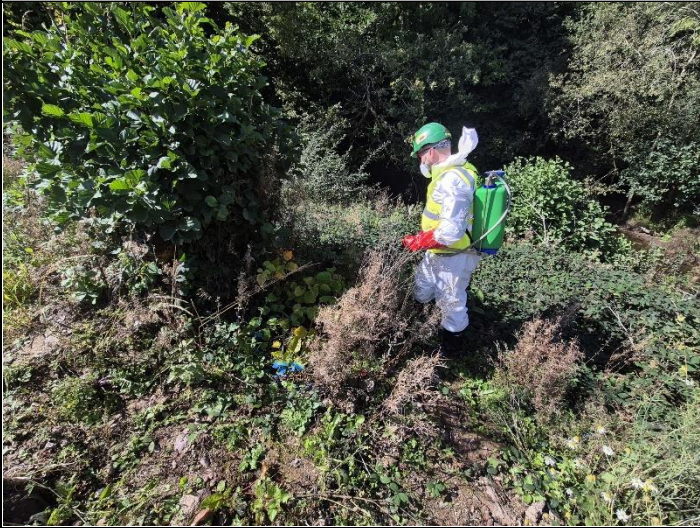
Figure 9			Figure 10

Caption 9			Caption 10		
Spraying of Bohemian and Japanese knotweed			Rock armour installed beneath New Line bridge and thalweg dug through the river gravels for fish passage.

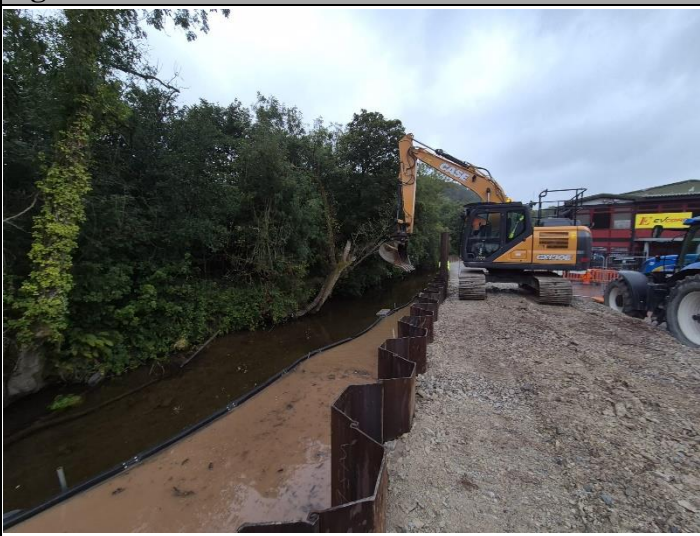
Figure 11			Figure 12

Caption 11			Caption 12		
Recovery of river gravels from the dry to accommodate rock armouring at Evcore Gym			Recovery of river gravels to accommodate rock armouring at Eurofins

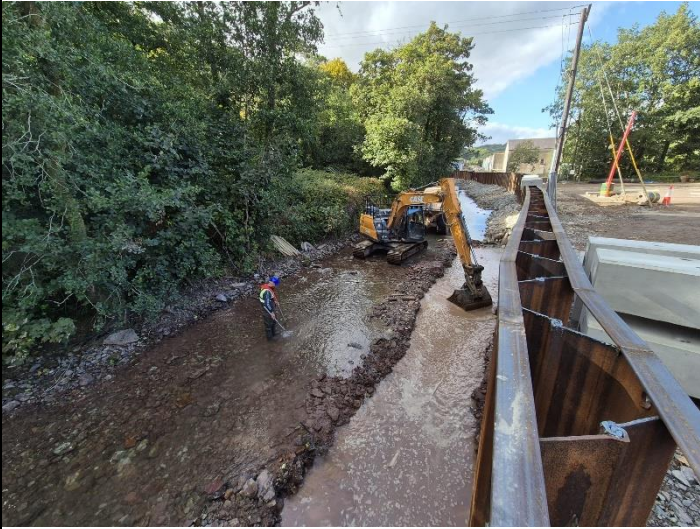
Figure 13			Figure 14

Caption 13			Caption 14		
Placement of rock armouring at Eurofins			What appears to be diesel contamination in ground water at Eurofins excavation for outfall 1/OF8.

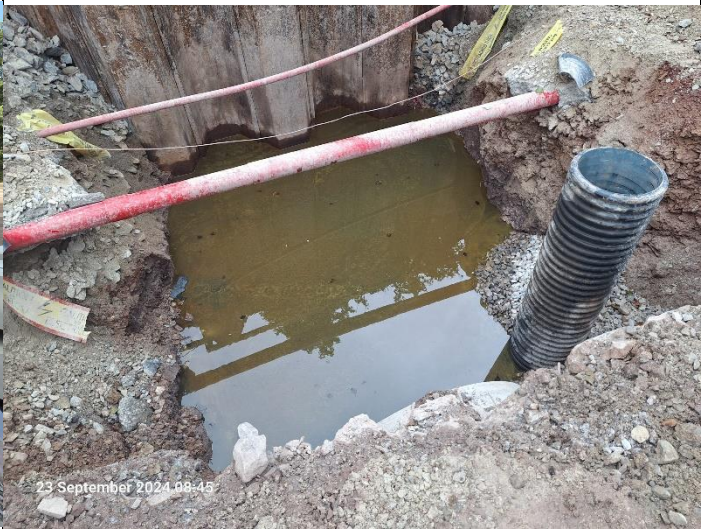
- Rock armour completed at upstream side of Springmount stream, stream released 23/09/24.
- Hydrocarbon contamination visible in the river at Eurofins – area bunded with oil booms 23/09/24. Hydrocarbon sheen visible throughout the river system 24/09/24, oil boom bund lengthened at Eurofins to better aid in the containment of contamination and oil booms placed at Meadowbrook and Hazelwood. River treated with Bioversal HC. Contamination present in groundwater at Eurofins, source of contamination and pathway to river currently unknown, appears to be emerging from the rock armour so may be seeping

through/beneath the SPW. Investigations underway.

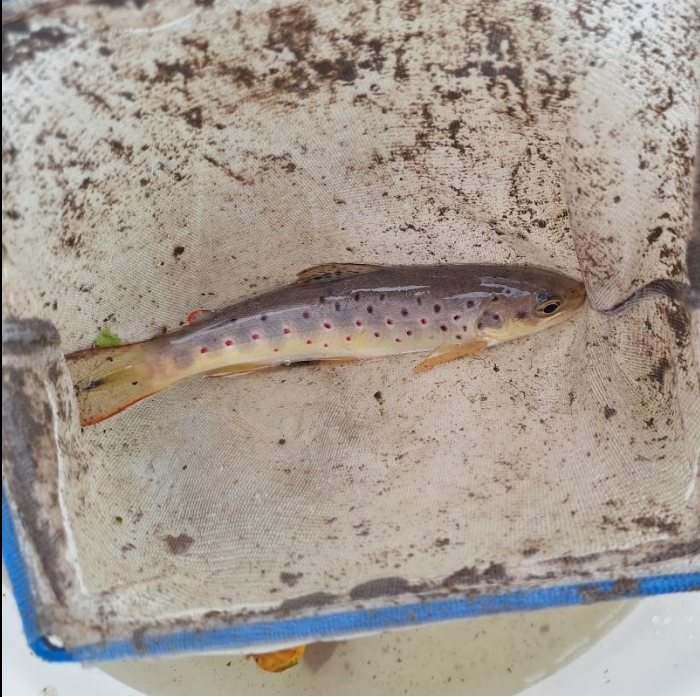
Figure 15			Figure 16

Caption 15			Caption 16		
Juvenile trout recovered during efishing operations of the Meadowbrook diversion channel.			Contaminated water from Eurofins was pumped through a settlement tank containing booms and pads before discharging through oil absorbent socks onto pads banded with booms.
