Environmental Report June 2025

Glashaboy Flood Relief Scheme

Prepared by: Rory O' Connor

Document code: FFEC-GFRS-2025-006

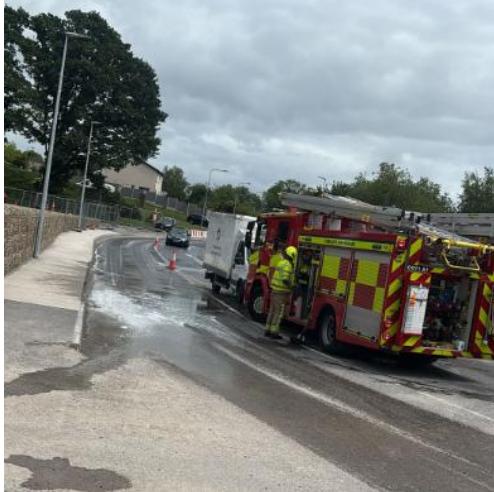
Item number	Date	Comment	Image	ECoW Action/Recommendation	Sorensens's Action response
6.1	03/6/2025	Significant oil spill caused by third party on road at entrance to Hazelwood Shopping Centre.

Informed of incident by site ecologist.	No action required by SCE. The local fire brigade responded to the incident and implemented appropriate control measures to address the fuel spill.
6.2	03/6/2025	Rotary pile driving operations are ongoing at the Hazel Shopping Centre. Saturated, muddy material is being contained within the designated work area through the use of a temporary bund.		Monitored ongoing works for implementation of environmental mitigations to protect the adjacent	The material was subsequently scraped and removed from the work area and transported to an appropriate designated location.

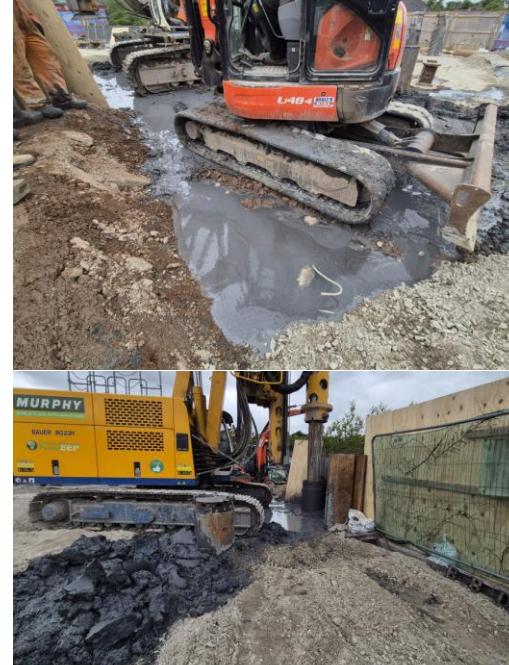
Item number	Date	Comment	Image	ECoW Action/Recommendation	Sorensens's Action response
6.3	03/6/2025	<p>The gravel and earth bund were maintained throughout the pile driving. Timber panels were put in place as well as an additional bund established along the riverbank. All measures aimed to prevent the risings from entering the Glashaboy river.</p>

<p>Monitored ongoing works for implementation of environmental mitigations to protect the adjacent watercourse.</p>	<p>Effective silt control measures were implemented throughout the piling operations.</p>

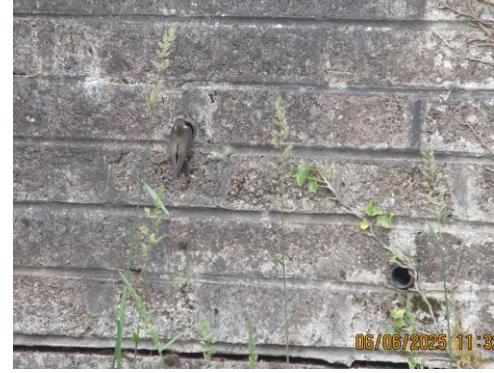
Item number	Date	Comment	Image	ECoW Action/Recommendation	Sorensens's Action response
6.6	06/6/2025	A sand martin was observed today actively accessing its nest within the weep hole of the Bean and Leaf revetment wall. This marks the second confirmed use of this particular weep hole as a nesting site during the current breeding season.

A photograph showing a sand martin bird perched on a small circular hole in a weathered, horizontal-lap-sawn timber revetment wall. The wall is covered in some green vegetation. The date '06/06/2025 11:32' is visible in the bottom right corner of the image.	Checks were carried out to determine the status of the weep holes and assess whether they are currently being used for nesting.	Regular monitoring at Hazelwood Bridge is being carried out by the Site Ecologist in consultation with NPWS Ranger Sam Bayley, to block weep holes once each brood has fledged.

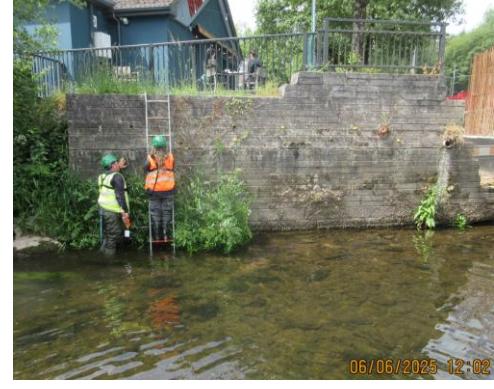
6.7	06/6/2025	Weep holes in the Bean and Leaf revetment wall were blocked off to facilitate works in accordance with the approved design, which includes the demolition of the wall. These weep holes were regularly monitored and inspected prior to final blocking to guarantee nest hole unoccupied.

A photograph showing two workers in high-visibility vests and hard hats standing on a ladder, working on a Bean and Leaf revetment wall. They appear to be blocking off weep holes. The wall is made of large, rectangular concrete blocks. The date '06/06/2025 12:02' is visible in the bottom right corner of the image.	Supervised the blocking off of 5 of the 8 weep holes.	The Site Ecologist, in consultation with NPWS blocked 5 out of 8 weep holes after inspection and survey confirmed they were no longer active.

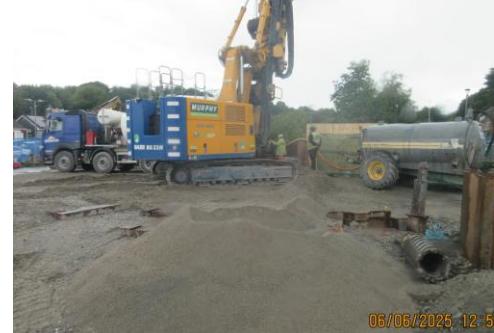
Item number	Date	Comment	Image	ECoW Action/Recommendation	Sorensens's Action response
6.8	06/6/2025	Concrete is being poured into the rotary holes, displacing water upward, which is then collected by a tanker. The area is partially bunded to contain runoff while allowing access, with gravel stockpiles placed on either side for rapid deployment in case additional containment is needed.

Partial supervision of the concrete pour was undertaken, with checks carried out on the effectiveness and implementation of mitigation measures.	Silt control mitigation during rotary pile driving works was well planned and effectively implemented. The inclusion of contingency measures, such as additional gravel stockpiles, provided a robust and reliable failsafe.

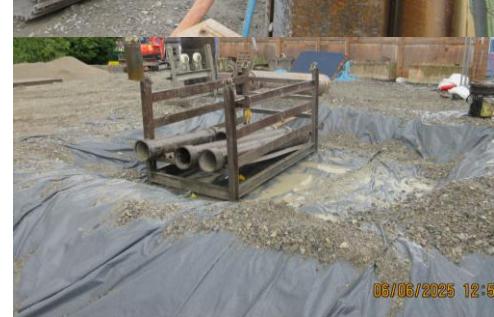
6.9	06/6/2025	A concrete washout area was established on-site prior to the commencement of rotary piling. It was used for cleaning the funnel and casing equipment. The setup remained in place at the designated location throughout the works. Concrete waste and slurry residue were scraped and removed from around the bore hole locations.

Partial supervision of the concrete pour was undertaken, with checks carried out on the effectiveness and implementation of mitigation measures.	Sound control measures for managing siltaceous materials during concrete pouring operations were well implemented and consistently maintained throughout the works.

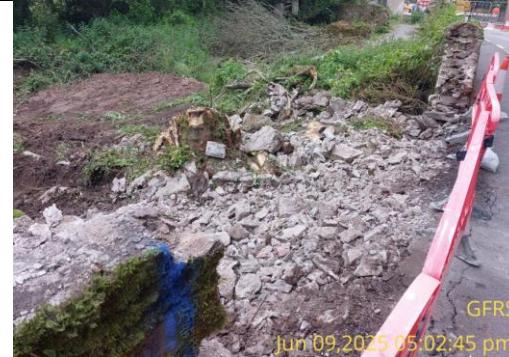
6.11	10/6/2025	Demolition of the wall in Area 4 commenced as planned. Biosecurity measures were followed throughout, including pre-demolition surveys. The wall was inspected for <i>Geranium purpureum</i> , but none was found on this section of wall.

Discussed mitigations with site ecologist prior to demolition works.	All activities were carried out in accordance with biosecurity protocols to prevent the spread of invasive or protected species.

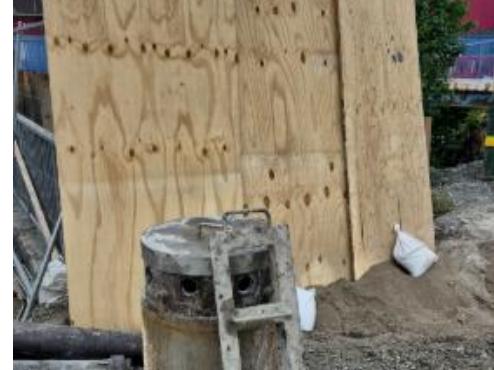
Item number	Date	Comment	Image	ECoW Action/Recommendation	Sorensens's Action response
6.12	10/6/2025	Concrete was poured for rotary piles. Additional timber hoarding was erected as a precautionary measure to prevent any potential sediment-laden water from entering the adjacent Glashaboy River.

Liaised with site ecologist regarding mitigations prior to concrete pour.	Preventive and control measures were effectively implemented and maintained throughout the works.

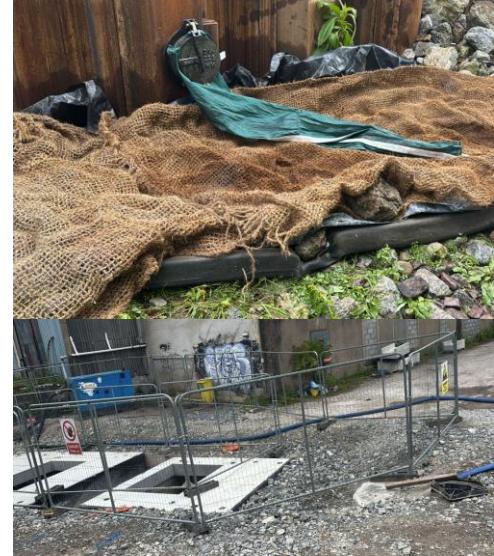
6.13	10/6/2025	<p>Permit to Pump No. 136 has been issued for the dewatering of tanks at the Sallybrook Pump Station. The same procedure previously implemented at the Meadowbrook Pump Station is being followed.</p> <p>A vacuum tanker is being used to remove the bulk of the water as part of the dewatering process.</p> <p>Installation of erosion control matting on the embankment at Sallybrook is ongoing today.</p>

Liaised with site ecologist.	Effective siltation control measures were put in place, with strong contingency plans established. Additional backup measures were available and ready to be deployed if required, ensuring robust management of any potential increase in silt levels.

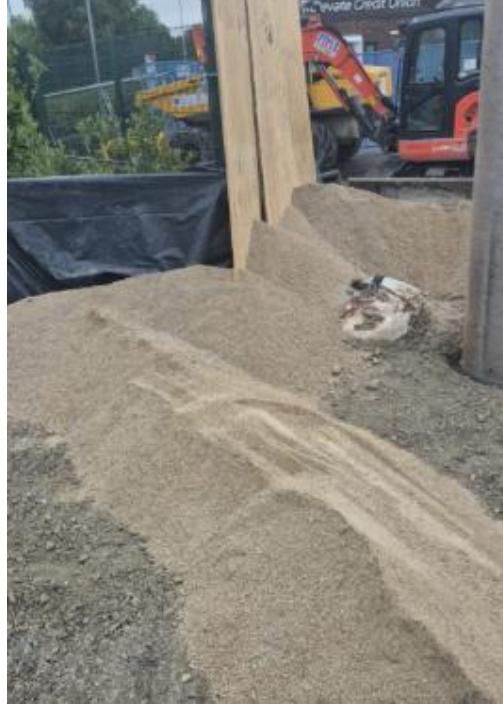
Item number	Date	Comment	Image	ECoW Action/Recommendation	Sorensens's Action response
6.14	11/06/2025	Rotary bored piling commenced on Pile No. 5 at the East Abutment. Control measures to contain spoil from the boring tool included the use of a berm, timber hoarding, metal road plates, and 1200-gauge plastic sheeting. These measures were implemented to prevent spoil migration and maintain environmental compliance.

Partial supervision of the concrete pour was undertaken, with checks carried out on the effectiveness and implementation of mitigation measures.	Effective siltation control measures were put in place prior to the works and maintained and supervised throughout the works.
6.15	11/06/2025	Rotary bored piling on the East Abutment - Pile No. 5, 6 and 7. Concrete pour completed for No. 5

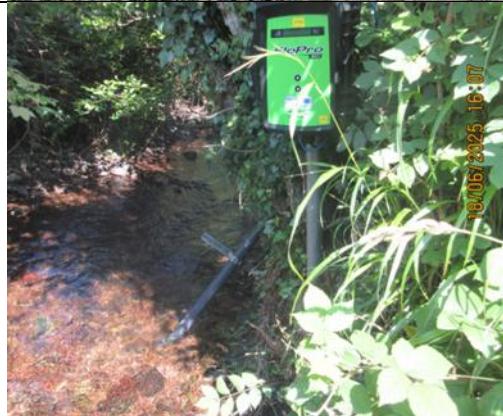
6.17	12/06/2025	Sondes were installed in advance of the instream works season to monitor water quality. Two sets were deployed: one in the Hazelwood area (Area 2 works) and another at the New Line (Area 3 works).

Inspected installations for compliance with work specifications.	Sondes installed as per the contract to monitor the flowing parameters during instream works 2025: NTU, pH, Conductivity, Dissolved Oxygen and Temperature.

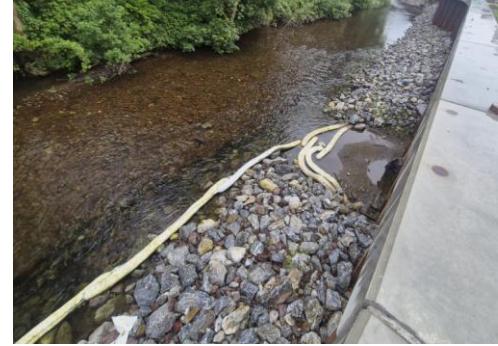
Item number	Date	Comment	Image	ECoW Action/Recommendation	Sorensens's Action response
6.18	12/06/2025	<p>A visual inspection for contamination was carried out at Sallybrook. No observable signs of contamination were detected at the drainage outfall or along the rock armour. Control measures were found to be well maintained, and containment systems remained in good order.</p>

Carried out inspection.	SCE's site ecologist and environmental team continued to implement control and treatment measures as required throughout June.

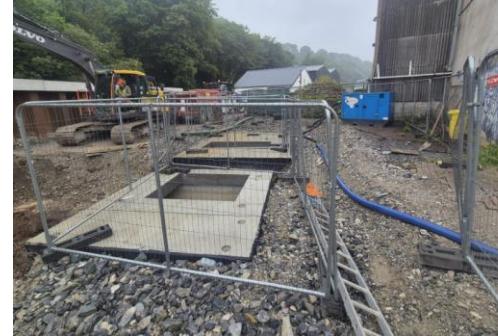
6.19	12/06/2025	<p>Excavation is ongoing for the connection to the pump station outfall. Water continues to be pumped from the sump into the stormwater drainage system, discharging into the Glashaboy River. A settlement tank and manifold system are in place as a precaution to manage any potential increase in suspended solids in the pumped water.</p>

Robust failsafe and backup measures have been established to ensure effective control throughout the works.

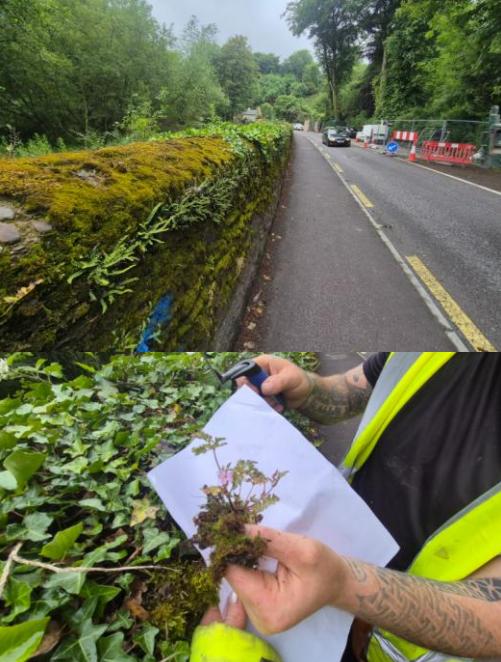
Item number	Date	Comment	Image	ECoW Action/Recommendation	Sorensens's Action response
		activity; none were recorded in the vicinity.			
6.21	12/06/2025	Little robin surveys commenced today. Plants were carefully removed and translocated to the compound to preserve them before wall demolition.

Liaised with ecologist to confirm surveys were planned and carried out prior to the wall demolition.	Effective measures are being undertaken to protect potentially rare flowering plant species.

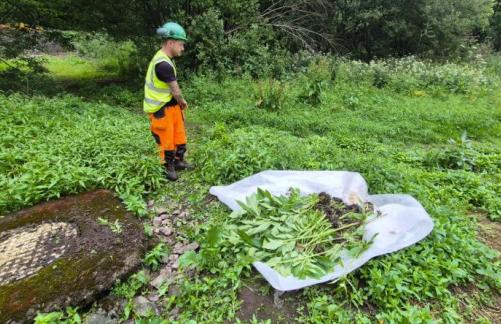
6.22	12/06/2025	Balsam bashing took place in Area 4 as part of standard practice to control the spread of Himalayan balsam. The method involves uprooting the shallow-rooted plants and leaving them to desiccate on-site. Crucially,

Surveyed the area in question for invasive plant species and discussed with site ecologist	Good biosecurity measures were implemented in relation to the management of Himalayan balsam, helping to prevent its spread during site activities.

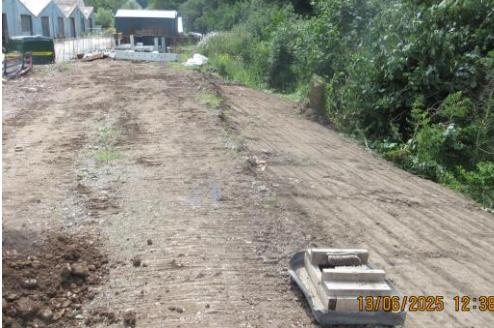
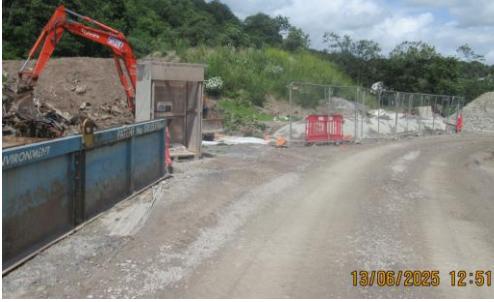
6.23	13/06/2025	Embankment works continued today at Sallybrook. Biosecurity measures were discussed on-site and are being actively followed. Protocols include supervision of all activities, mapping of Japanese knotweed (JKW) rhizomes, use of Terram membrane, boot wash stations, and the placement of all excavated contaminated material into a designated temporary holding cell. Works were carried out during optimal conditions of dry weather.

<p>Biosecurity measures were discussed on-site and continue to be actively implemented. These protocols are essential to prevent the spread of invasive species and ensure environmental compliance throughout the works.</p>	Good biosecurity measures were implemented in relation to the management of JKW.

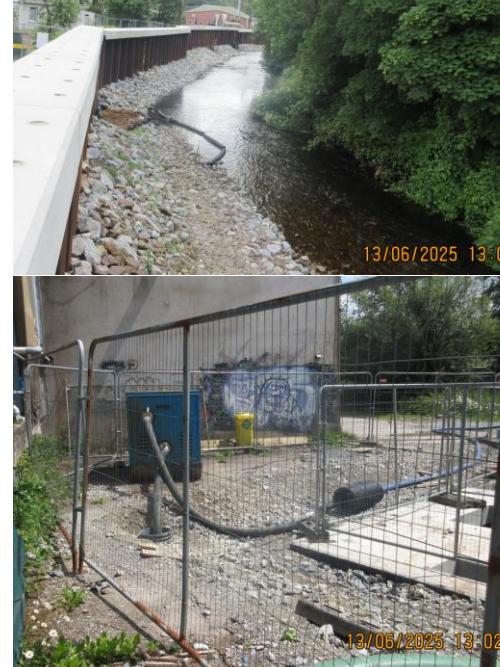
Item number	Date	Comment	Image	ECoW Action/Recommendation	Sorensens's Action response
6.24	13/06/2025	<p>The pumping arrangement at the Sallybrook Pumping Station was inspected, and adequate mitigation measures are in place to control potential siltation. However, periodic monitoring should be carried out to ensure there is no change in the condition of water entering the drainage system, as the current the drainage line offers no attenuation in the event of sedimented water.</p>

<p>Monitor pumping and manage accordingly.</p>	<p>No excavation works are taking place in the area of pumping, making siltation of the pumped water very unlikely.</p>

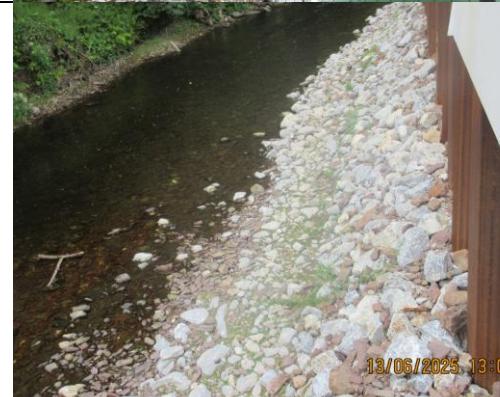
6.25	13/06/2025	<p>Himalayan balsam (HB) was removed along sheet piles at Sallybrook today. Plants were removed in good time prior to planting setting seed.</p>

<p>Discussed with site ecologist.</p>	<p>Positive proactive measures to control the possible spread of (HB).</p>

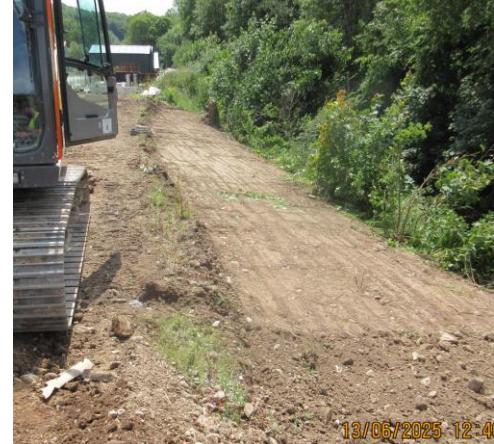
Item number	Date	Comment	Image	ECoW Action/Recommendation	Sorensens's Action response
6.26	13/06/2025	<p>Regarding the Change Order to replace a section of the flood embankment at Sallybrook with a sheet pile wall, the status of a nearby historic Otter Holt was discussed. Although the January 2025 otter specialist report recorded the holt as inactive, the specialist should be consulted again due to the time elapsed and the potential for disturbance if otters are now present.</p>

<p>Checks were conducted prior to vegetation clearance at this location to confirm the status of the holt. It was verified to be inactive at the time of inspection.</p>	<p>The holt was surveyed visually which yielded no signs the holt's status had changed. This was evidenced by the build up of leaf litter, cob weds and undisturbed ground at the entrance to the holt. There were also no markings around the holt or in the vicinity either. The otter specialist was consulted regarding the survey results.</p>

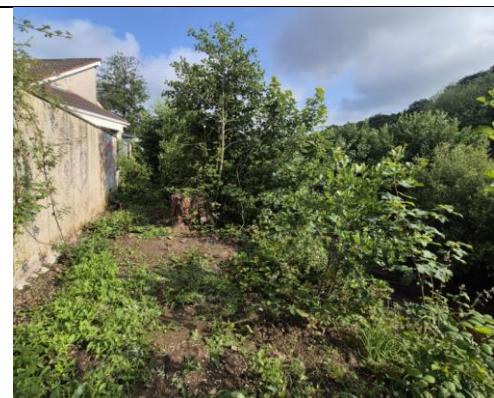
6.27	16/06/2025	<p>Clearing vegetation between Hazelwood Bridge and Hazelwood Shopping Centre Bridge– in advance of RC wall works.</p>

<p>Surveyed the area prior to clearance for signs of nesting birds and notable plant species.</p>	<p>Vegetation clearance included checks for nesting birds, none of which were found, and inspections for invasive plant species, which were also not present.</p>

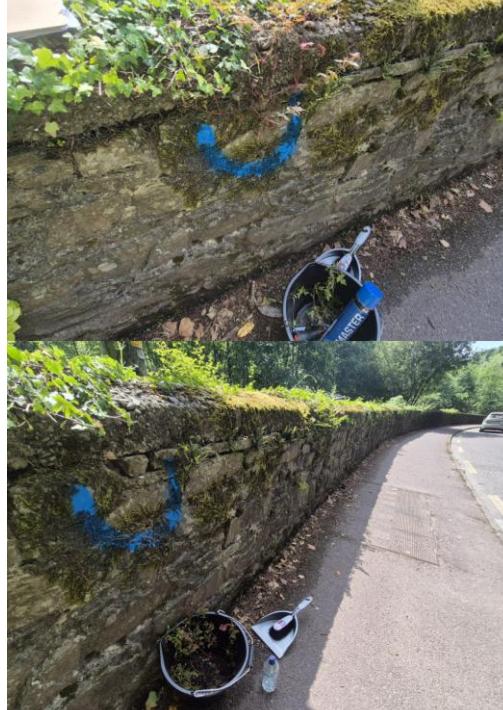
Item number	Date	Comment	Image	ECoW Action/Recommendation	Sorensens's Action response
6.28	16/06/2025	Further Little robin surveys along section of wall to be replaced by crash barrier.

Discussed with site ecologist.	Some plants were removed and relocated compound at Circus Field.
6.29	16/06/2025	Second phase of Balsam Bashing in Area 4 was carried out.

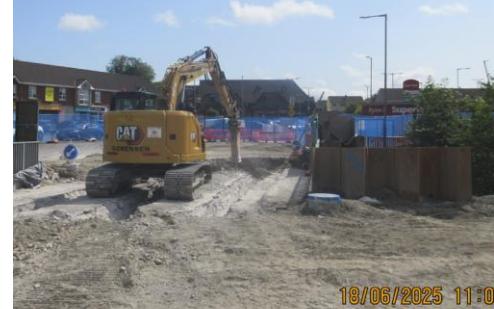
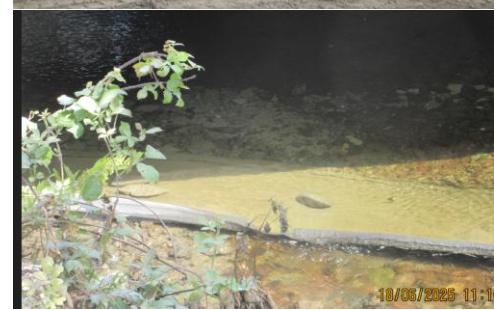
Item number	Date	Comment	Image	ECoW Action/Recommendation	Sorensens's Action response
6.30	18/06/2025	<p>Demolition works commenced on the shopping centre bridge. Silt curtains were positioned directly beneath the expected line of falling debris, with an additional curtain placed downstream to capture any disturbed silt or dust particles from the works.</p> <p>Material that entered the river was removed by hand into an excavator bucket positioned above the water.</p>

<p>Advice was given on improving measures to prevent debris from entering the river in the first instance. This includes reinforcing containment strategies at the source, enhancing physical barriers, and adjusting work methods where necessary to minimise the risk of material entering the watercourse.</p>	<p>Efforts were made to retain material on the bridge deck by controlling the depth of the rock breaker during demolition works. However, not all debris was prevented from entering the river.</p>

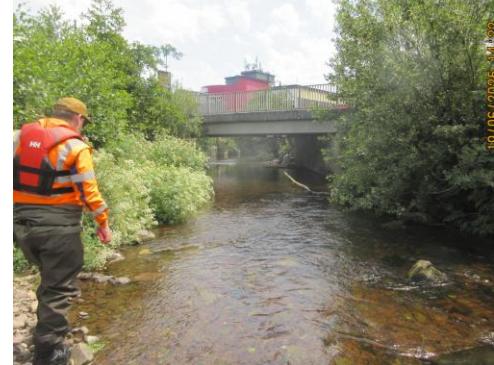
Item number	Date	Comment	Image	ECoW Action/Recommendation	Sorensens's Action response
6.33	19/06/2025	A river survey was undertaken from Hazelwood Bridge to the Shopping Centre Bridge in advance of instream works planned for this section of the Glashaboy River. As part of the survey, enhancement measures were identified for future reinstatement, to be implemented following modifications to the riverbed and riverbank.

Conducted river survey of hydro morphology features and aquatic plants.	A topographic survey was carried out by the SCE to allow riverbed levels to be reinstated once the instream works at this section of the river are completed.

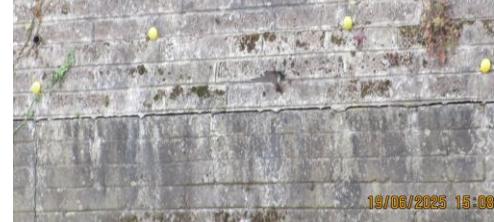
6.34	19/06/2025	Ongoing monitoring of the active sand martin nesting in the revetment wall at Bean and Leaf is being carried out.

Continue to monitor closely so weep holes may be blocked when birds have fledged, enabling works to proceed	Monitoring is continuing throughout this period.

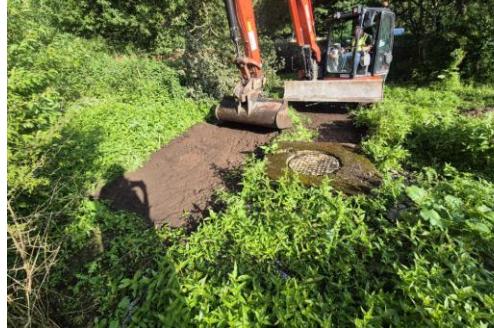
Item number	Date	Comment	Image	ECoW Action/Recommendation	Sorensens's Action response
6.35	20/06/2025	Vegetation clearance in Area 4 was carried out under the supervision of the site ecologist. Biosecurity measures and breeding bird surveys were conducted prior to and during the clearance works.

Received input from the site ecologist on ecological considerations	Good practise demonstrated.

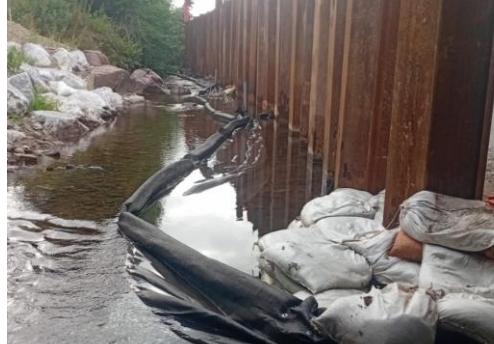
6.36	23/06/2025	<p>In advance of the temporary sheet pile removal at New Line, a silt management arrangement was installed to control silt generated during the works.</p> <p>The works were carried out under the supervision of an ecologist. The silt curtains were adjusted as needed throughout the progression of the works. A start-stop procedure was implemented to manage sediment release, allowing for dilution and avoiding elevated NTU levels. Sheet piles were removed</p>

Reviewed methodologies in consultation with the site ecologist.	Effective silt management was established, maintained, and supervised throughout the works.

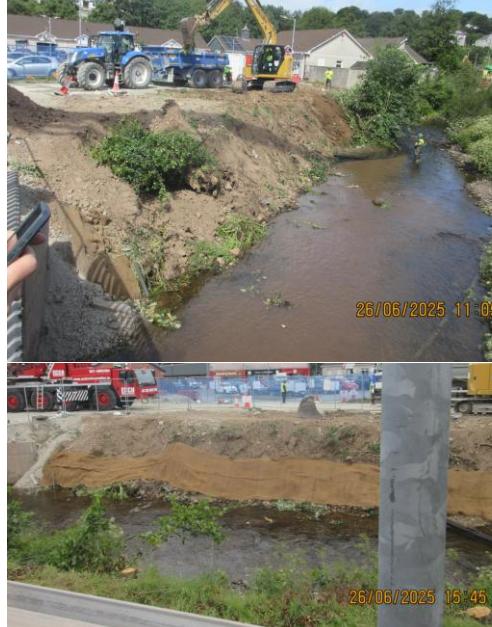
Item number	Date	Comment	Image	ECoW Action/Recommendation	Sorensens's Action response
6.37	26/06/2025	<p>Hazelwood – Works commenced to remove vegetation along the riverbank to facilitate RC wall construction. However, silt mitigation measures were inadequate, and the site ecologist was not present to supervise or implement the necessary environmental mitigations. As a result, the works were instructed to cease until these issues were addressed.</p>

<p>Liaised with ER team to coordinate a unified response to SCE.</p>	<p>Works were promptly halted upon instruction. While no major incident occurred, the approach did not reflect best practice.</p> <p>Coir mesh was installed on exposed riverbank as a temporary measure. Works recommenced next day when site ecologist was on site to supervise and implement necessary ecological mitigation measures.</p>

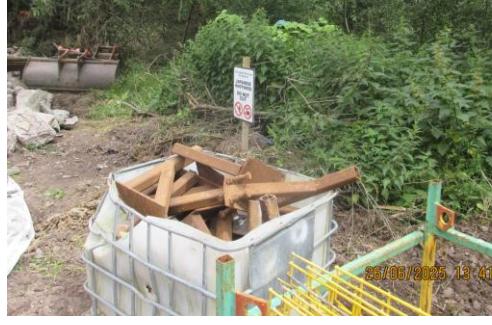
6.38	26/06/2025	<p>Area 4 – The Japanese knotweed zone was inadequately demarcated, resulting in the encroachment of material into the area. This is not in compliance with the site's biosecurity protocols.</p>

<p>Notified site engineer and site foreman of situation. Coordinated with the site ecologist.</p>	<p>The following week, the material was removed, and additional signage and barriers were installed around the known Japanese knotweed stand. While the encroachment was not best practise, no disturbance to invasive plants species occurred.</p>

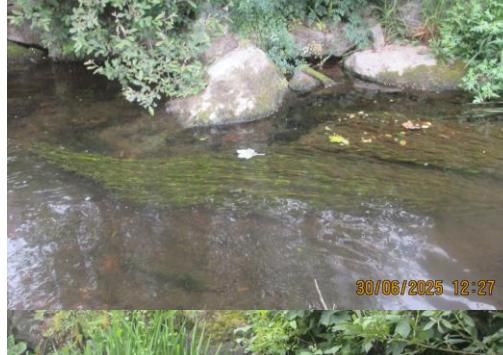
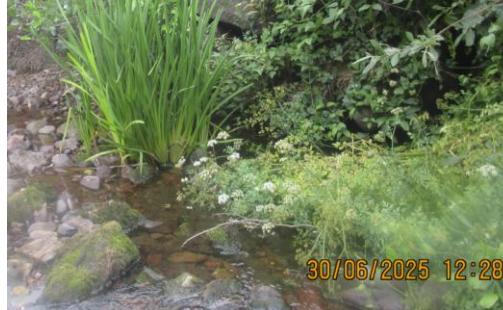
Item number	Date	Comment	Image	ECoW Action/Recommendation	Sorensens's Action response
6.39	30/06/2025	<p>Area 2 – Aquatic plants, including water crowfoot and common bur-reed, were removed and translocated in anticipation of later reinstatement. This was necessary to accommodate upcoming rock armour works. The intention is to replant these species once construction is complete. While success is not guaranteed, the measures were worthwhile, as the plants were due to be destroyed regardless.</p>

Plants were relocated.	If instructed to do, facilitate the reintroduction of translocated plants.
