A Appendix 1: Geomorphology Addendum (August 2016)

Appendix 7.2

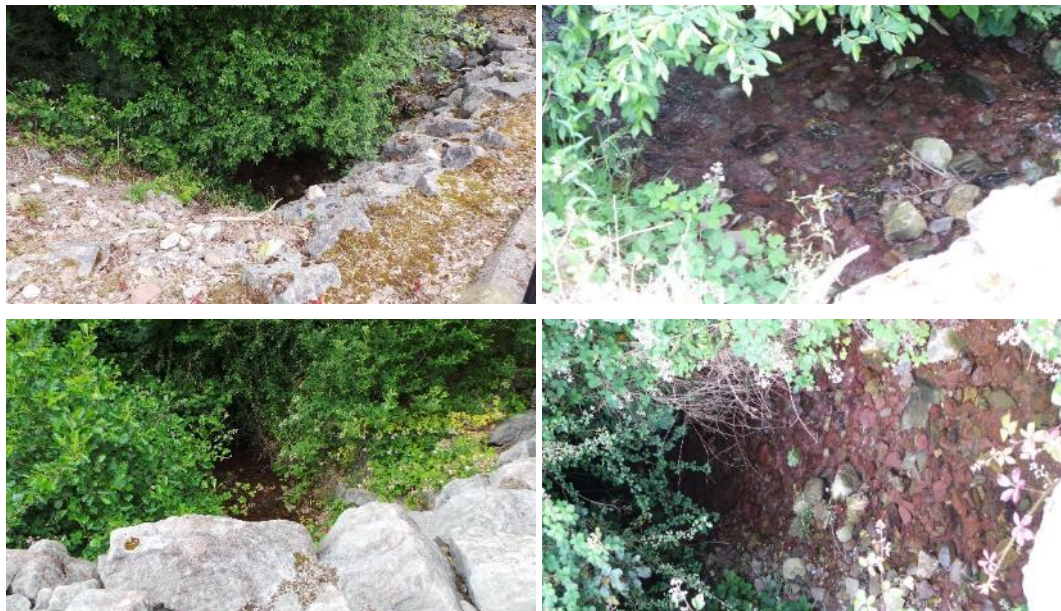
A.1 C09_B01: Replace existing twin 0.9m dia. culverts with new 1.6m by 1.2m high rect. culvert

Bleach Hill Stream at this location is entrenched (overly deep). As a result there is little floodplain connectivity except when flood water backs up behind the structure. The stream is dominated by a gravel and cobble bed which appears partially mobile (i.e. limited evidence of armouring). During flood conditions it is likely that this sediment will be mobilised and transported downstream, whilst new sediment will be delivered from upstream reaches. Due to the existing small culverts some sediment has accumulated upstream of the bridge. Whilst the existing culverts appear to be capable of allowing sediment to move downstream, it is likely that the culverts frequently become blocked with trash and debris which will hinder sediment continuity to downstream reaches.

The proposed larger culvert will improve sediment continuity through the system. The existing bed material should be maintained and matched where possible, however, any disturbance to the bed will quickly be rectified during subsequent high flow events. High flows event will be capable of transporting sediment to the structure from upstream reaches and the bed will quickly re stabilise.

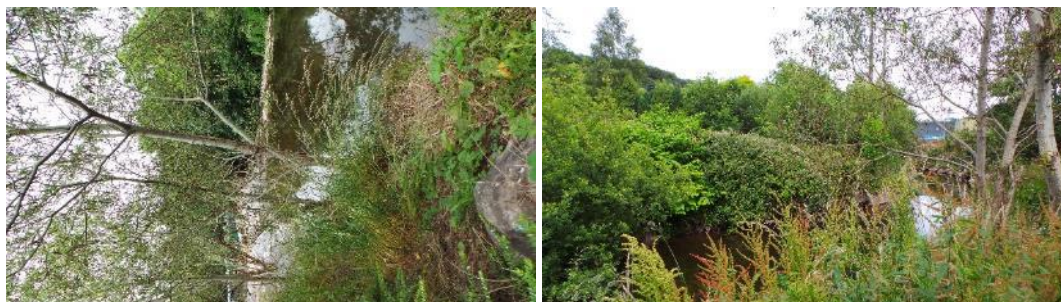
A.2 C01_L01: Concrete flood defence (Old weir at Petrol Stn North of Sallybrook)

There is an impounded reach upstream of an old weir adjacent to the petrol station. The weir is partially collapsed and appears unmaintained. The reach upstream of the weir exhibits low velocities due to the impoundment impacts. The weir has also, over time acted to trap sediment upstream which in turn has elevated the upstream channel bed level.

The main flow route over the weir is towards the left bank (outside bed) at the weir site. The steep gradient of the weir acts to elevate velocities and this has caused outer bank erosion problems.

Measures to protect the banks from erosion have been implemented using boulders and concrete which appear to be working in the short term.

In the long term there is a risk that the existing bank protection measures could fail due to their ad-hoc nature and the old weir structure could fail. If this occurs the existing river bed upstream of the weir will naturally lower as the trapped sediment is released. There may be a case for further investigation to determine the impact of the failure of this old weir structure on both the bed and bank upstream. Works are planned on the left hand bank, and this will stabilise this bank.

Any future failure would release trapped sediment downstream (which may impact structures) and cause upstream bank instability (which may impact the existing and future flood defences and erosion protection measures depending on foundation depth). This issue should be monitored and action taken if conditions deteriorate.

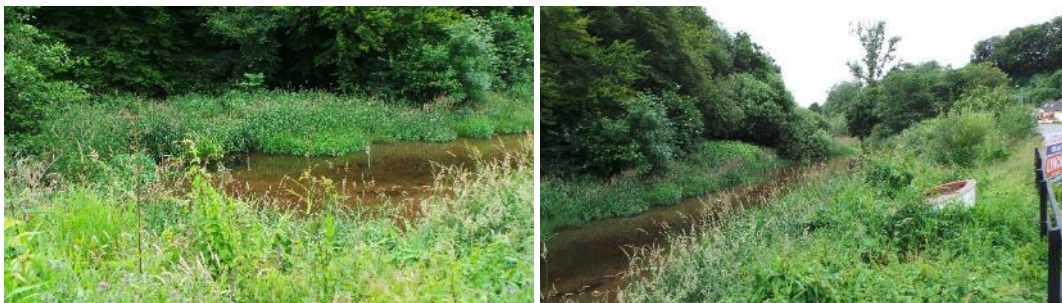
A.3 C08_700: Silted mill race

The redundant weir (noted above) feeds into the mill race shown in the photographs above. This is heavily silted due to the low velocities and limited variation in flow. Limited change is expected in this area following the construction of the new flood defences.

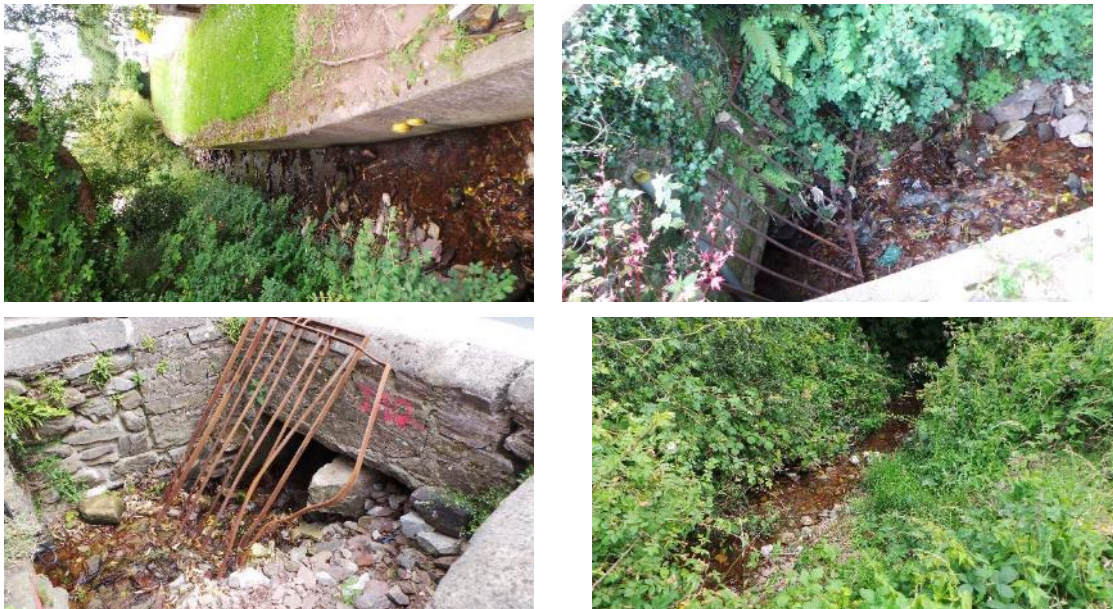
A.4 Cols na Gleann Stream: Replace existing culvert with a new 2m wide by 0.9m high rectangular culvert

The Cols na Gleann Stream is a small steep channel dominated by cobbles and gravels, which appear to readily transported downstream. The channel is very narrow and it is likely that it has been straightened historically. Such modifications act to elevate in channel velocities. Sediment has accumulated upstream of the culvert. Downstream of the culvert the channel gradient reduces and smaller gravels have been deposited (due to the reduced velocities associated with the reduced gradient). Within this area gravels dominate the channel bed and less cobbles are present. The existing culvert appears to disrupt the downstream continuity of sediment due to blockages at the small trash screen and the undersized nature of the bridge.

The proposals at this location should improve sediment continuity downstream. Care will be required to ensure large cobbles do not become trapped against the upstream trash screen (if one is to be constructed) as the high energy conditions will still be present.

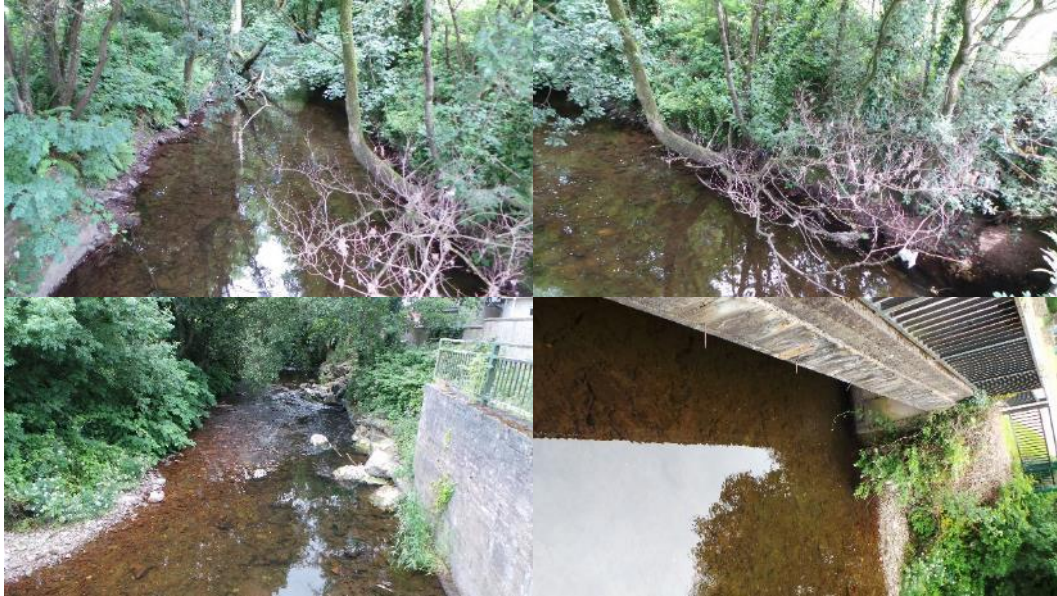
A.5 C01_C01, B02, C02: Proposed flood relief channel and culvert

The existing channel at this location is dominated by cobbles and gravels. The bed is partially armoured (evidenced by the moss over some of the larger cobbles) which suggests limited large sediment delivery. However, site conditions suggest higher velocity flows frequently transport smaller gravels through this reach. The construction of a flood relief channel is unlikely to significantly alter existing morphological conditions. However, the invert of the flood relief channel should be set at a point as to not decrease velocity as this could lead to an increase in deposition if in channel velocities are reduced significantly.

The existing bed material should be maintained and matched where possible. High flows event will be capable of transporting sediment; however several flood events may need to pass through the system before the bed restabilises.

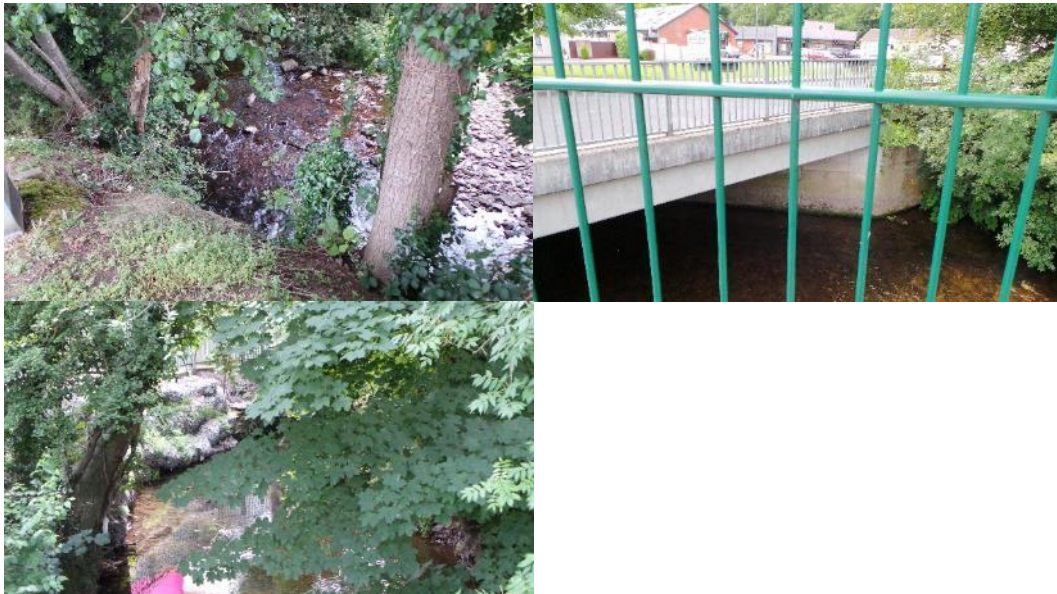
A.6 C01_B03: Replace bridge

The channel at this location is currently over wide which acts to influence morphological processes. As a consequence, depositional zones are noted within this reach. (i.e. the over wide nature of the channel may lead to lower velocities which in turn may encourage deposition). The proposed new

bridge should not change the existing morphological regime, as the channel width is remaining the same.

Upstream and downstream of this bridge some channel erosion is evident. In particular, downstream of the bridge, existing gabion basket protection has begun to fail on the outside of the bend. An alternative solution to bank protection is recommended at this location.

The existing bed material should be maintained and matched where possible. High flow events will be capable of transporting sediment, however several flood events may need to pass through the system before the bed destabilises.

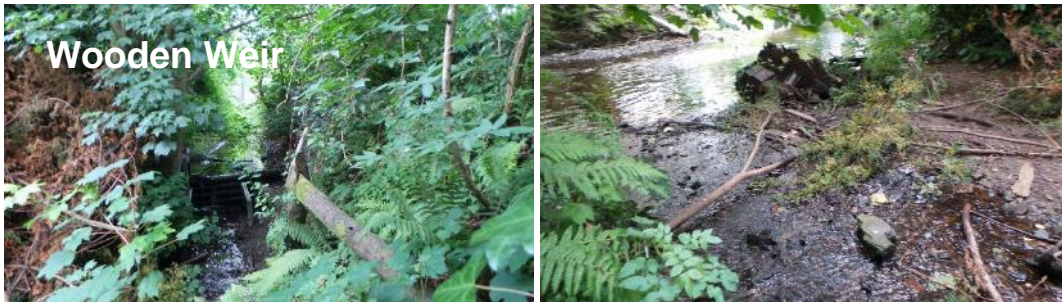
A.7 C06_B01: Replace existing twin 0.4m dia culverts with a new 1.8m wide by 0.9m high rect culvert

No safe access could be sought to see this culvert on the Springmount stream. However, extensive gravels and sands were present downstream. A wooden weir structure is also in place downstream which acts to impound water upstream for an unspecified distance. This appears to have collected a substantial amount of sediment. If this weir fails it could impact the stability of the channel upstream in the short term. Further investigation should be sought to see if this weir influences flow conditions at the upstream culvert.

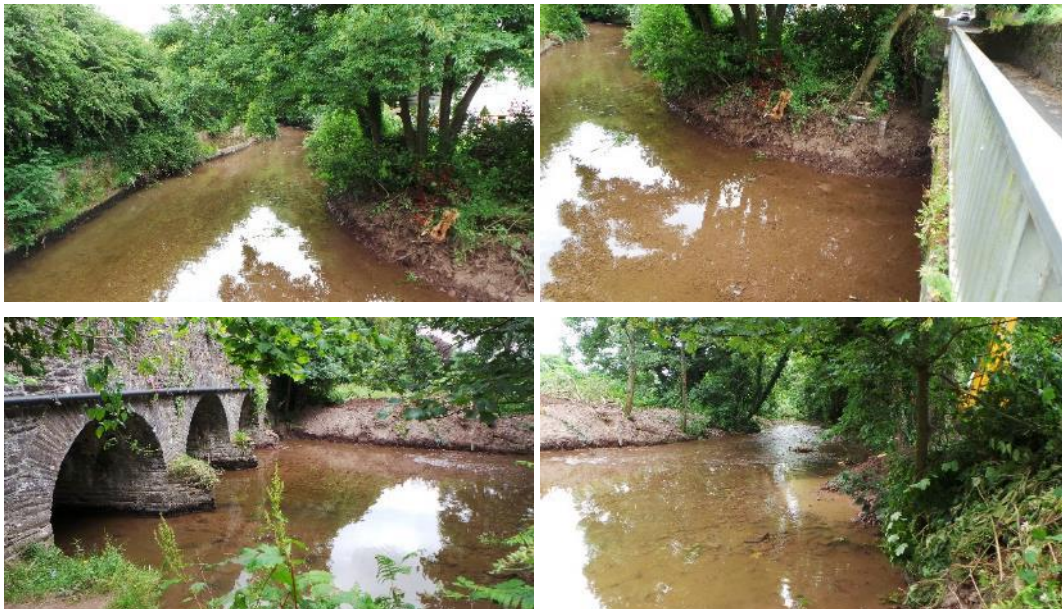
A.8 C01_C03: Bridge arch to be cleared by removing vegetation

Sediment was in the process of being removed from the channel during the site visit on the 03/07/16. Sediment was being removed several hundred metres upstream and downstream of the bridge. Some banks remain steeply profiled and could be subject to erosion until vegetation re-establishes.

Nevertheless, it is expected that the channel will quickly recover and new gravel bars will reform and the river attempts to re-establish a sediment equilibrium.

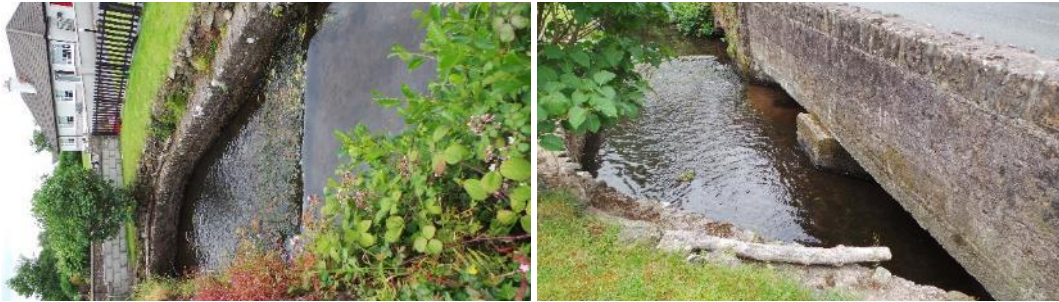
A.9 C09_C01 (channel deepening), C05_B01 (replace culverts), C05_C02 (channel widening), C05_C03 (widening)

Deepening and increasing the culvert size will increase conveyance through the bridge. There will be limited impact on the channel morphology. The weir downstream of the bridge acts to trap some sediment.

The delivery of sediment within this reach appears to be lower than over reaches. This means that the channel may take longer to recover following any in channel works.

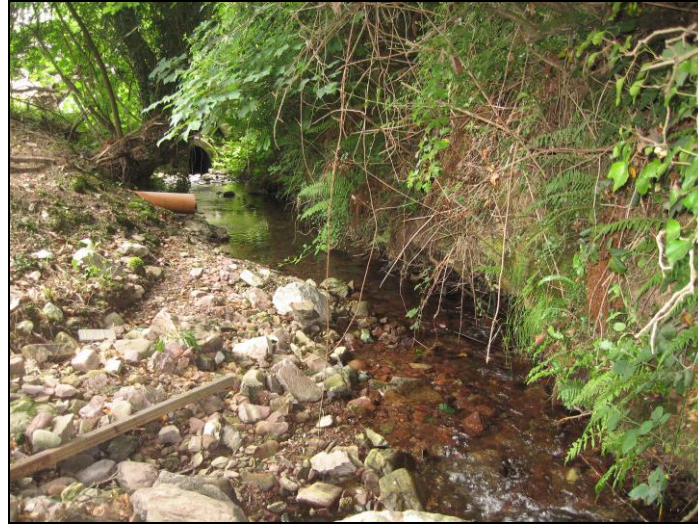
The stream runs southwest within a natural earthen channel divided into two sections by a culverted portion which runs under the access road to Cúil Chluthair. The bed of the stream is very stoney as are the sides. The western bank is defined by a near vertical slope while the eastern bank slopes steeply. Material has been dumped on the high ground at the top of the eastern bank.

The stream was generally quite clean although some metal pipes and debris were identified during the metal detector survey, all were modern in nature. There is a large concrete man-hole on the eastern bank of the stream on the southern downstream section. Otherwise this section was more overgrown than the upstream northern section. No features or finds of archaeological potential were identified.

Plate 1: Bleach Hill Stream, looking southwest

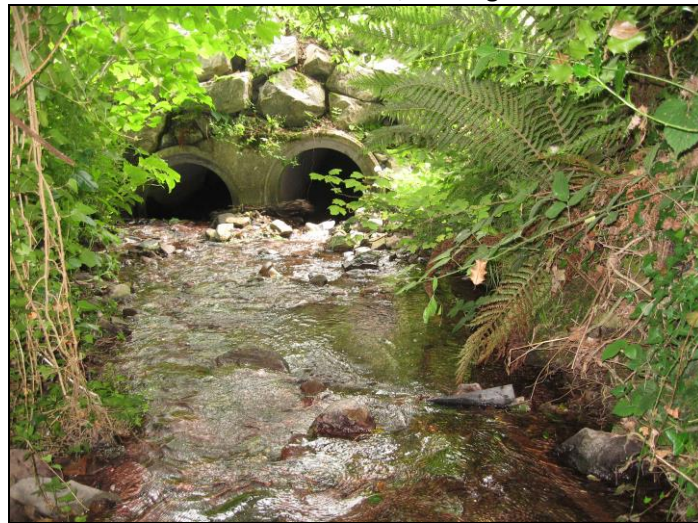
Plate 2: Bleach Hill Stream, opening of culvert under road, looking southwest

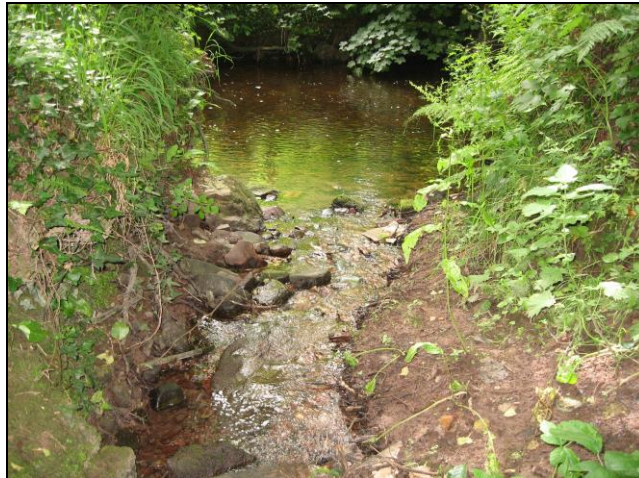
The channel bed is mostly stoney with some silty patches particularly where rubbish has built up. The rubbish is generally plastic and occasional modern metal objects were detected in the course of metal detecting. The sides are evenly cut and slope quite steeply and its appearance is consistent with a fairly recently constructed channel from the mid/late 20th century. Semi-mature trees have grown up around the channel. No features or finds of archaeological potential were identified.

Plate 3: Unnamed channel discharging into the Glashaboy River, looking west

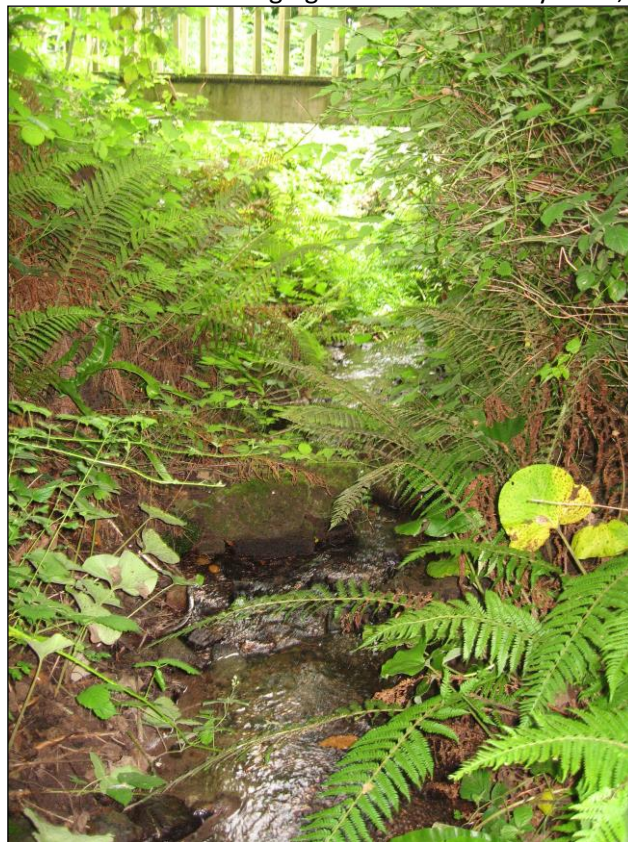
Plate 4: Unnamed channel showing bridge to Sallybrook House, looking northeast

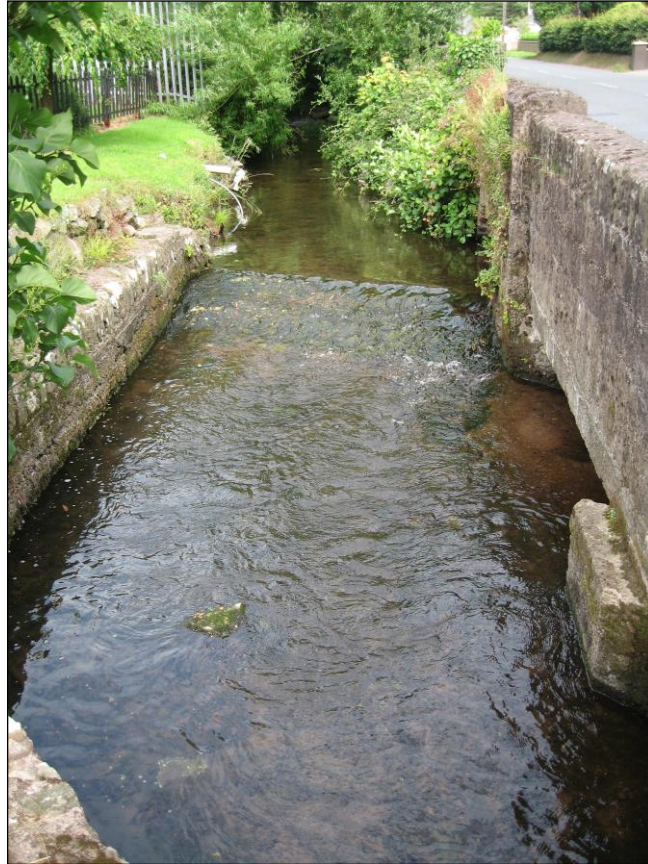
The eastern section of the stream was very clean with some modern pipes along the northern bank. The western section contained some modern rubbish including metal pipes and plastic rubbish. No archaeological features or finds were noted.

Plate 5: Glenmore Stream eastern section with garden to north (left) and Brooklodge Grove Road to south (right). Opening to the rectangular culverted channels are visible at bottom right, looking east

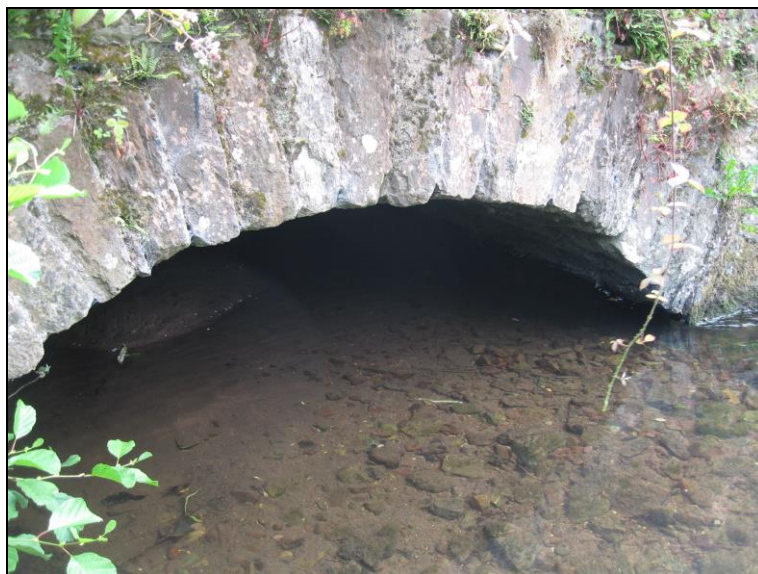
Plate 6: Eastern culvert opening, north-facing elevation

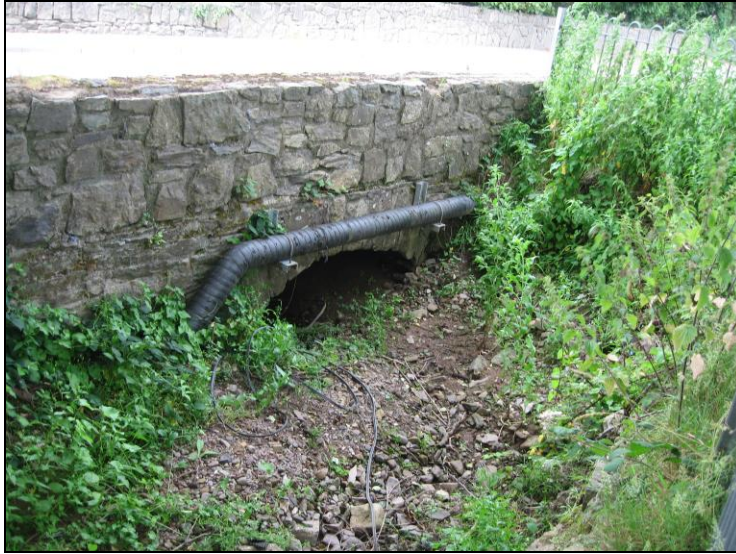
Plate 7: Eastern culvert opening, showing dry south-facing elevation

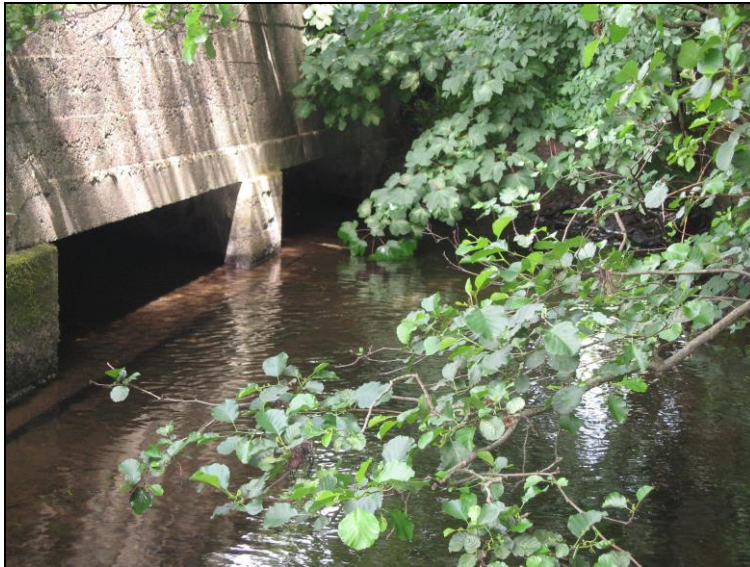
Plate 8: Western culvert openings, south-facing elevation

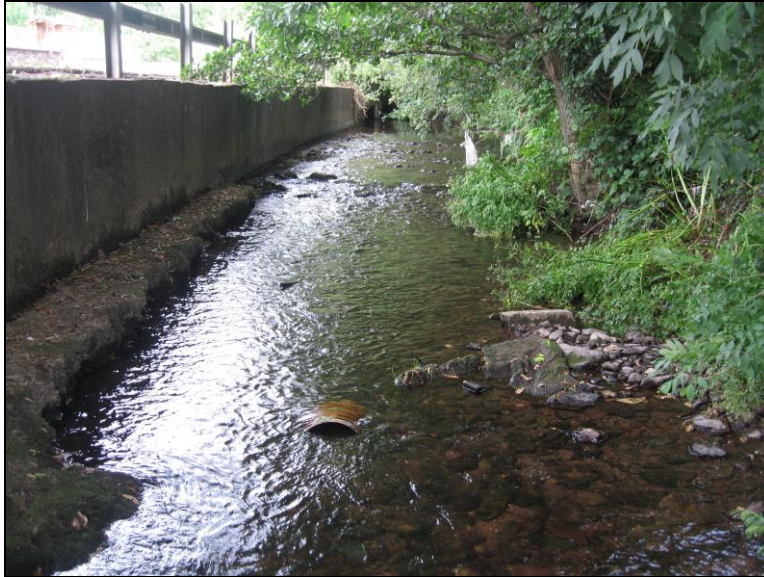
Plate 9: Glenmore Stream western section, looking east

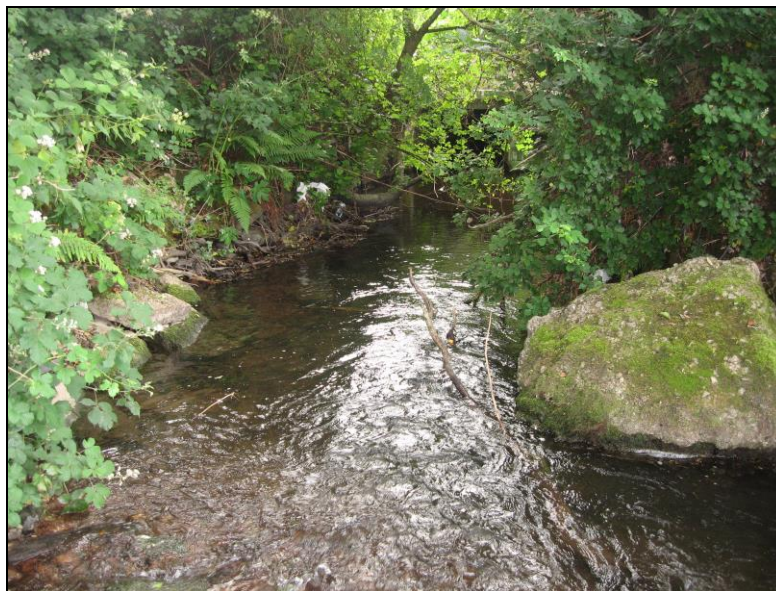
Plate 10: Glenmore Stream western section, looking west
