A Appendix 1: Geomorphology Addendum (August 2016)

Project: Glashaboy Flood Relief Scheme

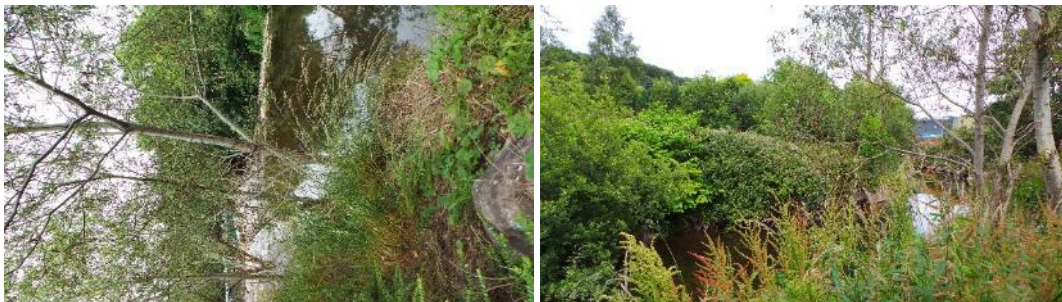
A.2 C01_L01: Concrete flood defence (Old weir at Petrol Stn North of Sallybrook)

There is an impounded reach upstream of an old weir adjacent to the petrol station. The weir is partially collapsed and appears unmaintained. The reach upstream of the weir exhibits low velocities due to the impoundment impacts. The weir has also, over time acted to trap sediment upstream which in turn has elevated the upstream channel bed level.

The main flow route over the weir is towards the left bank (outside bed) at the weir site. The steep gradient of the weir acts to elevate velocities and this has caused outer bank erosion problems.

Measures to protect the banks from erosion have been implemented using boulders and concrete which appear to be working in the short term.

In the long term there is a risk that the existing bank protection measures could fail due to their ad-hoc nature and the old weir structure could fail. If this occurs the existing river bed upstream of the weir will naturally lower as the trapped sediment is released. There may be a case for further investigation to determine the impact of the failure of this old weir structure on both the bed and bank upstream. Works are planned on the left hand bank, and this will stabilise this bank.

Any future failure would release trapped sediment downstream (which may impact structures) and cause upstream bank instability (which may impact the existing and future flood defences and erosion protection measures depending on foundation depth). This issue should be monitored and action taken if conditions deteriorate.

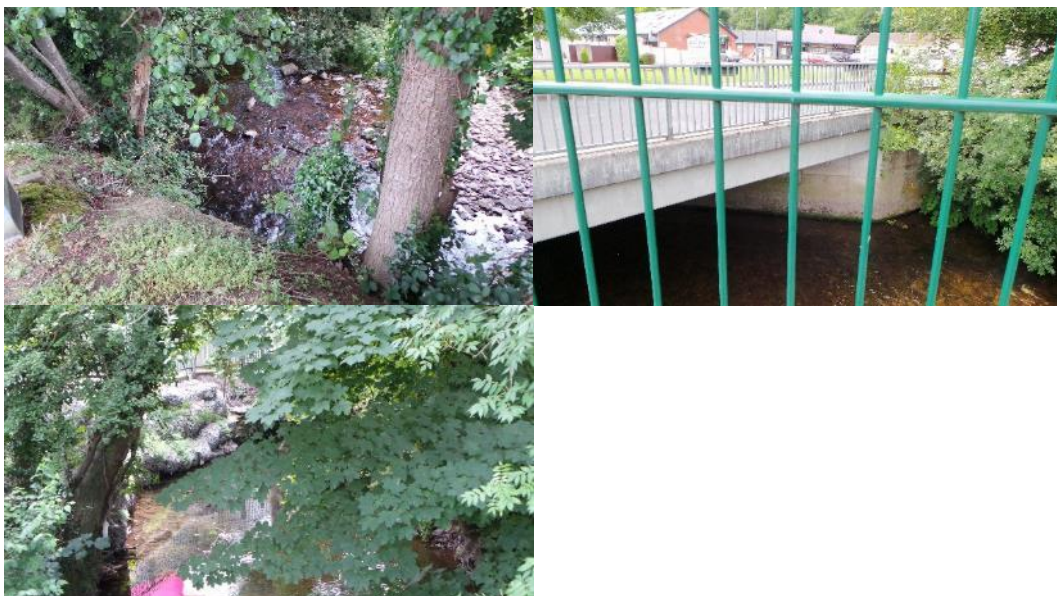
A.6 C01_B03: Replace bridge

The channel at this location is currently over wide which acts to influence morphological processes. As a consequence, depositional zones are noted within this reach. (i.e. the over wide nature of the channel may lead to lower velocities which in turn may encourage deposition). The proposed new

bridge should not change the existing morphological regime, as the channel width is remaining the same.

Upstream and downstream of this bridge some channel erosion is evident. In particular, downstream of the bridge, existing gabion basket protection has begun to fail on the outside of the bend. An alternative solution to bank protection is recommended at this location.

The existing bed material should be maintained and matched where possible. High flow events will be capable of transporting sediment, however several flood events may need to pass through the system before the bed destabilises.

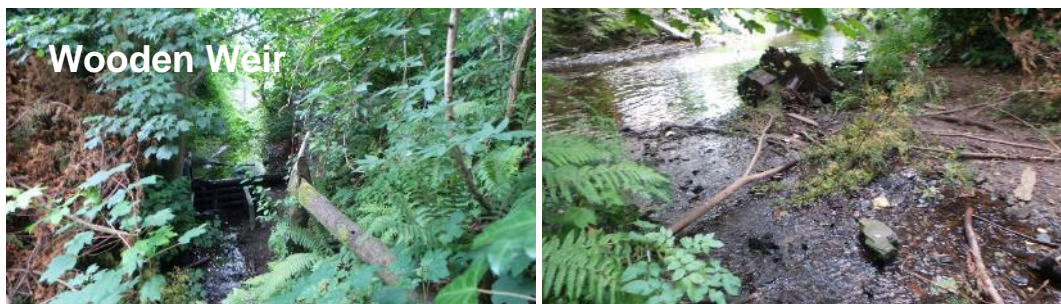
A.7 C06_B01: Replace existing twin 0.4m dia culverts with a new 1.8m wide by 0.9m high rect culvert

No safe access could be sought to see this culvert on the Springmount stream. However, extensive gravels and sands were present downstream. A wooden weir structure is also in place downstream which acts to impound water upstream for an unspecified distance. This appears to have collected a substantial amount of sediment. If this weir fails it could impact the stability of the channel upstream in the short term. Further investigation should be sought to see if this weir influences flow conditions at the upstream culvert.

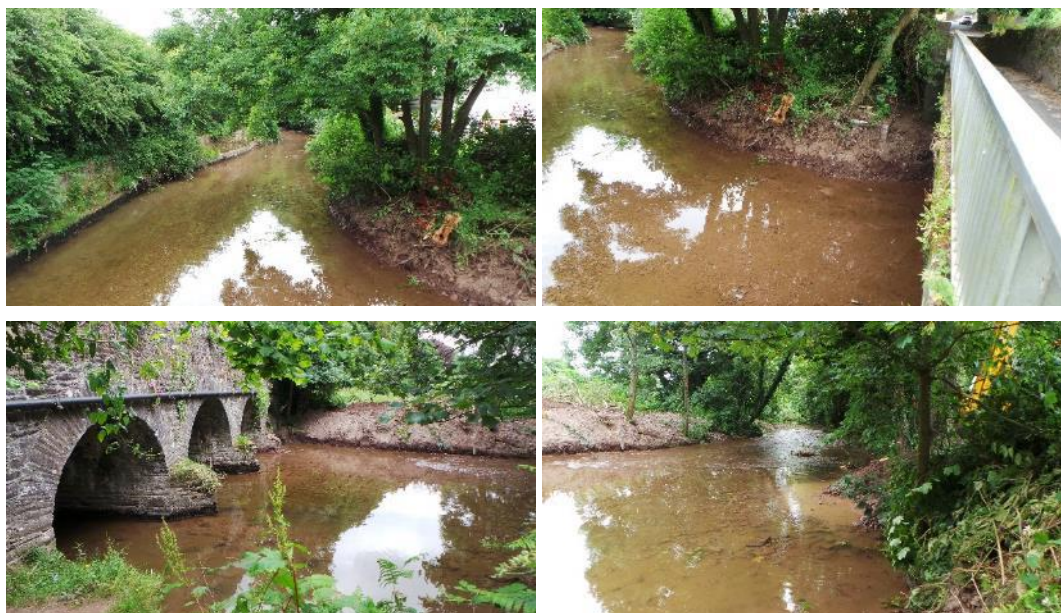
A.8 C01_C03: Bridge arch to be cleared by removing vegetation

Sediment was in the process of being removed from the channel during the site visit on the 03/07/16. Sediment was being removed several hundred metres upstream and downstream of the bridge. Some banks remain steeply profiled and could be subject to erosion until vegetation re-establishes.

Nevertheless, it is expected that the channel will quickly recover and new gravel bars will reform and the river attempts to re-establish a sediment equilibrium.

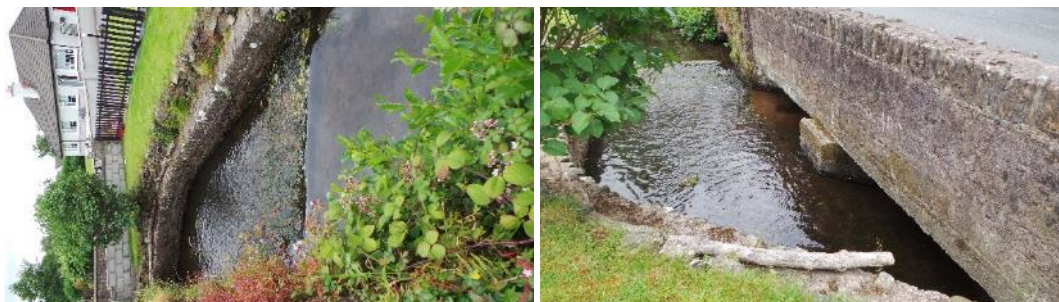
A.9 C09_C01 (channel deepening), C05_B01 (replace culverts), C05_C02 (channel widening), C05_C03 (widening)

Deepening and increasing the culvert size will increase conveyance through the bridge. There will be limited impact on the channel morphology. The weir downstream of the bridge acts to trap some sediment.

The delivery of sediment within this reach appears to be lower than over reaches. This means that the channel may take longer to recover following any in channel works.

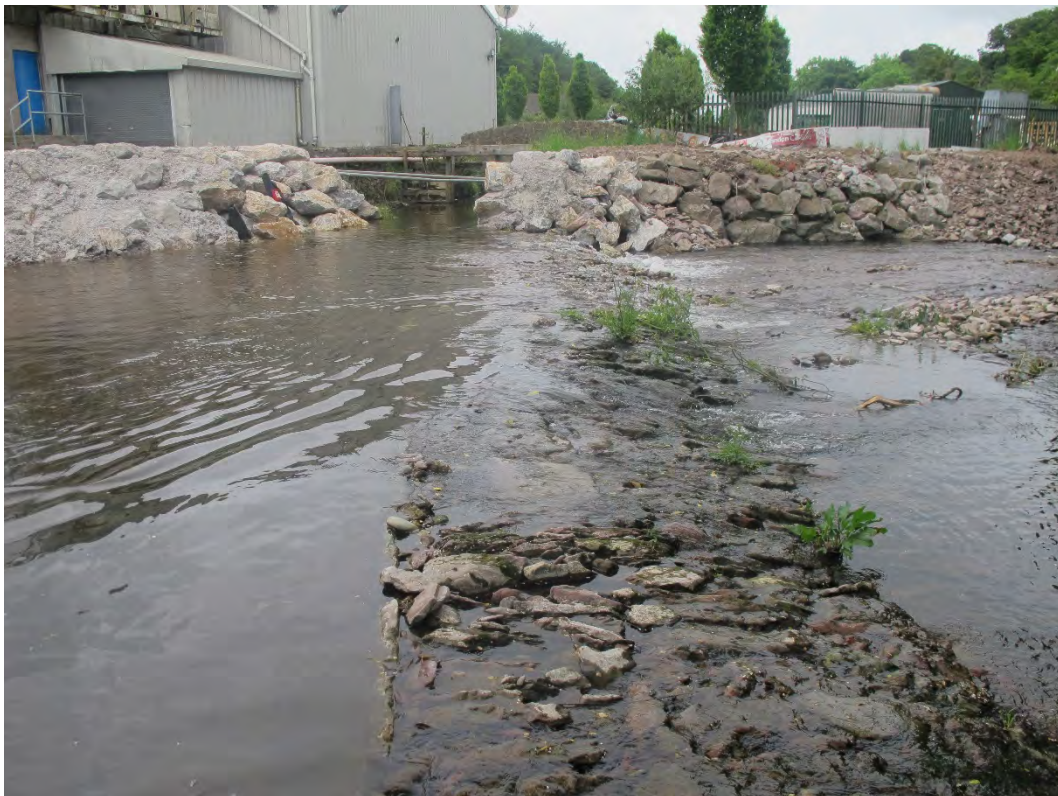
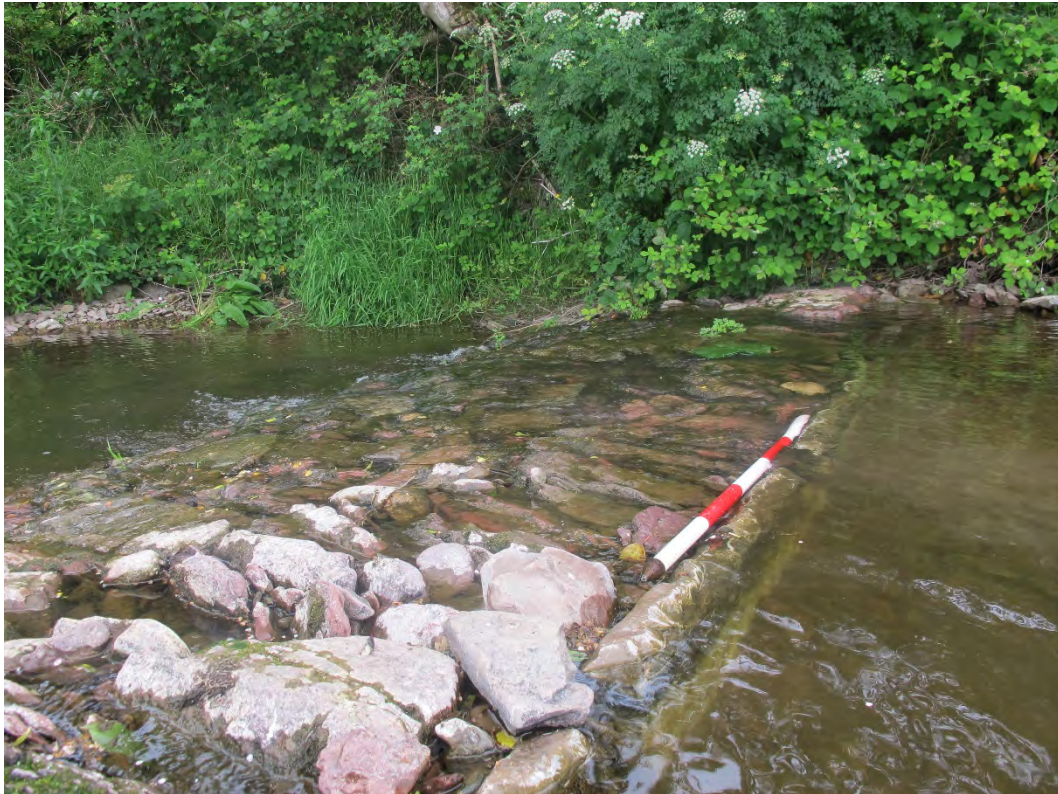
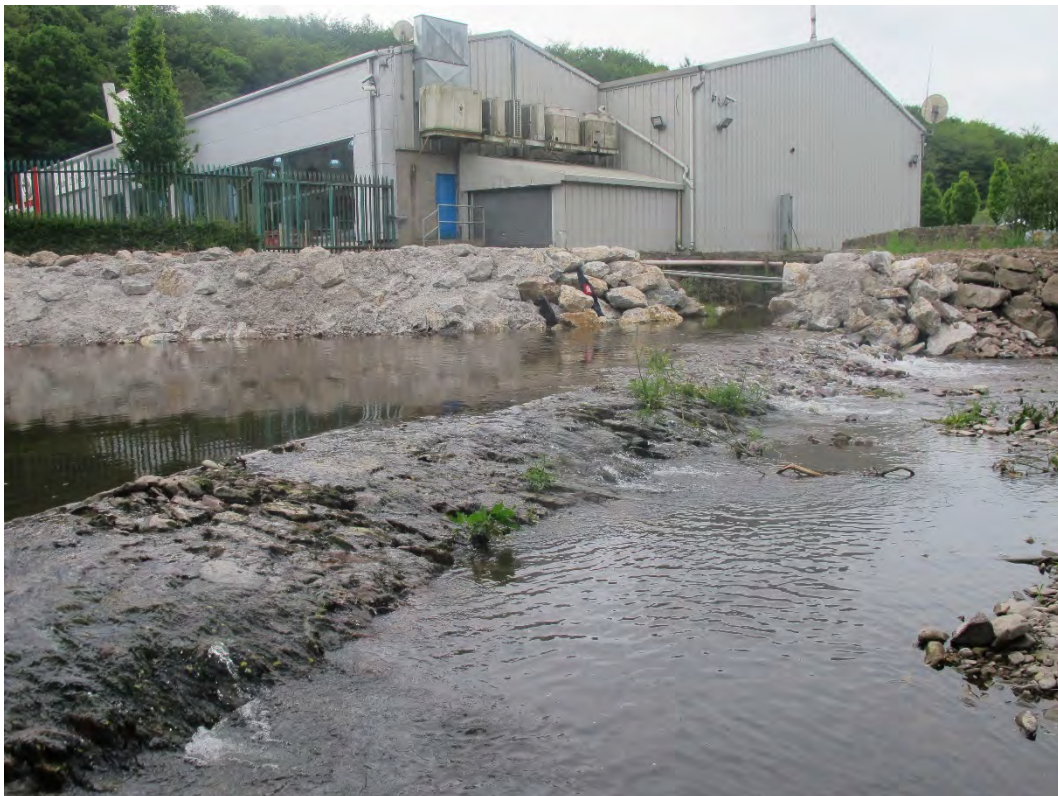
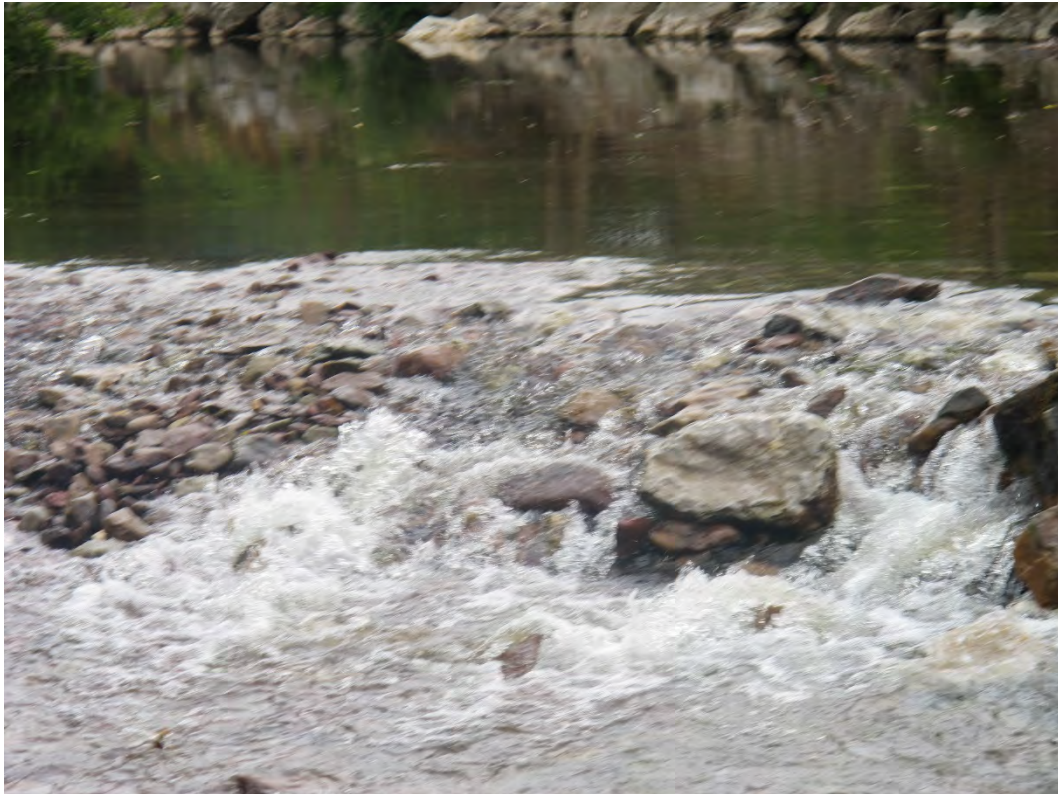
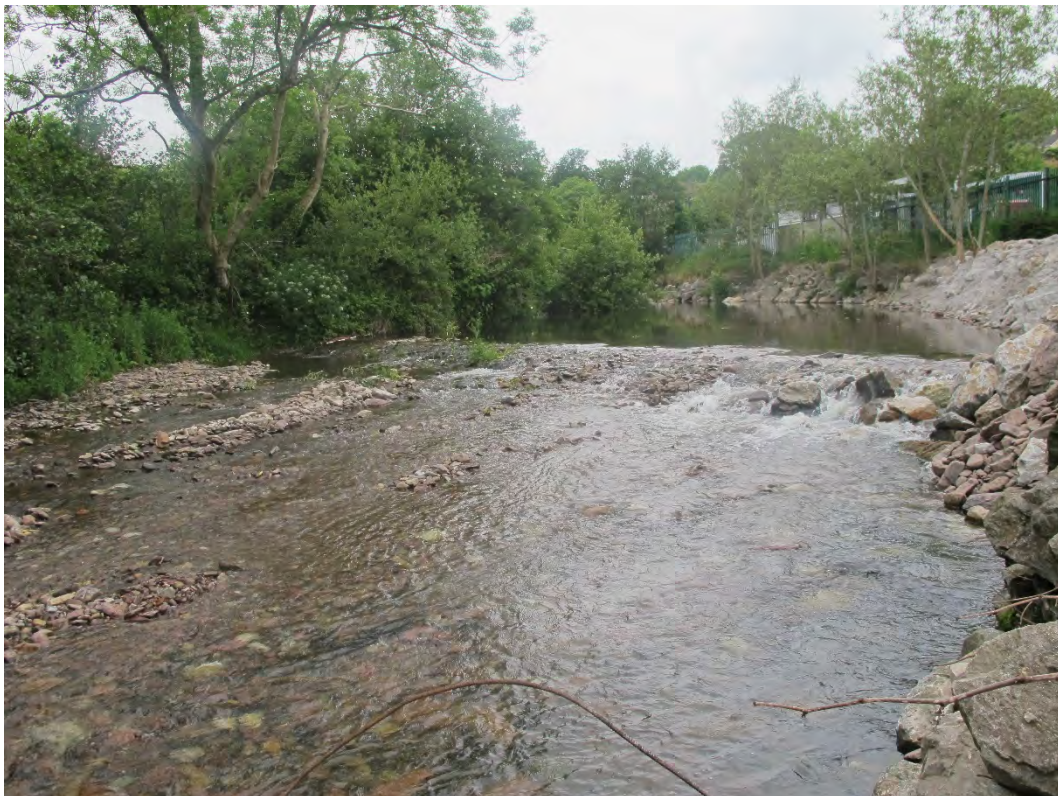
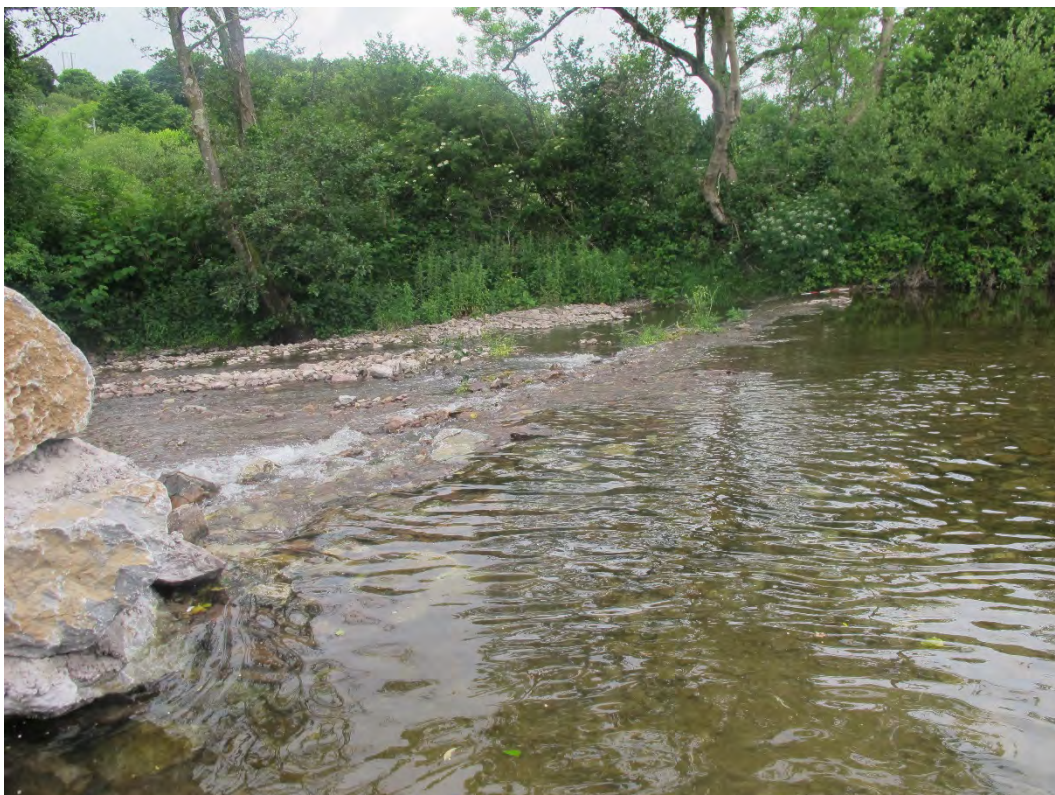
The main channel flows on the eastern side of the weir. The NW corner of the weir connects to the western riverbank which is concealed beneath dense vegetation that restricted close inspection. The SE limit of the weir abuts the sluice which serviced Pike Mill. The latter corner has been impacted by inappropriate modifications to the bank including the pouring of concrete onto the weir structure where it ties into the headrace. The consequential damage to the weir has negatively impacted the wider cultural aesthetics of the site.

Mitigation by avoidance. Where possible, impact by the construction works on the existing sluice wall should be avoided. If unavoidable the proposed construction works should be faced with sympathetic material to minimise potential negative aesthetic visual impacts.
