## **Environmental Report October 2024**

Glashaboy Flood Relief Scheme

**Document code:** FFEC-GFRS-2024-010-Rev02

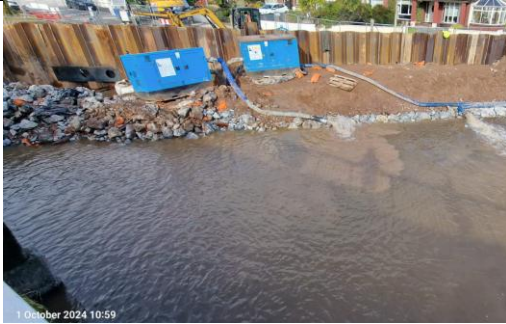
Item number	Date	Comment	Image	ECoW Action/Recommendation	Sorensens's Action response
10.1	1/10/24	Unsatisfactory pumping set up at Meadowbrook caused siltation in Glashaboy river.

Spoke to site ecologist about unacceptable siltation levels. Recommended to cease pumping until silt mitigation measures are in place before recommencing pumping.	Pumping set up was changed the following day avoiding any further siltation. Cause of event attributed to heavy rains on September 30 <sup>th</sup> that flooded works areas and nonactive drainage lines in the Meadowbrook estate prompting hasty dewatering to prevent possible water damage to nearby houses.

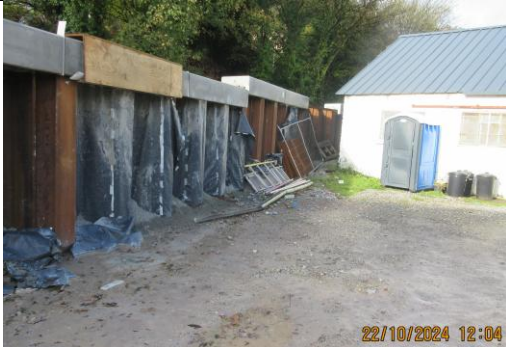
10.2	22/10/24	The area in front of the cabinet makers, which includes concrete waste, has not yet been cleaned following the shotcrete test on 09/09/2024.

Issue raised in ET019.	Cleaning completed 02/11/2024 -reported by Sorensen's site ecologist when returned from sick leave.

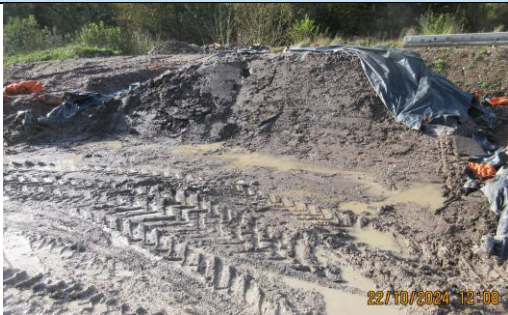
Item number	Date	Comment	Image	ECoW Action/Recommendation	Sorensens's Action response
10.3	22/10/24	The storage of contaminated material from Eurofins requires improvement, as the material is currently uncovered and the pile openly exposed on the side nearest the compound access road.

22/10/2024 12:00	Issue raised in ET019.	Bunded 01/11/24 as reported by Sorensen's site ecologist on 29/11/24. Delay in reporting by site ecologist because of absence due to illness.

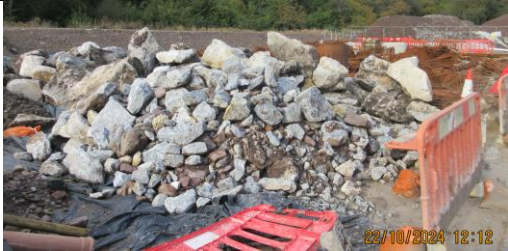
10.4	22/10/24	Boulders removed from Grandons, coated with contaminated material, to undergo repeated treatment with Bioversal HC until they are fully cleaned.

22/10/2024 12:12	Issue raised in ET019.	The planned treatment of the material for this month was not initiated, and its reuse within the project has now been cancelled. As a result, the need for material treatment will now depend on whether it is classified as hazardous or non-hazardous and its potential use elsewhere off-site.

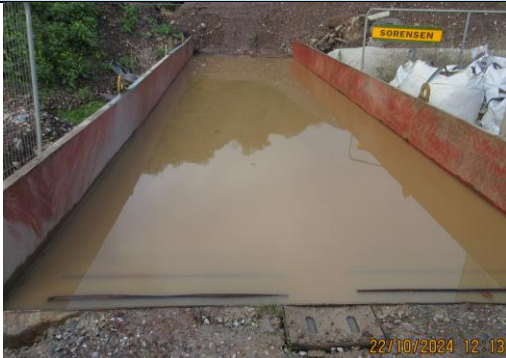
Item number	Date	Comment	Image	ECoW Action/Recommendation	Sorensens's Action response
10.5	22/10/24	The wheel wash at the holding cell noted as being full and overflowing.

Issue raised in ET019.  Construction staff should be instructed to ensure that this does not overflow.	Water levels were lowered in the following days.
10.6	22/10/24	The pumping setup, as discussed at the open excavation between the holding cell and Glashaboy, needs improvement. Enhanced use of the vegetated embankment area is recommended.

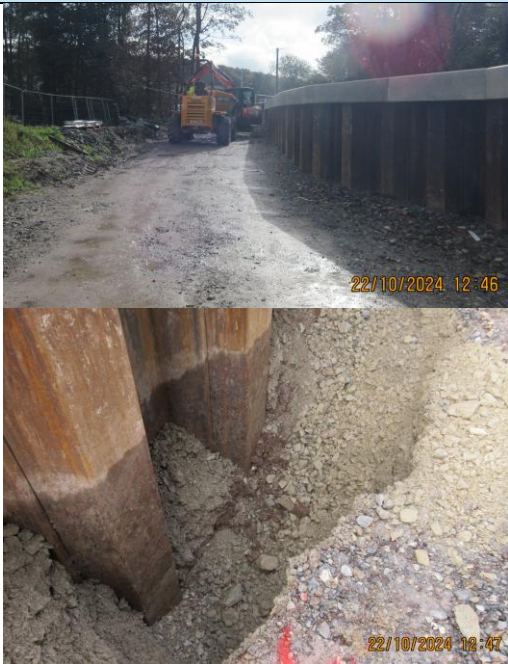
Item number	Date	Comment	Image	ECoW Action/Recommendation	Sorensens's Action response
10.7	22/10/24	<p>Trench excavations at Sallybrook House may potentially encounter contaminated water. Regular checks should be conducted during digging to identify any signs of contamination. If encountered, precautionary measures must be implemented to prevent any contamination from entering the Glashaboy River.</p> <p>No contamination of groundwater was observed during the inspection while the ET019 was in operation. Excavations were dry.</p>

Issue raised in ET019.	No ground water was encountered during excavation works.

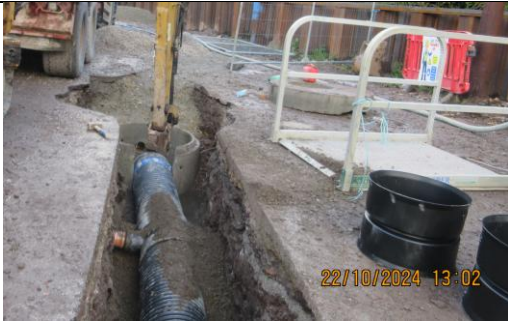
10.8	22/10/24	<p>The drainage line excavations at Grandon's were inspected for signs of contamination. The materials and water within the trenches were observed to be free of contamination during the Environmental Tour.</p>

Issue raised in ET019.	No further contamination within ground water was reported by Sorensen.

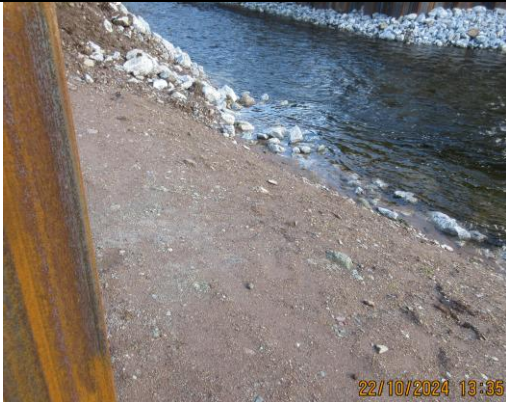
Item number	Date	Comment	Image	ECoW Action/Recommendation	Sorensens's Action response
		It was confirmed that the excavated material from this work site was removed to the Sallybrook compound for storage and subsequent testing.			
10.9	22/10/24	The newly created embankment above Riverstown Bridge to be seeded with grass seed and covered with coir mesh.

Issue raised in ET019.	Action completed 02/11/24 – reported by Sorensen's site ecologist on 29/11/24. Delay in reporting by site ecologist because of absence due to illness.
10.10	22/10/24	Waste materials piled at Meadowbrook to be cleaned up. JKW located in the immediate area.

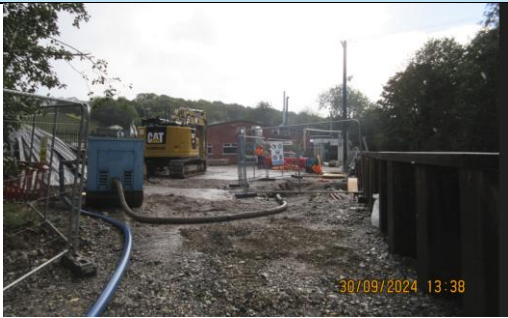
Item number	Date	Comment	Image	ECoW Action/Recommendation	Sorensens's Action response
10.11	22/10/24	The drainage line extending from Pat O'Donnell to its exit at Eurofins was discussed. It was agreed that, following the contamination of the pipe with polluted water, cleaning is required before final activation. The methods for cleaning the pipes are still under consideration.

Issue raised in ET019.	The drainage line was pressure washed by McBreen Environmental and water samples tested by BHP Laboratories. Results showed no hydrocarbons were present.

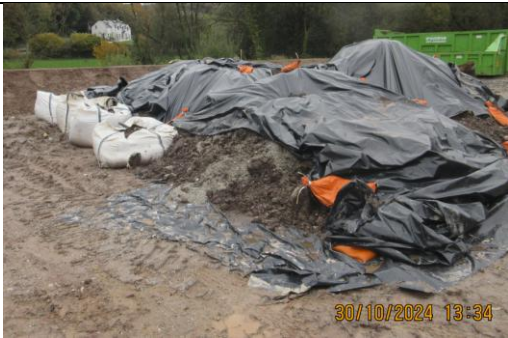
10.12	30/10/24	Material removed from Grandons during drainage works is now stored at the Sallybrook compound, where it is exposed to rain and runoff, increasing the risk of contamination spread. This risk is exacerbated by the lack of bunding or sandbagging where the material is exposed.

Requesting to securely cover exposed sections and consider adding sandbags or bunds to prevent runoff.	Completed 01/11/24 – reported by site ecologist 04/12/24. Delay in reporting by site ecologist because of absence due to illness.  Monthly environmental toolbox planned to cover storage procedures and maintenance of possible contaminated material.

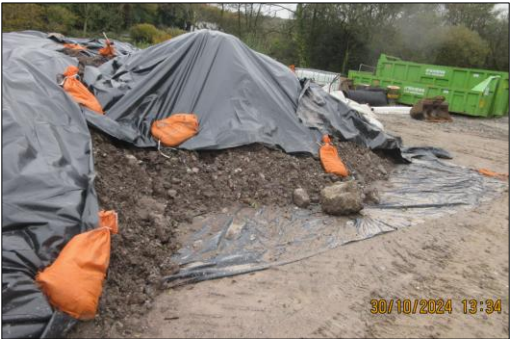
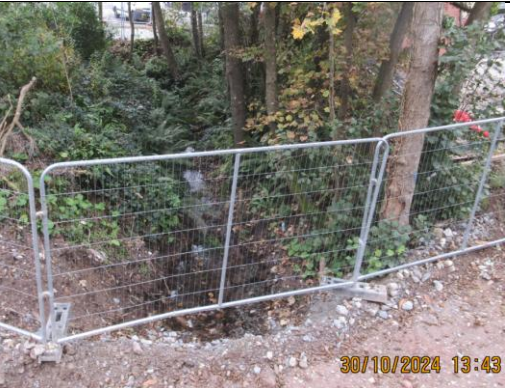
10.13	30/10/24	Sallybrook house stream/drain – when the drainage line at this location becomes active (when drainage line is cleaned following the storage of contaminated ground water last October) will this waterbody be permanently dried out?

Enquired as to the permanent plans for this stream?	Dewatering of this drain is not scheduled as part of works. Drain to continue to receive water from surface drains located in adjacent business premises.

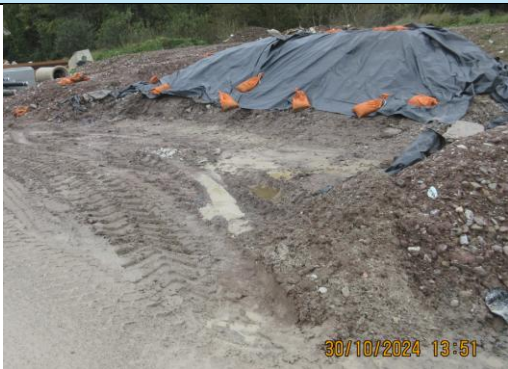
Item number	Date	Comment	Image	ECoW Action/Recommendation	Sorensens's Action response
10.14	30/10/24	Storage of Eurofins contaminated material at Sallybrook lacks bunding on the side nearest the access road.

Made enquires as to why has the contamination material not been bunded on this side?	Bunded 01/11/24 - reported by Sorensen's site ecologist on 29/11/24. Delay in reporting by site ecologist because of absence due to illness.  Monthly environmental toolbox planned to cover storage procedures and maintenance of possible contaminated material.

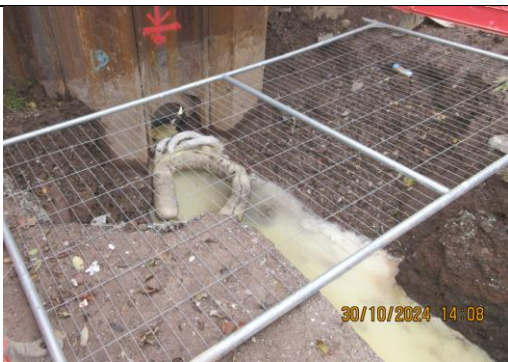
10.15	30/10/24	The drainage line at Grandons was observed to contain suspicious material settled within the open trench and at the outfall on the wet side of the sheet pile wall. The presence of an oil boom within the excavation area further suggests the possible presence of hazardous material.

Enquired about the nature and origins of this material, if it were tested and if it poses any environmental risks.	Site ecologist reported that pH reading of 7.81 taken 31st October. Unknown material present, however, the pH reading confirms that it is not cementitious in origin. The material is likely a natural limnic depositional layer such as marl in the existing ground water. Oil booms added initially as a precautionary measure.

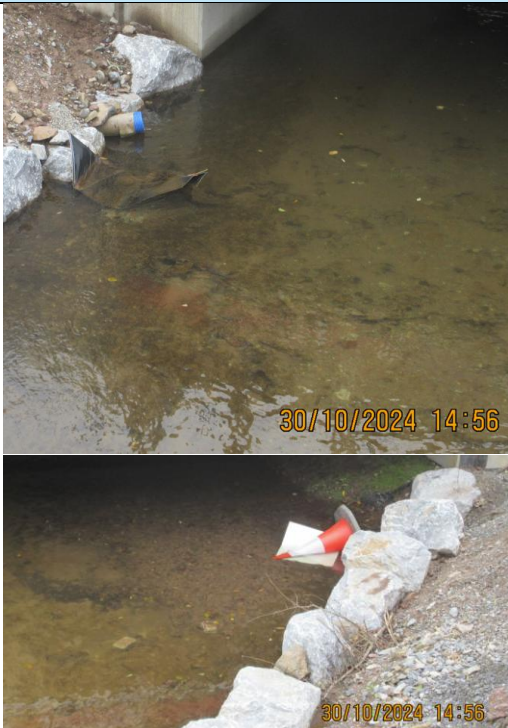
Item number	Date	Comment	Image	ECoW Action/Recommendation	Sorensens's Action response
10.17	30/10/24	Waste and traffic cone in Glenmore river a Copper Valley bridge.

Requested items be removed from watercourse asap.	Completed the 02/11/24 reported by site ecologist 04/12/2024. Delay in reporting by site ecologist because of absence due to illness.

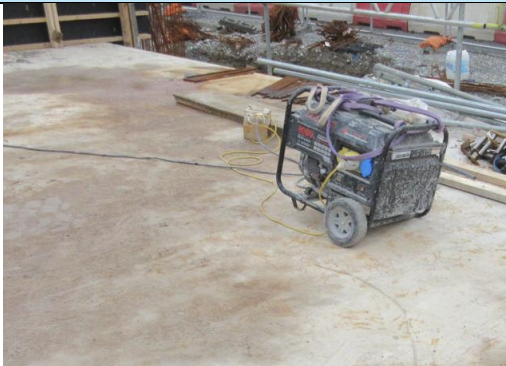
Item number	Date	Comment	Image	ECoW Action/Recommendation	Sorensens's Action response
10.18	30/10/24	The generator used for the concrete pour at CV yesterday did not have a spill mat / drip tray placed underneath. This is particularly concerning, as the generator was positioned on a hard surface above the watercourse. In the event of a leak or spill, access to the watercourse would likely have occurred.

Advised that spill trays and spill matting should be used as failsafe in situations such as this. Operatives to receive instruction as such.	Sorensen accepted slip tray should have been used in this case and this was an oversight to avoid in the future when similar work is being carried out.  Use of spill matts to be revisited in planned toolbox talk.

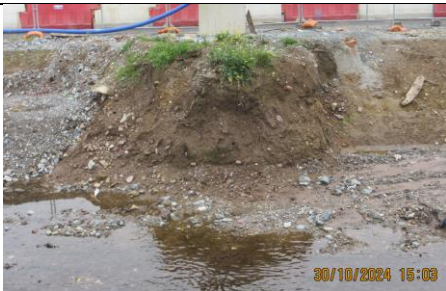
10.19	30/10/24	Eroding earth bank located between the Brooklodge and Copper Vally Vue structures.

Enquired as to the action required to prevent further erosion from this exposed bank.	Site ecologist reported on 04/12/24 that a watermain needs to be diverted prior to the riverbank being regraded locally and erosion control being installed with works scheduled for Dec. 2024. Delay in reporting by site ecologist because of absence due to illness.

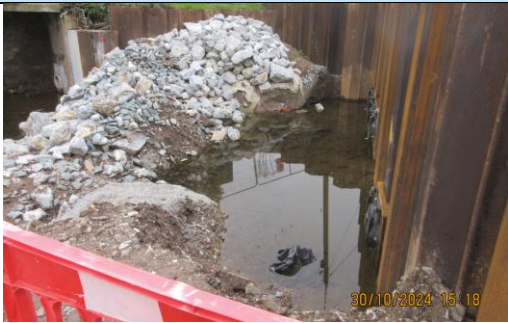
Item number	Date	Comment	Image	ECoW Action/Recommendation	Sorensens's Action response
10.20	30/10/24	Meadowbrook, located just upstream from Riverstown Bridge, has trapped water that could potentially serve as a point where fish might become stranded during a flood event.

Advised that action was required to avoid a possible fish trapping situation occurring.	Site ecologist reported on 04/12/24 that a channel was dug through the stone bund 29/11/24 to allow fish passage. Channel was dug from the dry with excavator bucket not entering the main channel.

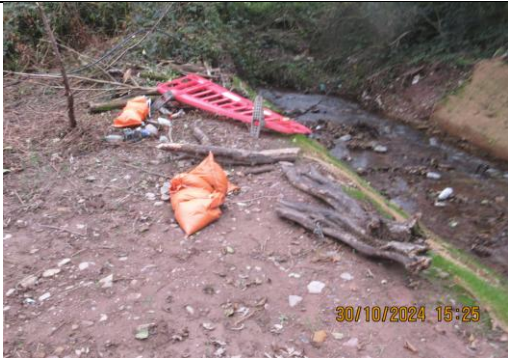
10.21	30/10/24	Housekeeping along Cois na Gleann at rear of compound.

Requested clean up.	The waste was removed and was completed 02/11/24.
10.22	30/10/24	Coir mesh slippage at Cosi na Gleann stream rear of compound. Vegetation has not yet become established.
