## Monthly Site Environmental Audit

## Glanmire Flood Relief Scheme

04/03/24 To 27/03/24

## ENVIRONMENTAL AUDIT

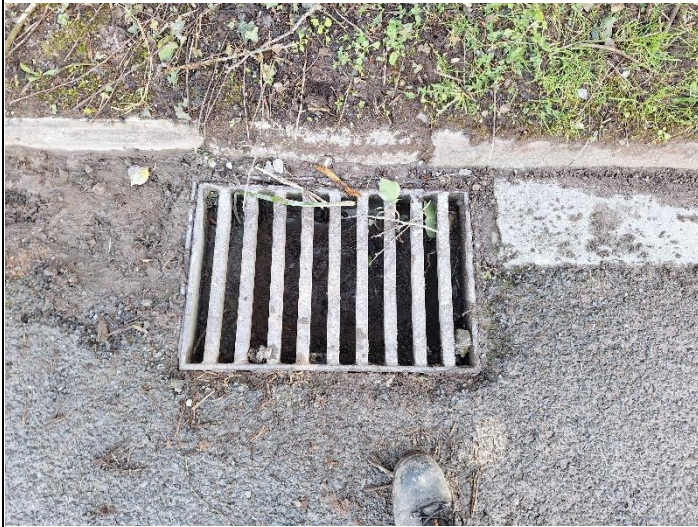
**Photo 1**

- Gullies cleaned out in Meadowbrook after silt control issues, raised in Env Tour 007. (Photo 1)
- Trees at Circus Field Compound and Copper Valley Vue surveyed for nesting birds prior to felling/delimbing.

Gully cleaned out in Meadowbrook.

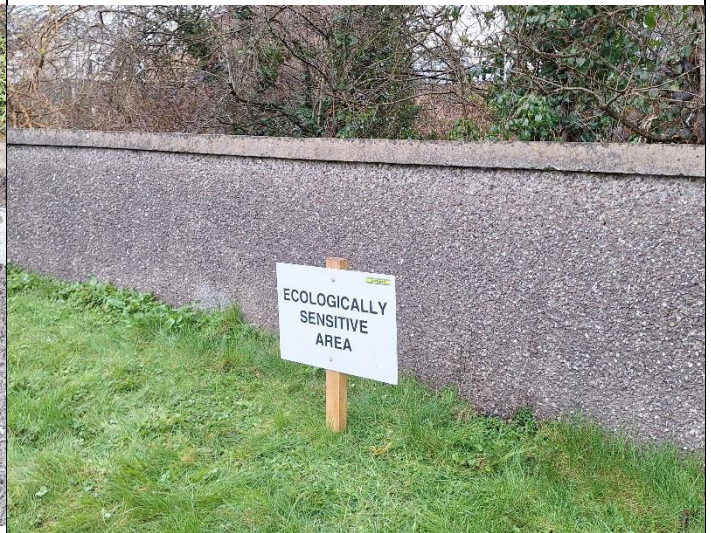
**Photo 2**

- Erosion control, coir-mesh, placed at Cuil Chluthair.
- Signage implemented for Otter holts N2, N6C, N6D and couch C2. (Photo 2)
- Kingfisher monitoring underway – no sightings (Meadowbrook)

Signage erected for otter holts N6C&amp;D

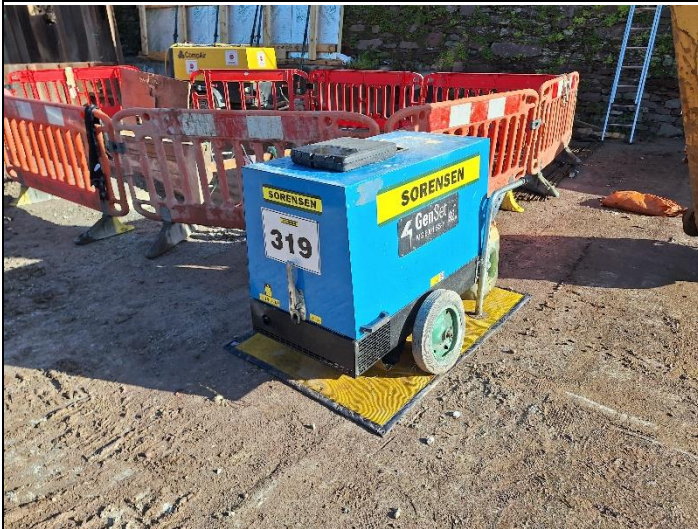
**Photo 3**

- Good use of absorbent pads under generators observed. (Photo 3)
- High winds exposed a section of the contaminated material from POD Yard, stockpiled in Sallybrook, this was recovered the following morning (Photo 4)

Oil absorbent pad in use under generator.

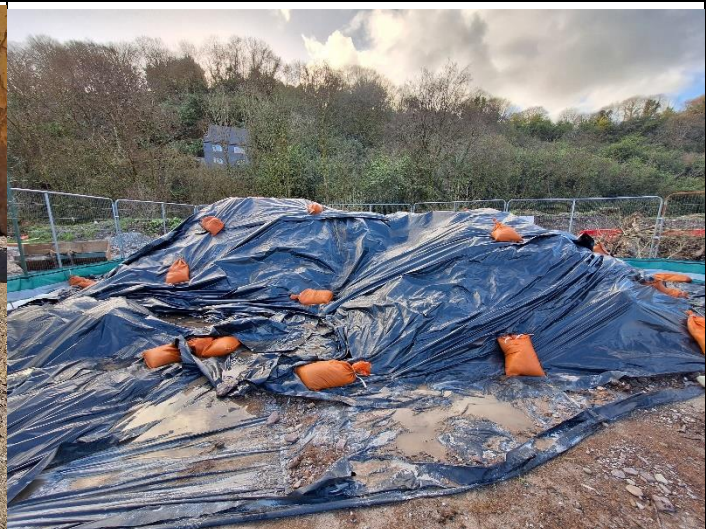
**Photo 4**

Contaminated material recovered after strong winds.

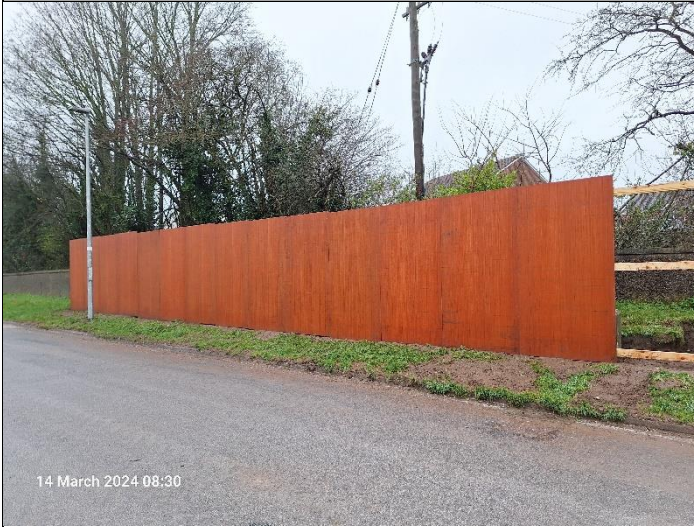
**ENVIRONMENTAL AUDIT**
**Photo 5**

- Environmental Tour 008 07/03/24 – Key findings:
  - Timber hoarding to be installed @ Meadowbrook as per otter derogation license – installation commenced 07/03/24 (ongoing – Photo 5).

Timber hoarding being erected for otter holts N6C and N6D.

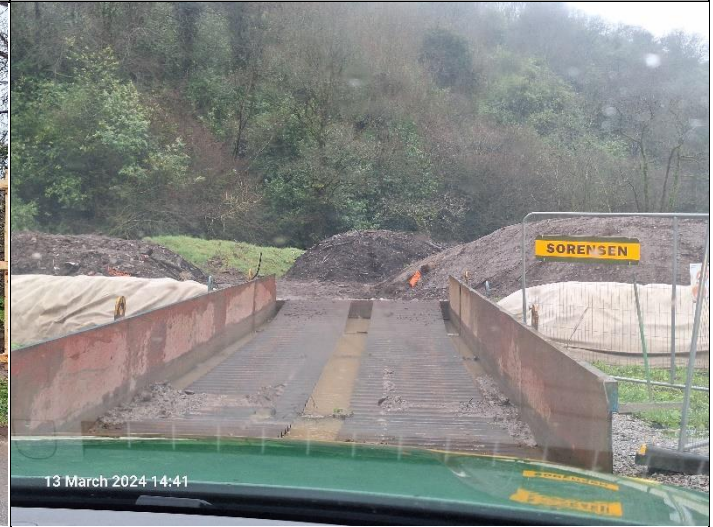
**Photo 6**

- Erosion control required at Copper Valley – installed 12/03/24.
  - Lower water level of J. knotweed wheel wash – completed 12/03/24. (Photo 6)
  - Good use of absorbent matting under generators observed.

Water level lowered in the J. knotweed wheel wash.

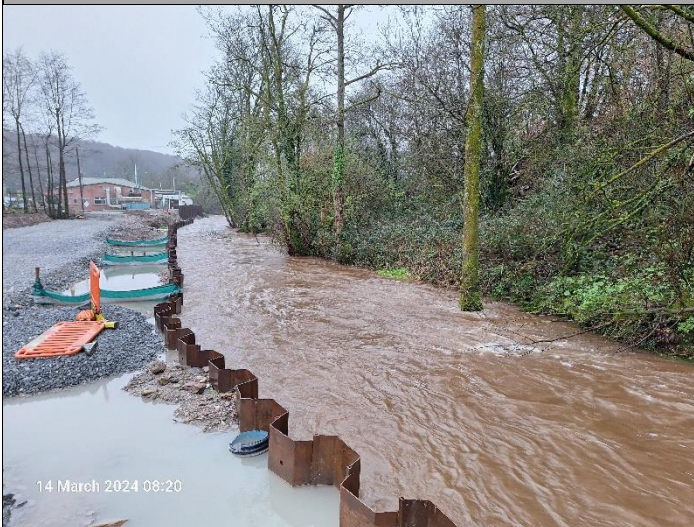
**Photo 7**

- River levels monitored during status orange weather event rain/wind. Removal of silt mitigation equipment from Sallybrook attenuation area not required – low risk of river overtopping temporary sheet piles. Attenuation area observed to collect “milky” waters from Yard drainage lines. (Photo 7)
- Good use of absorbent pads under generators observed. (Photo 8)
- Kingfisher monitoring underway – no sightings (Meadowbrook)

River level monitored during heavy rainfall event – low risk of overtopping observed.

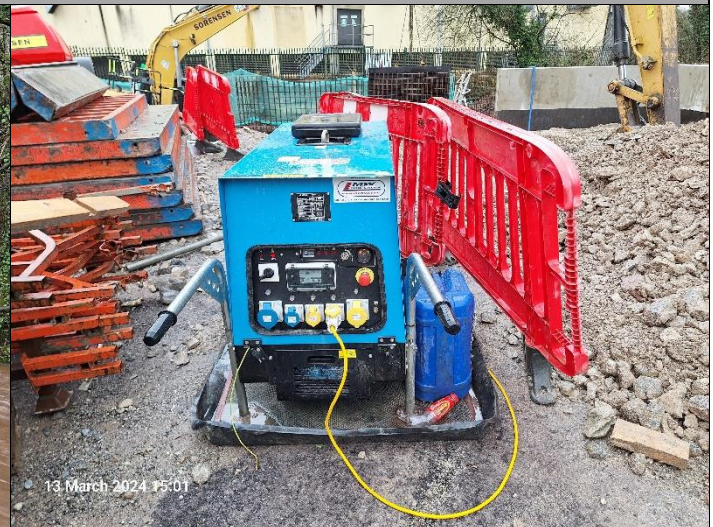
**Photo 8**

Drip tray in use under generator.

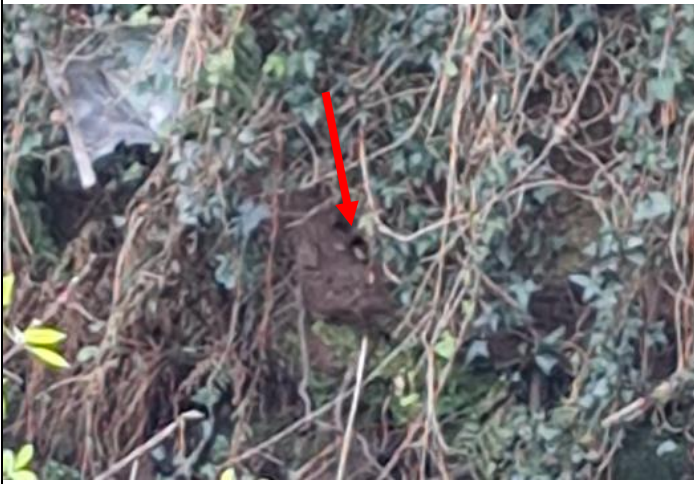
Photo 9

- Good use of absorbent pads under generators observed.
- Permit to pump water issued to crew at Copper Valley – 6” pump – foul line works. Active.
- Environmental Tour 009 21/03/24 – Key findings:
  - Housekeeping needs improvement at Copper Valley works.
  - Continue to assess Copper Valley pumped water quality and adjust discharge point as required.
- Kingfisher monitoring underway at Meadowbrook – no sightings. A Eurasian wren, *Troglodytes troglodytes*, was observed entering a burrow in the bank multiple times on 21/03/24. (Photo 9)

Wren standing in the entrance to a potential kingfisher burrow.

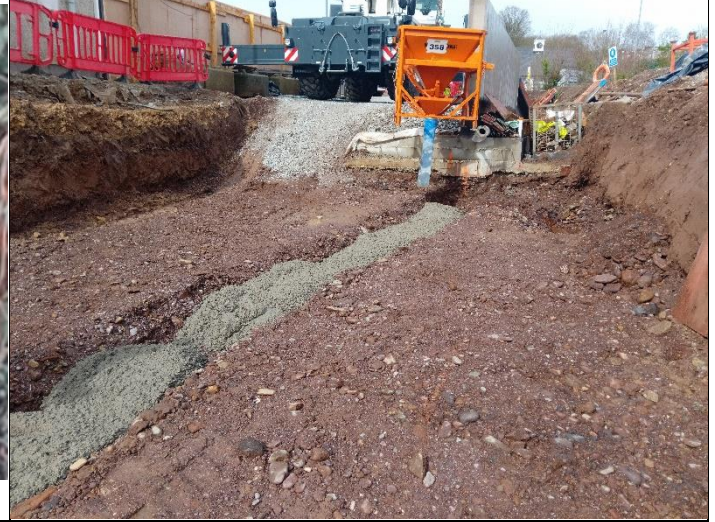
Photo 10

Concrete pour at Funeral Home site.

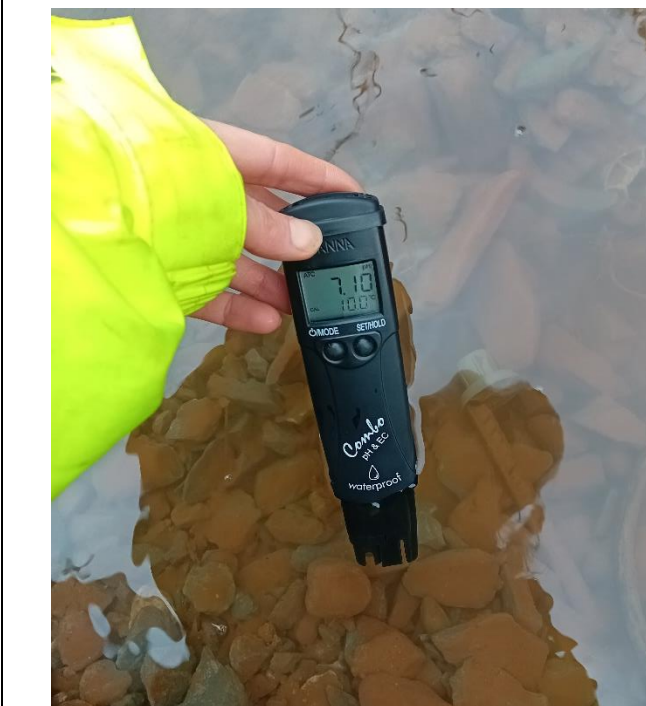
Photo 11

- River turbidity baseline calculated.
- Turbidity/TSS correlation equation updated to account for more recent sample results.
- Concrete poured at Funeral Home site – pumped groundwater monitored during and after pour; pH remained neutral – no impact from concrete on groundwater. (Photo 10 & 11)
- Kingfisher monitoring underway – no sightings (Meadowbrook)
- Permit to pump issued to crew at Meadowbrook – 4” pump – drainage works. Silt dewatering bag was fitted but failed to contain silt, a second green silt sock was immediately inserted inside the dewatering bag achieving sufficient silt control. Active. (Photo 12)
- Pump discharge point changed to an open and vegetated area at Copper Valley – waters running clean.
- Kingfisher monitoring underway – no sightings (Meadowbrook).

pH testing of potentially receiving waters during the concrete pour at Funeral Home site – no adverse impact observed to groundwater during pumping activity.

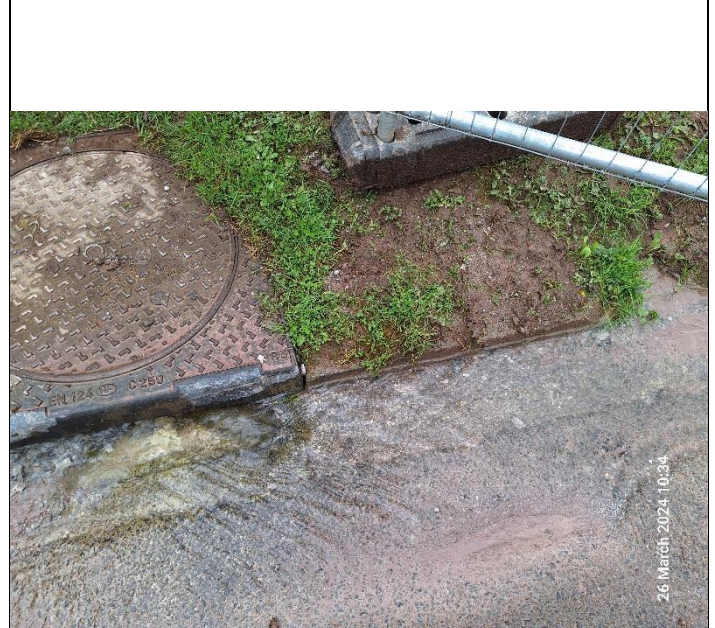
Photo 12

Water running clean at Meadowbrook after initial issues with silt mitigation rectified by adding a silt sock inside the silt dewatering bag.
