## Environmental Report March 2025

### Glashaboy Flood Relief Scheme

**Document code:** FFEC-GFRS-2025-003

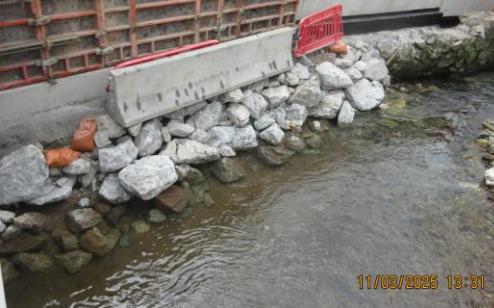
Item number	Date	Comment	Image	ECoW Action/Recommendation	Sorensens's Action response
3.1	01/03/2025	Environmental Incident at New line on March 1 <sup>st</sup> - To facilitate tie-in of RC wall with bridge, boulder material was added to margins of Glanmore river channel at New Line.

Issue Environmental Incident report (EIR).	An Environmental Incident Report was issued by SCE. The report was subsequently reviewed and returned to SCE for additional commentary.

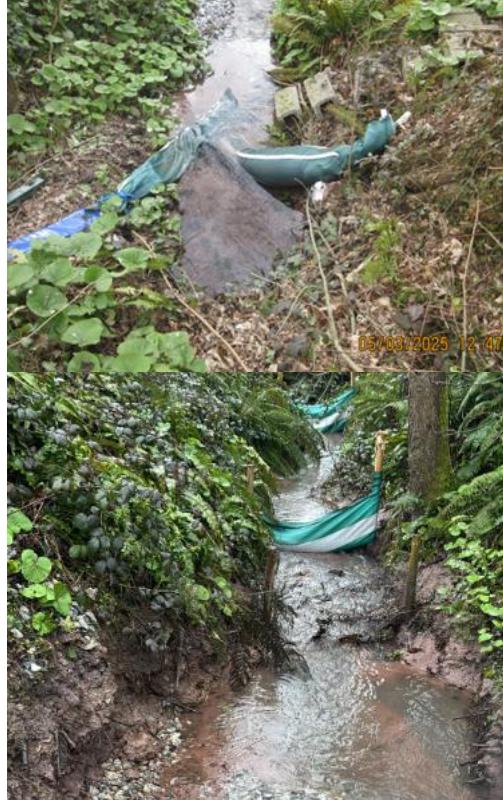
Item number	Date	Comment	Image	ECoW Action/Recommendation	Sorensens's Action response
3.2	5/3/2025	The dewatering activities at the Sallybrook Pump Station were inspected and found to be adequate. Silt mitigation measures in place included a silt sock, gravel check dam, and multiple silt screens.

Throughout the pumping operations at this location, ongoing communication was maintained with the site ecologist.	Daily inspections were carried out, and NTU readings were recorded and provided to the Environmental Clerk of Works (ECoW). Adjustments were made as necessary, and overall, the situation was managed effectively—aside from an unfortunate incident that occurred on the final day of pumping at this location.

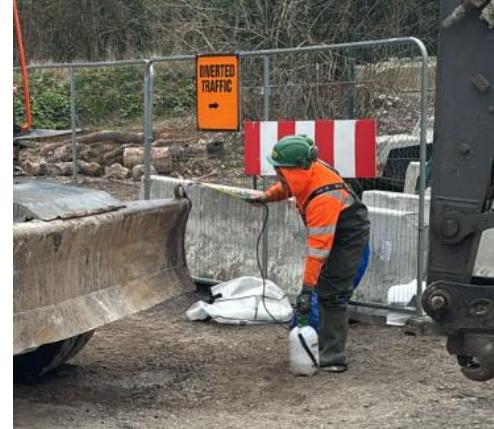
Item number	Date	Comment	Image	ECoW Action/Recommendation	Sorensens's Action response
3.3	5/3/2025	A hydraulic hose burst on the 'Rubber Duck' at Sallybrook.

Follow emergency plan. Use spill kits. Treat with Bioversal HC.	Spill kit and Bioversal HC deployed by SCE's Environmental Unit promptly and effectively.
3.4	5/3/2025	Additional works were carried out to block the entrance of the pipework at Newline. The entrance had previously been exposed due to natural erosion from the Newline River. These pipes pose a threat to fish if left exposed as they are not open non the other side.

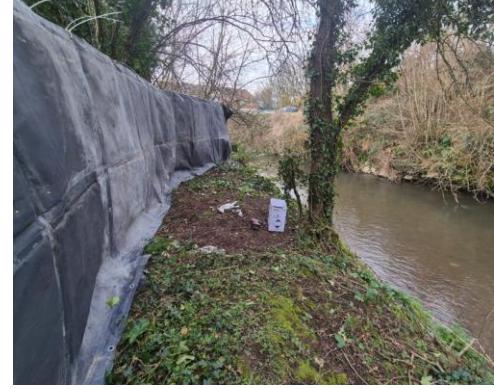
Item number	Date	Comment	Image	ECoW Action/Recommendation	Sorensens's Action response
3.5	5/3/2025	In line with conditions of the otter derogation license issued by the NPWS, a sound barrier was installed at Meadowbrook. Additional cameras were installed at the two potential holts for ongoing monitoring while works continue at this location.

Reviewed derogation licenses and discussed implementation details with site ecologist.	All mitigation measures were strictly adhered to. An additional potential holt was identified by the site ecologist, who informed the NPWS. As a result, an addendum was added to the licence.

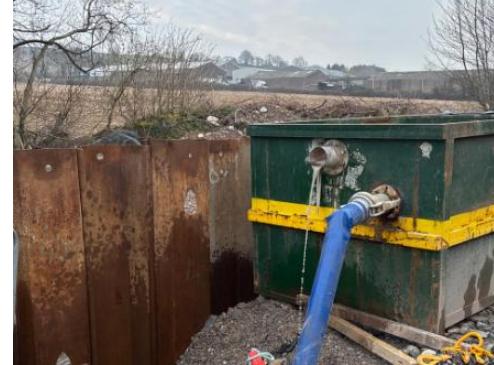
3.6	10/3/2025	NewLine: Settlement Tank overflowing this morning.

The water currently appears to be clean; however, it is advisable to route it through the existing filtration system as a precautionary measure, in the event of any fluctuations in sediment levels.	An additional hose and filtration bag were promptly installed as a precautionary measure, despite the water quality appearing to be relatively clear at the time.

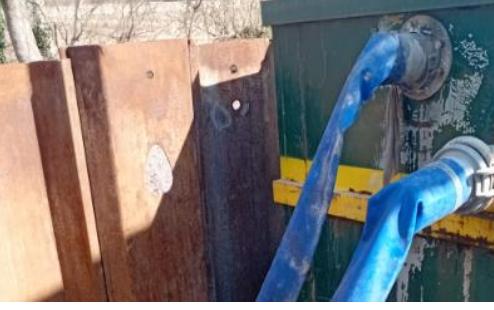
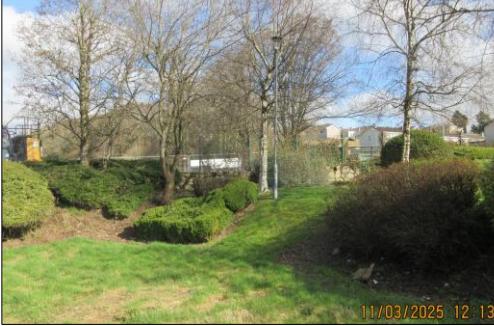
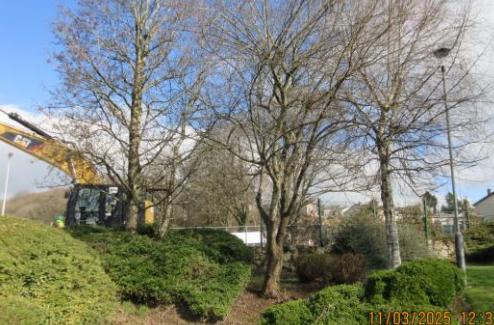
3.7	11/03/2025	<p>Clearance works commenced today on the grounds of the Credit Union to facilitate the construction of the downstream section of the Hazelwood Overflow Culvert. During the process, three trees outside the original design were considered for removal to accommodate temporary works. In particular, a birch tree located in close proximity to the excavation area is at risk, as root damage may be unavoidable due to its proximity to the works.</p>

<p>Every effort should be made to retain the trees in question. If retention is not possible, clear justification must be provided, along with proposed compensatory planting options.</p>	<p>To minimise potential damage to the birch tree, immediate efforts were made by switching from the digging bucket to the grading bucket to reduce root disturbance while clearing surface vegetation and excavating around the tree. A birch tree, following checks for possible bird nesting by the site ecologist, was subsequently removed due to unavoidable root damage. This was carried out in consultation with the landowner, the Credit Union, who raised no objection to its</p>

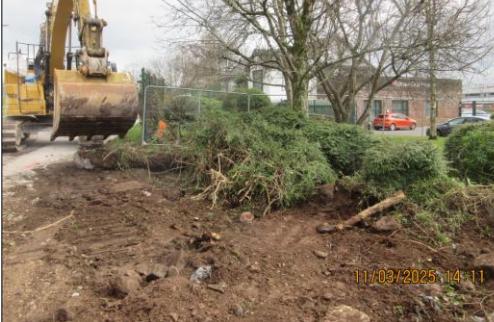
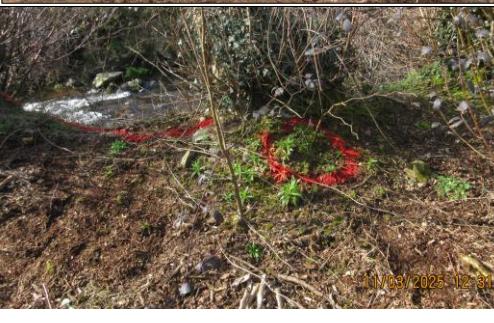
<p>removal. A compensatory tree will be replanted at the same location upon completion of the works.</p>
3.8	11/03/2025	The Credit Union grounds contain pre-existing Japanese Knotweed (JKW).

<p>Implement biosecurity actions as appropriate.</p>	<p>During a pre-clearance survey, the site ecologist identified at least two visible JKW canes, which were subsequently marked out and communicated to the ground crew. Excavation in the affected areas will be carried out under planned supervision to ensure proper handling and mitigation.</p>

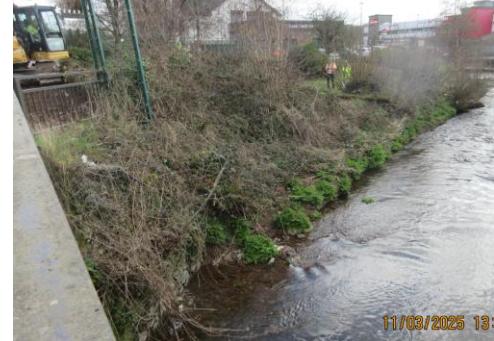
Item number	Date	Comment	Image	ECoW Action/Recommendation	Sorensens's Action response
3.9	11/03/2025	<p>The planned removal of ground vegetation at the Credit Union site along the riverbank will take place during the bird nesting season and should therefore be pre-surveyed before clearance begins. It was discussed that this section be cleared gradually, at a rate of c. 0.5m at a time, under the supervision of the site ecologist. This approach is necessary as the habitat is suitable for nesting mallards, which are ground-nesting birds and may not be easily identified using standard vantage point survey methods.</p>

<p>Riverside vegetation should be cleared under supervision as a precaution.</p>	<p>Vegetation clearance was carried out under the supervision of the site ecologist. The removal was conducted gradually, as previously agreed. No signs or indications of nesting birds were observed during the clearance process.</p>

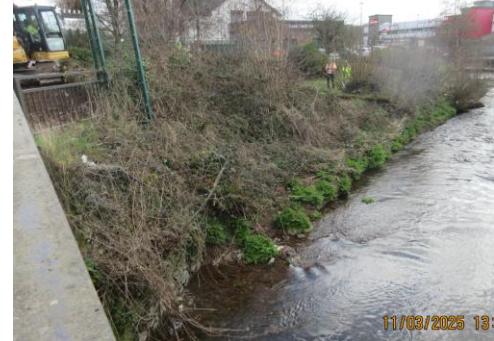
Item number	Date	Comment	Image	ECoW Action/Recommendation	Sorensens's Action response
3.10	11/03/2025	The removal of vegetation along the riverbank at the Credit Union grounds was discussed regarding erosion controls that will likely be required to prevent surface runoff and erosion, particularly in the event of heavy rain and rising river levels during rainfall events.

11/03/2025 13:00	Implement erosion controls measures as appropriate.	Once the vegetation was removed, appropriate erosion control measures were implemented, primarily utilising coir mesh to prevent run off of newly exposed bare ground.

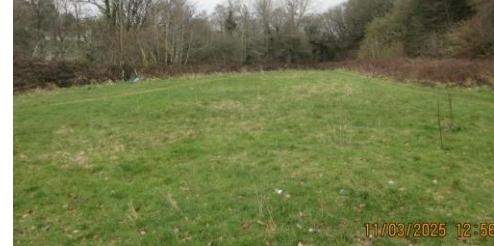
3.11	11/03/2025	Dewatering plans were discussed for the groundwater expected to be encountered during excavations for the downstream section of the Hazelwood Overflow Culvert. It was proposed that the area behind the basketball courts be used as an attenuation area, maximising the available ground and combining various methods to slow surface water flow.

11/03/2025 12:56	Revert with finalised dewatering plans.	An updated Method Statement of Works was issued and subsequently reviewed by the Ecologist. The statement includes clear diagrams and addresses ecological considerations, including environmental mitigations required.

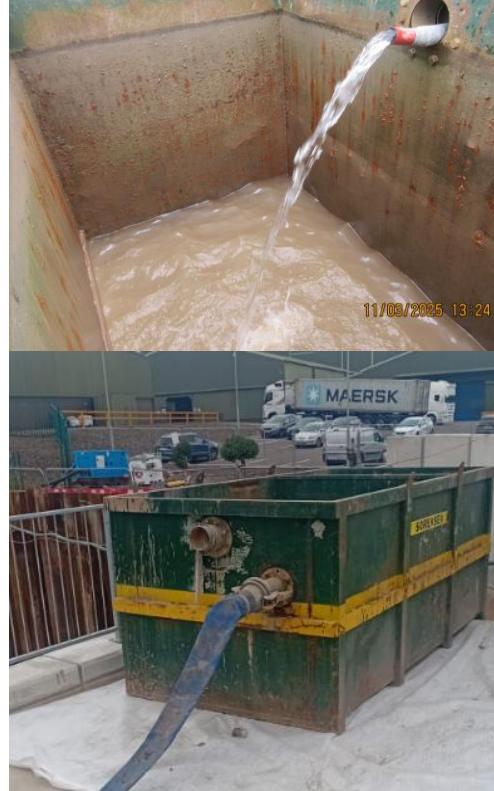
Item number	Date	Comment	Image	ECoW Action/Recommendation	Sorensens's Action response
3.12	11/03/2025	<p>New Line: Inspection of dewatering from the excavations was observed to be clean and clear.</p> <p>Change to pumping arrangement at New Line occurred later in the month.</p> <p>Throughout the month daily NTU reading were undertaken and reported to the ECoW.</p>

<p>Continue to monitor pumping and provide NTU readings.</p>	<p>The dewatering set up was regularly monitored and tested for NTU.</p> <p>The entire month the pumping at this location was carried out professionally and to a high standard.</p>

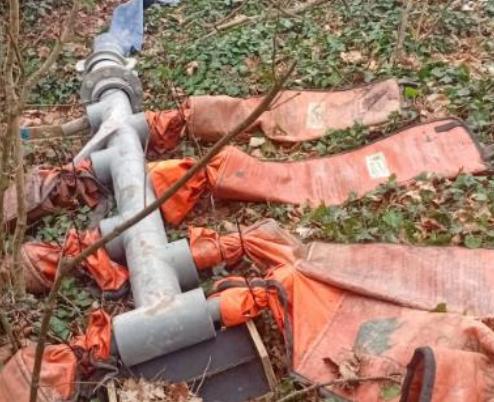
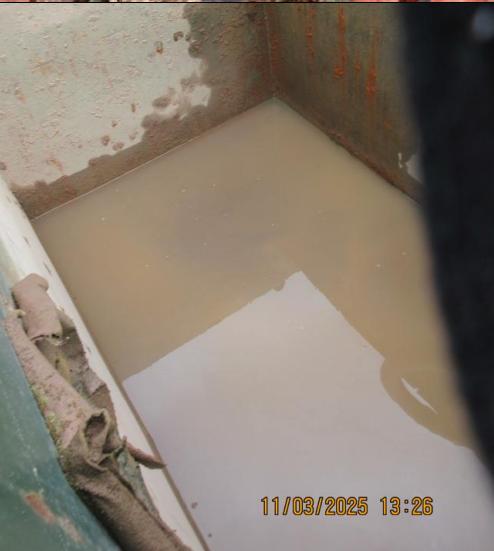
3.13	11/03/2025	<p>The settlement tank currently in use at New Line has accumulated a certain amount of silt over the past few weeks since pumping began at this location. This accumulated silt is now acting as a source of silt for the pumped water, even though the water itself appears clean. The current tanking out of water is not effectively removing the silt build up.</p>

<p>Remove silt build up within the settlement tank to improve overall functioning of silt control system.</p>	<p>The site ecologist reported that suction was employed to remove the built-up silt, thereby improving the dewatering system.</p>

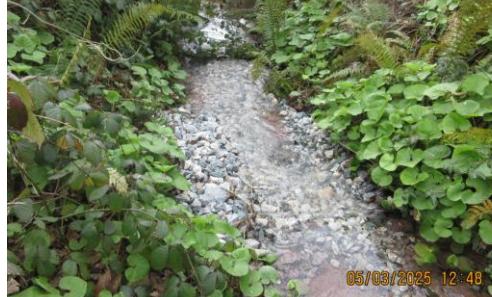
Item number	Date	Comment	Image	ECoW Action/Recommendation	Sorensens's Action response
3.15	11/03/2025	Gravels added to the Sallybrook drain/stream was discussed and if they will be removed once pumping is completed as they may present capacity issues if left in place.

Revert with final plans for gravels.	It was agreed that gravel could be left in place as no capacity issues were present.
3.16	12/3/2025	Coir mesh was added to exposed ground at Meadowbrook estate where weather monitoring station will be installed.

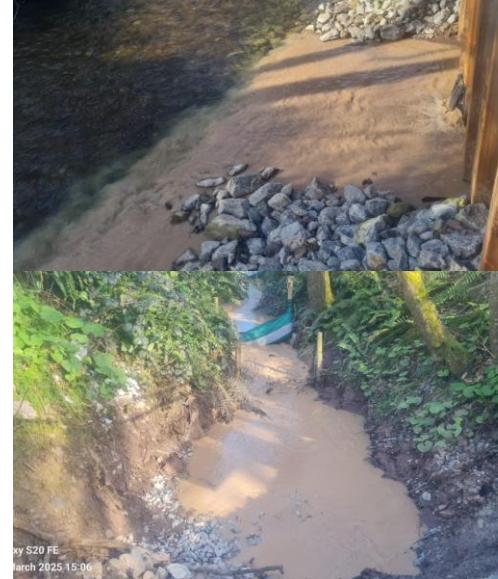
Item number	Date	Comment	Image	ECoW Action/Recommendation	Sorensens's Action response
3.17	12/3/2025	Release of silty water from the Sallybrook drain. This was being used for attenuation during pump station works.

Issue an environmental incident report.	EIR to be issued by SCE.
3.18		<p>As part of temporary works Coir Mesh was placed on the banks of the Glashaboy River at the location of the oversized culvert at Hazelwood.</p> <p>The ground and the coir mesh are 'uneven' as SCE tried to keep as much vegetation as possible.</p>

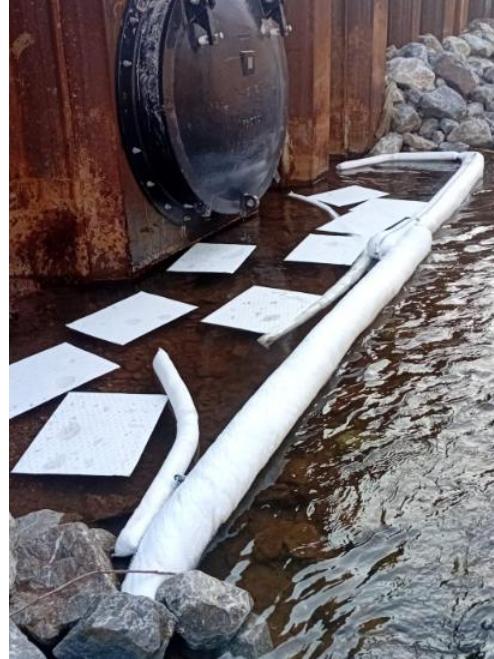
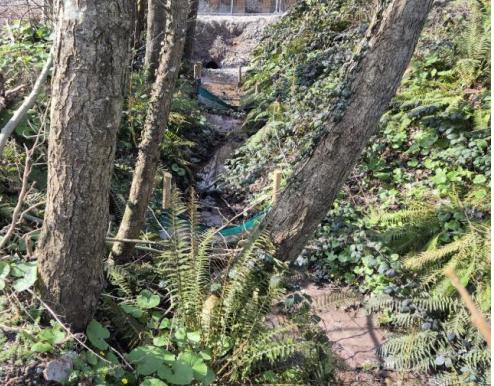
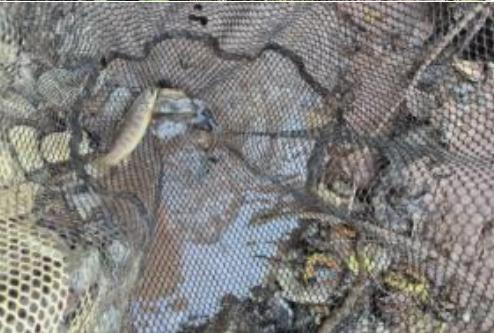
Item number	Date	Comment	Image	ECoW Action/Recommendation	Sorensens's Action response
3.20	20/3/2025	<p>Works were carried out to connect the newly constructed drainage line at Pat O'Donnell, which had been designed to intercept the majority of flow from the Sallybrook drain and redirect it through the updated network.</p> <p>On the morning of the operation, a phased testing procedure was undertaken, involving the controlled release of potable water into the stormwater system. This was completed in advance of the planned diversion of the Sallybrook Stream, as a precautionary measure as contaminated water was an issue at this location previously.</p> <p>SCE's Environmental Unit remained on standby throughout the testing. However, following two flushes of the system, no</p>

Item number	Date	Comment	Image	ECoW Action/Recommendation	Sorensens's Action response
		<p>visual signs of hydrocarbons were observed.</p> <p>As no contamination was identified, the Sallybrook Stream was successfully diverted into the new storm line. Monitoring of the stream was carried out during and after the diversion for the unlikely presence of protected species, including European eel and lamprey.</p> <p>A single trout was observed and successfully relocated during the operation.</p>

<p>Diversion and reconnected took place following discussion between the ECoW and site ecologist.</p>	<p>The operation was carried out in a highly professional and well-organised manner, particularly given the potential risk of contamination.</p>

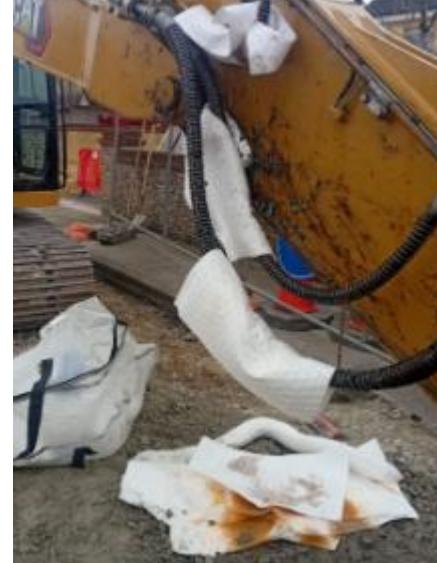
Item number	Date	Comment	Image	ECoW Action/Recommendation	Sorensens's Action response
3.21	21/3/2025	Hydraulic hose burst at CCV. SCE Environmental Unit have put hydrocarbon control measures in place

Good response to incident.	<p>The incident was promptly addressed through the deployment of absorbent pads and socks, which were available on hand. The affected area was subsequently treated with Bioversal HC to mitigate any potential environmental impact.</p> <p>Incidents of this nature are not uncommon on construction sites and cannot be entirely avoided. However, best practice involves maintaining spill kits within machinery and at each active work area to ensure a rapid response. In this case, such measures were in place and effectively implemented, resulting in a swift and controlled resolution.</p>

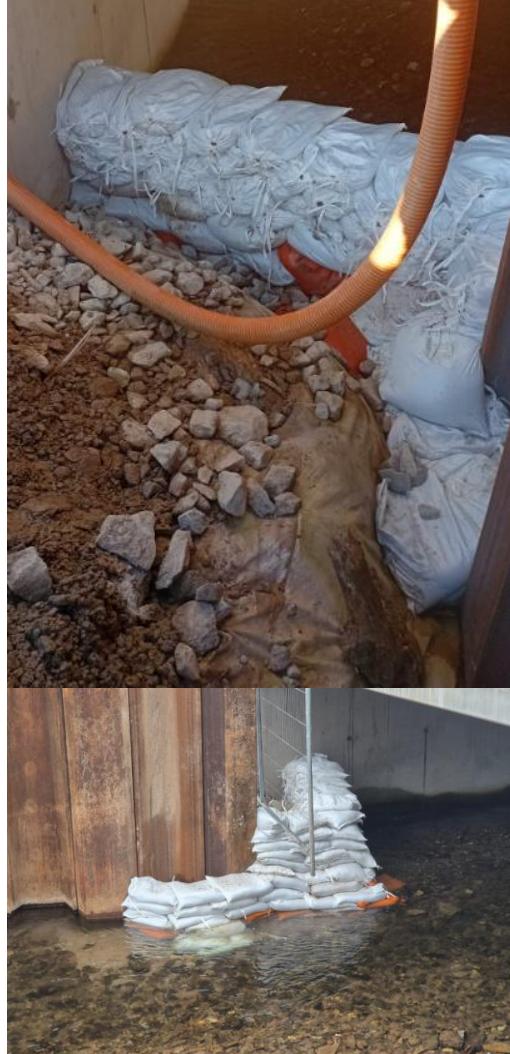
Item number	Date	Comment	Image	ECoW Action/Recommendation	Sorensens's Action response
3.22	22/3/2025	<p>An additional three temporary sheet piles were required at New Line to facilitate the connection of the reinforced concrete wall under construction to the new bridge structure. These piles were installed through the existing sandbags already in place at this location. No additional in-stream area was impacted as a result of this operation.</p>

<p>This operation was discussed and planned in advance with ecological input from both the Resident Engineer's ecologist and the contractor's ecologist.</p>	<p>The operation was carried out professionally.</p>

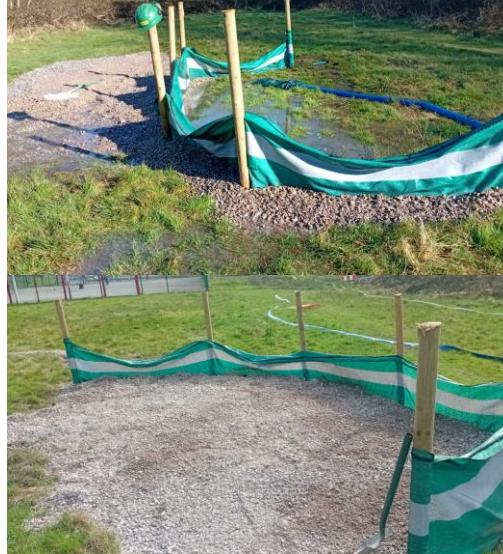
Item number	Date	Comment	Image	ECoW Action/Recommendation	Sorensens's Action response
3.23	25/3/2025	<p>The pumped water was directed to two separate locations with the attenuation field at the basketball court. One location, equipped with silt curtains and gravels, backed up due to heavy rains and total ground saturation, which obstructed an amenity walking route into the local woodland. As a result, the second location was used, which included silt screens and a heavily vegetated bank to control sediment levels before the water entered the Glashboy..</p>

<p>This planned pumping was discussed and planned in advance with ecological input from both the Resident Engineer's ecologist and the contractor's ecologist.</p>	<p>The pumping at this location was carried out professionally throughout the month with no incidents of siltation.</p>

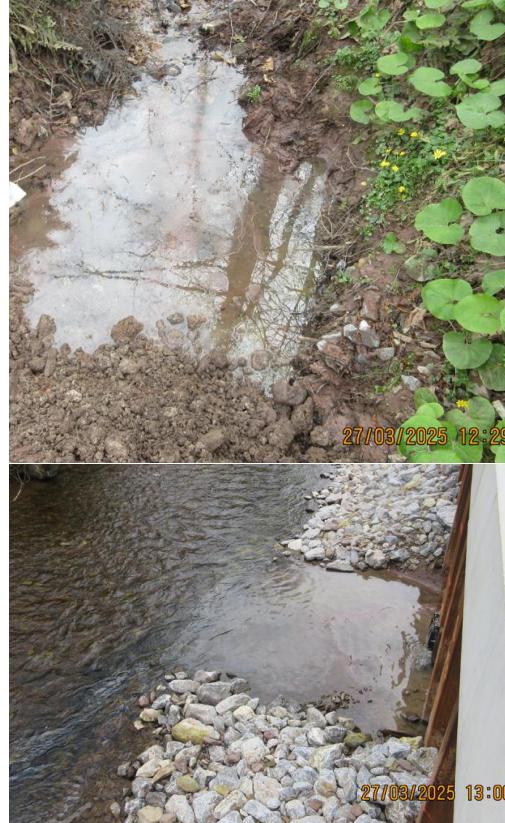
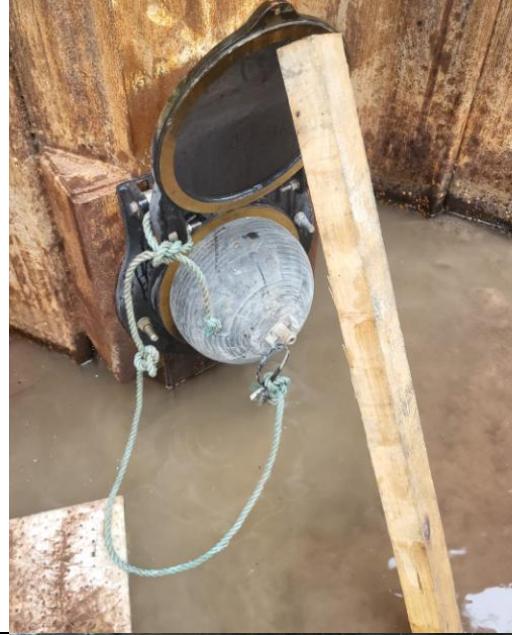
Item number	Date	Comment	Image	ECoW Action/Recommendation	Sorensens's Action response
3.24	27/3/2025	<p>Hydrocarbon contamination was encountered during works at Sallybrook Stream. A swift and effective response was implemented to prevent pollution from entering the main channel, initially by bunding the outlet when contamination was first observed, followed by the installation of a bung at the outfall.</p> <p>Additional containment measures were promptly enacted, including the application of Bioversal at both the source and the outlet where contamination was detected in the main channel. Booms and absorbent pads were deployed around the outfall to further mitigate the spread of contamination.</p>

<p>A strong and proactive initial response was taken to contain the contamination. Ongoing monitoring and treatment should continue to ensure the protection of the Glashaboy River.</p> <p>Issue permit to pump when finalised.</p>	<p>SCE continued implementing mitigation measures throughout the remainder of the month and into the following one. These measures included the deployment and replenishment of absorbent pads and booms in the main channel around the outlet, as well as the repeated applications of Bioversal HC at outlet, on rock armour and in main channel.</p>

Item number	Date	Comment	Image	ECoW Action/Recommendation	Sorensens's Action response
		<p>The final design for the works in this area is currently under review by the ER.</p> <p>The permit to pump that was originally envisaged here will require updating to address the unforeseen contamination once the design is confirmed and pumping requirements are established.</p>

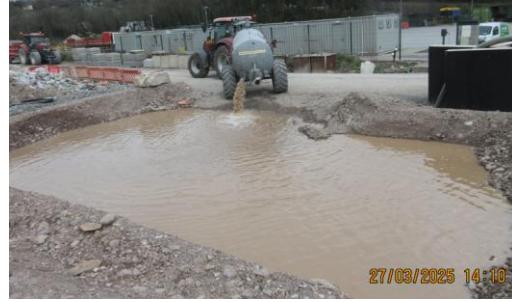
3.25	27/3/2025	The discharge of silty water from the settlement tank at New Line is being effectively managed. The attenuation area is functioning well.

Ongoing monitoring should continue of dewatering operations at New Line with adjustments implemented as the dynamic situation develops.	Newline pumping continued to be monitored throughout the month being adjusted as necessary.

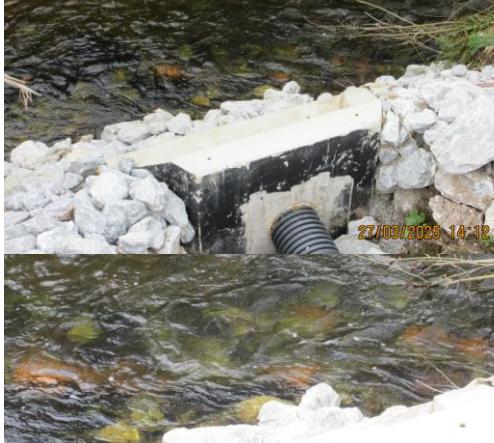
Item number	Date	Comment	Image	ECoW Action/Recommendation	Sorensens's Action response
3.26	27/3/2025	Housekeeping: Approximately four sandbags were observed in the main channel.

Remove sandbag waste from river when safe to do so.	Sandbags to be removed.
3.27	27/3/2025	A birch tree was removed at the Credit Union grounds. Although the tree lay outside the original design boundary, it was ultimately required to be removed to facilitate essential temporary works associated with the construction of the overflow culvert. Despite efforts to retain the tree, removal was necessary. The landowner provided consent for its removal, and compensatory planting will be undertaken.

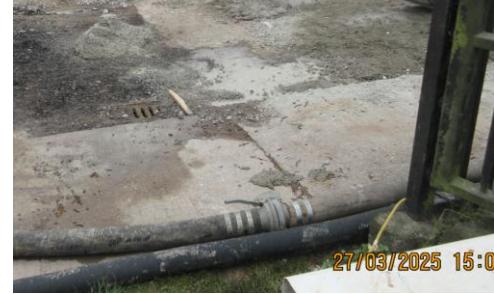
Item number	Date	Comment	Image	ECoW Action/Recommendation	Sorensens's Action response
3.28	27/3/2025	During a site inspection at Hazelwood, concrete pouring was taking place, with fresh concrete deposited near a storm drain. This presents a risk to the main channel in the event of rainfall (conditions were dry at the time), as the runoff could potentially carry cementitious material into the drainage system and compromise the Glashaboy water quality.

27/03/2025 15:05	Ensure storm drains are protected proactively, and concrete is managed	Concrete was promptly removed when observation was made.  This was a small amount of concrete waste however more efforts will be made to control concrete waste during pours.  Protecting storm drains proactively taking on board.

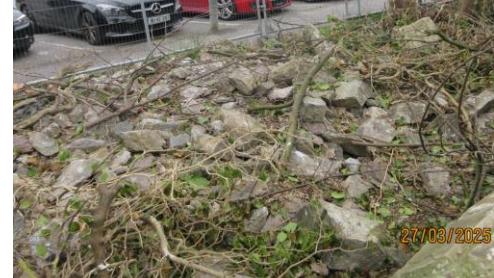
3.29	27/3/2025	An area at Springmonut used for masonry waste was discussed.

27/03/2025 15	Plans for the reinstatement was discussed included soil type, reseeded and ivy on adjacent trees.	This area to be reinstated next month.

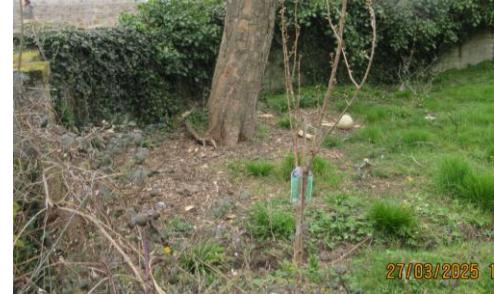
Item number	Date	Comment	Image	ECoW Action/Recommendation	Sorensens's Action response
3.30	27/3/2025	Plans to install drainage in the garden of Springmount house will require consideration for invasive plant species.

Ensure biosecurity measures are implemented when ground works commence at this location.	The area was subject to an invasive species survey, which confirmed the presence of Spanish bluebell ( <i>Hyacinthoides hispanica</i> ), a First Schedule invasive species. Appropriate control measures will be implemented when drainage works commence, in line with invasive species management protocols.
