Appendix D (NIS)

Geomorphological Audit

D Geomorphic audit of the Glashaboy River and assessment of the proposed Drainage Scheme

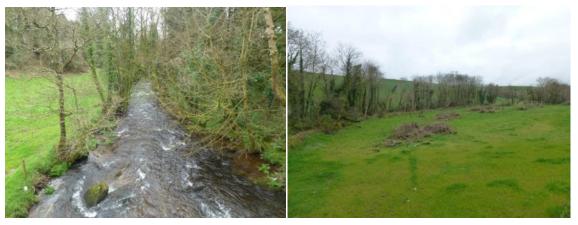
Figure 3-3 Dunbulloge Bridge (Point 2)

Evidence within the reach of historic channel management exists, including old dredging embankments (Figure 3-3) and channel straightening. Channel straightening and dredging has led to some disconnection of the channel from its floodplain in certain areas (although this is not excessive in the upper reaches). Modifications to the channel such as dredging and straightening

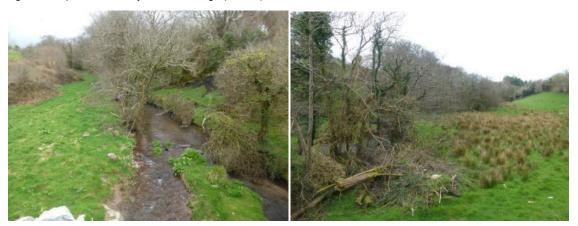
Figure 3-5 Upstream of Ballyskerdane Bridge (Point 4)

Stable vegetated bars were common throughout the reach (Figure 3-5) along with small pockets of fine sediment deposition along the lateral edges of the channel, mainly from localised bank erosion. Small areas of deposition like this are often an indication of the channel naturally attempting to narrow as a result of historic intervention, such as over widening. Several low weirs exist (see example in Figure 3-2), which cause limited upstream impoundment, but act to cause increased fine sediment deposition within their impoundment zones. Limited evidence was noted of weirs restricting movement of gravels.

Opportunities exist to improve connection through embankment removal and re-grading (Figure 3-5). This should act to improve floodplain storage in these upper reaches and act to reduce downstream flood risk.

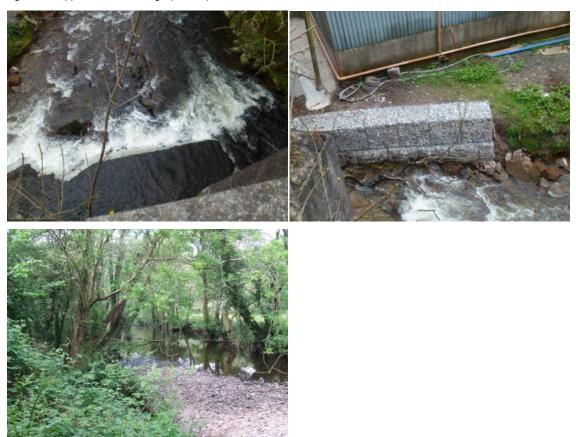
Figure 3-6 Upper Glanmire Bridge (Point 5)

In the reach between Upper Glanmire Bridge and Knocknahorgan the river valley narrows which results in a confined floodplain. At Upper Glanmire Bridge a weir is leading to local bank erosion (Figure 3-6), due to the direction of flows passing under the bridge. Banks have been reinforced using gabion baskets, however, in the long term the river may undercut these baskets.

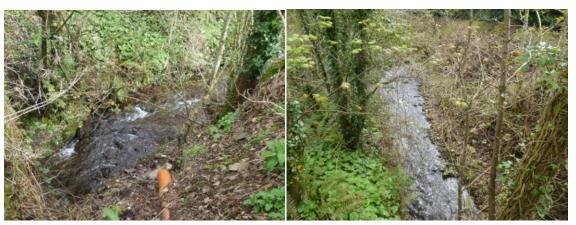
Figure 3-7 Knocknahorgan tributary (Point 6)

Downstream of Upper Glanmire Bridge, flow energy in the channel reduces and areas of gravel and small cobble deposition occur (sizes of gravels range from 4cm to 40cm). Gravel splays occur at tributary confluence points (Figure 3-6) along this section, suggesting an active supply of gravels is present from the steep tributaries joining the river (Figure 3-7).

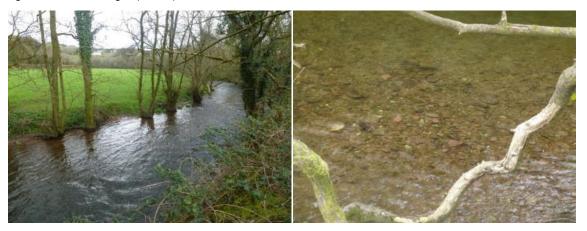
Figure 3-8 Knocknahorgan (Point 7)

The channel bed throughout this reach is again dominated by gravels and cobbles, in a plane bed and pool riffle morphology. Less algae was seen on the more gravelly sections on the bed which suggests a more active supply and movement of gravels through this reach (Figure 3-8).

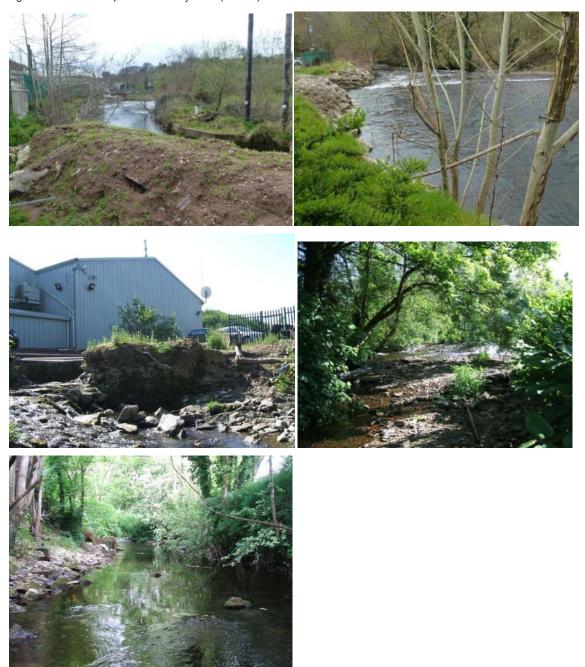
Figure 3-10 Channel upstream of Sallybrook (Point 8)

As the channel approaches Sallybrook the valley widens and becomes less confined. The wider floodplain along this reach has been developed / built upon which acts to constrict the channel. In some areas informal flood embankments have been constructed. In other areas active bank erosion is occurring as the channel attempts to naturally adjust within is confined channel. This is exacerbated by the higher energies during flood conditions as a result of the channel constriction. Hard measures, such as walls have been constructed to reduce the erosional impact of the river (particularly on the outside of bends) and some of these are now failing (such as adjacent to the petrol station). The erosion of banks acts as a strong sediment supply of gravels and fine materials. Deposition is also common through this reach, with several gravel bars (which are unvegetated, signalling frequent movement) being present. However, in the lower portions of the reach the channel becomes incised as a result of the influence of old mill leats and weirs (some existing and some now removed). As a result of these structures the channel is disconnected by over 1m from the floodplain (due to the channel eroding downwards in an attempt to adjust its bed gradient) and deposition is minimal, due to floodplain disconnection and high in channel energy levels. The channel in this lower section is dominated by coarser cobbles.

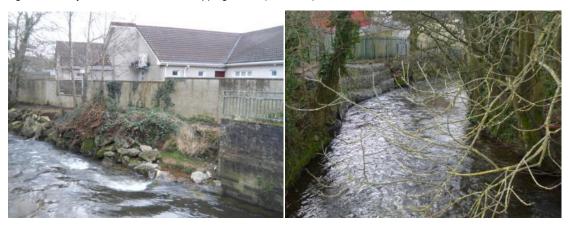
Figure 3-13 Adjacent to the Glanmire shopping centre (Point 10a)

At the Glanmire shopping centre several areas of bank instability exist (Figure 3-13 and Figure 3-14). The channel at this point is confined and relatively narrow compared to reaches upstream. There is limited deposition due to the steepness in some sections and disruption from upstream to the sediment transport process. The channel banks are high in most locations due to land raising and embankments. As a result, during flood conditions all energy is concentrated within the channel which is leading to bank erosion and instability. In many places existing bank protection has been undermined and has collapsed into the river. This section appears to be starved of sediment, suggesting upstream structures, such as the old weirs are influencing inchannel processes. As a result, the channel has excess stream power leading to the erosion processes along the beds and bank. In order to reduce the flood impact and erosion within this section various options could be investigated including flood storage options upstream and also improving the in-channel morphology which is currently degraded, to manage the existing high energy conditions.

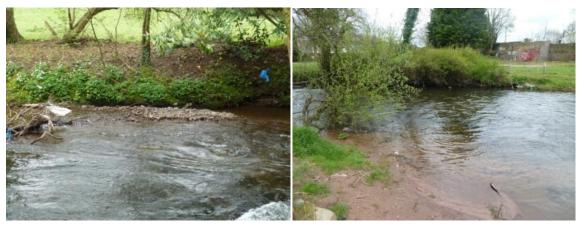
Figure 3-17 Parkland area (Point 13)

Downstream of the housing estate the channel enters a parkland area and connection to the floodplain is improved. In areas of the channel where flows are reduced fine sediment deposition is occurring (Figure 3-16) and in some areas small pockets of gravels (Figure 3-17) have been deposited, however, gravel deposition is not widespread. If sediment is removed as part of any future maintenance works, it should be expected that sedimentation will re-establish itself naturally.

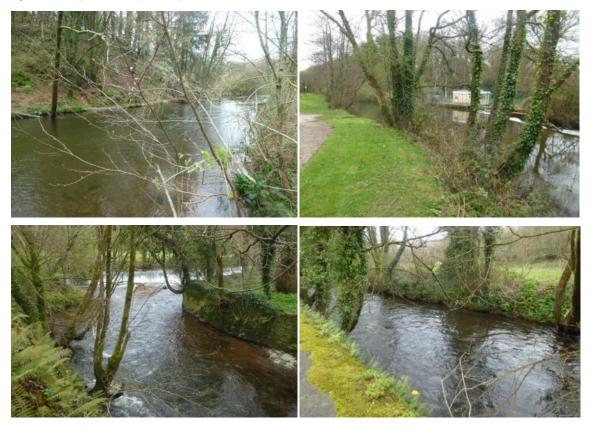
Figure 3-18 Impoundment (Point 14)

In the downstream section of the park a weir exists, which historically was used to feed a mill leat (which is still active). This causes upstream impoundment through the park increasing fine sediment deposition (Figure 3-18). Downstream of the weir some minor scour has occurred along

with a small area of gravel deposition, in a classic weir pool morphology. The channel then enters a canalised section with steep walls on both banks which act to prevent any channel migration. As a result, flows within this section have the ability to transport gravels downstream resulting in little deposition apart from coarser sediment at the edges of the channel through this section.

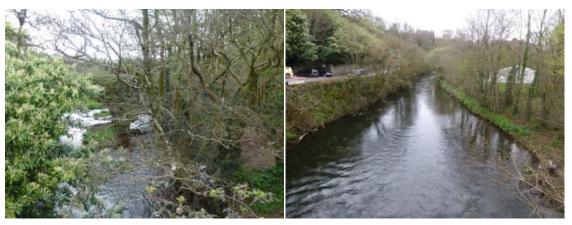
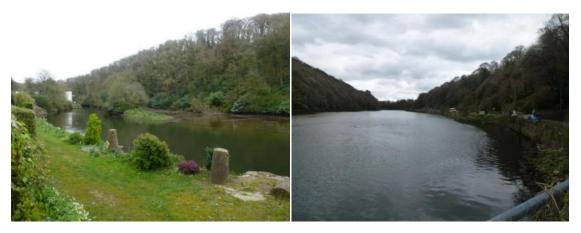
Figure 3-20 Sections downstream of Glanmire

At Glanmire bridge, deposition of gravels is occurring on the left bank (Figure 3-20). Downstream of the bridge the river gradually becomes wider and eventually is influenced by the tidal regime. This influences water levels and flow conditions downstream of Glanmire, resulting in some deposition of tidally derived muds and silts. The deposition of this sediment appears low therefore there is little risk of increased sedimentation in this section.

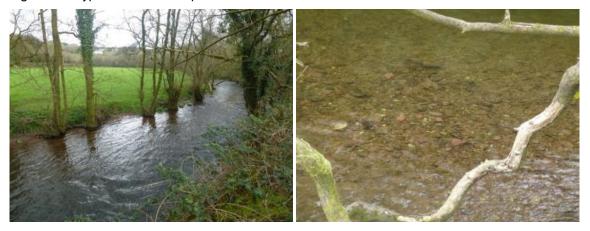
Figure 4-1 Typical conditions upstream of the industrial estate

This is a moderately active section of the channel upstream of the mill leat with a gravel / cobble bed that is partly mobilised during higher flows. The river is disconnected from its floodplain in several locations through this reach as a result of informal flood defences. This elevates inchannel energy levels during higher flows, preventing formation of significant gravel features. Under existing conditions, flow velocities vary between 1.0-2.4m/s for bankfull flows upstream of the mill leat, that are capable of moving medium to large gravels. Downstream of the old mill, the channel is moderately incised and the channel bed is dominated by cobbles. Bankfull flow velocities through this section range from 0.2-2.2m/s.

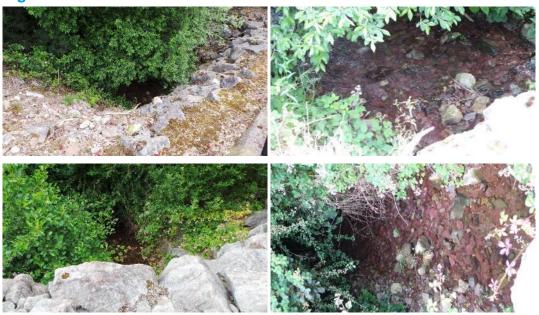
A.1 C09_B01: Replace existing twin 0.9m dia. culverts with new 1.6m by 1.2m high rect. culvert

Bleach Hill Stream at this location is entrenched (overly deep). As a result there is little floodplain connectivity except when flood water backs up behind the structure. The stream is dominated by a gravel and cobble bed which appears partially mobile (i.e. limited evidence of armouring). During flood conditions it is likely that this sediment will be mobilised and transported downstream, whilst new sediment will be delivered from upstream reaches. Due to the existing small culverts some sediment has accumulated upstream of the bridge. Whilst the existing culverts appear to be capable of allowing sediment to move downstream, it is likely that the culverts frequently become blocked with trash and debris which will hinder sediment continuity to downstream reaches.

The proposed larger culvert will improve sediment continuity through the system. The existing bed material should be maintained and matched where possible, however, any disturbance to the bed will quickly be rectified during subsequent high flow events. High flows event will be capable of transporting sediment to the structure from upstream reaches and the bed will quickly re stabilise.

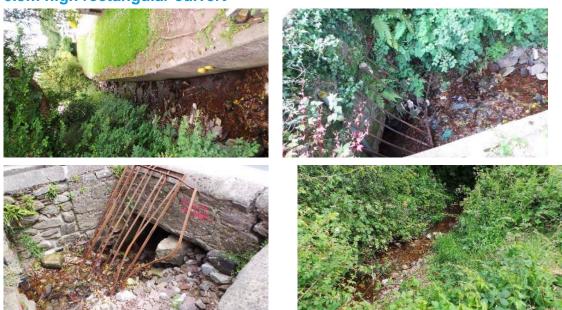
A.4 Cols na Gleann Stream: Replace existing culvert with a new 2m wide by 0.9m high rectangular culvert

The Cols na Gleann Stream is a small steep channel dominated by cobbles and gravels, which appear to readily transported downstream. The channel is very narrow and it is likely that it has been straightened historically. Such modifications act to elevate in channel velocities. Sediment has accumulated upstream of the culvert. Downstream of the culvert the channel gradient reduces and smaller gravels have been deposited (due to the reduced velocities associated with the reduced gradient). Within this area gravels dominate the channel bed and less cobbles are present. The existing culvert appears to disrupt the downstream continuity of sediment due to blockages at the small trash screen and the undersized nature of the bridge.

The proposals at this location should improve sediment continuity downstream. Care will be required to ensure large cobbles do not become trapped against the upstream trash screen (if one is to be constructed) as the high energy conditions will still be present.

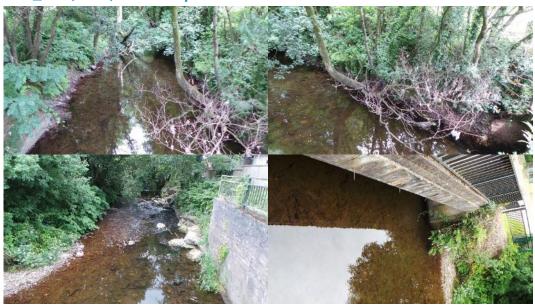
A.5 C01_C01, B02, C02: Proposed flood relief channel and culvert

The existing channel at this location is dominated by cobbles and gravels. The bed is partially armoured (evidenced by the moss over some of the larger cobbles) which suggests limited large sediment delivery. However, site conditions suggest higher velocity flows frequently transport smaller gravels through this reach. The construction of a flood relief channel is unlikely to significantly alter existing morphological conditions. However, the invert of the flood relief channel should be set at a point as to not decrease velocity as this could lead to an increase in deposition if in channel velocities are reduced significantly.

The existing bed material should be maintained and matched where possible. High flows event will be capable of transporting sediment; however, several flood events may need to pass through the system before the bed re-stabilises.

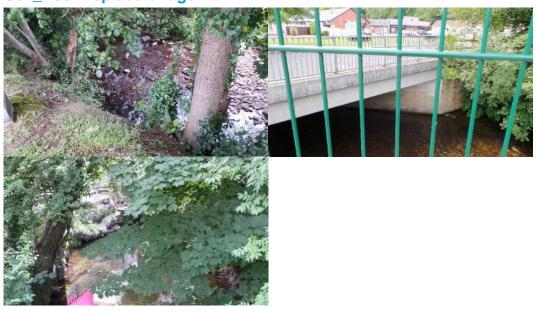
A.6 C01 B03: Replace bridge

The channel at this location is currently over wide which acts to influence morphological processes. As a consequence, depositional zones are noted within this reach. (i.e. the over wide nature of the channel may lead to lower velocities which in turn may encourage deposition). The proposed new

Upstream and downstream of this bridge some channel erosion is evident. In particular, downstream of the bridge, existing gabion basket protection has begun to fail on the outside of the bend. An alternative solution to bank protection is recommended at this location.

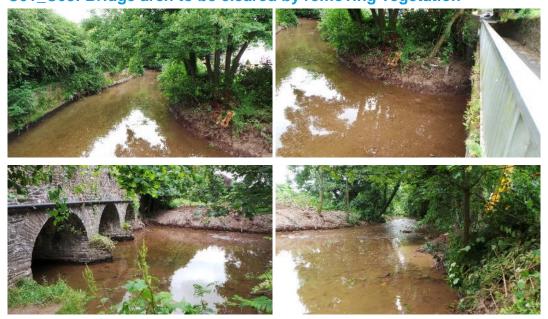
A.8 C01_C03: Bridge arch to be cleared by removing vegetation

Sediment was in the process of being removed from the channel during the site visit on the 03/07/16. Sediment was being removed several hundred metres upstream and downstream of the bridge. Some banks remain steeply profiled and could be subject to erosion until vegetation re-establishes.

Nevertheless, it is expected that the channel will quickly recover and new gravel bars will reform and the river attempts to re-establish a sediment equilibrium.
