Environmental Report November 2024

Glashaboy Flood Relief Scheme

Document code: FFEC-GFRS-2024-011-Rev02

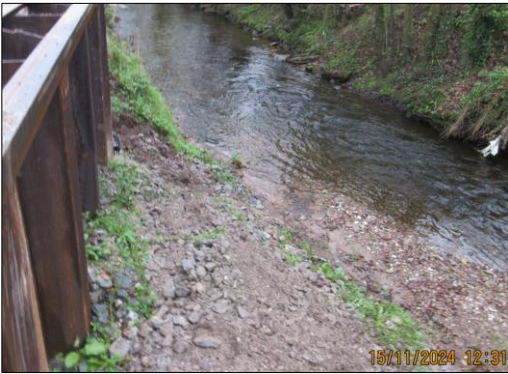
Item number	Date	Comment	Image	ECoW Action/Recommendation	Sorensens's Action response
11.1	15/11/24	Excavation risings from recent drainage works on the wet side of the sheet pile wall at Grandon's South, should be compacted and graded. This would help minimise runoff and erosion into the adjacent watercourse.

Compact and grade the mound of stony excavated material to ensure stability and minimise the risk of erosion or runoff.	Risings were regraded and compacted to a satisfactory standard later in the month. Since the material is largely made of gravels there is no need for coir mesh in this circumstance.

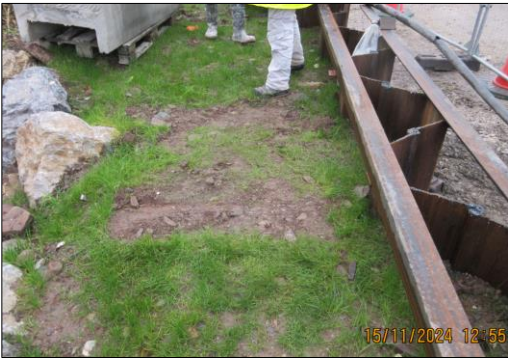
11.2	15/11/24	A substantial amount of waste, particularly spent angle grinder cutting discs, was observed discarded on the ground around the sheet pile wall near the car wash facility at Grandons.

Construction waste must be disposed of properly. A toolbox talk should be conducted for the subcontractors/ personnel installing the capping beams.	The area was tidied and construction waste removed. Site ecologist reports that Toolbox talk to be provided in December.

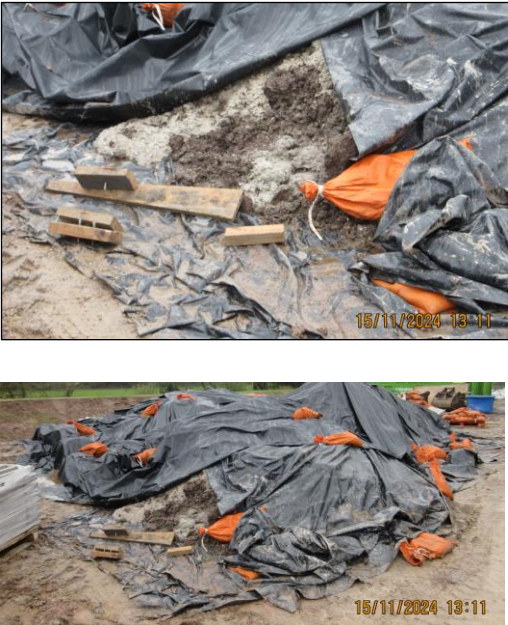
Item number	Date	Comment	Image	ECoW Action/Recommendation	Sorensens's Action response
11.3	15/11/24	Material removed from Grandon's during drainage works now stored at the Sallybrook compound, appears to have been added too with concrete waste. This section has also been left uncovered.

<p>Why is concrete waste being added to this stockpile?</p> <p>Advised that material be tested asap and recovered exposed material to prevent run off.</p>	<p>Material tested and returned non-hazardous. Results of testing submitted to client 20/11/24.</p> <p>Non-hazardous concrete waste added to stockpile for ease of disposal off site.</p> <p>Stockpile was recovered. Removal scheduled for December.</p>

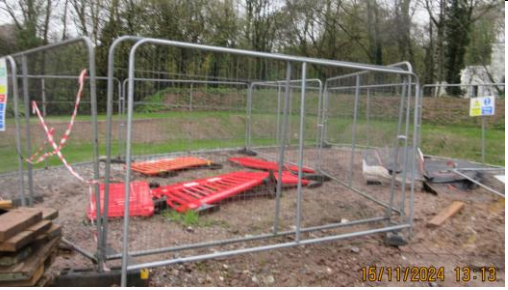
11.4	15/11/24	At the northernmost part of Sallybrook, a fenced-off area lacks signage to alert workers that it is a Japanese Knotweed exclusion zone.

<p>Install appropriate signage in this area to ensure biosecurity measures are clearly communicated.</p>	<p>Site ecologist reports that the signage will be installed in December.</p>

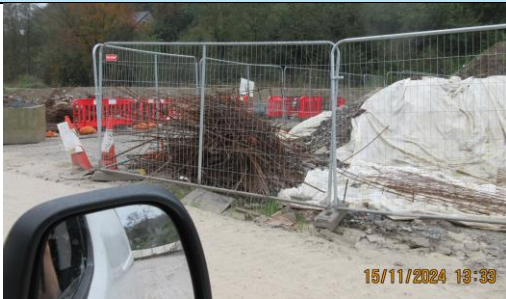
Item number	Date	Comment	Image	ECoW Action/Recommendation	Sorensens's Action response
11.5	15/11/24	Steel reinforcing offcuts are being inappropriately stored within the Holding Cell at Sallybrook. This misuse of the Holding Cell sets a poor precedent for further incorrect storage practices and undermines the biosecurity protocols established to prevent the spread of Japanese knotweed (JKW). The situation is further exasperated as there is inadequate JKW signage located on this side of the holding cell.

It is recommended that the rebar be relocated to an alternative location and that additional signage be installed along the holding cell fencing that runs adjacent to the access road.	<p>Site ecologist reports that additional signage is to be erected and rebar to be relocated on 06/12/24.</p> <p>Delays are accepted as not ideal by SCE. Non urgent in this circumstance so actioned when personal and machinery were available to carry out action.</p> <p>While this timeline is not ideal, the issue is non urgent and therefore the delay</p>

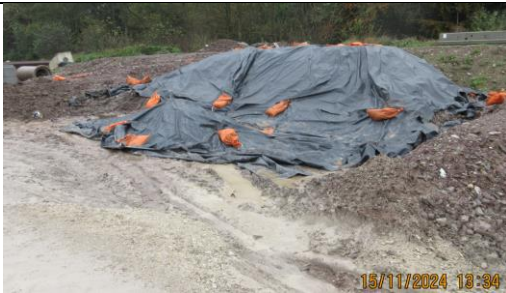
11.6	15/11/24	Storage of Eurofins contaminated material at Sallybrook is inadequate. There are indications of encroachment by wheeled vehicles into the stockpile. There are also signs of wash-out / run-off as surface water is accessing the contaminated stockpile.

Improve the temporary storage of this hazardous material until such time as it is removed off site.	<p>Removal and disposal of material commenced 25/11/24 by ENVA.</p> <p>Remaining material awaiting removal covered and bunded.</p>

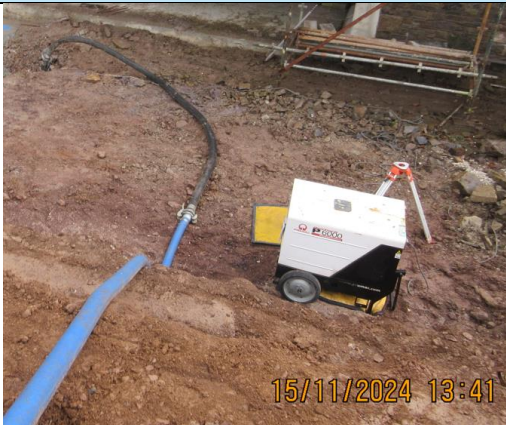
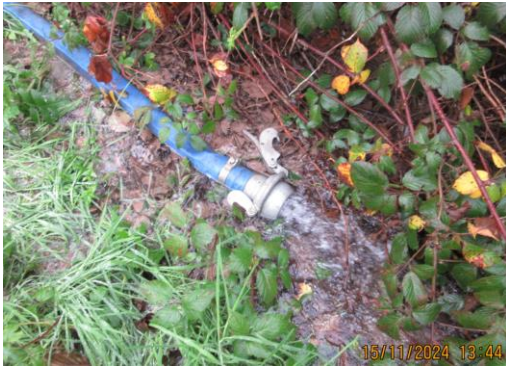
Item number	Date	Comment	Image	ECoW Action/Recommendation	Sorensens's Action response
11.7	15/11/24	Pumping of groundwater at the Hazelwood Bridge overflow culvert works area was carried out without a silt sock attached to the outlet of the hose, as per the conditions outlined in the Permit to Pump. Additionally, no sump was in use during the dewatering of excavations, which should have been implemented to minimise sediment generation.

<p>Given the reduced presence of the ecologist on-site, what measures are being implemented to ensure the conditions of the pumping permits are adhered to and properly enforced?</p> <p>Ensure that pumping is carried out in accordance with the conditions outlined in the Permit to Pump and the Work Requirements to minimise the</p>	<p>The site ecologist reports that in the absence of a Site Ecologist, the Site Foremen and Engineers are intrusted to issue and enforce the Permit to Pump (PtP) Water as required.</p> <p>The site ecologist reports that a refresher toolbox talk is to be provided regarding the PtP.</p>

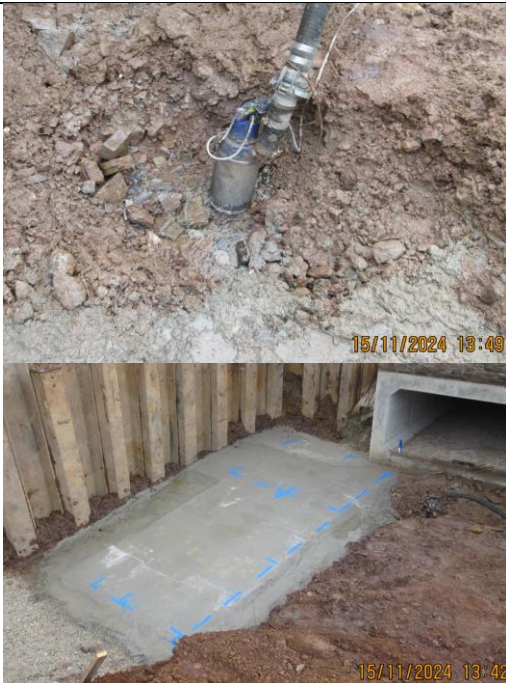
Item number	Date	Comment	Image	ECoW Action/Recommendation	Sorensens's Action response
				generation of silt during excavation dewatering.	
11.8	15/11/24	Hazelwood bridge overflow culvert works area: The concrete pour conducted the previous day suggests that seepage of wet concrete into the open dewatering area, which was located directly adjacent to the concrete slab being poured, likely resulted in the pumping of cementitious material.

<p>As it is now after event, review Permit to Pump procedures and how they are implemented.</p> <p>How can it be ensured that there will not be a repeat to this event?</p> <p>It is suggested that ground personnel receive a toolbox talk instructing on the correct procedures</p>	The site ecologist reports that a refresher toolbox talk is to be provided regarding the PtP.

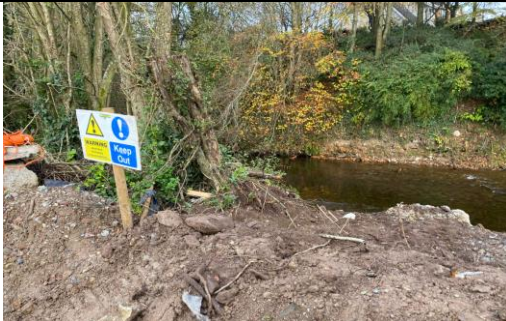
Item number	Date	Comment	Image	ECoW Action/Recommendation	Sorensens's Action response
				when dewatering excavations and dewatering while concrete pouring.	
11.9	15/11/24	Meadowbrook temporary slipway: As noted in the previous Environmental Tour (ET019), Item 11, although the waste material has been removed from this area, the work was completed without implementing the required biosecurity measures.

Indications suggest that the material removed is likely contaminated with Japanese Knotweed. Where is the waste material currently located? Why were biosecurity measures not implemented during this work?	The site ecologist reports that material was removed on 30/10/24. The material was gradually scraped away and checked for the presence of rhizomes by the Site Ecologist. The material was disposed of offsite without evidence of knotweed infestation.

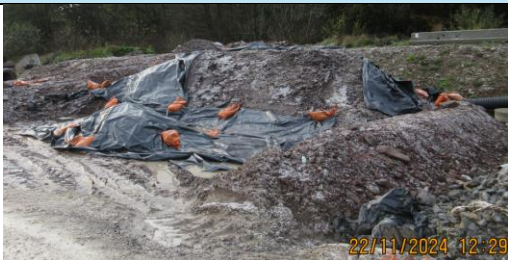
Item number	Date	Comment	Image	ECoW Action/Recommendation	Sorensens's Action response
11.10	22/11/24	Storage of Eurofins contaminated material at Sallybrook lacks bunding on the side nearest the access road. The material is also exposed on top.

Bund and recover over contaminated material with black plastic sheeting until ready for transport off-site.	Site ecologist reports that the removal and disposal of material commenced 25/11/24. Remaining material banded and covered while awaiting removal.

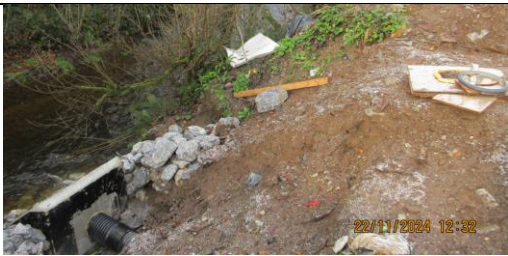
11.11	22/11/24	Housing keeping at Sallybrook. Construction waste material has potential to access the adjacent watercourse and spread off-site.

Clean up waste asap to avoid possible waste spreading.	Site ecologist reports that to be completed on 06/12/24.

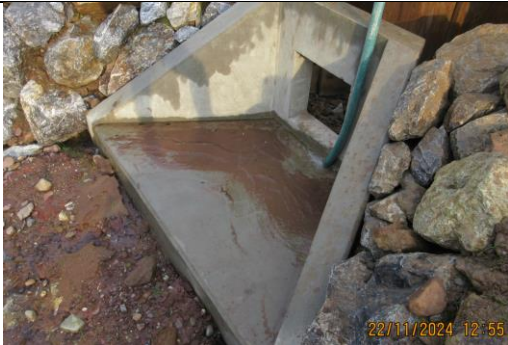
11.12	22/11/24	Grandons drainage works (next to Centra) Pumping operations were being conducted without silt mitigation measures in place. Additionally, a Permit to Pump was not available for inspection when requested from the grounds crew; one was later issued by an engineer. This is contrary to the CEMP (Rev5), which specifies that the Permit to

Item number	Date	Comment	Image	ECoW Action/Recommendation	Sorensens's Action response
		Pump should be designed and implemented by the site ecologist.		forward when pumping is required when no site ecologist is on site?	
11.13	22/11/24	The hoarding installed as part of the otter mitigation measures at Meadowbrook estate, as directed by the otter specialist, is being encroached upon and is partially compromised. Clarity was sought to make absolutely sure that no otter were present in the nearby holts.

Implement site specific silt mitigation at this location while pumping continues. Please inform the ER how the permit of pump system will operate going	Site ecologist reports that a permit to pump was issued on 22/11/24. Permit issued shortly after pumping had commenced. The site Ecologist will be contacted to prepare permits as required. Site Foremen and Engineers also entrusted to sign off on permits.

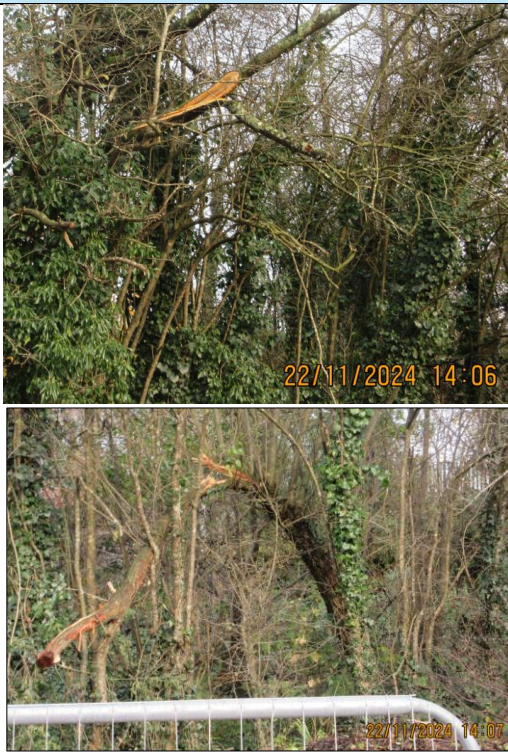
Item number	Date	Comment	Image	ECoW Action/Recommendation	Sorensens's Action response
11.14	22/11/24	At Meadow Brook Estate, the recent removal of the wall has resulted in damage to several tree limbs in the adjacent treeline.

<p>What measures were taken to avoid causing damage to the trees during the removal process?</p> <p>The damaged limbs should be cleanly cut with a saw to promote the health of the trees and minimise the visual impact of the damage.</p>	<p>Site ecologist reports that this will be completed 06/12/24.</p> <p>The protection of trees is a requirement for contractors. In this instance, the works would have been significantly improved with ecological supervision, which regrettably did not occur.</p>

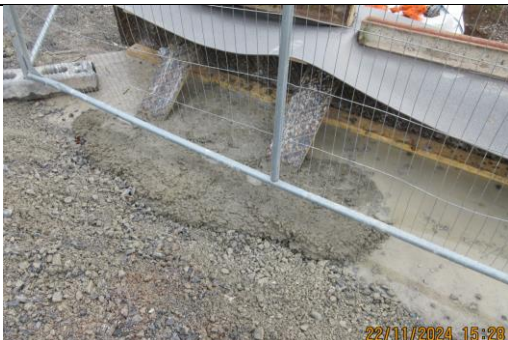
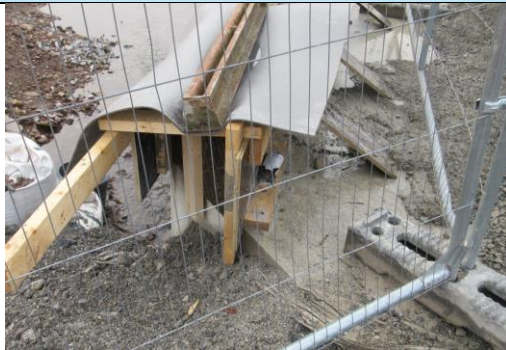
11.15	22/11/24	During concrete pouring at the Brooklodge culvert parapet walls, concrete waste was improperly deposited, creating a risk of runoff into the Glenmore River. The waste had direct access to the

Item number	Date	Comment	Image	ECoW Action/Recommendation	Sorensens's Action response
		watercourse, posing potential environmental risks.

<p>Greater care must be taken when pouring concrete, particularly in close proximity to watercourses,</p>	<p>The site ecologist reports that a refresher toolbox talk to be provided Thu 12/12/24.</p>

to prevent environmental contamination and protect aquatic ecosystems. The concrete waste should be transported to the designated Waste Storage Area and securely contained until appropriate disposal arrangements are made.
