Environmental Report January 2024

Glashaboy Flood Relief Scheme

Document code: FFEC-GFRS-2023-005

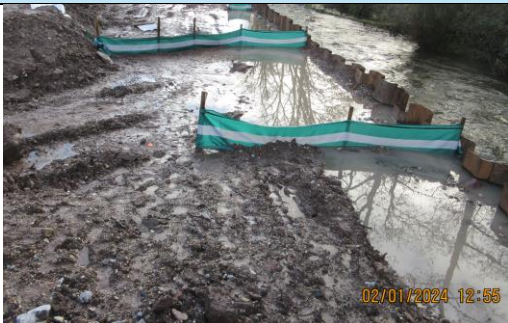
Item number	Date	Comment	Image	ECoW Action/Recommendation	Sorensens's Action
1.	02/01/24	Silt fencing reinstalled in attenuation area to rear of Sallybrook house following the Christmas break.

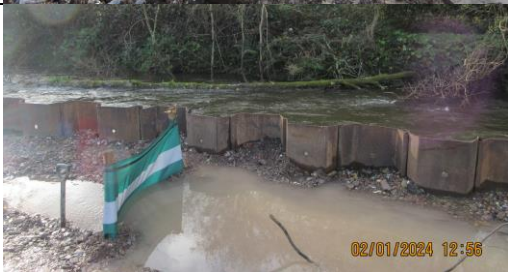
Documented.	No action required.
2.	02/01/24	Fallen tree in Glashaboy river on opposite bank across from attenuation area at rear of sallybrook house. Tree has fallen from natural causes. Will need to be removed during 2024 instream works to facilitate works.

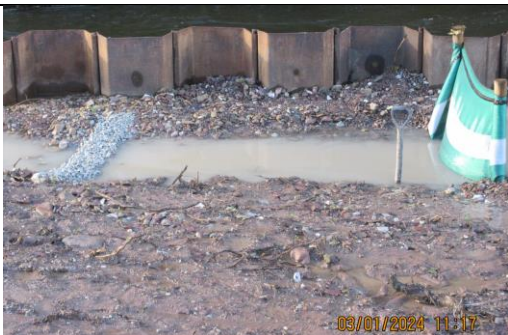
Documented	No action required.
3.	03/01/2024	Gravel check dams installed into attenuation.

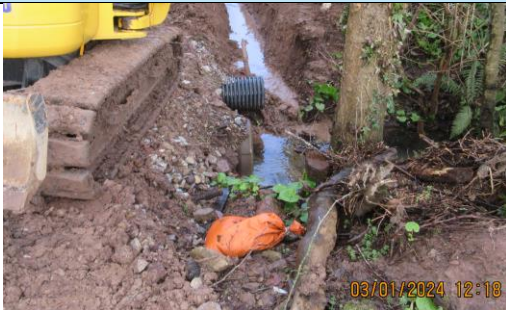
Item number	Date	Comment	Image	ECoW Action/Recommendation	Sorensens's Action
4.	03/01/2024	The drainage works at the rear of Sallybrook House conducted without adequate sediment control, as the attenuation area is not being utilized effectively, and preventative measures were not implemented when connecting the drain line to Sallybrook Stream. A minor siltation event has been acknowledged.

Discussed with site ecologist	Sorensen to ensure correct measures are followed during works to prevent sedimentation of water ways.
5.		Siltation tank in use at POD received water from contamination area. Water to be disposed of correctly before tank is reused elsewhere on site.

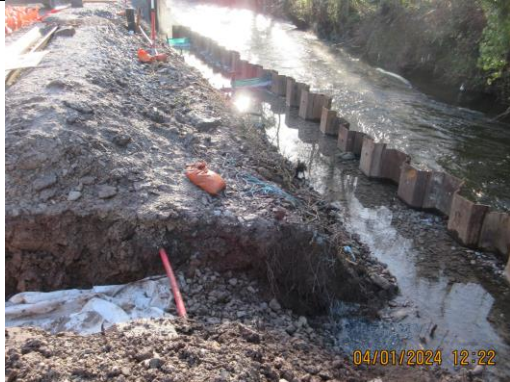
Item number	Date	Comment	Image	ECoW Action/Recommendation	Sorensens's Action
6.	03&04/01/2024	Filtration drain installed into the lower section of the attenuation channel to facilitate groundwater pumping from POD. Water checked daily for signs of contamination. No contamination was recorded.

Outflow checked daily for signs of contamination.	Site ecologist monitored while pumping continued for the remainder of the month of January. No contamination was recorded.

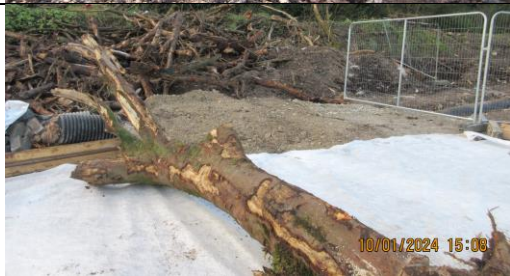
7.	10/01/2024	The timber log pile within the exclusion zone at Sallybrook underwent an inspection for JKW. Clean timber was segregated from unclean and stored separately.

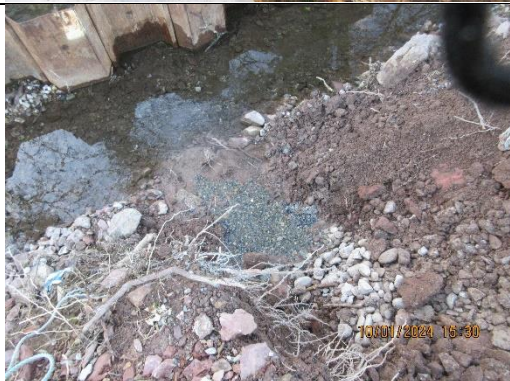
8.	10/01/2024	Visual inspections were conducted daily on the temporary sheet pile attenuation channel to check for any contaminated residues from the Eurofins works area. The outflow was found to be clean.

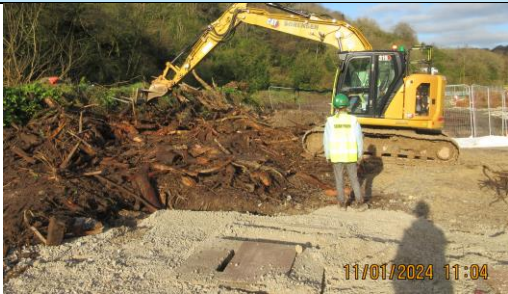
Item number	Date	Comment	Image	ECoW Action/Recommendation	Sorensens's Action
9.	11/01/2024	Timber pile at Sallybrook being sorted under supervision.

Discussed with site ecologist.	Biosecurity measures followed including removal of roots and placement of terram.
10.	11/01/2024	Excavations within the Sallybrook JKW zone to install the headwall was carried out following biosecurity measures.

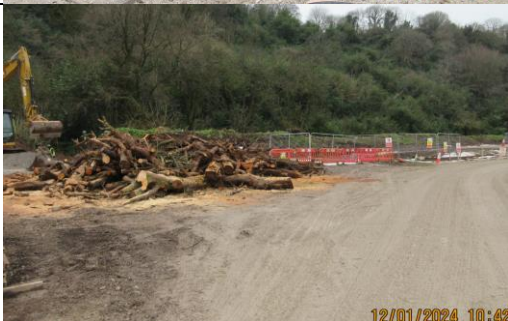
Documented	No action required.
11.	12/01/2024	Biosecurity measures inadequate today: insufficient barriers and lack of boot wash in operation

Discussed with site ecologist	Responded with improved barriers and boot wash.

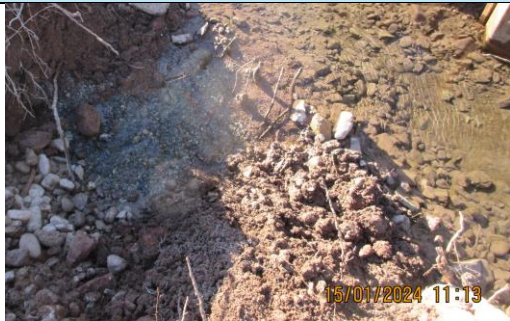
Item number	Date	Comment	Image	ECoW Action/Recommendation	Sorensens's Action
12.	15/01/2024	Outflow from POD works area in attenuation channel – clean flow of water with no signs of residues.

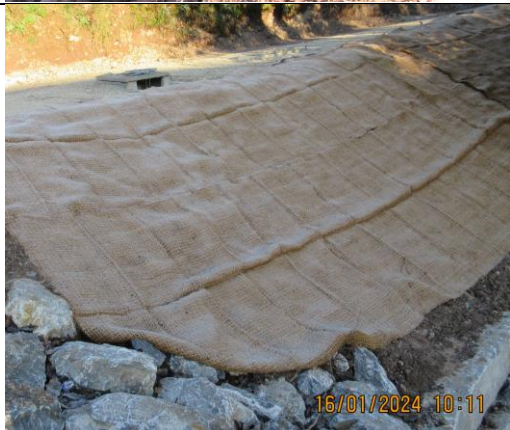
Documented	Similar checks ongoing for duration of works in POD.
13.	15/01/2024	Erosion control installed upstream of new culvert at Bleach hill. This addresses item 23 in ECOW's December audit.

Documented.	Area still requires topsoiling and grass seeding which is due to take place in 2024.

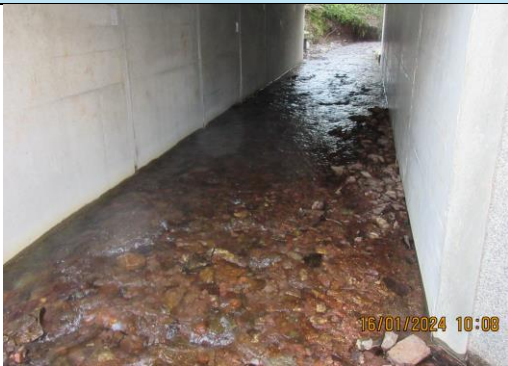
Item number	Date	Comment	Image	ECoW Action/Recommendation	Sorensens's Action
14.	16/01/2024	The deposition of gravel inside the recently installed culvert at Bleach Hill has effectively filled the gaps in the flagstones, creating a natural riverbed. This outcome reflects the success of implemented biodiversity measures as part of the design.

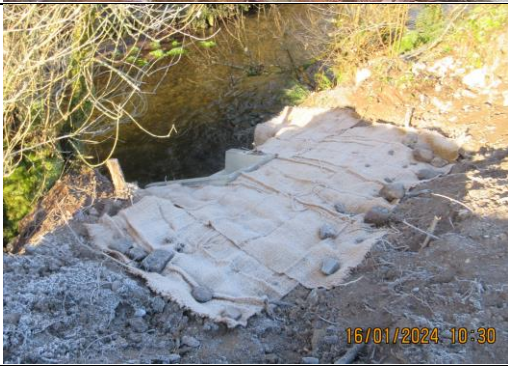
15.	16/02/2024	Erosion control installed at recently installed headwall at Sallybrook where works necessitated the removal of vegetation and the subsequent exposure of bare soil along the banks of the Glashaboy river.

Installed following discussions with site ecologist	Area to be monitored for vegetation regrowth and may require seeding depending on natural regeneration.

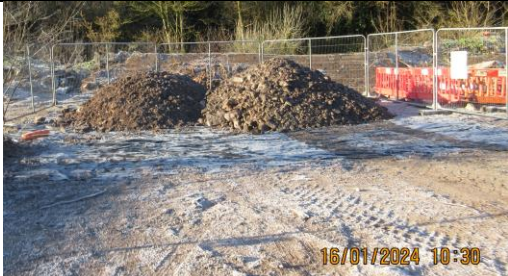
16.	16/01/2024	Contaminated material from POD temporarily stored at Sallybrook to facilitate testing by ER.

Documented.	Implement directions from ER to prevent possible run off.

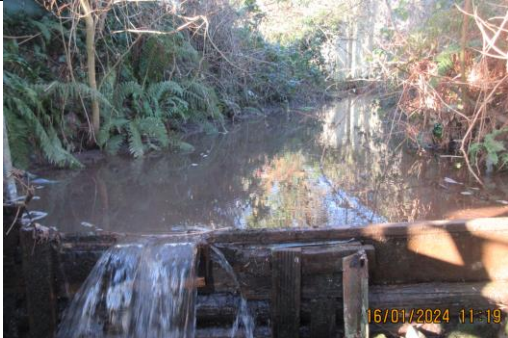
Item number	Date	Comment	Image	ECoW Action/Recommendation	Sorensens's Action
17.	16/01/2024	An private and unofficial dam at Springmount Stream has accumulated a significant amount of sediment. Caution should be exercised when resuming flow to the main channel to manage sediment release.

Discussed with site ecologist.	Consult with IFI prior to reconnecting.

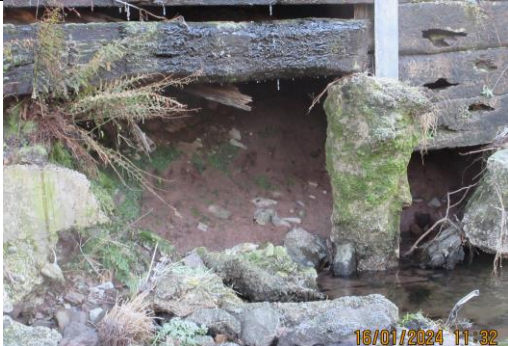
18.	16/01/2024	Couch C2 displays recent signs of use, with visible spraint observed. The couch is located adjacent to the works at the funeral home. No physical disruption to the couch is anticipated.

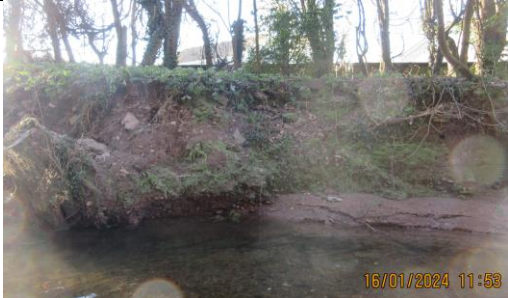
19.	16/01/2024	Survey of king fisher burrows. Two additional king fisher burrows were identified along the riverbank at Meadowbrook housing estate that are not in the 2018 drawings.

Discussed survey results with site ecologist.	The king fisher breeding surveys due to take place in March 2024 of Meadowbrook will factor in these survey results.

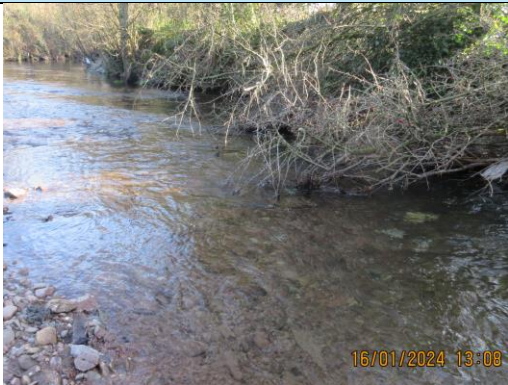
Item number	Date	Comment	Image	ECoW Action/Recommendation	Sorensens's Action
20.	16/01/2024	Riverbank collapse at Meadowbrook estate. It appears that some of the preexisting burrows may have been lost.

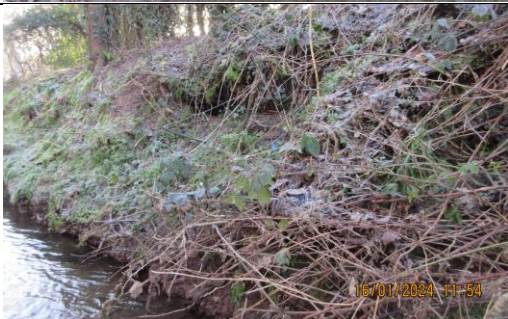
21.	16/01/2024	Otter holt N7 inactive during survey.

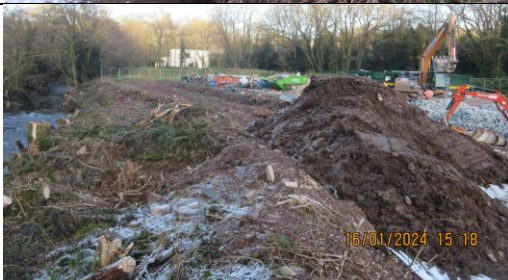
22.	16/01/2024	Northern section of JKW zone at compound 1 stockpiling area, pushing out into contamination zone. Terram put down as separation layer.

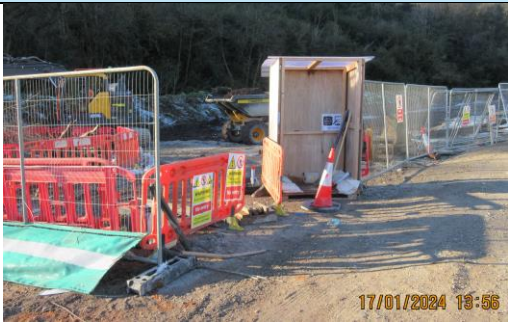
Item number	Date	Comment	Image	ECoW Action/Recommendation	Sorensens's Action
23.	17/01/2024	Improved barriers and documentation storage at JKW.

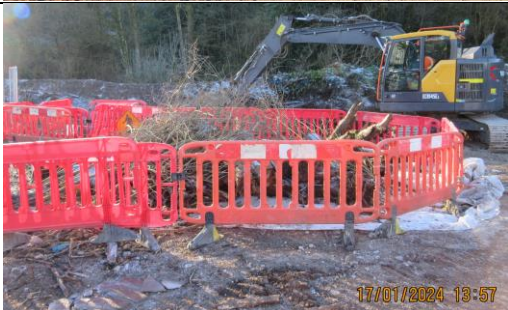
Documented.	Measures in response to item 11 in this audit.
24.	17/01/2024	Good separation of contaminated timber log pile.

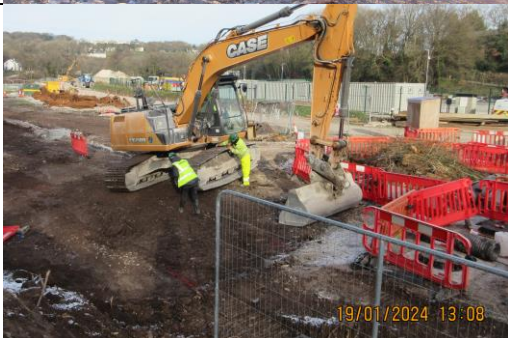
Documented.	No action required.
25.	17/01/2024	Good application of biosecurity measures.

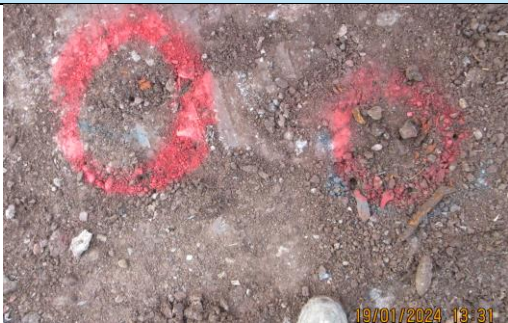
Item number	Date	Comment	Image	ECoW Action/Recommendation	Sorensens's Action
26.	17/01/2024	Good application of biosecurity measures identification of dormant JKW rhizomes and marked on GPS.

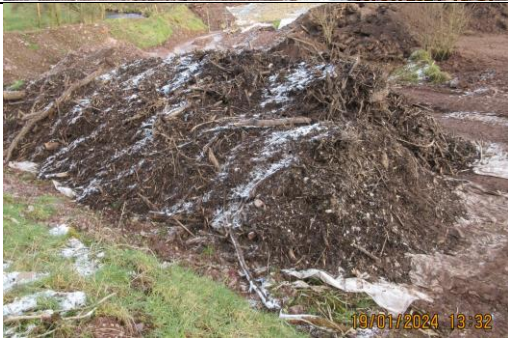
Documented.	No action required.
27.	19/01/2024	Wood chip pile in temporary stockpile area possible nesting habitat for wren (<i>Troglodytes troglodytes</i>).

Discussed with site ecologist.	To consider if moving during the bird nesting season.
28.	19/01/2024	JKW area at Sallybrook not fully fenced off.

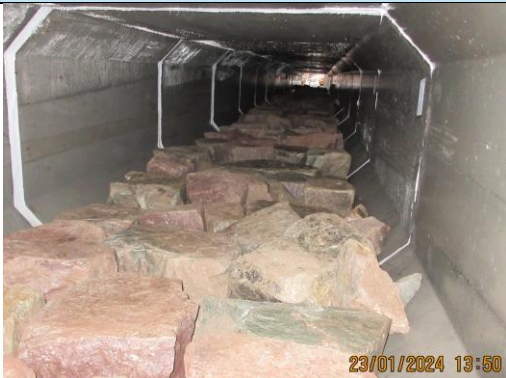
Item number	Date	Comment	Image	ECoW Action/Recommendation	Sorensens's Action
32.	23/01/2024	Springmount culvert installed with flagstones as per the design to encourage fish passage when culvert is in operation.

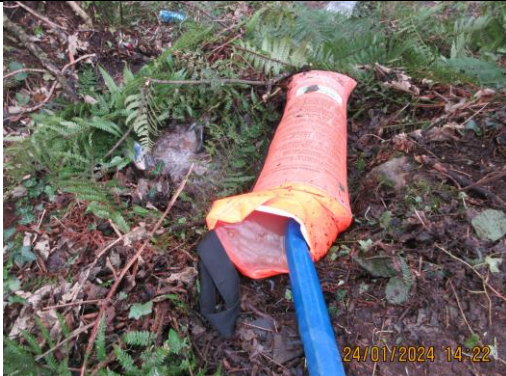
33.	24/01/2024	Pumping out works area at funeral home using newly purchased silt socks. Permit to pump in place. Sock checked regularly for silt build up.

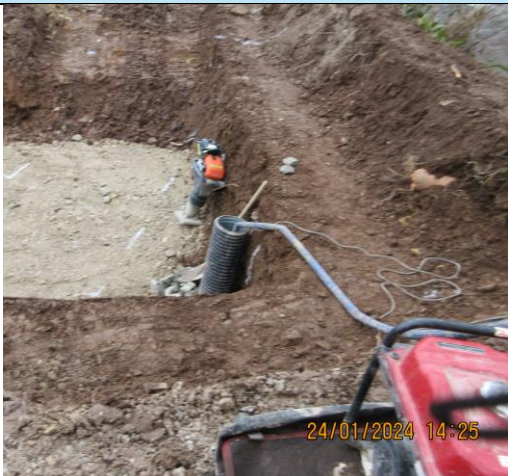
Item number	Date	Comment	Image	ECoW Action/Recommendation	Sorensens's Action
34.	24/01/2024	Sump and drip tray in use at funeral home pumping out works area.

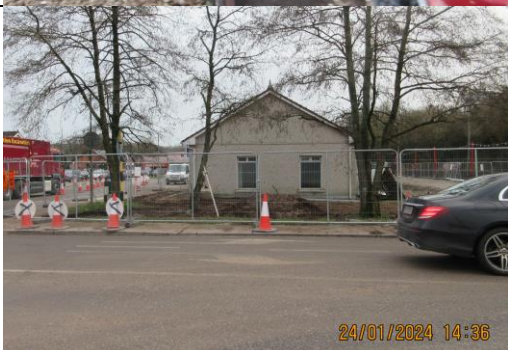
Documented.	No action required.
35.		Root damage to birch trees at Hazelwood. This could not be avoided due to the constraints in space and the wall building works.

Discussed with site ecologist.	Trees to be monitored for signs of damage relating to the works.

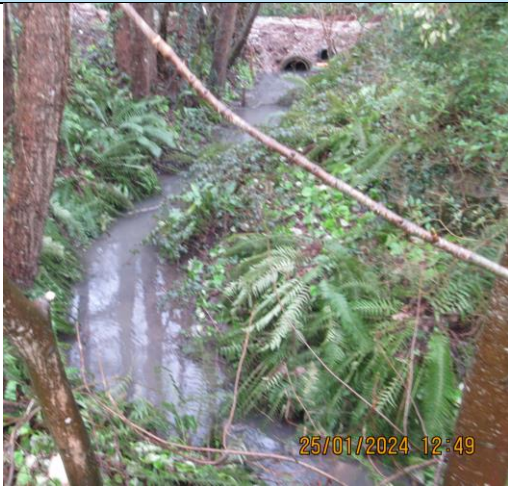
Item number	Date	Comment	Image	ECoW Action/Recommendation	Sorensens's Action
36.		Sallybrook stream /drain to be dried out a per the Design.

Discussed with site ecologist.	To consult with IFI prior to drying out stream/drain.
37.	25/01/2024	Washdown of excavator and dumper. Good adherence to biosecurity measures.

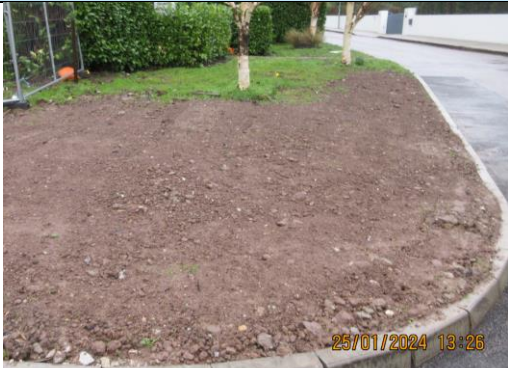
Item number	Date	Comment	Image	ECoW Action/Recommendation	Sorensens's Action
38.	25/01/2024	Topsoil reinstated at Bleach hill. Soil relocated from pump house works area at Meadowbrook housing estate. Good recycling of soil material.

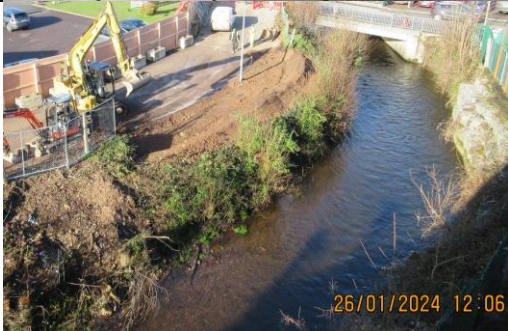
Documented.	No action required.
39.	26/01/2024	Soil consolidated along main channel to control runoff from exposed bare ground at Funeral home work site.

Documented and discussed with site ecologist.	Mesh to be installed for additional erosion control.

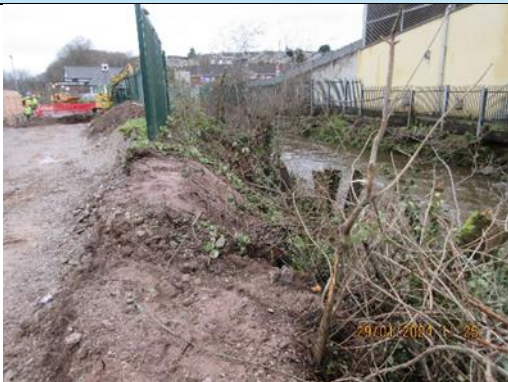
Item number	Date	Comment	Image	ECoW Action/Recommendation	Sorensens's Action
40.	29/01/2024	SSI Coir-mesh required along this section on bank to prevent erosion into main channel. Discussed during ET005.

Discussed with site ecologist.	Coir-mesh later installed.
41.	29/01/2024	Pumping out of pump house works area at Meadowbrook –not in line with GFRS-RAMS-040 Meadowbrook Pumping Station Installation.

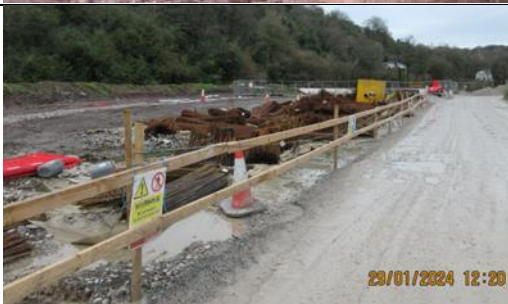
Amend silt mitigation measures immediately to conform to approved GFRS-RAMS-040.	Corrective action implemented on the 30/01/2024.
42.	29/01/2024	JKW exclusion zone fencing and sign-in improved.

Documented.	Issues implemented following issue raised in ET004.

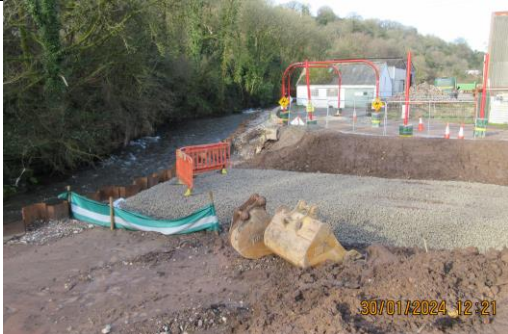
Item number	Date	Comment	Image	ECoW Action/Recommendation	Sorensens's Action
43.	30/01/2024	Filtration drain installed for Septic tank works at Sallybrook house. Good additional sediment protocol in the attenuation area.

Documented.	Continued to monitor sediment levels for the duration of works.

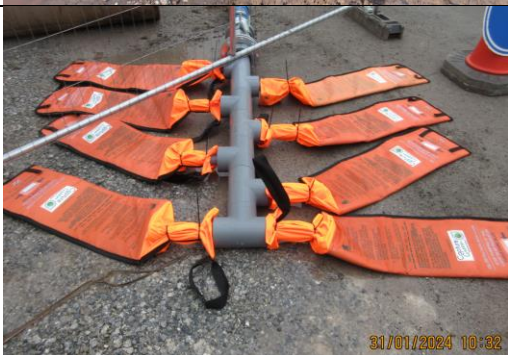
44.	31/01/2024	Siltation tank, sump and manifold system in place at pump station works area at Meadowbrook estate in line with RAMS 040.

Inspected new manifold system. Checked gully outlet in main channel for signs of sedimentation – none observed.	Actions addressed issue raised during ET005 and Item 24 in this audit.

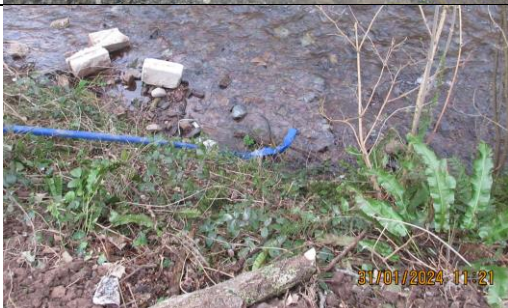
45.	31/02/2024	Pumping out works area into main channel from funeral home works area. While the water being pumped out was clean at the time of inspection, this is not best practise.

Discussed issue with GO.	GO redeployed hose to adjacent Springmount stream and attached silt sock.
