Environmental Report July 2025

Glashaboy Flood Relief Scheme

Document code: FFEC-GFRS-2025-007

The following is the clients Ecological Clerk of Works (ECoW) monthly review of the Glashaboy River (Glanmire/Sallybrook) Drainage Scheme. It details observations made on site regarding environmental and ecological factors involved in the scheme. This formulates a monthly review to be submitted to the Environmental Monitoring Group (EMG).

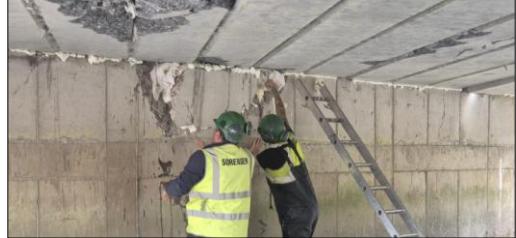
Item number	Date	Comment	Image	ECoW Action/Recommendation	Sorensens's Action response
7.1	01/07/2025	Sand martins were observed today investigating Hazelwood Shopping Centre Bridge, given that new openings are present underneath bridge due to its partial demolition for the new bridge to be built.

Liaised with site ecologist that sand martins were interacting with the bridge to prioritise blocking off as precaution.	The openings are considered unsuitable for Sand martins. However, as a precaution, expanding foam and terram were used to prevent entry and possibly establishing nesting which would delay works to complete demolition of bridge and commencement of new bridge construction works.

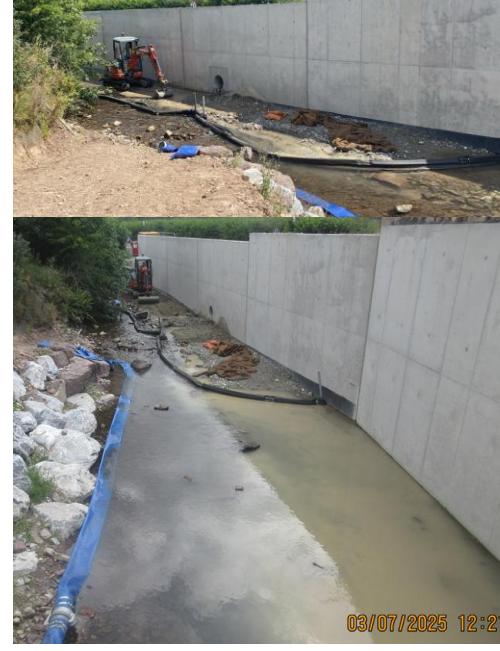
7.6	03/07/2025	<p>Works at New Line involved the removal of the temporary berm and excavation of a toe trench to anchor the rock armour. Activities were carried out in semi-dry conditions.</p>

<p>The works were supervised on site, with close coordination between the machine operator and the site ecologist.</p>	<p>The works were supervised by the site ecologist.</p> <p>Silt curtain arrangements were in place around the active work area to minimise the release of suspended solids into the watercourse. Water quality sondes were installed both upstream and downstream to record and transmit key parameters, including NTU, pH, dissolved oxygen, temperature, and conductivity.</p> <p>Start-stop protocols were implemented and enforced as needed to manage and</p>

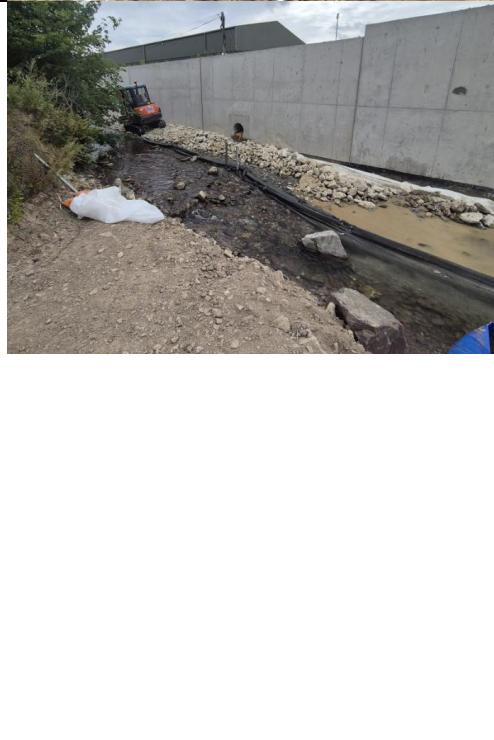
regulate silt loading during the course of the works.
7.7	04/07/2025	<p>New Line – Rock Armouring and Instream Enhancements:</p> <p>The rock armouring at the toe of the reinforced concrete wall was completed under dry working conditions.</p> <p>Adjustments were made to the existing rock armouring on the opposite bank to improve overall stability and flow conditions.</p>

<p>The works were supervised on site, with close coordination between the machine operator and the site ecologist.</p>	<p>The works were supervised by the site ecologist.</p> <p>Silt curtain arrangements were in place around the active work area to minimise the release of suspended solids into the watercourse. Water quality sondes were installed both upstream and downstream to record and transmit key parameters, including NTU, pH, dissolved oxygen, temperature, and conductivity.</p> <p>Start-stop protocols were implemented and enforced as needed to manage and</p>

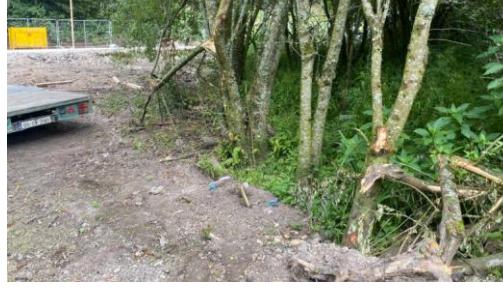
7.10	07/07/2025	<p>During works in Area 4, activity encroached onto an adjacent area due to the absence of clearly defined site boundaries. Minor limb damage to surrounding vegetation was observed. Additionally, Himalayan balsam—a biosecurity concern—was identified in the area.</p>

<p>Liaised with site ecologist about the situation.</p>	<p>Appropriate measures were implemented: damaged limbs were cleanly cut with a chainsaw, and signage and barriers were installed to clearly demarcate the site boundary and highlight the biosecurity risk.</p>

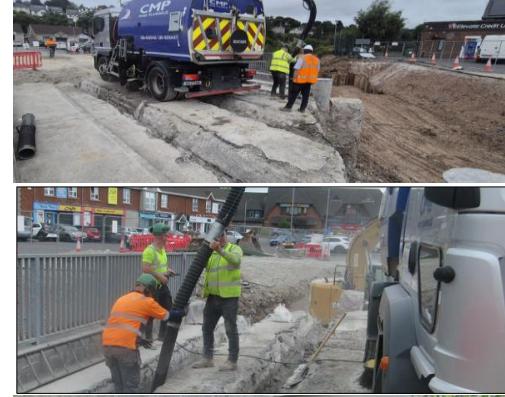
Item number	Date	Comment	Image	ECoW Action/Recommendation	Sorensens's Action response
7.11	08/07/2025	As part of preparatory works for the lifting of bridge beams from the old Shopping Centre Bridge, a road sweeper was deployed to remove dust and small debris, preventing these materials from entering the river.

Pre-works discussions were held to establish mitigation measures aimed at reducing the risk of material entering the watercourse during the operation.	Terram sheeting was also installed in the watercourse beneath the bridge to capture any falling debris during beam removal and to facilitate efficient retrieval once lifting operations are complete.

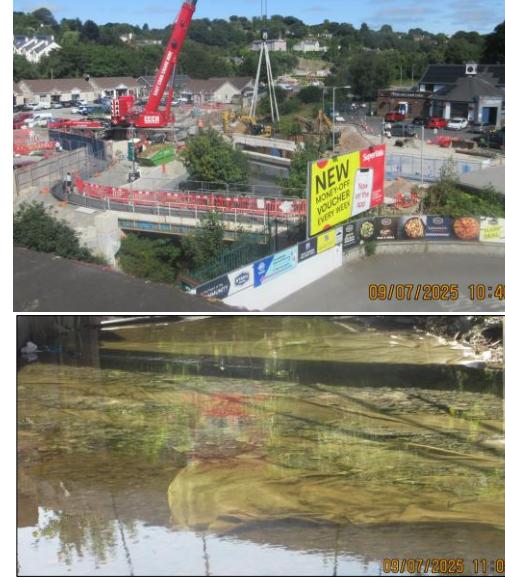
10/07/2025 11:42		
7.13	09/07/2025	<p>Bridge beams were lifted today. Some debris visibly entered the river but was largely contained by the previously installed Terram sheeting. Larger materials were moved to river margins where sheet piling for the cofferdam will create a dry working zone for removal during the upcoming abutment excavations.</p>

09/07/2025 10:40 09/07/2025 11:05	<p>Pre-works discussions were held to establish mitigation measures aimed at reducing the risk of material entering the watercourse during the operation.</p>	<p>Silt curtains were also in place downstream of Hazelwood Shopping Centre Bridge.</p>

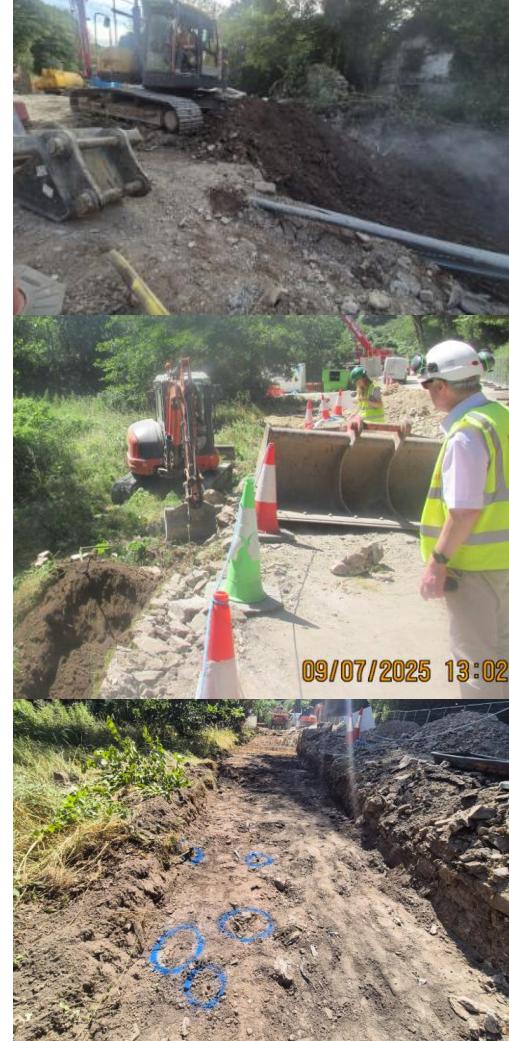
Item number	Date	Comment	Image	ECoW Action/Recommendation	Sorensens's Action response
7.14	09/07/2025	<p>Excavation works for RC Wall continuing today in Area 4 and road barriers under supervision with regards to the potential for knotweed.</p> <p>Japanese knotweed was encountered at several locations. Contaminated soil material was relocated to a temporary stockpile within Area 4, pending further direction regarding its treatment or disposal.</p>

<div data-bbox="1260 965 1477 992" style="position: absolute; color: orange;">09/07/2025 13:02</div>	Supervised works and locations for JKW.	The contaminated Japanese knotweed (JKW) soil was temporarily stockpiled within Area 4, pending the issuing of a licence from the NPWS to permit transport of the material on the public road network.

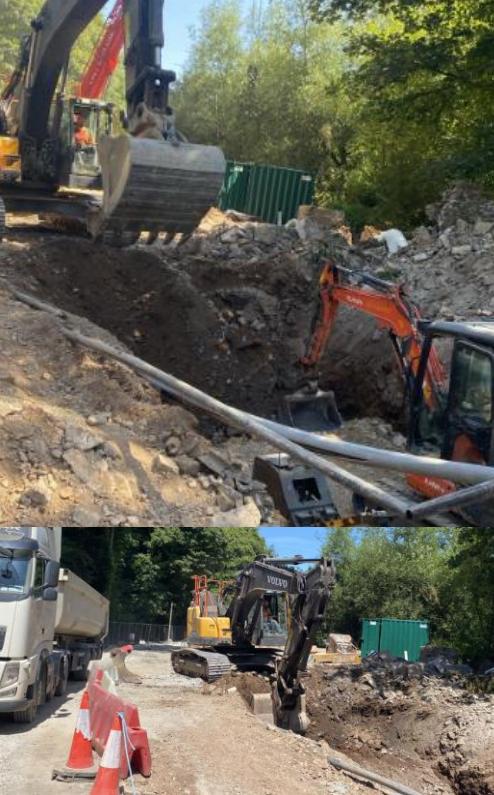
Item number	Date	Comment	Image	ECoW Action/Recommendation	Sorensens's Action response
7.16	10/07/2025	A breach of biosecurity occurred when potential Japanese Knotweed (JKW) material was moved off-site without ecological supervision.

<p>The issue was discussed with the site ecologist. An email was sent to the project manager outlining the seriousness of the situation and recommending that a formal Environmental Incident Report be completed.</p>	<p>This action was not in accordance with the biosecurity measures. However, subsequent supervision of the excavated area found no presence of Japanese knotweed which fortunately indicated that material moved off-site was clean material.</p>

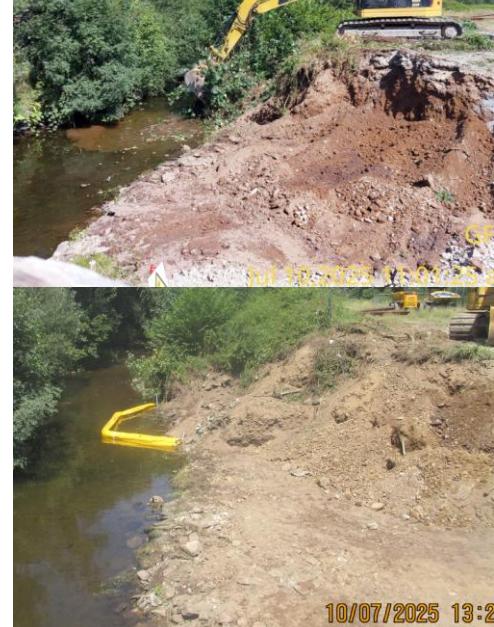
Item number	Date	Comment	Image	ECoW Action/Recommendation	Sorensens's Action response
7.17	10/07/2025	Area 2 – Overflow Culvert Works at Hazelwood Bridge Excavation commenced upstream of the overflow culvert to lower the existing riverbank and form a new channel for floodwater conveyance. A silt curtain was installed, though it was positioned retrospectively after initial groundworks had begun.

Works were supervised on site, with liaison carried out directly with the site foreman to implement appropriate silt control measures.	Particular attention was given to the potential for compounding effects, as concurrent works at the downstream bridge location on the same river were also generating silt. Measures were discussed and adjusted accordingly to manage cumulative impact on water quality

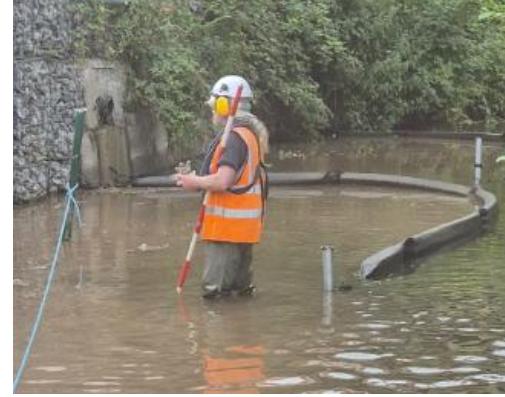
Item number	Date	Comment	Image	ECoW Action/Recommendation	Sorensens's Action response
7.19	11/07/2025	Silt curtains were repositioned at Hazelwood Shopping Centre Bridge in preparation for vegetation removal from the old stone wall immediately downstream of the shopping centre bridge, to facilitate archaeological investigation.

Partial supervision. Discussed work methods with grounds crew and archaeologist.	Good implantation of ecological controls.

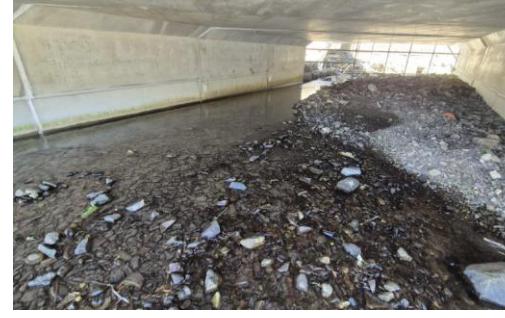
7.20	11/07/2025	Isolated pools of water beneath the Brooklodge culvert were inspected yesterday for trapped fish. Minnows were observed in a large pool near the downstream side of the culvert. To improve water flow and connectivity, deposited cobbles and gravels on the upstream side were removed, allowing fresh water to reach the pools.

Worked together with site ecologist to create outlet for trapped fish and freshwater circulation.	Appropriate measures were promptly undertaken once the situation was discovered.

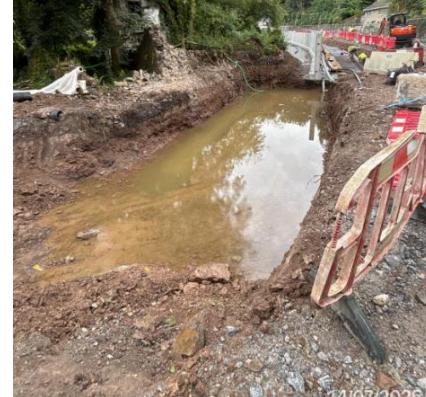
Item number	Date	Comment	Image	ECoW Action/Recommendation	Sorensens's Action response
7.21	14/07/2025	Dewatering of the excavation at Area 4 was carried out, with discharge directed to a green, vegetated area on the riverbank. Effective attenuation measures were implemented to manage the discharge.

The discharge area was regularly inspected throughout the pumping period, which spanned several days.	A permit to pump was issued, taking into account various ecological factors to ensure full compliance with environmental requirements.
7.22	15/07/2025	Excavating continuing in Area 4 for RC Walls through a known potential JKW infested area.

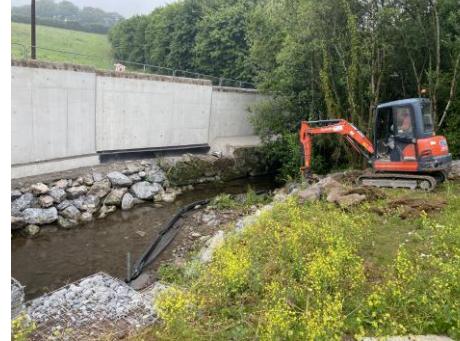
Item number	Date	Comment	Image	ECoW Action/Recommendation	Sorensens's Action response
7.23	16/07/2025	In-stream works involved the use of a small excavator to adjust and finalise the rock armour arrangement along the reinforced concrete wall downstream of the New Line bridge.

Sonde data was monitored, with particular attention to the difference in NTU levels upstream and downstream. The works were discussed with the site ecologist.	Three silt curtains set up down stream in way that also allow fish passage. Additional curtains set up around the immediate works. Water quality was monitored which the sediment load remained mostly within acceptable limits, aside from a brief spike that quickly subsided.

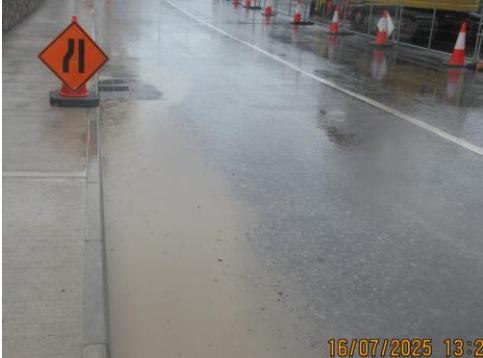
7.24	16/07/2025	Heavy rainfall has caused silty water—originating at least in part from the circus field stockpile yard—to enter the drainage system via surface gullies and drains. This water is discharging into the in-stream works at the shopping centre bridge, contributing to the sediment load associated with the sheet pile driving activities.

16/07/2025 13:22	Best practice would be to prevent silt from entering the surface water drainage network from Hazelwood Road, while still allowing water to flow to avoid flooding the roadway.	Although no preventive measures were implemented, water quality monitors were used to track NTU (turbidity) levels. The sediment load remained mostly within acceptable limits, aside from a brief spike that quickly subsided.

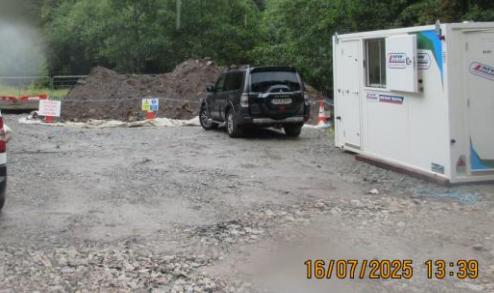
7.25	16/07/2025	Earth material excavated within Area 4 for the reinforced concrete (RC) wall, which is contaminated with Japanese Knotweed (JKW), has been stockpiled on a floodplain. The associated risks were communicated to the SCE, who acknowledged and accepted liability for these risks.

Discussed with site ecologist.	SCE are willing to accept the low risk, considering the time of year and the unlikely combination of significantly elevated water levels and severe weather conditions that would be required for this area to flood. The material is expected to be removed within the next few weeks, once the Regulation 49(2) transport licence is issued by the NPWS.

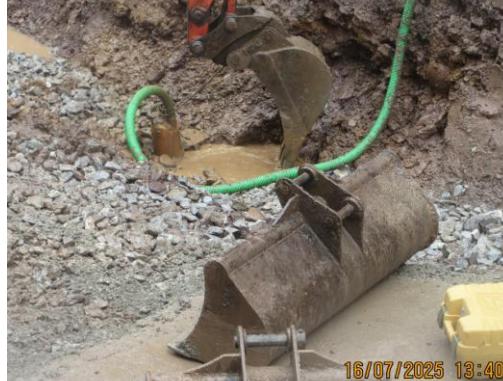
Item number	Date	Comment	Image	ECoW Action/Recommendation	Sorensens's Action response
7.26	16/07/2025	Area 4: Pumping of excavation ground water was being pumping without a sump installed.

When observed the sump was being installed.	The discharge location for this silty water occurred onto vegetated ground set back from the watercourse, allowing for effective filtration of sediment.

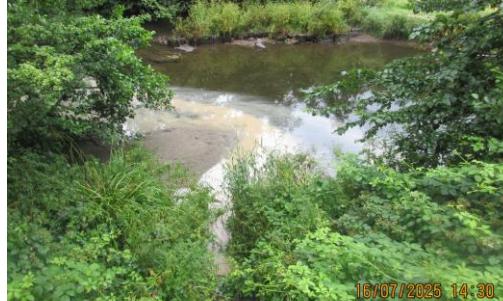
7.27	16/07/2025	Heavily silt-laden water was observed discharging from an outlet just upstream of the work site in Area 4. The source of this sediment load was investigated but could not be definitively identified.

Investigated the source and communicated the incidents to SCE and CCC. Informed IFI local officer via email.	This sediment discharge originates from a third-party source and is not the responsibility of the main contractor.

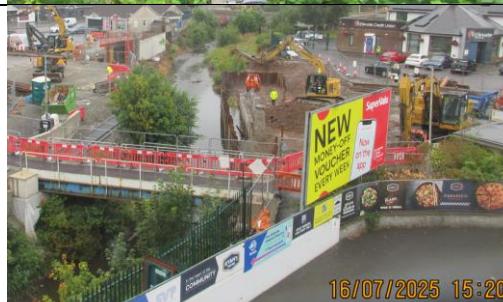
7.28	16/07/2025	Pile cropper was observed in operation which resulted in a few chunks of concrete falling into the coffer dam where aquic species may be present.

Advised caution which was acknowledged.	This was a single test of the cropper, which will not be used again until the cofferdam has been closed and backfilled, following the completion of electrofishing.

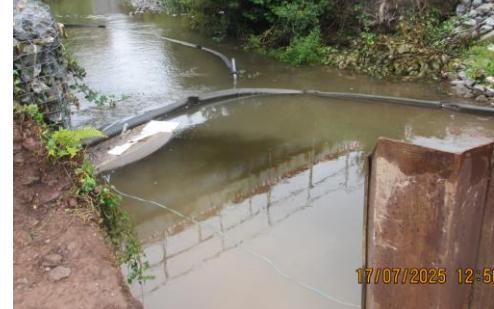
Item number	Date	Comment	Image	ECoW Action/Recommendation	Sorensens's Action response
7.29	17/07/2025	A surface slick was observed on the water at Hazelwood, accumulating around the silt curtain installed to control sediment from the sheet piling works taking place today.

A photograph showing a surface slick of oil or chemical on the water near a concrete wall and a silt curtain. The date 17/07/2025 12:50 is visible in the bottom right corner of the image.	Investigated the source and communicated to site ecologist once found.	Bioversal and absorbent pads were deployed as control measures. The source was investigated and found to have originated, at least in part, from activities where shuttering for the reinforced concrete (RC) walls was being sprayed down with a hydrocarbon-based material. Once identified, absorbent pads were installed around the gully, and Bioversal was applied to all visible residues.

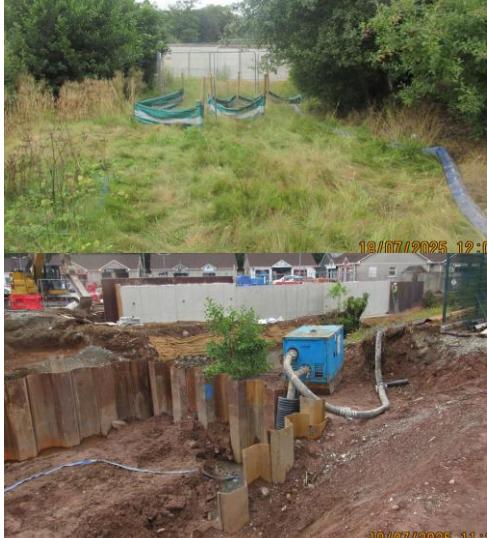
Discussed works and findings with site ecologist.	The e fishing was carried out professionally and in line with conditions granted by the license.
7.32	18/07/2025	Pumping commenced on the eastern coffer dam at hazelwood.

Inspected silt curtains and reviewed permit to pump.	The discharge at this location occurred on a grassed area near the Credit Union. Double silt curtains were installed to help attenuate the flow of silty water.

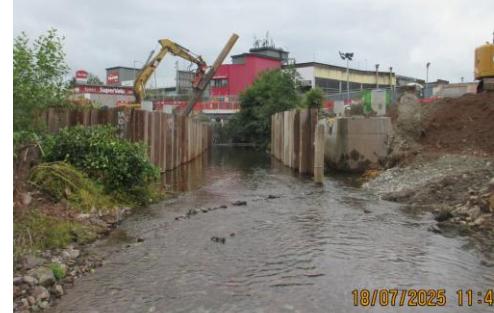
Item number	Date	Comment	Image	ECoW Action/Recommendation	Sorensens's Action response
7.33	18/07/2025	The eastern cofferdam was completed following electrofishing. Sheet piling was then carried out in dry conditions, rather than in the river, to minimise silt generation from the works.

18/07/2025 11:40	Documented.	Good silt management practices were in place, including the use of downstream silt curtains and ongoing water quality monitoring.

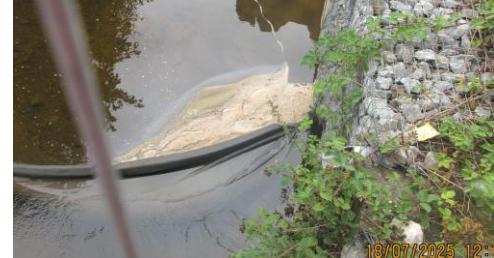
7.34	18/07/2025	A build-up of scum and residue was observed at the upstream silt curtain in Hazelwood. This area receives washout from an outlet pipe located a few metres upstream on the opposite bank which originate from the western hazelwood shopping centre building site.

18/07/2025 12:19	Raised issue to site ecologist.	The issue was actioned promptly, with Bioversal applied and fresh oil absorbent pads deployed.

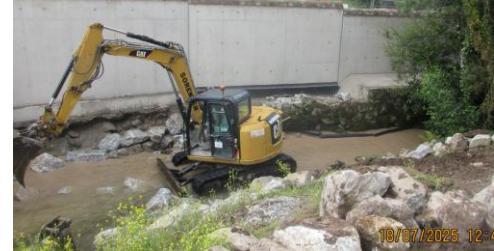
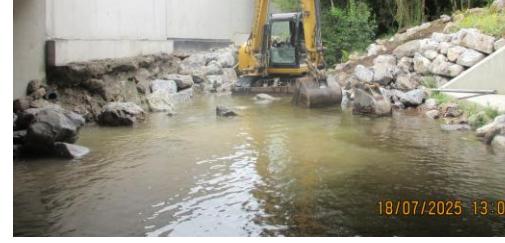
7.35	18/07/2025	Works continued today on the downstream side of the structure at New Line. The activities resulted in unavoidable silt generation, as temporary rock armour had to be removed and replaced with permanent

Item number	Date	Comment	Image	ECoW Action/Recommendation	Sorensens's Action response
		rock armour, which required adjustment to achieve the correct placement. The presence of lean mix within the temporary rock armour contributed to a spike in pH only briefly.

18/07/2025 12:44	Monitored the works and liaised with the driver and site ecologist to implement appropriate	A stop-start protocol was in place to manage silt loads in the Glanmore river. The river was monitored using sondes, with particular focus on dissolved oxygen, pH, and turbidity levels today. Silt curtains were installed to

mitigation measures.	slow the flow and help reduce turbidity. Mitigation measures were well applied, and the driver demonstrated good discipline in following the stop-start procedure and maintaining strong silt awareness.

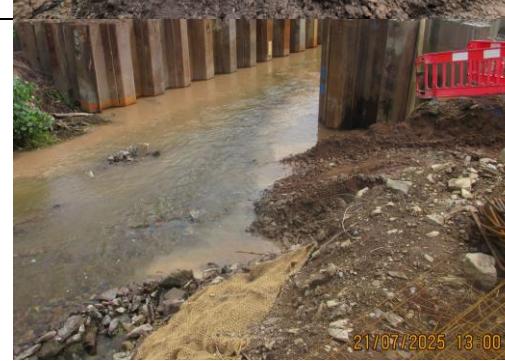
7.37	21/07/2025	The access ramp into the river at Hazelwood was not ideal, as loose soil material was exposed adjacent to the watercourse, resulting in minor and avoidable sediment mobilisation. However, following the exit of the Movax from the river following sheet piling, the bank was scraped back and some stone was added,

Raised issue with site ecologist.	The situation was remedied as soon as possible. The ramp will receive regular maintenance as plant continues to enter and exit the river via this access point.

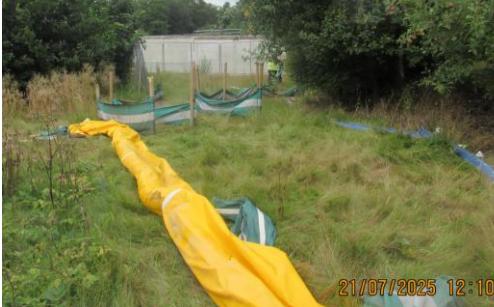
Item number	Date	Comment	Image	ECoW Action/Recommendation	Sorensens's Action response
		improving the condition and stability of the access point.			
7.38	21/07/2025	<p>The attenuation area within the grounds of the Credit Union was inspected and found to be functioning poorly.</p> <p>However, progress was slow, and the outcome could have been improved with closer supervision, greater on-site oversight, and increased availability of materials. As completed, the measures still fell short of fully achieving their intended purpose.</p>

<p>Liaised with site ecologist regarding improvements and adjustments.</p>	<p>Additional silt curtains, ground cover, and silt fencing were deployed.</p>

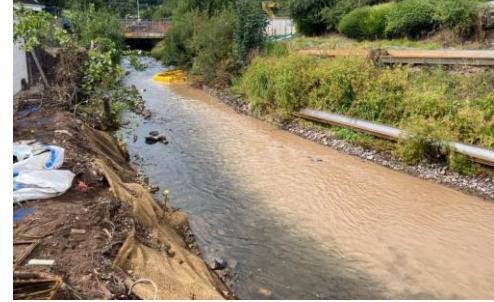
Item number	Date	Comment	Image	ECoW Action/Recommendation	Sorensens's Action response
7.44	22/07/2025	<p>In addition to the subpar attenuation setup for dewatering at the Hazelwood Shopping Centre bridge works area, there is a combined effect contributing to sediment issues. The heavy downpour has washed out fines along Hazelwood Road and works in hazelwood shopping centre originating from the works. This issue remains unaddressed, despite it being raised last week.</p>

<p>Ongoing monitoring of NTU levels via the online sondes data. Liaised with site foreman via shared Ecology Whats App.</p>	<p>Cobbles and boulders were used within the coffer dam channel to slow and filter the water. Ongoing efforts were made to reduce the water entering the coffer dam by sealing the sheet pile clutches. Digging was stopped on a number of occasions in effort to reduce the silt being generated from excavations and dewatering.</p>

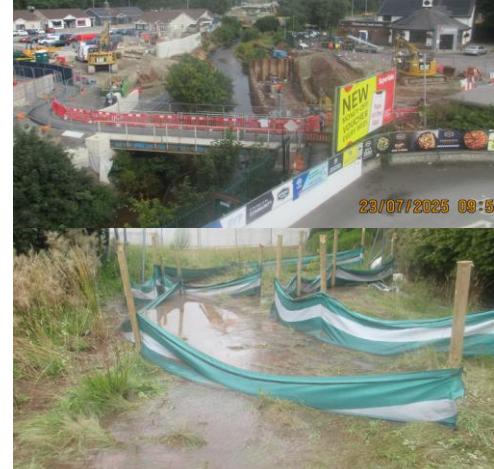
7.45	23/07/2025	<p>In response to elevated silt levels observed on the evening of the 22nd, mitigation measures were improved to better control sediment entering the Glashaboy River from the works at the Hazelwood Shopping Centre Bridge site.</p>

<p>Ongoing monitoring of NTU levels via the online sondes data. Ongoing discussions with site ecologist regarding silt management.</p>	<p>The following measures were implemented as part of the silt control strategy. A large silt sock was attached to the hose outlet to filter discharged water. Coir mesh was installed within the drainage channel inside the cofferdam, as well as on the top of the bank at the location of the discharge point. A controlled release of</p>

Item number	Date	Comment	Image	ECoW Action/Recommendation	Sorensens's Action response
					silt from the upstream silt curtain was carried out, and the curtain was subsequently adjusted to run parallel to the bank to improve its effectiveness.

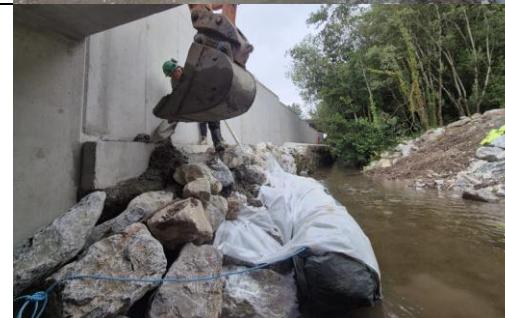
need to remove the material prior to heavy rains occurring.	such issues across the scheme's sites.
7.53	23/07/2025	Blinding was placed over the rock armouring at New Line. Bean bags and Terram were installed as control measures to contain cementitious materials. Additionally, Terram was placed within the rock

Liaised with site ecologist regarding the mitigation measures required for these works.	Well-conceived and implemented control measures. Notable improvement on yesterday's performance.

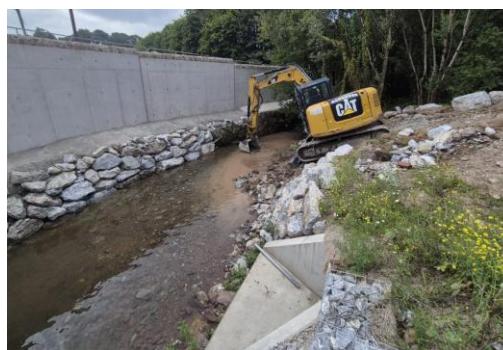
7.54	24/07/2025	Rock armour works at New Line was carried out. This resulted in short spikes in the turbidity levels which was unavoidable given the intrusive nature of the works.

Checks were carried out to ensure that works were undertaken in accordance with works specifications and general best environmental practice.	Start-stop protocols were in place, alongside silt curtains and periodic supervision of the physical works. Continuous monitoring was maintained via the sondes and through ongoing communication with the excavator operator.
