Environmental Report September 2025

Glashaboy Flood Relief Scheme

Document code: FFEC-GFRS-2025-009

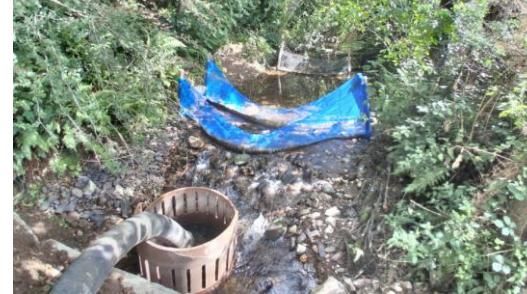
| Item number | | Comment | Image | ECoW Action/Recommendation | Sorensens's Action response |
|---|---|--|--|---|---|
| 9.1 | 01/09/2025 | <p>Over pumping of the Glenmore River is currently in place to facilitate works upstream of Brooklodge Culvert, including the installation of wing walls, rock armour, and step pools. Fish and debris netting has been installed above the pump to prevent the entrainment of fishery species. Regular maintenance of the fish guards will be required throughout the month to ensure the continued effectiveness of the netting.</p> | | <p>Periodic checks were carried out throughout the month to ensure that the fish guards remained fully effective.</p> | <p>The fish guards were maintained to good extent throughout the month while over pumping was in operation.</p> |

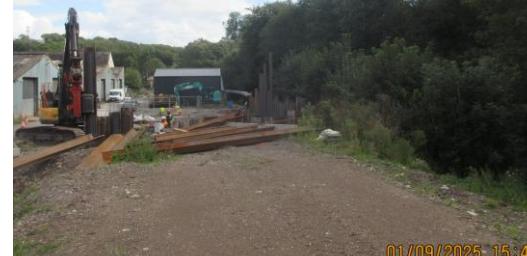
| Item number | | Comment | Image | ECoW Action/Recommendation | Sorensens's Action response |
|---|---|--|--|---|---|
| 9.2 | 01/09/2025 | <p>Sheet piling continued at Sallybrook. Biosecurity measures in place as Japanese knotweed was in the area.</p> | | <p>Supervised and inspected area to ensure biosecurity measures were adhered to.</p> | <p>The sheet piling works were carried out in line with all biosecurity measures. No additional material was added to the holding cell associated with these works.</p> |

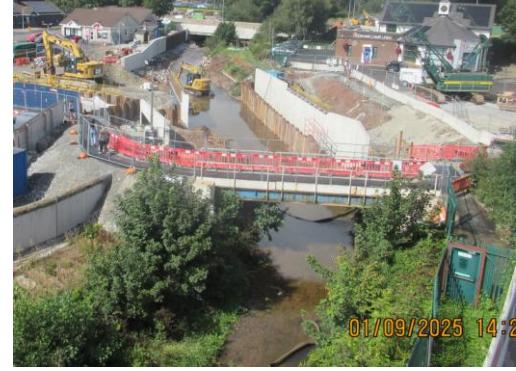
| Item number | | Comment | Image | ECoW Action/Recommendation | Sorensens's Action response |
|---|---|---|---|--|---|
| 9.3 | 01/09/2025 | Machine tracking instream at Hazelwood Shopping Centre Bridge to complete rock armouring along western flood defence wall. | | Monitoring of water monitor's parameters to ensure controls were having an effect. | The majority of the rock armour works were completed under semi-dry conditions by establishing a shallow bund between the excavation area and the main river flow. This approach significantly reduced siltation and proved more effective than initially anticipated. |

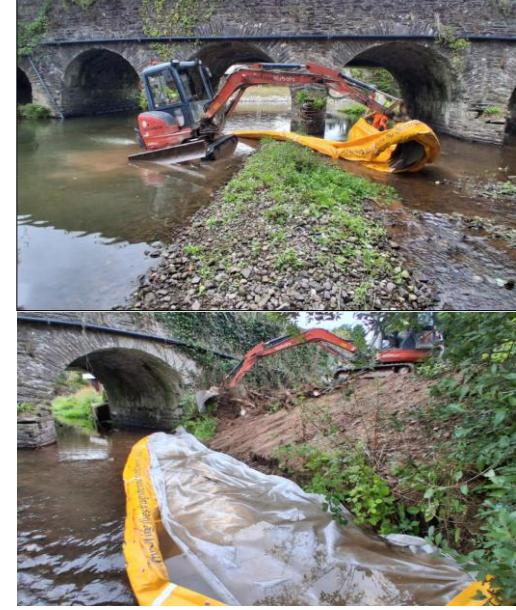
| Item number | | Comment | Image | ECoW Action/Recommendation | Sorensens's Action response |
|---|---|---|---|--|---|
| 9.4 | 02/09/2025 | Small track machine tracking instream just downstream of John O Callaghan bridge, to complete erosion matting on lefthand bank downstream of bridge. The main concern here is the visible presence Japanese knotweed. | | Surveyed area prior to works to establish up to date ground conditions and evaluate biosecurity measures required. Monitored progression of works and reviewed biosecurity measures implemented. | Biosecurity measures were successfully implemented for these works. Silt curtains lined with Terram were installed to capture any fragments of Japanese Knotweed that might enter the waterway during excavation. A boot-wash station was also provided. All works were supervised and directed by the site ecologist accordingly. All contaminated material was left in place and was added to the 2025 spraying |

| Item number | | Comment | Image | ECoW Action/Recommendation | Sorensens's Action response |
|---|---|---|---|---|---|
| | | | | | programme as per the Biosecurity Plan and Work Requirements. |

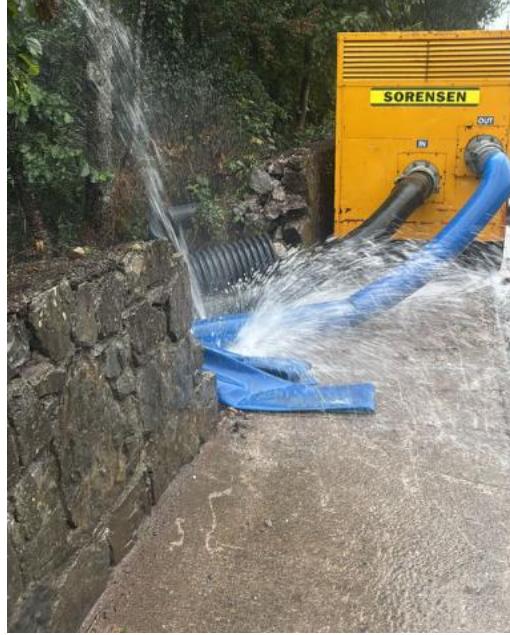
| Item number | | Comment | Image | ECoW Action/Recommendation | Sorensens's Action response |
|---|---|---|---|---|---|
| 9.5 | 03/09/2025 | <p>Glenmore overpumping: A lay-flat hose burst and discharged water into the dry works area and into the secondary pump located in a sump, in operation to pump out ground water. The dry works area contained lean-mix concrete. This incident caused a temporary spike in pH alkalinity that narrowly exceeded the threshold. However, the exceedance was short in duration. Given the heavy rainfall earlier in the day, additional natural dilution occurred, which further reduced any potential impact.</p> | | <p>Inspected the location after the incident occurred. Spoke with grounds crew and head foreman regarding the incident.</p> | <p>The affected hose section was promptly replaced, with additional clamps installed to secure it. Going forward, maintenance checks of hoses will be conducted alongside routine inspections of the fish guards to prevent recurrence.</p> |

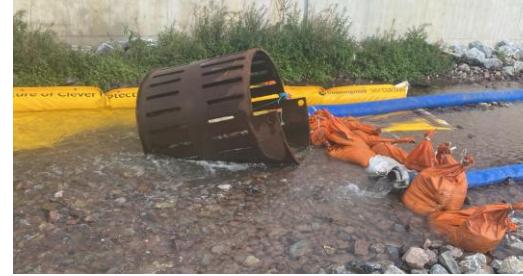
| Item number | | Comment | Image | ECoW Action/Recommendation | Sorensens's Action response |
|---|---|---|---|--|--|
| 9.6 | 03/09/2025 | The discharge location of the over pumping at Glenmore river has scoured out a gravel section previously installed to improve river ecology. | | Discussed situation with site ecologist who informed plans are for remedial works when pumping ceases. | Scouring occurred despite attempts to prevent this through the use of the heavy steel cage. Plans are in place to regrade the gravels at this location post pumping. |

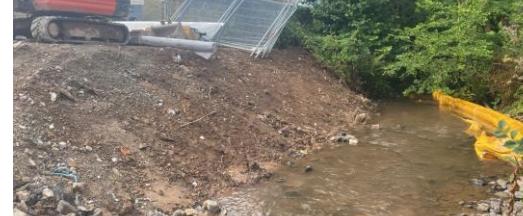
| Item number | | Comment | Image | ECoW Action/Recommendation | Sorensens's Action response |
|---|---|---|---|--|--|
| 9.7 | 03/09/2025 | Coir mesh was originally to be installed here following riverbank works. Upon inspected no such action had been carried out yet. | | Installed erosion protection cover. | Temporary mesh was installed temporarily as this bank is due to be regrading later in the month. No significant rain occurred during the interim period. |

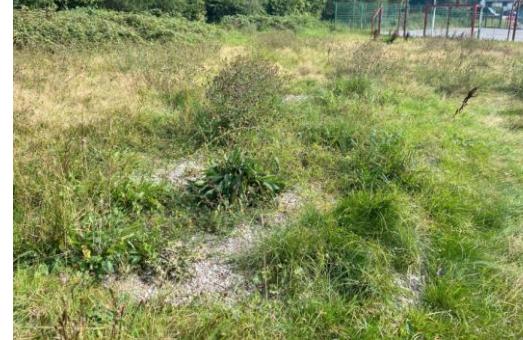
| Item number | | Comment | Image | ECoW Action/Recommendation | Sorensens's Action response |
|---|---|---|---|--|--|
| 9.8 | 03/09/2025 | A minor amount of gravel remains in the green area aside the basketball court. This was part for a former set up to manage silty water from excavation works at Hazelwood. There appears to be no ecological negative impact from leaving the gravel in place and appears that it contributes positively by supporting floral diversity at this location. | | Recommended leaving small amount of gravel in place for biodiversity reasons. | Long term, it's not clear what plans are for this area, if any, in the meantime the marginal amount of gravel has been left in place. |

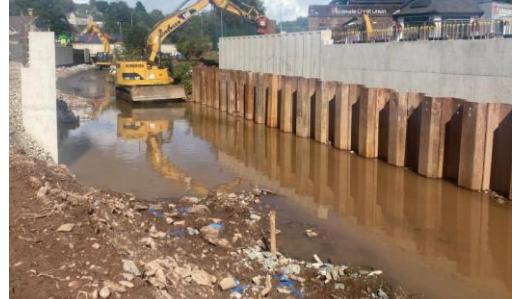
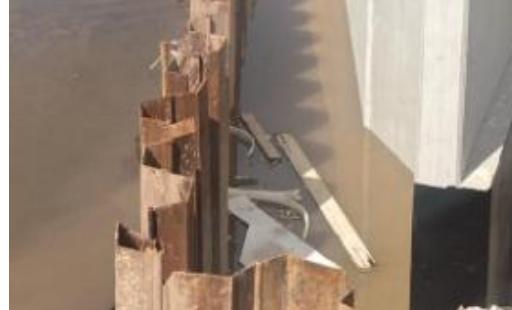
| Item number | | Comment | Image | ECoW Action/Recommendation | Sorensens's Action response |
|---|---|---|--|--|---|
| 9.9 | 04/09/2025 | <p>Sheet piles were removed from around the eastern abutment at Hazelwood. This generated silt, causing a series of turbidity spikes downstream. However, turbidity levels were not sustained and quickly returned to normal after each spike. Such highly intrusive instream works are unavoidable. While additional silt curtains might have slowed the silt release, it is very much a case of weighing trade-offs regarding the best approach, as silt generation is inevitable. Whether it is better to release the silt over a shorter or longer timeframe remains open to debate.</p> <p>Fisheries species have moved away from the area in response to the disturbance.</p> | | <p>Monitored works and water sondes. Liaised with site ecologist and site foreman.</p> | <p>The works proceeded despite visual conditions appearing severe, at least from a casual observation perspective. Silt curtains were in place at several locations downstream of the works area to control suspended solids which received a control release at the end of the end. Water quality sondes were regularly monitored. Construction waste and debris contained within the sheet-piled area were removed prior to the removal of the sheet piles.</p> <p>The river substrate remains silted and will require heavy rainfall to flush them before conditions return to normal.</p> |

| Item number | | Comment | Image | ECoW Action/Recommendation | Sorensens's Action response |
|---|---|--|--|--|---|
| | | The water cleared itself once piling works were completed. | | | |

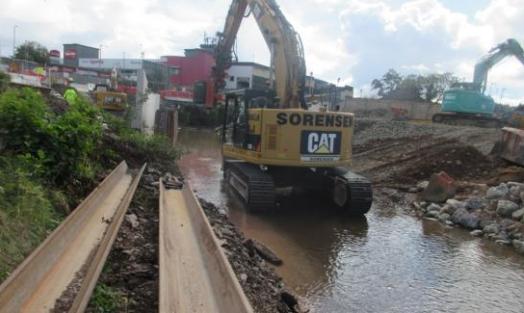
| Item number | | Comment | Image | ECoW Action/Recommendation | Sorensens's Action response |
|---|---|--|--|--|---|
| 9.10 | 05/09/2025 | During works at Hazelwood Shopping Centre Bridge, a machine operating within the river to remove sheet piles encountered a deep pool in the riverbed. To stabilise its position and manoeuvre safely, the operator was required to disturb and infill the affected area using available riverbed material. This activity resulted in a temporary but significant increase in turbidity levels. However, the turbidity spike was short-lived. | | Monitored sondes remotely and liaised with the site ecologist regarding the observed turbidity spikes. Recommended a temporary cessation of works to allow turbidity levels to stabilise before resuming operations. | Once elevated turbidity levels were detected, site personnel liaised with the site ecologist to assess the situation. The contractor implemented a temporary suspension of in-stream movements to allow turbidity levels to reduce. |

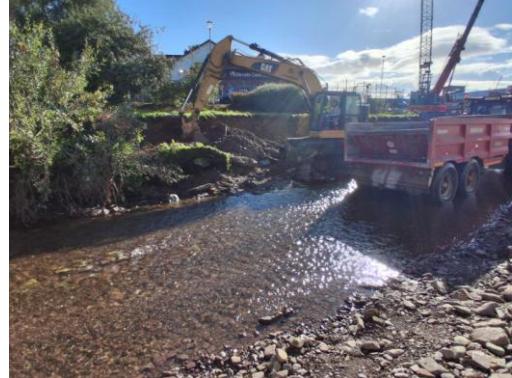
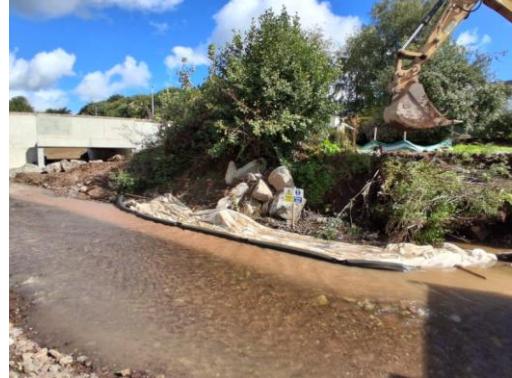
| Item number | | Comment | Image | ECoW Action/Recommendation | Sorensens's Action response |
|---|---|---|---|---|--|
| 9.12 | 08/09/2025 | <p>Works are progressing along the riverbank at the Credit Union to facilitate the installation of the new sheet pile wall design. Biosecurity protocols were implemented to prevent the spread of invasive species JKW. Vegetation clearance was undertaken as part of the works, with the relevant Permit to Clear Vegetation in place.</p> | | <p>Site inspection to check mitigations are in place.</p> | <p>All activities were conducted under ecological supervision and were carried out to a high standard of environmental management overall.</p> |

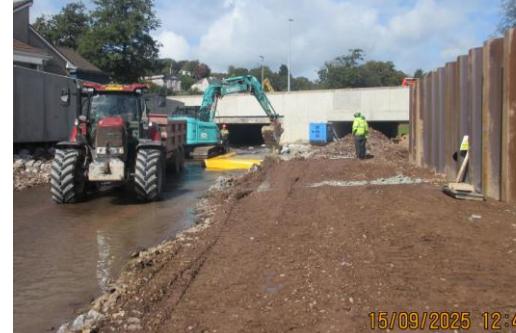
| Item number | | Comment | Image | ECoW Action/Recommendation | Sorensens's Action response |
|---|---|--|--|--|---|
| 9.13 | 09/09/2025 | Digging toe for rock armour at Hazelwood. | 15/09/2025 12:47 | Supervised works and liaised with site ecologist and grounds crew periodically throughout the day. | Following the initial excavation, works were relocated from the river channel to a dry, flat area. This helped reduce the potential for river siltation and allowed easier containment of the excavation area using a silt curtain arrangement. River gravels excavated from the channel were inspected for the presence of fish species. |

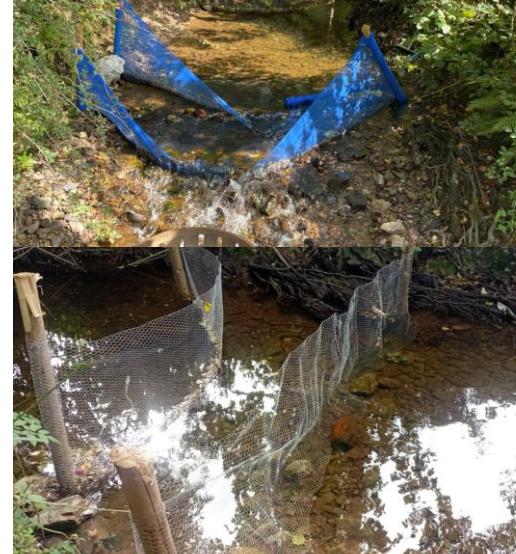
| Item number | | Comment | Image | ECoW Action/Recommendation | Sorensens's Action response |
|---|---|--|--|--|---|
| 9.14 | 09/09/2025 | Fencing at Brooklodge required maintenance when inspected. | | Liaised with site ecologist who directed site personnel to carry out urgent maintenance. | Maintenance was carried out that day. Additional measures have been placed above the fish guards to address increasing leaf fall. |

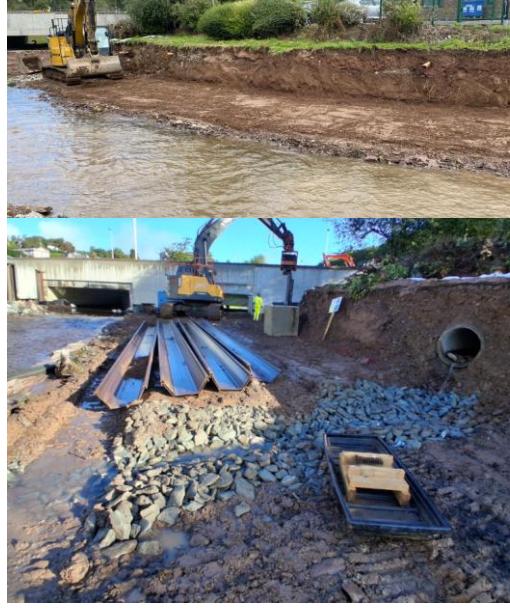
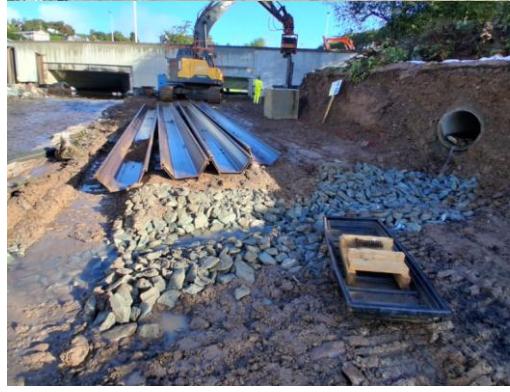
| Item number | | Comment | Image | ECoW Action/Recommendation | Sorensens's Action response |
|---|---|---|--|--|--|
| 9.15 | 09/09/2025 | Sheet piling has commenced in the dry at the Credit Union. Biosecurity protocols are in place. | | Monitor water levels and take steps to protect works area if required. | Conditions for September were very dry which really assisted works in the area and removed the need for certain mitigation measures. |

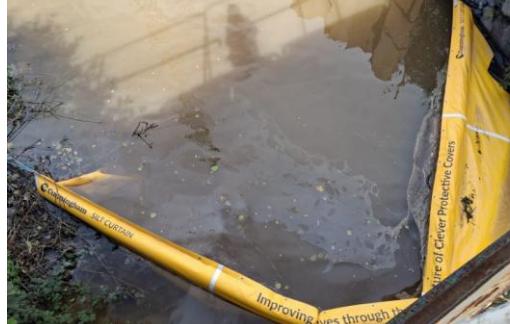
| Item number | | Comment | Image | ECoW Action/Recommendation | Sorensens's Action response |
|---|---|---|--|--|--|
| 9.16 | 10/09/2025 | Hydrocarbon sheen at Hazelwood Shopping Centre Bridge was observed today above one of the silt curtains in place. | | Treat with bioversal before releasing silt curtain at end of day. | Bioversal was applied to address hydrocarbon sheen at Hazelwood Shopping Centre Bridge. Plant working in the river were checked for leaks with none found. |

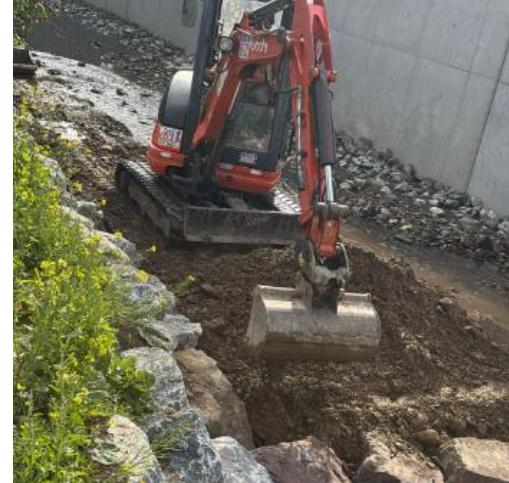
| Item number | | Comment | Image | ECoW Action/Recommendation | Sorensens's Action response |
|---|---|--|---|--|--|
| 9.19 | 12/09/2025 | <p>Additional river gravels were placed in the step pools at New Line. These works were carried out as part of ongoing adjustments to the steps at New Line, which currently do not provide adequate fish passage during low flow levels. The addition of river gravel is intended to raise water levels and fill gaps in the steps.</p> | | <p>Install gravels and reassess the situation if further measures are required to boost fish passage in low flows.</p> | <p>Works were carried out professionally with regard to the environment. Short term siltation inevitable occurred but were short in duration.</p> |

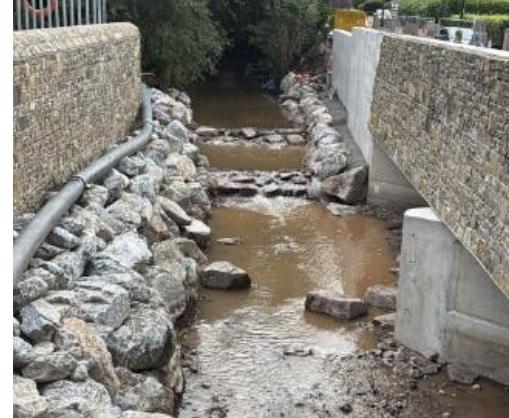
| Item number | | Comment | Image | ECoW Action/Recommendation | Sorensens's Action response |
|---|---|--|---|--|--|
| 9.20 | 12/09/2025 | <p>The dam at Brooklodge Culvert was removed following the completion of flood defence works, which included the installation of step weirs designed to moderate flow levels over a gradient drop and provide fish passage.</p> | | <p>Liaised with site ecologist while monitoring sondes remotely.</p> | <p>The works created unavoidable siltation downstream as dry work areas were rewetted. The siltation was relatively low and brief in duration, and once cleared, conditions returned to normal levels.</p> |

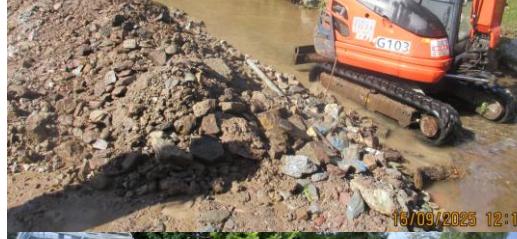
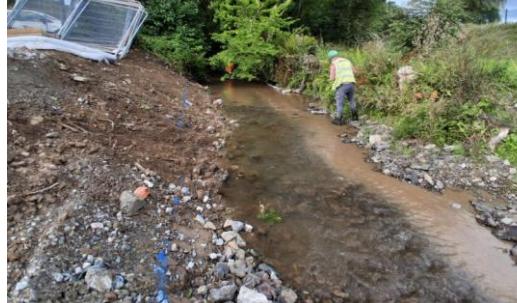
| Item number | | Comment | Image | ECoW Action/Recommendation | Sorensens's Action response |
|---|---|--|---|--|---|
| 9.21 | 15/09/2025 | Riverbank downstream of Copper Valley Vue bridge involved bank regrading and tracking the river. | | Liaised with site ecologist and conducted periodic inspections while monitoring the water sondes for NTU levels. | The works were supervised periodically by the site ecologist. Start-stop procedures and silt curtains were in place to manage silt levels. High spikes in silt were followed by periods of rest to allow conditions to stabilise. |

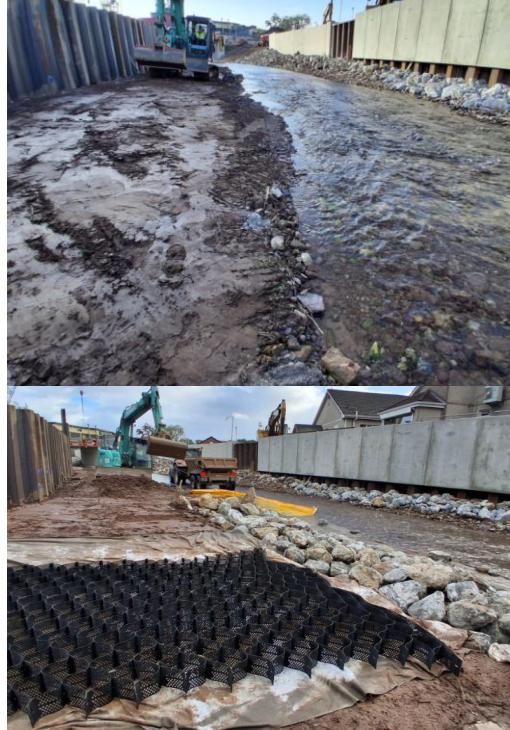
| Item number | | Comment | Image | ECoW Action/Recommendation | Sorensens's Action response |
|---|---|--|---|--|---|
| 9.22 | 15/09/2025 | <p>Hazelwood: Rock armouring commenced along the Credit Union side. These works also included the levelling of ground and installation of geocell erosion matting which forms the outlet to the new overflow culvert constructed at the hazelwood road bridge.</p> | | <p>Held discussions with the site ecologist regarding the planned works.</p> | <p>The works were carried out professionally under ecological guidance. Weather conditions were monitored on an ongoing basis, as a rise in water levels could affect the works area. Works were carried out during the dry weather window which persisted for the majority on the month.</p> |

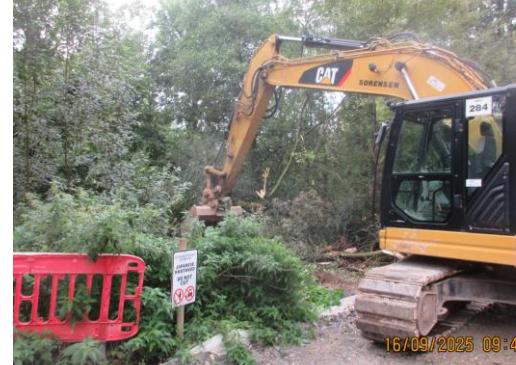
| Item number | | Comment | Image | ECoW Action/Recommendation | Sorensens's Action response |
|---|---|--|--|--|---|
| 9.23 | 16/09/2025 | Excavations and vegetation clearance for storm water outfall within JKW area in Area 4. | | Examined area and confirmed JKW extent with site ecologist. | The operations were carried out to ensuring that works were undertaken in accordance with the Biosecurity Plan and general best environmental practice. |

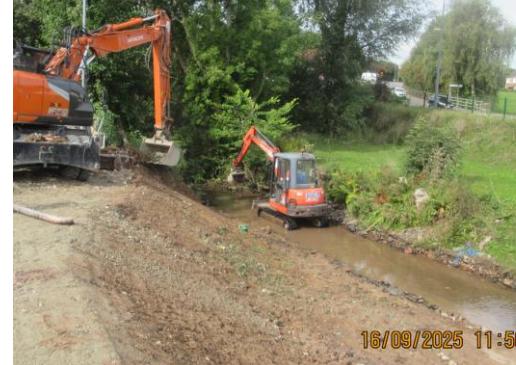
| Item number | | Comment | Image | ECoW Action/Recommendation | Sorensens's Action response |
|---|---|--|--|--|---|
| 9.24 | 16/09/2025 | Regrading of riverbank at Copper Vally Vue bridge and adjusting riverbed to design levels. Trees and debris fallen across the river were also removed. | | Liaised with site ecologist and conducted periodic inspections while monitoring the water sondes for NTU levels. | The works were supervised periodically by a site ecologist. Start-stop procedures and silt curtains were in place to manage silt levels. High spikes in silt were followed by periods of rest to allow conditions to stabilise. |

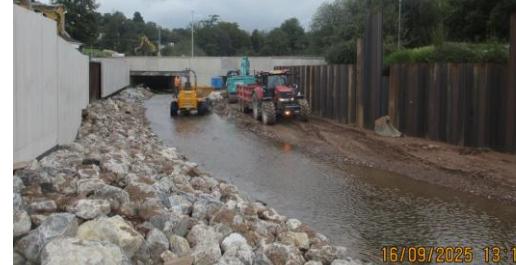
| Item number | | Comment | Image | ECoW Action/Recommendation | Sorensens's Action response |
|---|---|--|--|--|---|
| 9.25 | 16/09/2025 | Rock armour works continue at Credit Union side at Hazelwood. | | Held discussions with the site ecologist regarding the planned works. | Silt management measures included carrying out works primarily from dry areas and minimising movement within the riverbed. |

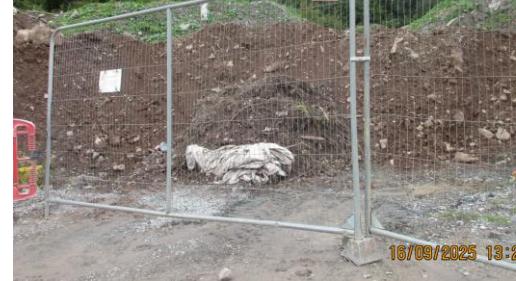
| Item number | | Comment | Image | ECoW Action/Recommendation | Sorensens's Action response |
|---|---|---|---|---|--|
| 9.26 | 16/09/2025 | Additional material added to holding cell at Sallybrook, from excavations at Credit Union. | | Checks were carried out to ensure that works were undertaken in accordance with the SCE Biosecurity Plan. | Implementation of Biosecurity plan. |

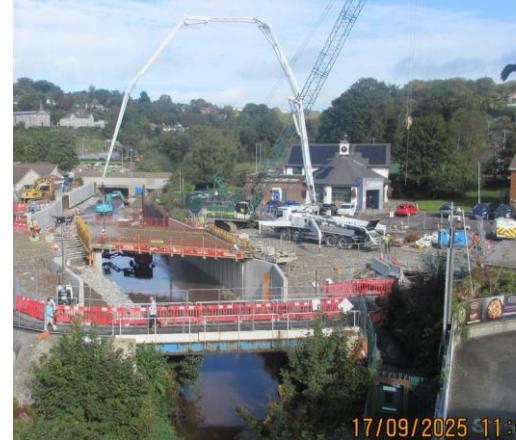
| Item number | | Comment | Image | ECoW Action/Recommendation | Sorensens's Action response |
|---|---|---|---|---|--|
| 9.27 | 17/09/2025 | Cement pouring on deck of new bridge. All wet cement contained within the deck steelwork by shuttering. | | Conducted site inspections. | Cement was applied carefully and gradually ensuring no wet cement entered the watercourse. |

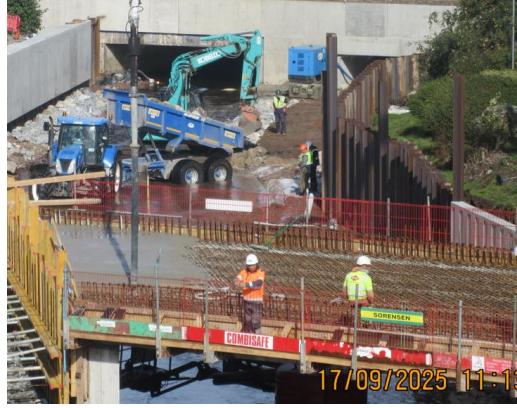
| Item number | | Comment | Image | ECoW Action/Recommendation | Sorensens's Action response |
|---|---|---|---|---|---|
| 9.28 | 17/09/2025 | Rock armour works are continuing along the Credit Union side at Hazelwood. Some unavoidable tracking occurred as the dry working area narrowed while excavations were carried out to install the permanent works. Downstream monitoring remains ongoing. | | Conducted site inspections and discussions with site personnel regularly through the work operations. | NTU levels were monitored throughout the works via the downstream sondes. Siltation during this phase was minor, as excavations were carried out in semi-dry conditions. Compaction of riverbed substrate was unavoidable from successive heavy plant tracking on riverbed. |

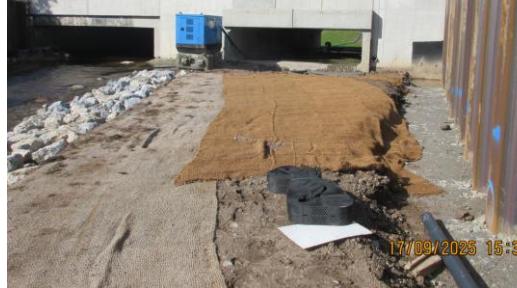
| Item number | | Comment | Image | ECoW Action/Recommendation | Sorensens's Action response |
|---|---|---|---|---|---|
| 9.29 | 17/09/2025 | Erosion control coir mesh was installed to prevent potential runoff. The area has been seeded with grass, and the coir mesh will help prevent the washout of soil material while the grass and other vegetation establish. This product can be left in place and will naturally degrade over time as it's made from natural fibres. | | Advised and encouraged on the use of coir mesh in this situation especially since the grass seed is being applied late in the growing season. | The coir mesh was deployed progressively as each section of ground was installed with geogrid, stone fill and layer of topsoil and grass seed as per the design. |

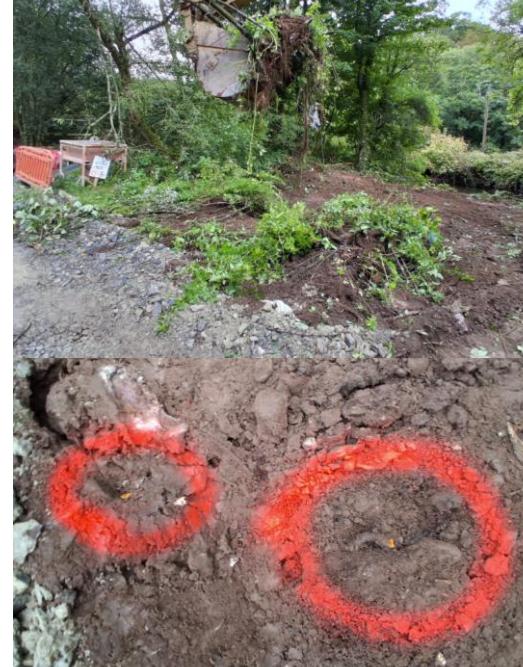
| Item number | | Comment | Image | ECoW Action/Recommendation | Sorensens's Action response |
|---|---|---|---|---|--|
| 9.30 | 17/09/2025 | Knotweed recovery works at Area 4 yesterday along route of storm water outfall. | | Discussed biosecurity measures with site ecologist during Environmental Tour. | The clearance of vegetation and earth works to construct the drainage line for the pump station was conducted in line with the biosecurity measures outlined in the Biosecurity Plan. |

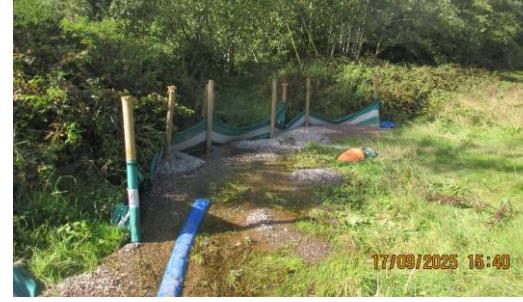
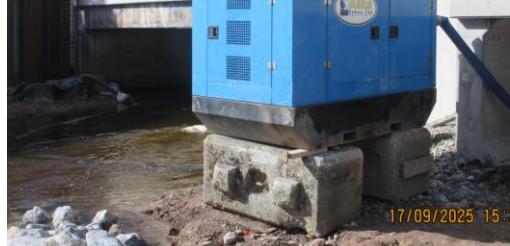
| Item number | | Comment | Image | ECoW Action/Recommendation | Sorensens's Action response |
|---|---|---|---|---|--|
| 9.31 | 17/09/2025 | Pumping of ground water was required for the western sheet pile wall tie in with the Hazelwood Road bridge which required a small excavation supported by temporary sheet piles to conduct form work and concrete pour for Bean and Leaf stitch. A pump was | | Reviewed permit to pump and pump set up for environmental compliance. | A series of silt curtains and gravels were in position at the discharge point which added to the vegetation already present to attenuate and filter any silty water that may be present being pumped from the excavations. |

| Item number | | Comment | Image | ECoW Action/Recommendation | Sorensens's Action response |
|---|---|--|--|--|---|
| | | positioned on the opposite bank on Kelly blocks with the discharge hose running through the dry Overflow culvert to the basketball court green area. | | | The temporary sheet pile was electro fished prior to dewatering. |

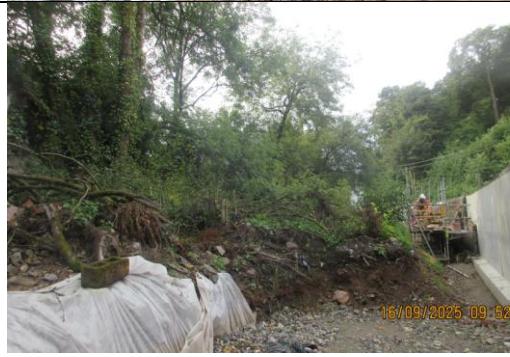
| Item number | | Comment | Image | ECoW Action/Recommendation | Sorensens's Action response |
|---|---|--|--|--|---|
| 9.32 | 17&18 th 09/2025 | Area 4 rock armour works required the removal of a number of mature trees. | | Documented and advised trees to be retained if possible. | Unfortunately, the footprint of the rock armour works was extensive with most trees and vegetation requiring removal. One alder was retained along the riverbank. |

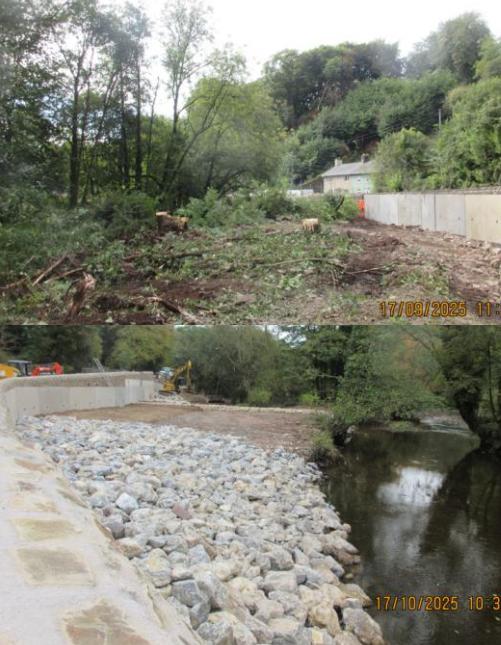
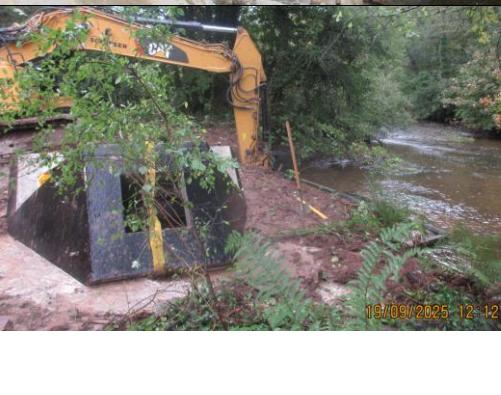
| Item number | | Comment | Image | ECoW Action/Recommendation | Sorensens's Action response |
|---|---|--|---|--|--|
| 9.33 | 19/09/2025 | <p>Excavations for Area 4 pumpstation headwall: Silt curtain deployed as part of silt mitigation. Riverbed material spread on bank and checked for fish species. A single stickleback was recovered and returned to the river.</p> | | <p>Supervised works and discussed measures to protect watercourse with site ecologist for lean mix to be used.</p> | <p>Works were carried out implementing mitigations to protect water quality and protect aquatic species.</p> |

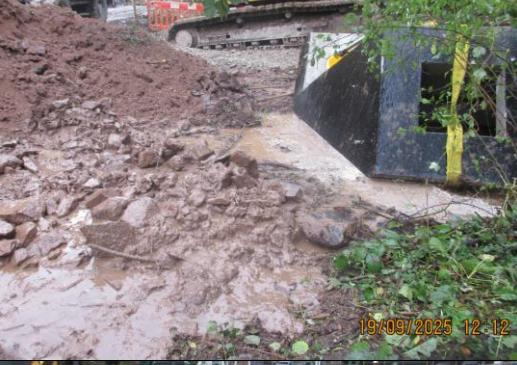
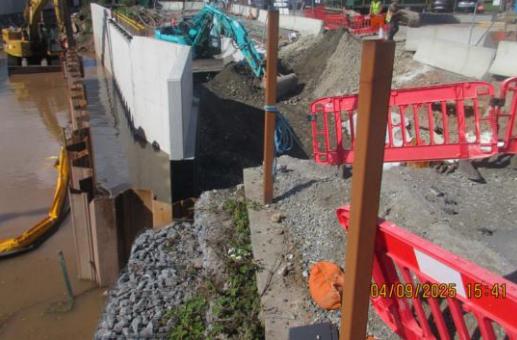
| Item number | | Comment | Image | ECoW Action/Recommendation | Sorensens's Action response |
|---|---|--|---|---|--|
| 9.34 | 18/09/2025 | Temporary sheet piles were installed around the gabion baskets downstream of the new Hazelwood Shopping Centre bridge. | | Liaised with site ecologist regrading planned works and ecological mitigations to be implemented. | The area was electro fished prior to being sealed off. E-fishing was undertaken by Triturus Environmental Ltd. |

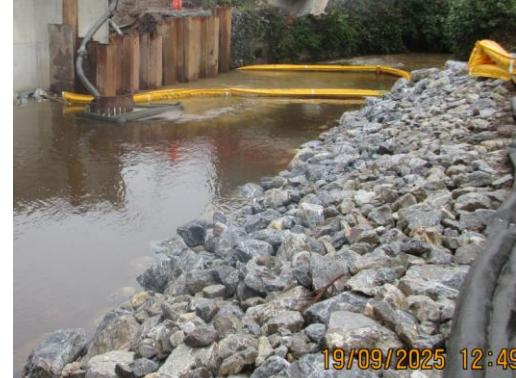
| Item number | | Comment | Image | ECoW Action/Recommendation | Sorensens's Action response |
|---|---|--|---|--|--|
| 9.35 | 19/09/2025 | Pumping out of coffer dam at Hazelwood for installation of gabion baskets conducted with silt curtains as part of silt mitigation. Cage was also used to prevent scour of riverbed. Permit to pump in place. | | Continue to monitor pumping. Start / stop maybe required based on sondes NTU levels. | The pumping setup was largely effective in managing silt, although some siltation of the watercourse still occurred. NTU levels were monitored via downstream sondes, which indicated that levels remained within acceptable ranges throughout the operation. |

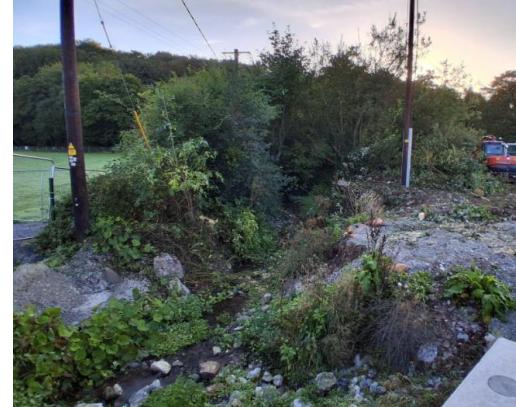
| Item number | | Comment | Image | ECoW Action/Recommendation | Sorensens's Action response |
|---|---|--|---|--|--|
| 9.36 | 22/09/2025 | The downstream section of the Cois na Gleann stream culvert required local regrading, widening, and rock armouring, which will necessitate vegetation clearance. | | Surveyed and discussed vegetation clearance with site ecologist. Efforts were made to retain trees where possible. | <p>The works were, of course, disruptive to the natural environment, but they were essential to implement the full flood mitigation measures at this location. Trees were retained, as was in-stream aquatic vegetation, wherever possible.</p> <p>The Hazelwood Upstream sonde acted as the remote monitoring device for Cois na Gleann rock armouring works.</p> |

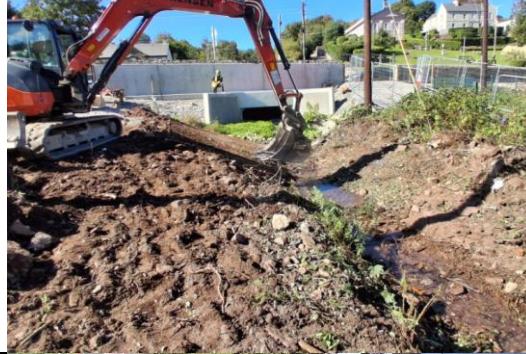
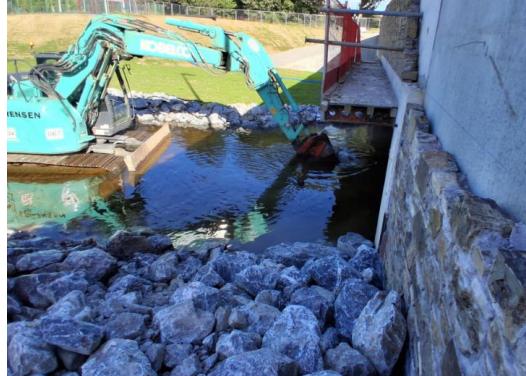
| Item number | | Comment | Image | ECoW Action/Recommendation | Sorensens's Action response |
|---|---|---|---|--|--|
| 9.37 | 22/09/2025 | <p>Rock armouring works were required as per the design within the channel just upstream of the Hazelwood Road Bridge. These works have potential to cause harm to fisheries species.</p> | | <p>Such works should be supervised by an ecologist and inspected for fish species.</p> | <p>Excavation of riverbed material was supervised by the site ecologist who inspected all spoil for fish species. 3 no. Adult European eel were returned to channel.</p> |

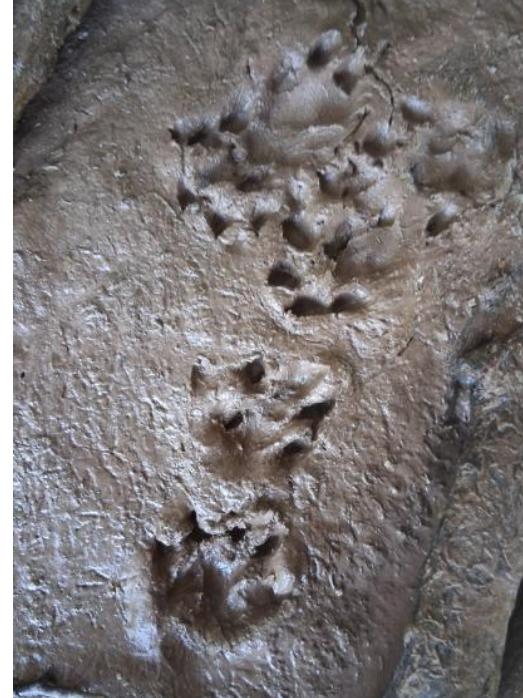
| Item number | | Comment | Image | ECoW Action/Recommendation | Sorensens's Action response |
|---|---|---|--|---|--|
| 9.39 | 23/09/2025 | Tracks observed beneath the Copper Valley Vue culvert were later confirmed to be Otter tracks. | | Discussed with site ecologist. | Tracks were inspected and confirmed to be otter tracks. |

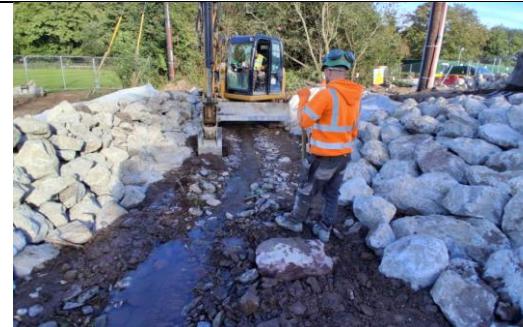
| Item number | | Comment | Image | ECoW Action/Recommendation | Sorensens's Action response |
|---|---|---|--|---|--|
| 9.40 | 24/09/2025 | Flagstones being installed in Cois na Gleann. Four boulders half buried alternating on stream bed approx. 3m apart. | | Confirmed with site personnel. | Flagstones added to improve stream hydromorphology and provide resting points for river bird species such as the dipper who is active in the area. |

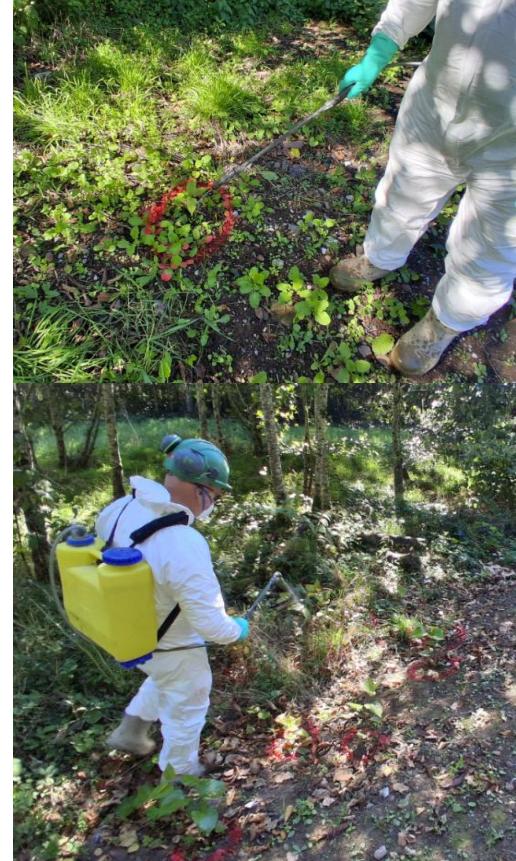
| Item number | | Comment | Image | ECoW Action/Recommendation | Sorensens's Action response |
|---|---|---|---|---|---|
| 9.41 | 25&29/09/2025 | <p>Spraying of visible Japanese knotweed (JKW) within the scheme's boundaries was undertaken to control the spread of JKW in the area. Once the scheme is completed, these areas will be managed by the City Council.</p> | | <p>Lised with site ecologist.</p> | <p>Spraying carried out to control spread of JKW. A report was submitted to the Employers Representative detailing locations and amounts sprayed.</p> |

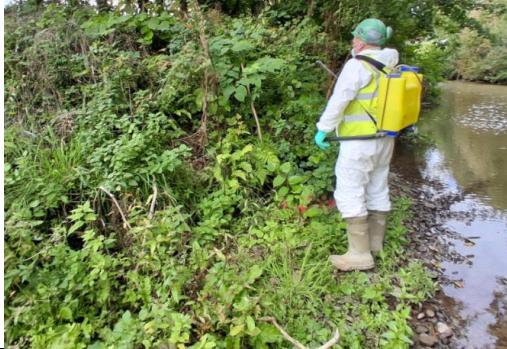
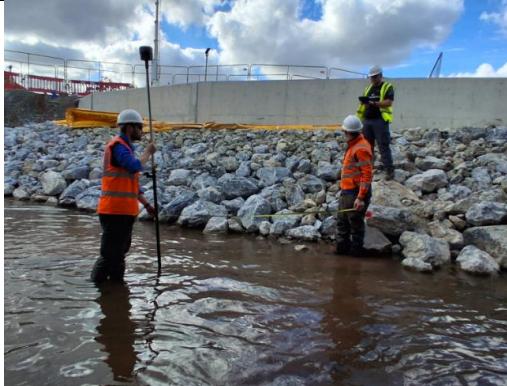
| Item number | | Comment | Image | ECoW Action/Recommendation | Sorensens's Action response |
|---|---|--|---|---|--|
| 9.42 | 26/09/2025 | River survey was conducted of the heavily disturbed Glashaboy river section between the Hazelwood Road and new shopping Centre bridge. | | Liaised with various parties to implement improvement to watercourse. | It was decided that the best course of action would be to add a pair of deflectors on opposite sides of the river in a staggered arrangement. This configuration is intended to accelerate the natural scour and deposition processes, gradually increasing the channel complexity. The current channel is relatively uniform, which is not ideal for river ecology. |

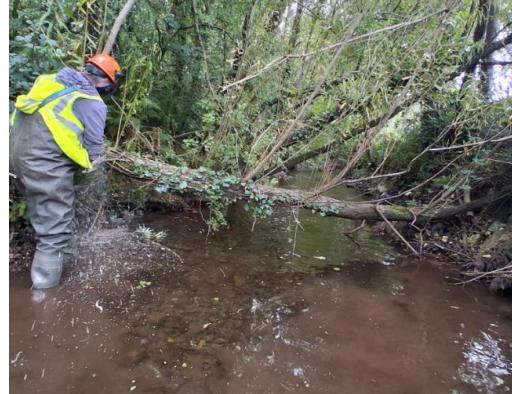
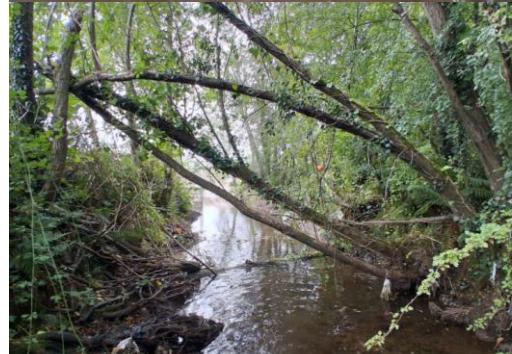
| Item number | | Comment | Image | ECoW Action/Recommendation | Sorensens's Action response |
|---|---|--|---|---|---|
| 9.43 | 29/09/2025 | Fallen trees and large woody debris in the Glashaboy and Glanmore Rivers were removed for flood prevention purposes. | | Checked locations prior to removals. | Trees and debris were removed to prevent potential snagging, blockage, and associated flooding risks. |
