Environmental Report September 2024

Glashaboy Flood Relief Scheme

Date of issue: 04/10/2024

Document code: FFEC-GFRS-2024-009

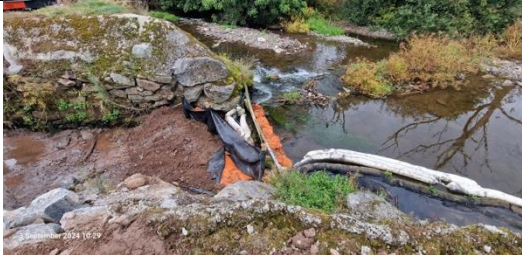
Item number	Date	Comment	Image	ECoW Action/Recommendation	Sorensens's Action response
9.1	03/09/2024	Grandon's. Mill race dewatered to facilitate works.

Continue to take steps to ensure health of fish in mill race and contain contamination present.	Bioversal HC added to contamination present accumulated at oil booms. Additional oil booms added outside the ones present prior to the works commencing. All contaminated material stored separately in Area one. Water was only temporarily stopped flowing in mill race.

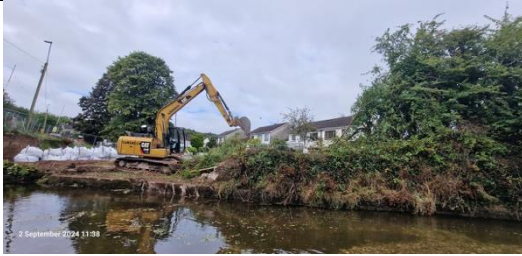
Item number	Date	Comment	Image	ECoW Action/Recommendation	Sorensens's Action response
9.4	02/09/2024	Meadowbrook. Trees being removed above bridge to facilitate wall removal works and regrading. Trees were to be removed as part of the design but were left uncut till now in an attempt to prevent their removal which was not possible.

Even though bird nesting season has officially ended, good precaution would be to check anyway in case late nesting.	Trees and area around were checked for bird nesting with none found.

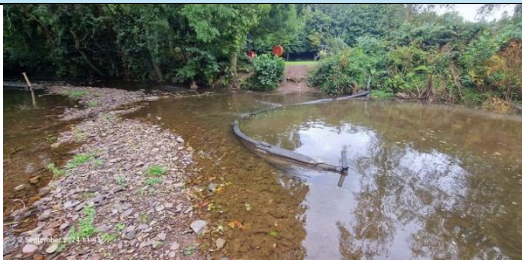
Item number	Date	Comment	Image	ECoW Action/Recommendation	Sorensens's Action response
9.7	02/09/2024	No. 2 Silt curtains installed for regrading works above and below Rivertown bridge.

Inspected silt curtains were installed correctly.	Silt mitigations installed to control silt. Works were supervised by site ecologist.

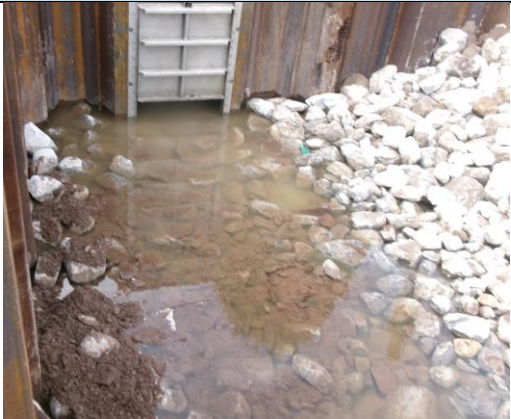
Item number	Date	Comment	Image	ECoW Action/Recommendation	Sorensens's Action response
9.11	04/09/2024	Rock armouring and river gravels installed around the entrance to Grandon's Mill race. Environmental concerns for the Mill race included siltation and pollution from Grandons.

Recorded work activities and discussed with workers carrying out works and site ecologists.	Flows to the Mill Race were temporarily halted to control silt entry, effectively preventing silt from reaching the area. Additionally, oil booms were used throughout the works to prevent any leaking contaminants from Grandon's fuel court from entering this area. River gravel was added to enhance the rock armour to enhance ecology.

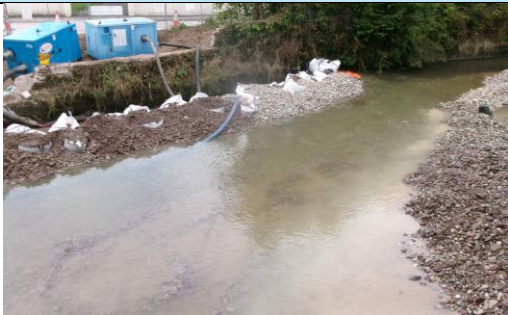
Item number	Date	Comment	Image	ECoW Action/Recommendation	Sorensens's Action response
9.13	04/09/2024	At the same location as Item 9.12, gravels were added on the upstream edge of the dam to deflect water and over sandbags as an added measures to prevent water ingress.

Monitored and discussed operations with site ecologist and site foreman.	Works to dry out this area would not be fully successful. Fish rescue nets and buckets would remain in place in the event of any aquatic species needing rescue. Workers were informed by the site ecologist to stop and report if such observations occurred. These steps were put in place and were subsequently not required.

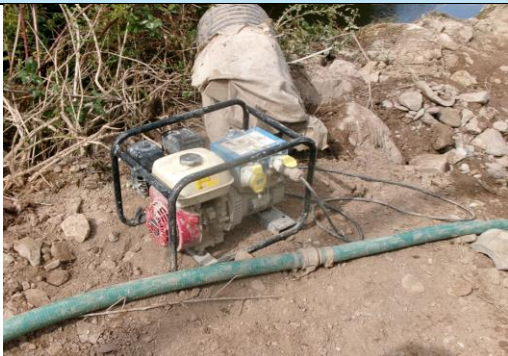
Item number	Date	Comment	Image	ECoW Action/Recommendation	Sorensens's Action response
9.15	05/09/2024	During the dewatering of the work area to install a headwall near Grandon's carwash, the generator was missing a spill mat, which is required when operating adjacent to a watercourse.

Reported situation to site ecologist.	Spill mat was installed later that day.

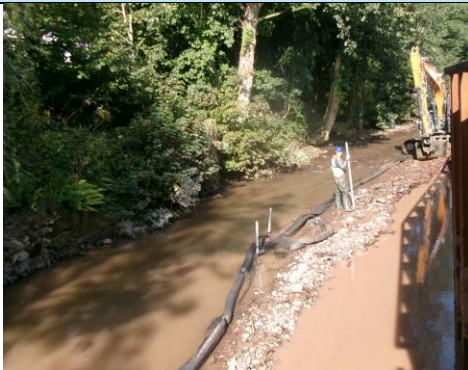
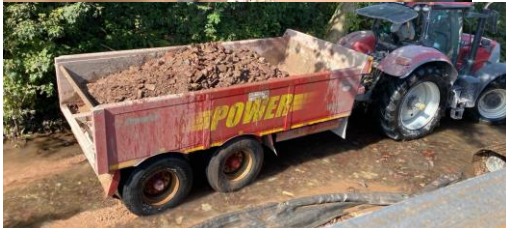
Item number	Date	Comment	Image	ECoW Action/Recommendation	Sorensens's Action response
9.18	09/09/2024	Rock armouring works at Sallybrook produce large amount of silt.

Partial supervision and ongoing discussions with site ecologist and excavator driver.	The silt curtain arrangement was supervised throughout the process, with intermittent start-stop operations to allow silt to dilute. Fish passage was accounted for in the setup, ensuring minimal disruption. The driver allowed water to drain before depositing materials into the trailer.

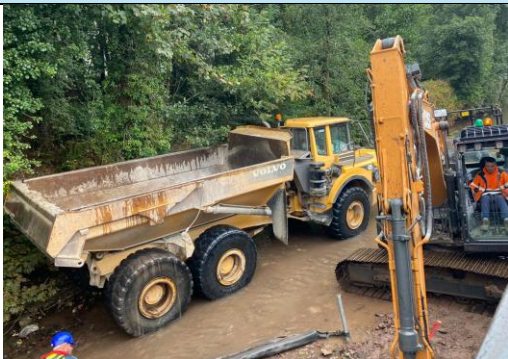
Item number	Date	Comment	Image	ECow Action/Recommendation	Sorensens's Action response
9.20	10/09/2024	Rock armouring excavations in the wet continue today.

Partial supervision and ongoing discussions with site ecologist and excavator driver.	Works were supervised by site ecologist. Silt configuration was effective at slowing down silt dispersal. Driver allowed water to drain before depositing into dumper. The work proceeded with a stop-start approach, balancing the need to completing works with the risk of prolonging the task. Stops lasted between 30 minutes to an hour.

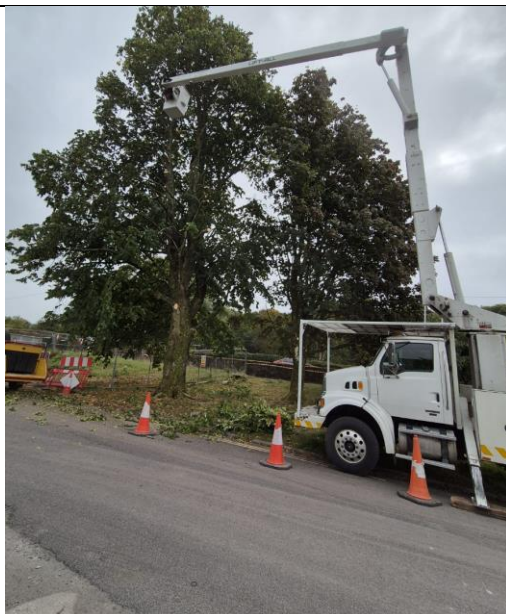
Item number	Date	Comment	Image	ECoW Action/Recommendation	Sorensens's Action response
					was then added over the work area.
9.23	10/09/2024	Trees were managed at the Meadowbrook housing estate. This was not part of the flood works. One dead tree was removed at the entrance and to the estate and two large trees was heavily pruned.

Documented.	N/A

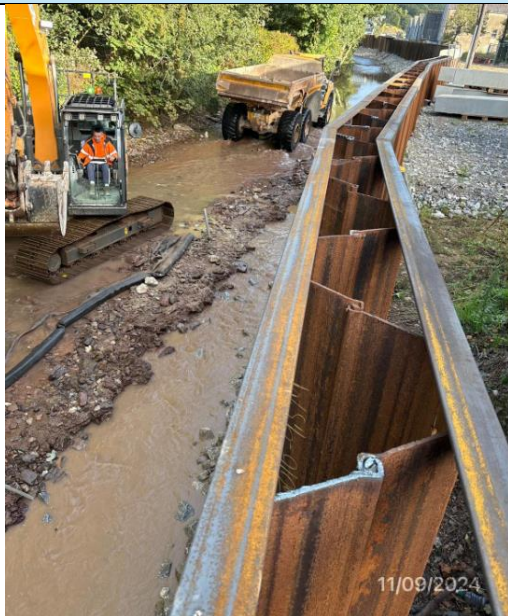
Item number	Date	Comment	Image	ECoW Action/Recommendation	Sorensens's Action response
9.24	11/09/2024	Final day digging instream for rock armouring at the base of the sheet pile walls.

Partial supervision of works with site ecologist. Stop / start approach.	Works were supervised by site ecologist. Silt configuration was effective at slowing down silt dispersal. Driver allowed water to drain before depositing into dumper. Works were stopped multiple times to allow silt to dilute and settle.
9.25	11/09/2024	Digging out for headwall in Area one with possible JKW present.

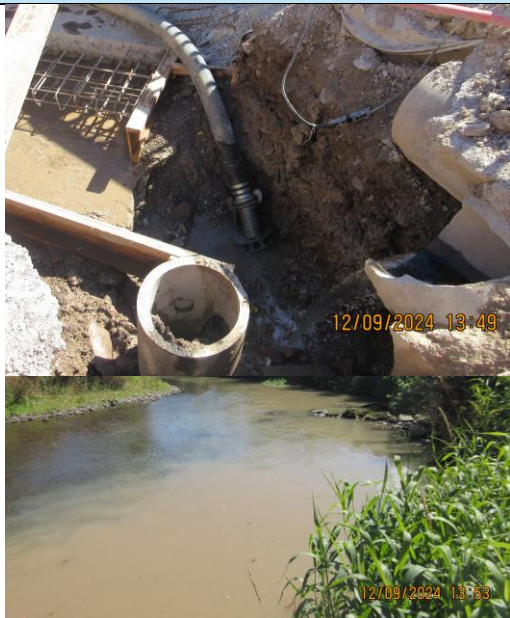
Item number	Date	Comment	Image	ECoW Action/Recommendation	Sorensens's Action response
9.26	12/09/2024	Springmount culvert: digging was carried out without a sump in place. Minor silt release into the main channel.

Investigated the origin of the dewatering. Digging was just completed when inspected. Reported to site ecologist.	The site ecologist conducted an investigation, and by that time, the digging had been completed due to the small scope of the digging. A reminder was given to the crew about the importance of silt mitigation and the necessity of using a sump when dewatering from a work area like this.

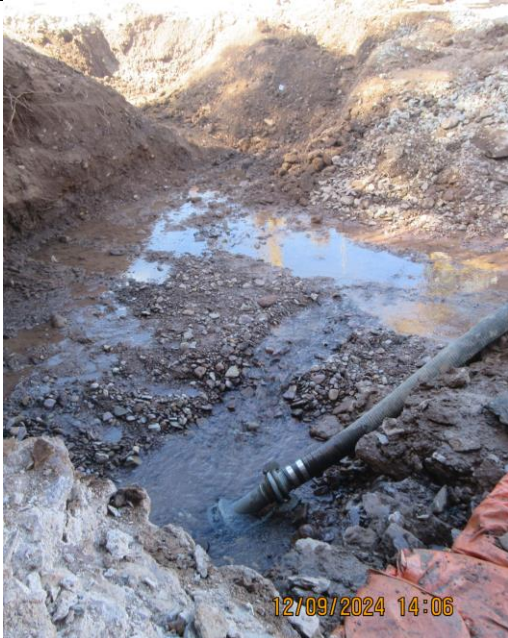
Item number	Date	Comment	Image	ECoW Action/Recommendation	Sorensens's Action response
9.27	12/09/2024	At Riverstown Bridge, with a different works crew then mentioned in Item 9.26, digging was carried out without a sump in place, with the pump discharging directly into the main channel. The pump was subsequently relocated from the dewatering site to the excavation area to keep the work zone clean.

Discussed with site ecologists.	Although most of the water being pumped out was clean river ingress, there remains an inherent risk of heavy rainfall or changes to the excavation line, which could lead to silt entering the water. This setup is not fail-safe in preventing silt contamination. Supervision of the area was then enacted by site ecologist. A reminder was given to the work crew about the importance of silt mitigation and the necessity of using a sump when dewatering from a work area like this.

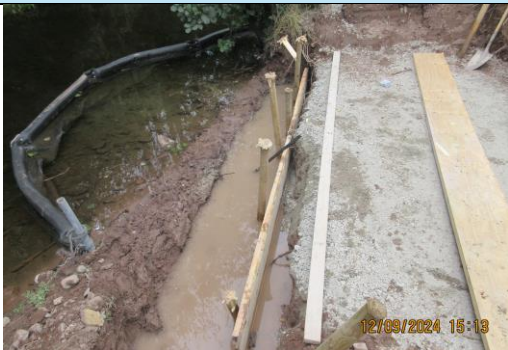
Item number	Date	Comment	Image	ECoW Action/Recommendation	Sorensens's Action response
9.29	12/09/2024	At the Sallybrook headwall, preparations are underway for dry blinding.

Discussed works with site ecologist.	A trench has been dug for the rip rap, serving as a failsafe for the blinding, though the area is intended to be fully sealed from water. A silt curtain is in place, and the exposed section from the backfilling of the trench will be covered with river gravel.

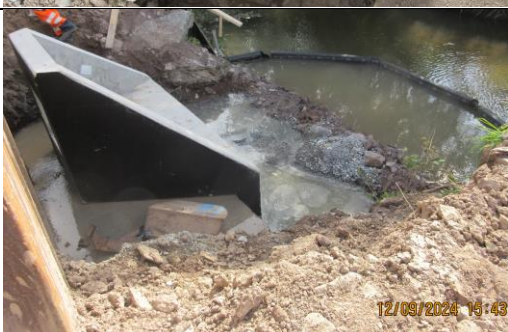
9.31	12/09/2024	A headwall being installed near Grandon's carwash was inspected and noted as possibly carrying pH risks to the main channel.

Discussed with site ecologist who was present at the time of observation. It was satisfactory that no pH risk was present.	The site ecologist was present and questioned the grounds crew about the use of dry blinding and the timing of the concrete base pour. The scum observed on the surface was identified as coming from the limestone gravel. The excavation was soon to be filled

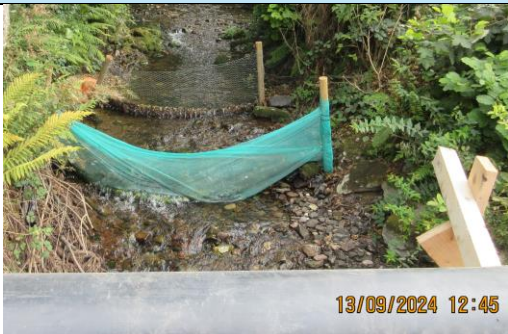
Item number	Date	Comment	Image	ECoW Action/Recommendation	Sorensens's Action response
9.34	13/09/2024	Brooklodge culvert, overpumping of Glenmore river: It was noted that the fish guards were positioned low at the sides, which could allow fish to bypass them if the water level rises.

Reported to site ecologist.	Fish guard were later sand bagged alongside the sides.

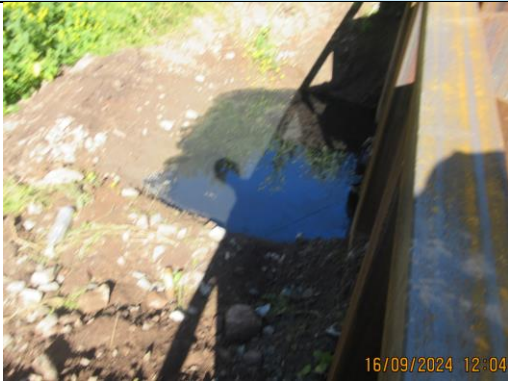
Item number	Date	Comment	Image	ECoW Action/Recommendation	Sorensens's Action response
9.37	16/09/2024	An outfall from Grandon's, located across from the Brook Inn car park, was observed to have discharged a thick, black, oil-like substance. Grandon's management reported that poor practices by car cleaning staff resulted in oil reaching the outlet that flows into the Glashaboy River. Reportly, engine cleaning had been performed at this location.

Spoke with Grandon's management about the issue.	Management reported that the activities responsible for the pollution had been rectified. The contaminated material was reportedly pumped into holding tanks that same day. It was decided not to report this incident further, as the pollution source had ceased, and remedial action had been agreed upon with Grandons to address it. The area was checked multiple times in the following weeks, with no further pollution observed.

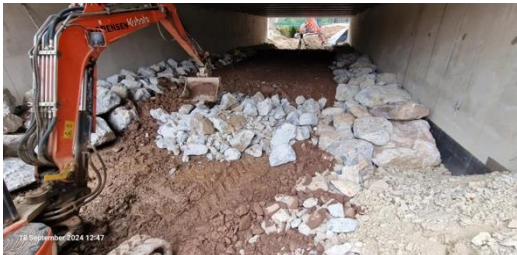
Item number	Date	Comment	Image	ECoW Action/Recommendation	Sorensens's Action response
9.39	18/9/24	New Line bridge on Glenmore River

Discussions took place within ER team and ECoW with Sorensen ecologists. Concern for fish migration highlighted. Actions to be agreed.	Low flow channel was later installed within the bridge.

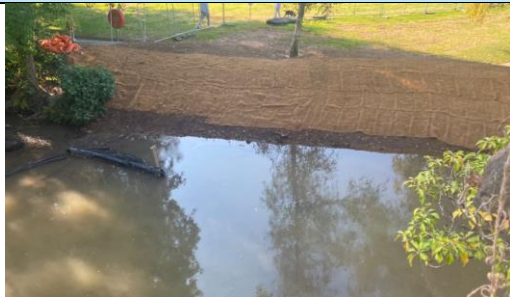
Item number	Date	Comment	Image	ECoW Action/Recommendation	Sorensens's Action response
9.41	19/09/2024	The exposed riverbanks downstream of Riverstown Bridge on the west side received coir mesh and grass seeding to prevent surface erosion.

Good erosion protection.	Coir mesh was installed as an additional measure to prevent runoff of topsoil while the grass seed establishes.

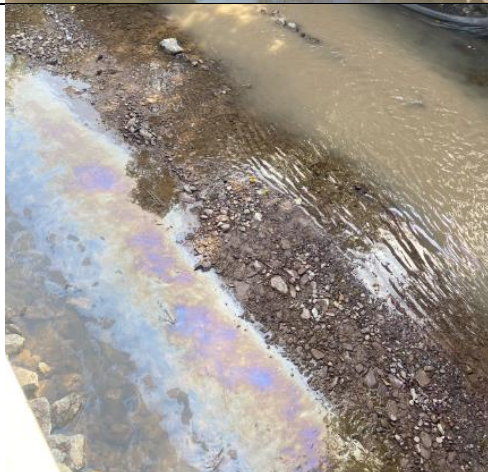
9.42	20/09/2024	Regarding the previous day's works at Eurofins (Item 9.40), what appears to be diesel is leaking into the main channel on the riverside of the sheet piles where the flap valve is to be installed.

Discussed mitigation strategies with site ecologist.	Oils booms and absorbent mats were deployed into the main channel where residue appeared in the river. Water from works area was pumped into the sealed drainage line to be pumped out later. Reported to the IFI by site ecologist. Reported to the CCC by ER.

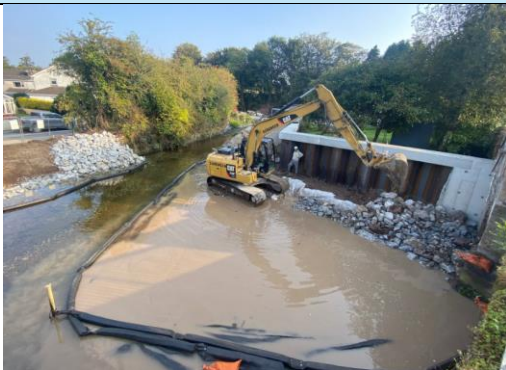
Item number	Date	Comment	Image	ECoW Action/Recommendation	Sorensens's Action response
9.43	21/09/2024	Rock armour being installed upstream of Rivertown bridge.

Discussed silt control measures with site ecologists.	Good silt control measures deployed around instream works area.
9.44	22/09/2024	Works commenced to reinstate the channel at Meadowbrook.

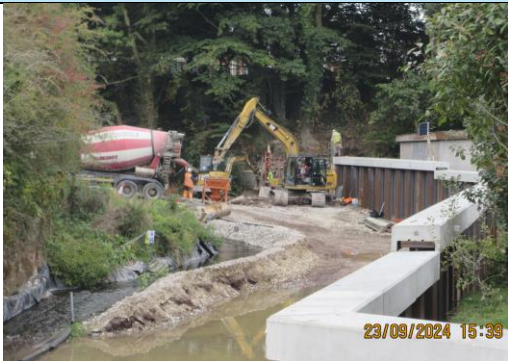
Item number	Date	Comment	Image	ECoW Action/Recommendation	Sorensens's Action response
9.47	23/09/2024	Concrete pouring at Meadowbrook to tie in sheet piles to riverbank.

Inspected and spoke site engineer. Discussion were on the locations of concrete wash out and the need to clean up the minor amounts of concrete on the ground as soon as possible.	Concrete washout was not present. Agreement made to wash concrete at circus field where wash out is present. Small piles of wet concrete deposited on the ground near river to be cleaned immediately.
9.48	23/09/2024	Excavated material from Eurofins (Item 9.40) covered to prevent wash out from rain. Material to be tested and disposed of accordingly.

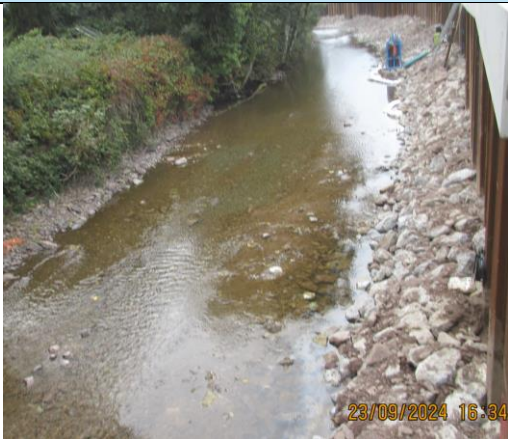
Item number	Date	Comment	Image	ECow Action/Recommendation	Sorensens's Action response
9.51	23/09/2024	Residue visible in the main channel following the excavation at Eurofins.

Documented and discussed with site ecologist.	Additional oil booms and absorbent mats were deployed in areas where residues were emanating from the rock armour.
9.52	24/09/2024	Removal of four sections of pipe total length c18m from Cois na Gleann stream.

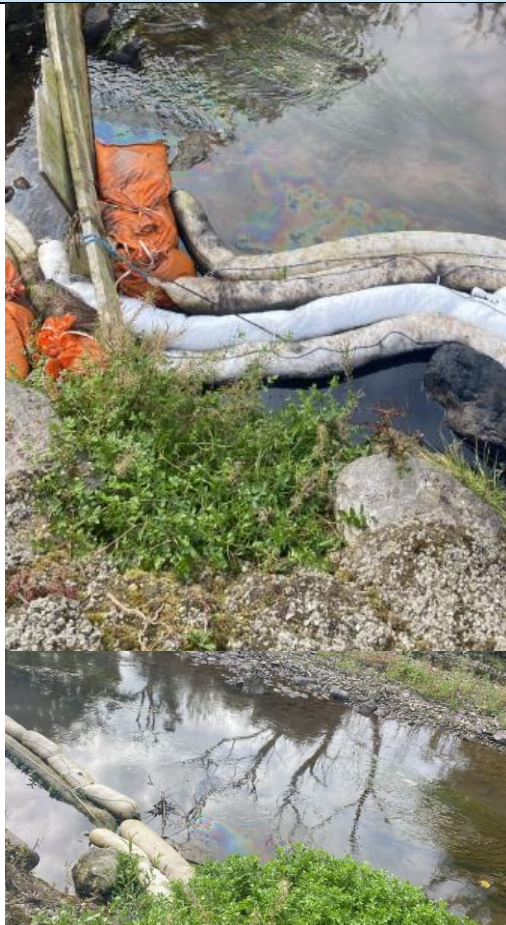
Item number	Date	Comment	Image	ECoW Action/Recommendation	Sorensens's Action response
9.55	24/09/2024	Oil slick residue leaking from Grandon's contaminated site at car show room. Contamination observed further downstream.

Recorded continued leaking of oil contamination from Grandons. Enquiries to be made as to the status works to address the pollution.	Oil booms have been deployed at this location. Grandons are responsible for this contamination. Work to address the pollution source, understood to be a leaking from a damaged receptor tank, has ceased following excavation activities earlier this year. The pollution was previously being pumped into tanks, but this activity has since stopped.

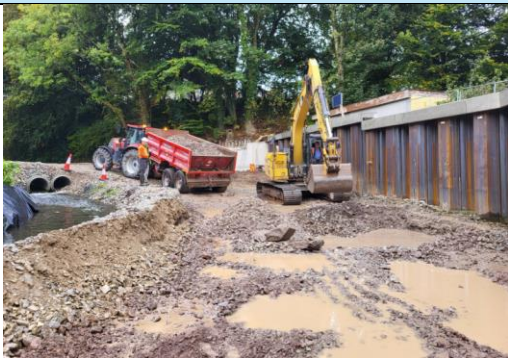
Item number	Date	Comment	Image	ECoW Action/Recommendation	Sorensens's Action response
9.59	25/09/2024	Reinstatement of the Meadowbrook channel inclusive of the deep pool.

Supervised works. Directed driver on channel reinstatement details.	Efforts were made to reduce the silt generated from the works but was not fully possible.
9.60	25/09/2024	Fish rescue carried on the Meadowbrook diversion channel prior to its dry out as water is redirected back into the main channel.

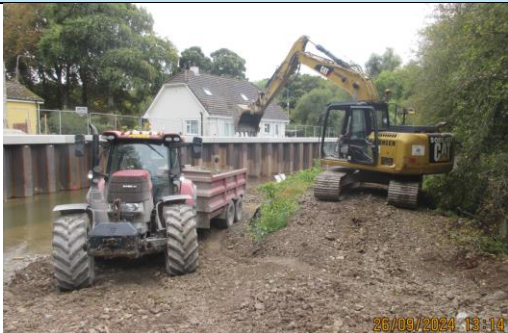
Item number	Date	Comment	Image	ECoW Action/Recommendation	Sorensens's Action response
9.64	26/09/2024	OPW requests removal of gravel deposits above Rivers town bridge. JKW located in gravels.

Biosecurity measures reviewed as part of Change Order design.	The works were supervised by a Japanese knotweed specialist, with biosecurity measures strictly followed throughout. Contaminated material was transported under license to the holding cell at Sallybrook.

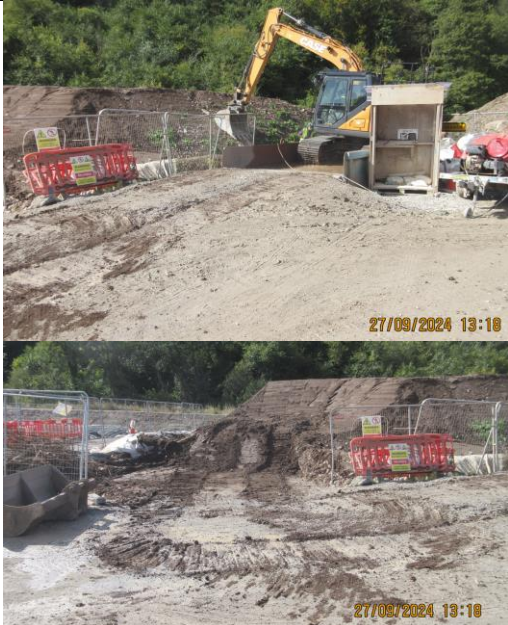
Item number	Date	Comment	Image	ECoW Action/Recommendation	Sorensens's Action response
9.70	27/09/2024	At the holding cell in Sallybrook, where Japanese knotweed material is temporarily stored, an excavator was reshaping the stockpile. However, while tracking out to access the wheel wash, contaminated material was unintentionally tracked out, potentially causing the unintentional spread of the invasive plant.
