## **Environmental Report May 2024**

### Glashaboy Flood Relief Scheme

**Document code:** FFEC-GFRS-2024-005

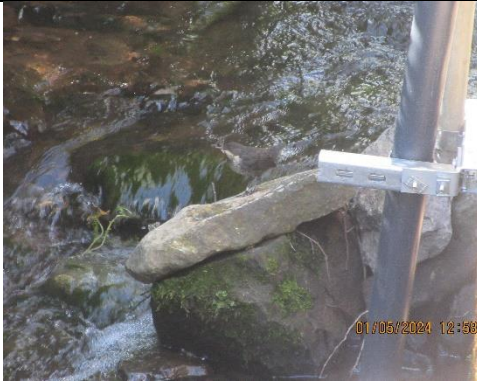
Item number	Date	Comment	Image	ECoW Action/Recommendation	Sorensens's Action response
5.1	01/05/2024	<p>Young dipper (<i>C. cinclus hibernicus</i>) photographed at Cois na Gleann with tag on right leg. This is most likely one of the individuals from the nest in the culvert at Cois na Gleann. This is a good sign as the bird is healthy; therefore the ecological intervention here was a success.</p> <p>The original stone culvert at Cois na Gleann was providing a nesting habitat for Dipper (<i>C. cinclus hibernicus</i>). The new replacement culvert will not provide a habitat for this bird as there will be no ledges or platforms in the interior. However, if a dipper nesting box is placed in the new culvert, this will provide a nesting habitat for the species for the duration that the box survives. Therefore, the nest box will have to be inspected and replaced as necessary in</p>

5.1	The original stone culvert at Cois na Gleann was providing a nesting habitat for Dipper ( <i>C. cinclus hibernicus</i> ). The new replacement culvert will not provide a habitat for	Add dipper nest box to new culvert once complete to maintain the habitat for this species.		Not yet resolved.  (Works not yet completed.)

Add dipper nest box to new culvert once complete to maintain the habitat for this species.	Awaiting response.

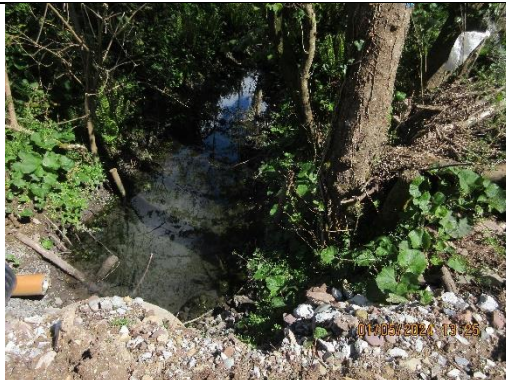
Item number	Date	Comment	Image	ECoW Action/Recommendation	Sorensens's Action response
		perpetuity to maintain the habitat.			
5.2	01/05/2024	Drainage ditch at Sallybrook House, Area 1. This is due to be filled in and replaced with an underground porous drainage pipe. Ecological potential here is low as the water is stagnant and disconnected.

Contractor to survey this habitat for aquatic species before replacement with underground pipe, though potential for species abundance and diversity is low.	Sorensen have agreed to survey this habitat prior to works.
5.3	01/05/2024	Silt sock discarded at funeral home site.

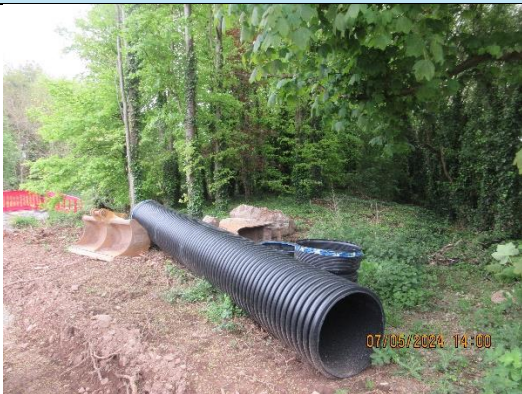
Item number	Date	Comment	Image	ECoW Action/Recommendation	Sorensens's Action response
5.4	07/05/2024	Stockpiling on this ecologically sensitive area at Meadowbrook continues.

<p>Recommendation: no further encroachment into this area. Opportunity to add native trees here once works are complete.</p> <p>This was communicated to the Site ecologists.</p>	Hazard tape was placed here to discourage access.
5.5	08/05/2024	Dust at Sallybrook and Circus field being kicked up in dry weather.

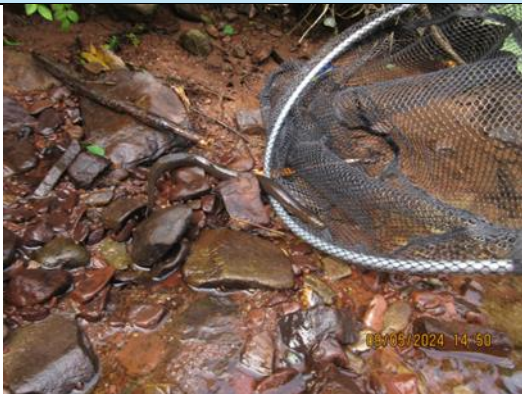
Item number	Date	Comment	Image	ECoW Action/Recommendation	Sorensens's Action response
5.6	09/05/2024	1no. freshwater eel and 4no. trout collected from Cois na Glean, as the stream was overpumped around the work area.

Contractor to be better prepared for future in-stream works: nets, containers and electrofishing equipment on hand.	Further electrofishing training was completed by the site ecologist. Future in-stream works at other locations will require electrofishing – Meadowbrook, Springmount, New Line, Copper Valley Vue.

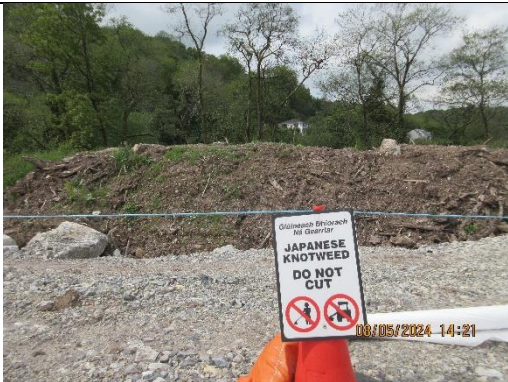
5.7	09/05/2024	Some Japanese knotweed remains at the Sallybrook embankment after removal of topsoil.

5.8	Some Japanese knotweed remains at the Sallybrook embankment after removal of topsoil.	Recommendation: Continue spot-treatment of shoots as they emerge. <u>Do not treat the whole ground area with herbicide.</u>  knotweed will be treated with foliar application of glyphosate in the late summer/autumn when herbicide is most effective.		Resolved.

Recommendation: Continue spot-treatment of shoots as they emerge. <u>Do not treat the whole ground area with herbicide.</u>	Updated invasive species management plan requested from Sorensen. As of now they aim to treat the knotweed with foliar application of glyphosate in the late summer/autumn when herbicide is most effective.

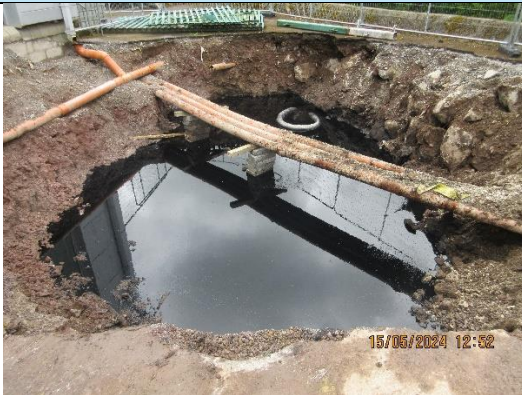
Item number	Date	Comment	Image	ECow Action/Recommendation	Sorensens's Action response
5.8	15/05/2024	Excavation has appeared at Grandon's. The black liquid on the surface of the water is used motor oil which has escaped from a faulty holding tank beneath the car showroom. This type of pollution is especially damaging as it contains polycyclic aromatic hydrocarbons, heavy metals and residual fuels.

5.9	Excavation has appeared at Grandon's. The black liquid on the surface of the water is used motor oil which has escaped from a faulty holding tank beneath the car showroom. This type of pollution is especially damaging as it contains polycyclic aromatic hydrocarbons, heavy metals and residual fuels.	Continue to monitor this legacy issue.		Not yet resolved.

Continue to monitor this legacy issue.	
5.9	16/05/24	Used motor oil continues to enter the Glashaboy river at Grandon's. One gallon of used motor oil can pollute one million gallons of water.

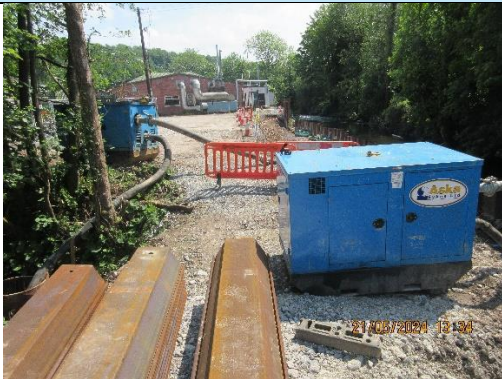
Item number	Date	Comment	Image	ECoW Action/Recommendation	Sorensens's Action response
5.10	21/05/2024	Pumps without absorbent mats at Sallybrook during pile driving.

Informed site ecologist, who asserted that mats are used when refuelling the pumps.	Sorensen clarified that these pumps have an internal sump to catch any leaking oil or fuel.
5.11	21/05/2024	Silt defences at Sallybrook House for pile driving works. These defences are appropriate and effective.

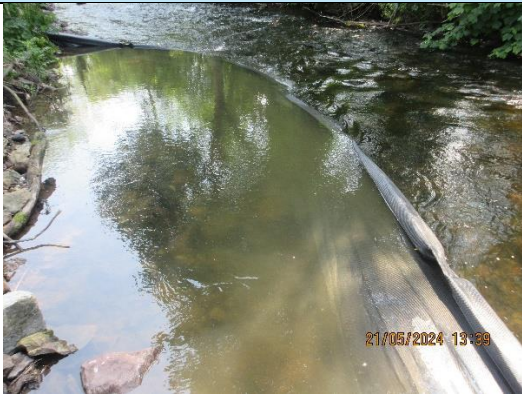
Item number	Date	Comment	Image	ECoW Action/Recommendation	Sorensens's Action response
5.12	22/05/2024	Silt curtains at Sallybrook in the Glashaboy are working well to reduce silt discharge.

As above.	
5.13	21/05/2024	Riparian vegetation recovering at Sallybrook. This biodiverse plant assemblage is made of up mostly native species.

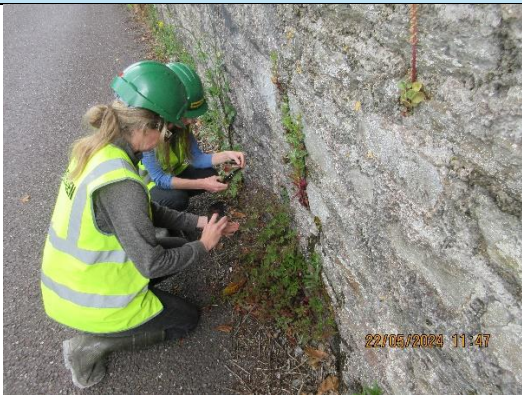
Item number	Date	Comment	Image	ECow Action/Recommendation	Sorensen's Action response
5.14	22/05/2024	World rarity <i>Geranium robertianum</i> X <i>purpureum</i> discovered at Springhill at base of old stone wall. This extremely rare plant was mentioned in the EIAR in the "Protected Flora" section. The parent plant <i>Geranium purpureum</i> is included in the OPW Red Species List.

5.15	World rarity <i>Geranium robertianum</i> X <i>purpureum</i> discovered at Springhill at base of old stone wall. This extremely rare plant was mentioned in the EIAR in the "Protected Flora" section. The parent plant <i>Geranium purpureum</i> is included in the OPW Red Species List.	Recommendation: Contractor to survey all suitable habitats for <i>Geranium robertianum</i> X <i>purpureum</i> prior to works beginning and to compile all records into a map for reference. Any specimens found should be carefully translocated to a suitable habitat before works commence. Vigilance is required as these plants are difficult or impossible to identify when not in flower. Each plant will fluctuate between	Ongoing surveys and translocations as populations are discovered.	Resolved.

A person wearing a green hard hat and a high-visibility yellow vest is kneeling on a paved surface next to a stone wall. They are examining a small plant growing at the base of the wall. A timestamp in the bottom right corner of the image reads "22/05/2024 11:47".	Recommendation: Contractor to survey all suitable habitats for <i>Geranium robertianum</i> X <i>purpureum</i> prior to works beginning and to compile all records into a map for reference. Any specimens found should be carefully translocated to a suitable habitat before works commence. Vigilance is required as these plants are difficult or impossible to identify when not in flower. Each plant will fluctuate between a flowering state and non-flowering state throughout the growing season.	Sorensen have acknowledged these plants and have conducted surveys and translocations to protect them.

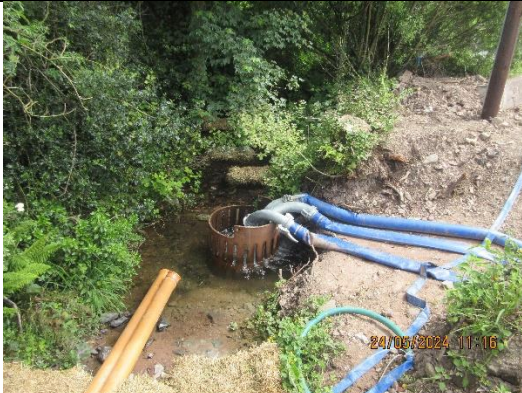
5.15	24/05/2024	Cois na Gleann instream works continue, water clear.

A stream with blue and orange pipes laid out on the bank, surrounded by green vegetation. A timestamp in the bottom right corner of the image reads "24/05/2024 11:16".	Inspect silt defences regularly, especially prior to new instream works.	Environmental team have been inspecting silt defences and pumping locations daily.

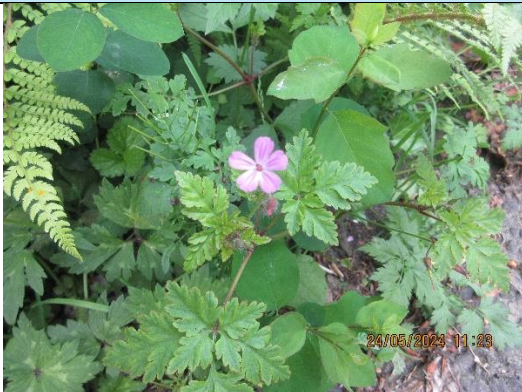
Item number	Date	Comment	Image	ECow Action/Recommendation	Sorensens's Action response
5.16	24/05/2024	<i>Geranium robertianum X purpureum</i> present on grounds of St.Joseph Roman Catholic Church.

Recommendation: Contractor to transplant any hybrids in danger of works to this location.	Sorensen have conducted translocation of plants to this location.
5.17	27/05/2024	Overpumping of drainage ditch at Sallybrook house.

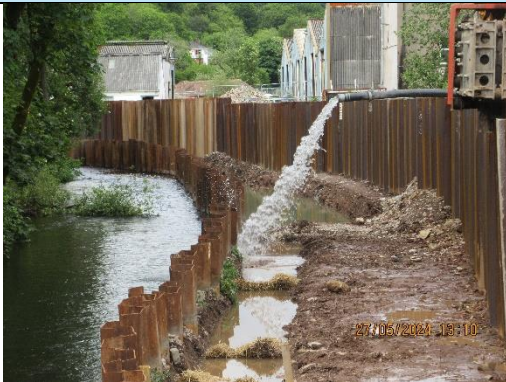
Item number	Date	Comment	Image	ECoW Action/Recommendation	Sorensens's Action response
5.18	29/05/2024	Overpumping of drainage ditch at Sallybrook house.

Hose is positioned too high above the water line and is kicking up sediment in the attenuation area.	Site ecologist agreed to correct and the issue was soon corrected.
5.19	29/05/2024	Clearance for river redirection and pedestrian access at New Line.

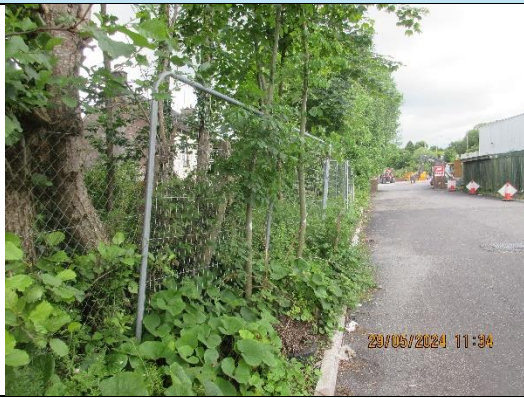
Item number	Date	Comment	Image	ECoW Action/Recommendation	Sorensens's Action response
5.20	29/05/2024	Ash trees marked for removal for fencing at Sallybrook house.

9 trees in total removed from here. Recommendation: These trees should be compensated by the planting of at least 9 native trees in a suitable location.  This will be included in the Biodiversity Plan	N/A
