3.4 Sallybrook to Glanmire

3.5 Glanmire to Lough Mahon

4 Flood Relief Options Review

A Appendix 1: Geomorphology Addendum (August 2016)

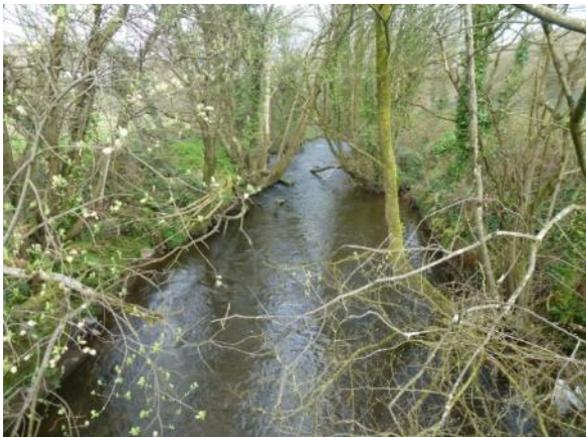
Figure 3-12 Downstream of Sallybrook (Point 9)

Downstream of Sallybrook the channel flows through a narrow urban corridor. The channel remains slightly incised, possibly due to historic straightening due to protected river banks. Sediment is delivered to this reach via several steep tributaries.

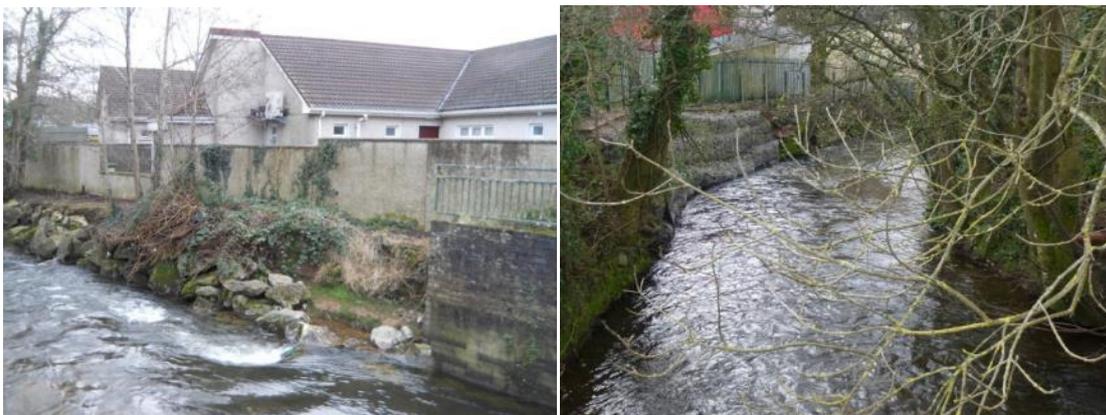
Figure 3-13 Adjacent to the Glanmire shopping centre (Point 10a)

At the Glanmire shopping centre several areas of bank instability exist (Figure 3-13 and Figure 3-14). The channel at this point is confined and relatively narrow compared to reaches upstream. There is limited deposition due to the steepness in some sections and disruption from upstream to the sediment transport process. The channel banks are high in most locations due to land raising and embankments. As a result, during flood conditions all energy is concentrated within the channel which is leading to bank erosion and instability. In many places existing bank protection has been undermined and has collapsed into the river. This section appears to be starved of sediment, suggesting upstream structures, such as the old weirs are influencing in-channel processes. As a result, the channel has excess stream power leading to the erosion processes along the beds and bank. In order to reduce the flood impact and erosion within this section various options could be investigated including flood storage options upstream and also improving the in-channel morphology which is currently degraded, to manage the existing high energy conditions.

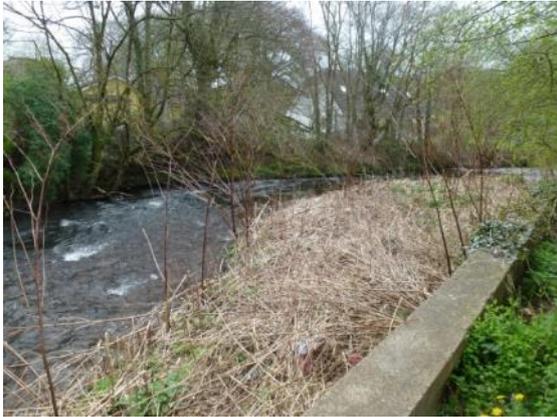
Figure 3-15 Defences downstream of the Glanmire shopping centre, adjacent to the housing estate (Point 11)

Downstream of the shopping centre the channel widens slightly. Flood defences exist, which protect an adjacent housing estate. The defences act as a constraint to the channel in terms of its floodplain connection. The wider nature (Figure 3-15) of the channel here has allowed for the

deposition of some sediment (dominated by fines). In the majority of cases the depositional features are vegetated which suggests that the channel has reacted following past intervention (i.e. it has adjusted to a more natural narrow channel), probably as a result of the construction of the flood defences. This indicates that if any future maintenance of this section occurs (such as sediment removal or flood defence improvements) deposition of this nature will continue to occur.

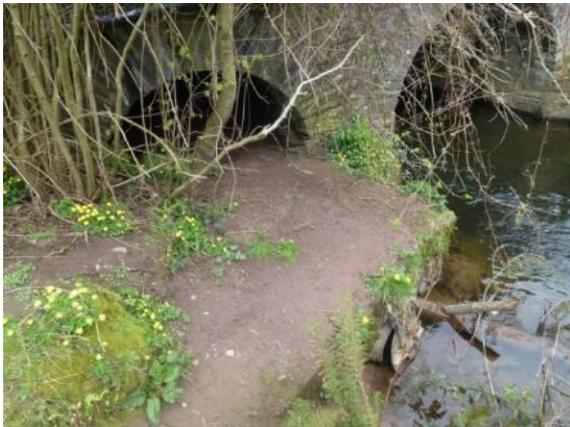
Figure 3-16 Upstream of the park (Point 12)

Downstream of the housing estate the channel enters a parkland area and connection to the floodplain is improved. In areas of the channel where flows are reduced fine sediment deposition is occurring (Figure 3-16) and in some areas small pockets of gravels (Figure 3-17) have been deposited, however, gravel deposition is not widespread. If sediment is removed as part of any future maintenance works, it should be expected that sedimentation will re-establish itself naturally.

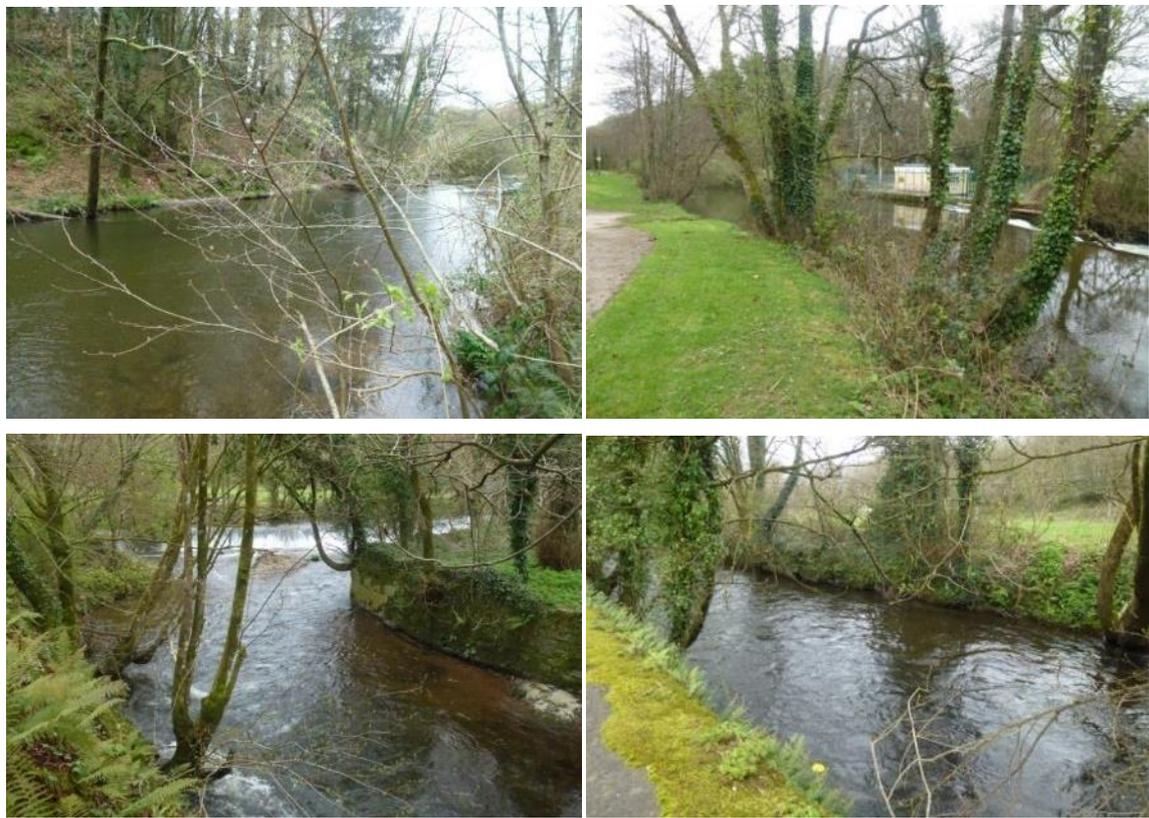
Figure 3-18 Impoundment (Point 14)

In the downstream section of the park a weir exists, which historically was used to feed a mill leat (which is still active). This causes upstream impoundment through the park increasing fine sediment deposition (Figure 3-18). Downstream of the weir some minor scour has occurred along

with a small area of gravel deposition, in a classic weir pool morphology. The channel then enters a canalised section with steep walls on both banks which act to prevent any channel migration. As a result, flows within this section have the ability to transport gravels downstream resulting in little deposition apart from coarser sediment at the edges of the channel through this section.

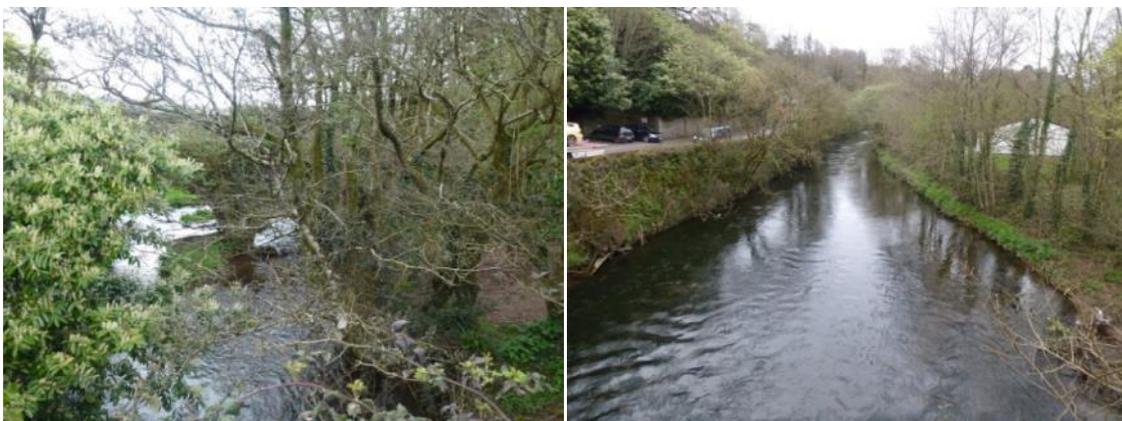
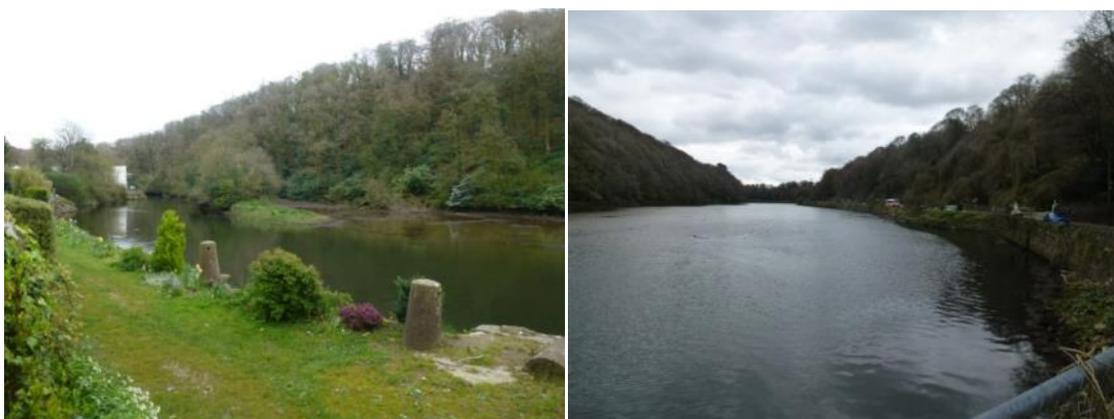
Figure 3-20 Sections downstream of Glanmire

At Glanmire bridge, deposition of gravels is occurring on the left bank (Figure 3-20). Downstream of the bridge the river gradually becomes wider and eventually is influenced by the tidal regime. This influences water levels and flow conditions downstream of Glanmire, resulting in some deposition of tidally derived muds and silts. The deposition of this sediment appears low therefore there is little risk of increased sedimentation in this section.

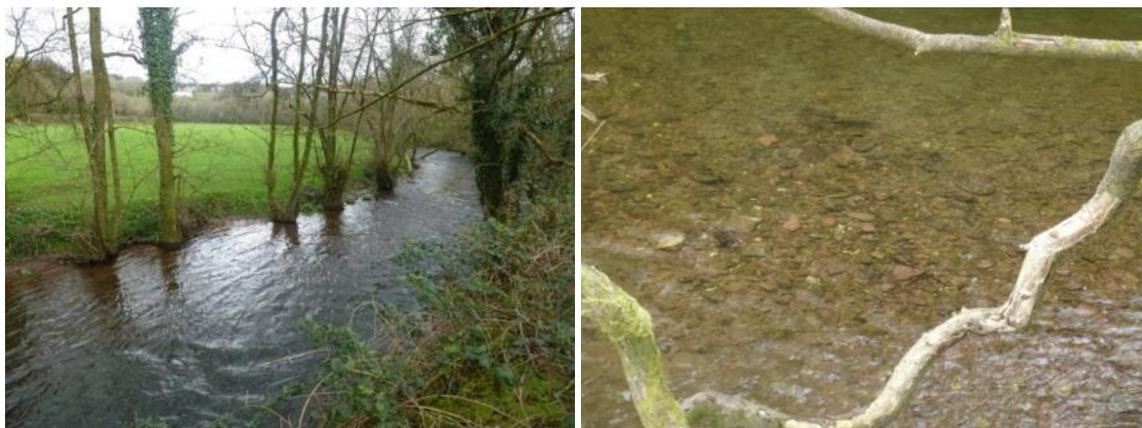
Figure 4-1 Typical conditions upstream of the industrial estate

This is a moderately active section of the channel upstream of the mill leat with a gravel / cobble bed that is partly mobilised during higher flows. The river is disconnected from its floodplain in several locations through this reach as a result of informal flood defences. This elevates in-channel energy levels during higher flows, preventing formation of significant gravel features. Under existing conditions, flow velocities vary between 1.0-2.4m/s for bankfull flows upstream of the mill leat, that are capable of moving medium to large gravels. Downstream of the old mill, the channel is moderately incised and the channel bed is dominated by cobbles. Bankfull flow velocities through this section range from 0.2-2.2m/s.

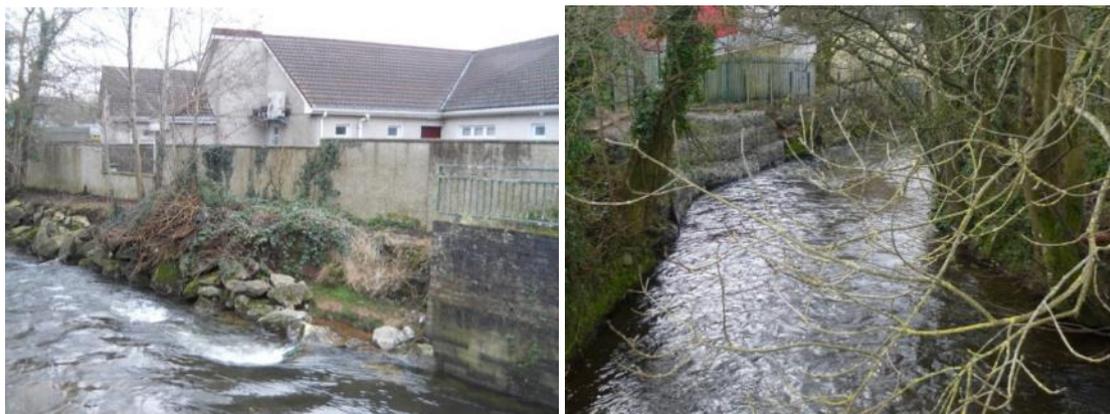
Figure 4-2 Typical conditions adjacent to the shopping centre

This reach is an active section of the river, with bank erosion common. Bank erosion is particularly occurring on the bend upstream of the confluence. There is a decent supply of sediment from upstream and adjoining steep tributaries. Historic straightening, possible dredging, informal flood embankments and bank protection works all act to increase energy levels during the channel during elevated flows as a result of the disconnected floodplain, loss of channel length through straightening and restriction of lateral processes. The channel is also relatively narrow through this section when compared to upstream reaches which again increases in-channel energy levels during elevated flows. This means there are few depositional features on the channel bed despite the strong supply of sediment to the reach.

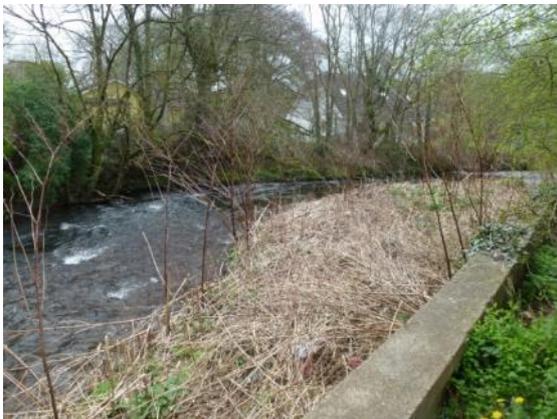
Figure 4-3 Typical conditions adjacent to Meadowbrook Housing Estate

In the section of the river downstream of the shopping centre the channel widens slightly. Flood defences exist on the right bank, which protect an adjacent housing estate. The defences act as a constraint to the channel in terms of its floodplain connection. The wider nature of the channel here has allowed for the deposition of some sediment (dominated by fines). In the majority of cases the depositional features are vegetated which suggests that the channel has reacted following past intervention (i.e. it has adjusted to a more natural narrow channel), probably as a result of the construction of the flood defences and disconnected floodplain over the right bank.

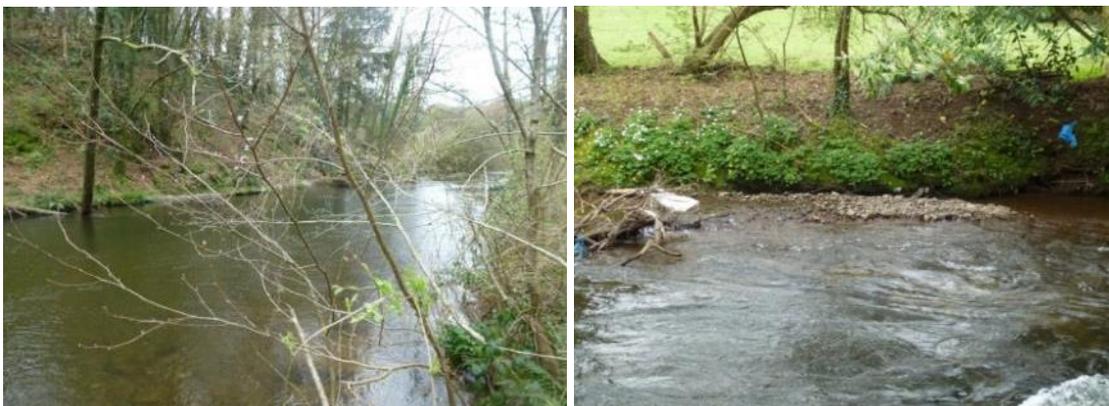
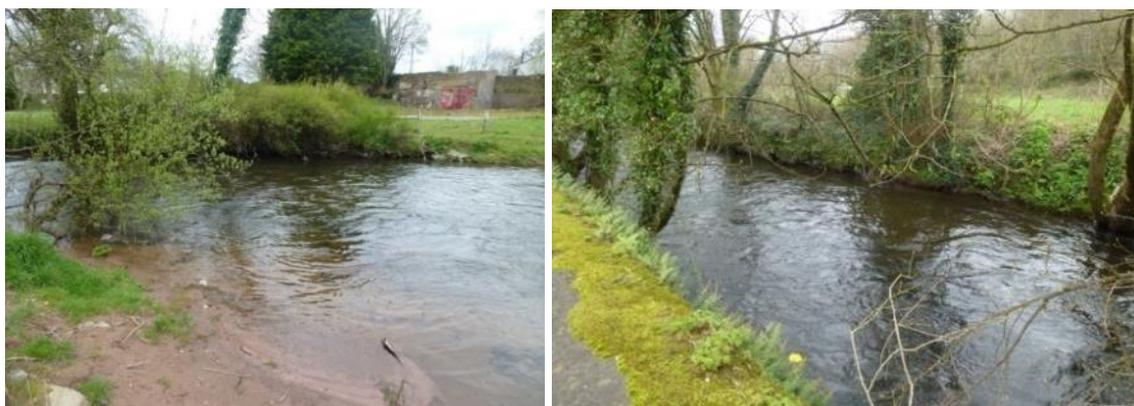
Figure 4-4 Typical conditions through O'Callaghan Park

This reach is characterised by a moderately active channel with some deposition of gravel and fines and some embryonic riffle pool sequencing. There is an impounded section of watercourse within this reach as a result of the large weir downstream, this creates elevated levels of fine sediment deposition on the channel bed. There is some evidence of bank erosion outside of the impounded area.

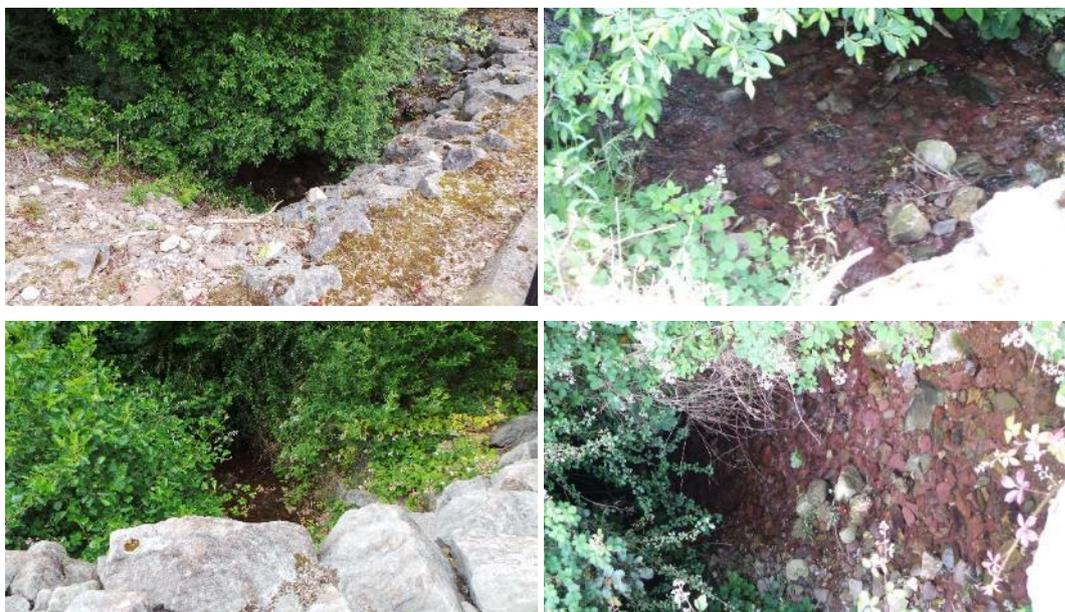
A.1 C09_B01: Replace existing twin 0.9m dia. culverts with new 1.6m by 1.2m high rect. culvert

Bleach Hill Stream at this location is entrenched (overly deep). As a result there is little floodplain connectivity except when flood water backs up behind the structure. The stream is dominated by a gravel and cobble bed which appears partially mobile (i.e. limited evidence of armouring). During flood conditions it is likely that this sediment will be mobilised and transported downstream, whilst new sediment will be delivered from upstream reaches. Due to the existing small culverts some sediment has accumulated upstream of the bridge. Whilst the existing culverts appear to be capable of allowing sediment to move downstream, it is likely that the culverts frequently become blocked with trash and debris which will hinder sediment continuity to downstream reaches.

The proposed larger culvert will improve sediment continuity through the system. The existing bed material should be maintained and matched where possible, however, any disturbance to the bed will quickly be rectified during subsequent high flow events. High flows event will be capable of transporting sediment to the structure from upstream reaches and the bed will quickly re stabilise.

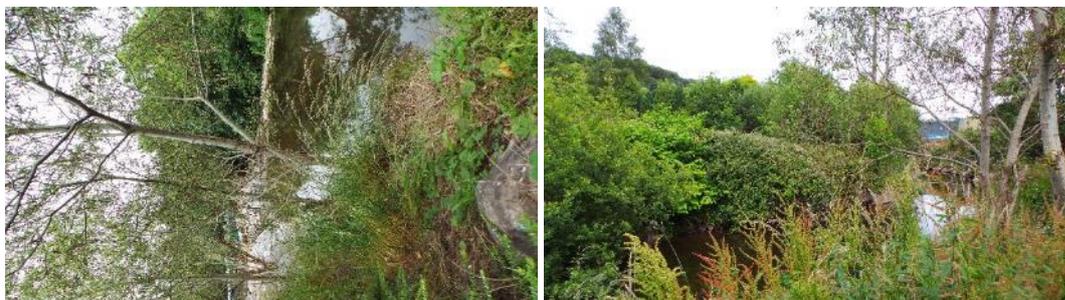
A.2 C01_L01: Concrete flood defence (Old weir at Petrol Stn North of Sallybrook)

There is an impounded reach upstream of an old weir adjacent to the petrol station. The weir is partially collapsed and appears unmaintained. The reach upstream of the weir exhibits low velocities due to the impoundment impacts. The weir has also, over time acted to trap sediment upstream which in turn has elevated the upstream channel bed level.

The main flow route over the weir is towards the left bank (outside bed) at the weir site. The steep gradient of the weir acts to elevate velocities and this has caused outer bank erosion problems.

Measures to protect the banks from erosion have been implemented using boulders and concrete which appear to be working in the short term.

In the long term there is a risk that the existing bank protection measures could fail due to their ad-hoc nature and the old weir structure could fail. If this occurs the existing river bed upstream of the weir will naturally lower as the trapped sediment is released. There may be a case for further investigation to determine the impact of the failure of this old weir structure on both the bed and bank upstream. Works are planned on the left hand bank, and this will stabilise this bank.

Any future failure would release trapped sediment downstream (which may impact structures) and cause upstream bank instability (which may impact the existing and future flood defences and erosion protection measures depending on foundation depth). This issue should be monitored and action taken if conditions deteriorate.

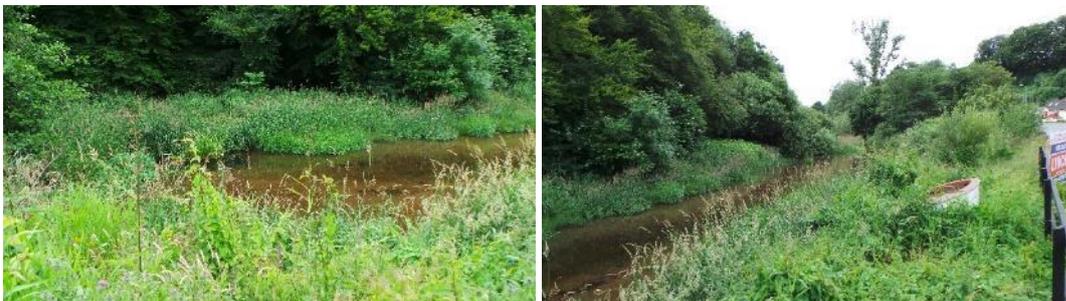
A.3 C08_700: Silted mill race

The redundant weir (noted above) feeds into the mill race shown in the photographs above. This is heavily silted due to the low velocities and limited variation in flow. Limited change is expected in this area following the construction of the new flood defences.

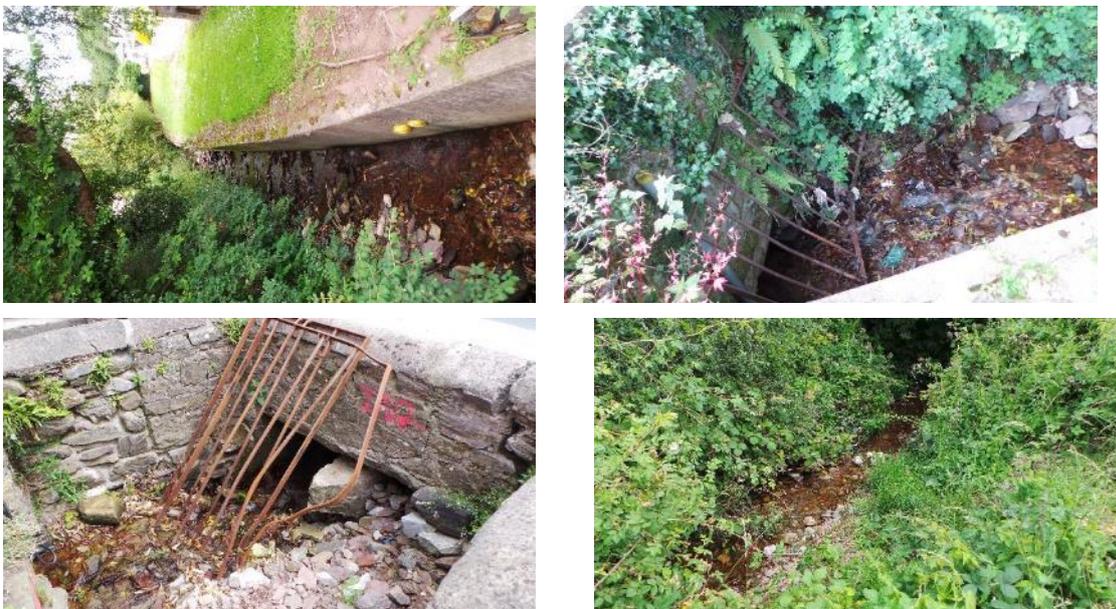
A.4 Cols na Gleann Stream: Replace existing culvert with a new 2m wide by 0.9m high rectangular culvert

The Cols na Gleann Stream is a small steep channel dominated by cobbles and gravels, which appear to readily transported downstream. The channel is very narrow and it is likely that it has been straightened historically. Such modifications act to elevate in channel velocities. Sediment has accumulated upstream of the culvert. Downstream of the culvert the channel gradient reduces and smaller gravels have been deposited (due to the reduced velocities associated with the reduced gradient). Within this area gravels dominate the channel bed and less cobbles are present. The existing culvert appears to disrupt the downstream continuity of sediment due to blockages at the small trash screen and the undersized nature of the bridge.

The proposals at this location should improve sediment continuity downstream. Care will be required to ensure large cobbles do not become trapped against the upstream trash screen (if one is to be constructed) as the high energy conditions will still be present.

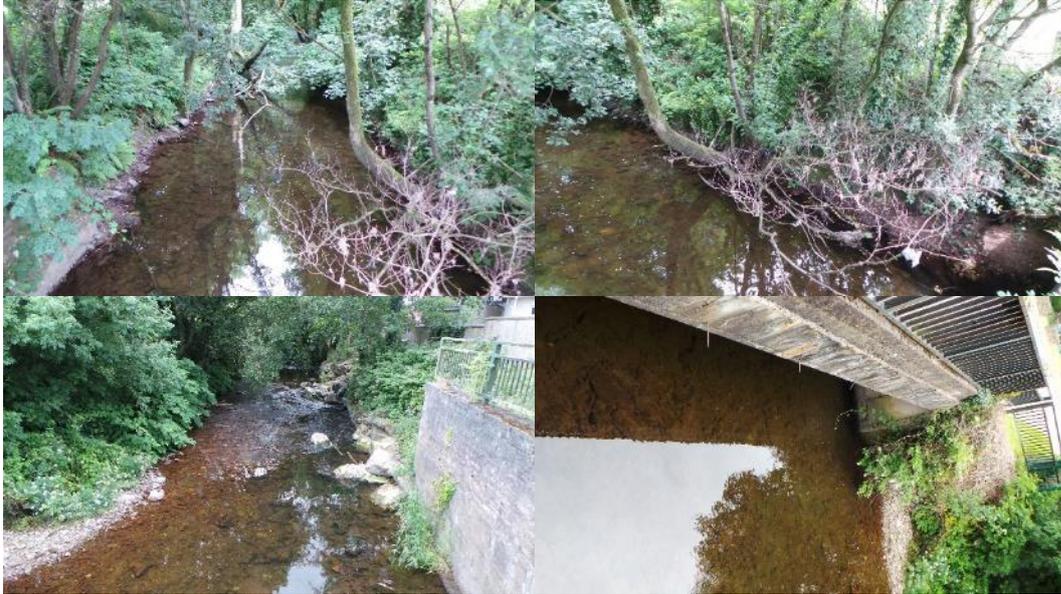
A.5 C01_C01, B02, C02: Proposed flood relief channel and culvert

The existing channel at this location is dominated by cobbles and gravels. The bed is partially armoured (evidenced by the moss over some of the larger cobbles) which suggests limited large sediment delivery. However, site conditions suggest higher velocity flows frequently transport smaller gravels through this reach. The construction of a flood relief channel is unlikely to significantly alter existing morphological conditions. However, the invert of the flood relief channel should be set at a point as to not decrease velocity as this could lead to an increase in deposition if in channel velocities are reduced significantly.

The existing bed material should be maintained and matched where possible. High flows event will be capable of transporting sediment; however, several flood events may need to pass through the system before the bed re-stabilises.

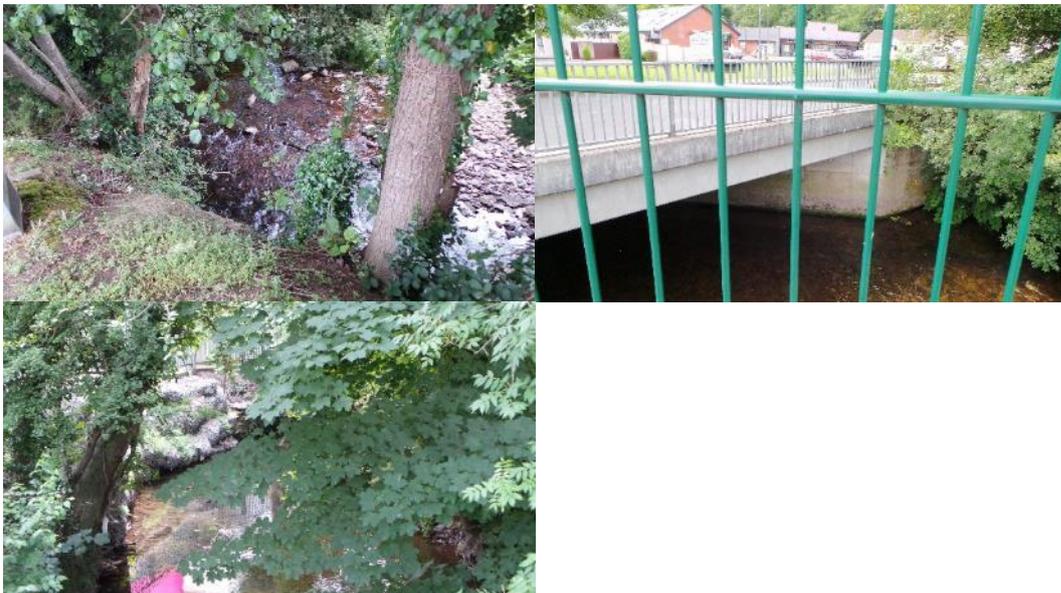
A.6 C01_B03: Replace bridge

The channel at this location is currently over wide which acts to influence morphological processes. As a consequence, depositional zones are noted within this reach. (i.e. the over wide nature of the channel may lead to lower velocities which in turn may encourage deposition). The proposed new

bridge should not change the existing morphological regime, as the channel width is remaining the same.

Upstream and downstream of this bridge some channel erosion is evident. In particular, downstream of the bridge, existing gabion basket protection has begun to fail on the outside of the bend. An alternative solution to bank protection is recommended at this location.

The existing bed material should be maintained and matched where possible. High flow events will be capable of transporting sediment, however several flood events may need to pass through the system before the bed destabilises.

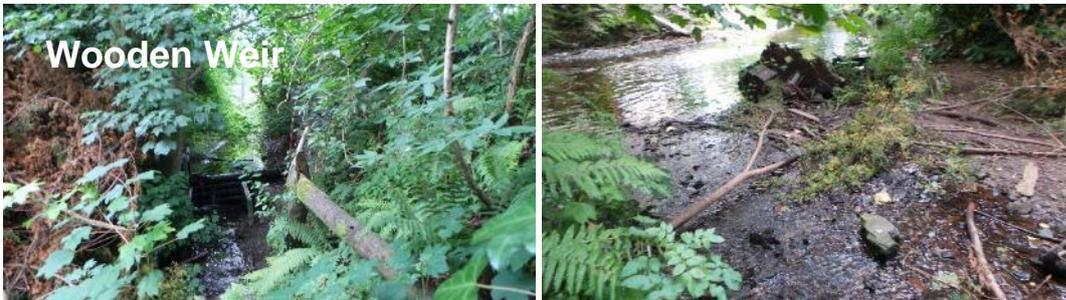
A.7 C06_B01: Replace existing twin 0.4m dia culverts with a new 1.8m wide by 0.9m high rect culvert

No safe access could be sought to see this culvert on the Springmount stream. However, extensive gravels and sands were present downstream. A wooden weir structure is also in place downstream which acts to impound water upstream for an unspecified distance. This appears to have collected a substantial amount of sediment. If this weir fails it could impact the stability of the channel upstream in the short term. Further investigation should be sought to see if this weir influences flow conditions at the upstream culvert.

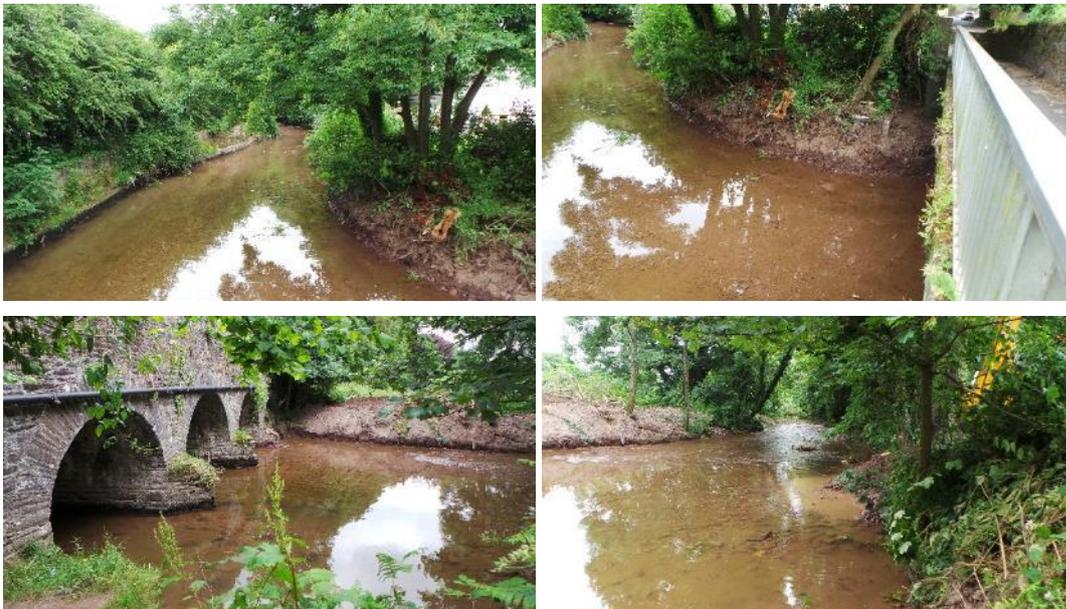
A.8 C01_C03: Bridge arch to be cleared by removing vegetation

Sediment was in the process of being removed from the channel during the site visit on the 03/07/16. Sediment was being removed several hundred metres upstream and downstream of the bridge. Some banks remain steeply profiled and could be subject to erosion until vegetation re-establishes.

Nevertheless, it is expected that the channel will quickly recover and new gravel bars will reform and the river attempts to re-establish a sediment equilibrium.

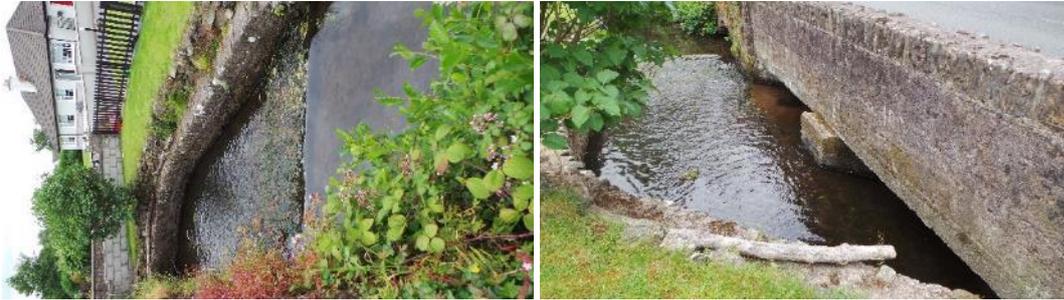
A.9 C09_C01 (channel deepening), C05_B01 (replace culverts), C05_C02 (channel widening), C05_C03 (widening)

Deepening and increasing the culvert size will increase conveyance through the bridge. There will be limited impact on the channel morphology. The weir downstream of the bridge acts to trap some sediment.

The delivery of sediment within this reach appears to be lower than over reaches. This means that the channel may take longer to recover following any in channel works.
