# 1 Project background and objectives

This section of the report summarises the qualitative findings of the geomorphological / fluvial audit conducted on the Glashaboy River and the lower sections of the Butlerstown River and Glenmore River during April 2014 and August 2016, following the large flood events of 2015. Tidal reaches were visited at low tide to maximise the opportunity to view the bed conditions within the watercourse / estuary.

# Glashaboy River (Glanmire/Sallybrook) Drainage Scheme

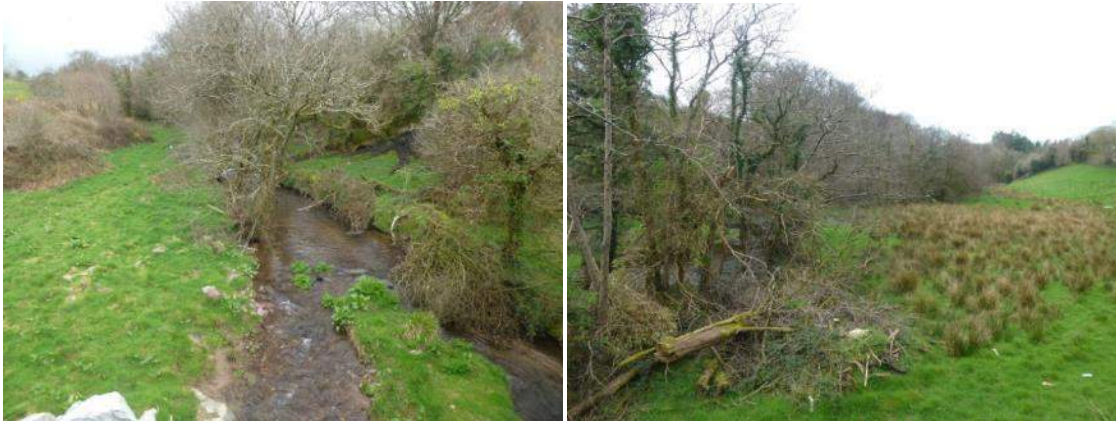
Figure 3-5 Upstream of Ballyskerdane Bridge (Point 4)

Stable vegetated bars were common throughout the reach (Figure 3-5) along with small pockets of fine sediment deposition along the lateral edges of the channel, mainly from localised bank erosion. Small areas of deposition like this are often an indication of the channel naturally attempting to narrow as a result of historic intervention, such as over widening. Several low weirs exist (see example in Figure 3-2), which cause limited upstream impoundment, but act to cause increased fine sediment deposition within their impoundment zones. Limited evidence was noted of weirs restricting movement of gravels.

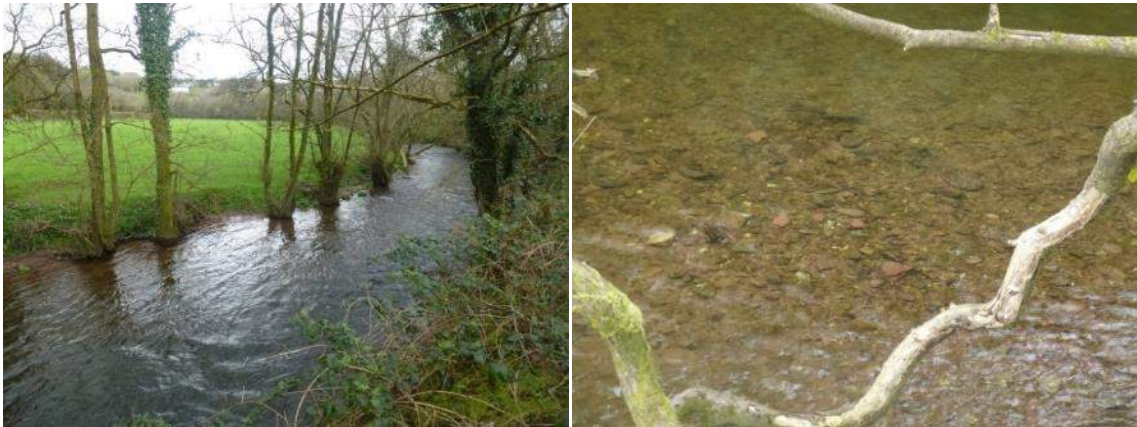
Figure 3-8 Knocknahorgan (Point 7)

The channel bed throughout this reach is again dominated by gravels and cobbles, in a plane bed and pool riffle morphology. Less algae was seen on the more gravelly sections on the bed which suggests a more active supply and movement of gravels through this reach (Figure 3-8).

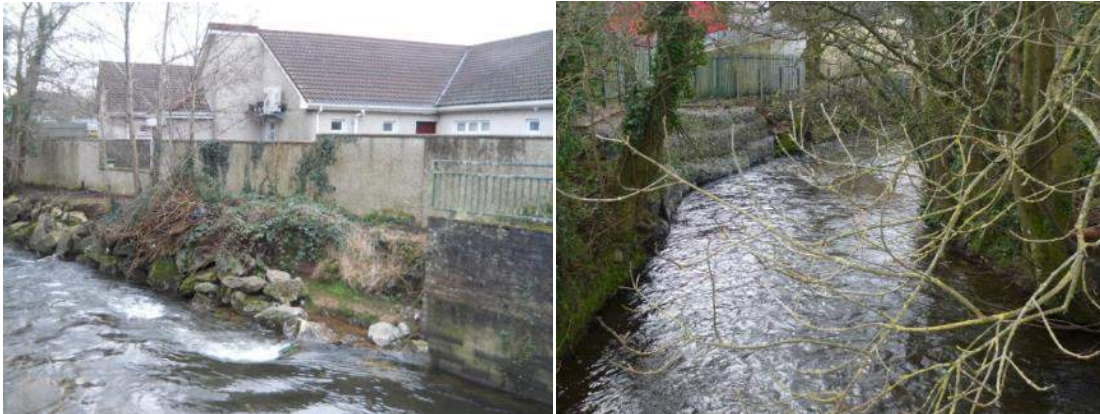
Figure 3-13 Adjacent to the Glanmire shopping centre (Point 10a)

At the Glanmire shopping centre several areas of bank instability exist (Figure 3-13 and Figure 3-14). The channel at this point is confined and relatively narrow compared to reaches upstream. There is limited deposition due to the steepness in some sections and disruption from upstream to the sediment transport process. The channel banks are high in most locations due to land raising and embankments. As a result, during flood conditions all energy is concentrated within the channel which is leading to bank erosion and instability. In many places existing bank protection has been undermined and has collapsed into the river. This section appears to be starved of sediment, suggesting upstream structures, such as the old weirs are influencing in-channel processes. As a result, the channel has excess stream power leading to the erosion processes along the beds and bank. In order to reduce the flood impact and erosion within this section various options could be investigated including flood storage options upstream and also improving the in-channel morphology which is currently degraded, to manage the existing high energy conditions.

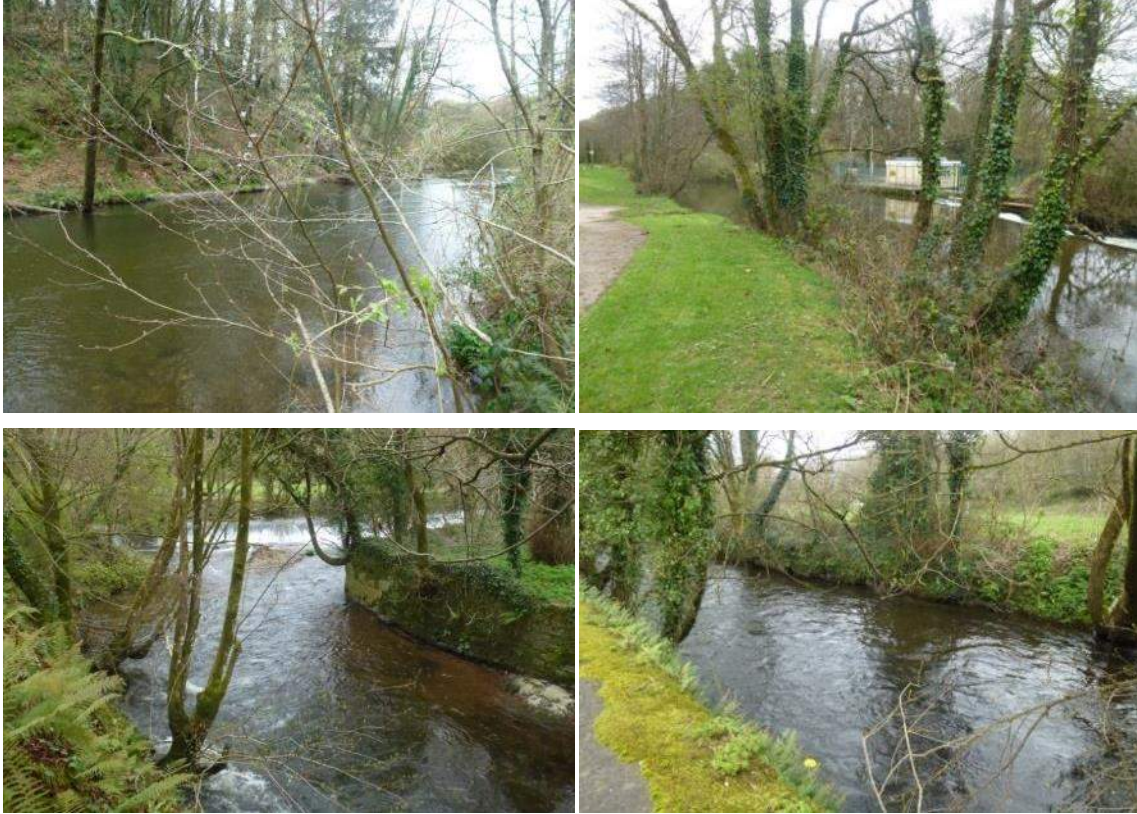
Figure 3-18 Impoundment (Point 14)

In the downstream section of the park a weir exists, which historically was used to feed a mill leat (which is still active). This causes upstream impoundment through the park increasing fine sediment deposition (Figure 3-18). Downstream of the weir some minor scour has occurred along

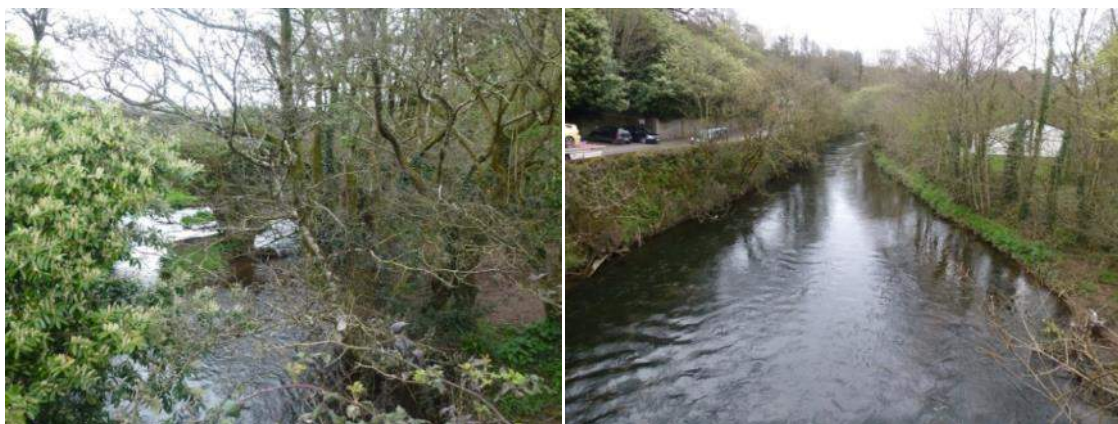
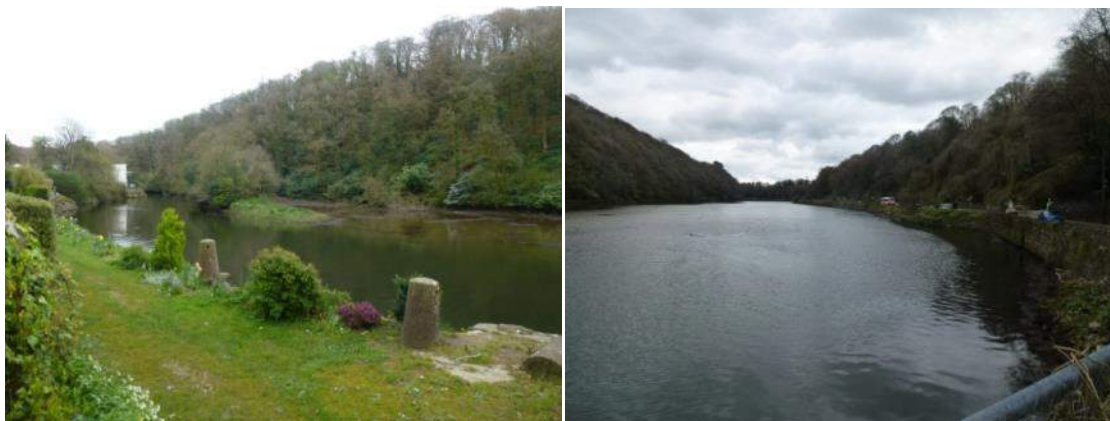
Figure 3-20 Sections downstream of Glanmire

At Glanmire bridge, deposition of gravels is occurring on the left bank (Figure 3-20). Downstream of the bridge the river gradually becomes wider and eventually is influenced by the tidal regime. This influences water levels and flow conditions downstream of Glanmire, resulting in some deposition of tidally derived muds and silts. The deposition of this sediment appears low therefore there is little risk of increased sedimentation in this section.

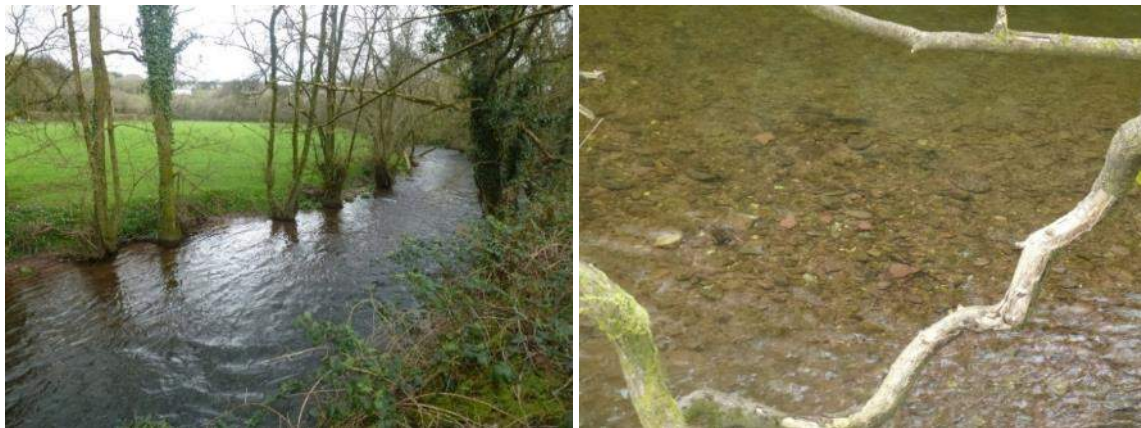
Figure 4-1 Typical conditions upstream of the industrial estate

This is a moderately active section of the channel upstream of the mill leat with a gravel / cobble bed that is partly mobilised during higher flows. The river is disconnected from its floodplain in several locations through this reach as a result of informal flood defences. This elevates in-channel energy levels during higher flows, preventing formation of significant gravel features. Under existing conditions, flow velocities vary between 1.0-2.4m/s for bankfull flows upstream of the mill leat, that are capable of moving medium to large gravels. Downstream of the old mill, the channel is moderately incised and the channel bed is dominated by cobbles. Bankfull flow velocities through this section range from 0.2-2.2m/s.

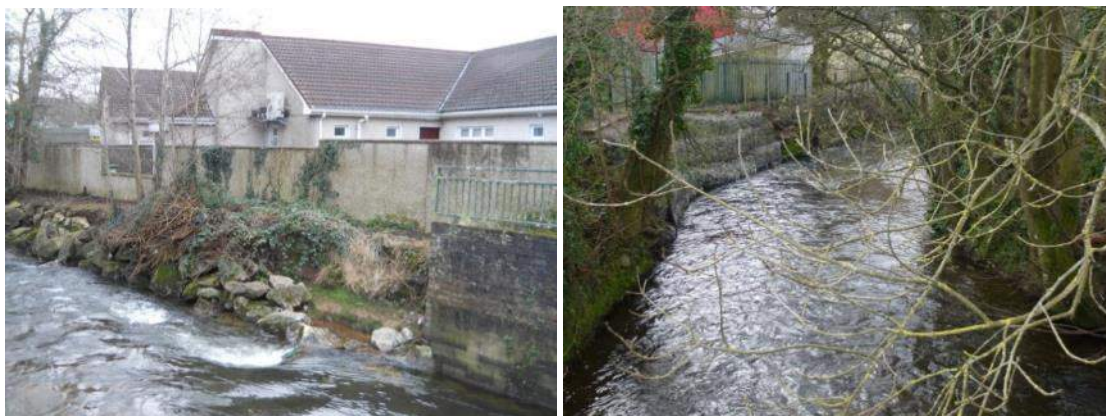
Figure 4-2 Typical conditions adjacent to the shopping centre

This reach is an active section of the river, with bank erosion common. Bank erosion is particularly occurring on the bend upstream of the confluence. There is a decent supply of sediment from upstream and adjoining steep tributaries. Historic straightening, possible dredging, informal flood embankments and bank protection works all act to increase energy levels during the channel during elevated flows as a result of the disconnected floodplain, loss of channel length through straightening and restriction of lateral processes. The channel is also relatively narrow through this section when compared to upstream reaches which again increases in-channel energy levels during elevated flows. This means there are few depositional features on the channel bed despite the strong supply of sediment to the reach.

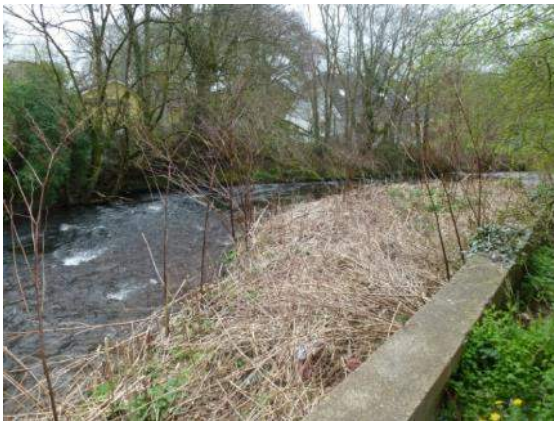
Figure 4-3 Typical conditions adjacent to Meadowbrook Housing Estate

In the section of the river downstream of the shopping centre the channel widens slightly. Flood defences exist on the right bank, which protect an adjacent housing estate. The defences act as a constraint to the channel in terms of its floodplain connection. The wider nature of the channel here has allowed for the deposition of some sediment (dominated by fines). In the majority of cases the depositional features are vegetated which suggests that the channel has reacted following past intervention (i.e. it has adjusted to a more natural narrow channel), probably as a result of the construction of the flood defences and disconnected floodplain over the right bank.

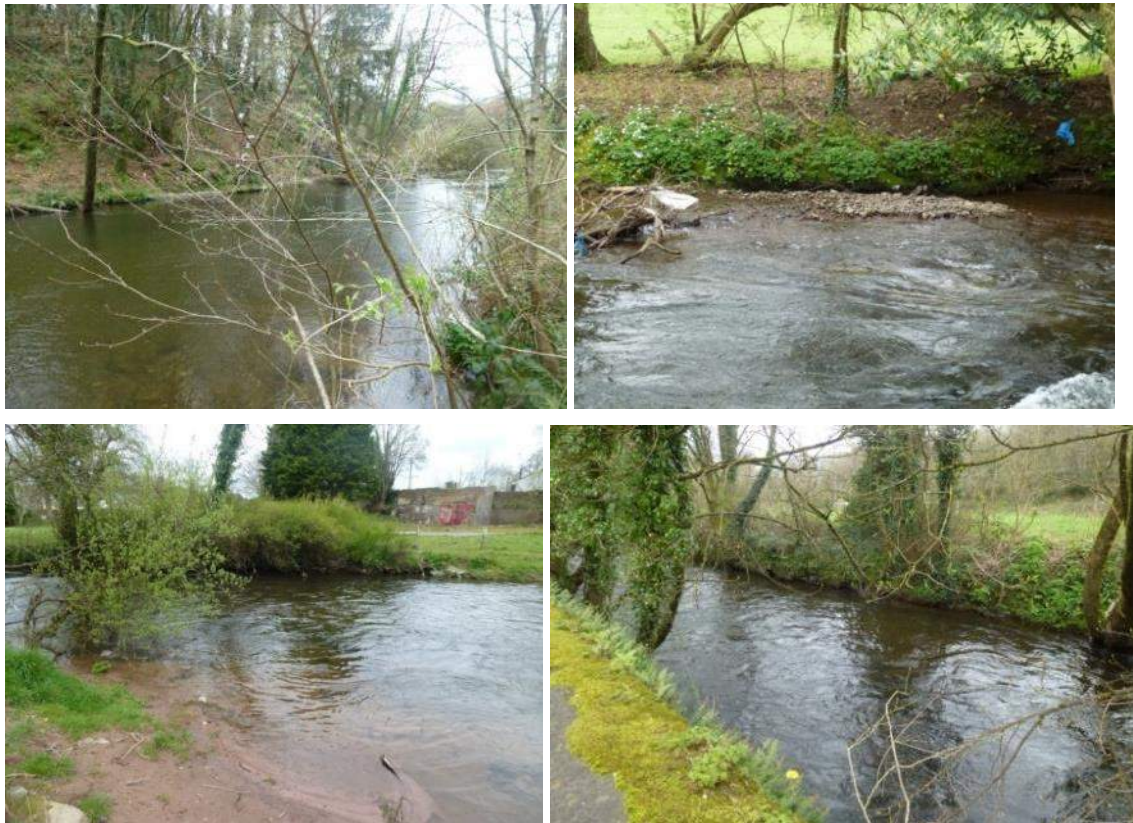
Figure 4-4 Typical conditions through O’Callaghan Park

This reach is characterised by a moderately active channel with some deposition of gravel and fines and some embryonic riffle pool sequencing. There is an impounded section of watercourse within this reach as a result of the large weir downstream, this creates elevated levels of fine

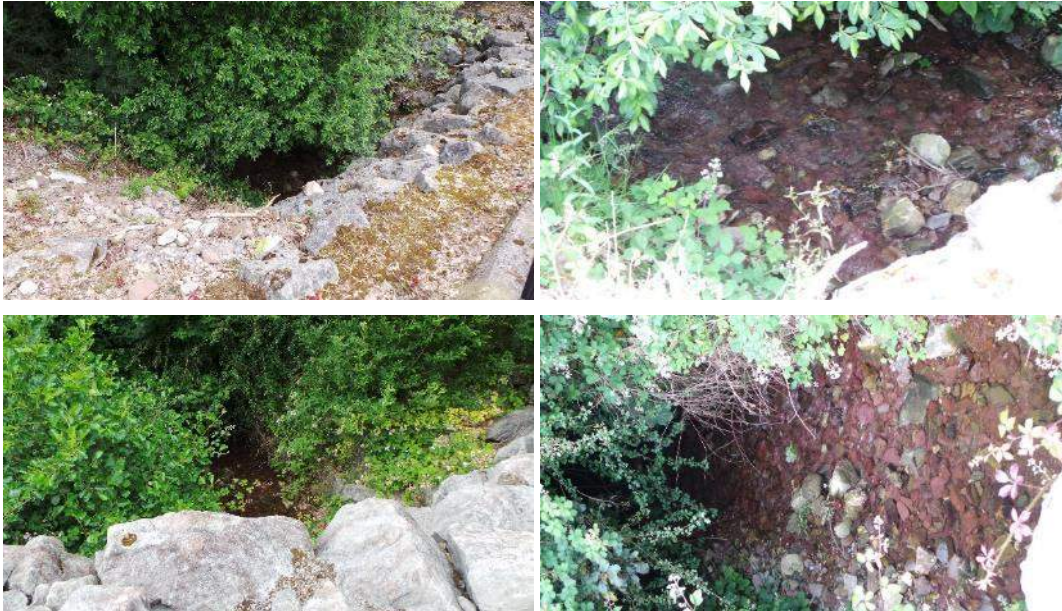
### A.1 C09\_B01: Replace existing twin 0.9m dia. culverts with new 1.6m by 1.2m high rect. culvert

Bleach Hill Stream at this location is entrenched (overly deep). As a result there is little floodplain connectivity except when flood water backs up behind the structure. The stream is dominated by a gravel and cobble bed which appears partially mobile (i.e. limited evidence of armouring). During flood conditions it is likely that this sediment will be mobilised and transported downstream, whilst new sediment will be delivered from upstream reaches. Due to the existing small culverts some sediment has accumulated upstream of the bridge. Whilst the existing culverts appear to be capable of allowing sediment to move downstream, it is likely that the culverts frequently become blocked with trash and debris which will hinder sediment continuity to downstream reaches.

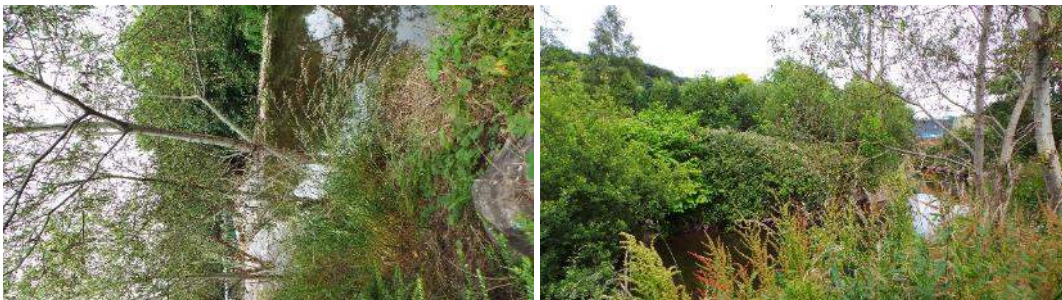
### A.2 C01\_L01: Concrete flood defence (Old weir at Petrol Stn North of Sallybrook)

There is an impounded reach upstream of an old weir adjacent to the petrol station. The weir is partially collapsed and appears unmaintained. The reach upstream of the weir exhibits low velocities due to the impoundment impacts. The weir has also, over time acted to trap sediment upstream which in turn has elevated the upstream channel bed level.

The main flow route over the weir is towards the left bank (outside bed) at the weir site. The steep gradient of the weir acts to elevate velocities and this has caused outer bank erosion problems.

In the long term there is a risk that the existing bank protection measures could fail due to their ad-hoc nature and the old weir structure could fail. If this occurs the existing river bed upstream of the weir will naturally lower as the trapped sediment is released. There may be a case for further investigation to determine the impact of the failure of this old weir structure on both the bed and bank upstream. Works are planned on the left hand bank, and this will stabilise this bank.

Any future failure would release trapped sediment downstream (which may impact structures) and cause upstream bank instability (which may impact the existing and future flood defences and erosion protection measures depending on foundation depth). This issue should be monitored and action taken if conditions deteriorate.

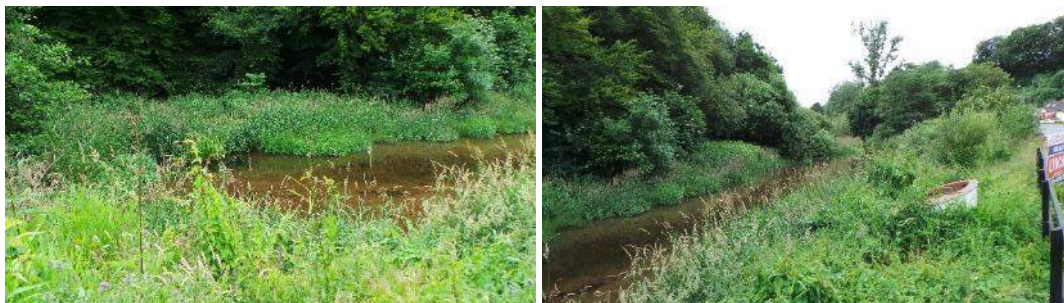
**A.3 C08\_700: Silted mill race**

The redundant weir (noted above) feeds into the mill race shown in the photographs above. This is heavily silted due to the low velocities and limited variation in flow. Limited change is expected in this area following the construction of the new flood defences.

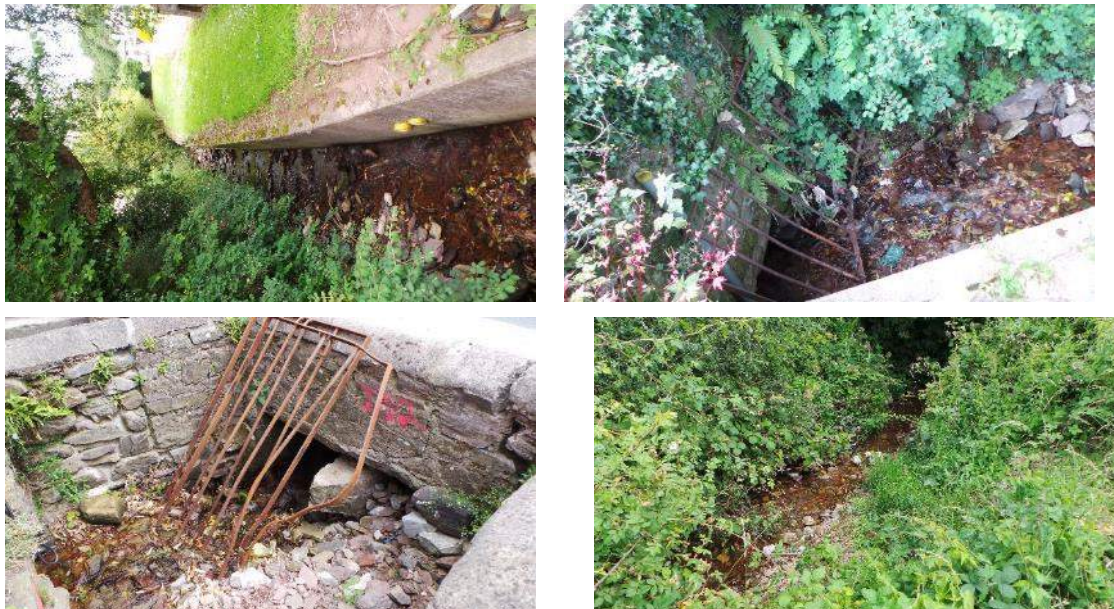
**A.4 Cols na Gleann Stream: Replace existing culvert with a new 2m wide by 0.9m high rectangular culvert**

The Cols na Gleann Stream is a small steep channel dominated by cobbles and gravels, which appear to readily transported downstream. The channel is very narrow and it is likely that it has been straightened historically. Such modifications act to elevate in channel velocities. Sediment has accumulated upstream of the culvert. Downstream of the culvert the channel gradient reduces and smaller gravels have been deposited (due to the reduced velocities associated with the reduced gradient). Within this area gravels dominate the channel bed and less cobbles are present. The existing culvert appears to disrupt the downstream continuity of sediment due to blockages at the small trash screen and the undersized nature of the bridge.

The proposals at this location should improve sediment continuity downstream. Care will be required to ensure large cobbles do not become trapped against the upstream trash screen (if one is to be constructed) as the high energy conditions will still be present.

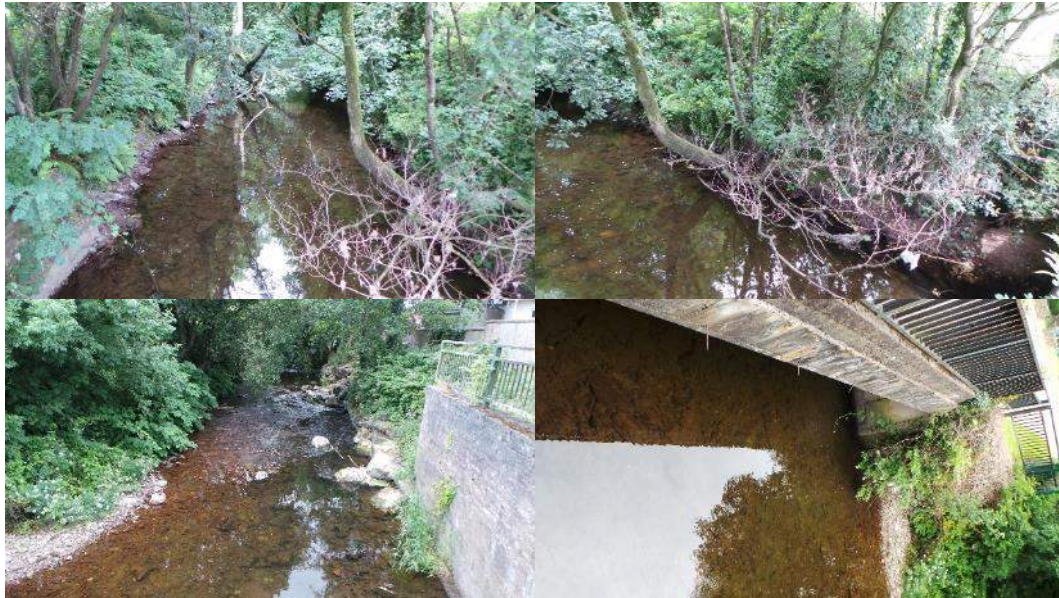
### A.5 C01\_C01, B02, C02: Proposed flood relief channel and culvert

The existing channel at this location is dominated by cobbles and gravels. The bed is partially armoured (evidenced by the moss over some of the larger cobbles) which suggests limited large sediment delivery. However, site conditions suggest higher velocity flows frequently transport smaller gravels through this reach. The construction of a flood relief channel is unlikely to significantly alter existing morphological conditions. However, the invert of the flood relief channel should be set at a point as to not decrease velocity as this could lead to an increase in deposition if in channel velocities are reduced significantly.

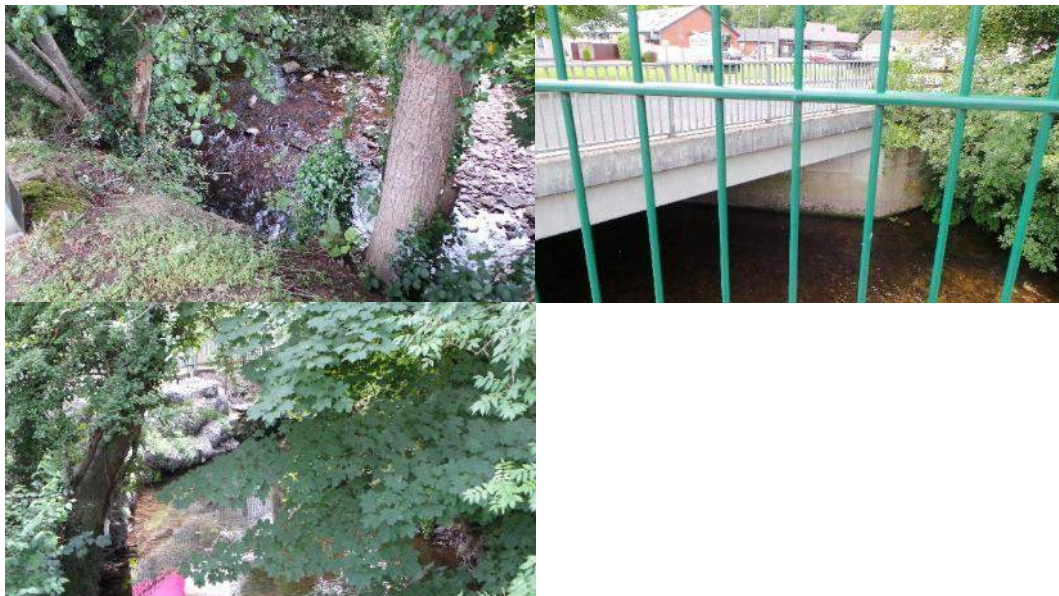
### A.6 C01\_B03: Replace bridge

The channel at this location is currently over wide which acts to influence morphological processes. As a consequence, depositional zones are noted within this reach. (i.e. the over wide nature of the channel may lead to lower velocities which in turn may encourage deposition). The proposed new

Upstream and downstream of this bridge some channel erosion is evident. In particular, downstream of the bridge, existing gabion basket protection has begun to fail on the outside of the bend. An alternative solution to bank protection is recommended at this location.

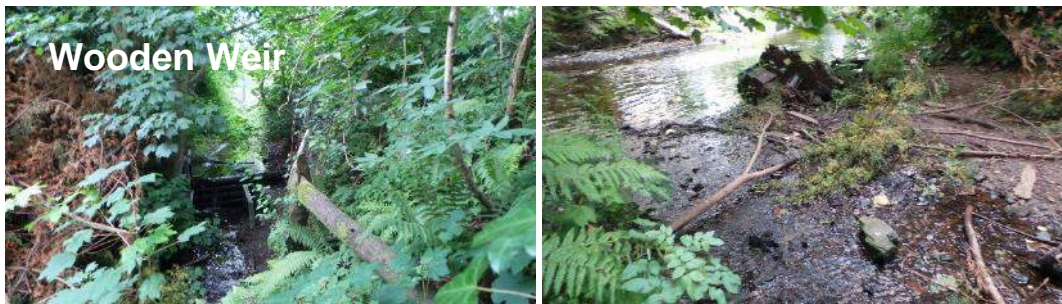
**A.7 C06\_B01: Replace existing twin 0.4m dia culverts with a new 1.8m wide by 0.9m high rect culvert**

No safe access could be sought to see this culvert on the Springmount stream. However, extensive gravels and sands were present downstream. A wooden weir structure is also in place downstream which acts to impound water upstream for an unspecified distance. This appears to have collected a substantial amount of sediment. If this weir fails it could impact the stability of the channel upstream in the short term. Further investigation should be sought to see if this weir influences flow conditions at the upstream culvert.

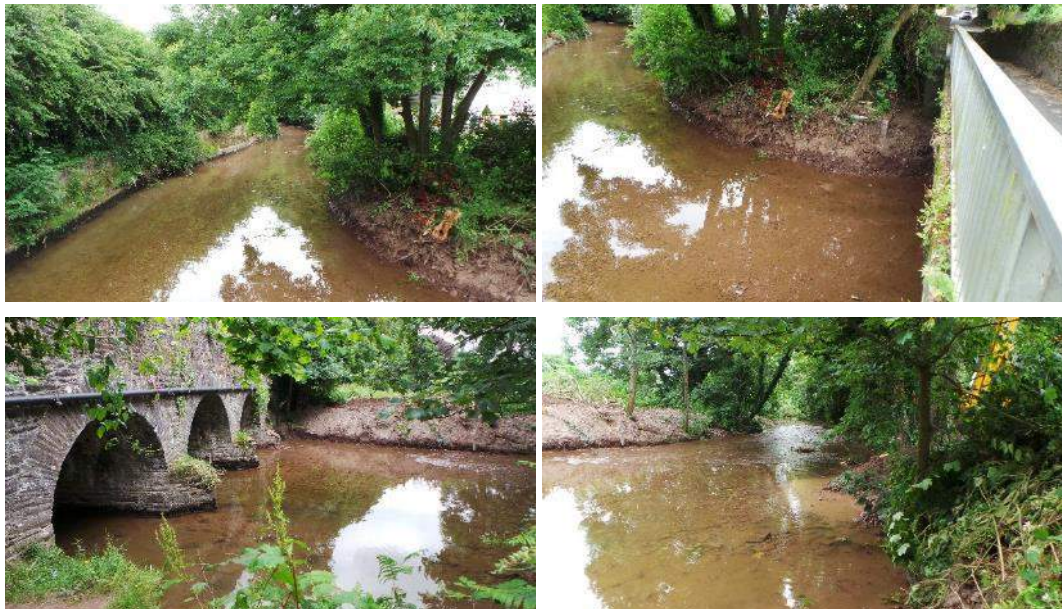
**A.8 C01\_C03: Bridge arch to be cleared by removing vegetation**

Sediment was in the process of being removed from the channel during the site visit on the 03/07/16. Sediment was being removed several hundred metres upstream and downstream of the bridge. Some banks remain steeply profiled and could be subject to erosion until vegetation re-establishes.

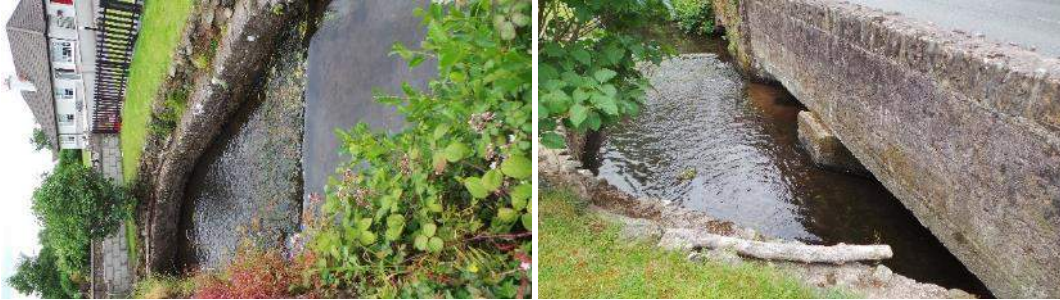
**A.9 C09\_C01 (channel deepening), C05\_B01 (replace culverts), C05\_C02 (channel widening), C05\_C03 (widening)**

Deepening and increasing the culvert size will increase conveyance through the bridge. There will be limited impact on the channel morphology. The weir downstream of the bridge acts to trap some sediment.

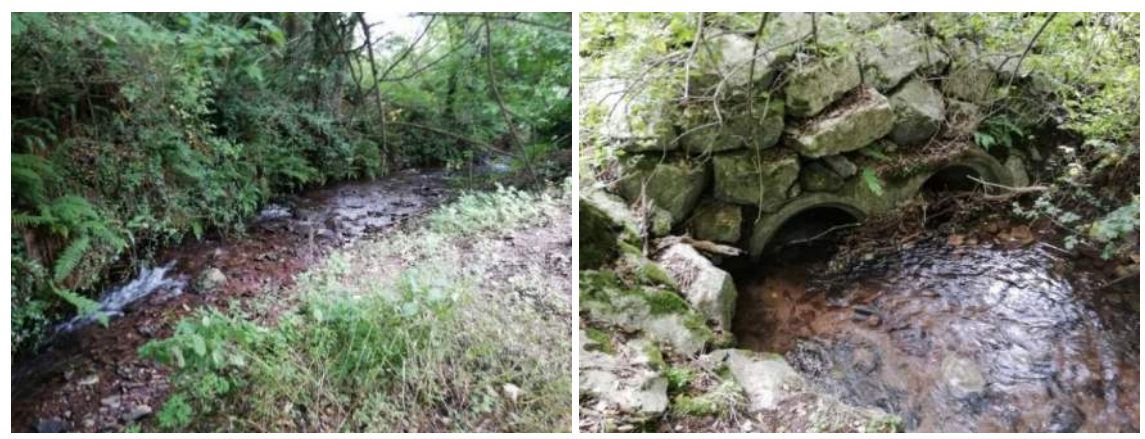
The bed in this section is gravel, cobble, and sand with little to no fine sediment. Active sediment transport in this area, with a build-up of gravel and sand noted at the existing culvert due to blockage by woody debris and under-sizing of the culvert. A small amount of undercutting was noted on both banks, indicating that the river in this section is sourcing some sediments from the lower banks and transporting it downstream. This is consistent with observations in the previous audit which suggested that this reach is overly deep/entrenched, which has contributed to armoring of the bed and little to no connectivity with the floodplain.

Figure 5-3. Cúil Chluthair culvert location (Left: looking upstream, right: looking downstream at existing culvert)

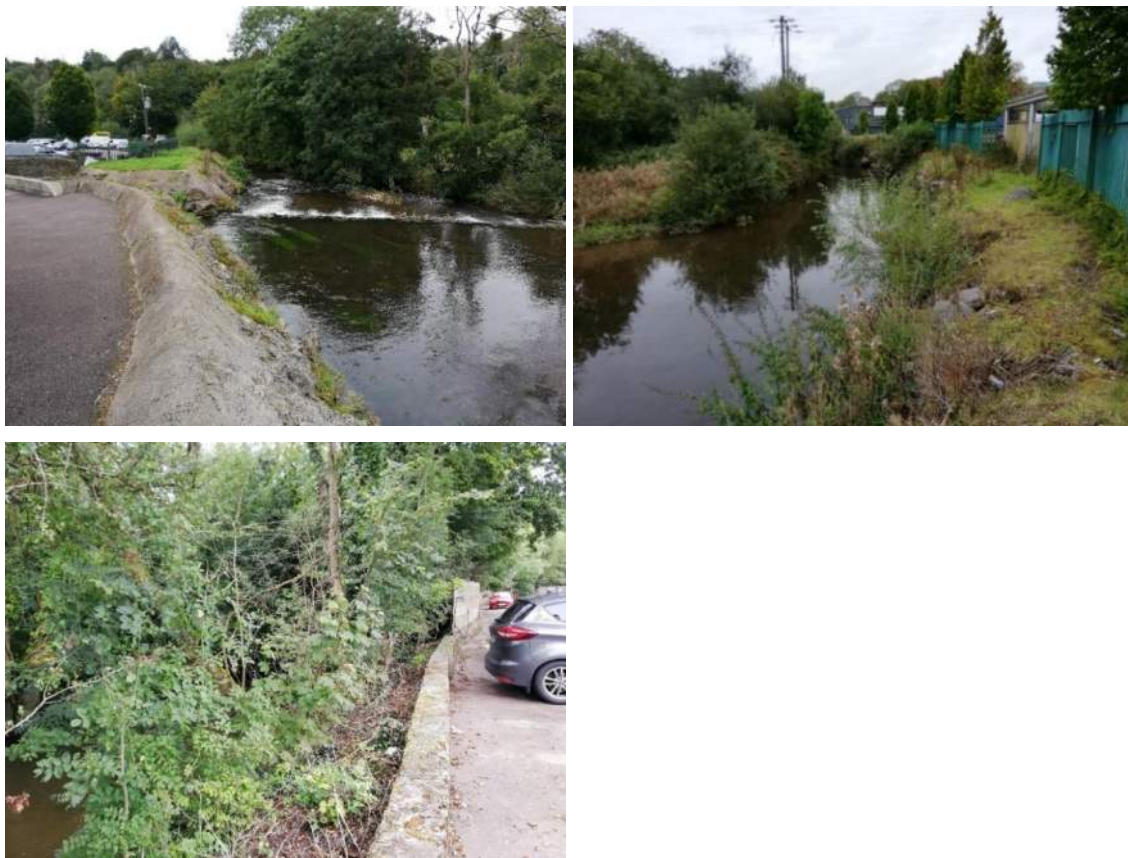
There are existing ad-hoc defences (rock armour and various concrete defences) on the left bank which are in various states of repair. The rock armour noted in Figure 5-4 (photo on the right) is shown to be unstable, while adjacent to it (photo on the top left) concrete defences remain in place.

Figure 5-4. Location of proposed RC walls and sheet pile walls at the Sallybrook Industrial Estate

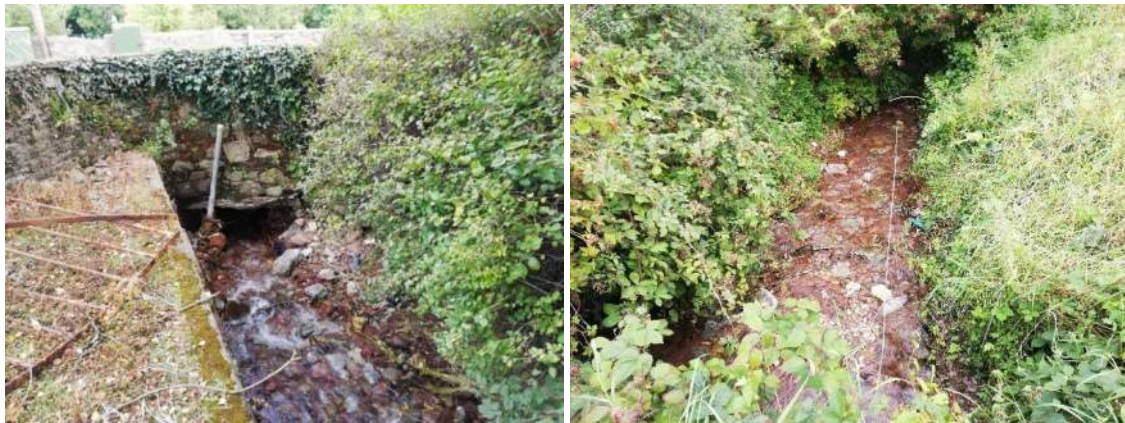
This tributary has been artificially straightened which increases the ability of this tributary to transport sediment due to increased flow energy in the system, however the existing culverts act as a barrier to sediment movement. The downstream reach is moderately armoured with cobble and gravels which further support that the culvert acts as a barrier to sediment transport. Downstream of the culvert the channel gradient reduces and smaller gravels have been deposited and there is little to no cobble sized material.

Figure 5-6. Existing culvert system at Cois na Gleann (Left: upstream end of culvert, right: downstream reach)

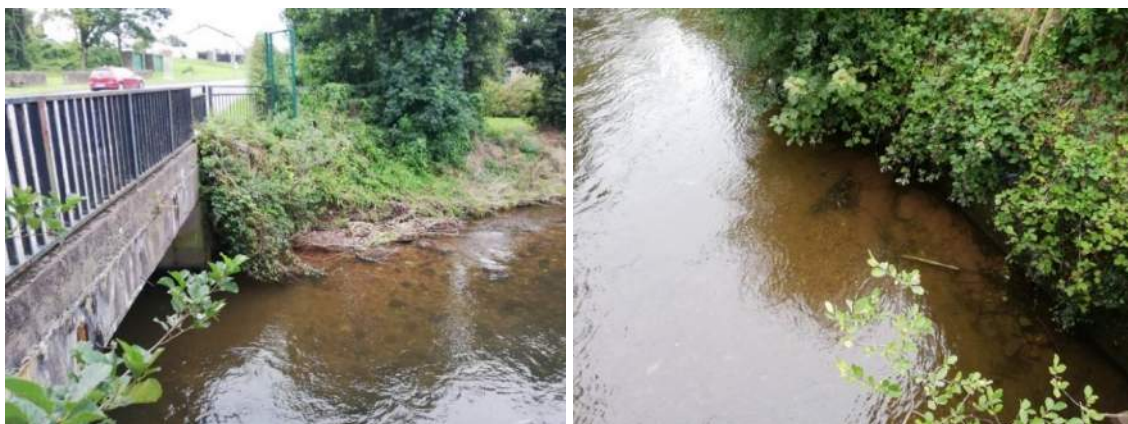
Figure 5-7. Location where new flood relief culvert to tie into existing bridge (left: bank failures observed at downstream,

right: fine sediment deposition observed upstream of bridge)

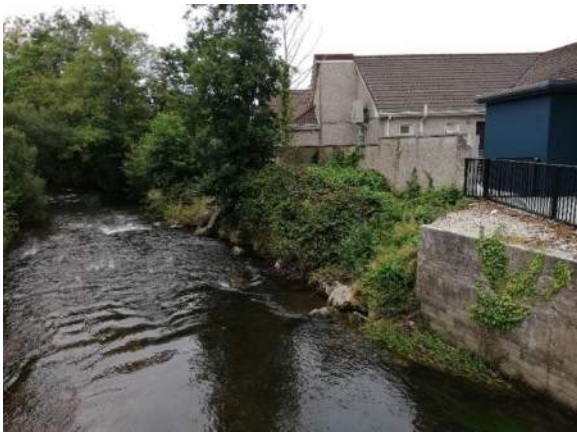
Figure 5-8. Existing retaining wall and rock armour to be replaced by RC walls (looking downstream at right bank)

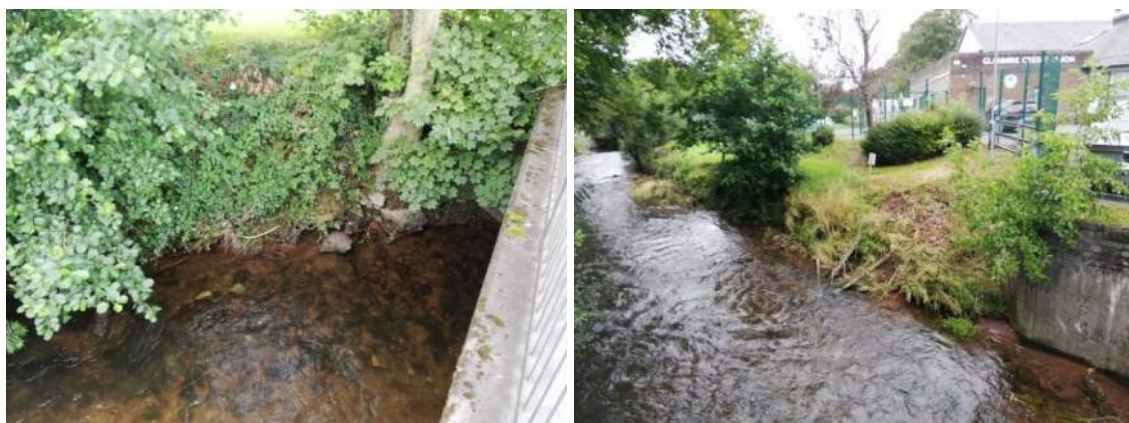
Figure 5-10. Bank instability noted around existing Hazelwood shopping centre bridge at downstream (left) and upstream (right)

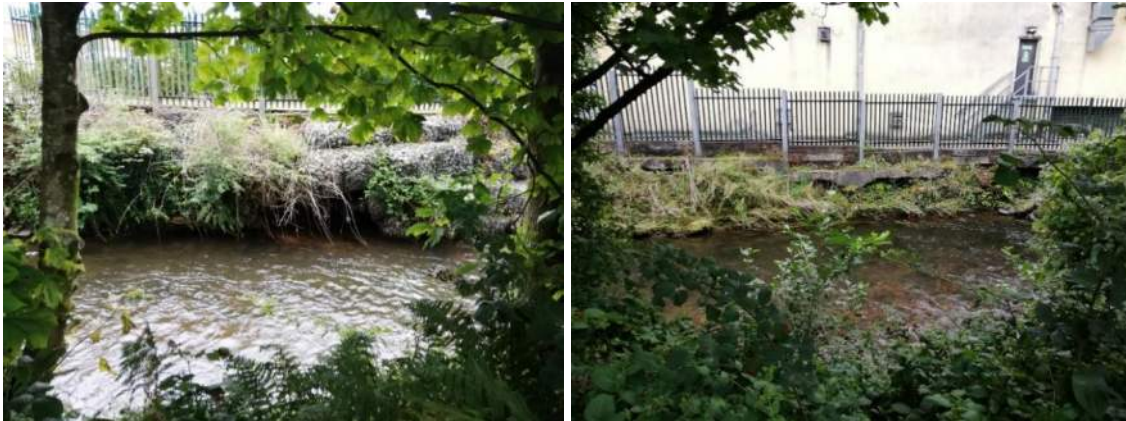
Figure 5-11. Undermining of ad-hoc defence structures observed on left bank

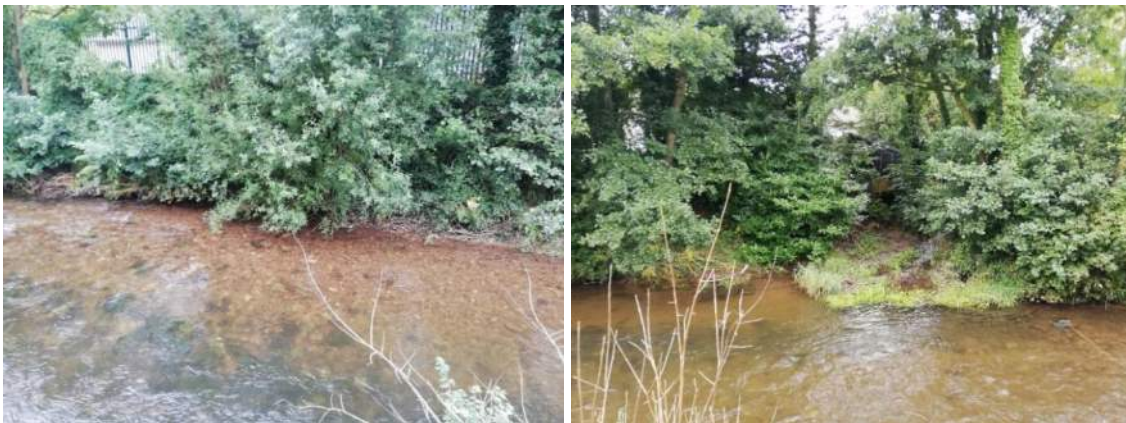
Figure 5-12. In-channel morphology contains point bars (left) and erosion at meander bends. Sediment input from Springmount Stream (right)

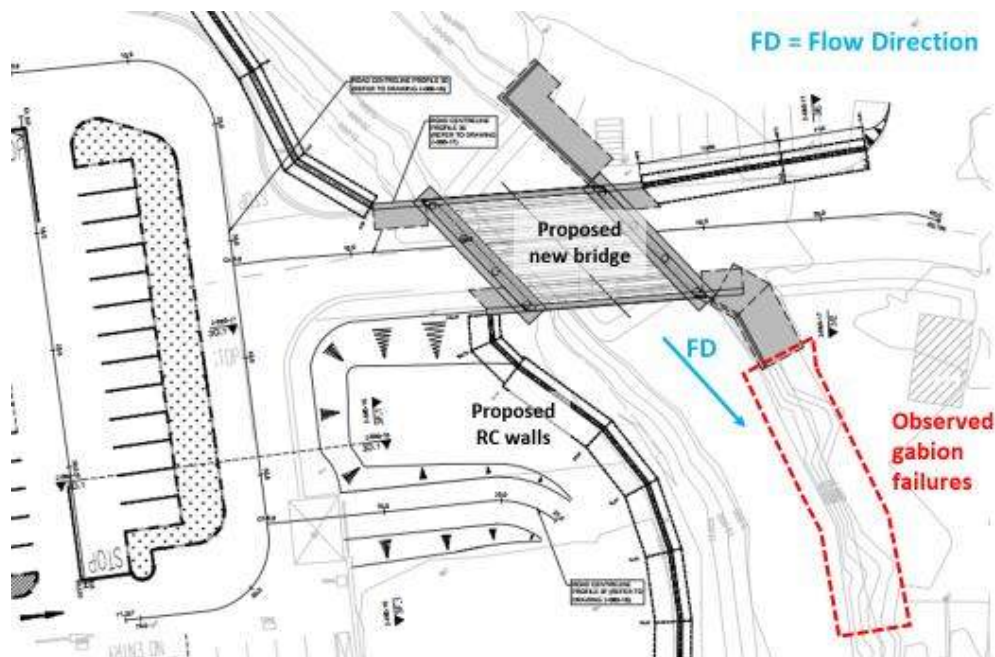
Figure 5-13. Observed bank failure relative to proposed elements of scheme (including new Hazelwood Shopping Centre bridge and RC walls)

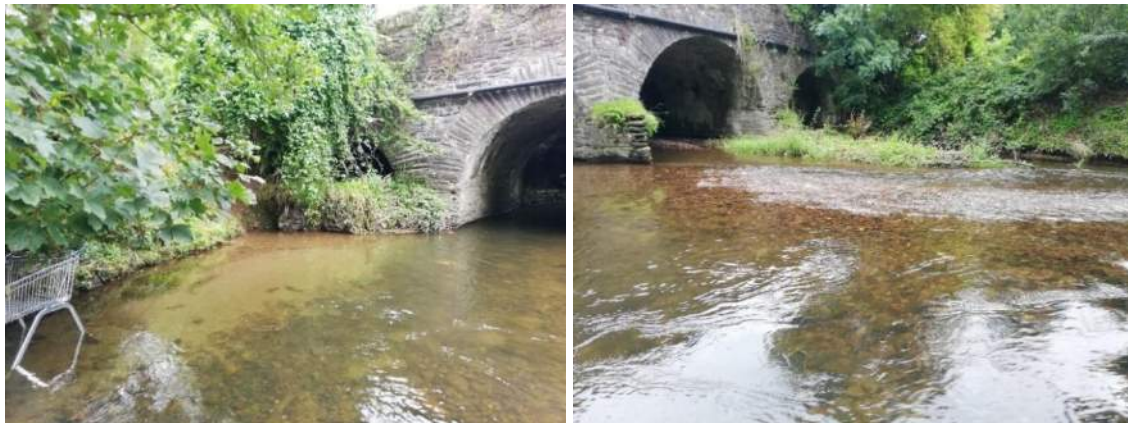
Figure 5-14. Deposition at Riverstown Bridge is primarily mid-channel gravel bars, with some fine sediments downstream of the east bank arch where outfalls are located and backwatering likely occurs during higher flows

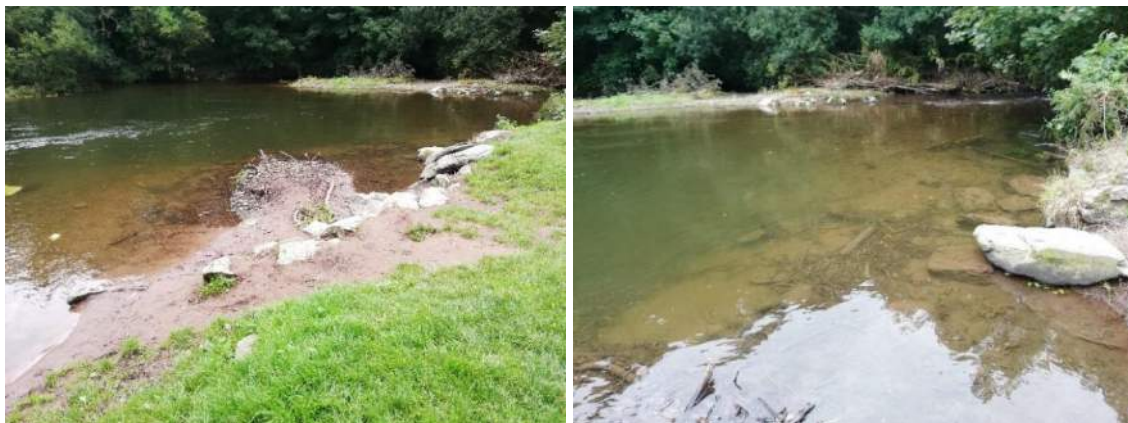
Figure 5-15. Fine sediment deposition observed at meander bend in John O'Callaghan Park

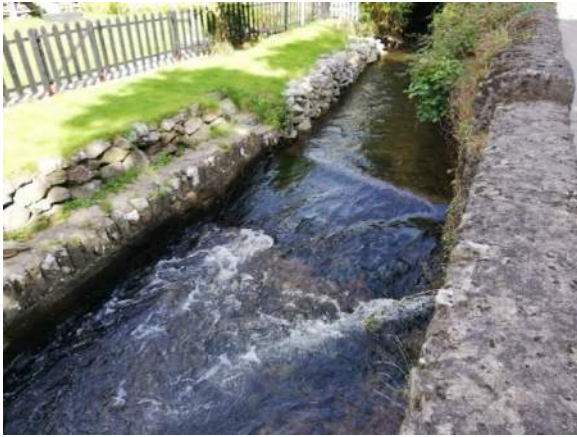
Figure 5-19. Observed small weir structure at location where Brooklodge walls are proposed (to be removed as part of the works)

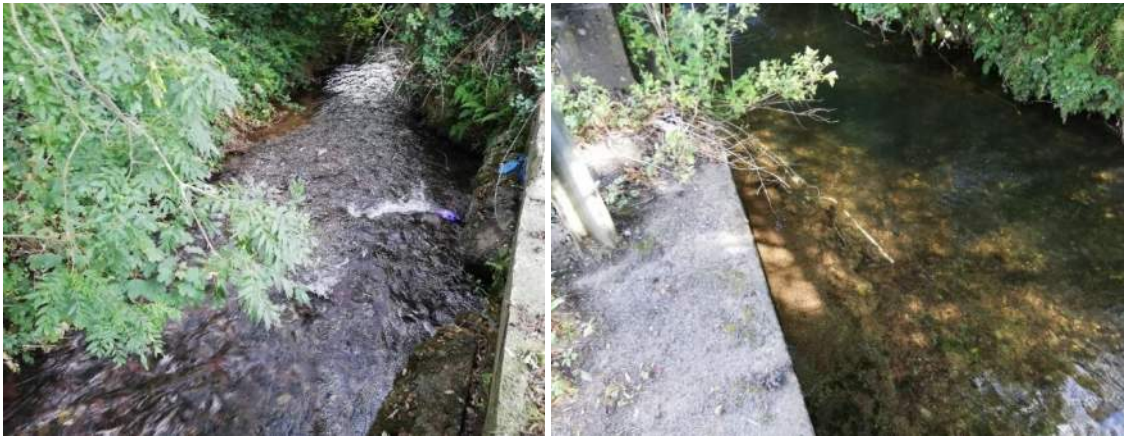
Figure 5-20. Observed downcutting at existing section of channel between Brooklodge Grove Culvert and Copper Valley Vue bridge, where bed lowering and widening is proposed

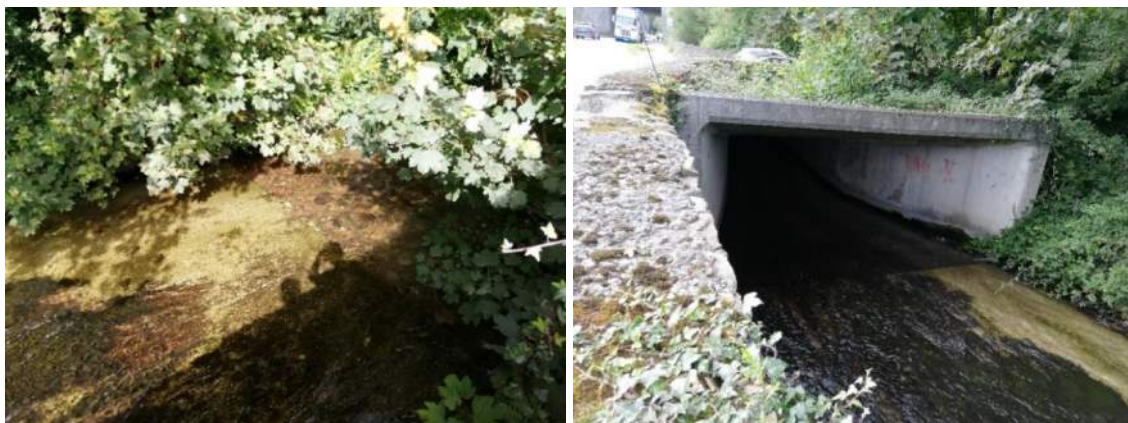
Figure 5-21. High gradient of culvert has resulted in bed scour at inlet of structure

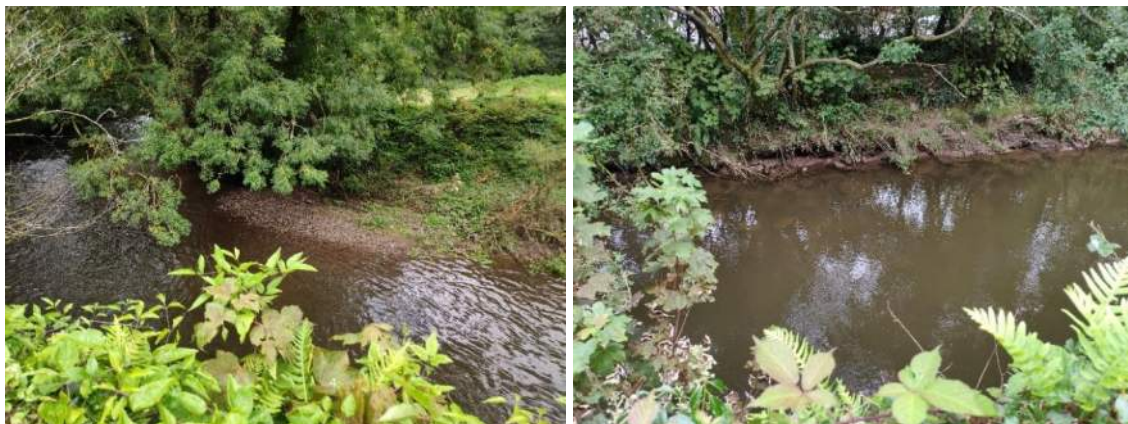
Figure 5-22. Observations included the presence of riffles and pools, low undercutting, and fine sediment deposition on the bed
