Monthly Site Environmental Audit

Glanmire Flood Relief Scheme

28/09/2023 To 27/10/23

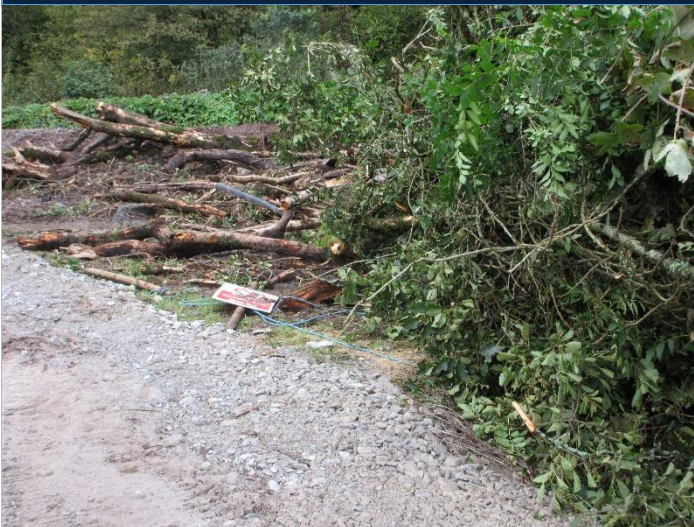
Photo 3

Unsatisfactory management of Japanese Knotweed Exclusion Zone

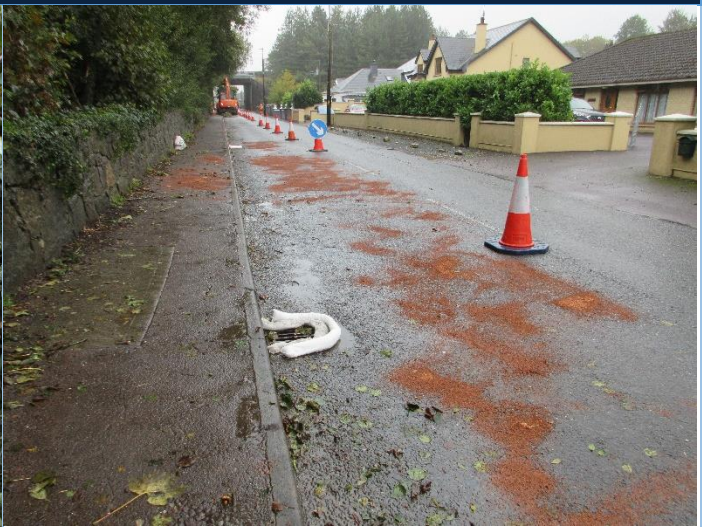
Photo 4

- Permit to pump system implemented across the site, permit system in place to better control pumping activities across the project. (see photo 1)
- Tree felling continuing AT Meadowbrook estate – Permit to clear vegetation in place for this activity and signed off by ECoW (See photo 2).
- Concrete poured at Bleach hill culvert works, ECoW supervision in place and pH monitoring of the water continuing during the pour. pH remaining stable at 8.1
- Review of Knotweed exclusion zone deemed unsatisfactory – Action to improve the exclusion barriers in this zone (See photo 3)
- Oil spill occurred on Thursday 5th by the tree surgeon supply chain partner, spill originating from a failure in a hydraulic hose. Emergency spill response plan deployed and the spill was contained with absorbent granules. Road sweeper deployed to clean up any residual oil from the public highway. (See photo 4 & 5)

Emergency spill response at New Line Road (5th Oct) Spill contained with absorbent granules and drains banded.

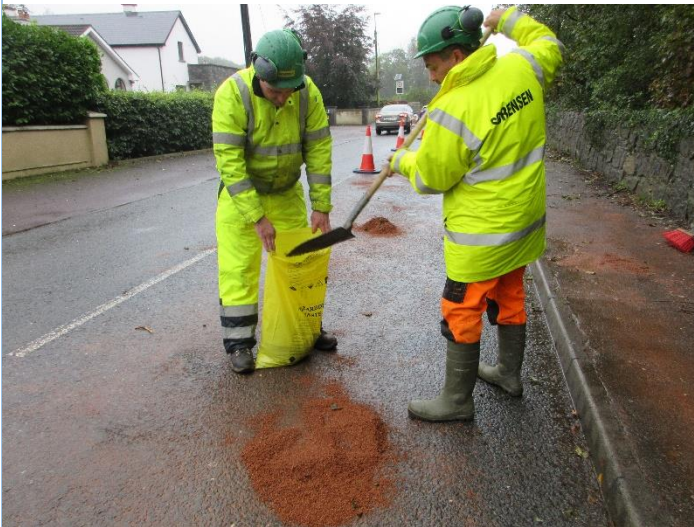
Photo 5

Contaminated granules removed by hand and double bagged for disposal.

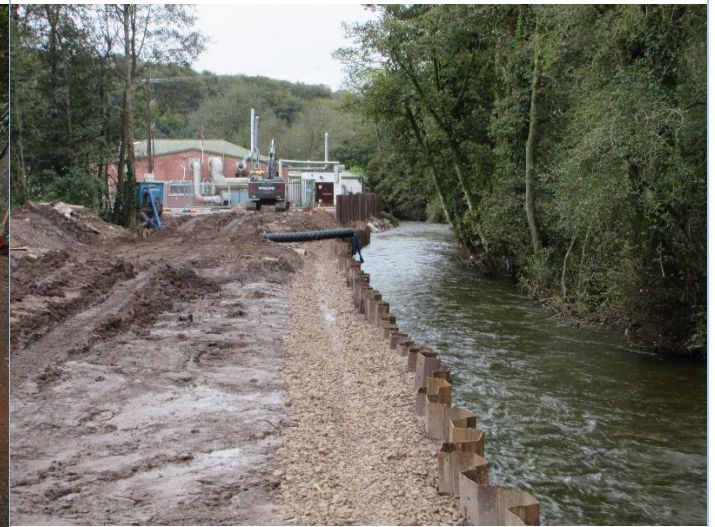
Photo 6

- Pumping activities continuing at Bleach hill to complete the in stream works under extension for in stream works.
- Pumping activities continuing at Sallybrook under Permit to pump – Settlement tank in place to remove silt from the water. Water discharging over ground at the rear of Sallybrook house which caused the discharging water to pick up more silt. Pumping was stopped and control measures reviewed with stone being placed at the discharge point to prevent eroding of the ground and silting of the water. (see photo 6)

Stone placed at Sallybrook discharge point to prevent eroding of ground and silting of water.

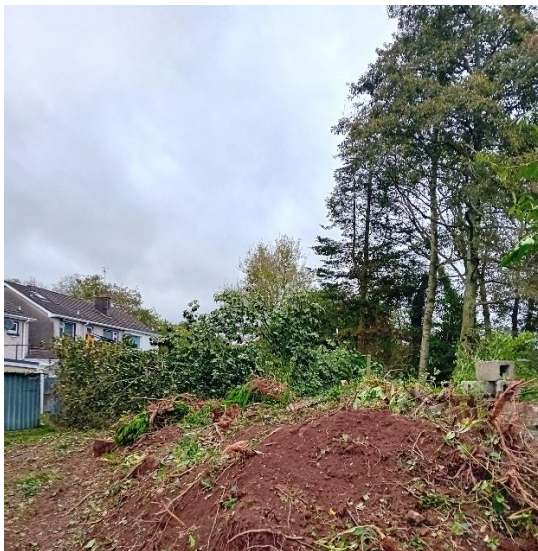
Photo 7

- Tree felling continuing at Meadowbrook, Ivy covered trees were removed under ECoW and placed on the ground for over 48 hours. (see photo 7)
- Backfilling at Bleach hill continuing to complete the works in this area – no ecological or environmental impact observed during these activities. Stone placed in the culvert was replaced with the correct stone.

Ivy-covered tree felled 10th Oct – left on ground until 13th Oct.

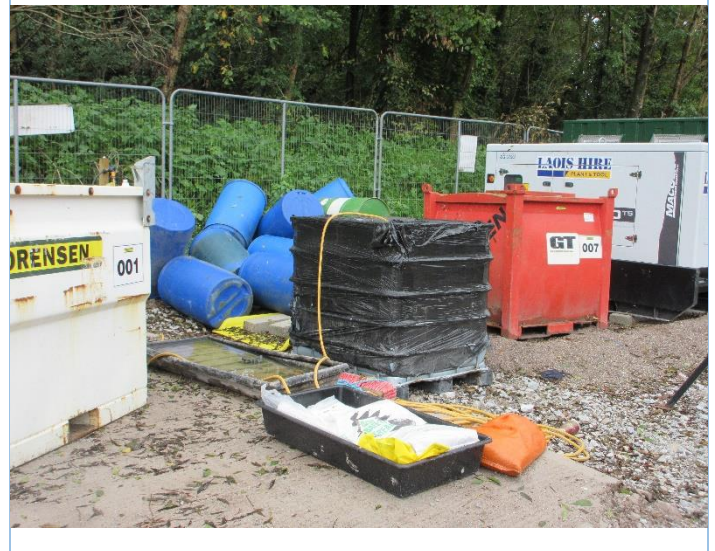
Photo 8

- Incorrect storage of waste drums in Area 1 compound (see photo 8)
- Flood event occurred on Wednesday 11th of October. Flooding overtopped the temporary sheet piles around the back of Sallybrook house – Floodwaters were allowed to escape via a designed channel released back into the river, mitigating the risk of trapping fish behind the sheet piles, area was assessed by the ECoW and confirmed that no fish were stranded behind the sheet piles. (see photo 9)

Incorrect storage of waste drums – Area 1 compound

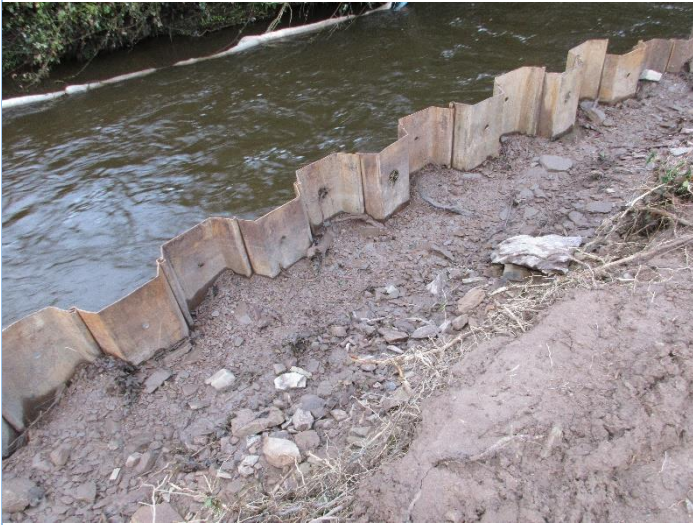
Photo 9

Designated flow out channel dry after overtopping event (11th Oct) no fish trapped. Image taken morning of 12 Oct.

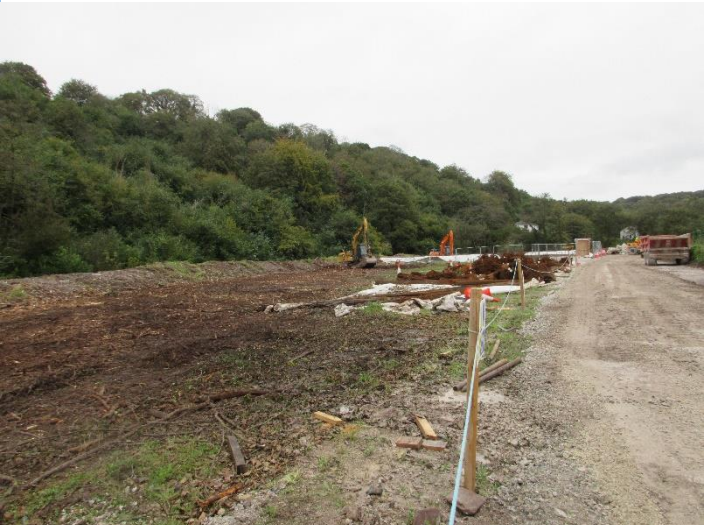
Photo 10

- Otter derogation license has been extended to the end of December 2023. Ongoing monitoring of the holts is being undertaken by specialist consultant.
- Tree mulching at site compound in area has finalised, with full biosecurity measures implemented (Washdown of machinery etc.) (See photo 10, 13, 14, 15).

Cut tree material mulched into Area 1 JK exclusion zone

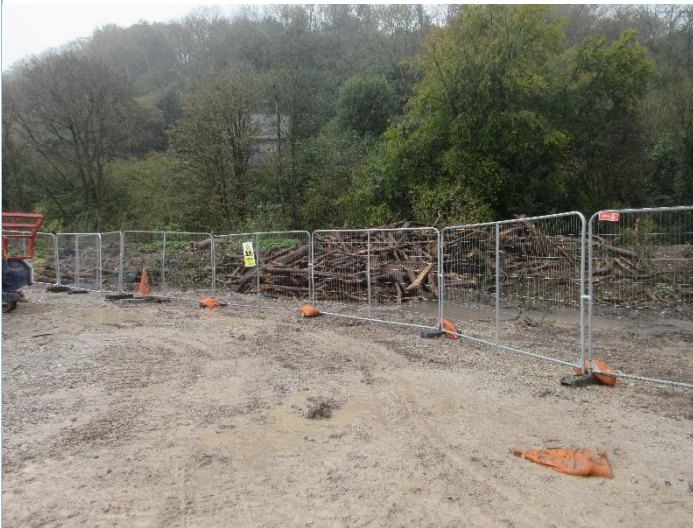
Photo 11

- TBT given on working in areas with Japanese Knotweed and on the Permit to Pump water process.
- Knotweed exclusion zone in area 1 compound has improved. (See photo 11 & 12)

JK exclusion zone demarcation improved (refer to photo 3 above)

| Action | Assigned to | Action Close Out Date |
|--|---|---|
| Further signage required for the knotweed area in area 1 compound | MD/TF | 10/11/23 |

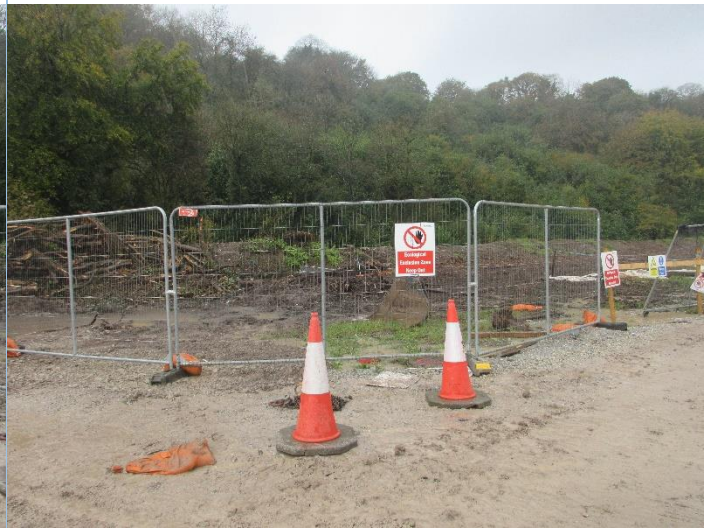
Photo 12

JK exclusion zone demarcation improved (refer to photo 3 above)

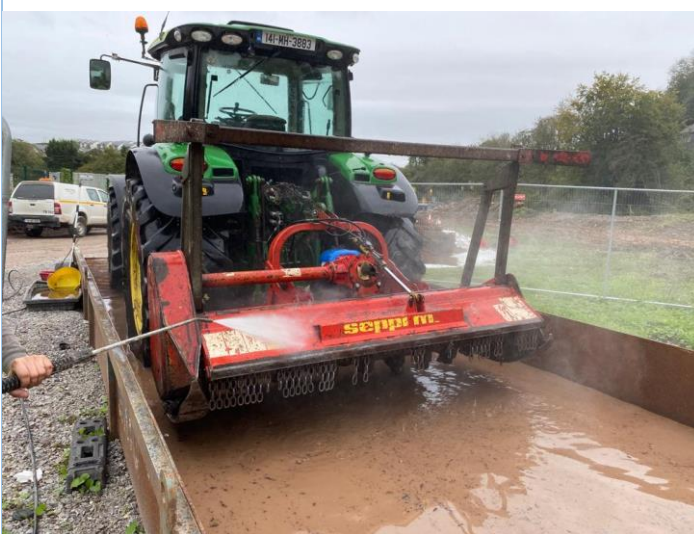
Photo 13

Wash down of mulcher exiting JK area

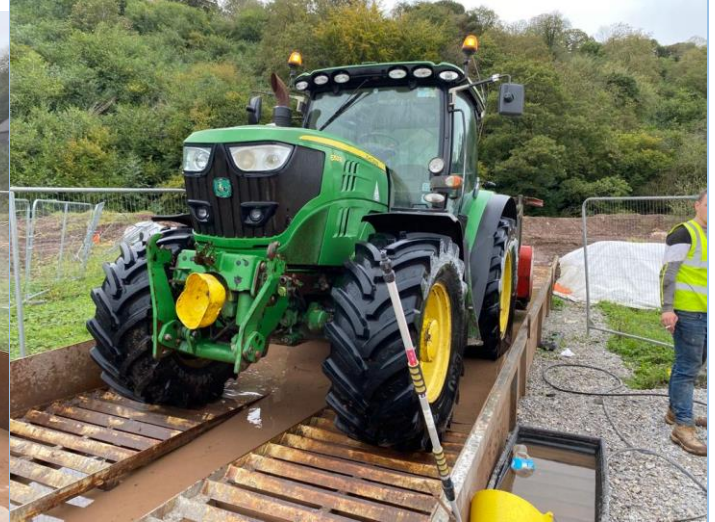
Photo 14

Washdown of tractor exiting JK area

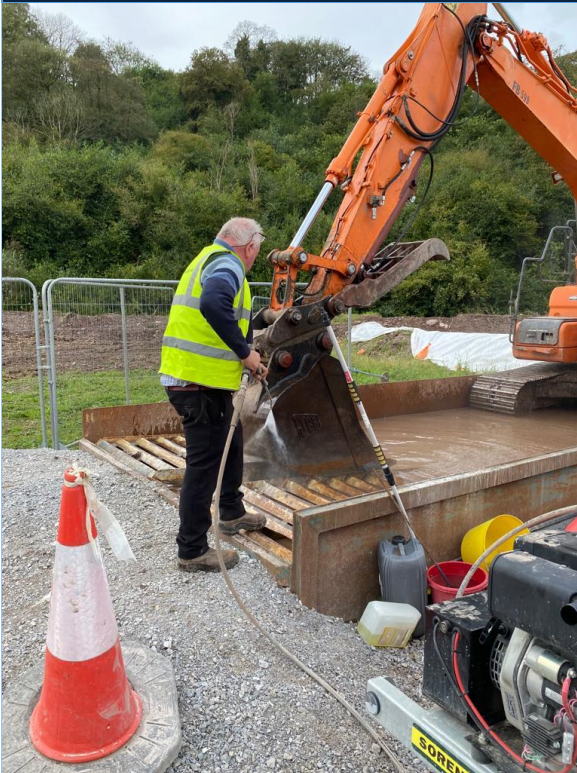
Photo 15

Washdown of bucket used in JK area.
