## Monthly Site Environmental Audit

## Glanmire Flood Relief Scheme

02/04/24 To 26/04/24

Details			
<b>Project:</b>	Glanmire Flood Relief Scheme		
<b>Auditor:</b>	SD/LD	<b>Audit Period:</b>	April
<b>Locations Audited:</b>	All sites.

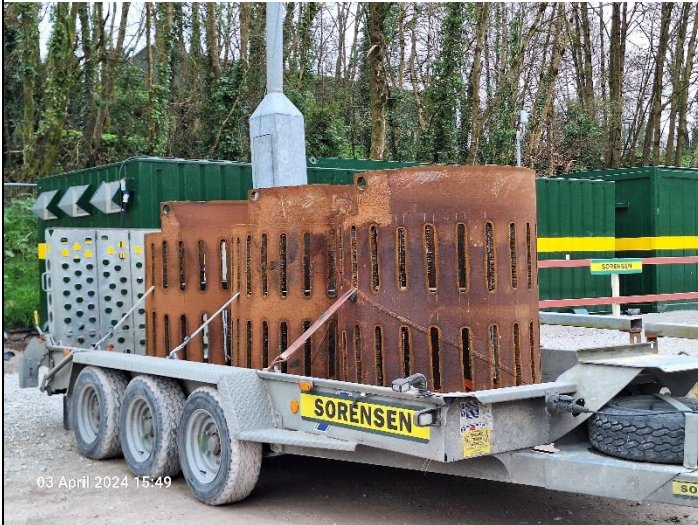
**Figure 1**

Fish guards for pumps.

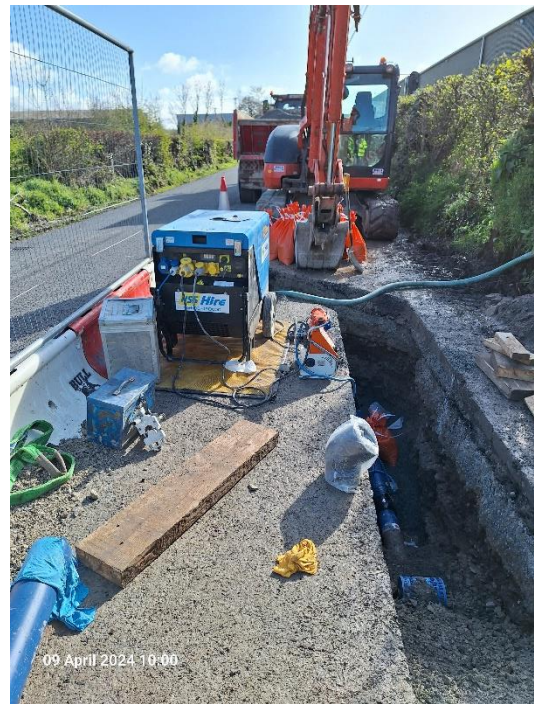
**Figure 2**

Use of spill pad under generator during pumping activity – New Line.

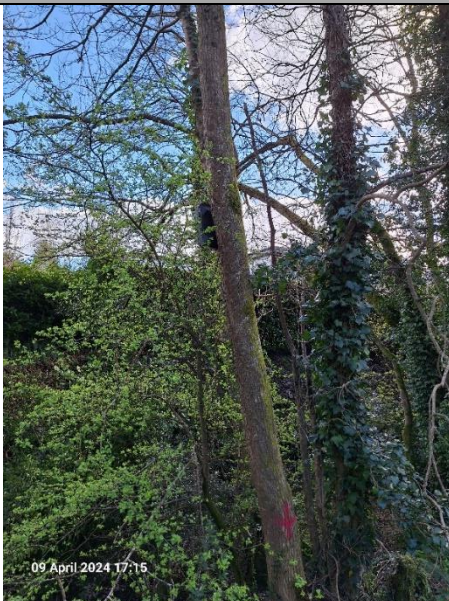
**Figure 3**

One of two bat boxes erected – Cuil Cluthair

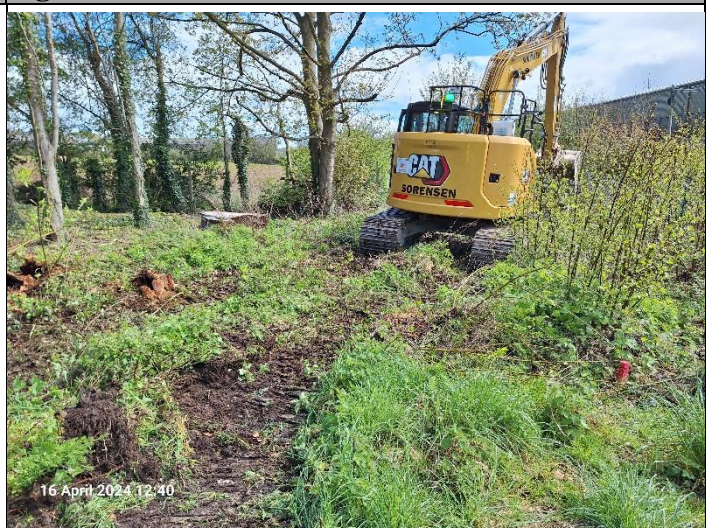
**Figure 4**

Vegetation clearance for Glenmore stream diversion. Area surveyed for nesting birds prior to
