Blackpool Culvert- Data Analyses and Rainfall Events Nov Dec Jan

Blackpool Flow Survey:

Blackpool Flow Survey: November 2014 Report

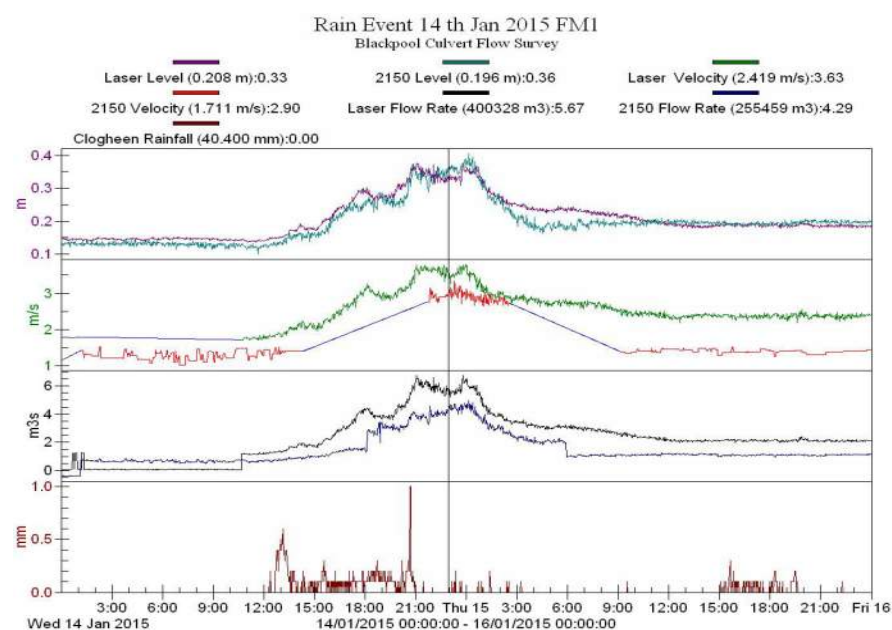
Fig 5: Rain Event 14th January at FM1- Level Velocity and Flows

Both Laser and 2150 AV show a peak level of 0.34 meters approx. The 2150 velocity data locked out during the increase but kicked in at the peak level for a period. However the Laser worked better and this is used as the benchmark for calculating an accurate flow at FM1 , (Bride River). The max flow recorded by the Laser logger was 6 m³/Sec approx.

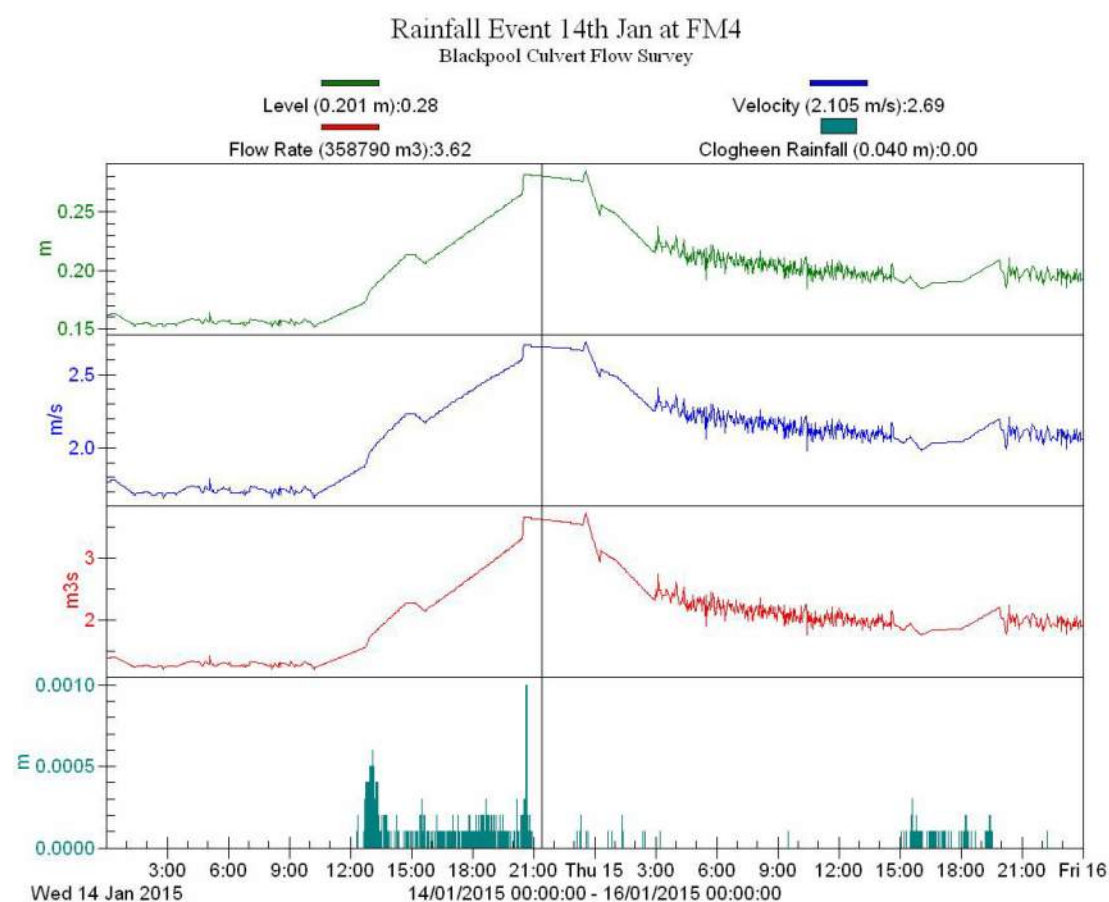
Fig 8: Rain Event 14th January at FM4- Level calculated Velocity and calculated Flows

At FM4 we recorded levels with the newly fitted Ultrasonic Flow logger which is placed 3 meters upstream of the old 2150 AV position. We used an equation derived from previous level ,velocity data to convert levels to velocities and subsequently to flows in order to provide an estimate of the flow rates at FM4. This is used for flow balancing calculations.

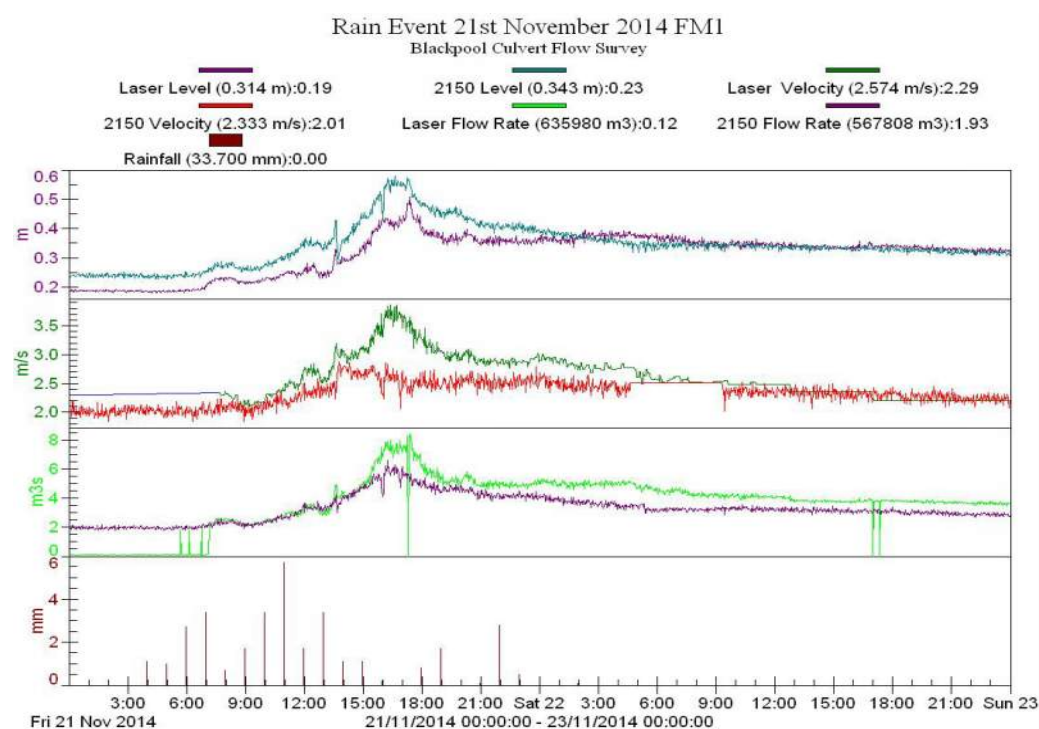
Fig 14: Rain Event 21st November at FM1- Level Velocity and Flows

Figure 14 compare levels velocities and flows of the Laser and 2150 at FM1. It is suspected that the 2150 AV logger was fouled as we were not able to get in to clean it. The Laser flow logger has constantly provided good scatter profiles and is not prone to ragging or fouling, thus is used once again as our benchmark for recording flows entering the culvert from the Bride River. A brief peak velocity of 3.72 m/s with equivalent flow rate of 7.72 m³/sec was recorded by the Laser flow logger.

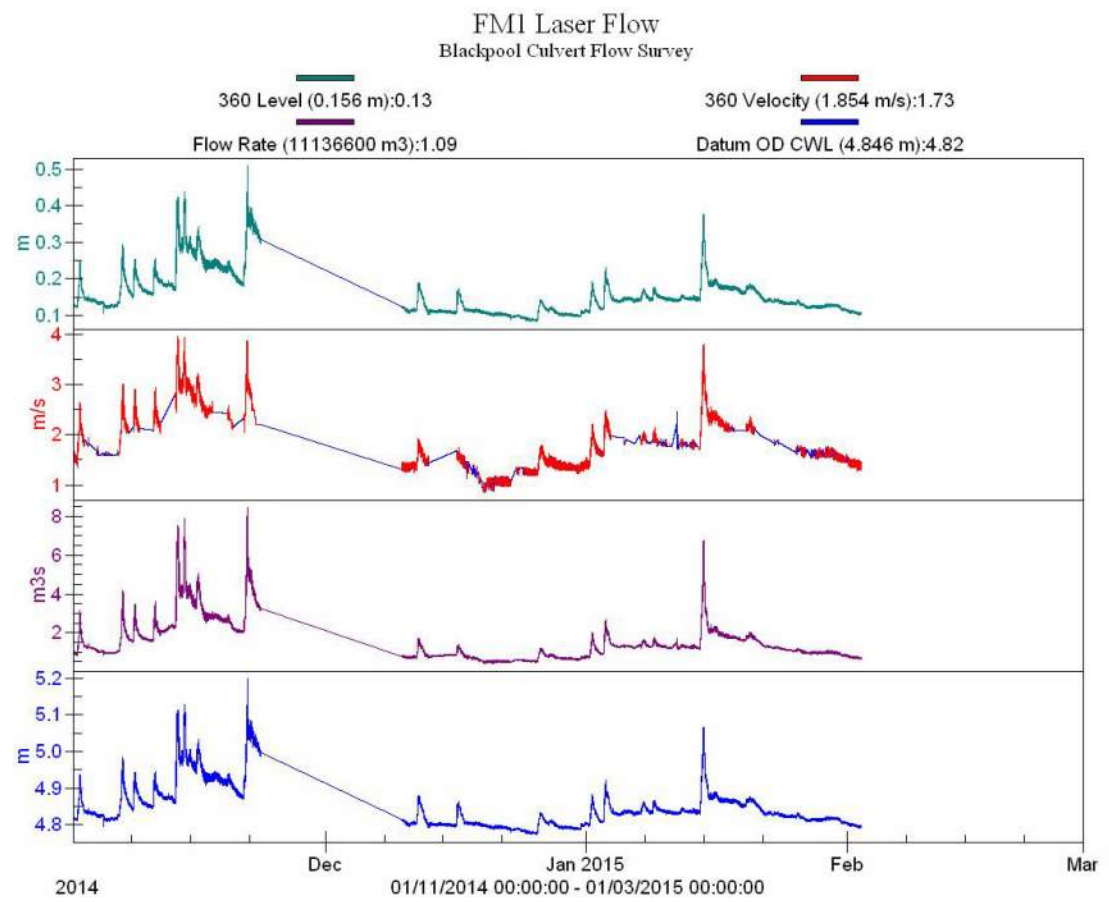
Fig 19th Laser Flow Logger complete recorded data Nov Dec Jan

Every time the levels have increased the Laser flow logger reads and provides good data with very good level to velocity correlation. Ideally it would have been better to have 4 of these Laser loggers to avoid the issues with ragging, one at each channel, but unfortunately this option was not available. At low flows the velocity can cut out and reach zero but it has been easy to edit these events from the data, (red trend), and create a good overall flow conversion. Data is missing for a period between ends of November to 9th December due to battery failure during a period when we were not able to get into the culvert. Fortunately no significant events were missed. Figure 19th shows the recorded data between November and December including datum levels.

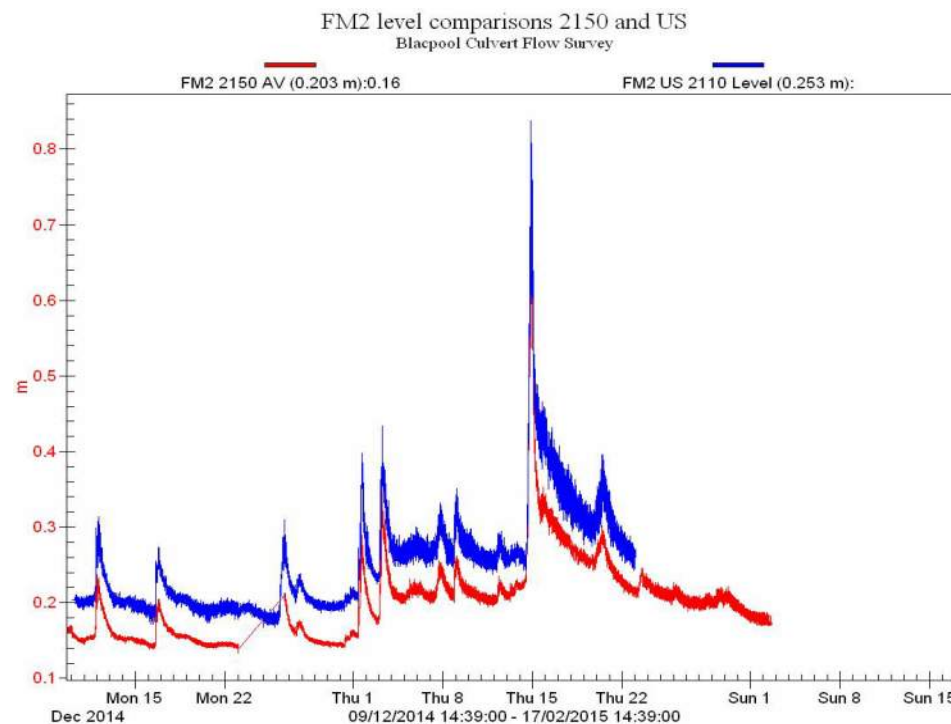
Fig 21: 2110 Ultrasonic, (US), Level Logger compared to 2150 AV logger

On the 9th December the Ultrasonic level logger in the culvert was moved as requested to the FM2 channel. This was installed in the channel 3 meters upstream of the 2150 V logger, as this was a suitable mounting point in the ceiling, and the flow was less turbulent at this point. The levels followed the same trends closely although the ultrasonic levels in general are higher as seen in figure 21. For flow calculations we used the 2150 AV logger level and velocity.

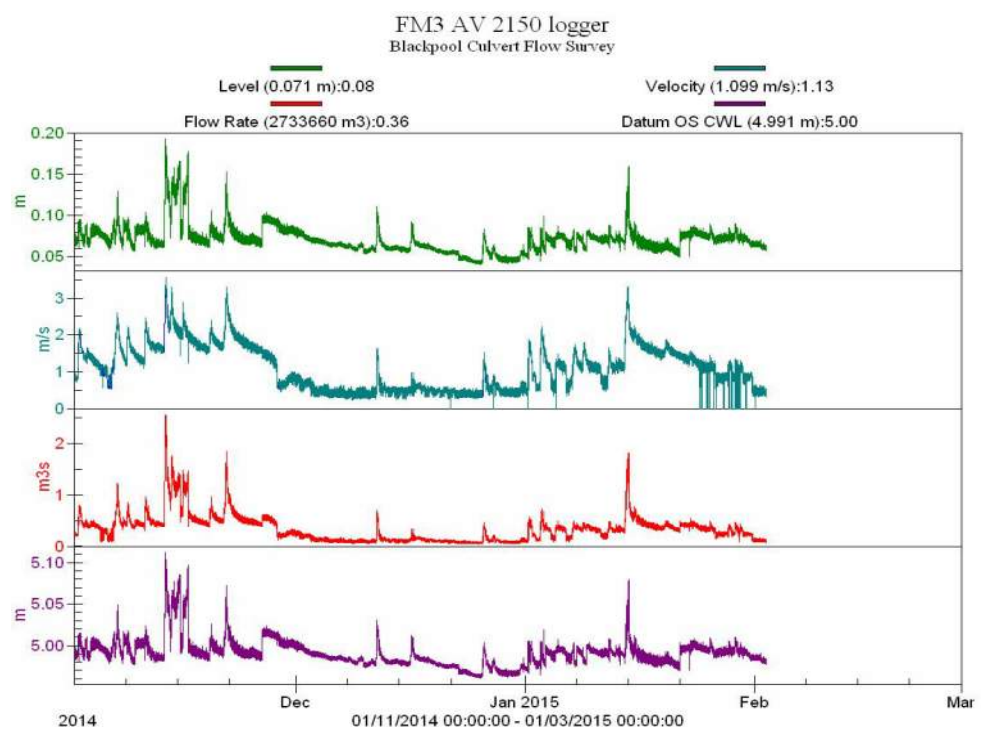
Fig 22 FM3 2150 AV Flow Logger complete recorded data Nov Dec Jan

In general data at FM3 was good despite the low levels and high velocities which are not ideal for measurement. Certain flow conditions however seemed to create a wave in front of the probe which seemed to come and go. This resulted in occasional step up and down in levels particularly at lower flows which created doubt about the accuracy of the flow measurement. However, the trend during rain events was typically elevated levels and velocities as expected, so we are reasonably confident that the more important rain event data should be accurate. Figure 22 shows the level, velocity flow, and datum trend for November, December and January.

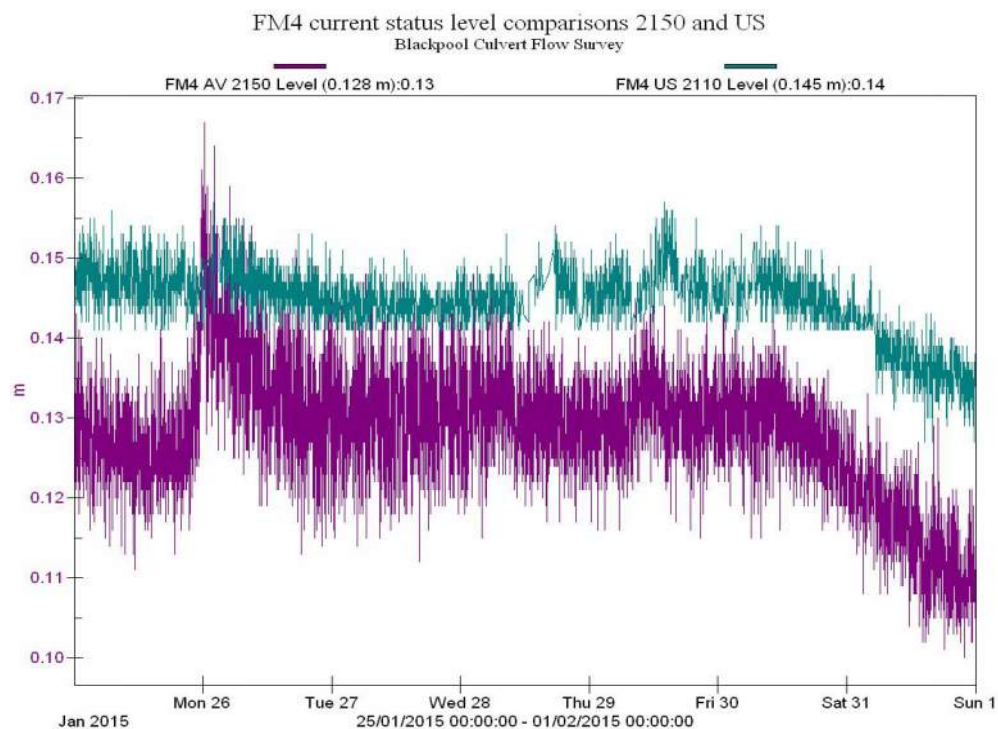
Fig 23: Recent Level comparison at FM4 between new 2150 AV and new 2110 Ultrasonic

Data from the 2150 AV logger at FM4 was often disappointing and not unusable despite changing the probe and meter earlier in the survey. It was not during the culvert entry on the 19th January when it was raining, that a considerable quantity of water was pouring down on the logger through cracks in the manhole cover. While it was always difficult to maintain good data at this site due to ragging and turbulence issues, since the middle of November we had an additional issue of drift on the level measurement rendering this data not usable, which effected the rain event of 21st November in particular. It is suspected now after witnessing conditions the logger was exposed to in the rain, that desiccant within the logger may have been wet which effected the automatic atmospheric compensation over the last few months. As previous results at this site had been disappointing, JBA requested we install an ultrasonic level logger at this site. This was installed back on the 9th December and we have been using this data since, although the varied and occasionally turbulent conditions have resulted in some noisy data at times, although the trend can be clearly identified. As we are determined to try and get some additional velocity data we have fitted a complete new logger 2150 AV logger at FM4 on the 22nd January in the hope that we might get one good event before the survey is complete.

Since the new 2150 logger has been installed result look much better. Figure 23 shows the recent comparisons between the new ultrasonic 2110 level logger and the new 2150 V logger. The Ultrasonic probe is 3 meters upstream of the 2150 AV probe. These levels we be rechecked during the next visit as it is difficult to take accurate levels in the turbulent conditions.

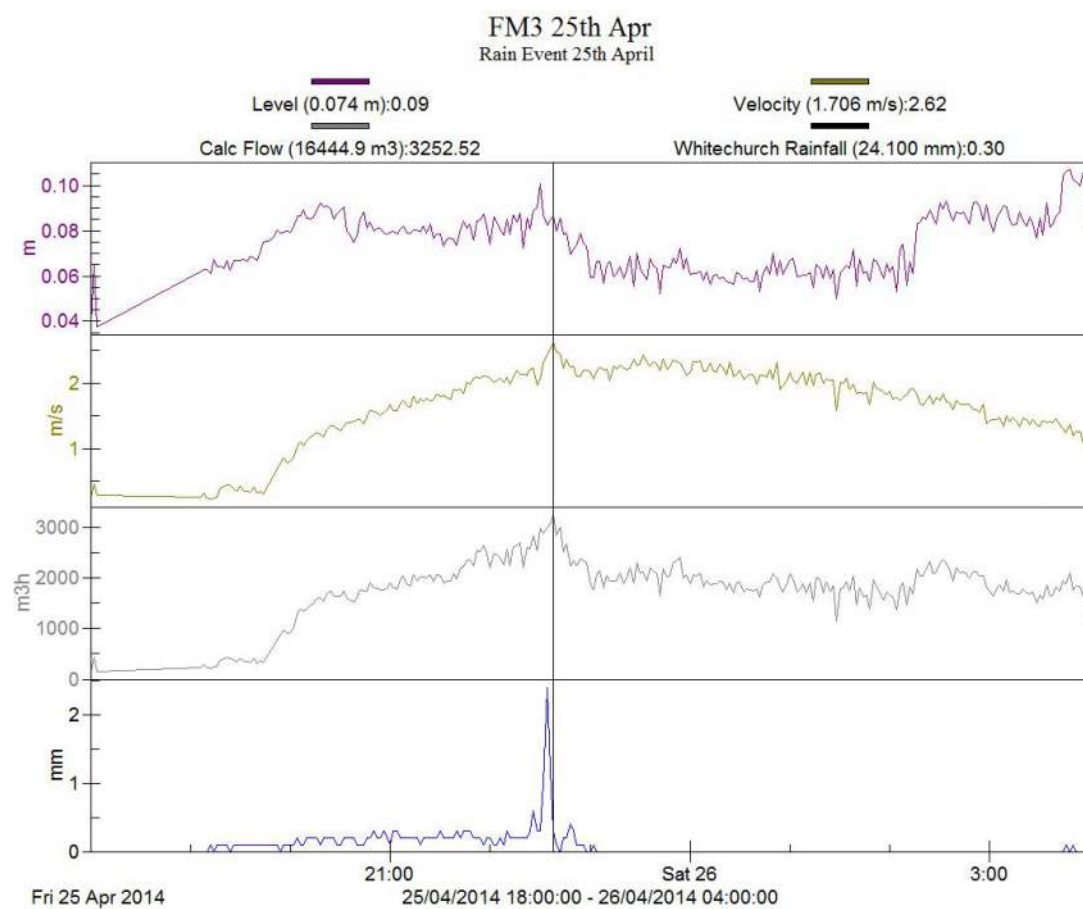
The event was picked up at FM3 with a good velocity profile , however some of the level data appears somewhat erratic. This could be due to some debris catching on the probe temporarily.

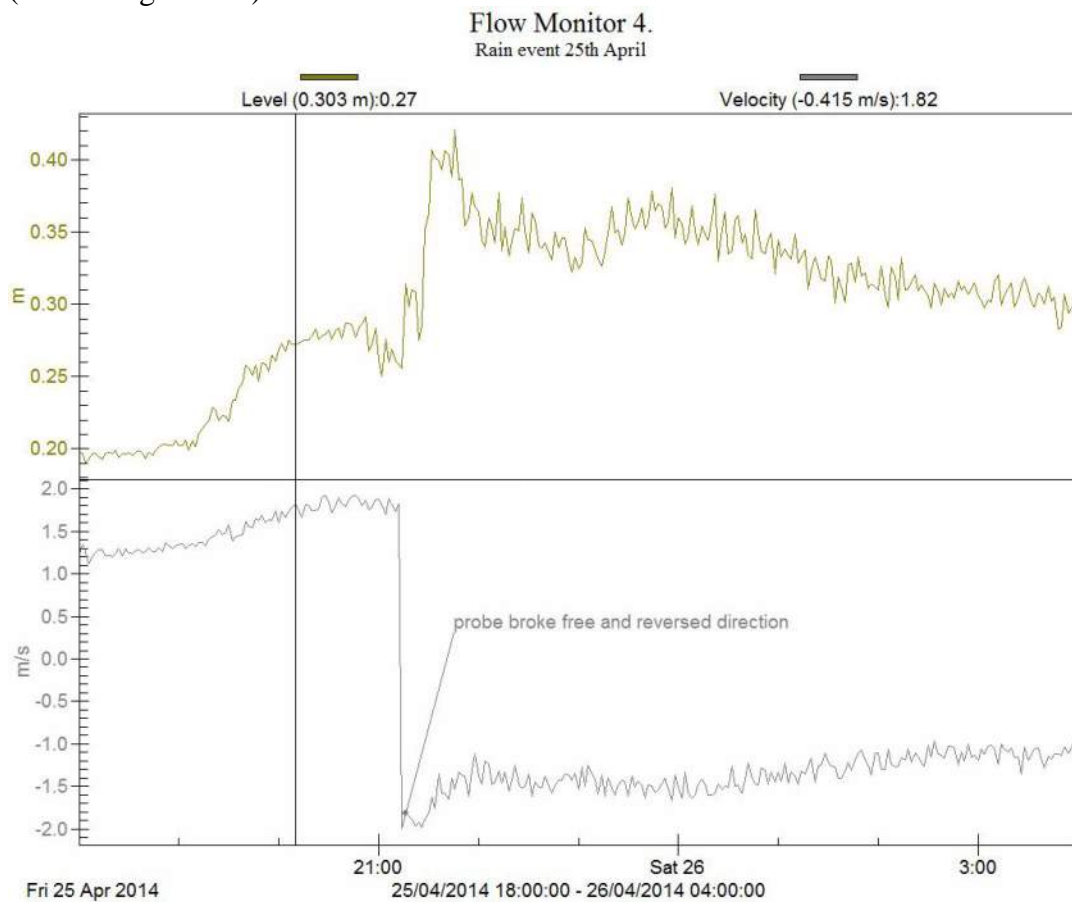
Unfortunately it would appear that the AV probe has become dislodged and has gone into a reversed position. This may have been hit by a stone or something hard travelling at high velocity.

While editing is possible we cannot be sure of peak levels so there is probably no advantage to deriving data by reversing velocity.

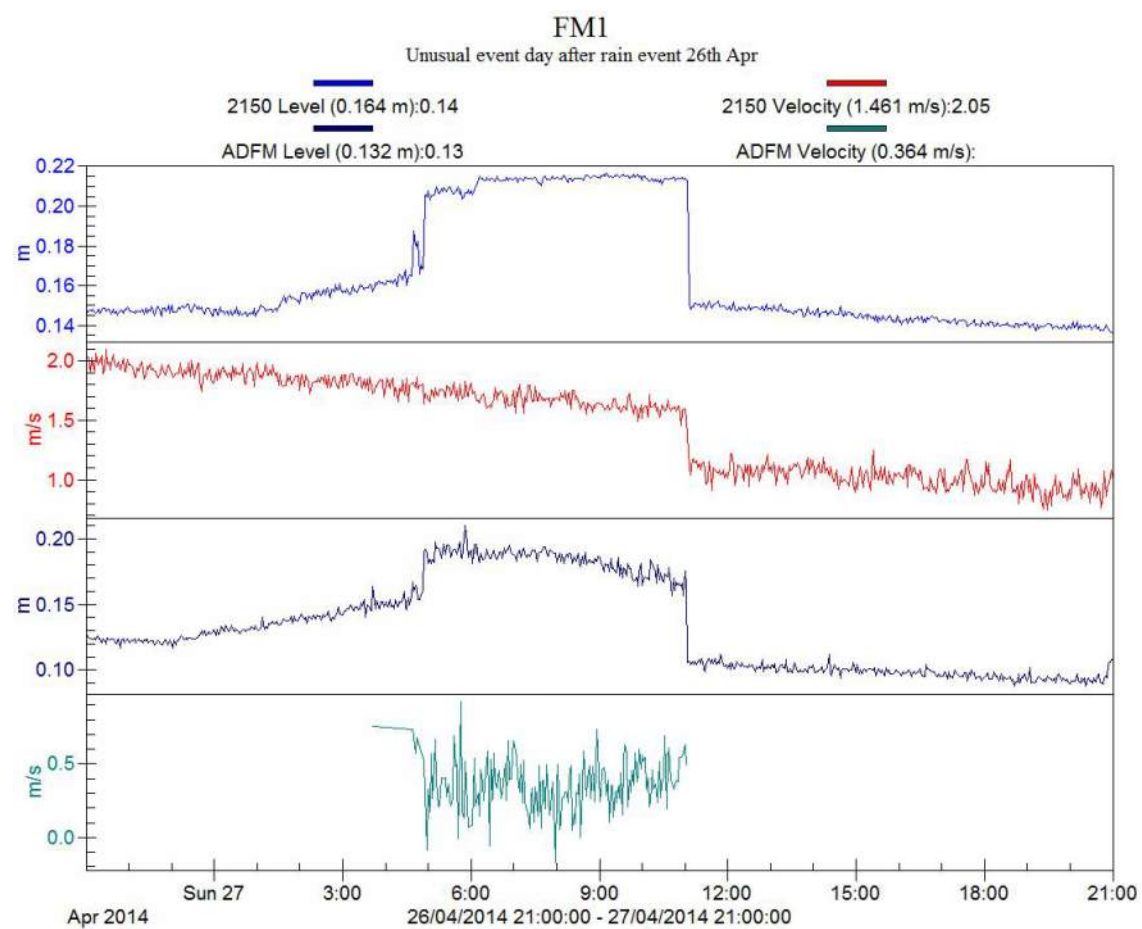
An unusual event occurred at 5 am approx on the 26th the day after the rain event the previous day. A sudden level increase was recorded by both the FM1 2150 and FM1 ADFM. No other loggers recorded an increase and rainfall was negligible.

The velocities were different and it is unusual that velocity stepped down suddenly with level. ADFM only logs velocities above 0.16 metres approx.

One possible theory here is that something large came down like a branch of a tree for example and got caught in the vicinity of the probes for the period of the event and finally freed itself. If this lodged slightly upstream of the probes it could have caused a standing wave which increased level but also a critical flow section at probes maintained high velocity at 2150 side. This may have been sweeping across the channel from the ADFM side which might explain the vary velocities and also the step down when it finally moved on.

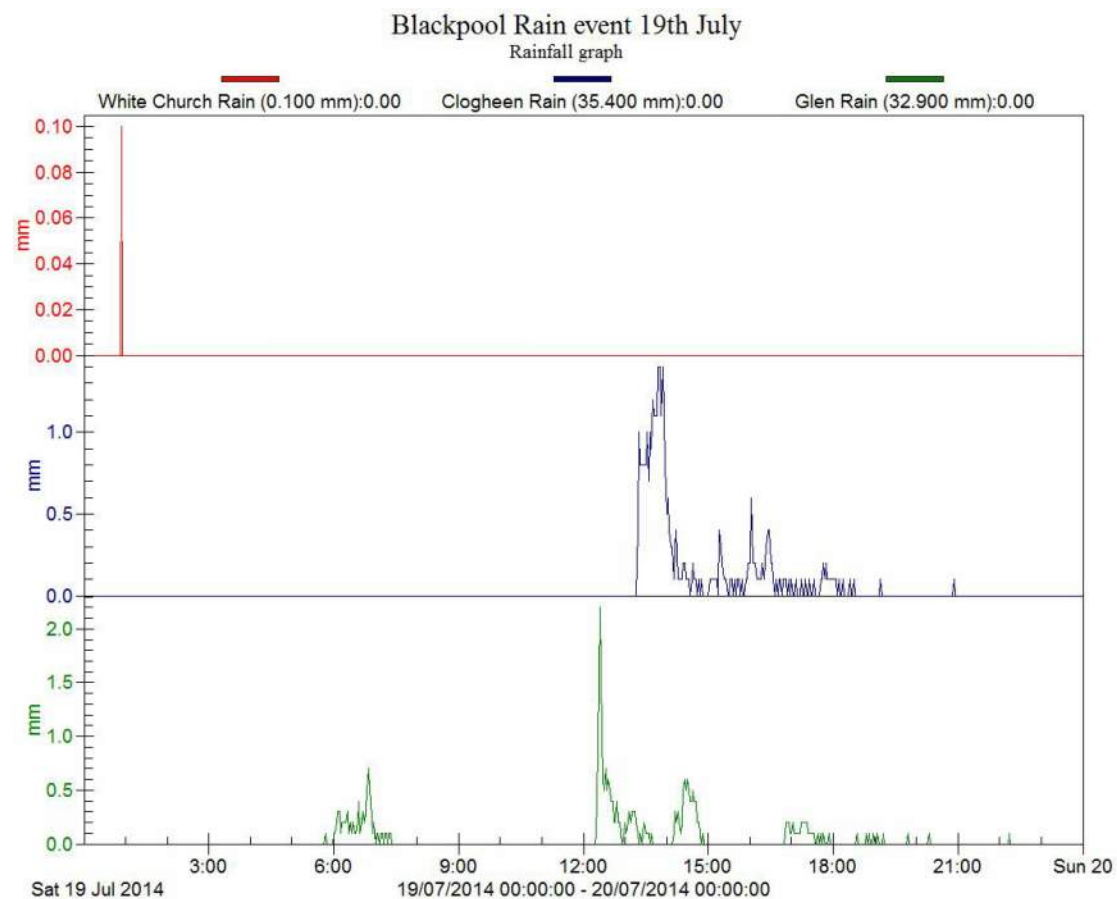
Clogheen Rain gauge read 35.4 mm while the Glen River recorded 32.9 mm. It emerged after investigating further that the Whitechurch rain gauge was not working at the time as the funnel had clogged up with leaves.

- 1/ clogging of Whitechurch Rain gauge needs to be rectified immediately
- 2/ An entry is required to clear all debris and check levels.
- 3/ ADFM needs to be removed from Culvert and tested in depths above 0.15 meters to ensure it is working correctly.

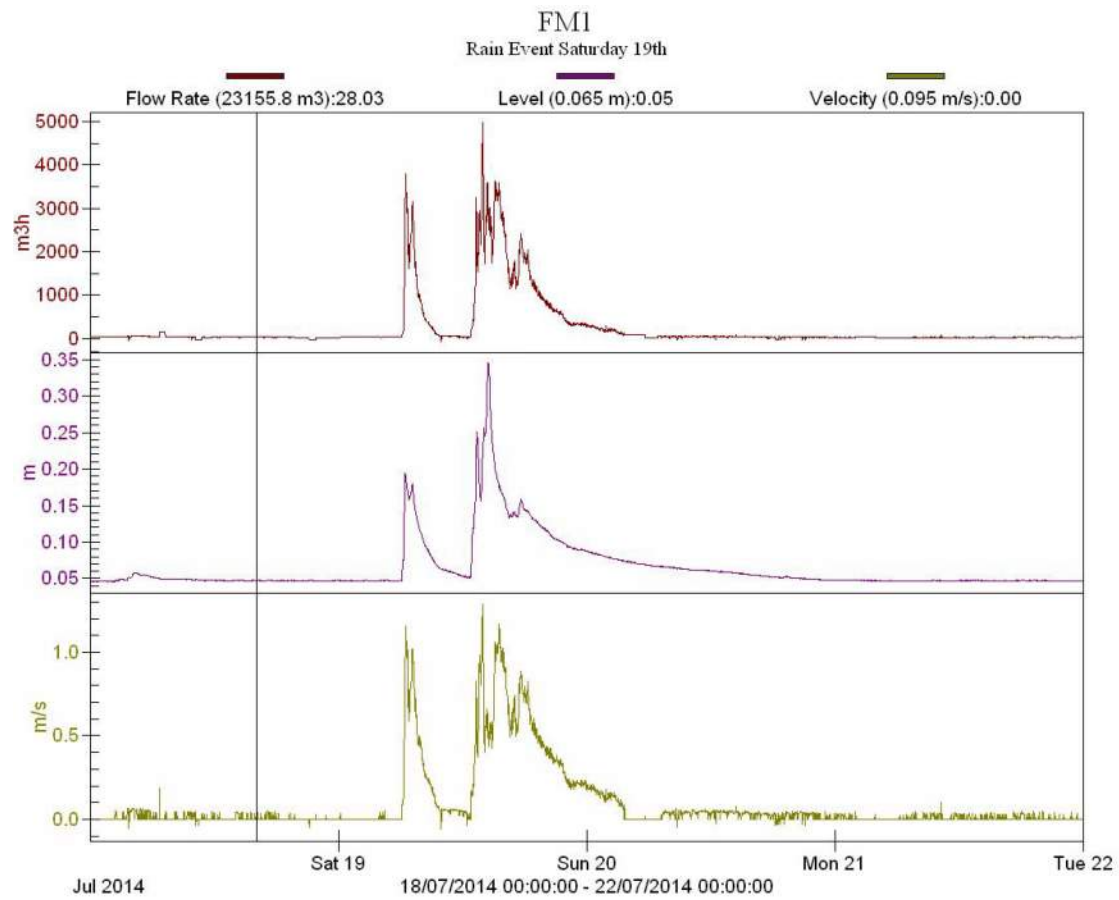
The event on the 2150 AV flow logger was picked up as below: While the trend looks good the velocity rate is less than expected which may indicate fouling at the front of the probe.

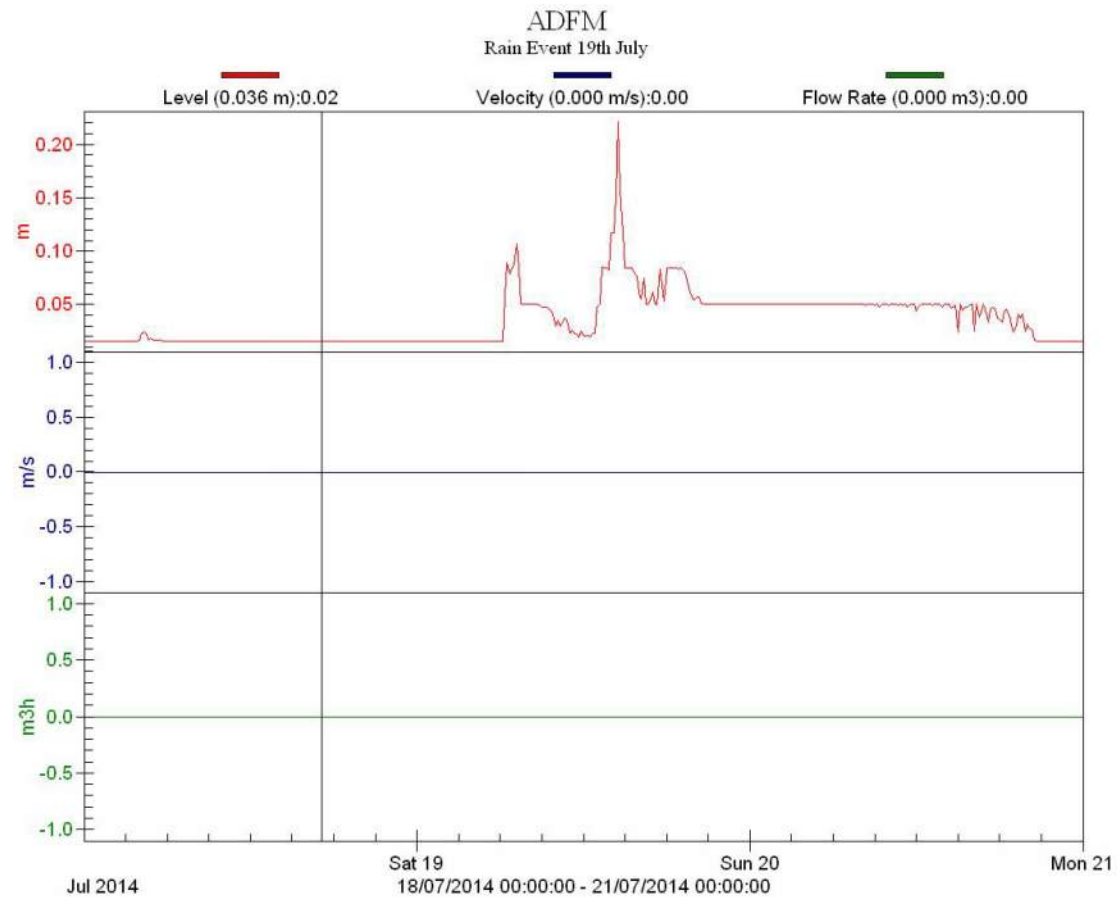
The level recorded by the ADFM logger exceeded the minimum required depth of 0.15 meters for a short period, however no velocity data started recording. It is not clear whether this was due to the fact that period was too short or whether there was some issue.

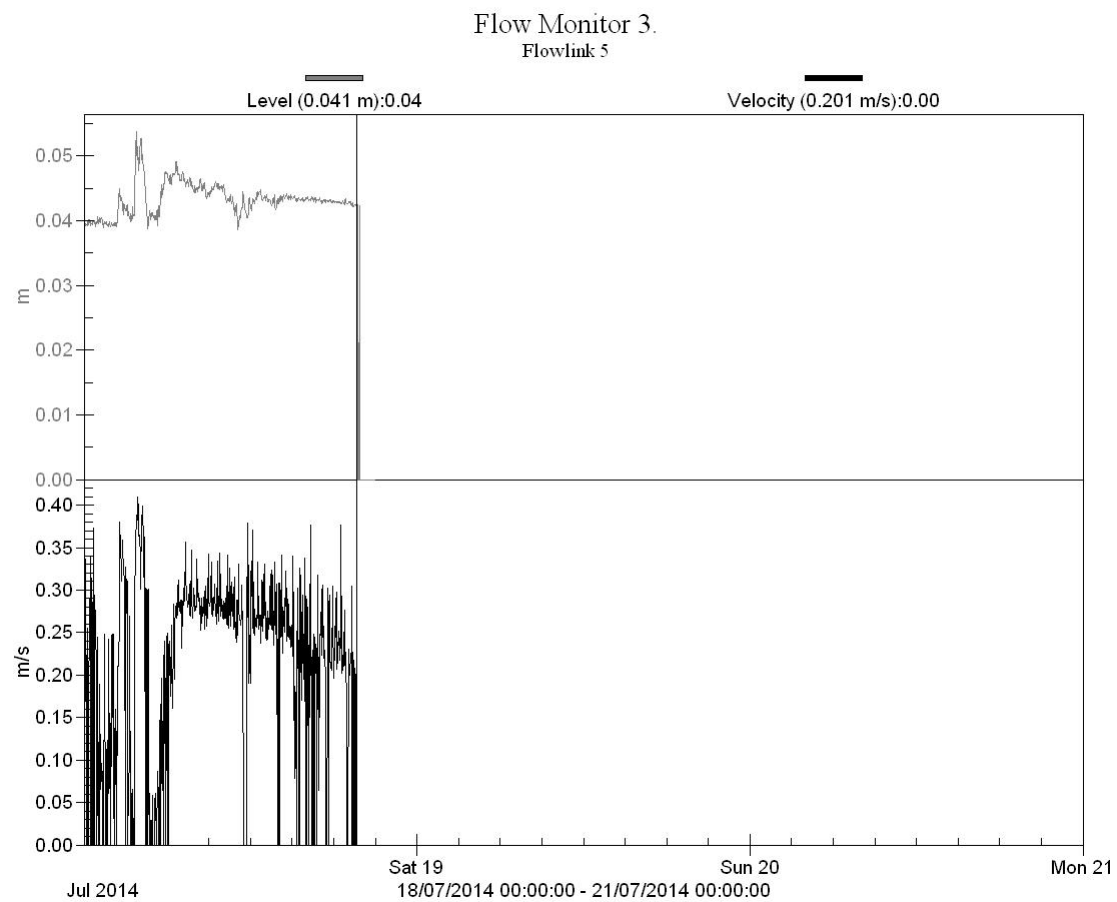
Unfortunately the battery power failed at FM3 prior to the 19th July event.

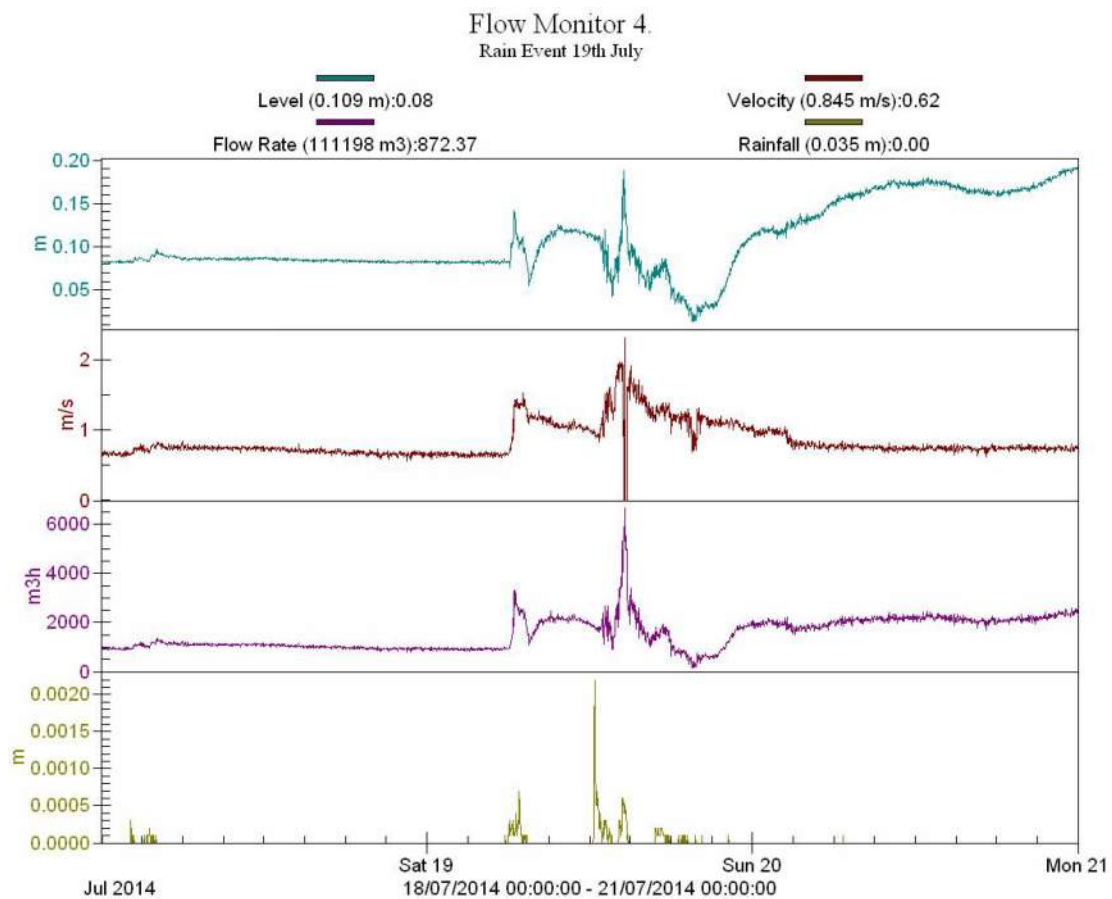
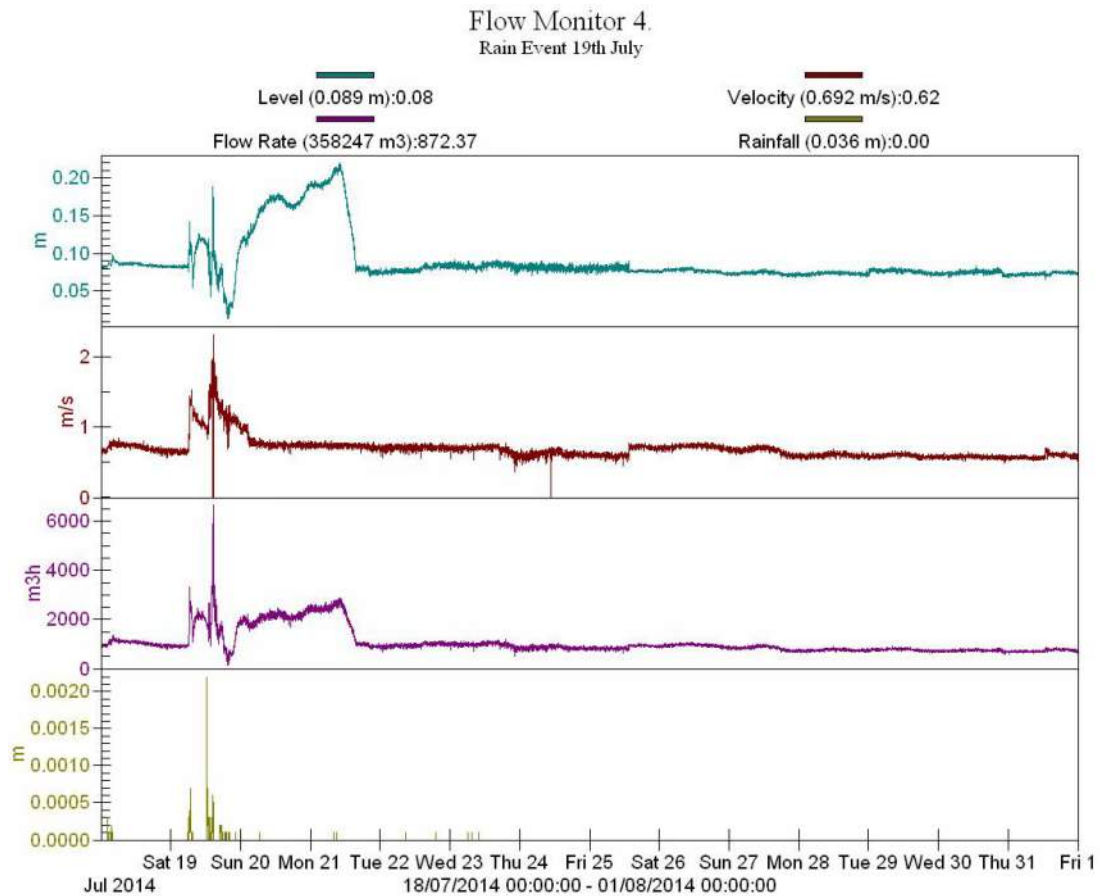
The event was picked up FM4 however there the graph trend would indicate that there was significant fouling. Fouling remained for several days until it was cleared and levels returned to normal as seen in second graph below

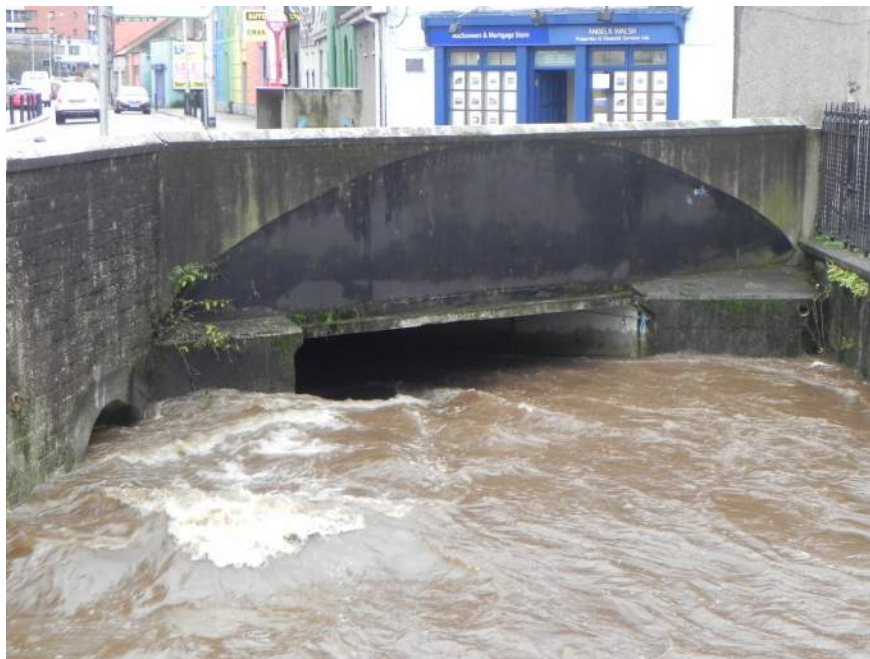
Fig 1: High Flow at the Culvert Entrance at Blackpool Church the morning after second rain event on the 14th November

Levels recorded as high as 0.8 metres on the level gauge under the bridge at the church which is the highest recorded since monitoring started last March. In Fig 1 above, the photograph was taken at 10 am approx on the 14th Nov, when the levels logged under the bridge at this time would have decreased back to 0.4 metres. Thus we can assume the level at the entrance during the previous 14th Nov peak of 0.75 metres logged 4 hours prior to this could have been noticeably higher. There is a standing wave noted on left side of channel in photograph below, (Fig2)

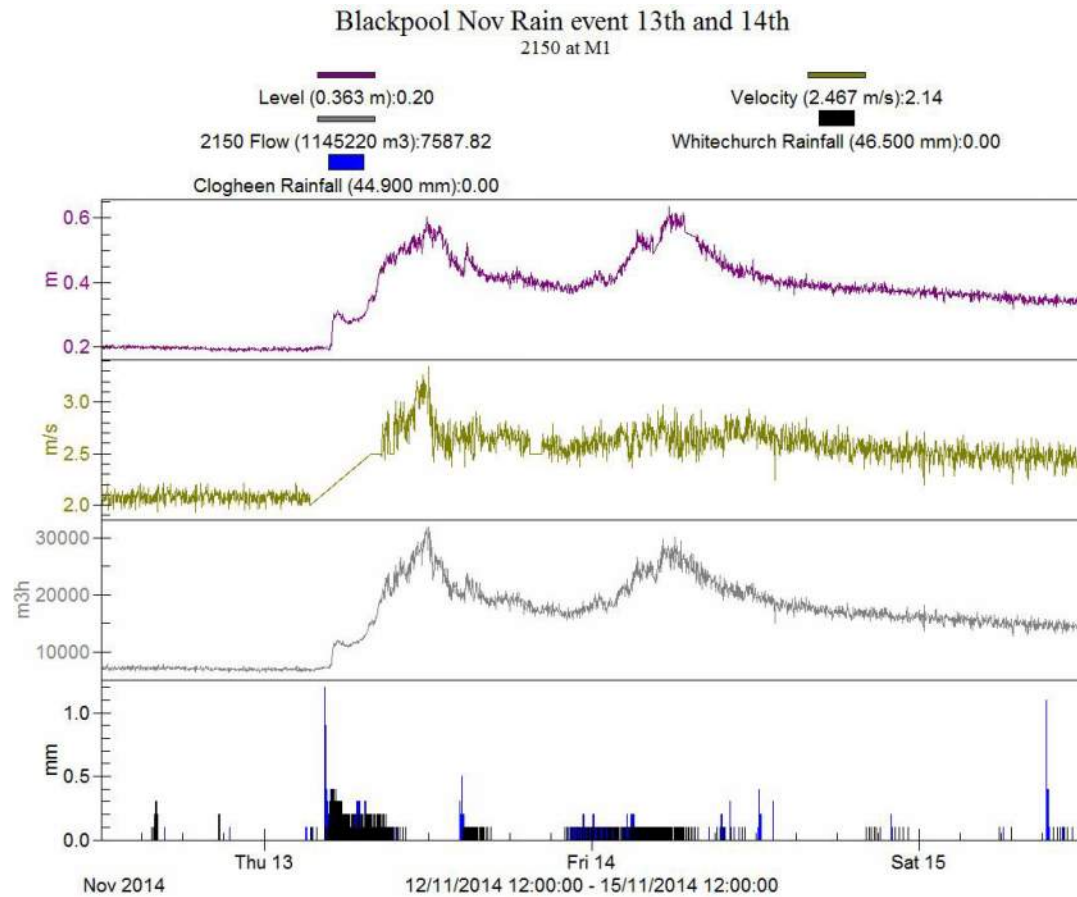
Fig 8: 2150 Flow Logger Level velocity and flows at FM1 during Rain Events

The 2150 Flow logger at FM1 recorded a higher flow peak of 8.4 m³/s during the first rain event. A section of velocity data where we assume the probe fouled or was over turbulent was corrected as seen in the graph at the start of the first rain event on the 13th Nov.

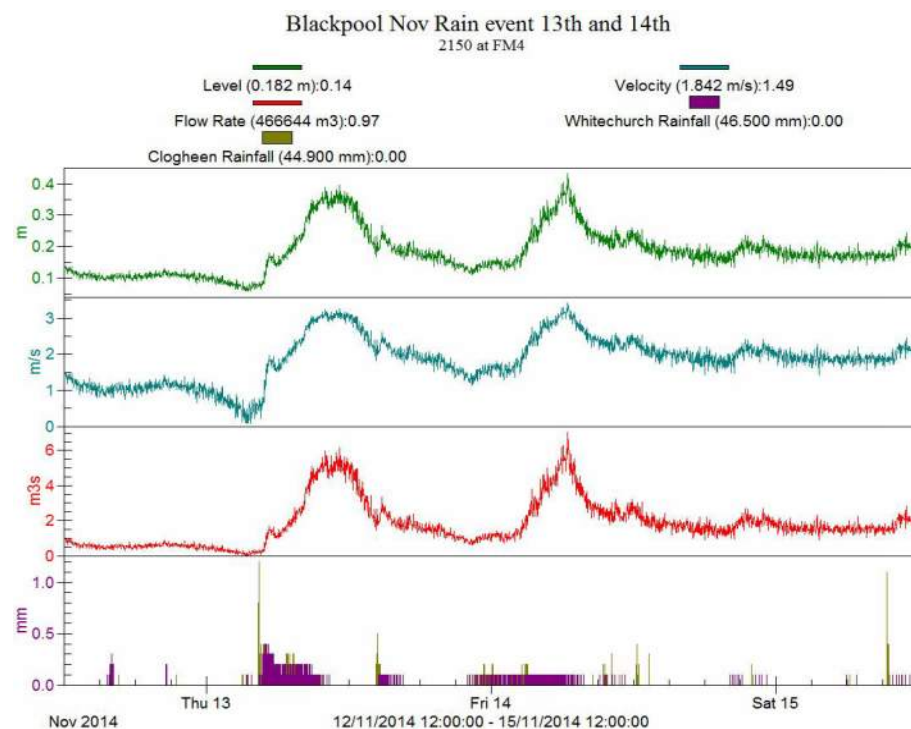
Fig 13: 2150 Flow Logger at FM4 with Level and derived Velocity and Flow data

Velocity data was not useable at FM4 due to ragging shortly into the start of the first rain event, however level data was intact. Due to the fact that all data to date would seem to indicate that flows were free flow without evidence of surcharging we concluded that we could apply a curve fit based on data analysed at FM4 during other events, to produce a reasonable virtual velocity trend. While we did not have points at the high end of the curve, in general the resultant velocity at the high levels seemed to be in line with velocities recorded in FM1 which is a similar channel. We further derived flows based on this velocity result. The resultant peak data during the first event was level 0.34 Metres, derived velocity 3 M/Sec , derived flow rate 4.84 M3/Sec

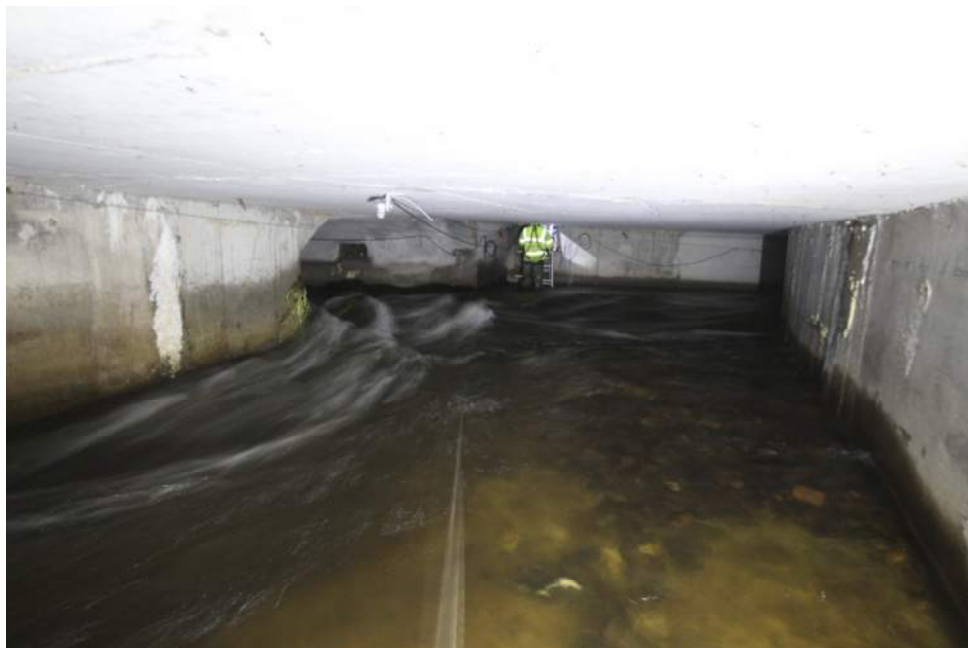
Fig 17th : Photograph in Bifurcation looking at FM1 to FM2 at 16:00 on Sunday 16th November

Fig 17 below shows a picture of the bifurcation looking back towards the flow going right to left from FM1 (church culvert), to FM2 , (Brewery). This picture was taken during the entry on Sunday afternoon the 16th November at 16:00 approx.. At this time levels were still relatively high, with Church bridge level at 0.3 metres, Laser level at 0.25 Meters with velocity of 2.46 m/s. The photograph would support the conclusion that the majority of the flow is carrying on down the brewery line at high flows at present.
