Monthly Environmental Audit – March 2025

Glanmire Flood Relief Scheme

ENVIRONMENTAL AUDIT

Site Manager/SCE Environmental Unit: Marcus Browne	Signature:	
Monthly Report	March 2025	Period	01/03/2025 – 31/03/2025
Audit Number	GFRS-EA-2025MAR	Date	02/04/2025
Locations Audited:	All works areas

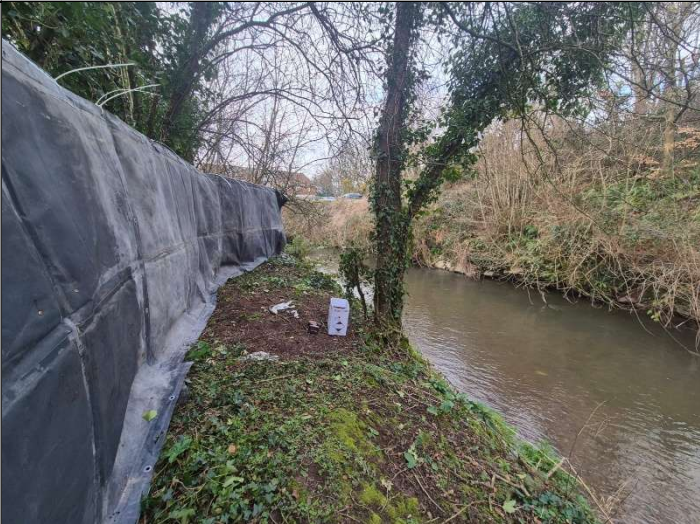
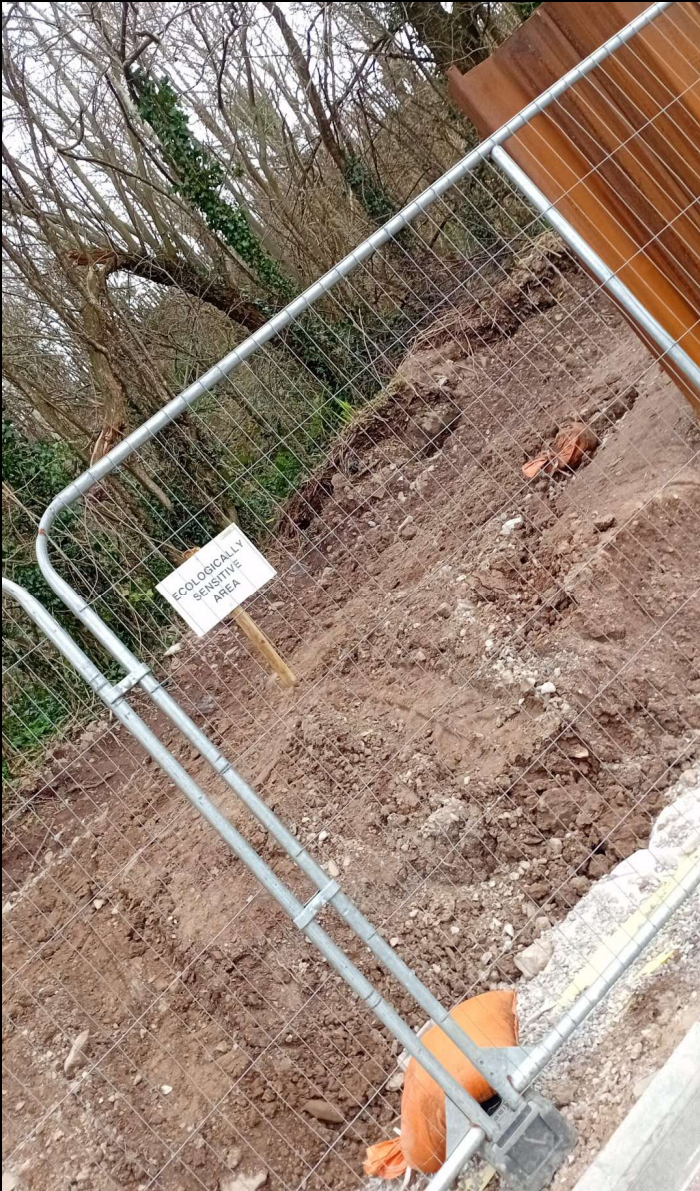
Photograph 1		Photograph 2

- The application for the licence to Photograph/Film a Protected Wild Animal (Otter) was granted by NPWS on 06/03/25 in respect of installing trail cameras to monitor 2 no holts (N7A and N7B) at Meadowbrook. The cameras, acoustic barrier and signage (stating 'Environmental Sensitive Area') were installed on the 06-07/03/25.

Captions 1 & 3	Meadowbrook	Captions 2 & 4	Meadowbrook
Acoustic barrier and signage in place for Otter holts N7A and N7B as per the Derogation licence		Cameras in place for Otter holts N7A & N7b as per the Derogation licence. A domestic short hair cat is a regular visitor to Holt N7A and has entered the holt. No Otter activity has been recorded	
Photograph 3		Photograph 4

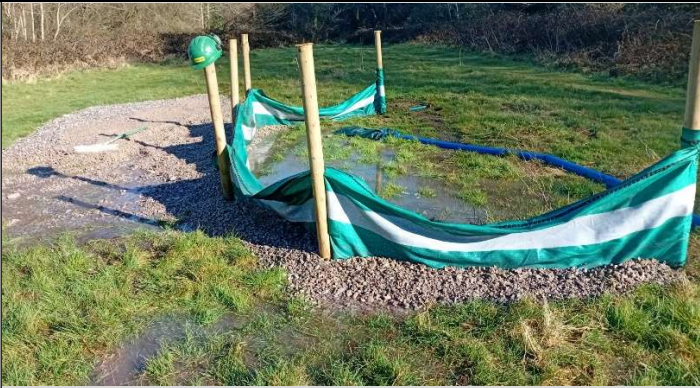
Photograph 7	Photograph 8

A photograph showing a silt control measure at an overflow culvert. A green and white striped silt fence is stretched across a gravel check dam. The area is surrounded by grass and trees.
Caption 7 Silt Control Measures at Overflow Culvert	Caption 8 Silt Control Measures at Overflow Culvert
Silt control measures (silt fences and gravel checks dams) in place at the discharge point for the Overflow Culvert at Hazelwood Bridge	Silt control measures (silt fences and gravel checks dams) in place at the discharge point for the Overflow Culvert at Hazelwood Bridge
