Environmental Report June 2024

Glashaboy Flood Relief Scheme

Document code: FFEC-GFRS-2024-006

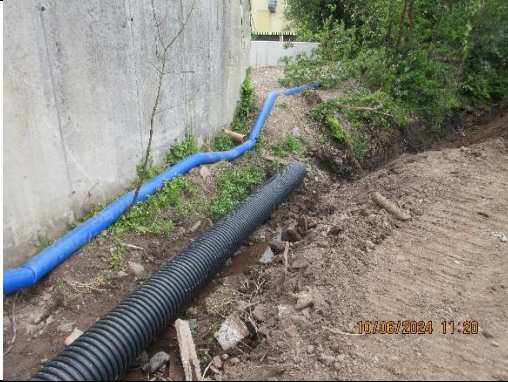
Item number	Date	Comment	Image	ECoW Action/Recommendation	Sorensens's Action response
6.1	10/06/2024	Layflat hose carrying overpumped water from the Springmount stream was leaking. This small supply of water seemed to attract a single eel which remained in a small pool here. The eel was removed and placed in the main channel by the ECoW.

Hoses must be inspected and maintained regularly to prevent leaks. Given the proximity to the main channel in this case, leaks may attract eels, which are known to travel considerable distances across land.	The hose was repaired promptly.

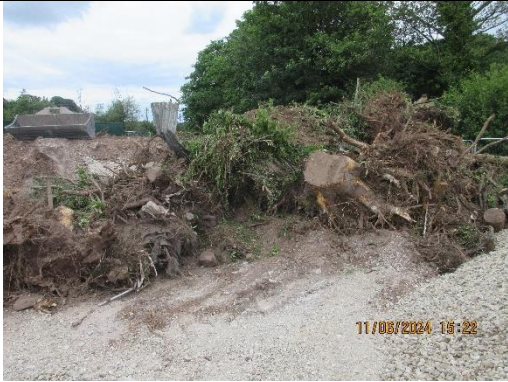
6.2	11/06/2024	Tree stumps and vegetation removed from Springmount stream bank. Regrettably this resulted in a removal of habitat at this location. Clearance of trees and vegetation was included in the design as it was necessary to enable works.

While the primary focus remains on completing the works, efforts should still be made to retain existing trees and vegetation, even if their clearance is specified in the design, as opportunities to preserve them can sometimes arise during on-site supervision, particularly at the clearance stage of each individual work site.	The site ecologist agrees on the importance of retaining trees and vegetation wherever possible and to continue efforts going forward.

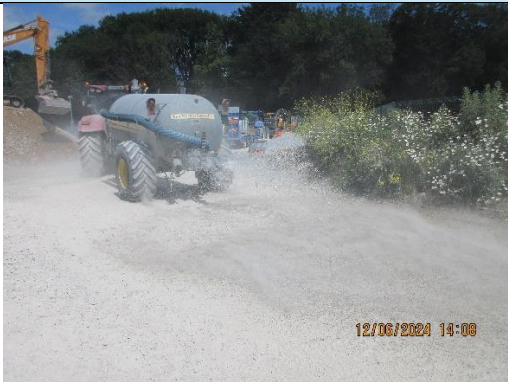
Item number	Date	Comment	Image	ECoW Action/Recommendation	Sorensens's Action response
6.3	12/06/2024	Dust suppression being carried out at Circus Field.

Action carried out in line the Work Requirements, Appendix 1/9 Clause 3, as it pertains to the control of dust.	Dust control measures should be implemented as necessary, based on prevailing weather conditions.

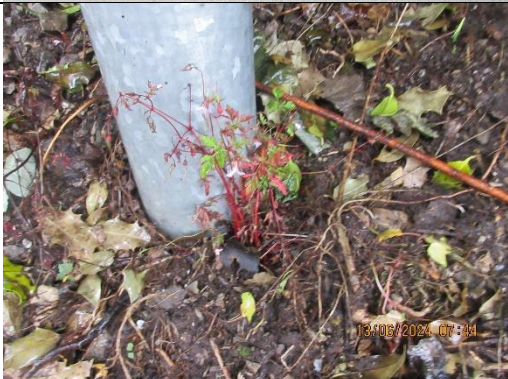
6.4	13/06/2024	An uncommon native geranium plant was identified within the project footprint. To preserve it, the specimen was transplanted to a receptor site at St. Joseph's Church. While this individual survived, approximately 30% of the other transplanted plants did not survive due to drought conditions.

Recommendation: Rescued plants should be placed in containers and watered until established. They can then be transplanted to the designated location at St Joseph's church.	Subsequent plant translocations were placed in containers with damp soil and watered immediately.

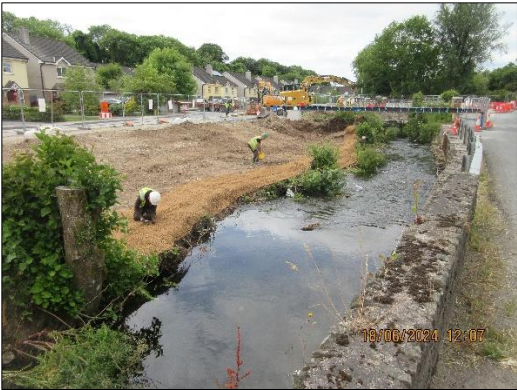
Item number	Date	Comment	Image	ECoW Action/Recommendation	Sorensens's Action response
6.5	18/06/2024	Coconut coir installed at Copper Valley Vue to prevent silt run-off in rainfall.

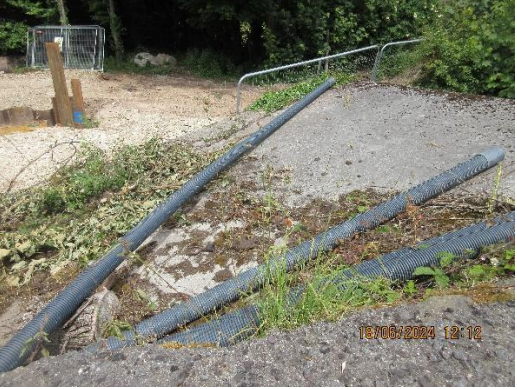
This installation is necessary and satisfactory.	No further action required.
6.6	18/06/2024	Culvert at New Line with the rare <i>Geranium</i> sp. removed

These rare species were successfully conserved, preserving this valuable species for the future.	No further action required, except to remain vigilant and survey for <i>Geranium purpureum</i> and <i>Geranium purpureum X robertianum</i> in suitable habitats which may be impacted by works.

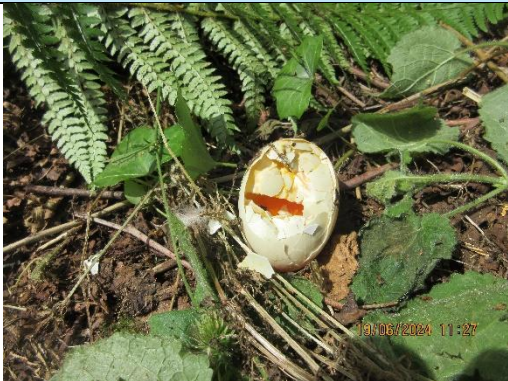
Item number	Date	Comment	Image	ECoW Action/Recommendation	Sorensens's Action response
6.7	19/06/2024	During the vegetation clearance along the Glashboy to facilitate sheet piling works, bird eggs, likely belonging to a mallard, were unintentionally damaged. This occurred despite the area undergoing two breeding bird surveys conducted by the site ecologist prior to the clearance. Unfortunately, the nest was concealed beneath a large fern and was inadvertently overlooked during the surveys.

The audit covered the main environmental and ecological events on site throughout the month. The audit notes the discovery of a mallard nest on 19/06/24 but did not address the associated damage or significance. However, this oversight was subsequently addressed through the issuance of an Environmental Incident Report, which provided a more detailed account of the event.

<p>Recommendation: During surveys, the contractor must ensure that the bird surveys are performed at a high standard. For example, the document from TII: “<i>Ecological Surveying Techniques for Protected Flora and Fauna during the Planning of National Road Schemes</i>” offers useful guidance.</p> <p>This issue is not in breach of the work requirements as the survey was completed ahead of the works.</p>	An Environmental Incident Report was subsequently issued by Sorensen.

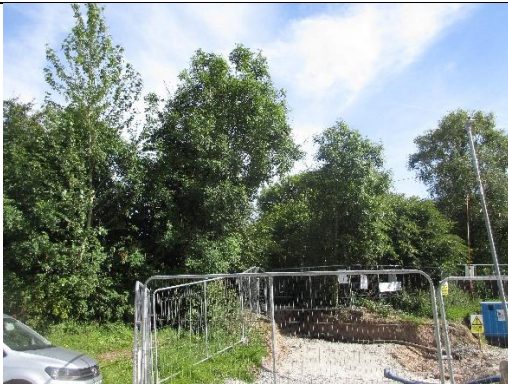
6.8	19/06/2024	c. 18m stand of trees proposed to be felled to facilitate works at Meadowbrook adjacent to the Riverstown Bridge. Note the rare species black poplar (<i>Populus nigra</i>) on the left.

<p>Recommendation: These trees were surveyed for nesting birds several times, as there was high nest potential due to the high value habitat close by and birds displaying nesting behaviour.</p> <p>The potential black poplar was recommended to be protected from felling.</p>	Contractor ensured this stand of trees was free of nesting birds before the gradual felling under the supervision of the site ecologist. The potential black poplar was left standing.

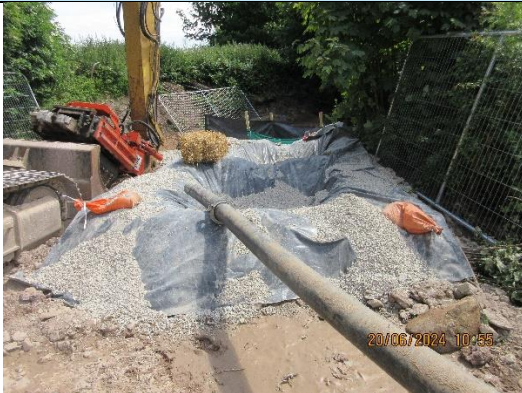
Item number	Date	Comment	Image	ECoW Action/Recommendation	Sorensens's Action response
6.9	20/06/2024	Attenuation area at New Line set up to ensure pumped groundwater is allowed to settle before entering the river.

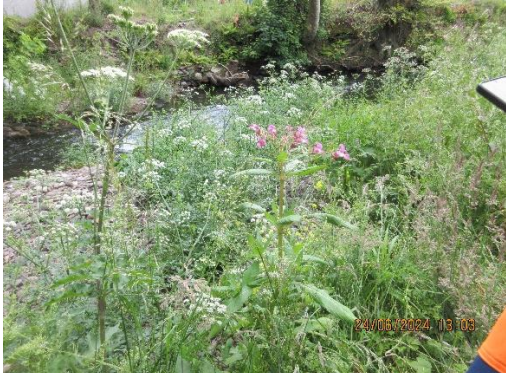
This set up was prudent, though ultimately not necessary as there was very little groundwater in the excavation at this location.	No further action necessary, except to continue to set up attenuation areas when needed.
6.10	24/06/2024	Himalayan balsam (<i>Impatiens glandulifera</i>) discovered at Meadowbrook gravel deposit which will be disturbed during instream works.

Recommendation: Remove these plants by pulling up by hand. Hand pulling is recommended as long as the plant is not setting seed.	Contractor removed these plants successfully.

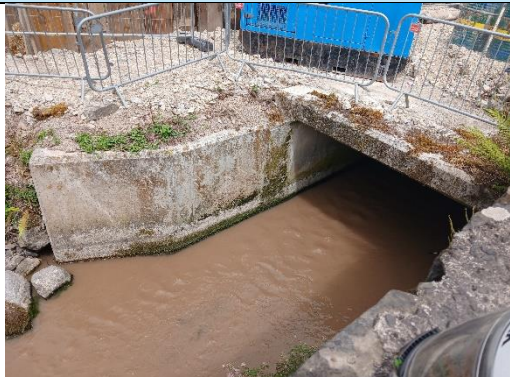
Item number	Date	Comment	Image	ECoW Action/Recommendation	Sorensens's Action response
6.11	25/06/2024	Siltation event occurred; sonde alarms triggered at New Line. Source of the turbidity was unrelated to the Glanmire Flood Relief Scheme Works. The source of the silt was found to be earth works and rock armour placement upstream at a farm.

The source of the pollution was found, earthworks and rock armour at the bank of the river in a private field, unrelated to works.	No response required.
