Environmental Report January 2025

Glashaboy Flood Relief Scheme

Document code: FFEC-GFRS-2025-001

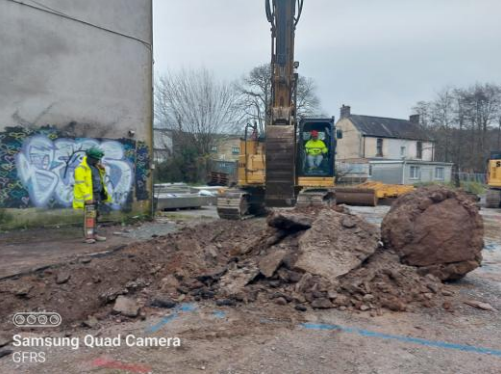
Item number	Date	Comment	Image	ECoW Action/Recommendation	Sorensens's Action response
1.1	08/01/2025	Works to Area one pump station were suspended due to archaeology. Plans to dewater excavations still needs to be addressed in the contractor's Method Statement.

Discussions were held with the site ecologist about ecological mitigation measures of the proposed works.	An updated Method Statement is required before work resumes.
1.2	10/01/2025	The improper storage of rebar within the temporary holding cell for invasive plant species' contaminated material was removed.

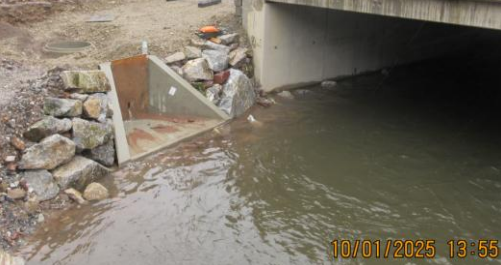
Recorded	This action was in response to a previous enquiry made by the ECOW.
1.3	10/01/2025	Concrete pouring at New Line carried out with due care for the adjacent watercourse.

Discussed works with ground crew regarding environmental issues.	No response required.

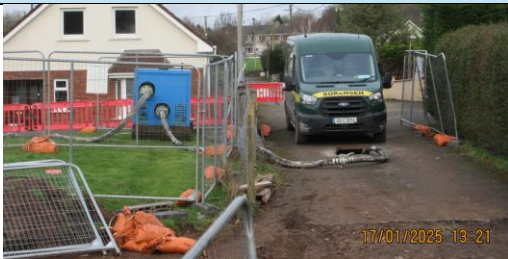
Item number	Date	Comment	Image	ECoW Action/Recommendation	Sorensens's Action response
1.4	17/01/2025	Permit to Pump at Copper Valley Vue to facilitate dewatering of manhole for tie-in to the existing foul line.

Inspection carried out and works discussed with grounds crew.	SCE informed the ER team of planned pumping prior to commencement. Permit to pump was in place.
1.5	20/01/2025	The remaining Eurofins contaminated material removed from Sallybrook. ENVA removed the material to a licensed waste facility.

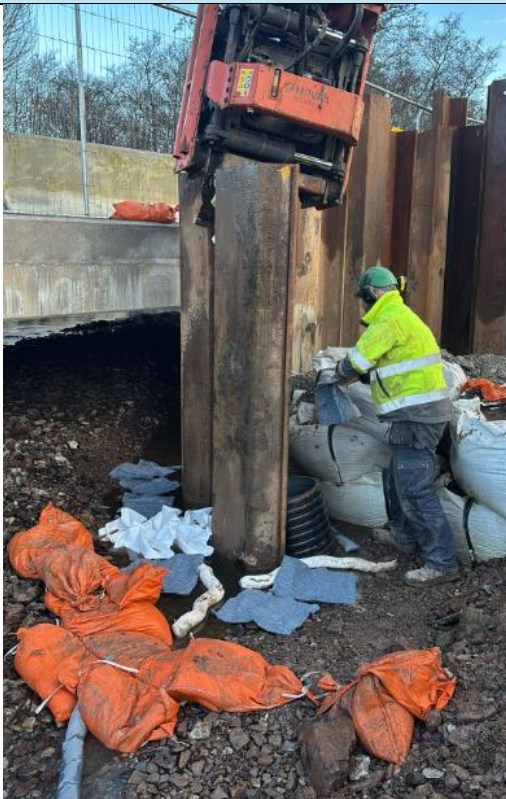
Item number	Date	Comment	Image	ECOW Action/Recommendation	Sorensens's Action response
1.6	21/01/2025	An Environmental Incident occurred at Brooklodge culvert. A small hydraulic hose burst on the excavator working adjacent to the Glenmore River

The incident was reported promptly to the ECOW by the site ecologist via the Ecology Whats App Group.	Oil socks and pads were promptly deployed. The burst hose was wrapped in plastic. Bioversal was applied to the area. This addressed the hydrocarbon issue. No contamination entered the adjacent Glenmore River.
1.7	23/01/2025	Newline: The recent construction of riverbank above armouring and outfall has resulted in steeply sloped, exposed soils. Although the bank has been compacted and graded, the bare soil surface

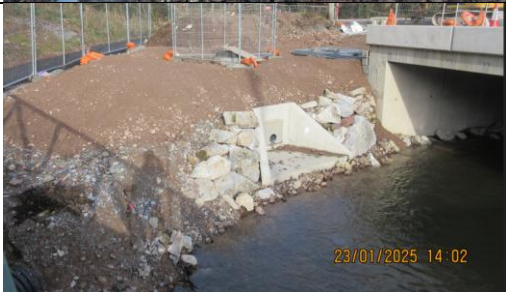
Item number	Date	Comment	Image	ECoW Action/Recommendation	Sorensens's Action response
		remains vulnerable to surface water runoff.			
1.8	23/01/2025	A small area adjacent to the M8 overpass has been used for stockpiling soil following recent works. Currently, there is no clear delineation of the works area, creating the potential for encroachment into the surrounding natural environment.

Recommended erosion protection measures be put in place.	Completed 28/01/25. See Item 1.16 below.

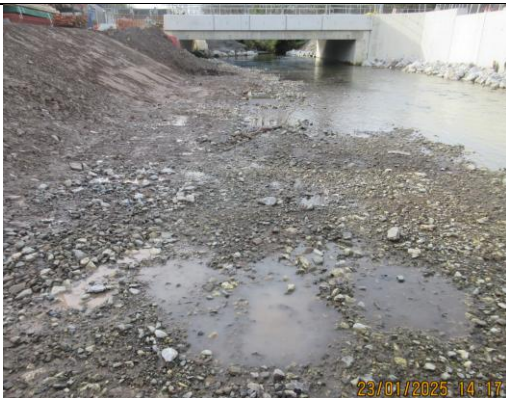
1.9	23/01/2025	Recent earthworks between the Brooklodge Culvert and Copper Valley Bridge have exposed bare soil, making the area susceptible to surface water runoff and potential erosion from the Glanmore river, especially if water levels rise. Although the bank has been compacted and graded, the unprotected soil surface remains vulnerable to these processes.

Recommendation: Consider measures to limit the loss of soils into the adjacent watercourse by implementing measures such as silt fencing and/or coir mesh.	Due to be completed this month but was not carried out before the months end.

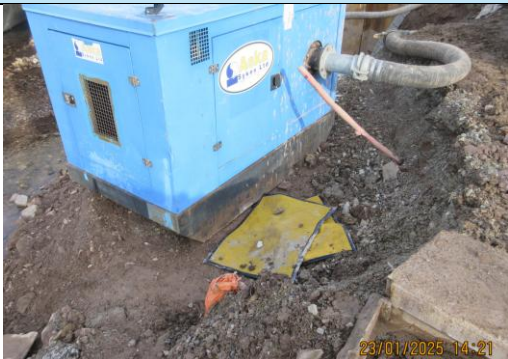
Item number	Date	Comment	Image	ECoW Action/Recommendation	Sorensens's Action response
1.10	23/01/2025	At the Brooklodge culvert, during the downstream wingwall construction, spill mats are positioned below the refuelling point of waterpump to catch any accidental fuel spills during refuelling.

Observation: Good practise by SCE to protect adjacent water course.	No further action required.

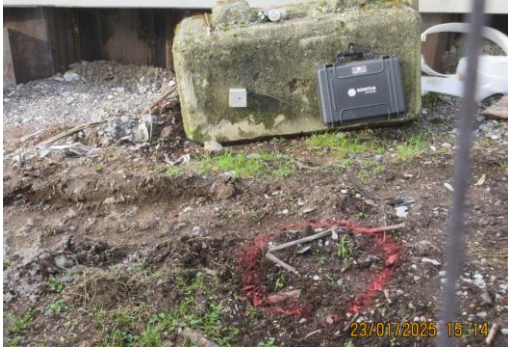
1.11	23/01/2025	Three-cornered leek (<i>Allium triquetrum</i>) has been identified in the gardens of bungalows opposite the Meadowbrook estate. The plants have been marked, and plans are in place to avoid disturbing them during the removal of noise and vibration monitoring equipment.

Observation: Good implementation of biosecurity measures.	Biosecurity measures were followed when monitoring equipment was moved from this location.

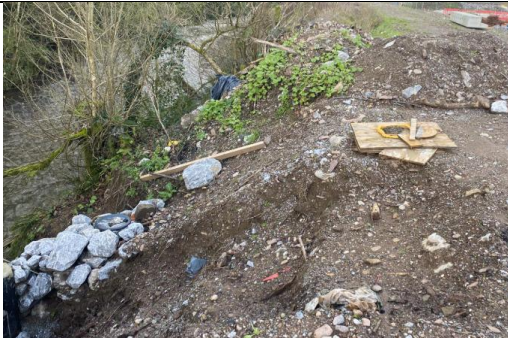
1.12	23/01/2025	At Area One embankment, construction materials such as discarded signage, empty sandbags, and wood scraps are present. With the impending arrival of Storm Éowyn, strong winds could potentially blow this debris into the adjacent

Item number	Date	Comment	Image	ECoW Action/Recommendation	Sorensens's Action response
		watercourse, leading to pollution.

Recommendation: Clean up all waste/materials before end of day.	Completed 23/01/25 before the arrival of Storm Eowyn

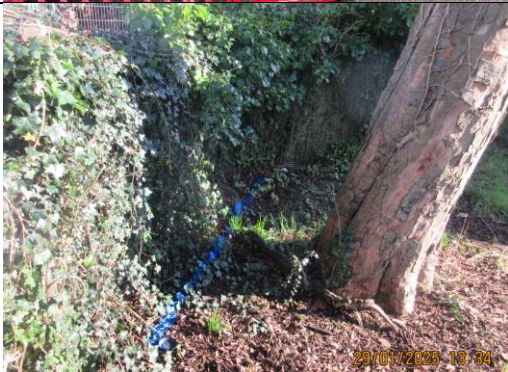
1.13	29/01/2025	In response to GFRS-RFI-344 Springmount Stream Wall C06_L04 Tree Removal, the tree in question and the ground surrounding the tree was inspected. It was noted that there may be the possibility that Spanish Bluebell (<i>Hyacinthoides hispanica</i>) is growing at this

Item number	Date	Comment	Image	ECoW Action/Recommendation	Sorensens's Action response
		location. Subsequently, the proposed works and possible tree removal may require the application of biosecurity measures.			
1.14	29/01/2025	Housekeeping at New Line. A minor amount of waste is present and looks unsightly.

Recommendation: SCE to follow biosecurity measures where necessary.	Where Spanish bluebell is confirmed to be present (further into the growing season) biosecurity measures will be deployed during works. Works will be supervised by the IAPS Specialist Ecologist.

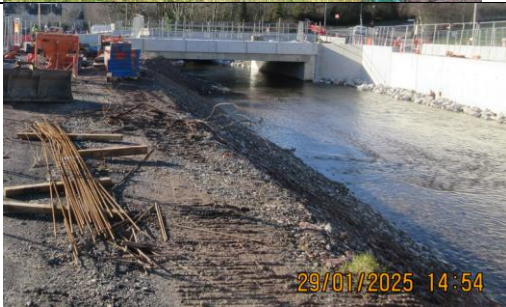
Recommendation: At this location, clean up all waste that is the responsibility of SCE.	To be actioned in February 2025.
1.15	29/01/2025	The riverbank in between the Brooklodge and CVV structures have mostly been graded except for the bank that ties into the CVV structure. There exists potential for erosion and run off.

Recommendation: Consider measures to limit the loss of soils into the adjacent watercourse by implementing measures such as silt fencing and/or coir mesh	Coir mesh due to be installed early in February 2025.

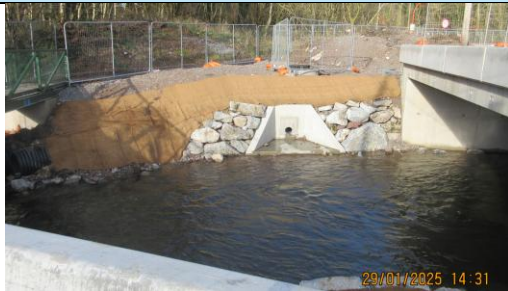
Item number	Date	Comment	Image	ECoW Action/Recommendation	Sorensens's Action response
1.16	29/01/2025	Coir mesh installed at New Line to prevent run off into water course.

This action was carried out in response to an earlier recommendation.	No further action required.

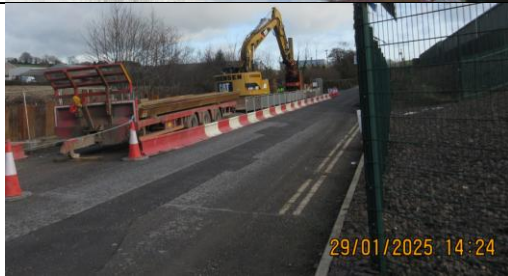
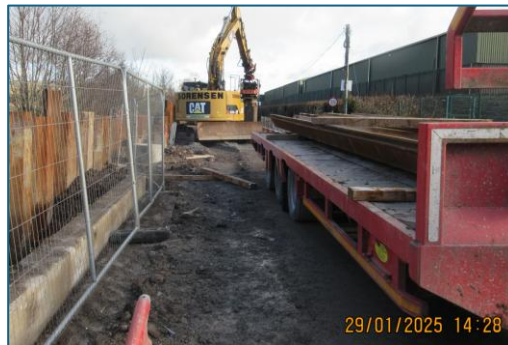
1.17	29/01/2025	Works have commenced at New Line with temporary sheet piling. These works require excavation works to be carried out which are anticipated to necessitate dewatering efforts. The current strategy that was communicated involves creating an artificial settlement pool between the two sheet pile walls to manage sediment during dewatering.

To develop a contingency plan in the event that the proposed settlement pool proves inadequate for silt management and to implement monitoring protocols.	GFRS-MS-053 C05_L02 & C05_L03 (New Line Road) Rev02 was issued by email on the 30/01/2025. This was reviewed by the Resident Engineer (RE) team and returned with comments. In response, the dewatering plans were revised to incorporate a settlement tank and manifold system, which were considered well-suited to the conditions of this particular situation.

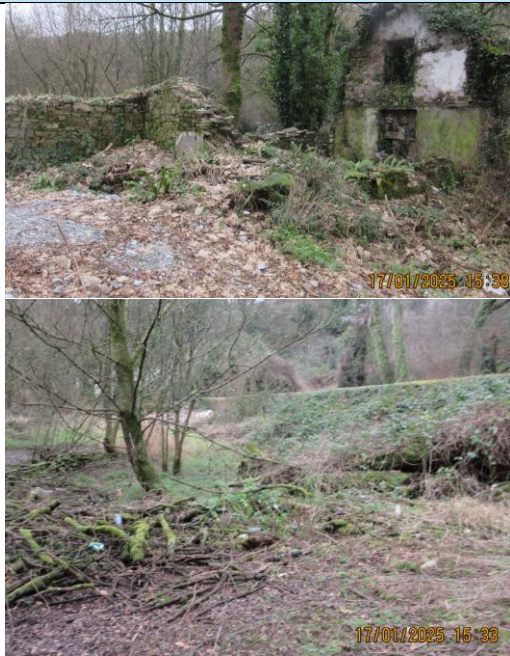
Item number	Date	Comment	Image	ECoW Action/Recommendation	Sorensens's Action response
1.18	29/01/2025	Plans are in progress for vegetation clearance in Area 4 to prepare for upcoming work later this year. A discussion briefly covered these works, with a focus on the potential presence of bird, bat, and mammal species in the area.

Ensure that all ecological procedures are followed during the planned vegetation and/or tree clearance in Area 4 to prevent unnecessary harm to bats, birds and mammals.	<p>Site Ecologist to undertake a walkover survey prior to the commencement of works. A Permit to Clear Vegetation will be issued in advance of works by the site ecologist to the client's ecologist.</p> <p>In addition to bats, birds and mammals there is also potential for Japanese knotweed. Vegetation clearance and soil stripping works will be supervised by the IAPS Specialist Ecologist (site ecologist also) and biosecurity measures deployed as required. Any vector material uncovered during works will be transported to the temporary holding facility at Area 1 Sallybrook Site Compound.</p>
