Environmental Report April 2024

Glashaboy Flood Relief Scheme

Document code: FFEC-GFRS-2024-004

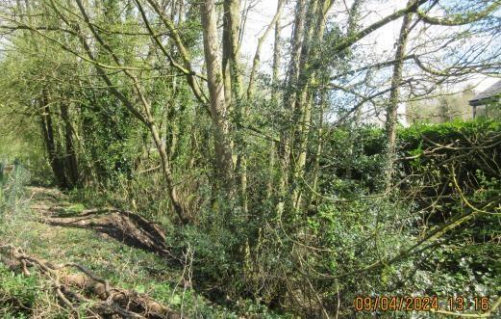
No.	Date	Comment	Image	ECOW Action/Recommendation	Sorensens' action response
4.1	9/4/24	At Bleach Hill, the site ecologist and ECOW agreed on installing bat boxes on two designated trees (one per tree), as it was not feasible to install them on the new culvert due to head height restrictions and the need to position the boxes high enough to avoid potential high flood events.

Install bat boxes on agreed trees. Bat conservation Ireland to be informed.	Bat boxes were installed onto agreed trees in April.

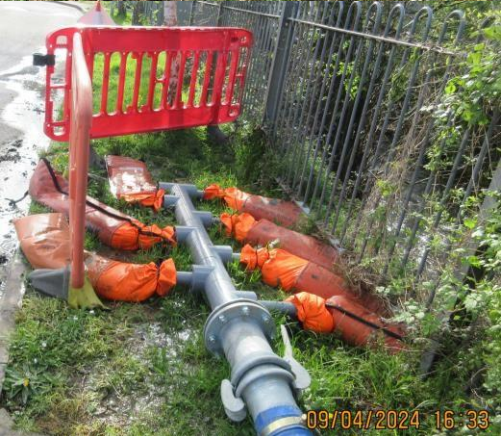
4.2	9/4/24	Copper Valley Vue estate: Pumping out of excavation works area utilising a combination of two surface gullies and vegetation on the embankment. Mitigation measures to control for sediment include the use of pump-sump, a settlement tank and the manifold system that uses up to 8 silt bags at a time.

Pumping was monitored through the month by the ECOW. No sediment was observed or reported though the month.	Maintained pumping set up successfully for duration of the month.

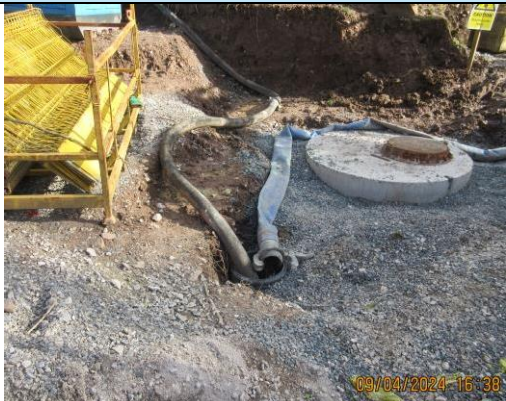
No.	Date	Comment	Image	ECoW Action/Recommendation	Sorensens' action response
4.3	9/4/24	Pumping out of ground water ingress and rainwater from the Meadowbrook pump station into storm drainage manhole positioned nearby at John O' Callaghan bridge. Water was clean at the time of inspection.

Monitor closely for sedimentation.	This pumping set was in operation up for the duration of the Month of April.

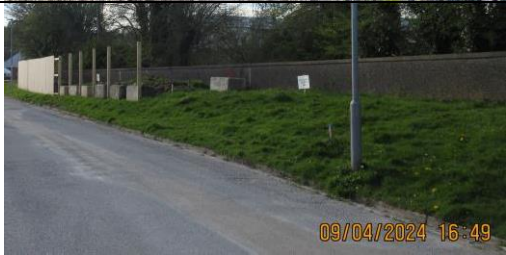
4.4	9/4/24	The hoarding was not completed by the end of April. However, no construction work took place in the area during that time, which was the primary purpose of the hoarding. The hoarding is scheduled for completion next month before construction works resume in the immediate area.

Complete hoarding prior to commencing sheet piling works in this area.	Hoarding was not completed in April.

3.25	Hoarding to be completed at Meadowbrook.	Hoarding was not completed this month. Hoarding works to be completed prior to Sheet piling works commencing along this section of Meadowbrook estate.

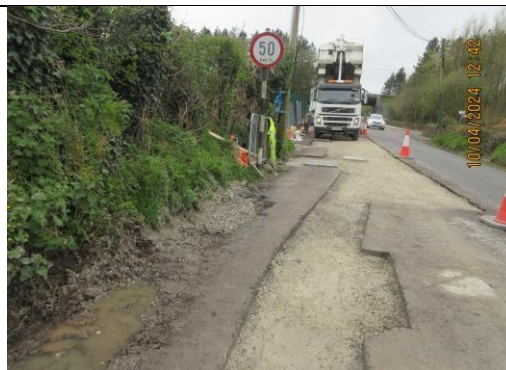
4.5	9/4/24	Pumping was conducted at the New Line works, directing water into a nearby gully. Additionally, check dams installed in the gully to enhance filtration.

Effective utilisation of space and check dams can help manage the potential sediment resulting from excavation works in the area.	The system was operational throughout the two days it took to complete excavation works in this section of the roadway.

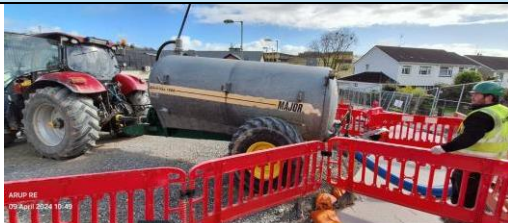
No.	Date	Comment	Image	ECoW Action/Recommendation	Sorensens' action response
4.6	9/4/24	It was observed on April 9th that a tanker was discharging into the combined line at Springmount.

Enquiries were made regarding this observation to the site ecologist who was unaware of this activity.	Clean water was being flushed through the foul to reduce the risk of sediment build up within the system.

3.25	Hoarding to be completed.	Hoarding to be completed at Meadowbrook.
4.6	It was observed on April 9th that a tanker was discharging into the combined line at Springmount.	The contractor is requested to provide information regarding the origins of the material and specify what material was being discharged.

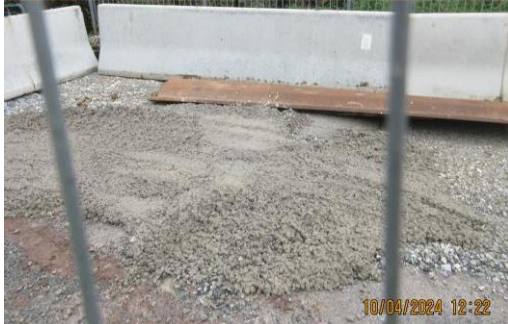
4.7	10/4/24	Waste concrete has been deposited near the Glenmore River within the Copper Valley Vue estate. Although no evidence of wash-off or contamination to the river has been observed, this action does not align with the Work Requirements aimed at preventing harm from waste disposal (1/37 section 14.11).

Ensure that waste concrete is deposited in accordance with the Work Requirements.	This was discussed with the site ecologist. The concrete was cleaned up afterward. The subcontractor who is responsible for concrete delivery was again instructed to use designated concrete wash outs when working on site.

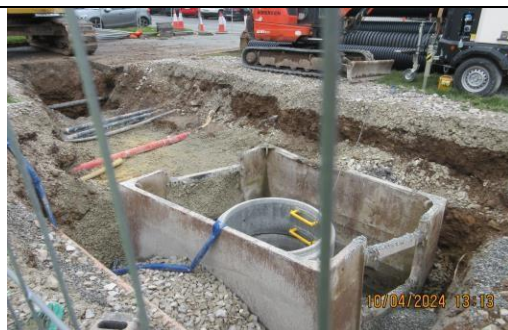
4.8	10/4/24	Drainage works at Hazelwood Centre, in front of funeral home. Pumping from excavations into foul system during evening time works. Pumping took place over two evenings following the completion of drainage works in this immediate area.

Written permission from the utility owner is necessary for discharging into the public sewers.	There was no license in place. Contractor ensures this will not be repeated.

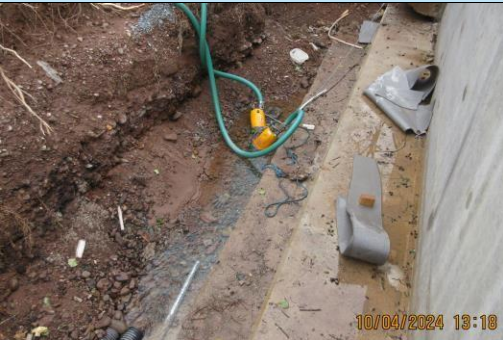
No.	Date	Comment	Image	ECow Action/Recommendation	Sorensens' action response
4.9	10/4/24	Ground water from funeral home works area observed to be clean. Silt socks in place.

Continue to monitor turbidity daily and monitor pH when concrete works are in progress.	Monitoring carried out throughout the month. Records were submitted at the end of the month in Contractors monthly audit.

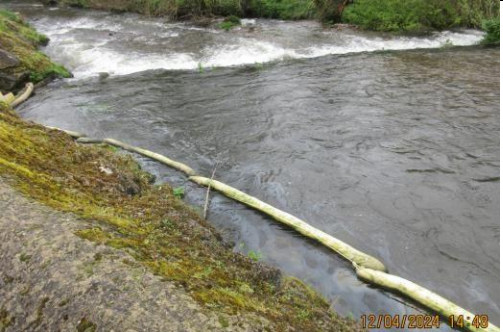
4.11	12/4/24	Contamination from Grandons, which is a legacy issue independent of the Flood Relief Works, continues to leak petrochemicals directly into the Glashaboy river. Oil booms are in place to direct the surface residues away from the main channel but observed repeatedly to be ineffective.

Continue to monitor this situation.	Main Contractor to manage contamination as sheet piling works and rock armour are planned to be installed at this location during the 2024 instream works July – September.

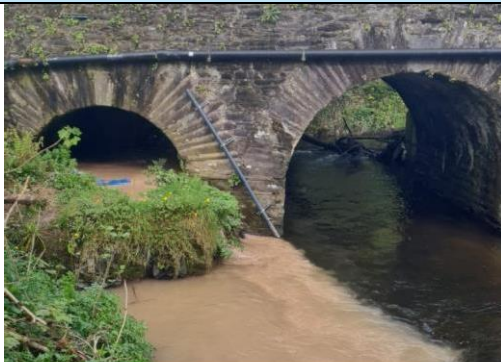
No.	Date	Comment	Image	ECoW Action/Recommendation	Sorensens' action response
4.12	13/4/24	During Saturday works at Meadowbrook pump station, during additional digging, a siltation incident was observed by the ER.

An email was sent requesting an Environmental Incident Report be raised.	Environmental Incident Report EIR006 was issued by the contractor.

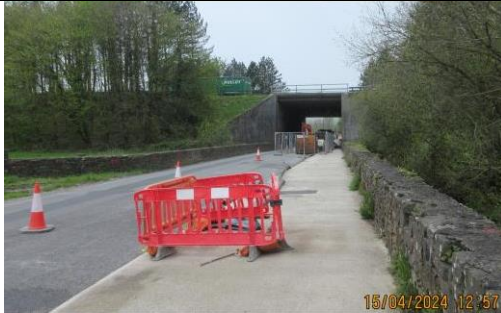
4.13	15/4/24	Excavation works at New Line involve pumping out groundwater ingress from excavations, which occasionally results in sediment entering the foul line during the month of April.

Written permission from the utility owner is necessary for discharging into the public sewers.	The pumping setup remained in place for the majority of April as diversion works continued in this area. No written permission was in place during pumping.

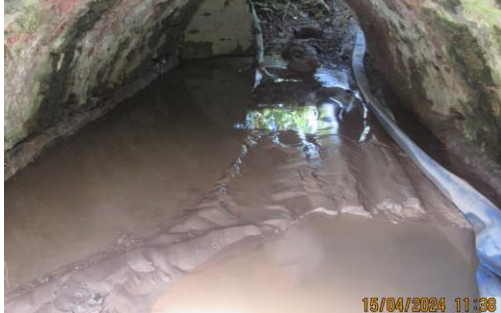
4.14	15/4/24	Build-up of silt added to already blocked eye of John O' Callaghan bridge in association with siltation incident (Item 4.12).

Recorded and discussed with site ecologist.	Blocked eye of bridge to receive dredging later in the year as per the design to increase conveyance. This does not affect the Flow Management Plan as the eye has long been blocked and cut off from Glashboy river.

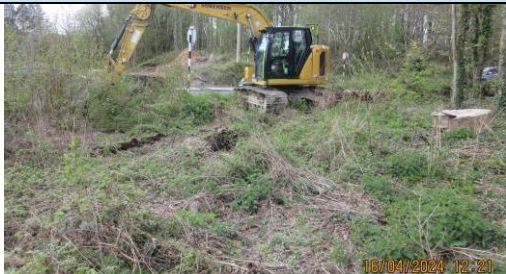
No.	Date	Comment	Image	ECow Action/Recommendation	Sorensens' action response
4.15	16/4/24	Scrub and regenerating vegetation cleared for enabling works at New Line. Site ecologist surveyed for nesting birds prior to clearance. No bird nesting was found.

A yellow excavator is clearing scrub vegetation in a wooded area. The ground is covered with dry leaves and branches. A timestamp '16/04/2024 12:21' is visible in the bottom right corner.	Recorded and surveyed; no nesting birds were observed.	Survey in line with Work Requirements and legal requirements to protect birds during the bird nesting season.

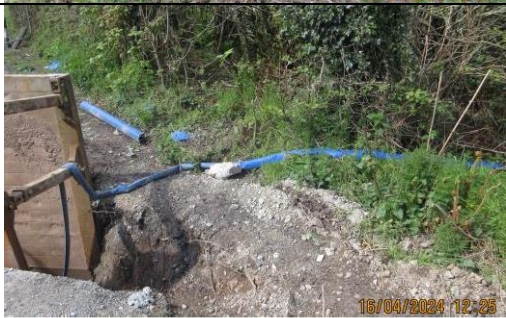
4.16	16/4/24	Pumping out of excavation along the eastern section on New Line Road directly into Glenmore River.

A blue pipe is discharging water into a gully. The water is flowing over a concrete structure. A timestamp '16/04/2024 12:25' is visible in the bottom right corner.	Discussed with site ecologist.	The site ecologist reported that pumping was conducted for a short duration, with a silt sock attached to the outlet. The pump was relocated across the road to a preexisting roadside vegetated gully, which enhanced attenuation with satisfactory results.

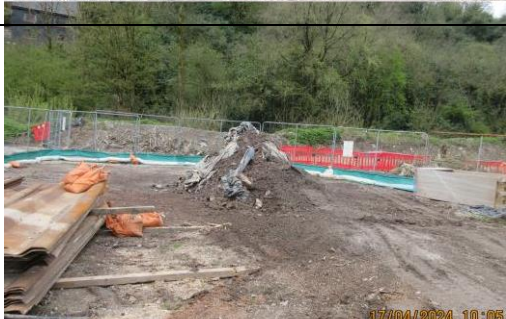
4.17	17/4/24	Contaminated material originating from the Pat O'Donnell works area is removed to a licensed waste facility by Enva.

A pile of contaminated material is being removed. The material is dark and appears to be soil or debris. A timestamp '17/04/2024 10:05' is visible in the bottom right corner.	Documented.	No further action required.

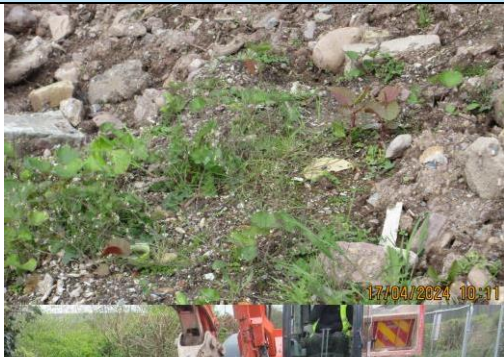
No.	Date	Comment	Image	ECow Action/Recommendation	Sorensens' action response
4.18	17/4/24	JKW observed to be growing at entrance to temporary stockpile.

It may be worthwhile treating visible JKW canes with herbicide prior to its burial and elsewhere on site.	The invasive species specialist plans to spray visibly growing Japanese knotweed within the LMA of the project. This action is scheduled for September, the most effective time for JKW treatment. Spraying of JKW is already accounted for in the Bill of Quantities.

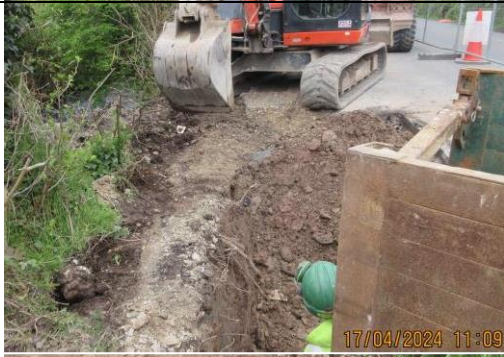
4.19	17/4/24	During works on eastern end of New Line works site, encroachment by small digger into the Glenmore river. Partial collapse of riverbank and surface herbaceous vegetation.

Spoke with driver and site ecologist. Bank was later reinstated.	Area to be grass seeded.

4.19	The reinstated riverbank following the partial collapse of riverbank at New Line could benefit from being grass seeded.	Contractor to grass seed following grass seed mix approval.

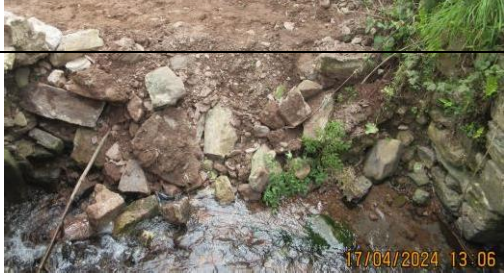
4.20	17/4/24	Minor collapse within stream bank during enabling works for Cois Na Gleann culvert.

Raised with site ecologist.	Stream bank was regraded, and sand bagged before work was finished for day. This is a good temporary solution until permanent works are completed at this location.

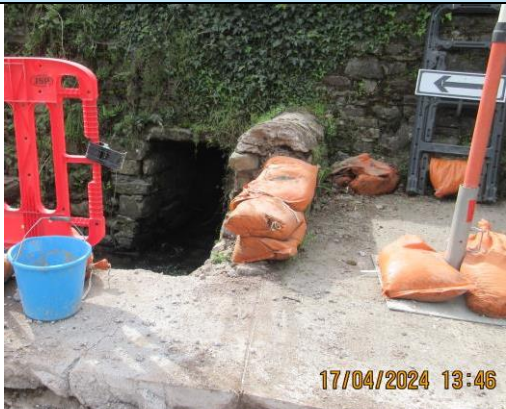
No.	Date	Comment	Image	ECow Action/Recommendation	Sorensens' action response
4.21	17/4/24	Active dipper nest found inside the stone culvert during the enabling works for Cois na Gleann.

Discussed with site ecologist.	NPWS ranger was on site the following morning. Dipper nest was inspected and found to contain four well developed dipper chicks who were all ringed by NPWS ranger. Enabling works were agreed to proceed with agreement that culvert works would not begin till chicks have fledged.

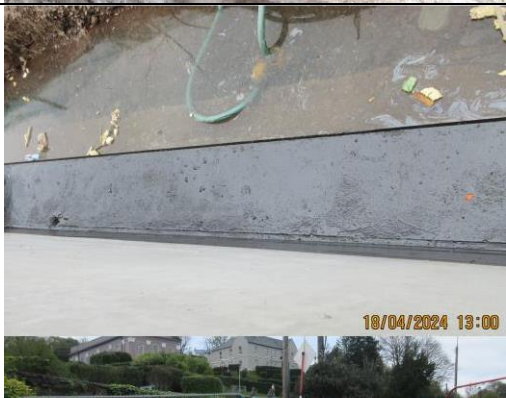
4.22	18/4/24	Minor contamination incident observed at funeral home works site. Ground water being pumped out via a pair of two-inch pumps, which were not turned on at the time which allowed ground water to pool and raise to meet the foot of the RC wall that was recently painted with EPICON, a concrete sealant toxic to aquatic life.

Spoke with ground crew and site ecologist.	Oil booms were deployed in the area to absorb the residues. Personnel received instructions from the site ecologist to maintain water levels in the works area at a low level, with additional inspections by the site ecologist scheduled during this stage of the works.

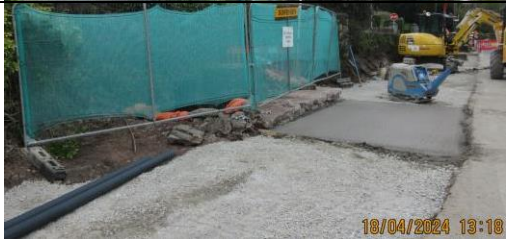
4.23	18/4/24	Screening erected in front of the dipper nest at Cois Na Gleann.

Documented.	Screening to remain in place until dipper chicks have fledged.

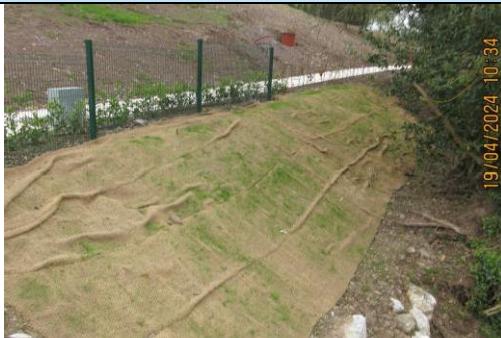
No.	Date	Comment	Image	ECoW Action/Recommendation	Sorensens' action response
4.24	19/4/24	Grass seed at Bleach hill shows healthy growth.

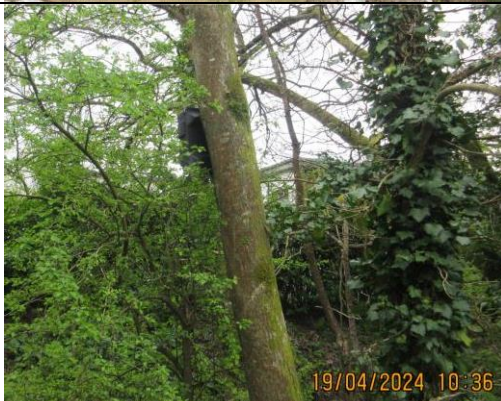
Recorded.	No further action required.
4.25	19/4/24	Bat boxes installed on two separate trees down stream of the new culvert at Bleach hill as per the design specifications.

Recorded.	Contractor to inform Bat Conservation Ireland about the two installed bat boxes.
4.26	19/4/24	Possible badger sett earth mound adjacent to the works site for the new line bridge is inspected for badger and found to be not present.

4.25	Sorensen to inform Bat Conservation Ireland about no. 2 bat boxes installed at Bleach hill.	Inform Bat Conservation Ireland about no. 2 bat boxes installed at Bleach hill.

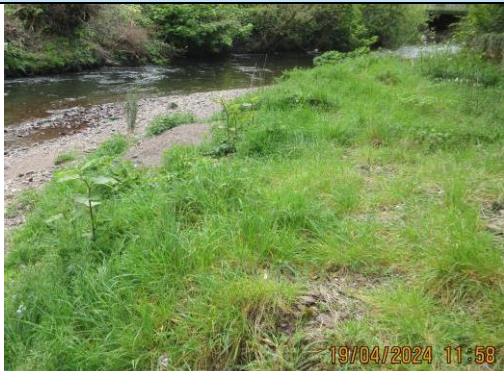
No.	Date	Comment	Image	ECoW Action/Recommendation	Sorensens' action response
4.27	19/4/24	JKW observed to be growing on the riverbank at Meadowbrook were proposed access ramp is to be installed. This JKW location was mapped previously and included in the design drawings.

Discussed with site ecologist.	Biosecurity measures have been incorporated into the access ramp method statement which takes into account the extensive JKW present at this location.

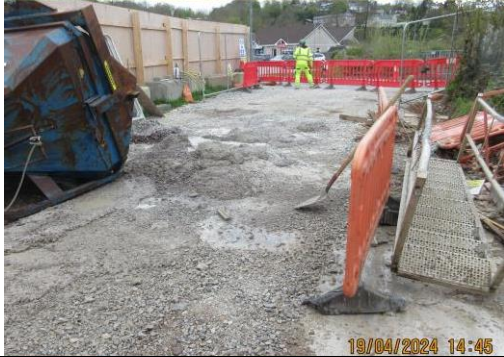
4.28	19/4/24	Concrete wash out at funeral home works area not being carried out using the concrete wash out at circus field.

Develop a system to wash concrete from skip in accordance with work requirements.	Instructions were again issued to the concrete subcontractor to use designated concrete wash out areas when working onsite.

4.28	No concrete wash out in use at Funeral home.	Develop a system to wash concrete from skip in accordance with work requirements at the Funeral home.

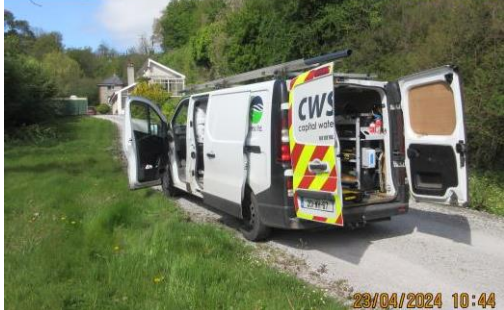
4.29	23/4/24	Capital Water on site to install four sondes in advance of culvert works at Cois na Gleann stream and Springmount stream.

ER to receive access to data logs when operational and in advance for in stream works at these locations.	Arrange access for the ER to water sondes data. The ER team will have full access to this data.

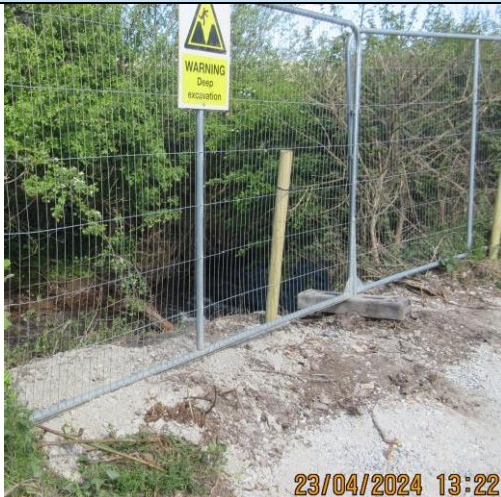
No.	Date	Comment	Image	ECoW Action/Recommendation	Sorensens' action response
4.30	23/4/24	Encroachment into Glenmore stream from services diversion works rectified by bank reinstatement inclusive of safety fencing.

Discussed with site ecologist.	Bank to be reseeded with grass seed following the final approval for seed mix as per Material Approval Request 120.
4.31	23/4/24	Enabling works to install diversion on Glenmore stream retains vegetation along bank in line with work requirements to prevent surface water run off.

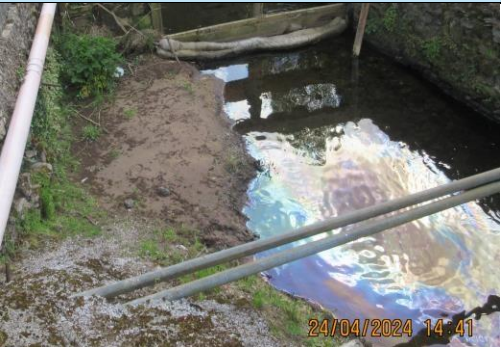
No.	Date	Comment	Image	ECoW Action/Recommendation	Sorensens' action response
4.32	24/4/24	Contamination emitted from Grandons, previously mentioned in Item 4.11, particularly heavy today.

Documented.	Sorensen to revert with works method and mitigation measures to control risk from contamination for the scheduled sheet piling and rock armourworks.

4.32	Scheduled works at Grandon's necessitate the implementation of mitigations to prevent further harm to the waterway from preexisting contamination.	Sorensen to revert with works method and mitigation measures to control risk from contamination for the scheduled sheet piling and rock armour works.
4.36	Diversion pipes installed on Glenmore river could benefit from additional erosion control measures.	Contractor to consider additional erosion protection measures such as the use of rip rap or sandbags around the outlet pipes.
4.37	New line: area outside works area being used as stockpile area for construction materials and equipment.	The contractor to remove stored materials and equipment and erect fencing and signage to prevent encroachment, thereby safeguarding the natural environment.

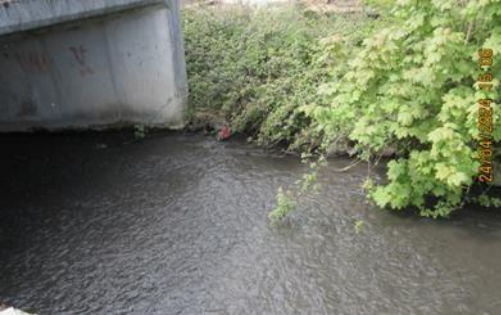
4.33	24/4/24	New Line: A pollution incident in the Glenmore River by a third party, which was unrelated to the flood relief works, was observed. The email reporting the incident to the relevant authorities has been forwarded to the site ecologists for their records.

A report email regarding the incident was sent to the relevant authorities – CCiC environmental division, Lawpro and IFI.	Continuous monitoring of this section of the Glenmore River is necessary to detect any potential further pollution incidents. All personnel working in the area should be instructed by the site ecologist to report any suspicious behavior or water discoloration incidents they observe.

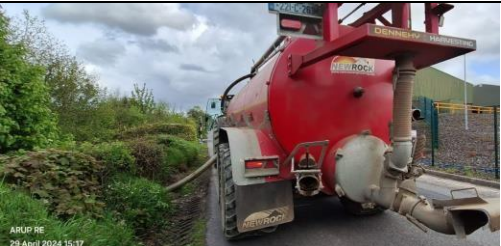
4.34	29/4/24	An agricultural tractor and tanker, unrelated to the works, were observed extracting water from the Glenmore River adjacent to the works at New Line.

Recorded.	Continue to monitor and record such incidents.

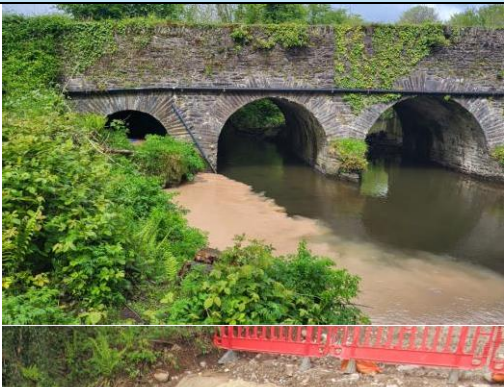
No.	Date	Comment	Image	ECoW Action/Recommendation	Sorensens' action response
4.35	30/4/24	Siltation event at Meadowbrook. Pumping was stopped when informed to do so by the ER.

An email was sent to the contractor.	Silt fencing and erosion mesh were installed the following day as a precautionary measure. Contractors acknowledged a previous failure to implement silt control measures. A toolbox talk (TBT) was provided to workers by the site ecologist.
4.36	30/4/24	Erosion mesh installed at New Line diversion outlet.

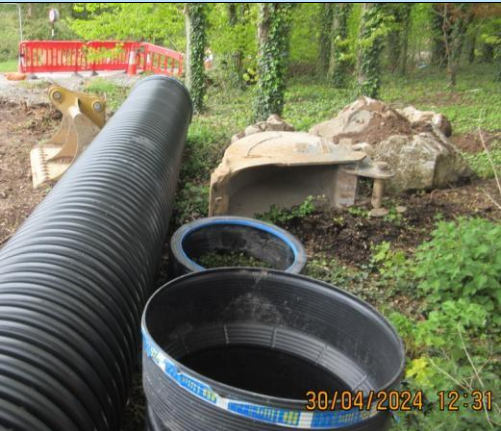
No.	Date	Comment	Image	ECow Action/Recommendation	Sorensens' action response
4.37	30/4/24	New line: area outside works area being used as stockpile area for construction materials and equipment.

This area should be fenced off to prevent accidental encroachment by machinery and to deter its use for storage, therefore protecting the trees from potential damage.	The contractor to remove stored materials and equipment and erect fencing and signage to prevent encroachment, thereby safeguarding the natural environment.
