## **Environmental Report July 2024**

Glashaboy Flood Relief Scheme

**Document code:** FFEC-GFRS-2024-007

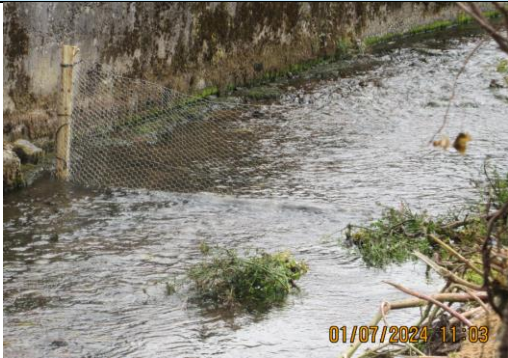
Item number	Date	Comment	Image	ECoW Action/Recommendation	Sorensens's Action response
7.1	01/07/2024	Poor fish protection at CVV with over pumping. A fence was installed instream above the pumps which consisted of a single layer of wire netting.

Discussed with site ecologist.	The fish guards underwent numerous improvements until reaching a satisfactory level of performance.
7.2	01/07/2024	At Meadowbrook, the river was diverted to facilitate sheet piling works. An erosion membrane was placed along the exposed Japanese Knotweed (JKW) stands to prevent the possibility of JKW entering the river and washing downstream.

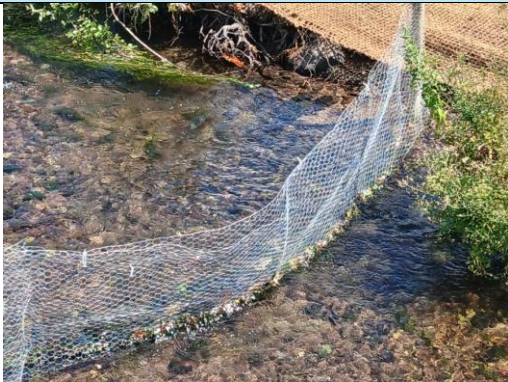
Item number	Date	Comment	Image	ECoW Action/Recommendation	Sorensens's Action response
7.3	02/07/2024	Improved fish protection at CVV – double layer of wire netting.

Inspected Fishguard fencing and discussed with site ecologist.	Fencing improvements continued with the installation of additional wire netting fence downstream from the initial installation.

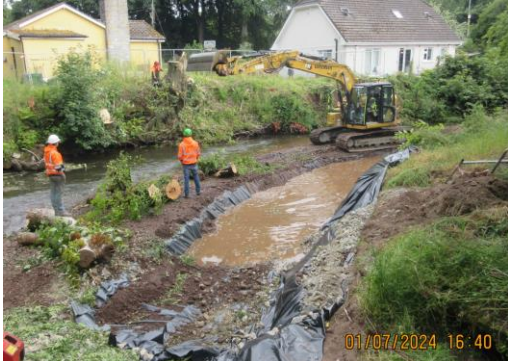
7.4	01/07/2024	Tree stumps and trees at Meadowbrook needed to be removed to facilitate flood protection sheet pilings. Most of these trees and stumps were part of the original clearance design, except for one additional mature ash tree that posed potential health and safety issues for the landowner. The tree and surrounding vegetation were surveyed for nesting birds and bat roosting potential (BRP), but none were found.

Recorded activities and ecological mitigations that were utilised to carry out works.	Vegetation clearance works carried out in line with the Work Requirements regarding protection to birds and bats. Sediment controls could have been improved during stump removal, however downstream sondes, which were working correctly at the time of works, did not record levels above the threshold.

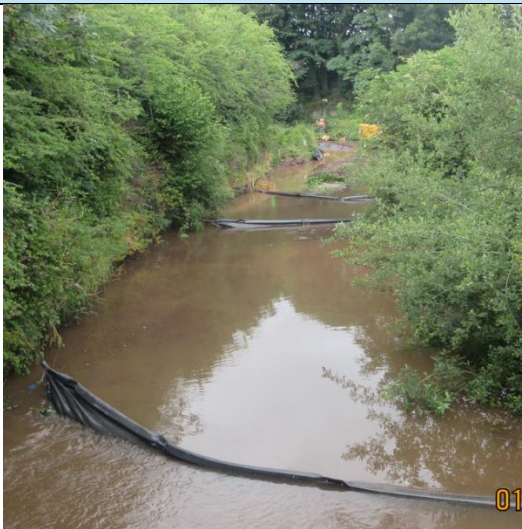
Item number	Date	Comment	Image	ECoW Action/Recommendation	Sorensens's Action response
7.5	01/07/2024	Silt mitigation measures were implemented during the activities mentioned in Item 1. However, despite these efforts, high levels of silt were generated for a period of time during the day.

Discussed with site ecologist.	Turbidity levels were monitored using downstream sondes. The turbidity levels did not exceed the established limits.

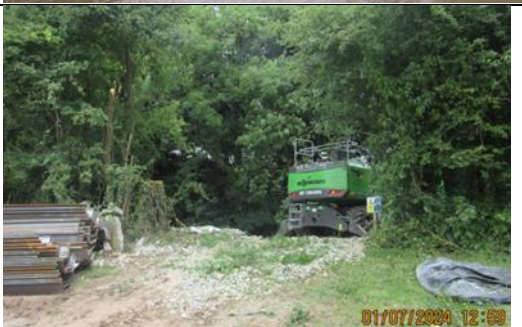
7.6	01/07/2024	A hawthorn tree was removed to facilitate access for the piling rig into the river at Meadowbrook. The tree was not part of the original design however prior to its removal a request was made by the contractor which was agreed. Compensatory planting is to take place. The tree and surrounding vegetation were surveyed for nesting birds and bat roosting potential which found none. The tree was professionally cut by a tree surgeon.

Recorded activities and ecological mitigations that were utilised to carry out the work.	Tree removed was recorded for later compensatory planting.

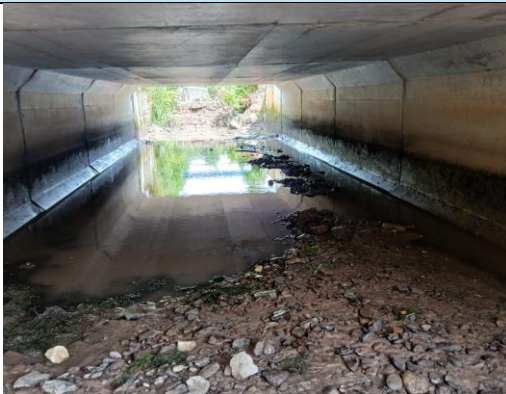
Item number	Date	Comment	Image	ECoW Action/Recommendation	Sorensens's Action response
7.7	02/07/2024	Fish rescue was carried out at CVV following the drying out of the culvert prior to its demolition and replacement with a new bridge.

Ecological mitigation activities were supervised by the ECoW.	Fish rescue carried out under license Section 14 license. Fish measured and record sent to IFI.
7.8	02/07/2024	Excessive turbidity was generated when scouring occurred at the intake to the over pumping location at CVV.

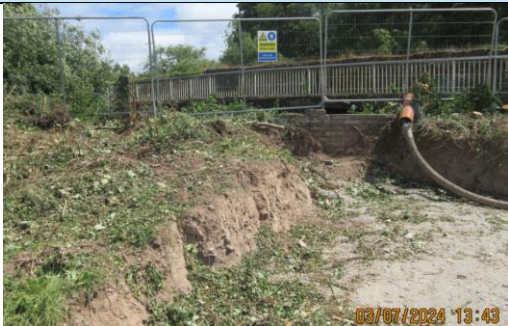
Item number	Date	Comment	Image	ECoW Action/Recommendation	Sorensens's Action response
7.9	02/07/2024	Vegetation at Meadowbrook next to the newly constructed underground pumphouse was removed to facilitate works to install an outlet. This vegetation had been overlooked during the initial clearance works but was called up for removal as per the original design.

The ECoW conducted independent checks for nesting birds and found none present.	The vegetation was surveyed by the site ecologist for nesting birds and BRP prior to clearance. No nesting or BRP was present.

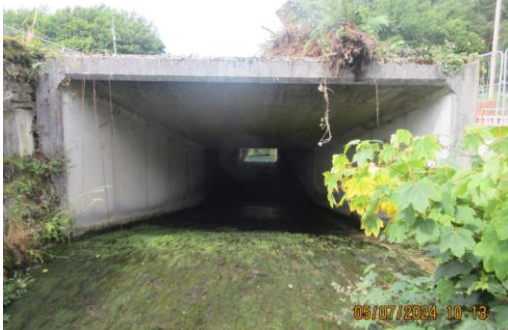
7.10	05/07/2024	The culvert at New Line was dried out using the triple pipe river diversion. Fish rescues was carried out by site ecologist using a net as per agreements with IFI.

The ECoW did not supervise this activity due to a miscommunication error, which has since been rectified.	The fish netting operations and the results of which were reported to the EcoW . Fish rescue carried out under a Section 14 license. Records sent to IFI.

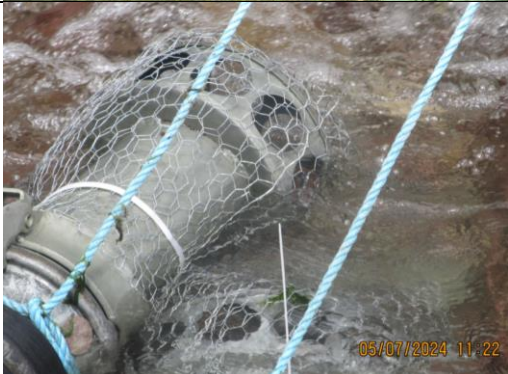
7.11	05/07/2024	In response to the ECoW's comments on fish guards for over-pumping at CVV, the intake at the pumps was fitted with a double layer of wire netting as a failsafe if fish were to get past the fencing located instream above the pumps.

Discussed with site ecologist	The wires around the pumps were added in addition to the two fences already placed upstream.

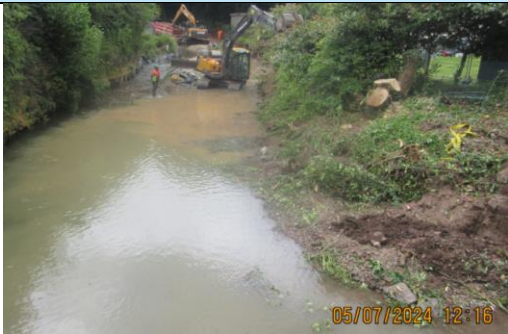
Item number	Date	Comment	Image	ECoW Action/Recommendation	Sorensens's Action response
7.12	05/07/2024	Work was halted due to inadequate silt control at Meadowbrook, as the works area and the diversion channel were not properly separated. Silt was washing out from the works area because it was not fully enclosed. Although a silt curtain was initially in place, it was removed to allow the track machine to move further downstream.

Work was temporarily halted. Silt protection measures were discussed with the site ecologist.	The site ecologist and site foreman quickly established improved silt control by repositioning and adding additional silt curtains around the work area. Work recommenced shortly thereafter.

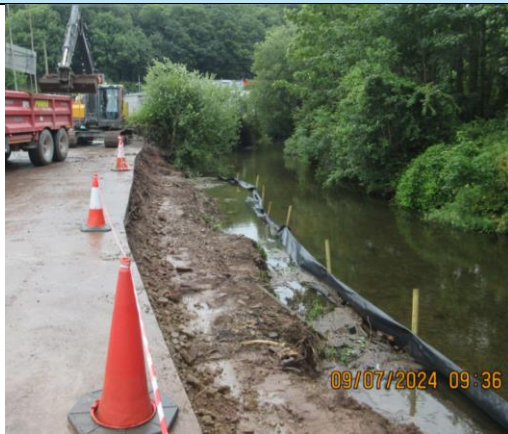
Item number	Date	Comment	Image	ECoW Action/Recommendation	Sorensens's Action response
7.14	09/07/2024	<p>Vegetation removal at the gym carpark was surveyed for birds and Bats prior to clearance.</p> <p>Effective silt control was established at this area prior to the sheet piling.</p>

Monitored and record works. Discussed with site ecologist and workers.	Mitigation measures were established and adjusted as works progressed in this area.

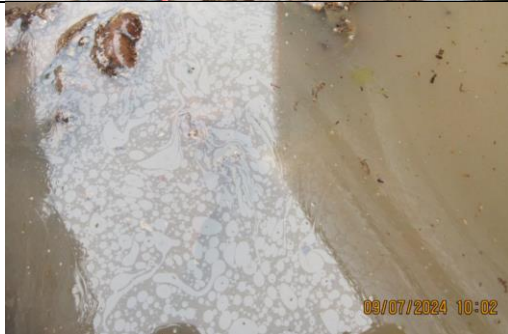
7.15	09/07/2024	At Meadowbrook instream works area: A hydraulic hose burst on sub-contractor Trench Control's piling rig releasing biodegradable hydraulic oil onto the gravels in close proximity to the Glashaboy River.

The ECoW was on site at the time of the occurrence to observe both the sub and main contractors response to the incident.	Oil booms were promptly deployed along the edge of the works to prevent the oil from entering the watercourse. Oil absorbent pads were utilised to remove oil from the machinery and the affected ground where possible. The entire area was then treated with Bioversal to prevent oil particles from adhering to the ground, plants, and animals, and to expedite the biological degradation of any remaining residue. An Environmental Incident Report was also issued by the main contractor.

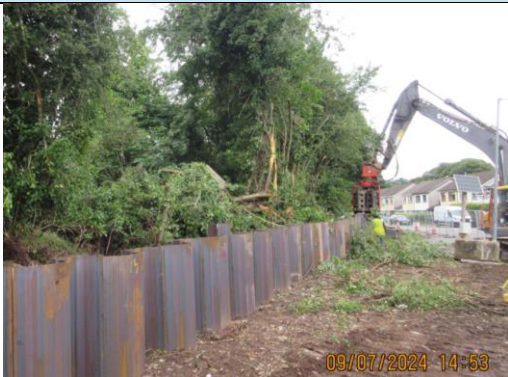
Item number	Date	Comment	Image	ECoW Action/Recommendation	Sorensens's Action response
7.16	09/07/2024	At Meadowbrook, beside the road, sheet piling was being carried out. Sub-contractors inadvertently damaged hawthorn trees by striking them with machinery. Due to the proximity of the sheet piles to the trees, some damage was unavoidable.

Discussed with site ecologist. The site ecologist who reported that prior to sheet piling works, these trees were surveyed for nesting birds.	The site ecologist assured that any necessary tree branches would be cut cleanly with a saw. The need to avoid trees and minimise damage to trees was reemphasised to the sheet piling driver.

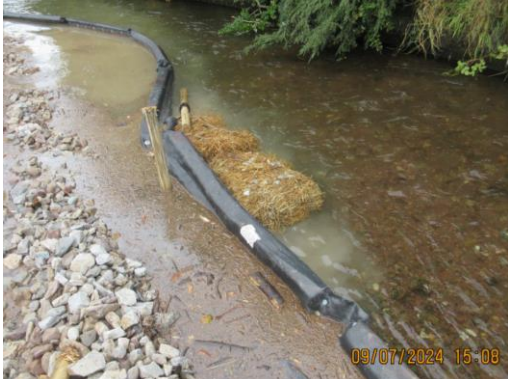
7.17	09/07/2024	At Meadowbrook, the silt curtain was damaged by subcontractors, leading to some silt escaping into the river.

Discussed with site ecologist.	The site ecologist agreed to address the issue, and the environmental champion subsequently repaired the silt curtain.

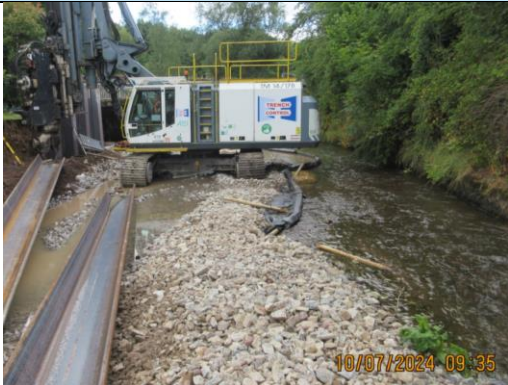
Item number	Date	Comment	Image	ECoW Action/Recommendation	Sorensens's Action response
7.18	10/07/2024	Damage to the silt curtains at Meadowbrook occurred due to subcontractor activities. Trench control sheet piling machinery tracked over the silt curtains and stakes.

This issue was highlighted for site ecologists to monitor and prevent potential silt curtain failure.	The site ecologists monitored the works at Meadowbrook, made repairs where necessary. No further damage was reported.

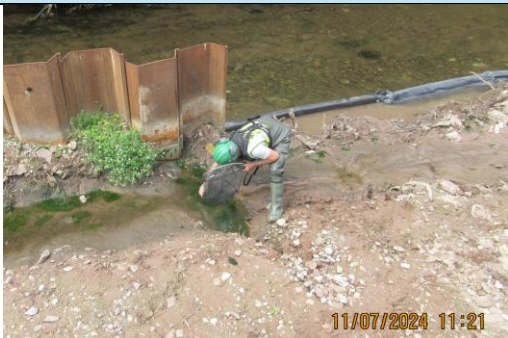
Item number	Date	Comment	Image	ECoW Action/Recommendation	Sorensens's Action response
7.20	11/07/2024	Fish were netted at Sallybrook. A small number of fish had become separated from the main channel during the removal of temporary sheet pilings.

11/07/2024 11:21	Discussed with site ecologist.	Fish rescue was supervised by the site ecologist. Actions were taken to minimise the negative impacts on fish from the works, in accordance with Work Requirements. Fish rescue carried out under a Section 14 license issued to the site ecologist and person(s) nominated by her.

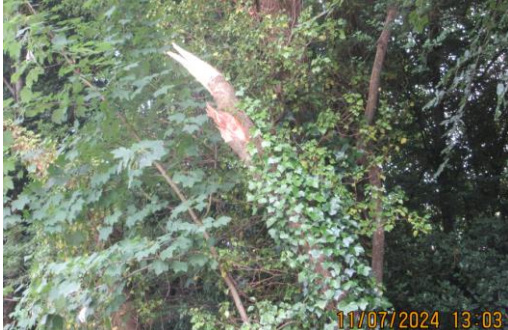
7.22	11/07/2024	Tree limb accidentally damaged at Meadowbrook instream works area during piling works.

11/07/2024 13:03	Discussed with site ecologist.	The tree was later clean cut using a saw. Subcontractor piling rig driver and banks man were ordered by the site ecologist to make greater efforts to avoid damage to trees surrounding the works area.

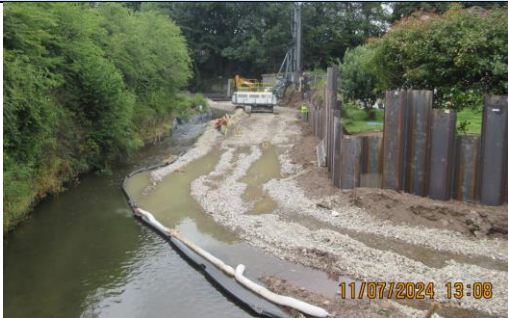
Item number	Date	Comment	Image	ECoW Action/Recommendation	Sorensens's Action response
7.23	11/07/2024	Good silt control at Meadowbrook instream works area.

Recorded.	Silt control was effectively maintained through the month of July.
7.24	11/07/2024	Fish protection measures in place above the pump inlet at CVV required maintenance and /or improvement.

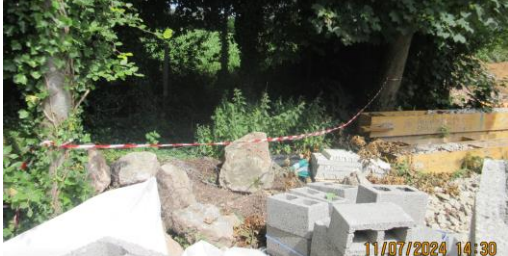
Discussed with site ecologist	The wire netting was cleared of debris build up. The wire fences were improved in the following days with the installation nylon green coloured fencing which has finer mesh than the wire netting.
7.25	11/07/2024	Poor delineation of site boundary at New Line works area.

Discussed with site ecologist.	The constraints on site for storage have put pressure on the natural areas. Improvements were made throughout the month but still needs refinement.

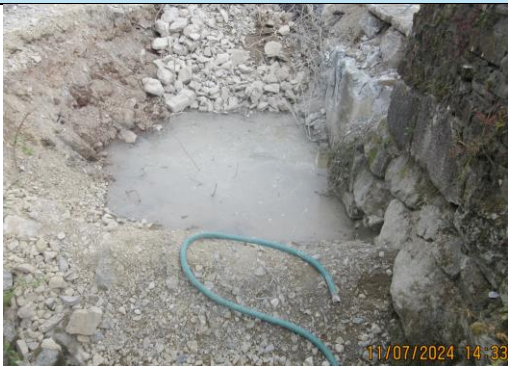
Item number	Date	Comment	Image	ECoW Action/Recommendation	Sorensens's Action response
7.26	11/07/2024	Located immediately upstream of the diversion outlet at New Line, a bunded stagnant pool has formed. The water in this pool likely contains concrete dust originating from the culvert demolition and should not be allowed to enter the adjacent Glenmore River.

Discussed issue with site ecologist, who agreed that pumping will not occur directly into the Glenmore River.	The ecologist agreed to test the water using a handheld pH meter. Initially, the plan was to tank the water, but after further discussion, it was agreed to pump the water into the adjacent wooded land, which would not negatively impact the area.

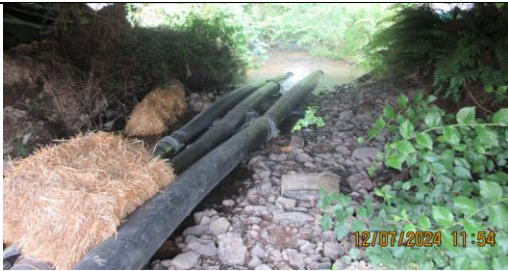
7.28	12/07/2024	Trapped fish were discovered in isolated pools at the overpumping area for the Copper Valley Vue works. It appears this was caused by a natural drop in water levels due to a decrease in water volume.

Discussed with site ecologist. Agreements were made to reconnect the isolated pool to the main channel.	Works to reconnect the pools to the main channel were carried out promptly by digging a low flow channel with a spade following the phone call discussion.

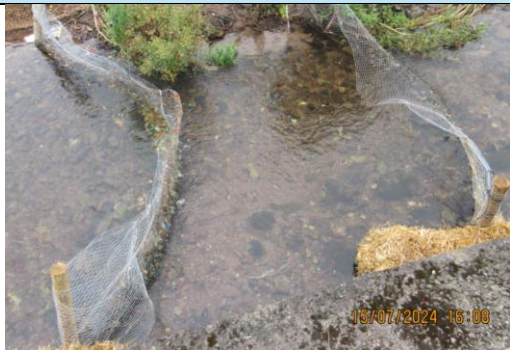
Item number	Date	Comment	Image	ECoW Action/Recommendation	Sorensens's Action response
7.29	15/07/2024	Fish guards at CVV need maintenance.

Discussed with site ecologist	Wire netting received maintenance later that day.

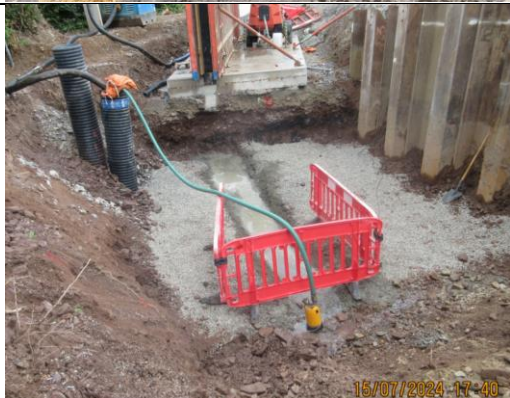
7.30	15/07/2024	Groundwater from the funeral home works area, which came into contact with uncured concrete, was observed to have entered the main channel, exhibiting elevated pH levels. Despite being pumped through a sump, the pH levels remained high. However, the overall volume and duration of the incident were minimal.

Discussed with site foreman.	Pump was switched off.

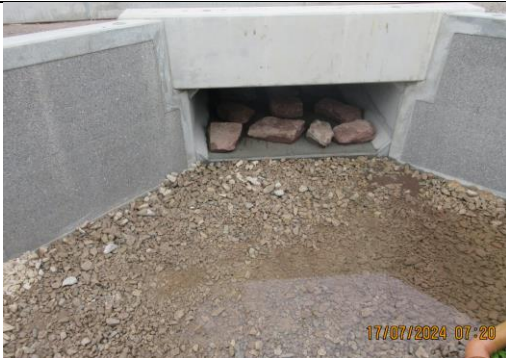
Item number	Date	Comment	Image	ECoW Action/Recommendation	Sorensens's Action response
		outlet. Sondes recorded the moderately elevated pH levels.			
7.32	17/07/2024	A high pH alarm was triggered at the sondes downstream of Cois na Glean. This was caused by the washout of stone material placed under the culvert.

Discussed with site ecologist. Sent follow up email.	Monitoring sondes were not recording accurate pH readings (16th – 17th July) issue assessed by sonde supplier 22/7/24 and rectified 24/7/24. pH monitored using a handheld monitoring was carried out during the interim.

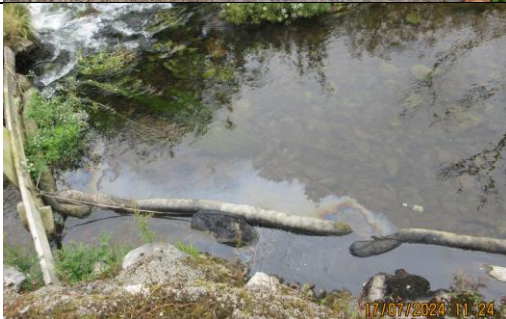
7.33	17/07/2024	An existing oil leak at Grandons was observed to be contaminating the main channel. The mitigation measures that were already in place by Grandons to contain the contamination required maintenance and improvement at the time of inspection. The mitigation measures were later maintained and improved with additional oil booms by Sorensen when works began in this area.

Documented and discussed with site ecologist.	Preexisting contaminated conditions are not the contractor's responsibility to rectify. However, they are responsible for containing the contamination entering the Glashaboy River as a result of their works which was managed well through the use of additional oil booms during works at this location.

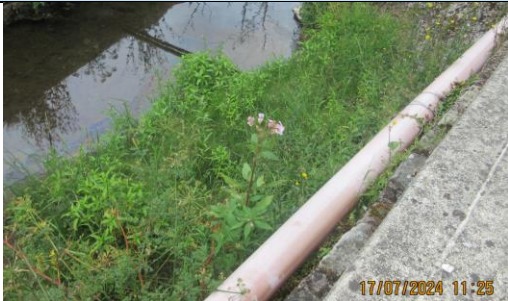
Item number	Date	Comment	Image	ECoW Action/Recommendation	Sorensens's Action response
7.34	17/07/2024	Invasive plant Himalayan balsam observed in the zone of works at Grandons.

Discuss with site ecologist	Plant was removed and disposed of in line with Biosecurity measures.
7.35	17/07/2024	Silt curtains were installed at the Meadowbrook works area, where the eastern eye of the bridge was regraded.

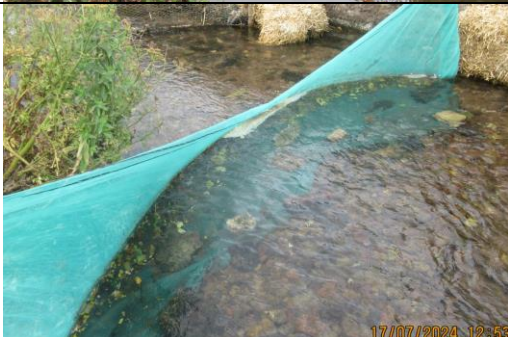
The inspected silt measures were found to be effective.	Established and maintained silt protect during this phase of works.
7.36	17/07/2024	Additional fish protection measures deployed at CVV.

Fish protection measures were inspected and found to be effective at time of inspection.	Instream fencing received regular inspection and maintenance as needed.

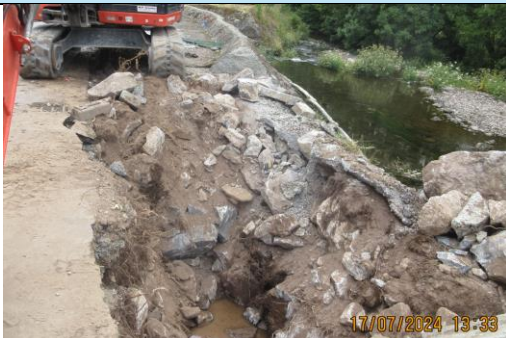
Item number	Date	Comment	Image	ECoW Action/Recommendation	Sorensens's Action response
7.37	17/07/2024	Preexisting oil contamination encountered at Grandons during rock armour removal.

Recorded and discussed with site ecologist.	Works were stopped by site ecologist. A temporary storage area was created for the contaminated boulders in the Area 1 compound, which was bunded and lined with heavy duty plastic to contain contamination run off.

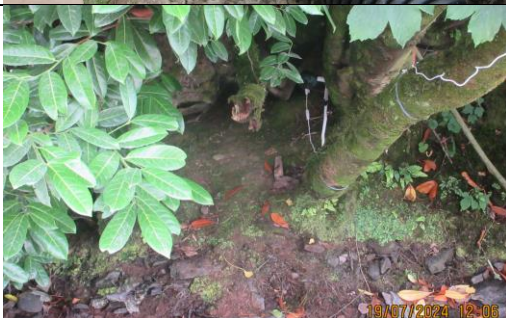
7.39	19/07/2024	During the site inspection, it was observed that the N2 otter holt had possible otter spraint outside its entrance. Otter camera monitoring records showed no otter activity at this holt in the past month. However, a mink was recorded here on the camera.

Emailed pictures to site ecologist. Requested a review of otter mitigation given the upcoming rock armour works planned adjacent to N2.	The site ecologist consulted with the otter specialist to discuss the current mitigation measures and the possibility of spraint. The otter specialist confirmed that the current mitigation measures were acceptable and noted that it was unlikely this otter sett would be used this season.

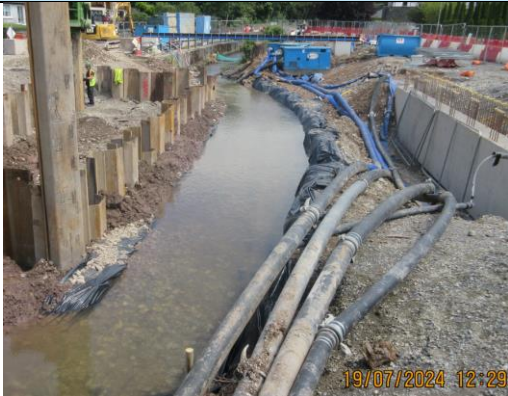
Item number	Date	Comment	Image	ECoW Action/Recommendation	Sorensens's Action response
7.40	19/07/2024	Diversion installed at Copper Valley Vue. The downstream sondes were not transmitted data at this time.

Email sent to contractor requesting environmental information on works carried out.	The site ecologist conducted handheld turbidity readings during the diversion works and shared the results with the ECoW. Since then, Capital Water Ltd. has been on-site to repair the sondes.
7.41	19/07/2024	Concrete bucket dumped on ash tree at New line caused damage of cracked branches.

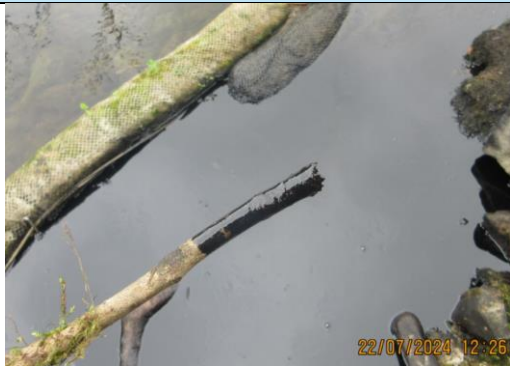
Item number	Date	Comment	Image	ECoW Action/Recommendation	Sorensens's Action response
7.42	22/07/2024	Observation of thick layer of black oil on water surface at Grandon's.

Advised Sorensen on preparations for sheet piling due to take place here tomorrow. Advised additional oil booms, absorbant material etc	New oil booms in place, black oil still floating on surface of water, held by existing oil booms. Sheet piling delayed. Silt defences put in place for sheetpiling.
7.43	23/07/2024	Sheet piling at Copper Valley Vue was generating unacceptable turbidity levels due to the fast water flow rate past the sheet piles during installation.

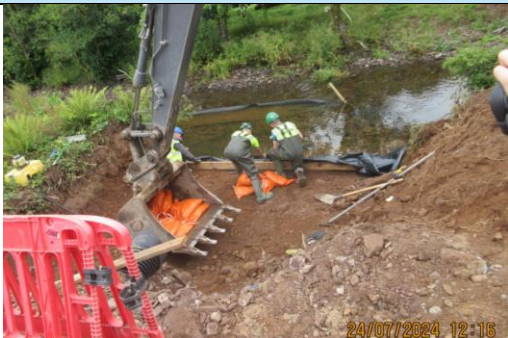
Item number	Date	Comment	Image	ECoW Action/Recommendation	Sorensens's Action response
7.44	24/07/2024	Headwall installation in Area 1.

Discussed water quality mitigations with site ecologist.	The preparation work to contain concrete entering the river from the headwall installation was well executed. Concrete pouring activities were managed effectively, and supervised by ecologist during most sensitive parts of works.

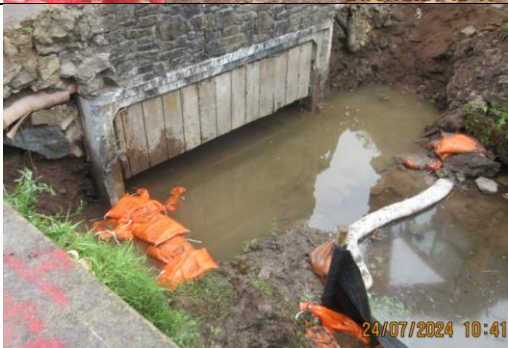
7.45	24/07/2024	During sheetpiling works at Grandons, the Mill Race stream was cut off for a time with measures to control for contamination. Concerns were raised about the welfare of fish observed to be in the mill stream.

The ecologist and site ecologist thoroughly inspected the Mill Race stream. Sticklebacks were observed in one section of the stream.	Sandbags holding back water from entering the Mill Race were soon removed to return flow, however this raised concerns about the potential for turbidity and oil contamination. The sandbags were reinstated for a brief time while silt and oil booms were added to the Mill Race stream. Refer to item 7.49 for further information.

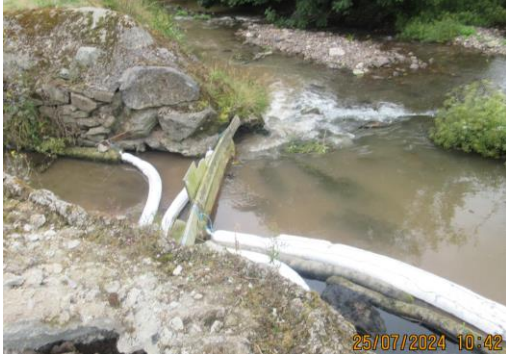
Item number	Date	Comment	Image	ECoW Action/Recommendation	Sorensens's Action response
7.47	25/07/2024	Sheet piling at Grandons – oil booms deployed.

Discussed with site ecologist. inspected oil booms for effectiveness.	Oil booms were maintained in place through the sheet piling works.
7.48	25/07/2024	Contaminated boulders stored at designated area at circus field.

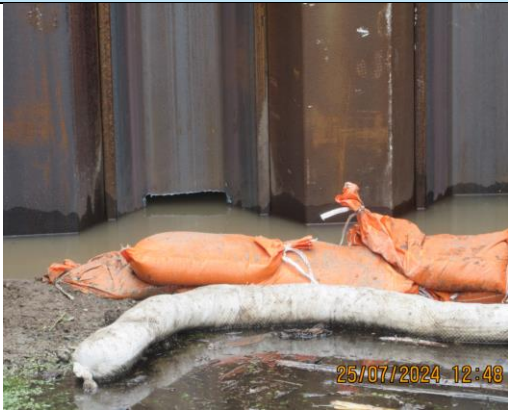
Item number	Date	Comment	Image	ECoW Action/Recommendation	Sorensens's Action response
7.49	25/07/2024	Sheet pile opening cut at Grandon's mill race to allow it receive water.

Monitor conditions in mill stream in stream	The fish in the stream were monitored throughout the month, and no adverse effects were reported.
7.50	25/07/2024	At Grandosn Mill race sheetpiling works area: During the period when this section of water was isolated it was necessary check for aquatic life.

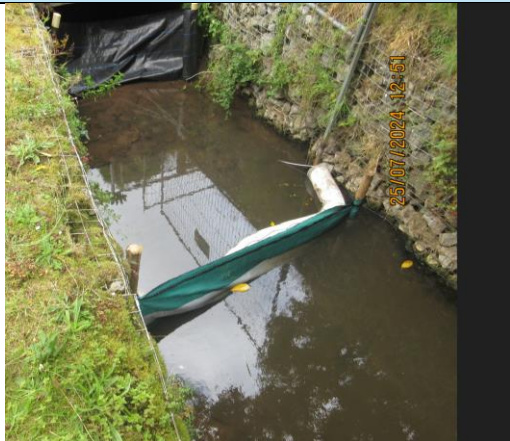
Item number	Date	Comment	Image	ECoW Action/Recommendation	Sorensens's Action response
7.51	25/07/2027	Concerns about oil and silt into the mill stream were present.

Documented.	Silt and oil measures deployed into the mill race stream.
7.52	25/07/2024	Boulders to be removed from main channel alongside Texico garage – silt measures put in place, willow and ranunculus plants were avoided, works supervised by site ecologist.

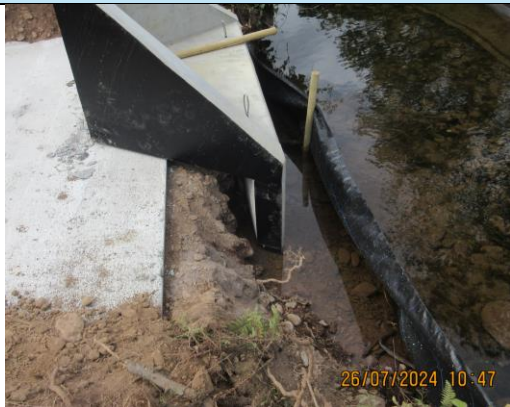
Item number	Date	Comment	Image	ECoW Action/Recommendation	Sorensens's Action response
7.53	26/7/2024	Blinding for headwall at sallybrook, water quality measures in place throughout. The works were supervised by the site ecologist.

26/07/2024 10:47	Discussed proposed work plans with site ecologist prior to start.	The work was carried out as planned, and no problems occurred.
7.54	29/07/2024	Construction debris in the river will need to be removed before flooding occurs or before the completion of in-stream work.

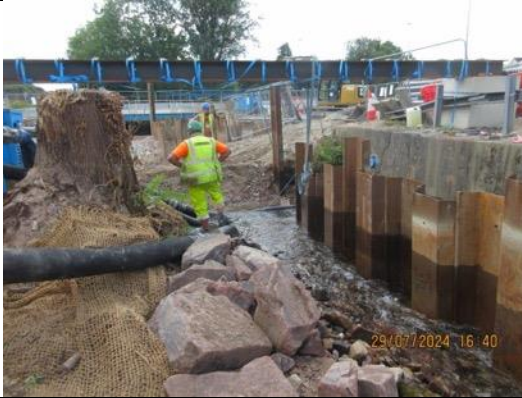
Item number	Date	Comment	Image	ECoW Action/Recommendation	Sorensens's Action response
7.55	29/07/2024	Pump failed at CVV over pumping area. Bund put up and pump replaced. No evidence of overtopping. Spoke to site ecologist about pump backups etc. This area would cause a lot of silt if the works overtop.

Discussed with site ecologist and suggested back up pumps.	It was agreed that backup pumps would serve as a valuable failsafe in case the situation recurred. Backup pumps were put in place the following day and remained until over-pumping operations ceased and were relocated to above the Brooklodge culvert at the beginning of the next month.

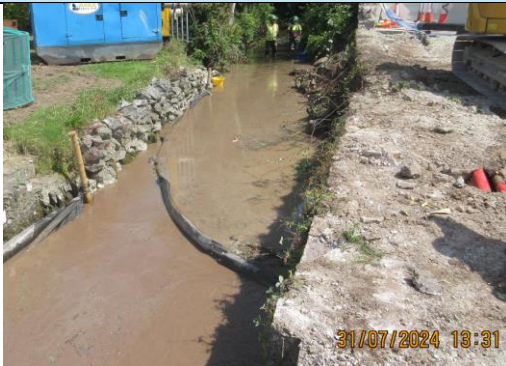
Item number	Date	Comment	Image	ECoW Action/Recommendation	Sorensens's Action response
7.58	31/07/2024	A significant amount of turbidity was generated during the installation of a sump into the Glenmore River at Brooklodge. The downstream sondes reported a delay of approximately 45 minutes, indicating a nearly 800 NTU spike in turbidity. Although the work was brief, lasting 20-30 minutes, it resulted in substantial siltation. The site ecologist and ECoW were unaware of the delay in alerts. After lunch, the water was clear upon return.

It was suggested by the ECoW that work could be staggered to allow turbidity levels to decrease before proceeding with further digging; however, by that time, most of the digging had already been completed. Sondes delays should be examined.	Main contractor to investigate the delay to data transmission from the downstream CVV sondes. Handheld readings may be required in the interim.

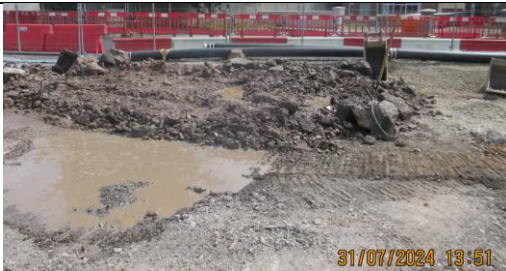
7.59	31/07/2024	During the sump installation, the river gravel spoils were spread out as they were deposited by the excavator and monitored for aquatic life. Two small fish were rescued and returned to the river. No eels or lampreys were observed.

Supervised and inspected river gravels.	Gravel to be retained and stockpiled for later use.
