Monthly Site Environmental Audit

Glanmire Flood Relief Scheme

02/01/24 To 26/01/24

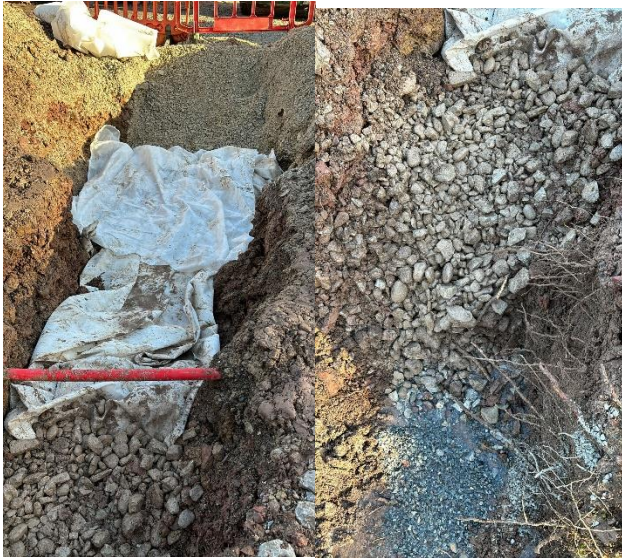
Photo 1

(Left) Terram and stone used to filter water being discharged from POD yard (Right) Water emerging clean from drainage stones.

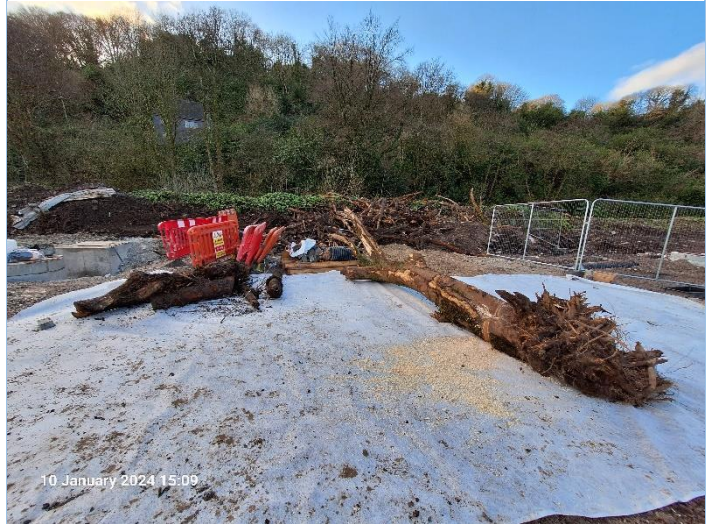
Photo 2

- Extension of Reg 49 licence received from NPWS, licence expires: 30/06/24
- Timber removed from Area 1 embankment under supervision from IAPS Specialist + outfall pipe from manhole dug through embankment. (Figure 2)

Timber removed from embankment at Area 1 under supervision by IAPS specialist with biosecurity measures in place.

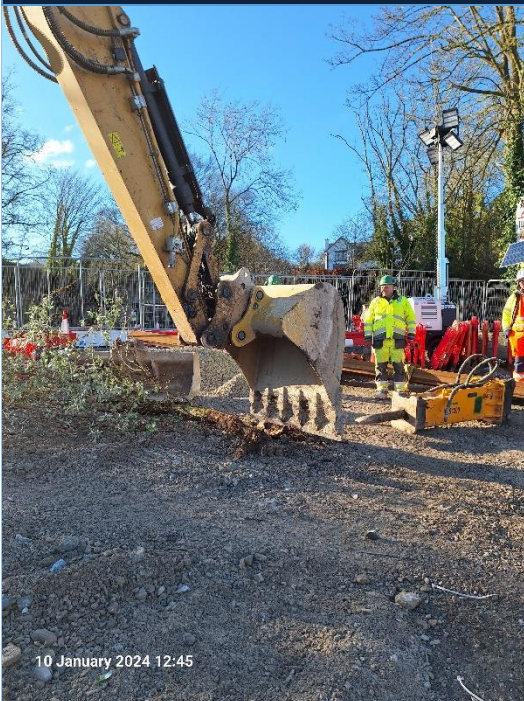
Photo 3

- Buddleia (*Buddleja davidii*) removed from Hazelwood following NRA *guidelines on the management of noxious weeds and non-native invasive plant species*. Root ball removed from plant and smashed to prevent regrowth. (Figure 3)

Root ball being crushed and removed from Buddleia bush to prevent regrowth.

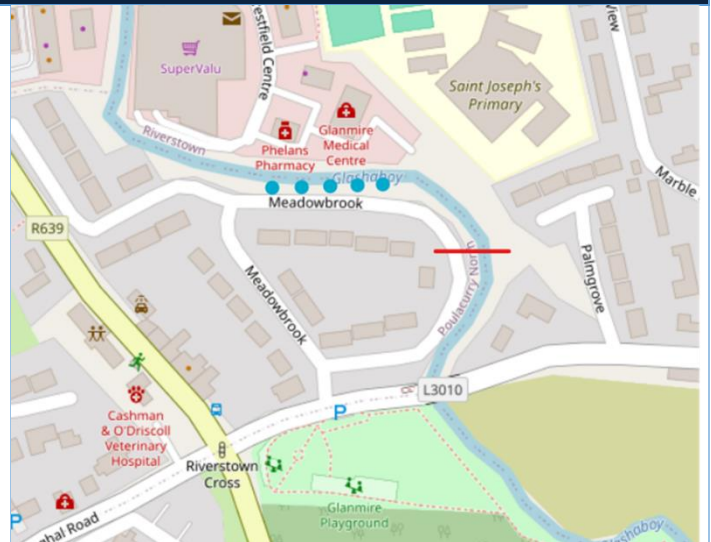
Photo 4

- NPWS Ranger site visit – discussions held on the potential for Kingfisher, *Alcedo atthis*, to nest in the vicinity (within 150m) of works planned for during the 2024 bird nesting season (March – August incl.). Discussions concluded that if nesting occurs in the bank (Figure 4 - blue dots) then works may proceed no closer than beyond that (south) of the red line (Figure 4). All works must cease in March to allow surveys of banks to be done and confirm the location of Kingfisher nests – if nesting occurs in a bank, other than that marked with blue dots and within the vicinity of works, NPWS will be consulted prior to works continuing.

Map of Meadowbrook estate showing potential Kingfisher nesting bank (blue dots) and the agreed upon point that works can continue beyond if nesting occurs (red line – agreed with NPWS Ranger)

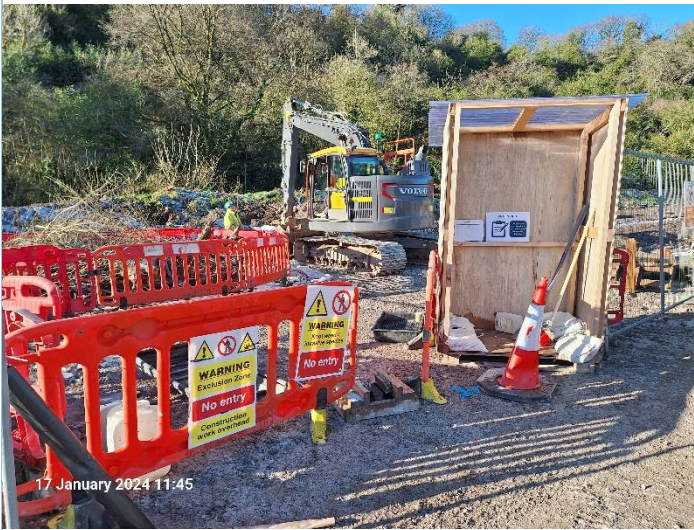
Photo 5

- Embankment works commenced under supervision of IAPS Specialist. Improvements made to the access/egress point of the Japanese knotweed exclusion area, risk of unauthorized entry reduced (Figure 5).

Improved access/egress biosecurity procedure at Area 1 Japanese knotweed exclusion area.

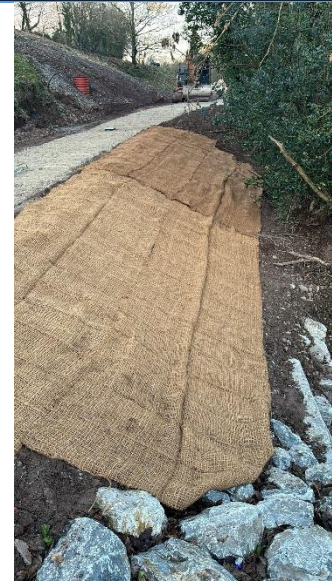
Photo 6

Erosion control placed on bank at Cuil Cluthair

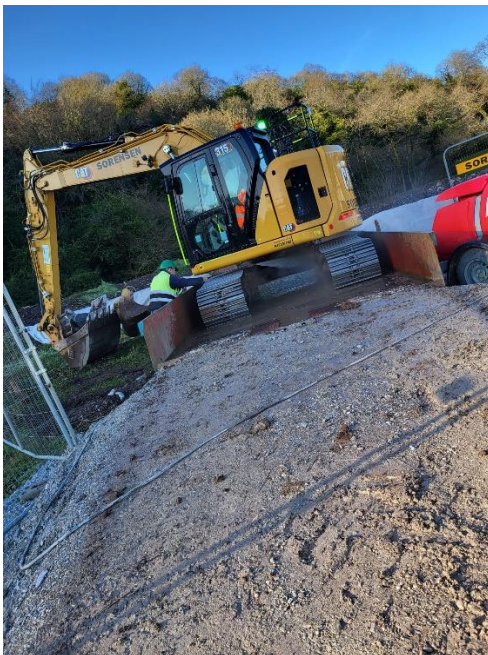
Photo 7

Washdown procedure being implemented on plant exiting Japanese knotweed infested area.

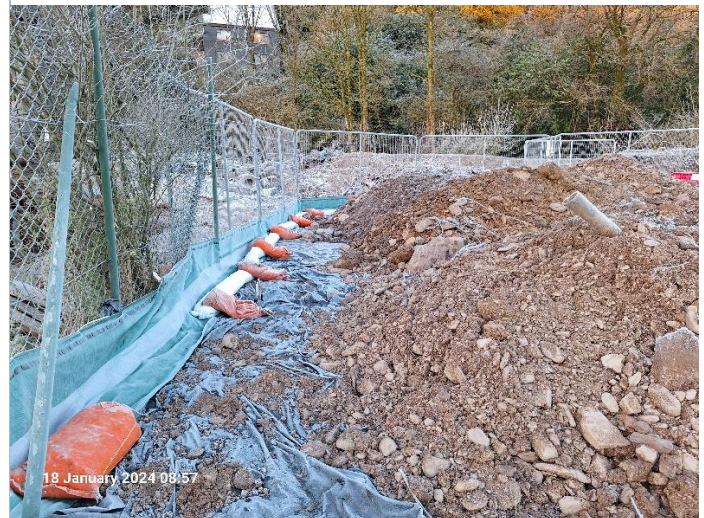
Photo 8

- POD yard – contaminated material stockpiled in Sallybrook compound as instructed by RE. Covered with H.D. Polythene prior to rainfall events. (Figure 8 & 9)

POD yard - contaminated material correctly stored and banded in Area 1 compound.

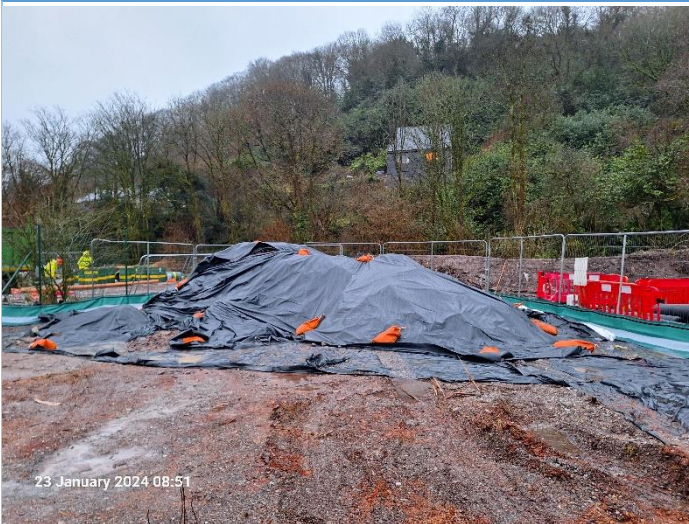
Photo 9

POD yard - contaminated material correctly stored and banded in Area 1 compound.

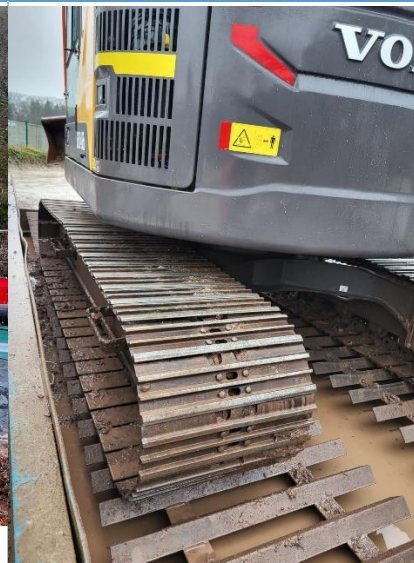
Photo 10

Washdown procedure being implemented on plant exiting Japanese knotweed infested area.
