Monthly Site Environmental Audit

Glanmire Flood Relief Scheme

01/07/24 To 29/07/24

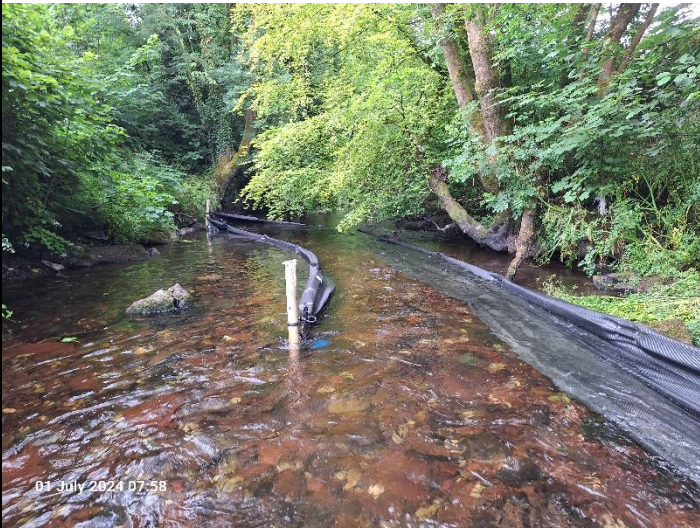
Caption 1			Caption 2		
Silt curtains at Grandons installed prior to instream works			Tree removal at Grandons

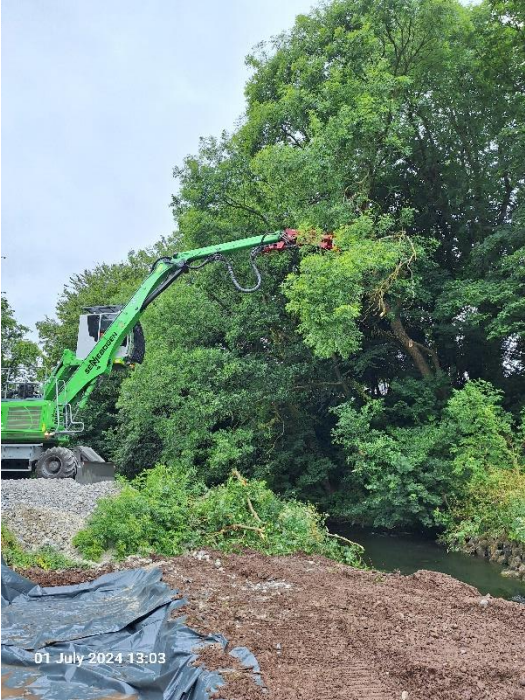
Caption 3			Caption 4		
Tree removal at Meadowbrook			Silt curtains installed at Meadowbrook prior to digging of diversion channel.

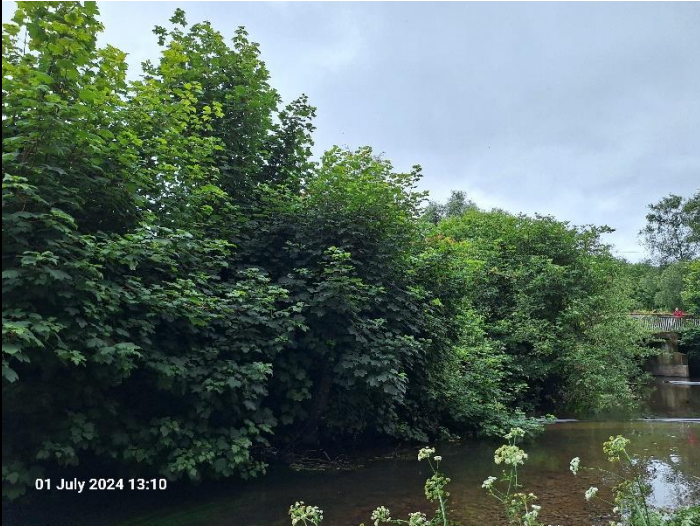
Caption 5			Caption 6		
Trees surveyed prior to clearance - Meadowbrook			Electrofishing operation undertaken at Copper Valley. Sample catch.

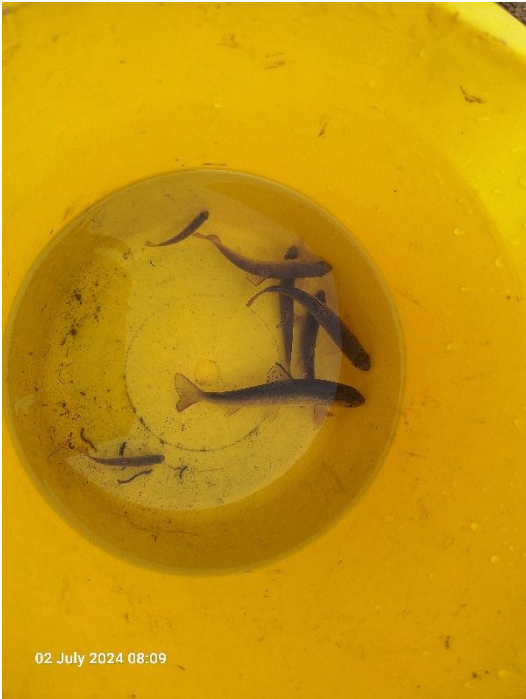
- Electrofishing undertaken at Copper Valley 2/7/24, ECOW and RE present for periods of the efishing operation – Numbers: 102 juvenile Brown trout, 1 juv trout fatality, 24 lamprey, 7 eels. Total: 134

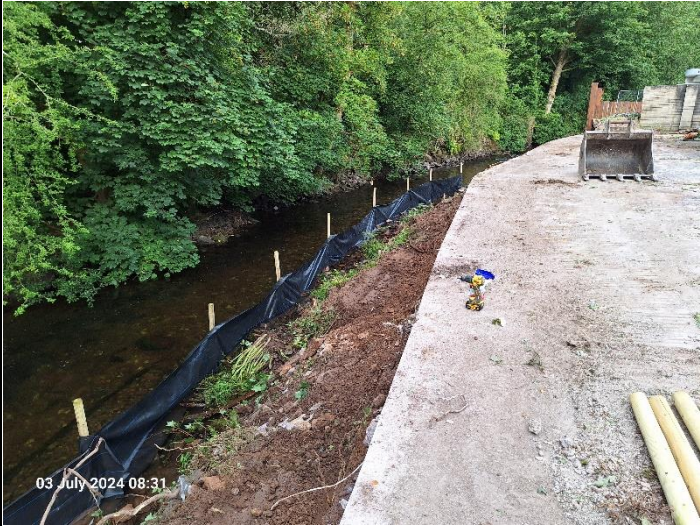
Caption 7			Caption 8		
Silt fence installed at Evcore gym for bank clearance works.			Trees/scrub surveyed prior to clearance – Hazelwood Bridge

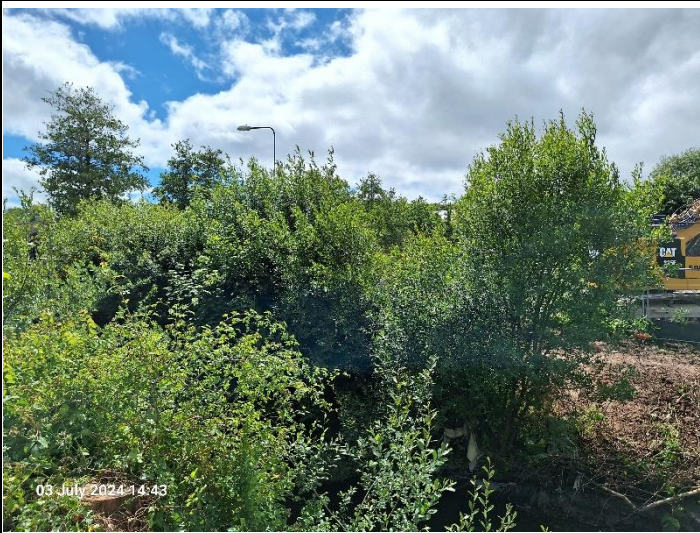
Caption 9			Caption 10		
Trees/scrub surveyed prior to clearance – Hazelwood Bridge			Electrofishing operation undertaken at Meadowbrook.

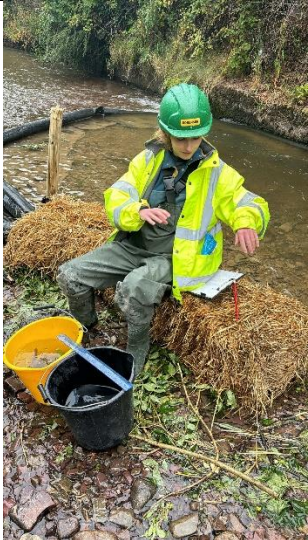
- Erosion control installed on exposed riverbanks @ Hazelwood Bridge
- Electrofishing undertaken at Meadowbrook/Riverstown 4/7/24, ECOW and RE present for periods of the efishing operation – Numbers: 103 juvenile Brown Trout, 24 juvenile Atlantic salmon, 35 eels, 1 lamprey, 0 fatalities. Total: 163

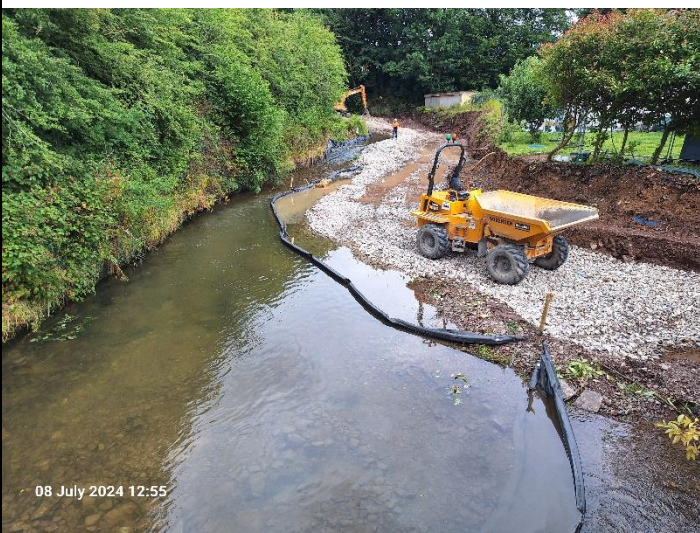
Caption 11			Caption 12		
New silt curtain setup at Meadowbrook			Spraying of Bioversal HC post hydraulic hose burst - Meadowbrook

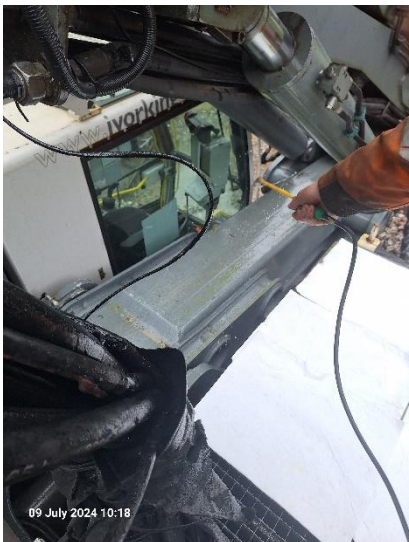
- Clearance works continued at Evcore gym – no nesting birds located and no BRP.
- Silt curtains installed for removal of temporary sheet piles and edge of riverbank at Eurofins/Sallybrook.
- Single small fish removed via hand net from ponding water behind temporary sheet piles.
- Oil spill at Meadowbrook 9/7/24 – source Trench Control piling rig. Site Environmental Team undertook clean up immediately with use of Bioversal spray, oil absorbent booms and pads. Incident report issued 18/7/24.
- Further tree removal at Meadowbrook, no bird nests located or BRP.
- Temporary sheet piles and edge of riverbank removed at Eurofins/Sallybrook.
- Environmental Tour 10/7/24 – No significant findings
- 8th – 14th July: No Otter sightings on cameras monitoring N2, C2, N6C and N6D.
 - Mammal sightings: **Holt N2** – Cat 11/7/24. **Holt N6C** – Fox 11/7/24, Cat 12/7/24 & 14/7/24.

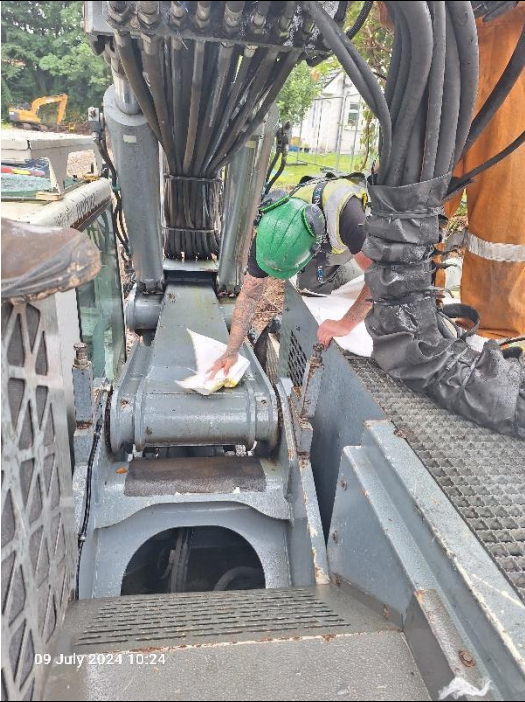
<p>09 July 2024 10:37</p>		
Caption 13			Caption 14		
Clean up of Hydraulic oil post hose break.			Trench Control – hose burst released bio-degradable hydraulic oil.

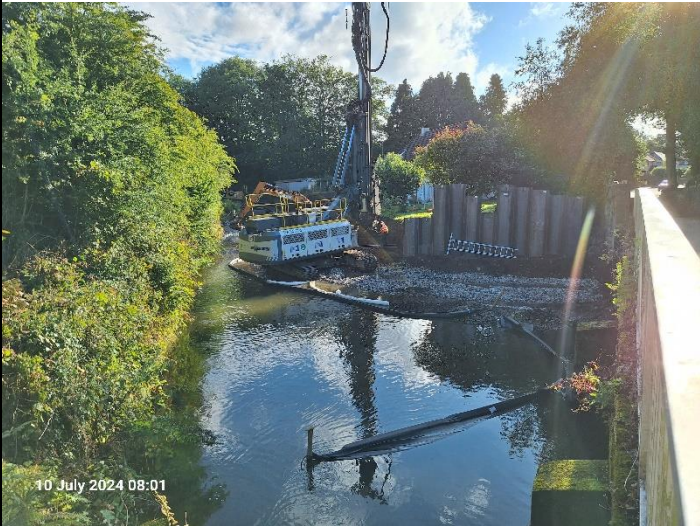
<p>10 July 2024 08:01</p>			  <p>11 July 2024 8:11 am</p>		
Caption 15			Caption 16		
Meadowbrook Sheet Piling			Erosion control coir mesh installed at Hazelwood bridge.

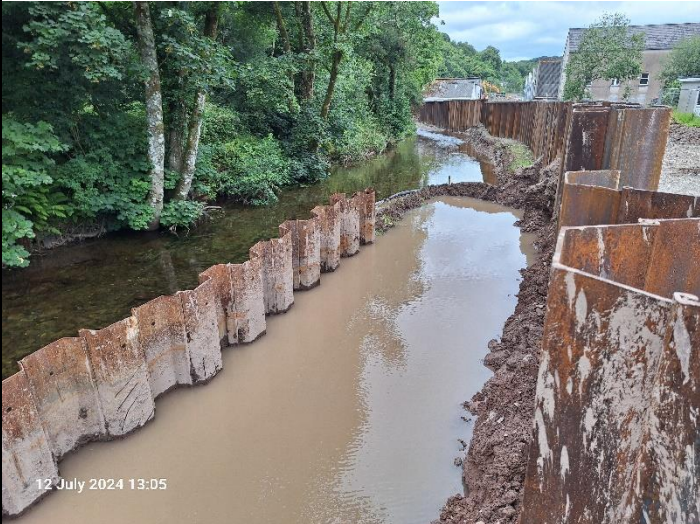
Caption 17			Caption 18		
Temporary sheet pile removal at Sallybrook/Eurofins			Silt fence installed at Hazelwood prior to installation of cofferdam.

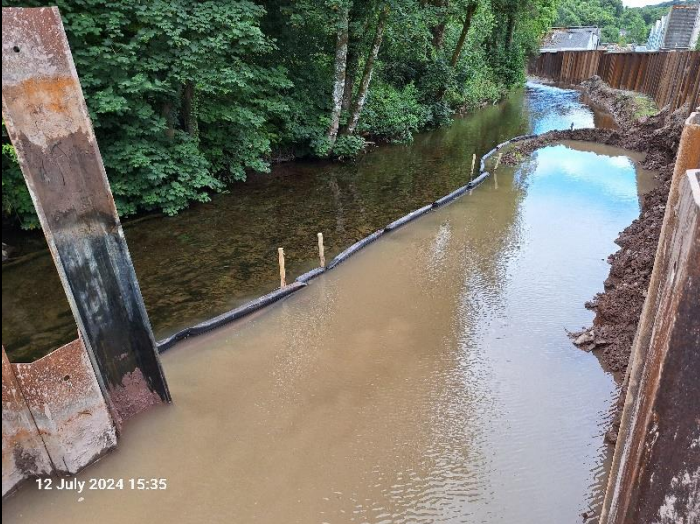
Caption 19			Caption 20		
Temporary sheet pile removal at Sallybrook/Eurofins – effective use of silt curtains			Temporary sheet pile removal at Sallybrook/Eurofins – effective use of silt curtains

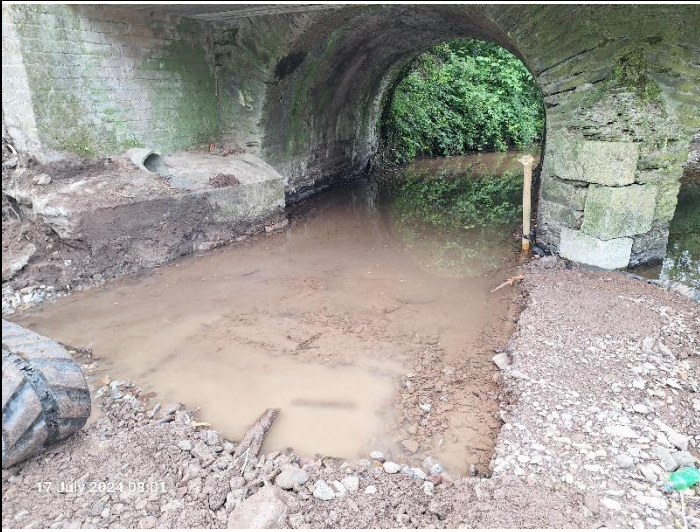
Caption 21			Caption 22		
Regrading completed at eastern eye of Riverstown Bridge.			Silt fence in place for regrading works at Riverstown Bridge.

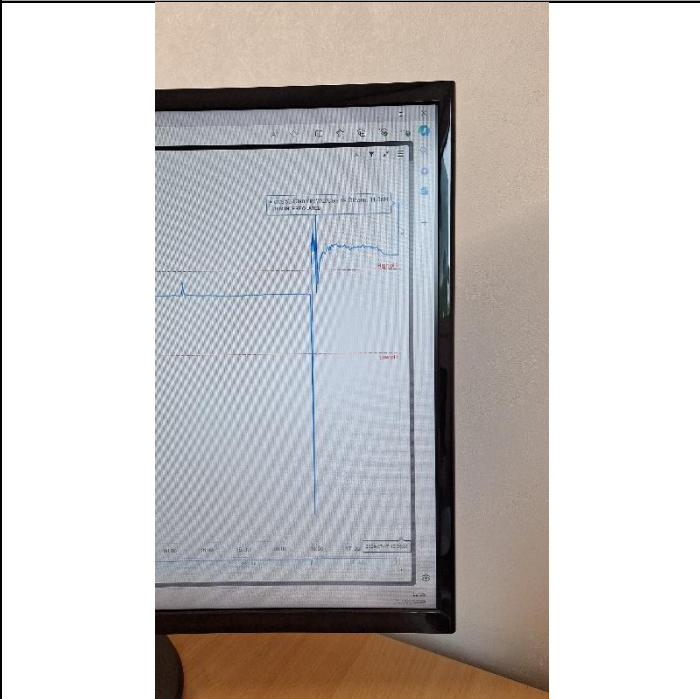
- Flagstones installed at Cois na Gleann culvert.
- Pumps temporarily turned off at Cois na Gleann – issues with Cois na Gleann downstream water quality monitoring sondes not recording accurate pH readings (16th – 17th July) issue assessed by sonde supplier 22/7/24 and rectified 24/7/24. pH monitored using a handheld monitor during the interim. pH exceedances were noted on the upstream Hazelwood bridge sonde.
- Oil contamination encountered at Grandon's during rock armour removal. Temporary storage area created for contaminated boulders in Area 1 compound, which was bunded and lined with heavy duty plastic. Oil booms placed on the riverbank in case of an accidental release of oil during the recovery of the boulders.
- 15th – 21st July: No Otter sightings on cameras monitoring N2, C2, N6C and N6D.
 - Mammal sightings: **Holt N6D** – Cat 25/7/24

Caption 23			Caption 24		
Erratic pH readings at Cois na Gleann downstream sonde. Monitor adjusted and recalibrated.			Handheld monitoring completed while the sonde was malfunctioning.

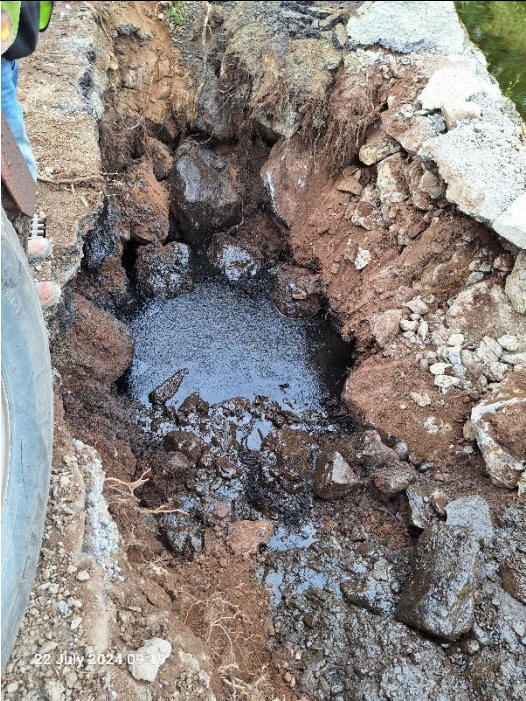
- Oil contamination at Grandons - Millrace – oil booms placed instream parallel to the riverbank in case of an accidental release during the recovery of the boulders and installation of sheet piles. Silt fences and oil booms installed perpendicular to the riverbank both upstream and downstream of the existing millrace culvert. Bioversal spray was deployed on three occasions during the works to minimise any potential impacts in case of the accidental release of oil. Water levels monitored and managed during works. Three eels removed using hand nets from the instream works area.

Caption 25			Caption 26		
Oil contamination - Grandons			Storage area for oil contaminated boulders removed from Grandons.
