Environmental Report August 28th to September 28th, 2023

Glashaboy Flood Relief Scheme

Prepared by: Rory O Connor
Date of issue: 06/10/2023

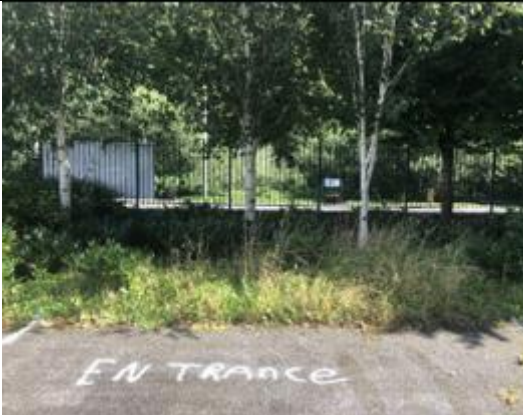
Date	Comment	Image	ECoW Action/Recommendation	Sorensens's Action Response
28/8/23	Two trees removed at Grandons

Memo generated	Trees ecologically surveyed prior to felling
29/8/23	Vegetation removal at Grandons. Third schedule invasive plants not demarcated prior to works

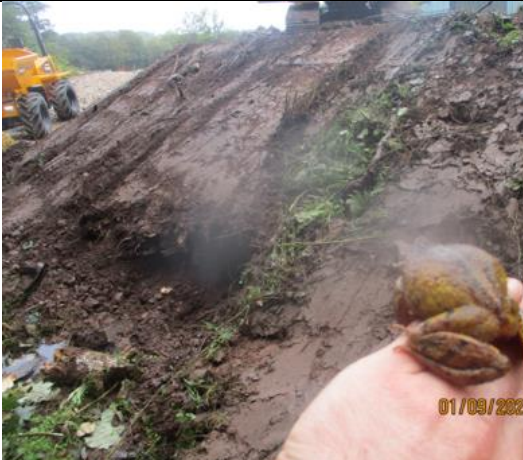
<p>1/9/23</p>	<p>Frog translocated from works area at ramp installation at Sallybrook adjacent to N2 otter holt. No ecological supervision</p>

<p>Informed contractor's site ecologist</p>	<p>Site ecologist to survey for frogs and supervise future vegetation clearance in this area</p>
<p>5/9/23</p>	<p>Storing of rebar in the JKW exclusion zone at Sallybrook. This long-term action was not detailed in Sorensen's biosecurity plan. No signage present. Terram shows sign of wear and tear</p>	 	<p>Informed contractor's site ecologist</p>	<p>Fence to be fixed. Sorensen's exploring ways to improve JKW exclusion zone such as additional signage and possible Heras panels</p>

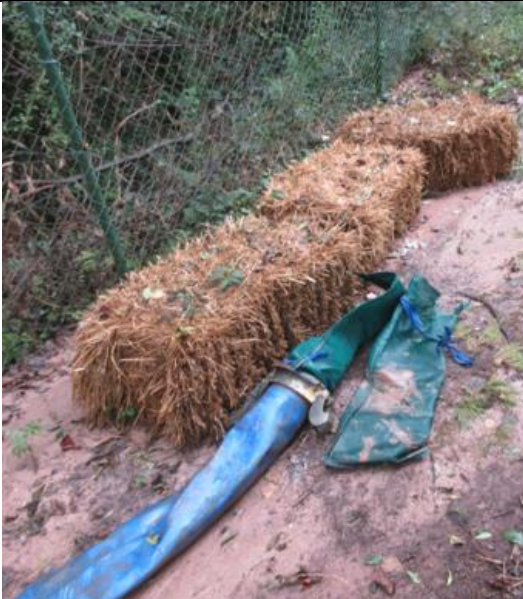
<p>19/9/23</p>	<p>Pumping at Bleach hill of sediment rich water from works area to high ground above the downstream causing siltation of downstream due to inadequate silt management silt sock in place torn and nonfunctioning</p>

<p>Informed contractor's site ecologist</p>	<p>Permit to pump has been put in place</p> <p>Lessons Learned Report issued</p>
<p>19/9/23</p>	<p>No fish protection on two pumps at Bleach hill</p>

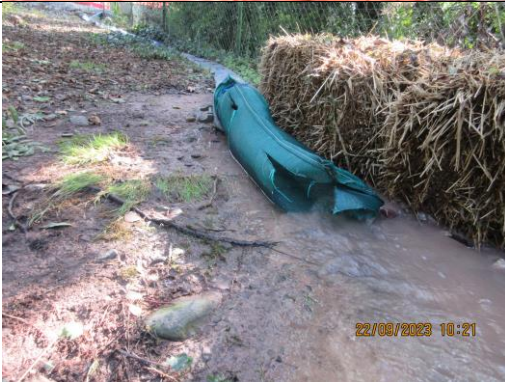
<p>22/9/23</p>	<p>No fish protection on two pumps at Bleach hill</p>	 	<p>Informed contractor's site ecologist</p> <p>Main contractor to consider sourcing fish protection attachments for their hoses when over pumping</p>	<p>Permit to pump system now in place that includes control measures and checks on fish protection</p>
<p>22/9/23</p>	<p>Pumping of sediment rich water from works area to high ground above the downstream causing siltation of downstream due to inadequate silt management</p>

<p>Informed contractor's site ecologist</p> <p>Main contractor to source a more sophisticated silt sock</p>	<p>Permit to Pump has been put in place</p> <p>Lessons Learned Report issued</p>

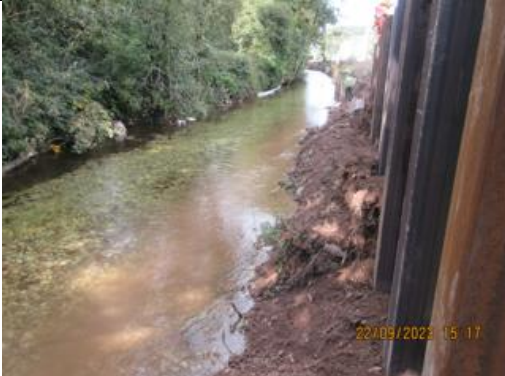
<p>22/9/23</p>	<p>Vegetation clearance at Eurofins, no silt protection in place. No oil boom in stream present</p>

<p>Informed contractor's site ecologist</p> <p>Main contractor to consider the use of a silt curtain when such works are carried out in the future. Ensure oil boom is in place prior to entry of plant into in stream works areas</p>	<p>Silt mitigation methodology to be reviewed for future works</p>
<p>25/9/23</p>	<p>Working in stream at Sallybrook while downstream monitor not transmitting readings on this day</p>
