Environmental Report May 2025

Glashaboy Flood Relief Scheme

Document code: FFEC-GFRS-2025-005

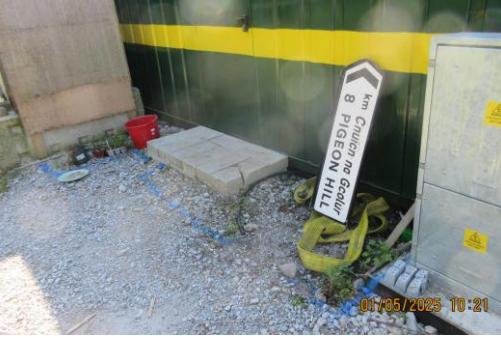
Item number	Date	Comment	Image	ECoW Action/Recommendation	Sorensens's Action response
5.1	01/05/2025	<p>Protection of Potential Rare Plant – Little Robin (<i>Geranium purpureum</i>)</p> <p>No signs of flowering have been observed yet. The area would benefit by being more clearly delineated and communicated, especially now that the door is experiencing increased use during the hot weather.</p> <p>It is acknowledged that the location of the plants is less than ideal and was poorly planned by the client's ECoW. However, this does not diminish the importance of protecting and preserving the plants, despite their location in a high-traffic and exposed area.</p>

<p>Manage this environmentally sensitive area accordingly.</p> <p>The plants and stone material are to be relocated.</p> <p>Efforts are ongoing to source a permanent location to facilitate this relocation.</p>	<p>SCE advised members of the ER Team, which utilise this rear entrance, to take care not to trample on the emerging seedlings on 11/04/2025. The extent of emergent seedlings on 11/04/25 was delineated with blue spray paint. Materials and equipment were also removed from the door entrance. The extent of emergent seedlings visible on the 01/05/2025 was again delineated with blue spray paint since this is an active fire exit and cannot be blocked with fences, etc. The extent of visible emergent seedlings was again delineated on the 15/05/2025. Signs were also erected inside the meeting room/canteen and outside to highlight the presence of the plants on 15/05/2025.</p>

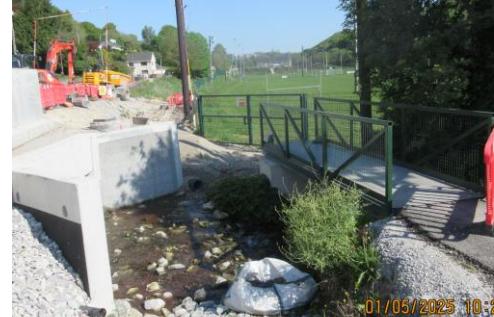
Item number	Date	Comment	Image	ECoW Action/Recommendation	Sorensens's Action response
5.2	01/05/2025	The nesting tube located in the CNG culvert is currently not in use by any bird species. As such, works to the downstream banks and the removal of the pedestrian bridge can proceed without obstruction.

01/05/2025 10:22	Continue to monitor nesting tube while permanent works in this area are being carried out.	Periodic monitoring is taking place.

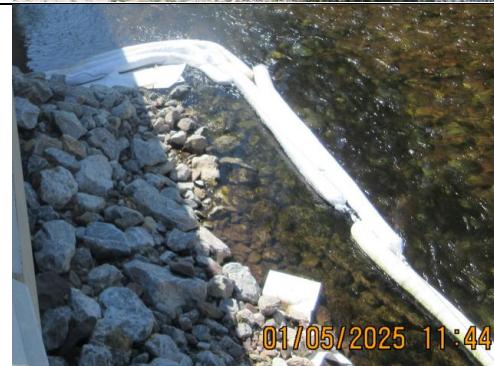
5.3	01/05/2025	A visual inspection of contamination at Sallybrook was carried out. The area appeared mostly clean, with only a minor visible contamination present. Arup has yet to return with design changes for this section.

01/05/2025 11:44		Monitoring of hydrocarbon control measures are ongoing at Sallybrook Stream outlet. The hydrocarbon control measures were impacted by heavy rainfall and higher fluvial flows on the 25/04/25. The hydrocarbon control measures were replaced on the 28/04/2025.

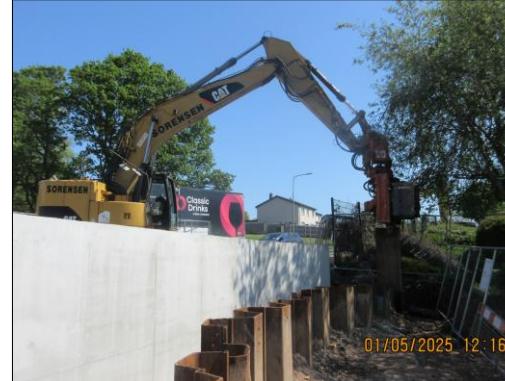
Item number	Date	Comment	Image	ECoW Action/Recommendation	Sorensens's Action response
5.4	01/05/2025	Sheet piles are being removed from the overflow culvert today. Pumping is being directed to the attenuation area north of the basketball court. The discharged water was observed to be clear.

Continue monitoring the pumping and ensure attenuation is effective while pumping continues.	Pumping and monitoring of pumping is ongoing as per the RAMS (GFRS-MS-053) and Permit to Pump No. 130 (GFRS-PTP-130) issued by the Site Ecologist on 20/03/25 and the revised Permit to Pump No. 133 (GFRS - PTP-133) issued on 27/03/25. Backfilling and the pulling of the temporary sheetpiles commenced on 28/04/25. SCE redirected the pumped water behind the basketball court to the gravel check dams/silt fences and the vegetated infiltration area to reduce down the level of suspended solids prior to discharge to the Glashaboy River.

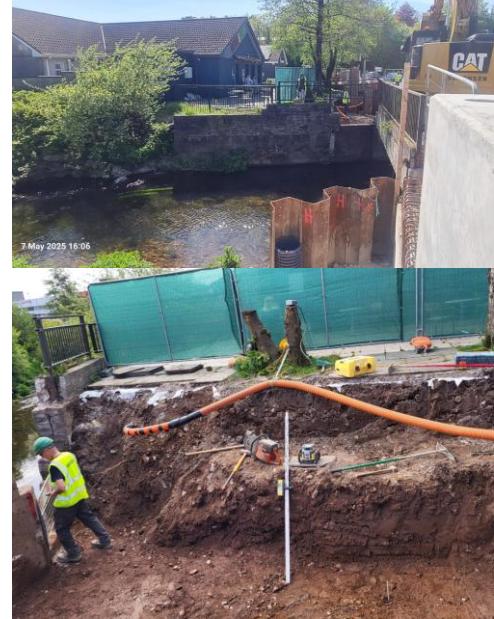
Item number	Date	Comment	Image	ECoW Action/Recommendation	Sorensens's Action response
5.5	07/05/2025 & 08/05/2025	<p>At the Bean and Leaf revetment wall, will is scheduled for full removal as per the design, weep holes have been taking up by sand martins (<i>Riparia riparia</i>) for nesting. Temporary sheet piling and 9 no. courses of blocks were removed to facilitate on going works. The works were carried out in consultation with NPWS and under the supervision of site ecologist. The welfare of the nest birds was evaluated through the works.</p>

<p>Bird nesting surveys were conducted prior to the proposed works and mitigations discussed. NPWS was consulted.</p>	<p>These works were carried out professionally and with the upmost consideration for the nesting sand martins nearby. The sheet piling works, and partial wall removal works were completed without any impact upon the nests or the nesting birds. The adult birds were observed post work continuing to actively feed the young birds in all the nests.</p>

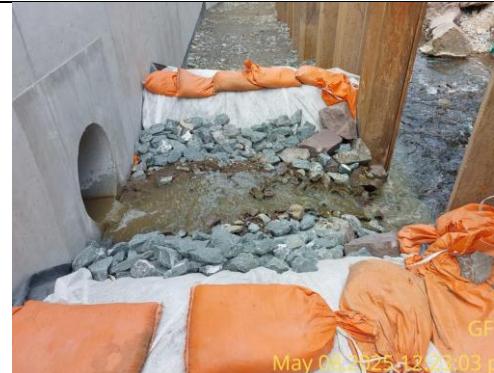
5.6	08/05/2025	<p>Discoloured water was observed flowing from beyond the O'Connell Transport outlet. The origin or cause of the discolouration is currently unknown. The outlet intersects with the New Line works area and discharges into the</p>

<p>Recorded, but not directly observed. Duration unknown. No samples were taken. Insufficient information available to</p>	<p>No action required as this originated outside the works area and is not the responsibility of the main contractor.</p> <p>The duration of the incident was brief and over before control measures such as absorbent pads could be</p>

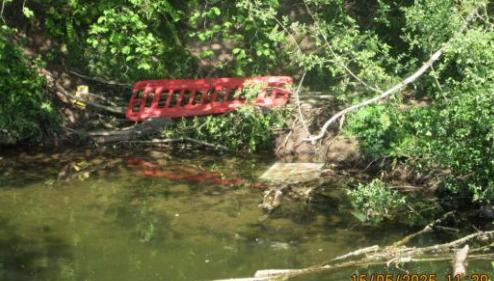
5.7	15/05/2025	On the opposite bank of the river at Sallybrook, where the river bends sharply and forms a deep pool, a red barrier and other waste are present.

A photograph showing a red metal barrier and other debris in a pool of water, likely a river bend. The water is greenish and shallow. The background shows dense green foliage.	Remove waste.	A barrier and other construction materials displaced by a previous flood event were removed from the banks of the Glashaboy River at Area 1: Sallybrook Compound on 09/06/25.

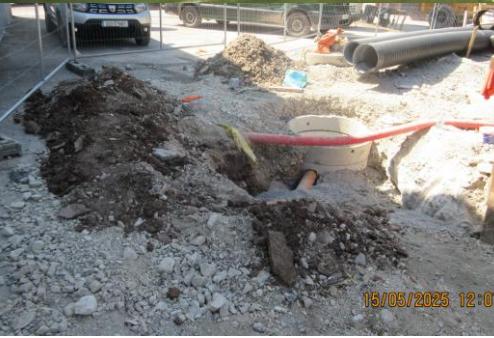
5.8	15/05/2025	The spoil generated from Grandon's drainage works was examined, with particular attention given to any potential risk of contamination. Unlike previous instances at this location, there were no visible signs or detectable odours indicating contamination.

A photograph of an excavation site for a stormwater drainage line. The ground is rocky and uneven. A red pipe is visible in the trench. In the background, there is a fence and some construction equipment.	Issue raised as a precautionary measure.	Given that soil and stone material contaminated with hydrocarbons was previously encountered during the sheet piling works at Grandon's, all resulting excavated soil removed during the installation of the stormwater drainage line was inspected for the potential presence of hydrocarbons. Based on visual and olfactory inspection no indicators of hydrocarbon contamination were noted. The trench for the stormwater drainage line

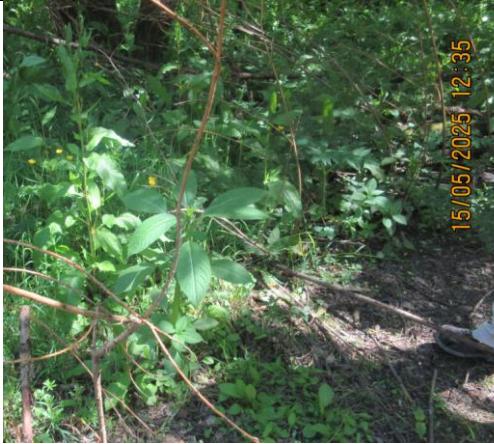
5.9	15/05/2025	In Area 4, two Himalayan balsam (<i>Impatiens glandulifera</i>) plants were identified within the footprint of the works. To prevent them from reaching the flowering stage, they were uprooted and suspended to desiccate, following best practice.

15/05/2025 12:35	Biosecurity measures should be strictly adhered to at this location given the potential for additional Himalayan plants to be present.	Himalayan balsam (<i>Impatiens glandulifera</i>), a regulated invasive species, was observed in Area 4 of the works site. During an Environmental Tour, the Site Ecologist manually removed two plants, including their roots, to prevent flowering and seed dispersal. The plants were placed upside down in a tree fork to prevent re-rooting and promote drying. This manual removal method is known as "balsam bashing." Given the plant's ability to disperse seeds explosively and persist in soil for up to 18 months, ongoing monitoring is planned.

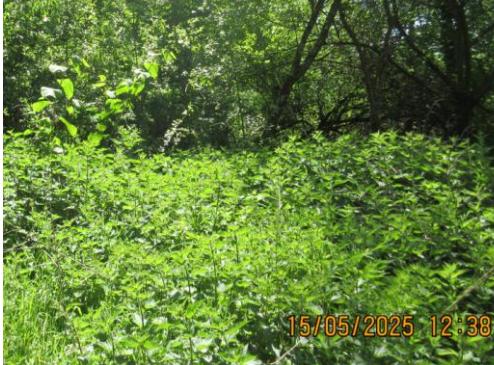
Item number	Date	Comment	Image	ECoW Action/Recommendation	Sorensens's Action response
5.10	15/05/2025	In Area 4, knotweed species were observed either within the footprint of the works or in close proximity.

15/05/2025 12:38	<p>Biosecurity measures must be strictly followed at this location due to the presence of Japanese knotweed and other knotweed species.</p>	<p>Japanese knotweed and Bohemian knotweed were identified in or near Area 4 (The Grove). The Site Engineer will mark out the works area for the Pump Station, RC Wall, and Crash Barrier to assess proximity to the plants and potential underground rhizomes. Due to the risk of dormant plants and hidden rhizomes, supervision by the Invasive Alien Plant Species (IAPS) Specialist Ecologist and implementation of biosecurity measures will be required and implemented.</p>

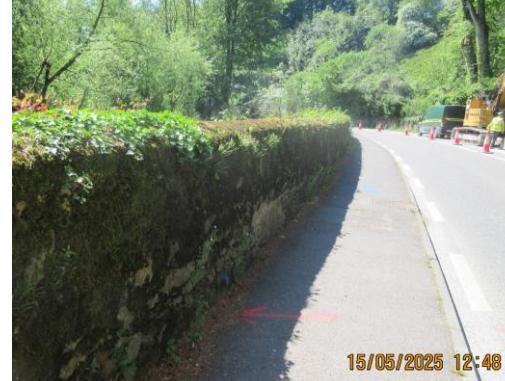
Item number	Date	Comment	Image	ECoW Action/Recommendation	Sorensens's Action response
5.11	15/05/2025	Due to its known presence in the Glanmire area, the wall scheduled for demolition in Area 4 was inspected for the rare plant species Little Robin (<i>Geranium purpureum</i>). No signs of the species were observed today.

15/05/2025 12:48	The wall should be inspected again prior to its demolition.	Surveys for Little robin and its hybrid will be undertaken by the Site Ecologist in advance of the programmed demolition of the stone masonry wall (to accommodate the construction of the RC Wall and Crash Barrier).

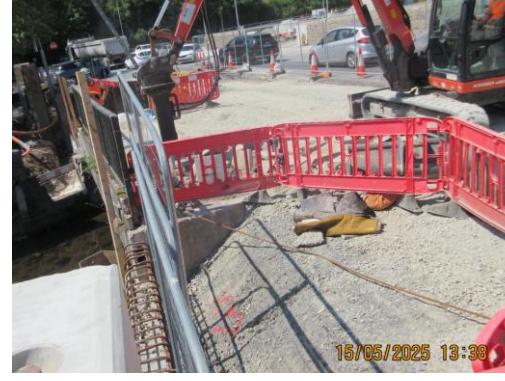
5.12	15/05/2025	The works observed today on Hazelwood Bridge involved the removal of old road surfacing using a hydraulic breaker. This process posed a risk of dislodging the brickwork along the base of the railing, potentially causing them to fall into the watercourse below. Careful measures should be taken to minimise this risk and prevent environmental impact.

15/05/2025 13:38	Works to be carried out while preventing any material entering the water course.	During the Environmental Tour, a rock breaker was observed on the deck of Hazelwood Bridge breaking out an existing concrete footpath. These works were being undertaken in close proximity to the handrail which is fixed to blockwork (two courses high) on the bridge parapet. The Site Ecologist spoke with the machine operator during the Environmental Tour

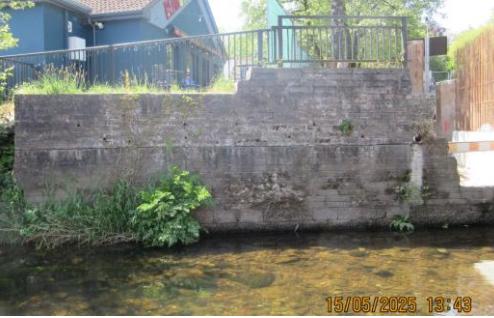
5.13	15/05/2025	The brick wall, known to be a nesting site for sand martins (<i>Riparia riparia</i>), was visually inspected for a short duration. During this time, no interactions between the sand martins and the wall were observed, although the birds were actively present in the area. The brick removal works appear to have been successfully carried out, with the wall appearing intact, consistent with its condition prior to the sheet piling and brick removal process.

The area should undergo ongoing monitoring to assess the impact of nearby works on sand martin nesting. If interference likely, works should be halted and reassessed to ensure that nesting can proceed successfully.	No feeding activity was observed during the Environmental Tour due to high noise and visual disturbance. Monitoring has shown that adult birds reduce feeding during peak disturbance but resume once conditions normalize. The Site Ecologist returned afterward to confirm that feeding activity had resumed. Monitoring between 15:30 and 16:15 confirmed active feeding by adult birds. Video footage documenting this activity was shared with the ER's Ecologist via the Glanmire Ecology WhatsApp Group at 16:15 on 15/05/25.

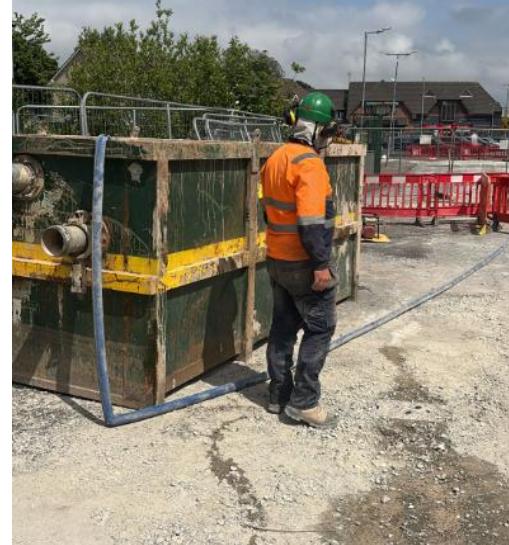
Item number	Date	Comment	Image	ECoW Action/Recommendation	Sorensens's Action response
5.14	19/05/2025	GFRS – PTP – 034 rev01 – permit to pump in operation at Shopping Centre bridge.

Review of Permit and inspection.	Pumping was carried out professionally, management of silt was excellent.
5.15	21/05/2025	Vegetation was removed at the Shopping Centre Bridge and Copper Valley Vue following a breeding bird survey. While old nests were identified at both locations, no active nesting was observed at the time of clearance.

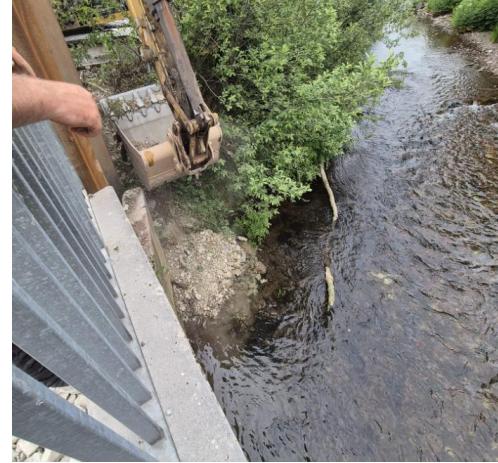
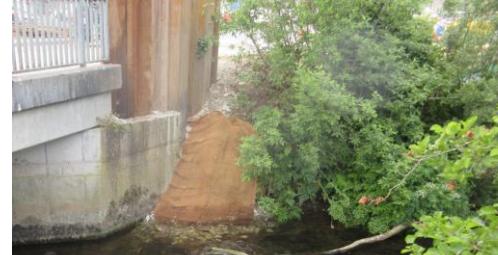
Item number	Date	Comment	Image	ECoW Action/Recommendation	Sorensens's Action response
5.16	22/05/2025	A minor amount of gravel slipped into the margin of the watercourse at the Shopping Centre Bridge. The material was removed as much as possible using a bucket without entering the water. Erosion control mesh was installed as a temporary measure, and full removal is scheduled for the 2025 in-stream works season.

Discussed with site ecologist.	This was unintentional and minor. Corrections measures were implemented satisfactorily.

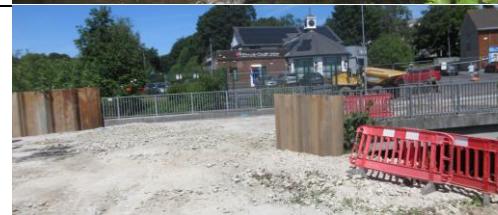
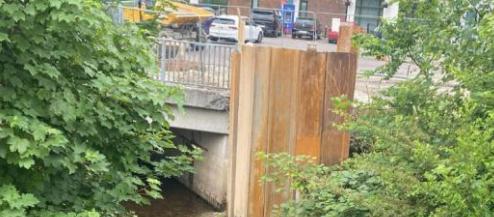
5.17	23/05/2025	As part of ongoing works at Hazelwood Shopping Centre Bridge, three sheet piles were installed into the sandbags located along the riverbank margin on the left-hand bank downstream of the bridge. Immediately prior to the commencement of

Item number	Date	Comment	Image	ECoW Action/Recommendation	Sorensens's Action response
		these works, the Site Ecologist waded instream to mobilise any free-swimming fish from the immediate area.

Works were carried out in good regard for water quality. Later inspection of the water course substrate showed no	Ongoing works in advance of rotary sheet piling schedule for June 2025.

signs of sedimentation.

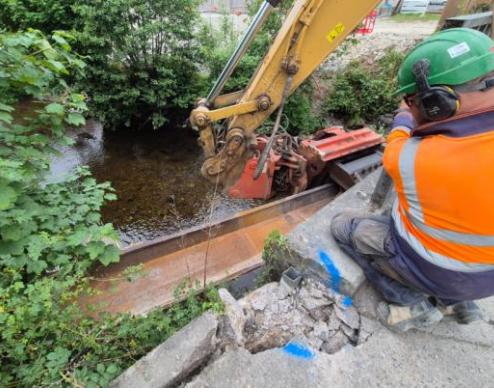
5.18	23/05/2025	<p>A short section of the concrete ledge on the deck of the bridge in front of the railings is to be removed (also under supervision) to facilitate driving a sheetpile flush with the bridge.</p> <p>Sheetpile used to catch falling debris before it entered the water course.</p>

Liaised with site ecologist on methodologies employed during these activities.	Creative solution to catch falling debris. Well planned and executed.

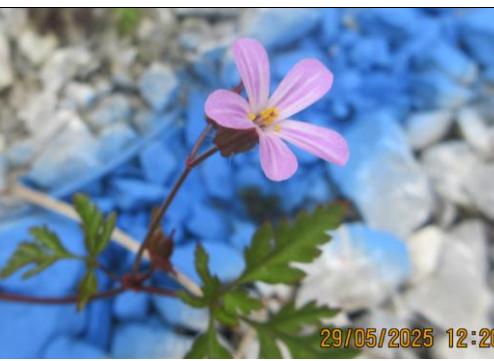
5.19	29/05/2025	<p>The ecologically sensitive zone located at the compound kitchen fire escape was inspected.</p> <p>One of the plants in particular appears to be exhibited at least some of the characteristics of the rare</p>

It was requested that the blue boundary line be extended to accommodate the growth of the plant, which has now exceeded the	The boundary was extended as requested. The sensitive area continued to be monitored and maintained throughout the month.

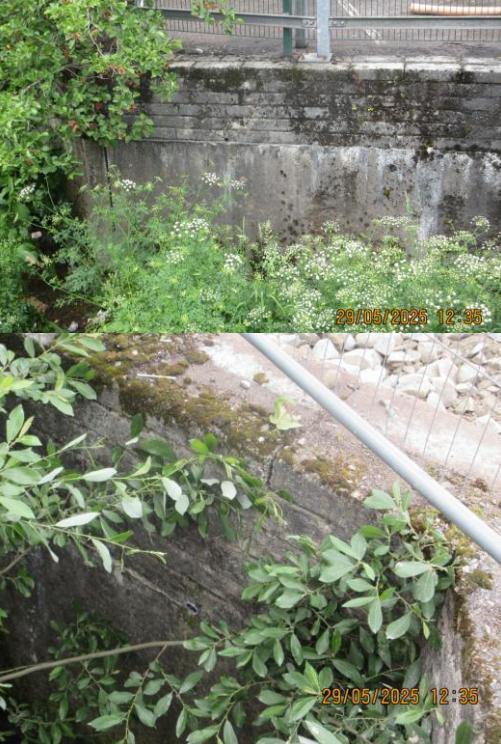
Item number	Date	Comment	Image	ECoW Action/Recommendation	Sorensens's Action response
		<i>Little Robin (Geranium purpureum).</i>		original boundary.	
5.20	29/05/2025	Two weep holes with potential for sand martin nesting were inspected immediately upstream of the Hazelwood Shopping Centre bridge. One of the holes appears particularly suitable, as it is exposed in a similar way to others further upstream that are now occupied.

Recommended to block it off to prevent the possibility of Sand Martins nesting, as they are known to be present in the immediate area. This will help avoid potential delays to the works, as the wall is scheduled for demolition in accordance with the design.	Both these holes were checked, found to be non-active for any breeding bird species, and subsequently blocked off.

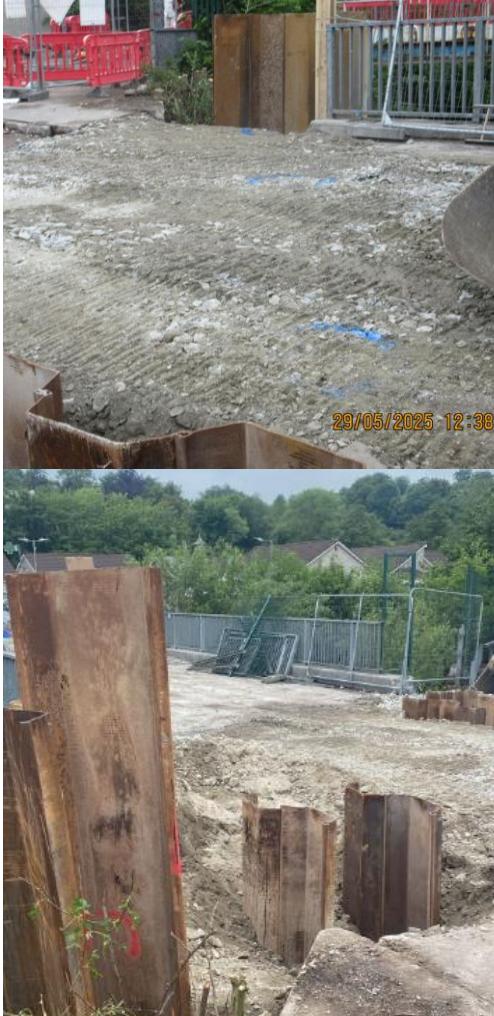
Item number	Date	Comment	Image	ECoW Action/Recommendation	Sorensens's Action response
5.21	29/05/2025	<p>Rotary sheet piling is scheduled to take place next week at Hazelwood Shopping Centre bridge. This activity is expected to be particularly messy, generating a high-turbidity slurry that is expected to be ejected into the air. The RAMS for this work should provide full mitigation measures to address this.</p> <p>The RAMS should consider how silty material may be driven either through or beneath the existing temporary sheet pile arrangement. During today's observations (after the Tour), the driving of four sheet piles resulted in a minor release of silt, as shown in the attached photo.</p>

<p>Mitigation measures to prevent siltation of Glashaboy river should be clearly outlined in the Rotary Sheet Piling RAMS for review and input by the ER team prior to commencement of works next week</p>	<p>Subsequently, RAMS 084 – Rotary Bored Piling Rev 01 was issued by SCE, incorporating all appropriate mitigation measures including measure prevent silty water moving under sheet piles.</p>

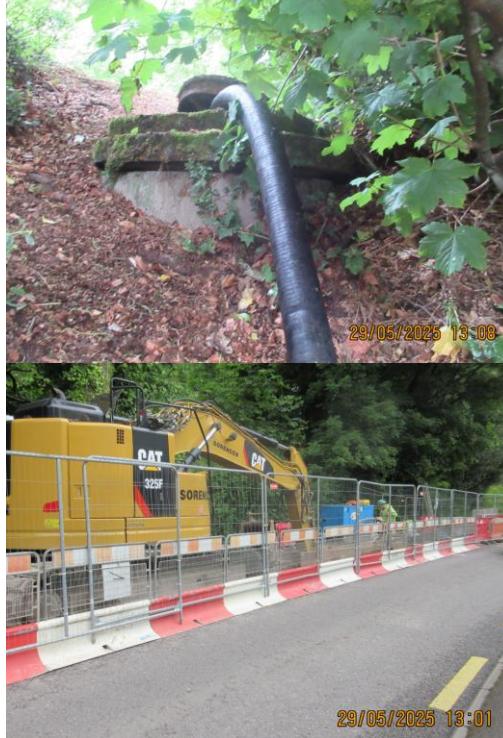
Item number	Date	Comment	Image	ECoW Action/Recommendation	Sorensens's Action response
5.22	29/05/2025	<p>It was noted that pumping was taking place in Area 4 without a valid permit to pump.</p> <p>No pumping should occur on site unless a valid permit to pump is in place.</p>

<p>The Permit to Pump process should be reviewed for procedural weaknesses to ensure it is effectively applied by site personnel.</p>	<p>It was acknowledged that pumping undertaking should have been conducted under the permit to pump system. This was a rare occasion as the permit to pump system has proved itself effective. In this circumstance discharge was into local foul with no risk to surrounding water course.</p> <p>An Environmental Incident Report was considered for this incident but was deemed unnecessary given the absence of any environmental impact and the effective operation of the Permit to Pump system operating well across the Scheme's work sites for the majority of the time.</p>

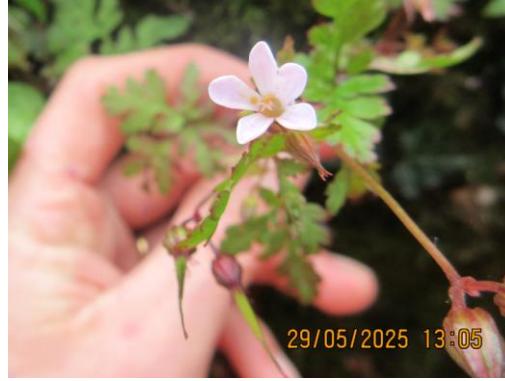
Item number	Date	Comment	Image	ECoW Action/Recommendation	Sorensens's Action response
5.23	29/05/2025	<p>The wall in Area 4, which is scheduled for demolition, was inspected for the presence of the rare plant species Little Robin (<i>Geranium purpureum</i>), due to its known occurrence in the Glanmire area.</p> <p>A number of flowering <i>Geranium</i> plants were observed to be exhibiting some interesting characteristics which were growing on the wall. While a definitive identification could not be made at this time, there is a strong possibility it may be <i>Little Robin</i> (<i>Geranium purpureum</i>).</p>

Continue to conduct surveys leading up to wall demolition.	Before wall demolition, a number of plant were successfully removed and translocated to the sensitive area in the compound for holding.

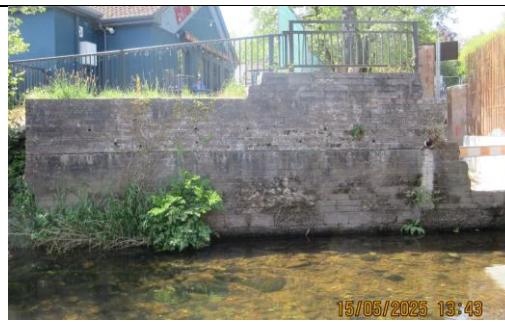
5.24	29/05/2025	The sand martins (<i>Riparia riparia</i>) at Bean and Leaf revetment wall were not directly monitored during the site tour, but their activity and presence were discussed. It was noted that sand martins are currently very active in the area, with

Item number	Date	Comment	Image	ECoW Action/Recommendation	Sorensens's Action response
		<p>most of the eight weep holes observed recently to be in use for nesting. Discussions focused on the timing of the breeding season and the potential for a second clutch of eggs being laid. It was acknowledged that any attempt to prevent a second breeding attempt would require meticulous planning and consultation with the NPWS.</p>		<p>actions to prevent a second clutch of eggs from being laid.</p>

The area should undergo ongoing monitoring to assess breeding and fledging status, which may inform any potential	Site Ecologist regularly monitored Sand Martin nests at Hazelwood Bridge in consultation with NPWS Conservation Ranger Sam Bayley, coordinating the blocking of weep holes as each brood fledged.
