Environmental Report Month 2024

Glashaboy Flood Relief Scheme

Document code: FFEC-GFRS-2023-004

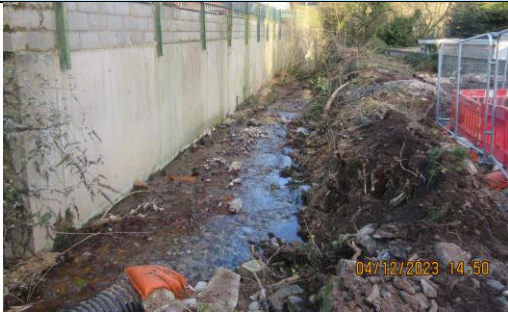
Item number	Date	Comment	Image	ECoW Action/Recommendation	Sorensens's Action response
1.	04/12/2023	There are two sandbags present in the Springmount watercourse at the outlet of the diversion. These are considered waste and require removal.

Discussed with site ecologist.	Sandbag waste was removed from the waterway.

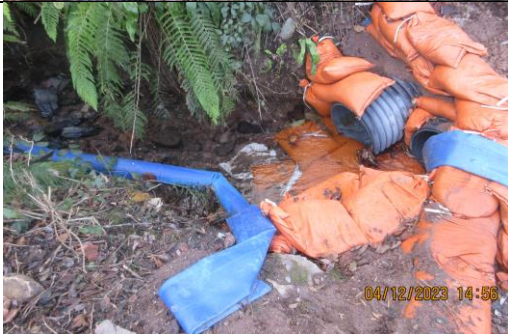
2.	04/12/2023	Cut hose (waste) left in entrance to diversion inlet at Springmount. Hydrocarbon slick visible in settlement tank at Joinery (Sallybrook). Oil boom added to tank and discharge location – Tue 5th.

Discussed with site ecologist.	Removed from stream during Springmount site tidy up.

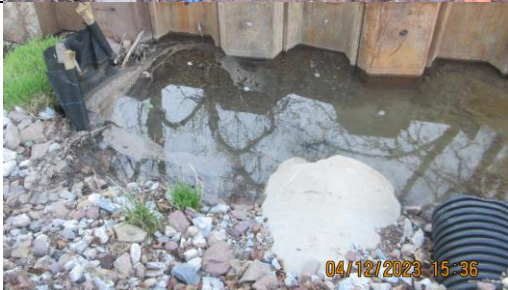
3.	04/12/2023	Minor amounts of oil-based residue were present in the siltation tank and attenuation channel at Sallybrook. This relates to surface water from the Sallybrook Industrial Estate that is pumped from the furniture shop works area.

Discussed with site ecologist.	An oil boom was installed within the siltation tank and within the attenuation channel.

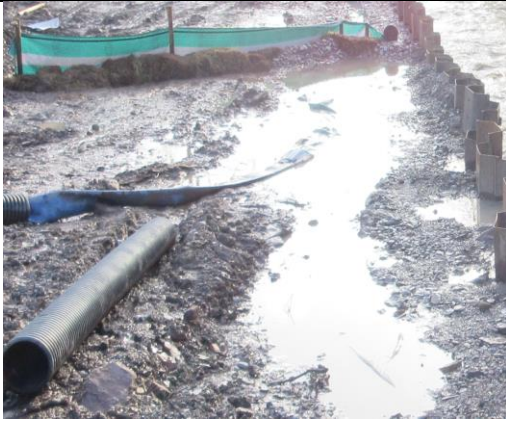
<p>13.</p>	<p>07/12/2023</p>	<p>During discussions on the attenuation area, it was emphasized that the silt dams/screens would need periodic silt removal to ensure their optimal functioning. Regular removal is necessary to prevent the buildup of sediment and to mitigate the risk of washout, particularly in the event of a flood that might lead to overtopping of the temporary sheet piles.</p>

<p>Discussed with site ecologists on ET002.</p>	<p>Sorensen to monitor the accumulation of sediment behind dams within the attenuation area.</p>
<p>14.</p>	<p>07/12/2023</p>	<p>Housing keeping in the region of the furniture shop needs improvement. The area currently has a mixture of accumulated waste, including metal and wood off-cuts, broken fencing, old spray cans, and pipe sections.</p>

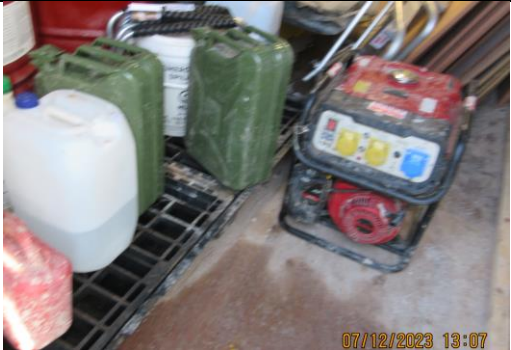
15.	07/12/2023	Good storage in compound storage area.

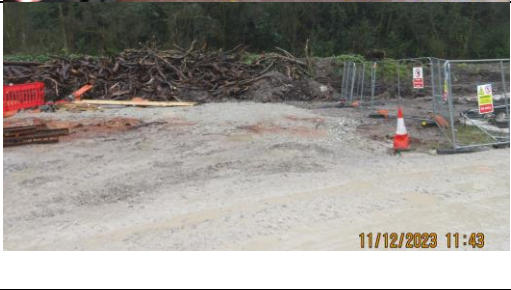
Documented.	No action required.
16.	07/12/2023	The southern end of the JKW exclusion zone has been adjusted. Currently the timber log pile and works area here is open. Discussed the need to provide fencing and demarcation here to adhere to biosecurity measures.

Discussed with site ecologists on ET002.	No fencing or demarcation was installed at timber log pile in December 2023.
17.	14/12/2023	A siltation event occurred in the works area at Meadowbrook estate, where dirty water was pumped from excavations to the nearby gully

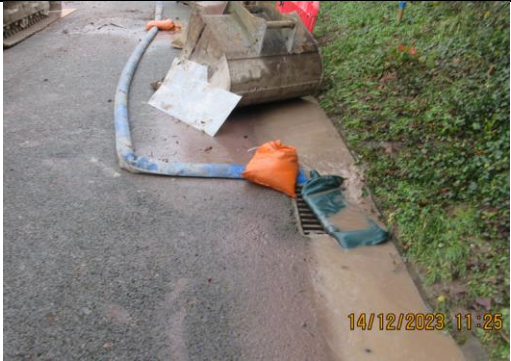
- No mention of the siltation event on 14/12/2023 at Meadowbrook, where sedimented water was pumped into a nearby gully with insufficient measures in place to contain the heavy sediment loads.

Informed site ecologist. Followed up with an email.	Site ecologists and environmental manager on site immediately to investigate. Pumping stopped. Sump installed. Time allowed for settlement prior to pumps being turned back on. A larger silt sock was fitted.

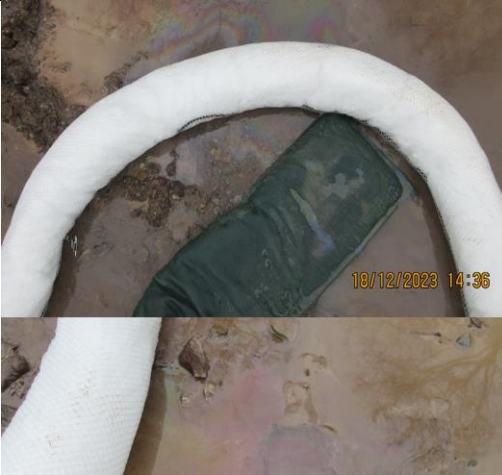
<p>21.</p>	<p>18/12/2023</p>	<p>The works area in operation today and yesterday at Eurofins has been dewatered into the upper section of the attenuation area at Sallybrook house (See attached photos). As discussed on site, this section of the attenuation area now contains water with a sheen on it and strong odour that could be potentially contaminated.</p>

<p>Informed site ecologist. Followed up with an email.</p>	<p>Oil booms installed around outtake and discharge point. Pumping ceased 19/12/23 to assess extent of contamination. Water samples taken and sent for testing.</p>
<p>22.</p>	<p>18/12/2023</p>	<p>Gully blocked up with mud related to archaeology trenching works at Meadowbrook.</p>	 	<p>Informed site ecologist.</p>	<p>Gully was unblocked the following day.</p>

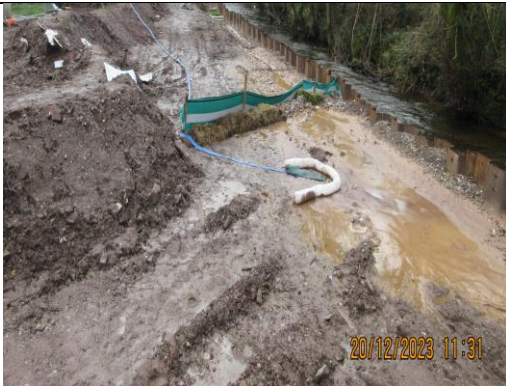
are carried out during the appropriate time of the year.			
26.	20/12/2023	The upper section of the attenuation area at Sallybrook house, which underwent dewatering from the Eurofins works area, is found to contain potentially hazardous material. It is recommended that this material be removed before the removal of the silt fence and before the Christmas break and a possible flood event.

Discussed with site ecologists on ET003.	It was proposed that the ground be scraped, and the material to be relocated to a trial hole in Pat O'Donnell's or the works area at Eurofins, essentially returning the material to its original location. Sorensen confirmed this action was carried out.

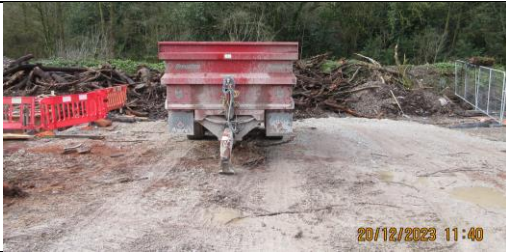
27.	20/12/2023	The ongoing plans for the removal of the timber stockpile were discussed. Need for demarcation agreed to separate drainage works area from timber pile.

Discussed with site ecologists on ET003.	Timber removal ongoing. Demarcation to be installed around timber in adhere with biosecurity measures.

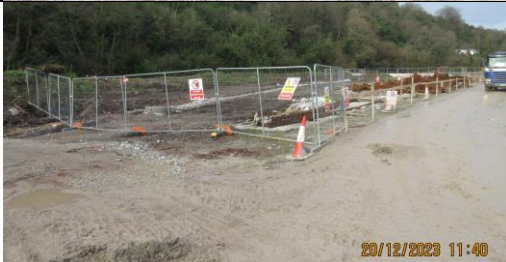
28.	20/12/2023	It was agreed that following the drainage works in this area, the fence is to be reinstated according to the JKW exclusion zone layout as it was prior to these works.

Discussed with site ecologists on ET003.	Fence to be reinstated following drainage works.
