Monthly Environmental Audit – Sept 2025

Glanmire Flood Relief Scheme

01/09/25 to 30/09/25

ENVIRONMENTAL AUDIT

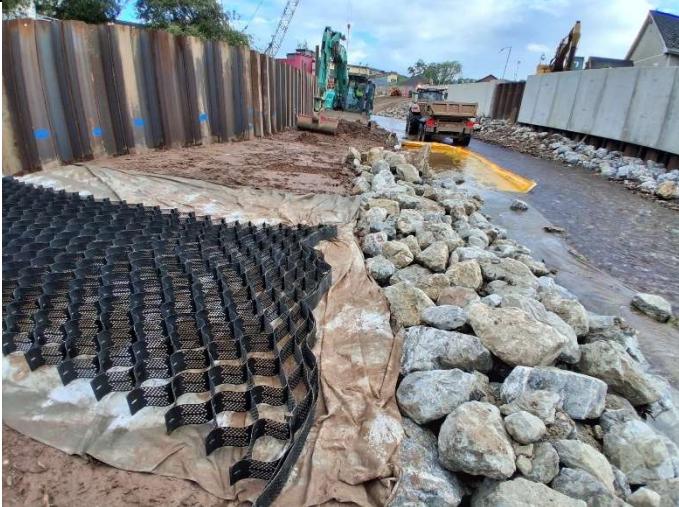
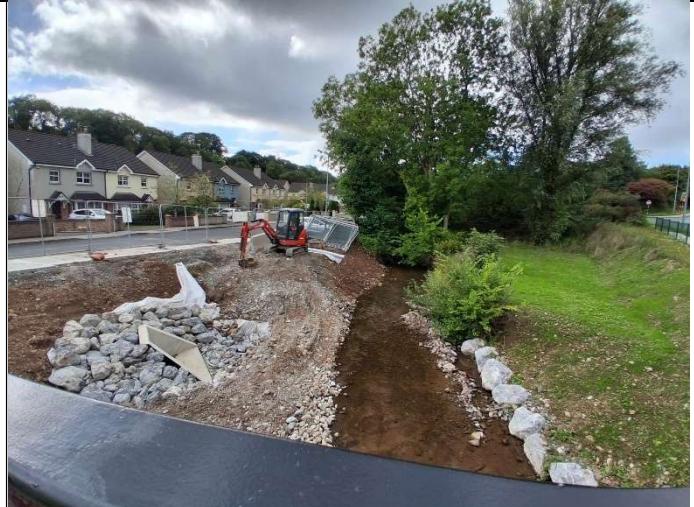
Photograph 1

- Coir mesh was installed over the access track reinforcement for the overflow culvert at the Credit Union on 22/09/25 to prevent soil erosion.
- Installation of rock armouring across the channel upstream of Hazelwood Bridge “from the wet” commenced on 22/09/2025. Recovered gravels were monitored and fish salvage works returned 3 no. Adult European eels to the channel.

Installation of coir mesh at Hazelwood and Copper Valley Vue to prevent soil erosion post installation of access track reinforcement (geocell) and erosion matting

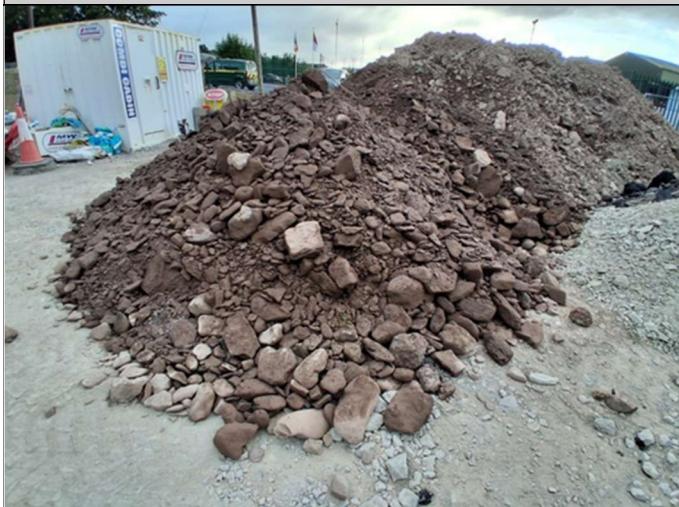
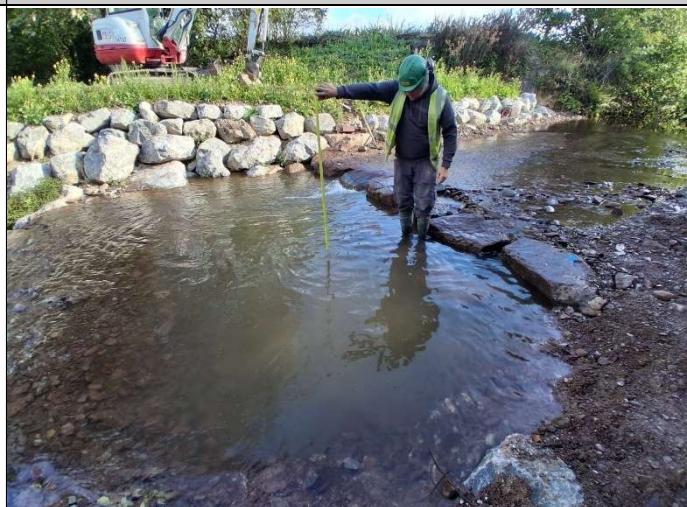
Photograph 3

- Installation of rock armouring "from the dry" upstream of Hazelwood Bridge commenced on 12/09/25.
- Additional river gravels, removed from the cofferdam of the eastern abutment of Hazelwood Shopping Centre Bridge, were added to the Step Pool Arrangement at New Line on 12/09/25.

Additional river gravels, removed from the cofferdam of the eastern abutment of Hazelwood Shopping Centre Bridge, were added to the Step Pool Arrangement at New Line

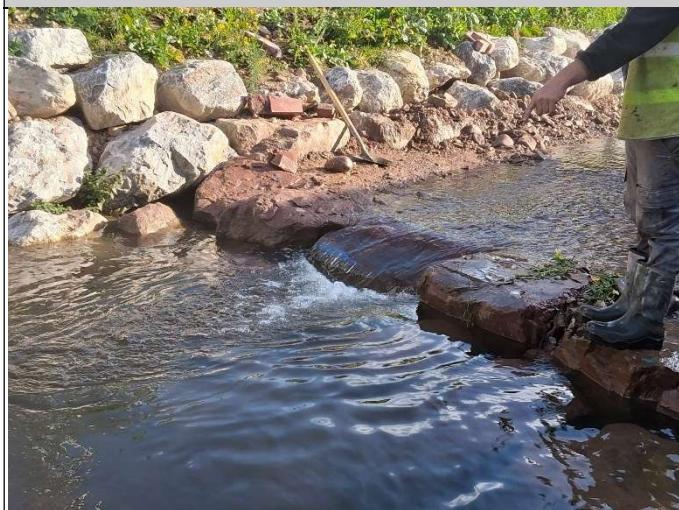
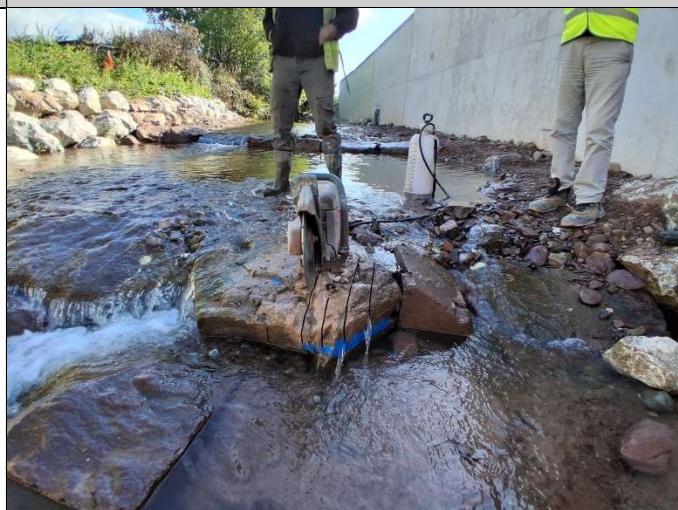
Photograph 5

- Alterations were made to the two *in situ* transverse alignments of anchor boulders in the Glenmore River at New Line in order to create the characteristic alternating step pool features. These works involved the use of cutting equipment to create a step in both rows of anchor boulders to create a low flow path and a low flow resting pool (deep scour pool) for fish. A third row of anchor boulders with a step was also installed on 23/09/25.

Alterations were also made to the two *in situ* transverse alignments of anchor boulders in order to create the characteristic alternating step pool features (as per the above figure). These works involved the use of cutting equipment to create a step in both rows of anchor boulders to create a low flow path and a low flow resting pool (deep scour pool) for fish. A third row of anchor boulders with a step was also installed

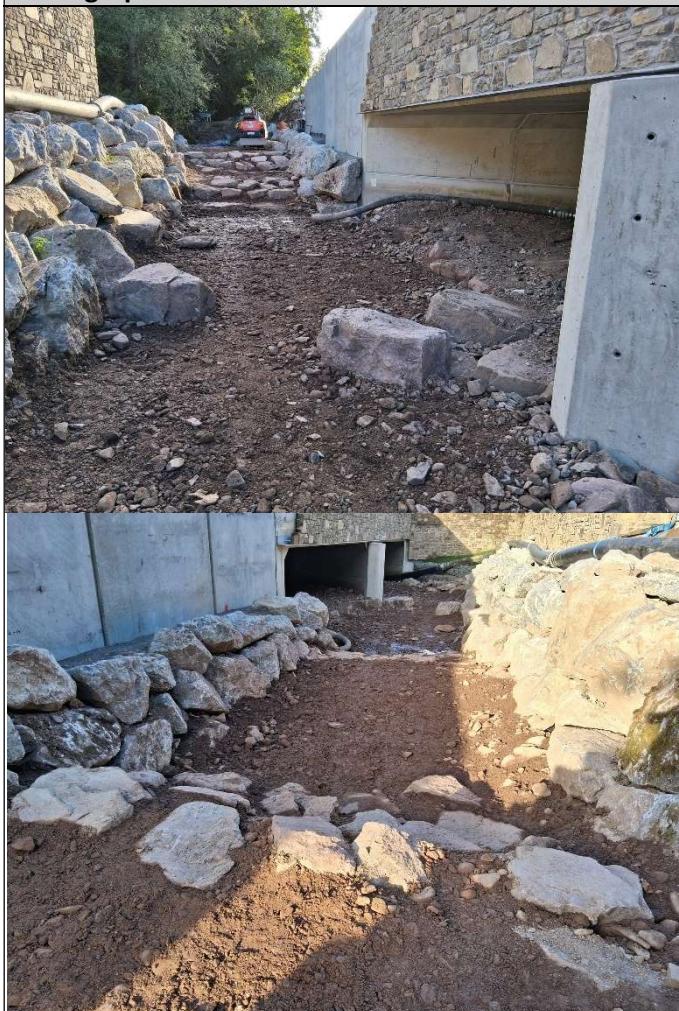
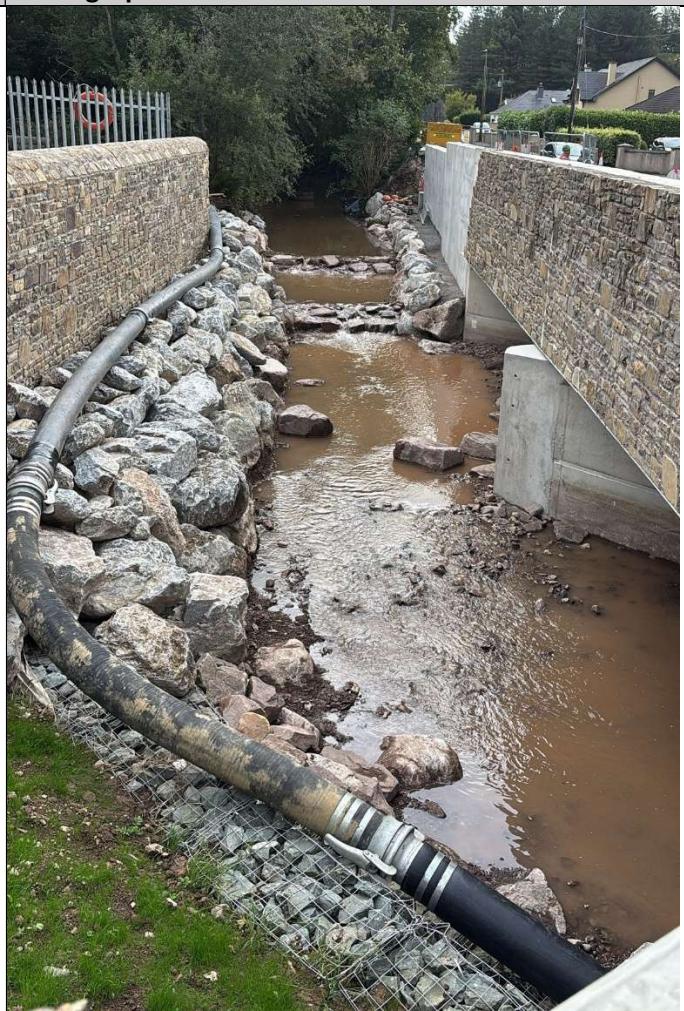
Photograph 7

- Two transverse alignments of anchor boulders (Old Red Sandstone) were installed in the dry instream works area at Brooklodge Culvert for the Step Pool Arrangement on 11/09/25.

Installation of Step Pool Arrangement for fish passage at Brooklodge

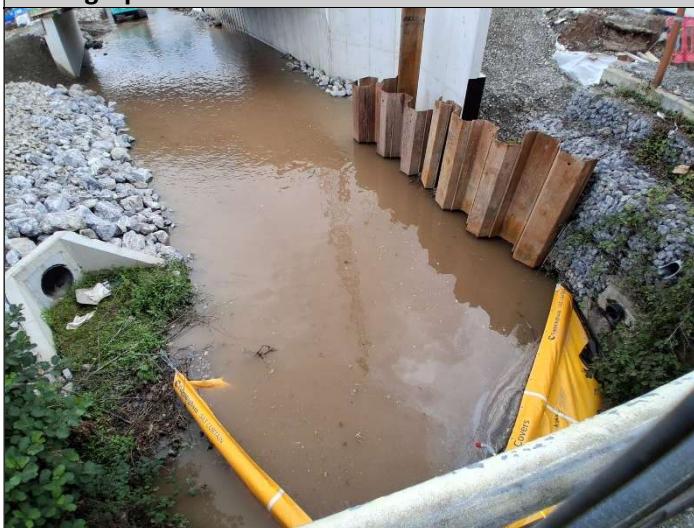
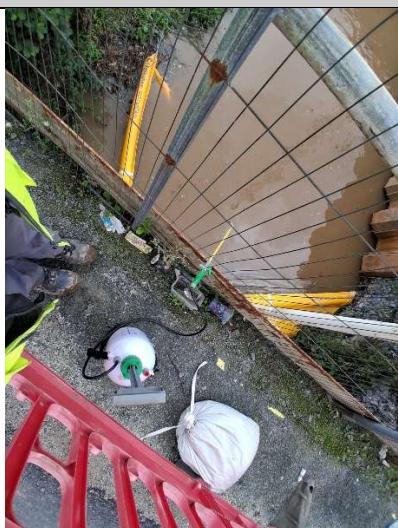
Photograph 9

- Hydrocarbon control measures i.e. Bioversal RC was deployed at Hazelwood Shopping Centre Bridge due to the presence of a localised hydrocarbon sheen on 10/09/25. Machines working instream were also sprayed with Bioversal RC prior to deployment.

Deployment of hydrocarbon control measures at Hazelwood to address a localised hydrocarbon sheen

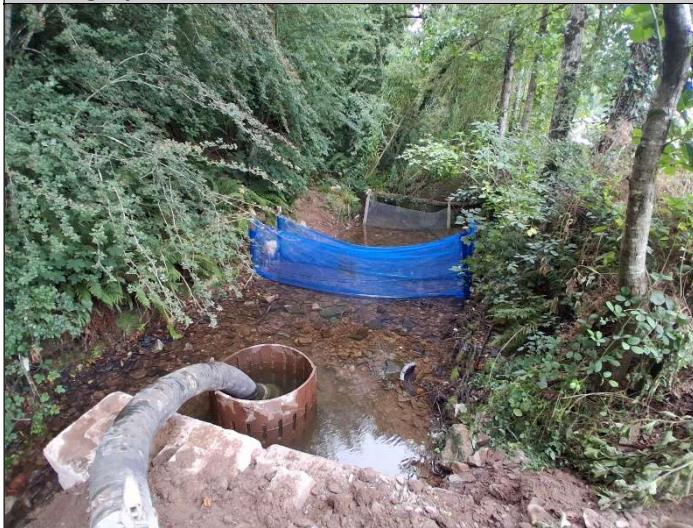
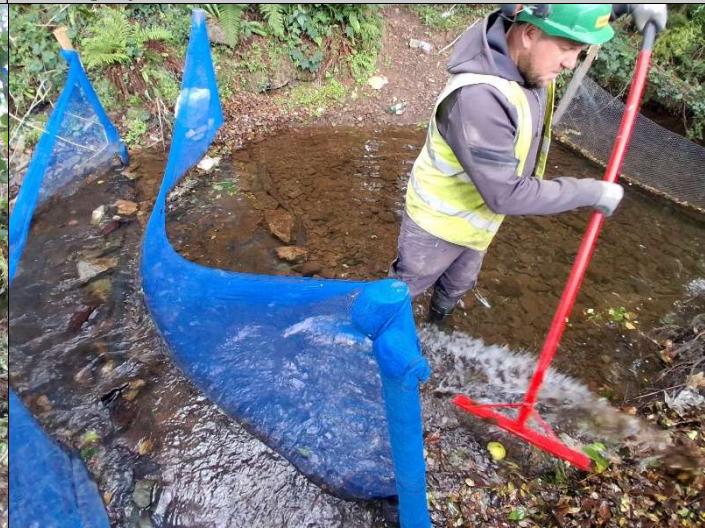
Photograph 11

- Monitoring of the pumping arrangement at Brooklodge Culvert continued under Permit to Pump No. 143 issued on 14/08/2025 for the overpumping of the Glenmore River to facilitate the completion of RC Walls, rock armouring and step pools for fish passage. Monitoring included checks on the 3 no. upstream fish guards to ensure fish could not gain entry to pumping system. The fish guards have to be regularly cleaned to remove fallen leaves to avoid blockage and subsequent damage from high velocity flows. An additional fish guard was added on 10/09/25 to address increasing autumn leaf fall.

Cleaning of leaves from the fish guards at sump for overpumping of Glenmore River

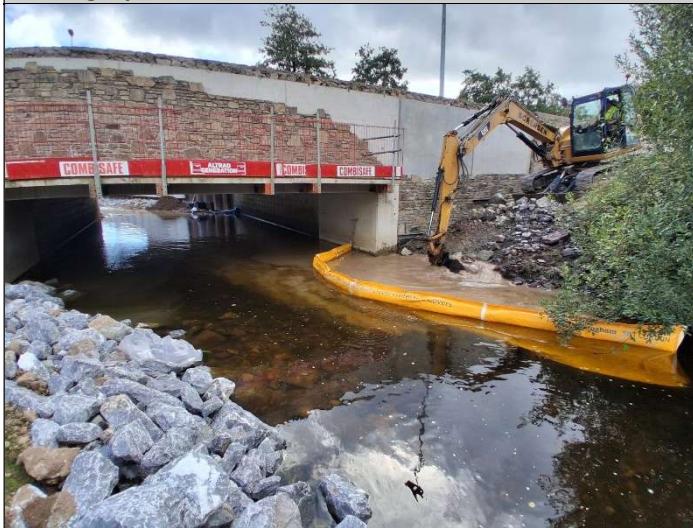
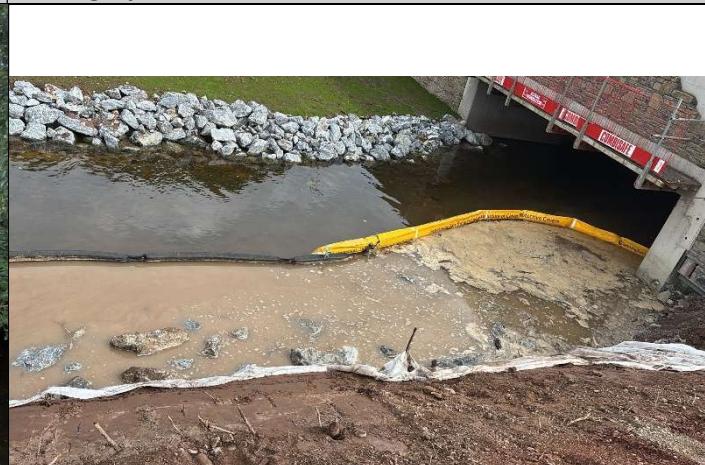
Photograph 13

Installation of rock armouring at Hazelwood Bridge

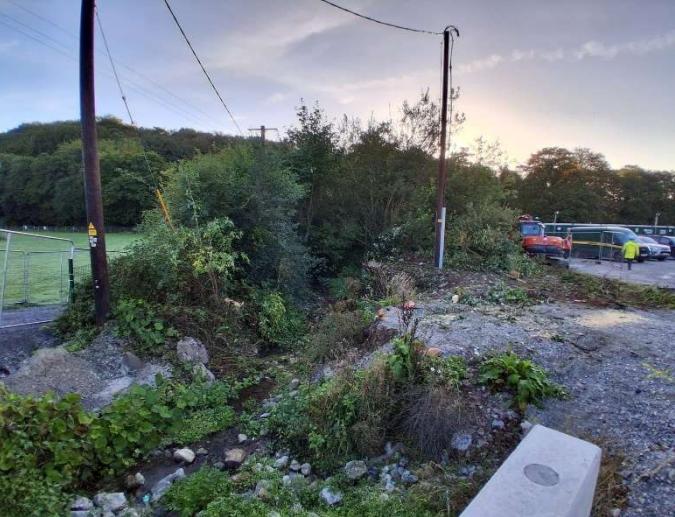
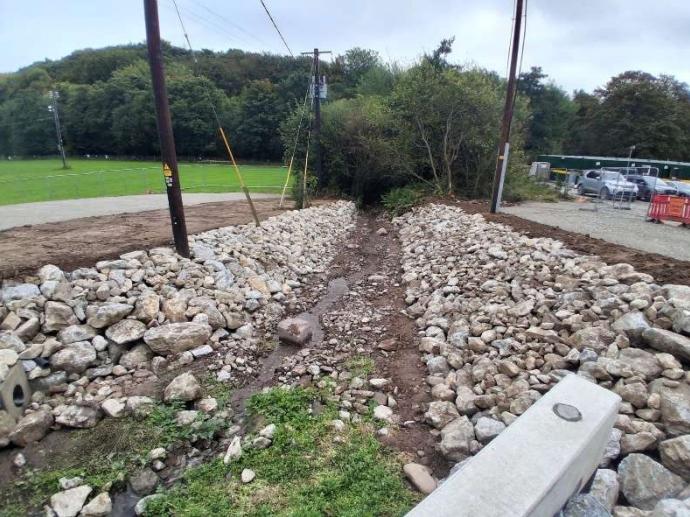
Photograph 15	Photograph 16

- 4 no. Old Red Sandstone flagstones were installed on the Cois na Gleann Stream to improve the habitat for Dippers on 24/09/25.
- Japanese knotweed & Bohemian knotweed surveys and chemical treatment commenced on 25/09/25.

Installation of rock armouring at Cois na Gleann Stream. 4 no. Old Red Sandstone flagstones were also installed to improve the habitat for Dippers

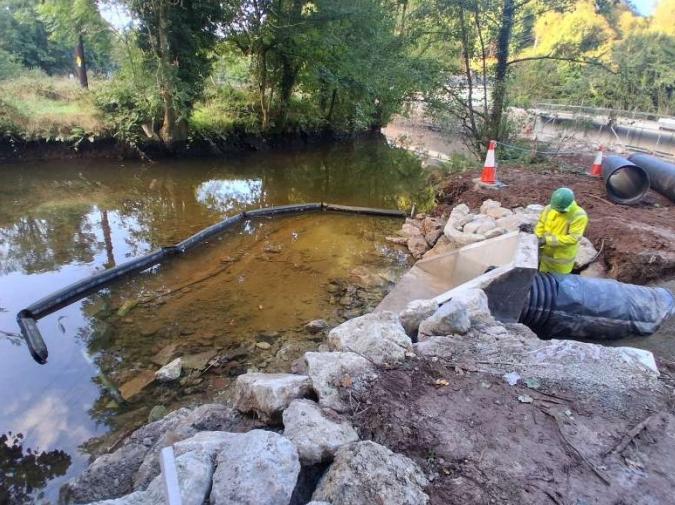
- Instream works to facilitate the installation of the headwall for the stormwater outfall in Area 4: The Grove commenced on 19/09/25. Recovered gravels were monitored and fish salvage works returned 1 no. stickleback to the channel.

Caption 17 The Grove	Caption 18 Riverstown
Installation of headwall for stormwater outfall and rock armouring in Area 4	Installation of erosion matting on banks of the Glashaboy River at Riverstown Bridge

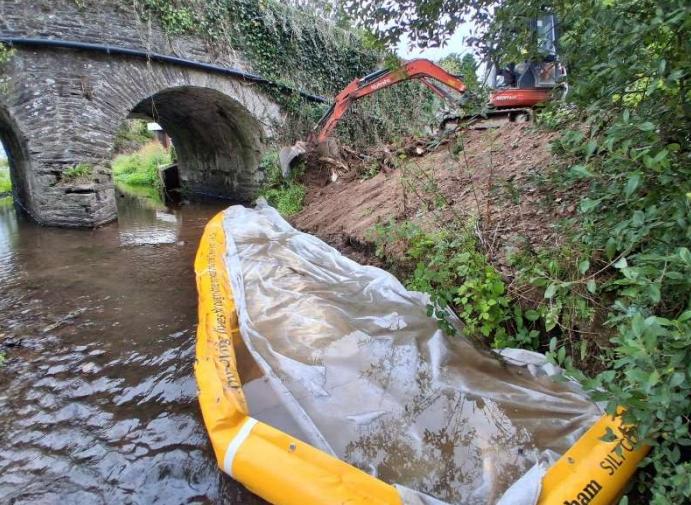
- Installation of erosion matting on the banks of the Glashaboy River downstream of Riverstown Bridge commenced on 02/09/2025. Works were supervised by the IAPS Specialist Ecologist due to the presence of Bohemian knotweed.

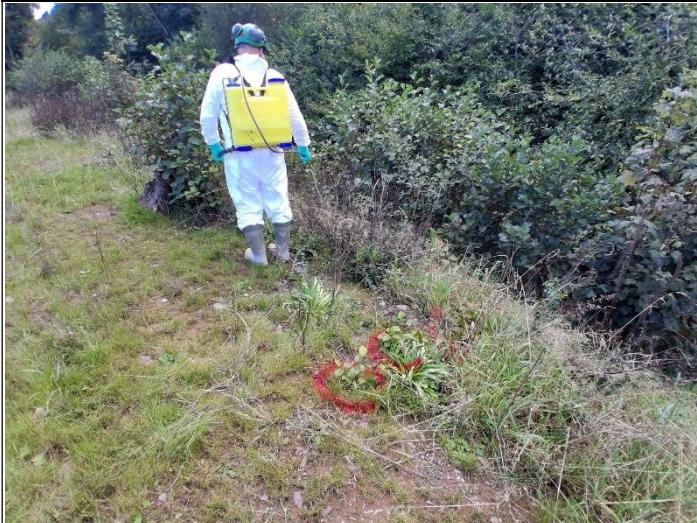
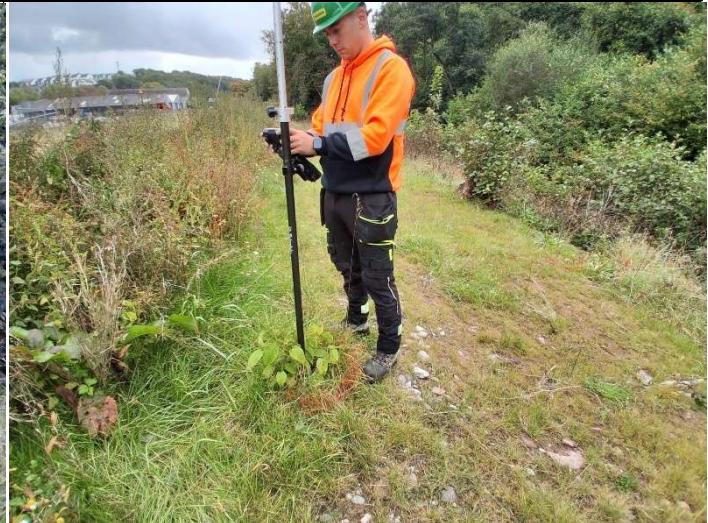
Photograph 19

Japanese knotweed & Bohemian knotweed surveys and treatment

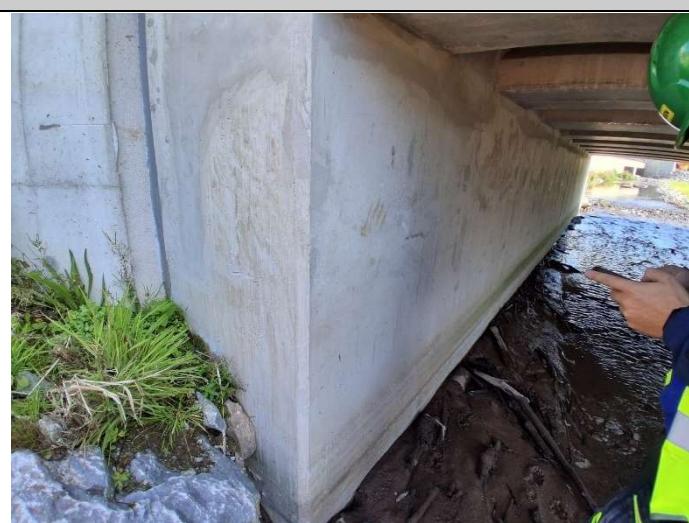
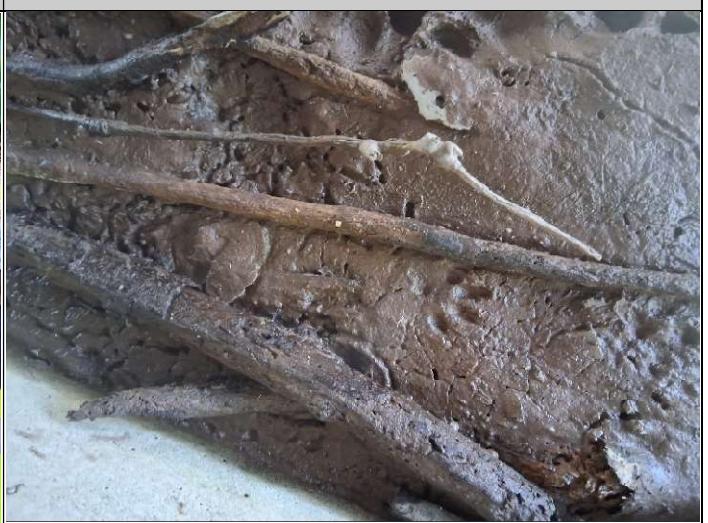
Photograph 21

- An advanced survey to design localised tie-ins for Otter ledges for the bridge culverts was undertaken in conjunction with the ERs ECOW on 23/09/25. During this survey Otter tracks were recorded underneath Copper Valley Vue culvert.

Advanced survey to design localised tie-ins for Otter ledges. Otter prints observed beneath Copper Valley Vue Culvert during the survey

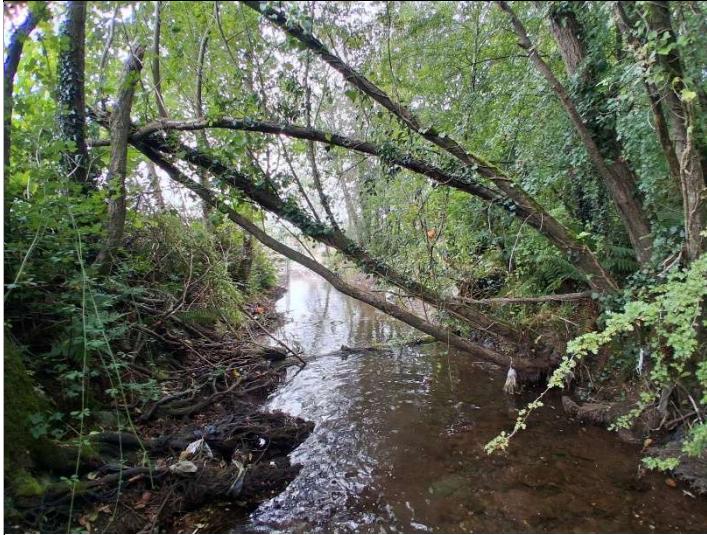
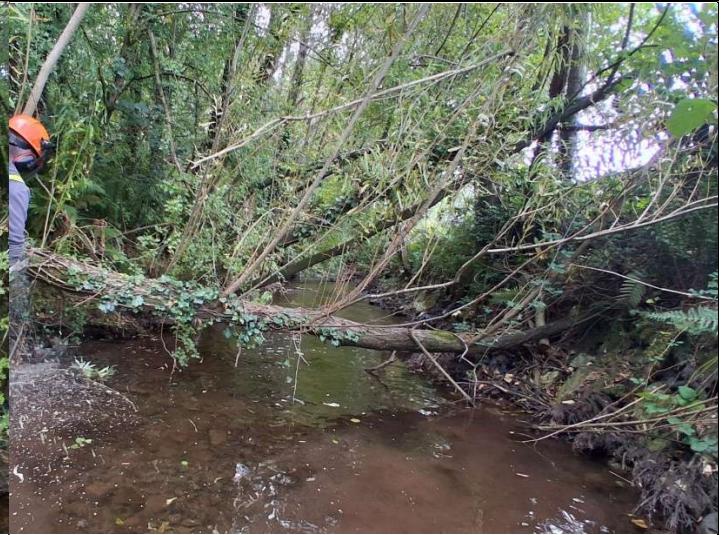
Photograph 23

- Installation of Otter ledges continued.
- Removal of fallen trees and deadwood material took place at Brooklodge Culvert on 29/09/25.
- Instream works to facilitate the installation of a cofferdam for the tie-in to Hazelwood Shopping Centre Bridge commenced on 29/09/25. A silt curtain was installed around the works area prior to the removal of rock armouring to prevent fish entering the works area.

Removal of fallen trees and dead wood material from Glenmore River
