Monthly Site Environmental Audit

Glanmire Flood Relief Scheme

31/10/2023 To 28/11/23

Discharge Water Quality Monitoring – November (GFRS) 2023

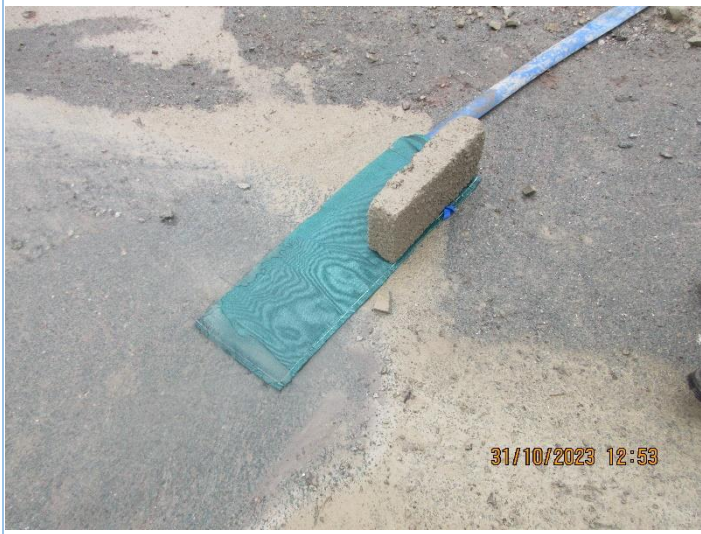
- A 2" pump was turned on at Hazelwood SC site (31/10/23) without a silt sock in place causing siltation in an area of the public carpark. Site ecologist was present and the issue was rectified immediately. (Image 1)

Caption 1	Section	W/C 30/10/23	Caption 2	Section	W/C 30/10/23
Silt sock on outlet point of pump, which caused siltation at Hazelwood SC site.			Silty water on road R639 from trailer stationary in Springmount site.

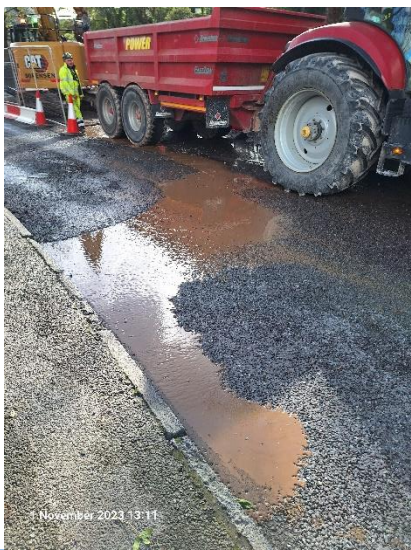
- Trailer spilling dirty water on road R639 – road sweeper deployed following ECoW request. (Image 2)
- Placing of Heras panels and minor site clearance occurred within the 20m buffer zone of holt N6 (Circus field) on the evening of Fri 27/10/20 (Image 3). Area refenced 03/11/23 and Contractor's otter specialist notified – disturbance deemed minor as clearance work did not encroach on riparian habitat and a wheeled, rather than tracked, excavator was used for the activity. (Image 4)

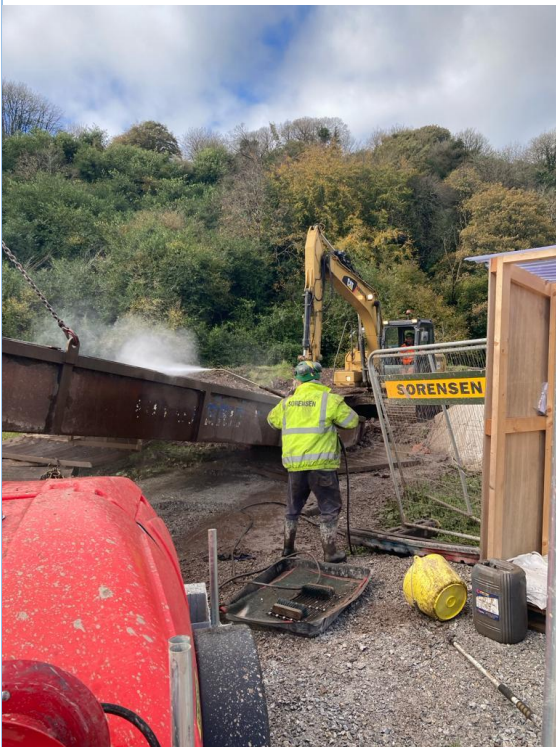
Caption 5 Section W/C 30/10/23

- Wheel wash at point of entry to JKW stockpile location, Area 1, washed out into the JKW area, removed off site and replaced on 4/11/23. (Image 5, Image 6 & Image 7)

Wheel wash washed out into JKW stockpile area prior to being removed from site.

Replacement wheel wash installed in same location as removed wheel wash.

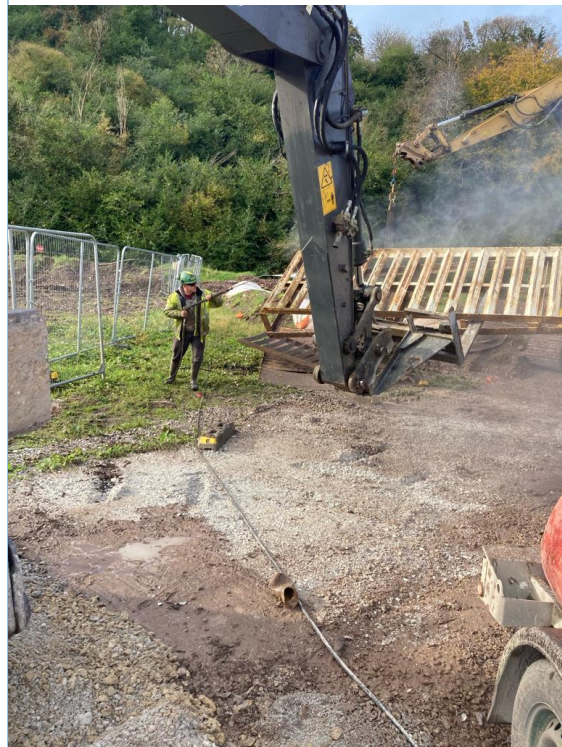
Caption 6 Section W/C 30/10/23

Grate from wheel wash washed out in JKW exclusion zone prior to removal from site.

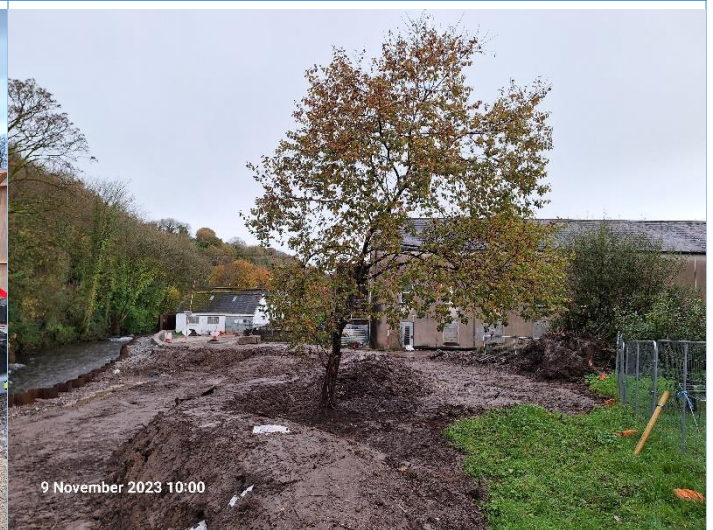
Caption 8 Section W/C 06/11/23

- IFI were notified of pumping activity at Springmount culvert.
- Bund removed from trunk of tree at Sallybrook House. (Image 8)
- Turbidity and pH monitoring was completed for areas with potential to be impacted by works/pumping activity.

Bund removed from trunk of tree at Sallybrook House.

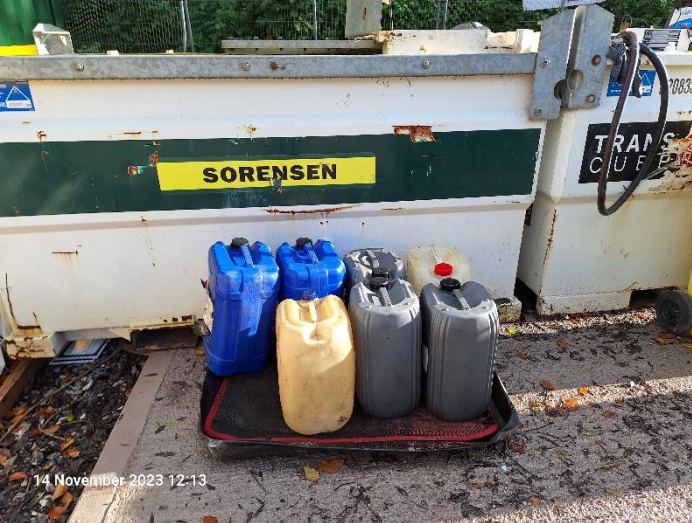
- Correct storage of fuel containers on spill tray observed at Area 1 compound. (Image 9)
- Turbidity of water entering river from behind temporary sheet piles (Area 1) testing high (14/11/23). NTU 26.4 at 10.30am – silt fencing adjusted, straw dam extended with stone, cofferdam implemented further upstream of flow and pumping diverted through settlement tank. Turbidity remained high for a period after implementation of mitigation measures but had returned to acceptable levels morning of 15/11/23.

Caption 9	Section	Caption 10	Section
W/C 13/11/23		W/C 13/11/23	
Containers stored correctly, on spill tray, Sallybrook main compound.		Drainage works underway in JKW exclusion zone, supervised by LD

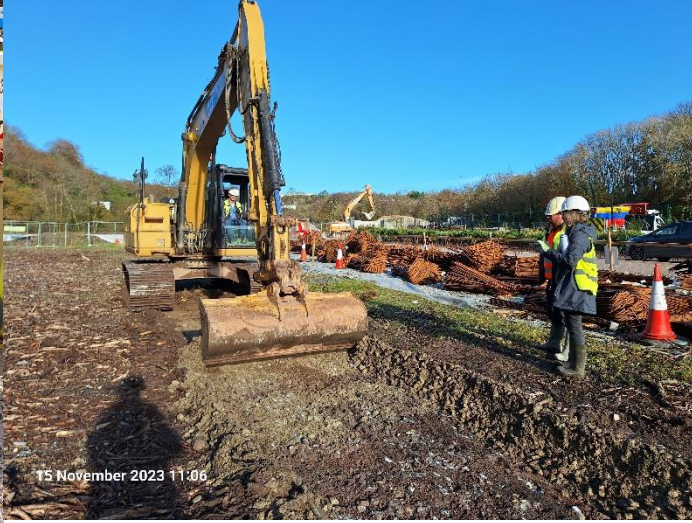
- Lisa Dolan on site 15/11/23 supervising drainage works in Area 1 JKW exclusion zone. Widespread evidence of JKW infestation within exclusion zone. Biosecurity measures implemented throughout works. (Image 10 & Image 11)

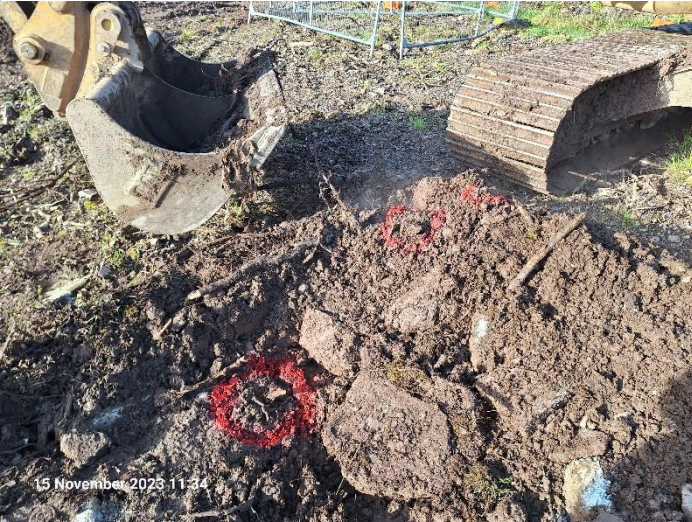
Photo 11		Photo 12	
 	 	Caption 11	Caption 12
W/C 13/11/23		W/C 20/11/23	
JKW identified during excavations in JKW exclusion zone.		Trench at Sallybrook House backfilled with excavated material.

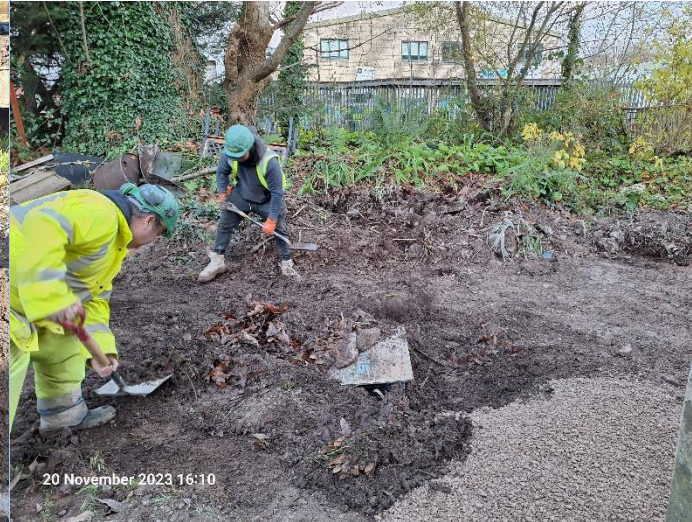
- Drainage works commenced in front of Sallybrook house. ER ECOW noted the presence of non-third schedule IAPS on the bank adjacent to works (Montbretia, Crocosmia × crocosmiiflora, and Winter Heliotrope, Petasites fragrans). Soil with potential of containing IAPS was not removed from the works area – trench was backfilled with excavated material. (Image 12)

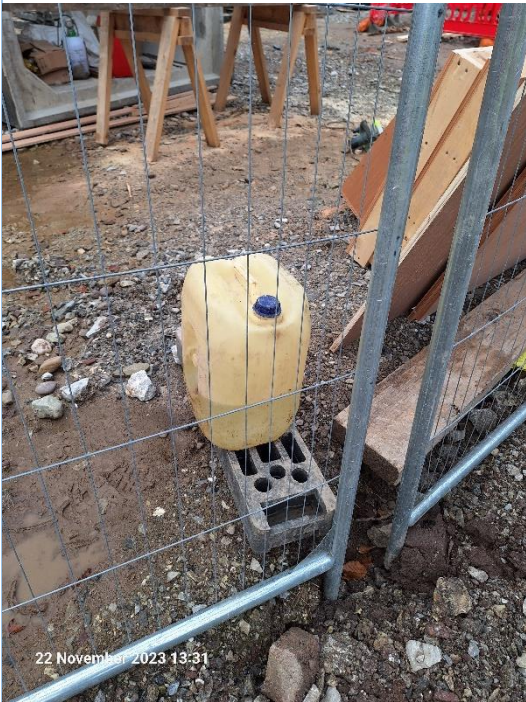
Caption 13 Section W/C 20/11/23

- The first Environmental Tour was completed by ER ECoW and Contractor Ecologists on 22/11/23. Overall, the site was to a high standard from an environmental and ecological view point – effective silt mitigation in place for pumping activities, no spills around pumps/generators – points of note include housekeeping of waste storage location, labelling of jerry can’s/containers and use of spill trays for storage of containers in live locations. (Image 13, Image 14, Image 15 & Image 16)

Unlabeled container not stored on spill tray on live site. Identified during Environmental Tour 001.

Action	Assigned to	Action Close Out Date
Label all jerry can’s/containers	MC	29/11/23
Housekeeping at waste storage area, Sallybrook	SD/MB	21/12/23
TBT on storage of fuel containers	SD	11/12/23
Provide Client ECOW with specification sheets for silt socks and silt de-watering bags.	SD	01/12/23
Silt socks to be fitted to all 2” pumping activity at risk of impacting watercourse. Mark Cronin to ensure compliance.	MC	Ongoing

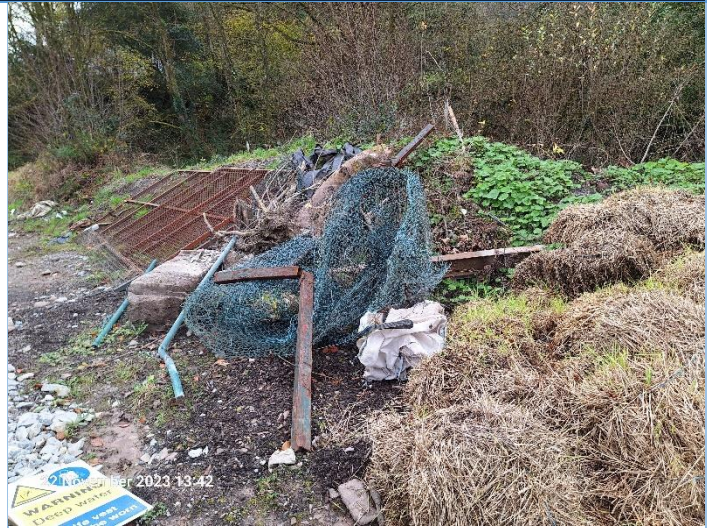
Caption 14 Section W/C 20/11/23

Waste storage location identified as requiring housekeeping during Environmental Tour 001.

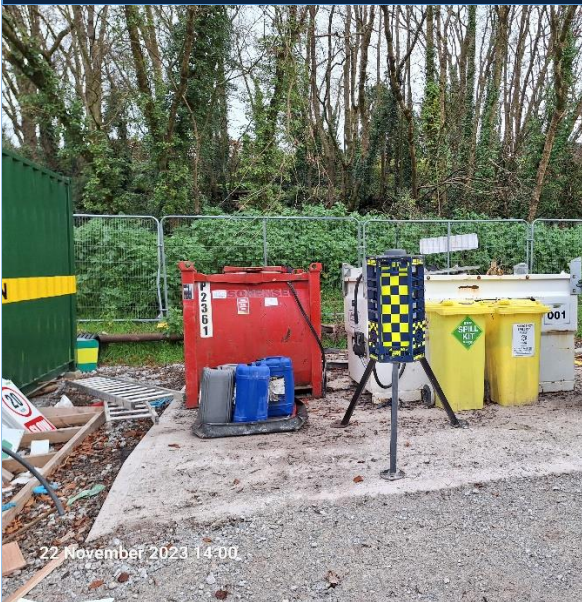
Caption 15 Section W/C 20/11/23

Correct storage of Jerry can's/containers at Sallybrook Compound identified during Environmental Tour 001.

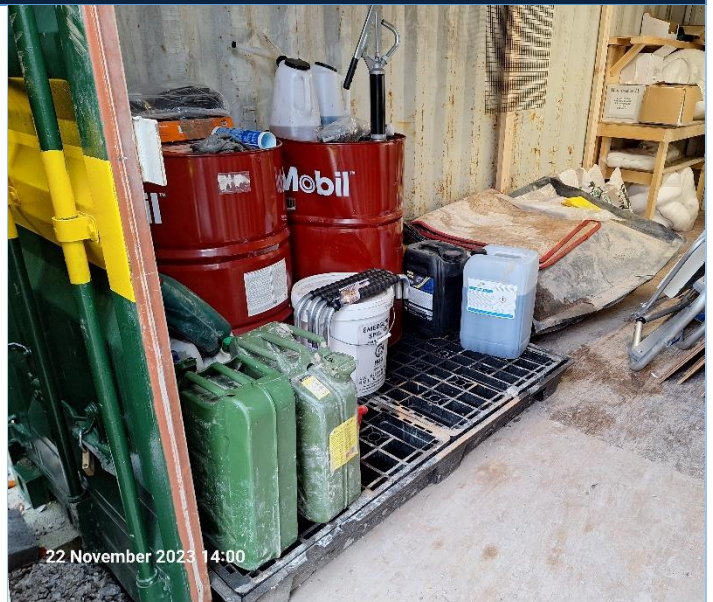
Caption 16 Section W/C 20/11/23

Correct storage of Jerry can's/containers at Sallybrook Compound identified during Environmental Tour 001.
