Cavan Town Flood Relief Scheme

Flood Report - October 2022

Cavan County Council

Report No. W3673-BLP-R-W-003 15 August 2023 Revision 02

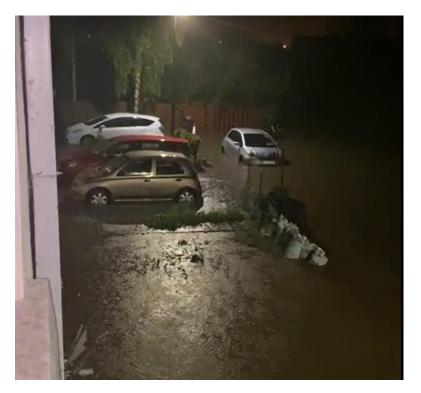
The Maples housing estate experienced flooding on October 17th, 2022, after a Yellow Status for wind and rain. Heavy downpours continued over the course of the week resulting in a recorded peak of flood level on the 28th of October 2022. Flood wrack markers and flood levels were not surveyed on site. But recorded internal flood depth from residents, ground levels and thresholds of each of the six houses an external flood depth ranging from 316mm to 367mm was calculated. Residents had restricted access to their homes because these significantly high levels of water partially covered their access routes to property, see Figure 2-2.

Figure 2-2 - Driveway Flooding at The Maples (28th October)

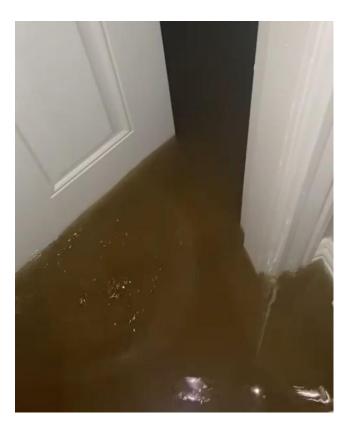
Internal flooding was reported within six houses of the estate (Figure 2-3 below). Residents reported to Anglo Celt newspapers that internal flooding that occurred on the 17th of October left the floors wet but did not have a significant depth. On the 28th of October, sandbags were breached which caused water levels to rise within the six homes overnight leaving their furniture, kitchen appliances and home luxuries submerged. One house owner reported 150mm of internal flooding with the other properties recording 100mm of internal flooding, (Figure 2-3). Internal household flood depths varied due to different threshold heights and external ground profiles.

Figure 2-3 - Internal Flooding of The Maples Housing Estate (28th October)

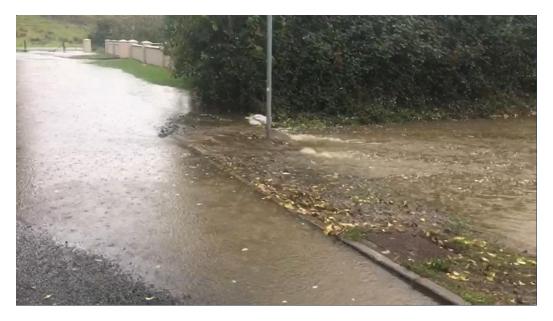
Spot flooding continued on the 1^{st} of November 2022, as shown in Figure 2-4. Footways, drives and routes to properties were dangerous to access as a result of deposited debris, waste, and mud from the flooding.

Figure 2-4 - 01/11/22 - Flooding at The Maples

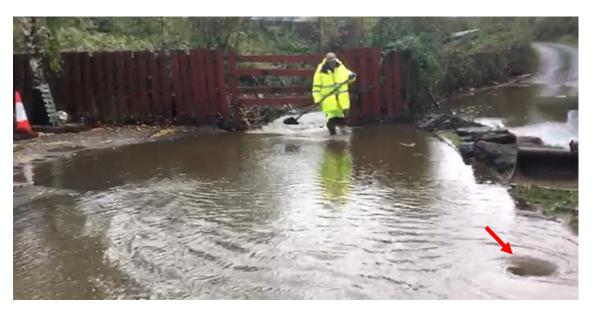
Figure 2-5 - CCC Alleviating Flood Measures

Cavan County Council (CCC) implemented restoration operations to clear The Maples housing estate of excessive water. These measures included freeing drains of debris and digging up areas surrounding the driveway to direct the flow of water into a nearby field. Effective debris removal resulted in water rapidly draining from the area (Figure 2-5 red arrow). Obstructions were removed such as fencing and branches were removed from their original position to alleviate the excess surface water. The obstruction removal increased the flow of the surface water, allowing it to be easily diverted into the nearby drain. The diversion of surface water did not result in flooding in other regions. Video footage taken the afternoon of the 2nd of November demonstrated the effective restoration of infrastructure by CCC, illustrated in Figure 2-6.

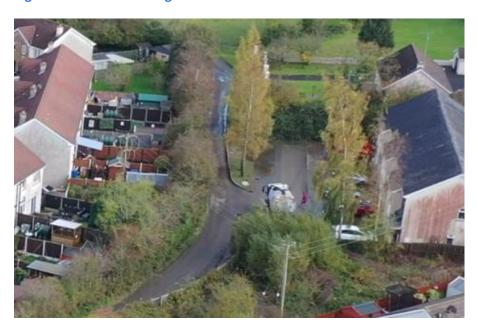
Figure 2-6 - Results after restoration from flood event at The Maples Housing Estate

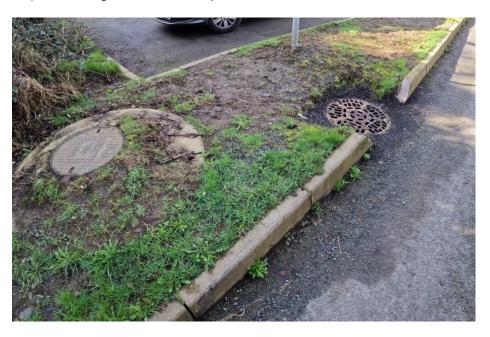
Figure 2-7 also indicated that there was loose debris several months later (23/02/2023) at The Maples housing estate which may have resulted from the flood event.

Figure 2-7 - Utility provision at The Maples housing estate

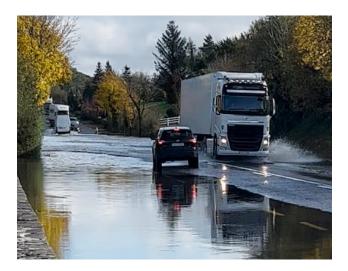
Killygarry Chapel, located on the N3 Dublin Road, in the Eastern region of the Cavan Town Flood Relief scheme area, was subjected to flooding on the 28th of October 2022. The heavy wind and rain occurred overnight on the 27th and continued into the morning of the 28th, which led to the busy national road becoming immersed in surface water, see Figure 2-9. The road was impassable for a period, then later became passable for westbound traffic with diversions for eastbound traffic via the Old Dublin Rd.

Figure 2-9 - N3 Killygarry Chapel Flood

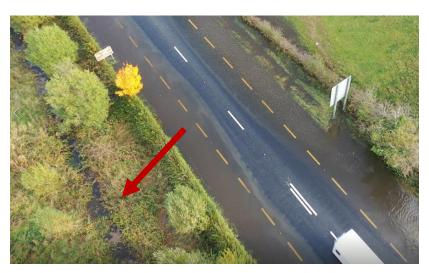
The Drumcrauve River that runs parallel to the flooded area was unable to support the volume of water from the downpours, causing the watercourse to overtop the embankment. The Drumcrauve River has shown evidence of overflowing its banks annually, leaving the road liable to flooding. Drone footage taken on the 28th of October shows the minimal volume capacity of the river due to dense vegetation within the Drumcrauve River, see Figure 2-10.

Figure 2-10 - Drumcrauve River Channel along the N3

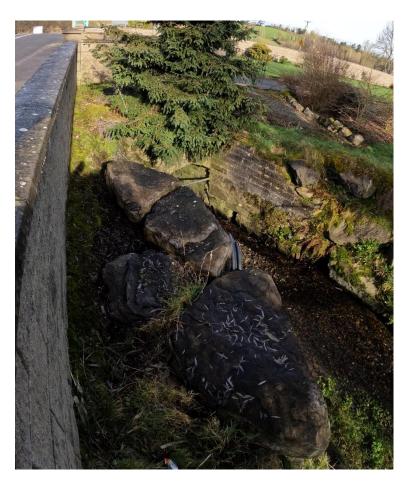
Figure 2-11 - Culvert opening near Killygarry Chapel

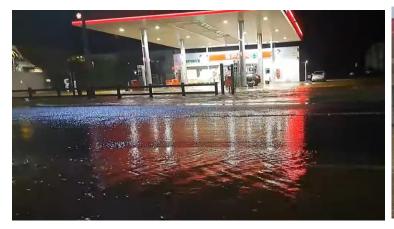
During this flood event, fire services attended flooding west of Killygarry Chapel at Kiernan's Service station and McDonalds on the N3. 150mm of water covered the forecourt of the two service facilities; see Figure 2-12. Significant flooding in this area occurs on a recurring basis; the last recorded flooding occurred on 02/09/2020 and is illustrated in Figure 2-13. It is likely that remnants of fuel on the service station forecourt contaminated the water during these floods and may have caused negative environmental effects to the surrounding environment. Effects of contamination have not been observed or reported.

Figure 2-12 - Kiernan's Service Station (2022)

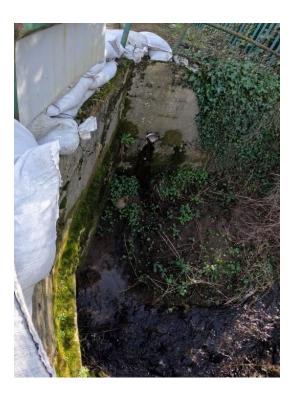
The service station and McDonalds are situated where the Reask River is culverted to join the Drumcrauve River (Figure 2-14). The associated catchment for the Reask (Figure 2-15), may be capturing extra surface water drainage from the N55 and commercial development, exceeding the culverts capacity capability, possibly causing the overspill at the entrance to the culvert. Assessing capacity, drainage profile and behaviour in due course could verify that the culvert is undersized. In order to expand the culverts diameter to increase flow of water, evaluations are to be conducted to mitigate flooding occurring on the forecourt without resulting in flooding at the confluence of the Reask and Drumcrauve River.

Figure 2-14 - Watercourse and culvert opening at rear of Service Station

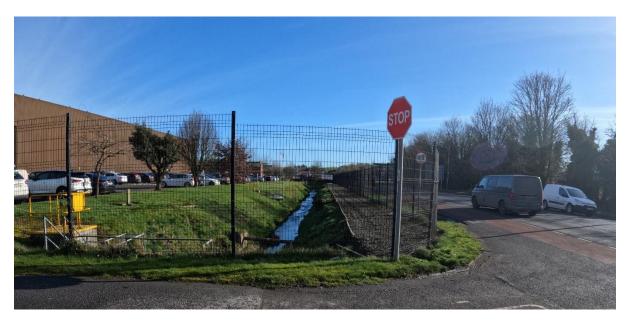
Figure 2-16 - Watercourse flowing parallel to N3 carriageway.

The Drumcrauve watercourse runs parallel to the N3 before it culverts under the North exit of the Dublin Road Roundabout. Evidently, from Figure 2-14 to Figure 2-16 there is limited area for storage during a storm event causing the N3 to be vulnerable to overtopping of the river banks. Drainage behaviour and systems worked efficiently to quickly dissipate the stagnant water from road infrastructure after flow intensity decreased in the watercourse.

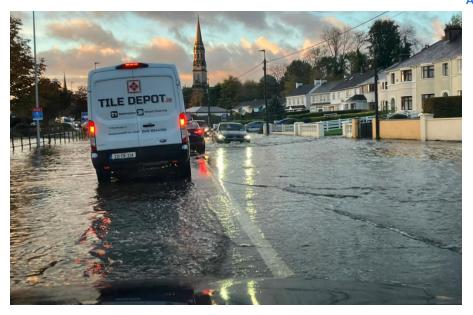
The Curragho River occasionally overflows its banks after heavy rain which results in Cathedral Road becoming flooded. The image in Figure 2-18 was taken on the 28th of October 2022 illustrating a flood depth that presented a significant restriction for vehicular access along Cathedral Road.

Figure 2-18 - Flooding at Cathedral Road, Cavan Town

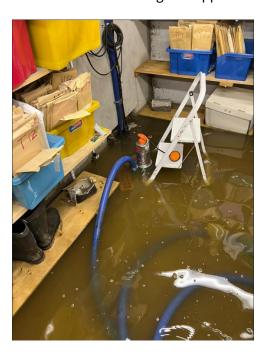
GV Maloney & Co. Solicitors reported heavy flooding on October 28th, 2022, see Figure 2-19. Pumps extracted water at a height of approximately 300mm from the bottom level of the basement.

Figure 2-19 - Basement Flooding of GV Maloney & Co. Solicitors

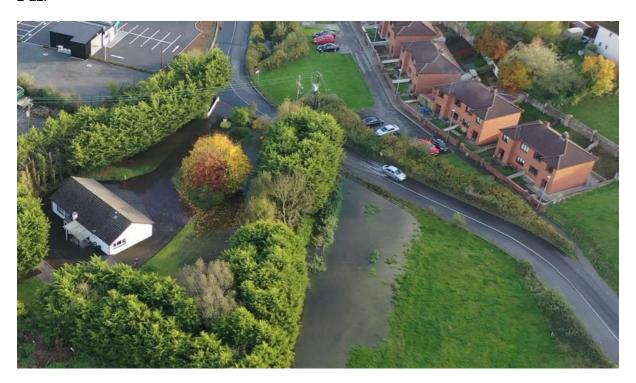
Drone footage indicated that the road was flooded from the route up to Tullymongan from the Aldi supermarket at Dublin Road. Extracts from the drone footage are indicated in Figure 2-21 and Figure 2-22.

Figure 2-21 - Drone footage indicating flooded road near Laragh Crescent from route of Dublin Road to Tullymongan - Extract 1

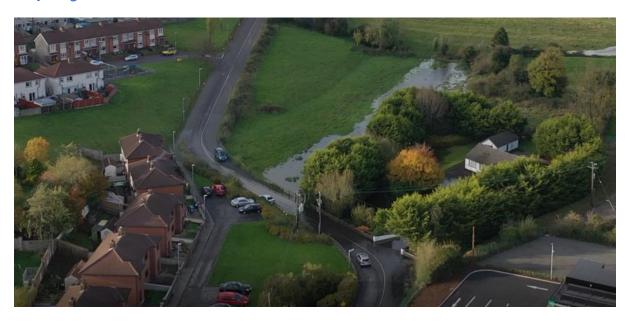
Figure 2-22 - Drone footage indicating flooded road near Laragh Crescent from route of Dublin Road to Tullymongan - Extract 2
