Environmental Report April 2025

Glashaboy Flood Relief Scheme

Document code: FFEC-GFRS-2025-004

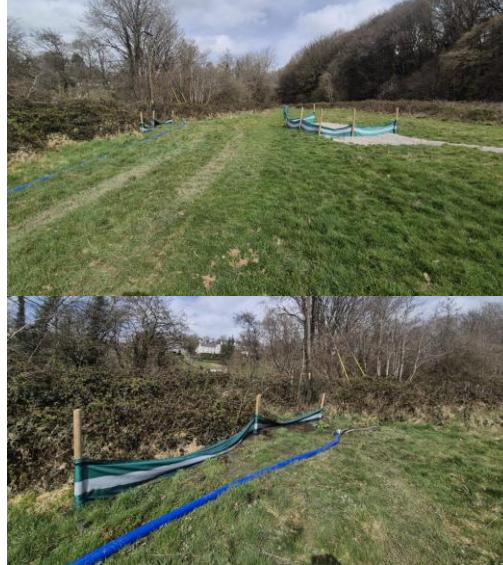
Item number	Date	Comment	Image	ECoW Action/Recommendation	Sorensens's Action response
4.4	02/04/2025	The attenuation area associated with the Hazelwood overflow culvert pumping continues to be monitored during periods of use. The two discharge locations are alternated as needed, based on ground infiltration and percolation capacity.

Liaised with site ecologist regards pumping activities and monitoring.	The site ecologist regularly communicated site updates and the latest pumping arrangements through the Ecology WhatsApp group.

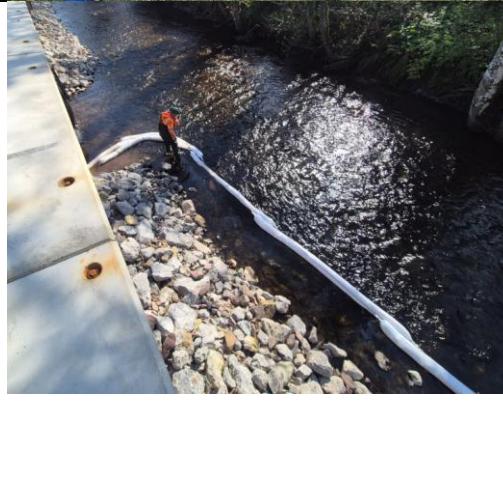
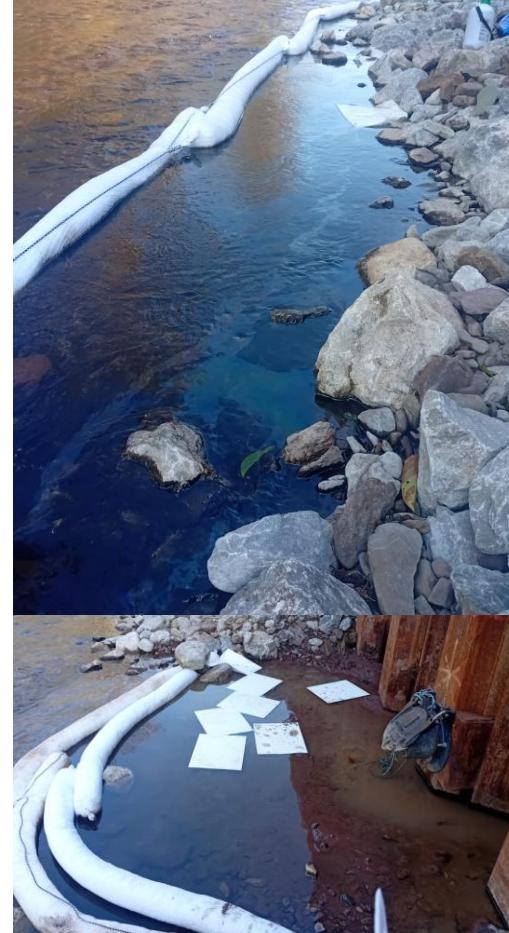
4.5	02/04/2025	The preexisting hydrocarbon contamination present within the sediment of Sallybrook stream that was activated during excavation works to install drainage line is leaching into the main channel. The pollution is receiving ongoing treatment using Bioversal HC to support the natural breakdown of pollutants.

Item number	Date	Comment	Image	ECoW Action/Recommendation	Sorensens's Action response
		The presence of pollutants in the water has been sporadic—at times quite pronounced, and at other times nearly absent. This variability may be influenced by precipitation events and/or changes in groundwater flow patterns.

The site ecologist was regularly consulted regarding the monitoring and treatment of the affected area.	Treatment was applied based on daily visual inspections, with Bioversal HC used promptly whenever signs of contamination were observed. The solution to stop this contamination, which originates outside the scheme, may require an interceptor be installed on the drainage line.

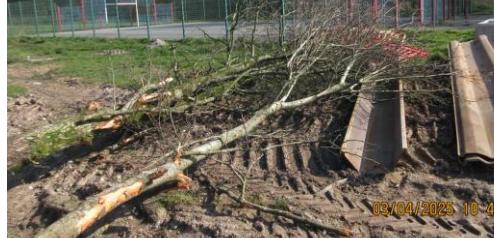
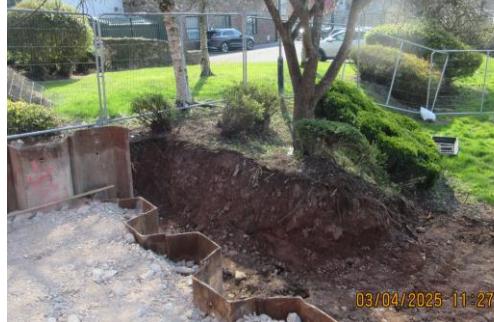
Item number	Date	Comment	Image	ECoW Action/Recommendation	Sorensens's Action response
4.6	03/04/2025	<p>A mature birch tree was removed from the Credit Union grounds to facilitate the overflow culvert works at Hazelwood Bridge. This was agreed in advance with the landowners. A replacement tree will be planted upon completion of the works, as part of the reinstatement and landscaping of the grounds.</p>

<p>Tree removal was discussed with the site ecologist. Although efforts were made to retain the trees, this was ultimately not possible due to the need for temporary works in the immediate area.</p>	<p>All efforts were made to retain the tree. Once its removal became unavoidable, the landowner was consulted, and compensatory planting was agreed upon.</p>

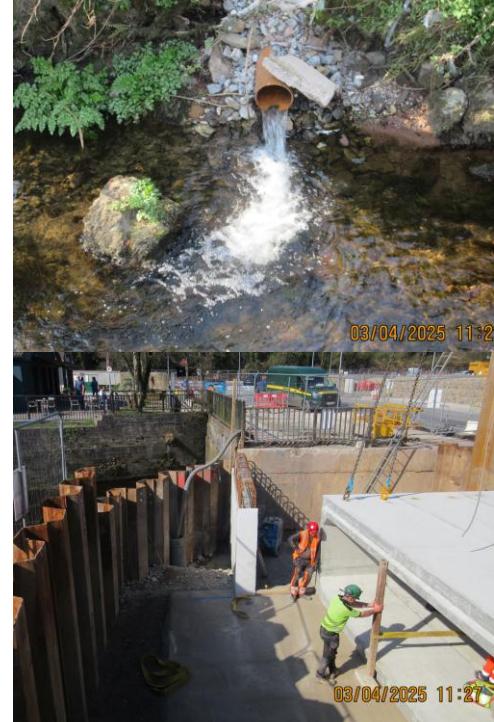
Item number	Date	Comment	Image	ECoW Action/Recommendation	Sorensens's Action response
4.7	03/04/2025	Pumping from the Hazelwood overflow culvert was subject to ongoing monitoring. The outlet was only used during non-intrusive works, and visual inspections throughout the day consistently confirmed that the discharged water was clean and clear.

03/04/2025 11:21 03/04/2025 11:27	This pumping arrangement was previously discussed with the site ecologist and the grounds crew.	The discharge point was regularly monitored to good practise.

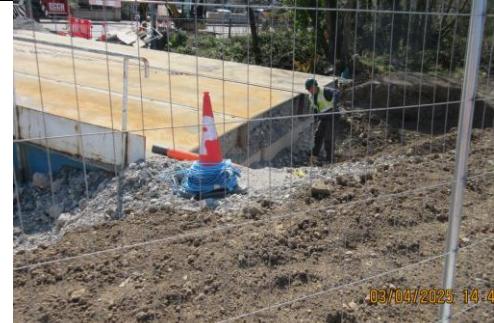
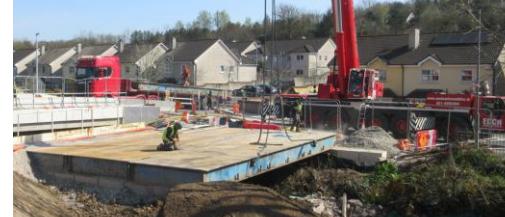
4.8	03/04/2025	The Bailey bridge was removed today. Good care was taken to remove all loose stone and silty material prior to lifting, as the bridge sections were being moved across a watercourse.

03/04/2025 14:48	Part of the works was supervised to ensure best practice was followed throughout.	The bridge removal was carried out in a clean, controlled, and professional manner, with appropriate measures in place to prevent environmental impact.

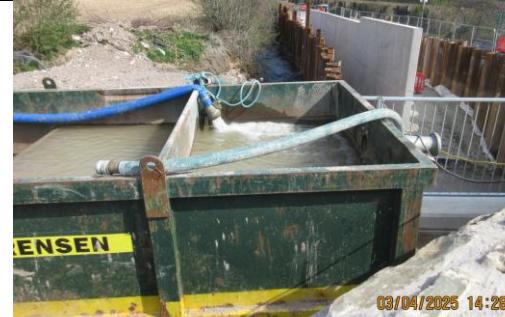
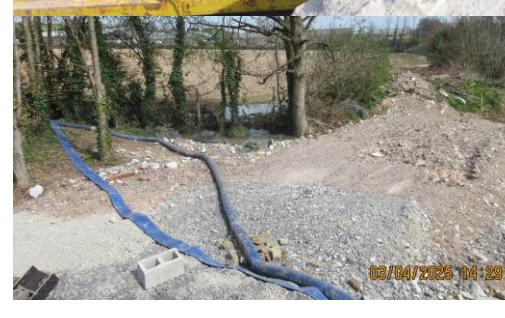
03/04/2025 14:52		
4.9	03/04/2025	<p>Pumping operations at the New Line works area are ongoing and continue to be conducted in a controlled and professional manner. Daily NTU readings are being recorded, and attenuation through the settlement tank, manifold system, and adjacent wooded and agricultural field area is functioning effectively. The landowner was consulted and granted permission for a small section of the field to be temporarily used for attenuation purposes.</p>

03/04/2025 14:29	<p>The pumping arrangement was discussed on multiple occasions with the site ecologist, particularly whenever any modifications or adjustments were proposed.</p>	<p>The pumping was carried out to a high standard, with no silty water entering the Glashaboy River at any point during the operation—an effective and well-executed outcome.</p>

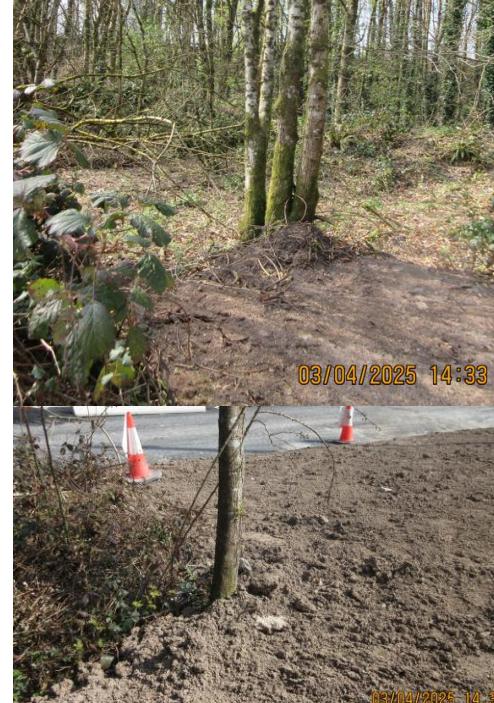
Item number	Date	Comment	Image	ECoW Action/Recommendation	Sorensens's Action response
4.10	03/04/2025	Earth material was deposited around the base of number of trees at New Line. This is not good for the long-term health of the trees.

Discussed the situation with site ecologist.	<p>The earth material was carefully removed from around the base of the affected trees, and no long-term negative impacts are expected, given the short duration of the issue.</p> <p>The site ecologist included in toolbox talk for workers best practise when working around trees to avoid a possible repeat incident in the future.</p>

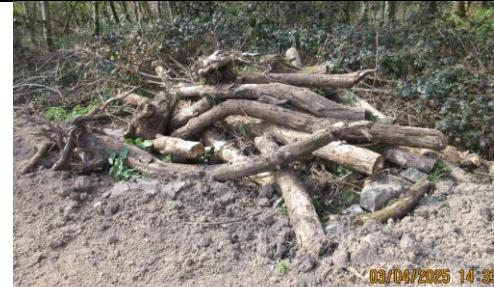
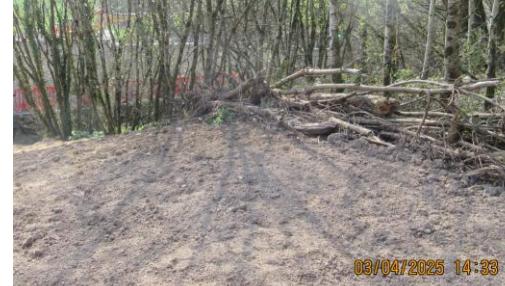
4.11	03/04/2025	New Line dead wood was consolidated and positioned into two piles. This is a biodiversity action that will be of benefit to insects that utilize decaying wood as part of their life cycle.

Discussed with site ecologist.	Wood was put into position in conjunction with the reinstatement works in this area.

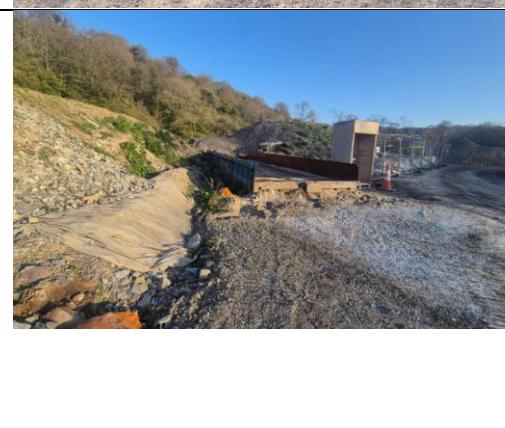
4.12	09/04/2025	Works on the Sallybrook embankment are required to finalize the flood protection structures. The material to be removed is contaminated with Japanese Knotweed. Due to limited space in the holding area, the wheel wash has been relocated to just outside the holding area.

Discussed works with site ecologist prior to start to ensure all biosecurity measures were incorporated into the plan.	The operation was carried out under the supervision of the site ecologist. All contaminated materials were placed in the holding cell, and all biosecurity measures were successfully followed. The wheel wash will be on hand for future works that would require its use on the scheme.

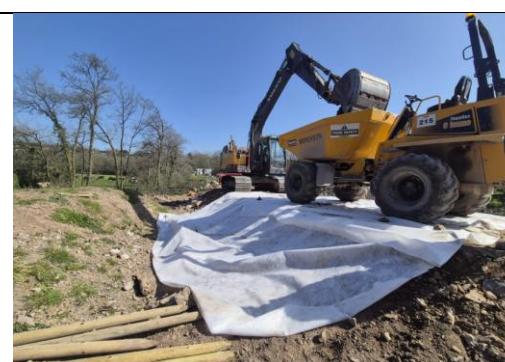
4.13	09/04/2025	Works begin on Sallybrook embankment under supervision.

Discussed works with site ecologist prior to start ensure all biosecurity measures were incorporated into the RAMS.	A comprehensive RAMS was submitted for these works. The works were carried out under supervision. All biosecurity measures were successfully followed.

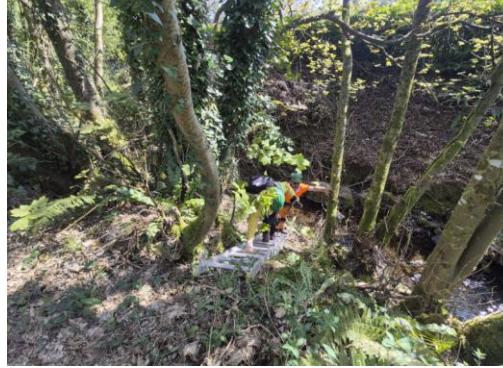
Item number	Date	Comment	Image	ECoW Action/Recommendation	Sorensens's Action response
4.14	09/04/2025	<p>Bat Boxes, installed as part of the design last year, were inspected by a Bat Specialist. Bat Box A was examined using a fibre optic scope. No bats or droppings were detected. The bat specialist advised leaving the box in its current position, as it has only been in place for one summer season and may require more time to be utilised.</p> <p>Bat Box B was obscured by a young hawthorn tree and could not be inspected using the fibre optic scope. Due to the dense vegetation, it is considered unlikely that bats are currently using the box. The hawthorn tree is scheduled for removal, which will improve visibility and increase the likelihood of future bat roosting.</p>

<p>Liaised with SCE site ecologist to locate bat boxes. Inspection by bat specialist organised in collaboration also.</p>	<p>The consultation with the bat specialist was best practice. The young hawthorn tree to be removed to encourage uptake.</p>

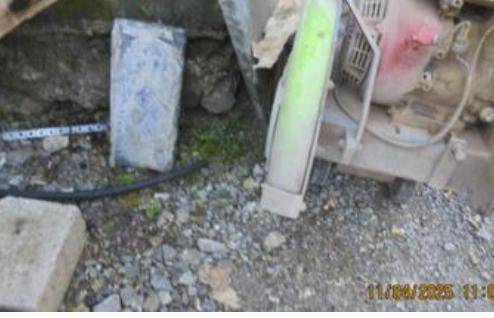
4.16	11/04/2025	<p>As part of last year's conservation and protection measures, specimens of the nationally rare plant <i>Little Robin</i> (<i>Geranium purpureum</i>) were collected from an old stone wall that was removed during construction works. The plants were temporarily placed outside the compound's fire escape door.</p> <p>Given the species' annual lifecycle and its tendency to self-seed in the area where it was last growing, relocating the plants further was no longer considered the best</p>		Discussed during Environmental Tour 027.	SCE have delineated the area and removed any materials and equipment from the doorway to protect emerging seedlings. Signage has been installed both inside the meeting canteen and outside the entrance to raise awareness of the sensitive area. The extent of seedling emergence has been marked with blue spray paint. SCE have also advised personnel who regularly use this rear entrance to exercise caution and avoid trampling the seedlings.

Item number	Date	Comment	Image	ECoW Action/Recommendation	Sorensens's Action response
		<p>option. Although the location is not ideal, plants now germinating in this area may potentially be <i>Little Robin</i>. As a result, the area has been designated an ecologically sensitive zone. It should be protected from disturbance until it can be confirmed whether the emerging plants are indeed the rare species.</p>

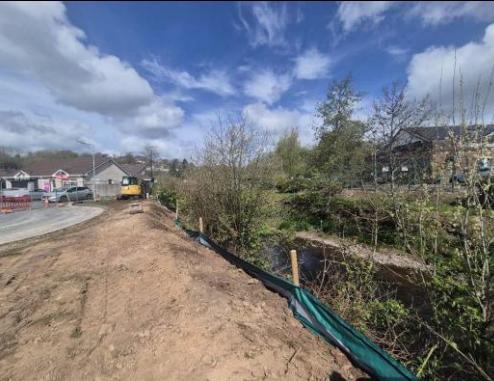
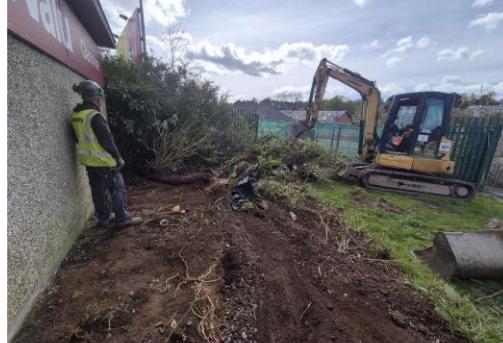
4.17	11/04/2025	<p>Hazelwood Shopping Centre Bridge Enabling Works: The ecological components included silt control measures, riparian vegetation removal, and the implementation of biosecurity protocols.</p>

<p>Discussed during Environmental Tour 027.</p>	<p>Vegetation clearance was carried out under a valid permit, and silt fencing was installed both as a sediment control measure and to clearly delineate the site boundary. All enabling works were undertaken under the supervision of the site ecologist to ensure compliance with environmental protection measures.</p>

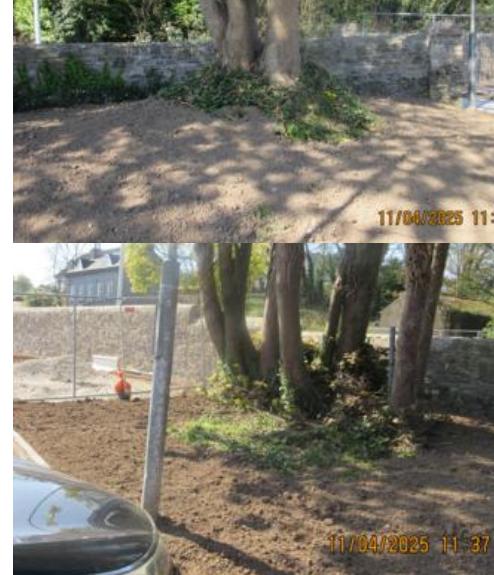
Item number	Date	Comment	Image	ECoW Action/Recommendation	Sorensens's Action response
4.18	11/04/2025	<p>Springmount – Site Reinstatement: Ground reinstatement works have been completed at Springmount. It was positively noted that a section of wildflowers and native vegetation has been retained as part of the restoration efforts, contributing to local biodiversity.</p> <p>However, it was observed that mature ivy surrounding several trees at the site has recently been cut. As a result, the ivy is now decaying and appears unsightly. This action is considered a setback in terms of biodiversity value.</p>

Discussed during Environmental Tour 027.	<p>Reinstatement was carried out with sensitivity to existing native plants which were safeguarded.</p> <p>It was observed that mature ivy surrounding several trees at the site has recently been cut. As a result, the ivy is now decaying and appears unsightly. This action is considered a setback in terms of biodiversity value. The ivy removal was not carried out by SCE, but rather by an unknown third party who entered SCE's designated works area without authorisation.</p>

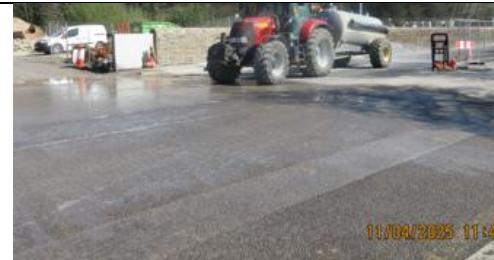
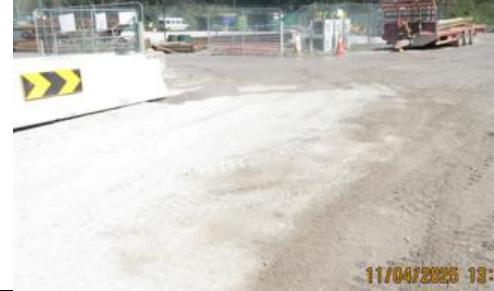
4.19	11/04/2025	Dust Control Measures: During today's inspection, there was clear evidence of recent watering at the locations of Circus Field, New Line, and Sallybrook,

Item number	Date	Comment	Image	ECoW Action/Recommendation	Sorensens's Action response
		confirming that dust control measures are actively being implemented.

Discussed during Environmental Tour 027.	Ongoing dust suppression is being carried out at all relevant work areas through regular wetting down using a tractor and water tank.

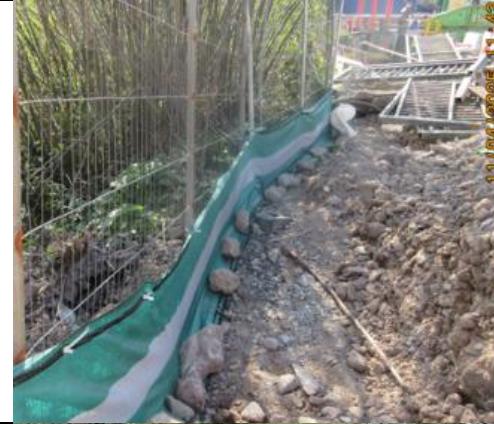
4.20	11/04/2025	SCE's Environmental Unit identified a potential risk of loose material entering the Glashaboy River due to stockpiling activities in Circus Field.

Discussed during Environmental Tour 027.	SCE proactively installed a silt fence to contain loose material.
4.21	11/04/2025	Cos na Gleann Reconnection Area – JKW Inspection: The area cleared last September to facilitate the Cos na Gleann reconnection was inspected for Japanese Knotweed (JKW). No signs of actively growing JKW were observed.

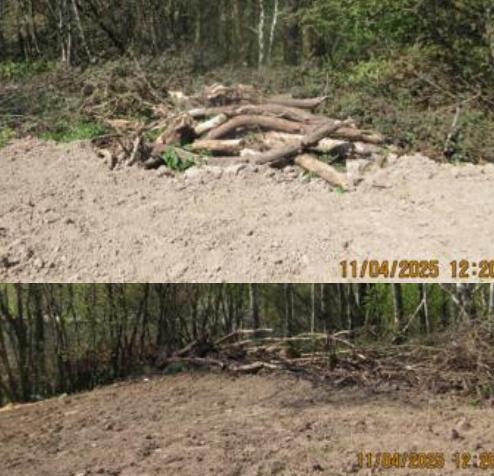
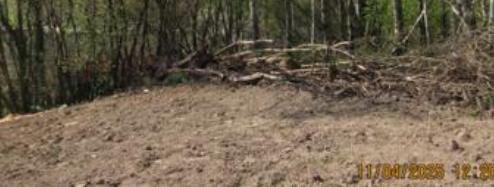
Item number	Date	Comment	Image	ECoW Action/Recommendation	Sorensens's Action response
4.22	11/04/2025	New Line – Reinstatement Works: During reinstatement works at New Line, dead wood piles were observed to have been created. This is considered a positive outcome for biodiversity, as such features provide valuable habitat for invertebrates.

Discussed during Environmental Tour 027.	Dead wood was gathered into two piles which will be left in place for its biodiversity value.

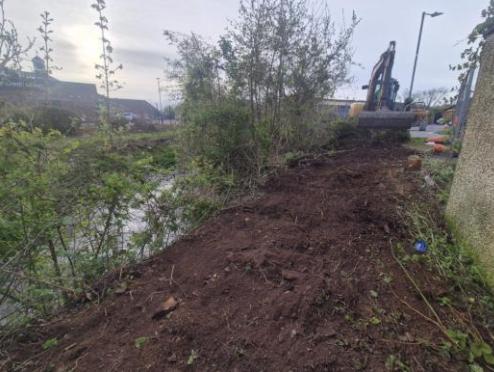
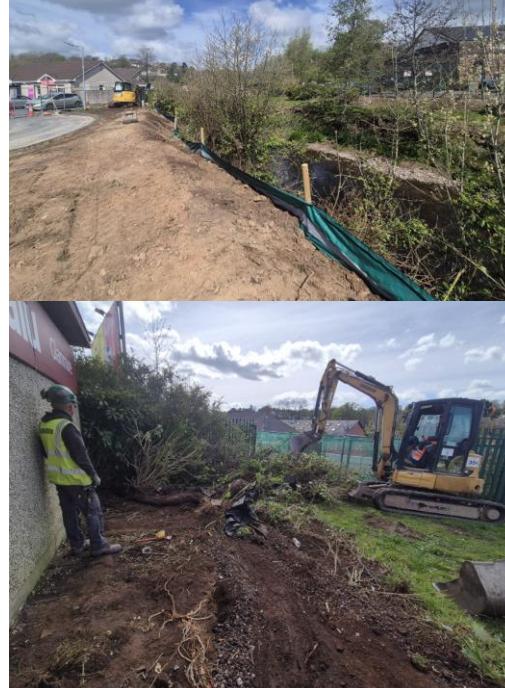
4.23	14/04/2025	Enabling works for the Hazelwood SC Bridge, including the installation of a temporary Bailey bridge and service diversions, required vegetation clearance. This clearance was supervised by the site ecologist and was informed by ecological surveys, including a breeding bird survey, an invasive plant species survey, and a small mammal survey. The vegetation clearance was carried out in phases to

Item number	Date	Comment	Image	ECoW Action/Recommendation	Sorensens's Action response
		support and align with these targeted surveys. To mitigate potential, prevent sediment runoff, silt curtains were installed, particularly where bare ground was exposed adjacent to a watercourse.

Discussed works and the relevant ecological concerns with site ecologist prior to clearance.	All clearance works were conducted with due professionalism and with full regard for the significant ecological sensitivities of the site.

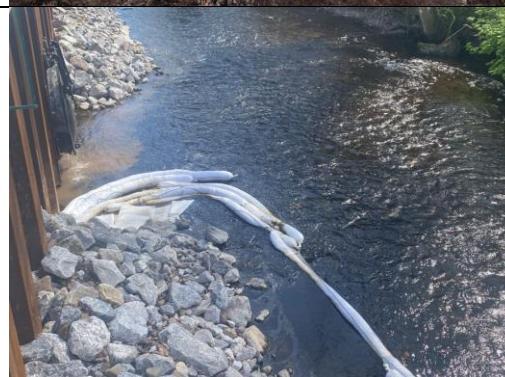
4.24	16/04/2025	An inspection of the Sallybrook Stream contamination incident found evidence of minor ongoing leakage. The POD drainage line, located immediately downstream of the absorbent pads and oil retention booms, showed

Item number	Date	Comment	Image	ECoW Action/Recommendation	Sorensens's Action response
		<p>signs of a small amount of sediment entering the main Glashaboy channel. This sediment release was traced to third-party roadworks being conducted today at the junction between the R639 and L2973. These works were not related to the Flood Scheme.</p>		<p>Inland Fisheries Ireland (IFI) or Cork City Council.</p>

The level of sediment was considered minor, and as such, it was not deemed necessary to report the incident to	No action required regarding the sediment release. SCE are performing ongoing monitoring and maintenance of contamination containment measures.

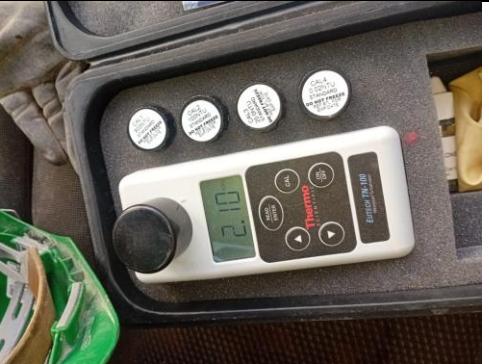
4.25	17/04/2025	<p>NTU levels at the overflow culvert near Hazelwood Bridge were monitored today and recorded as consistently low, indicating minimal turbidity. Water continues to be pumped into the stormwater drainage network under normal conditions. However, during periods of disturbance works that may generate silt, pumping is redirected to the attenuation area located at the basketball court field. measures.</p>

<p>Liaised with site ecology regarding the ongoing monitoring and adjusting of silt controls at Hazelwood Overflow culvert works.</p>	<p>An adaptive approach helps mitigate potential sediment runoff and supports environmental protection measures.</p>

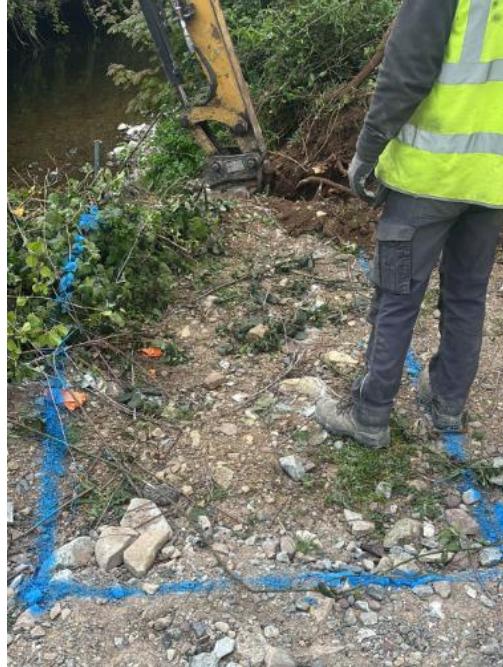
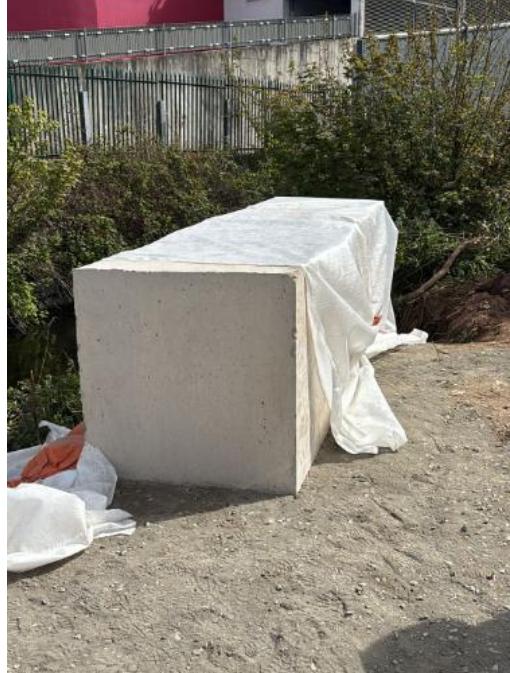
Item number	Date	Comment	Image	ECoW Action/Recommendation	Sorensens's Action response
4.26	17/04/2025	<p>Temporary supports were installed for the Bailey Bridge over the Glashaboy River. Importantly.</p> <p>The works necessitated the removal of regenerating tree growth, which had originally been cut back to facilitate earlier phases of the project. This clearance was carried out carefully and with due consideration for the adjacent watercourse. No sediment disturbance or instream activity occurred during the process.</p>

<p>Site inspections. Discussions with site ecologist regarding the proposed works. Mitigation measures developed.</p>	<p>The works were completed with appropriate environmental safeguards in place.</p>

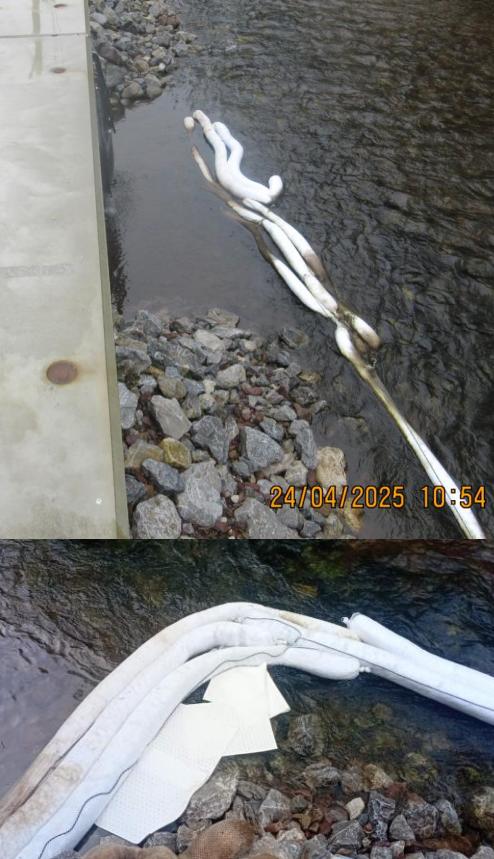
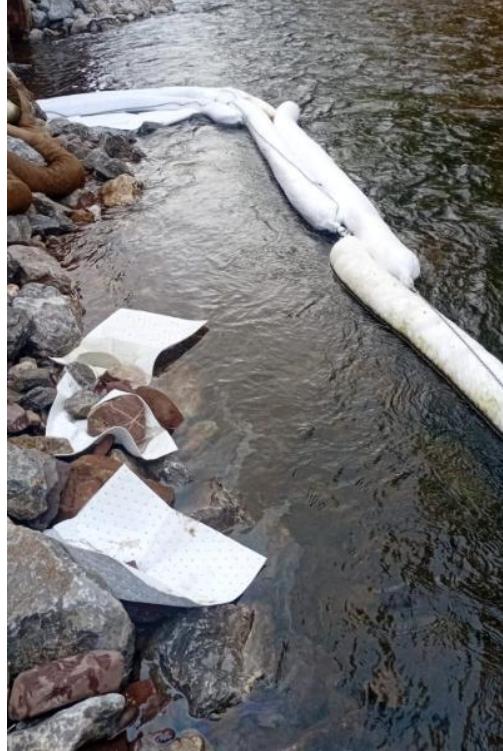
Item number	Date	Comment	Image	ECoW Action/Recommendation	Sorensens's Action response
4.27	24/04/2025	Sallybrook contamination was again visible today observed dissipating in small amounts from the rock armour area.

<p>Liaised with site ecologist re ongoing monitoring and containment measures.</p>	<p>Containment measures remain in place, including booms and absorbent pads, which were renewed as part of ongoing response efforts. Bioversal has been regularly applied in this area whenever contamination is detected.</p> <p>SCE are waiting for the final design from ARUP at this location that will address lingering contamination issue.</p>

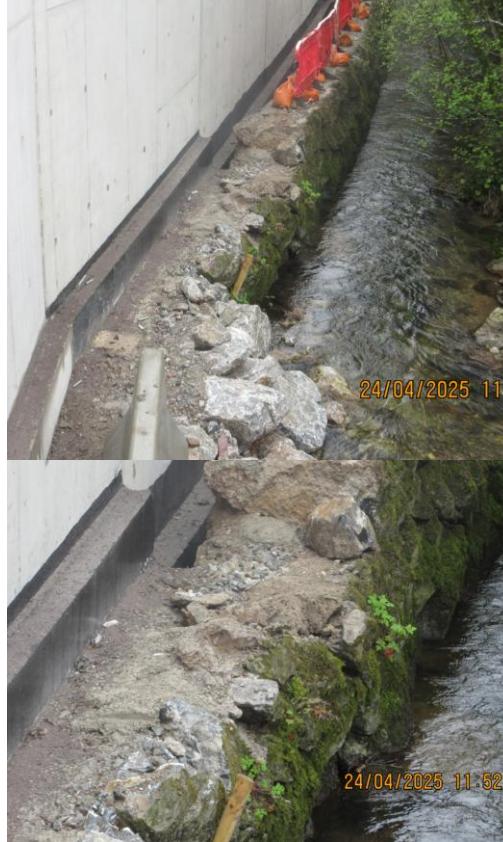
Item number	Date	Comment	Image	ECoW Action/Recommendation	Sorensens's Action response
4.28	24/04/2025	<p>Concrete waste has been observed near the watercourse at the New Line RC wall. While the material is not fresh and therefore poses only a minor risk to the watercourse, its presence is not in line with best practice, particularly in such a sensitive waterway environment.</p>

<p>Discussed with site ecologist.</p>	<p>The area is scheduled for completion in July 2025, coinciding with the start of the 2025 in-stream works season. At that time, all material will be removed and transported to an appropriate licensed waste facility.</p> <p>Until then, the risk of material entering the watercourse remains minimal, with only a marginal possibility due to exceptionally high-water levels.</p>

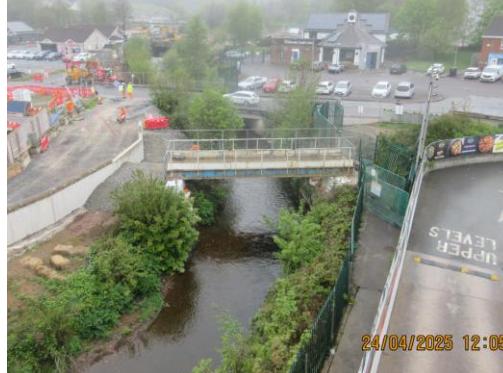
Item number	Date	Comment	Image	ECoW Action/Recommendation	Sorensens's Action response
4.29	24/04/2025	Bailey bridge pedestrian crossing installed as part of enabling works for the demolition and construction of Hazelwood shopping centre bridge.

Inspections and discussion with SCE.	Works carried out professionally with regard to ecology of the immediate surrounding area.

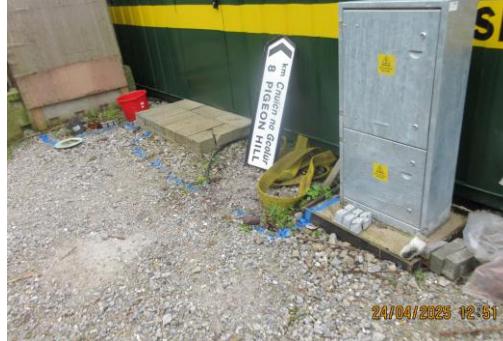
4.30	24/04/2025	The fire escape area at the compound kitchen is currently under monitoring for the possible presence of the rare plant species Little Robin (<i>Geranium purpureum</i>). Following recent rainfall, the designated area appeared somewhat faded but remains under active observation.

Monitoring is being conducted by both the client and the contractor's ecologists.	If little robin is confirmed on site following identification of its floral characteristics when the plant comes into bloom, any required vegetation clearance will be carried out carefully, with seed material recovered and preserved in accordance with best ecological practice. Designated area received further delineation and signage.
