Environmental Report November 2023

Glashaboy Flood Relief Scheme

Document code: FFEC-GFRS-2023-003

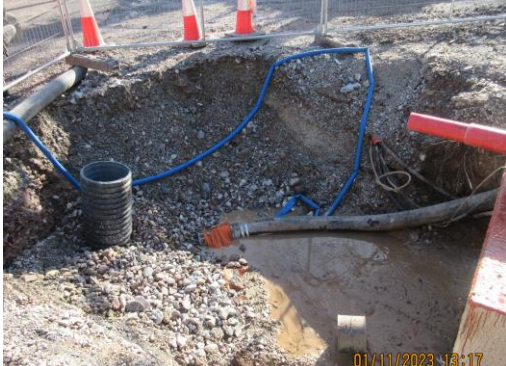
Item number	Date	Comment	Image	ECoW Action/Recommendation	Sorensens's Action response
1	1/11/2023	Springmount culvert – pumping of works area into the stream. No silt mitigation in place.

Informed site ecologist. Email sent to project manager.	Contractor ecologist immediately went to location, the pump was turned off and redirected to a location that would not come into contact with the watercourse, a silt sock was attached before the pump was turned back on.
2	1/11/2023	Springmount - Dumper leaking dirty water from works area onto main road.

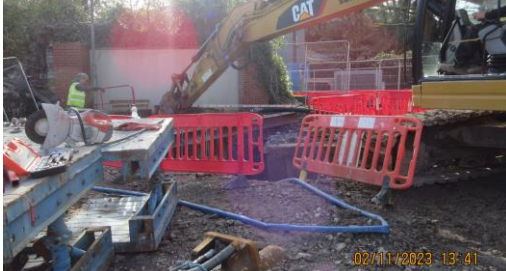
Informed site ecologist. Email sent to project manager.	Steps taken to prevent sedimented water reaching drain system. Road sweeper deployed to clean road.
3	2/11/2023	Springmount - there was a brief period during which pumping from the works area, where concrete pouring was taking place, discharged directly into the stream. No monitoring measures were in place.

Informed site ecologist.	Pumped water was diverted into the combined system avoiding the watercourse.

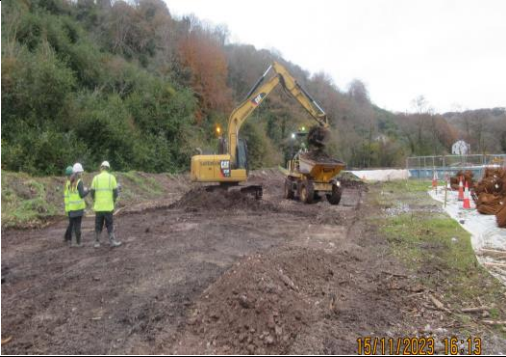
<p>11</p>	<p>15_16_17/ 11/2023</p>	<p>Lisa Dolan on site supervising drainage works in Area 1 JKW exclusion zone. Widespread evidence was found of JKW infestation within the exclusion zone. Biosecurity measures implemented throughout works.</p>

<p>Discussions onsite with knotweed specialist.</p>	<p>No action required.</p>
<p>12</p>	<p>15/11/2023</p>	<p>Fresh JKW canes growing from stockpile within the temporary cell.</p>

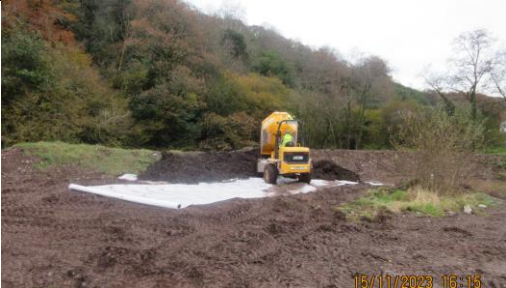
<p>Advised that, though not strictly necessary, canes could be sprayed with herbicide to increase biosecurity during future relocation.</p>	<p>Advice taking into consideration.</p>
<p>13</p>	<p>15/11/2023</p>	<p>Contaminated mulched material from the JKW exclusion zone is transferred to a designated area within the temporary cell.</p>

<p>Discussions with site ecologists about the long-term plan for this material.</p>	<p>The official plan has not been issued yet. From discussions on site, the preliminary plan is to stockpile and manage the material to facilitate decomposition and mitigate JKW growth throughout the duration of the works.</p>
