## Environmental Report August 2025

### Glashaboy Flood Relief Scheme

**Document code:** FFEC-GFRS-2025-008

*The following is the clients Ecological Clerk of Works (ECoW) monthly review of the Glashaboy River (Glanmire/Sallybrook) Drainage Scheme. It details observations made on site regarding environmental and ecological factors involved in the scheme. This formulates a monthly review to be submitted to the Environmental Monitoring Group (EMG).*

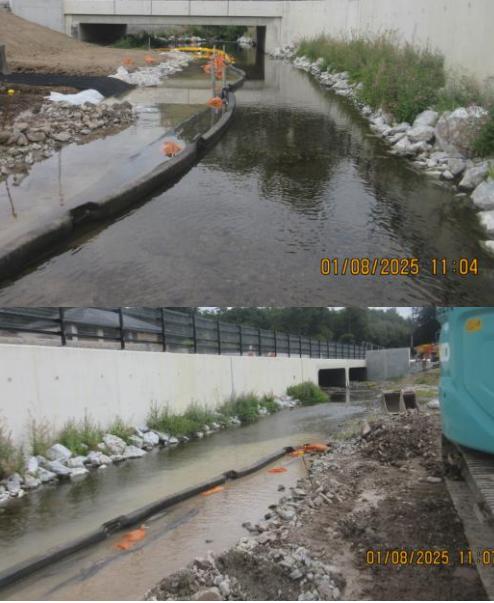
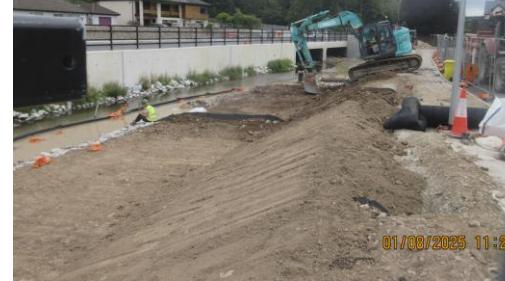
| Item number | Date | Comment | Image | ECoW Action/Recommendation | Sorensens's Action response |
|---|---|---|---|---|---|
| 8.1 | 01/08/2025 | <p>Erosion control works at Copper Valley Vue involved the installation of Secumat erosion control matting, topsoil, and riprap along the southern bank of the Glanmore River.</p> <p>To complete the installation, an anchor trench was excavated at the toe of the matting. As this trenching took place in wet conditions, effective silt management was identified as the primary environmental concern.</p> <p>A downstream water quality monitoring unit was installed to transmit and record data.</p> | | <p>Discussed works and ecological mitigations with site ecologist prior to works. Periodic supervision and monitoring of water quality data throughout.</p> | <p>Silt curtains were deployed in advance of the works in a linear arrangement, separating the working area from the river channel. As the works progressed and flow conditions fluctuated, the configuration of the silt curtains was adjusted accordingly.</p> <p>The role of the site ecologist was central in both minimising sediment release and interpreting real-time data to determine whether work should be paused. Throughout, the operations were conducted in a controlled and measured</p> |

| Item number | Date | Comment | Image | ECoW Action/Recommendation | Sorensens's Action response |
|---|---|---|---|--|--|
| | | | <br>01/08/2025 11:21 | | manner, guided by informed ecological oversight. |

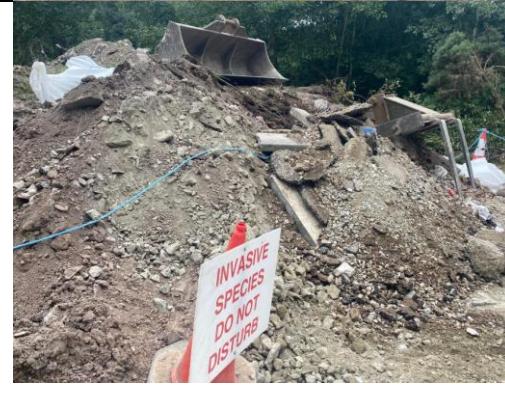
| Item number | Date | Comment | Image | ECoW Action/Recommendation | Sorensens's Action response |
|---|---|---|---|--|--|
| <b>8.2</b> | 01/08/2025 | A breach of biosecurity protocols occurred in Area 4 at the temporary JKW stockpile due to the improper storage of an excavator bucket and forks. The situation highlights the importance of strict adherence to biosecurity measures and proper waste segregation on-site. | | Recorded event and notified site ecologist. | Bucket and forks were removed without issue. Stockpiles were relocated to Sallybrook temporary holding cell. |

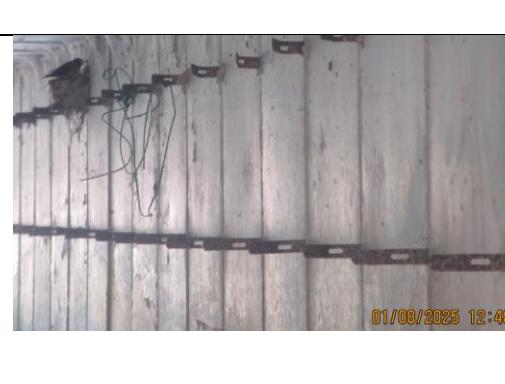
| Item number | Date | Comment | Image | ECoW Action/Recommendation | Sorensens's Action response |
|---|---|---|---|--|--|
| <b>8.3</b> | 01/08/2025 | The Swallow nest located under the Hazelwood Road bridge was rechecked. One chick remained in the nest and had not yet fledged. A subsequent check confirmed that the nest was empty with all chicks now having fledged successfully. | <br>01/08/2025 12:48 | Discussed with site ecologist and carry out periodic checks. | All works in the area were undertaken without any adverse impact on the Swallow chicks. |

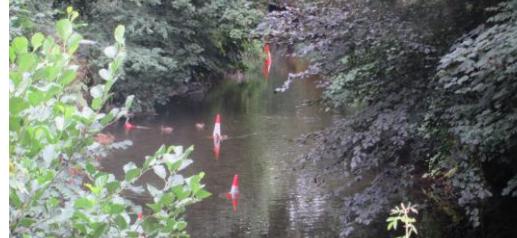
| Item number | Date | Comment | Image | ECoW Action/Recommendation | Sorensens's Action response |
|---|---|---|---|---|---|
| 8.6 | 05/08/2025 | Cones thrown into river upstream of Area A4. Up to five cones that were positioned along this closed road. | | Notified SCE. | SCE later retrieved these from the river. |

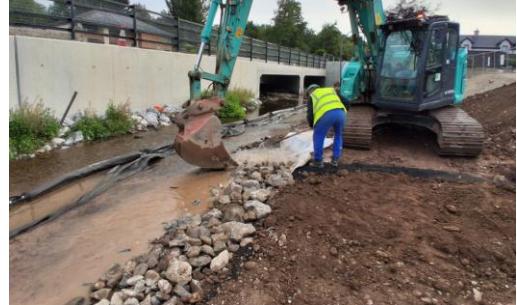
| Item number | Date | Comment | Image | ECoW Action/Recommendation | Sorensens's Action response |
|---|---|---|---|---|---|
| 8.7 | 06/08/2025 | Works continuing at Copper Valley Vue. Silt screens and deflector in place. This created a clean channel and an enclosed sedimented section that received controlled releases with the aim of spreading out the sediment loads into the Glanmore. | | Partial supervision and liaising with site ecologist. | Works were supervised by the site ecologist. Silt measures were adjusted as need on an ongoing basis. Water quality parameters were monitored continually. |

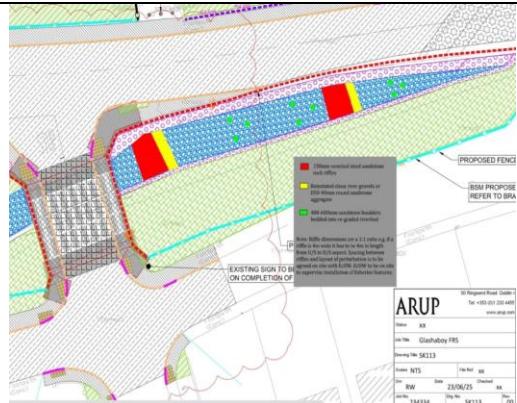
| Item number | Date | Comment | Image | ECoW Action/Recommendation | Sorensens's Action response |
|---|---|---|---|---|---|
| 8.8 | 06/08/2025 | Hydro morphological features will be installed today at CVV overseen by fisheries specialist JN. | | Supervised by employer's ecologist - JN. | Fisheries enhancement features were installed along this section of the Glanmore River, including the addition of riffles and boulders, to increase in-stream habitat diversity and support fish populations. |

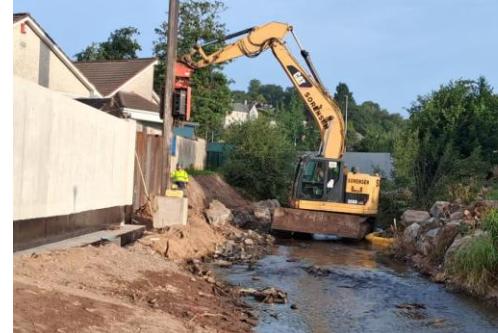
| Item number | Date | Comment | Image | ECoW Action/Recommendation | Sorensens's Action response |
|---|---|---|--|--|--|
| 8.9 | 06/08/2025 | At Hazelwood, the permanent sheet piles were driven from within the river into the dry riverbank. Silt controls were in place, and only minor silt release was observed. Monitoring sondes were deployed throughout to record and track water quality parameters. | | Periodic supervision. All controls were place. | Tracking was kept to a minimum as possible within the river by the track machine. |

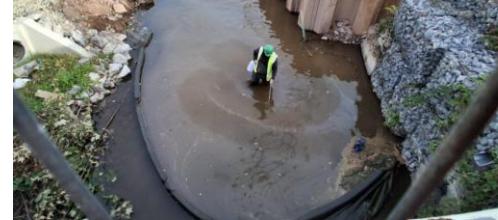
| Item number | Date | Comment | Image | ECoW Action/Recommendation | Sorensens's Action response |
|---|---|---|--|--|--|
| 8.10 | 06/08/2025 | A build-up of hydrocarbon pollution was observed at the silt curtain located at hazelwood. | | Looked for source and discussed with site ecologist. | Regular application of BioVersal continues within the silt curtain area at Hazelwood Shopping Centre Bridge. A suspected hydrocarbon leak was investigated, focusing on potential sources within the works area and nearby plant. No definitive source was identified. The tracked excavator in the area had recently undergone maintenance, which may be the source from recently lubricated parts being in contact with water. |

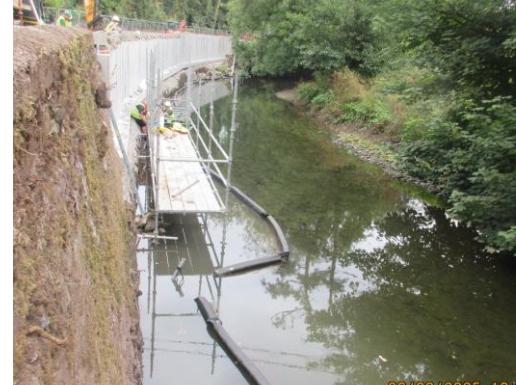
| Item number | Date | Comment | Image | ECoW Action/Recommendation | Sorensens's Action response |
|---|---|--|---|---|---|
| 8.11 | 06/08/2025 | Scaffolding being installed in Area 4 inside silt curtains to allow stonemason carry out cladding works. | | Recorded. | Scaffolding has been placed in the river for the instream works. In line with seasonal restrictions, it must be fully removed prior to the close of the instream works window |

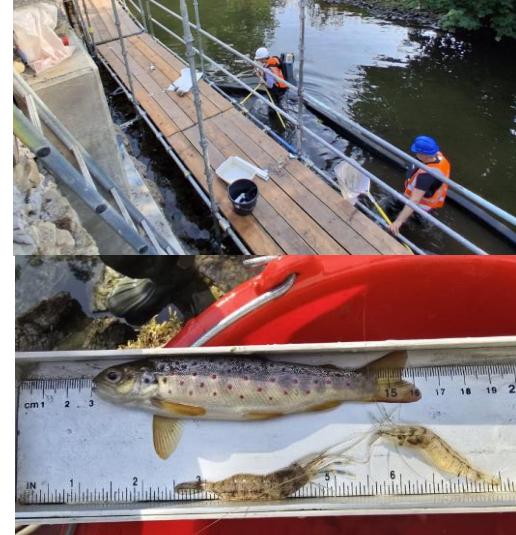
| Item number | Date | Comment | Image | ECoW Action/Recommendation | Sorensens's Action response |
|---|---|--|---|---|---|
| 8.12 | 07/08/2025 | Electrofishing in Area 4 - No fish found in void. But fish removed from inside silt curtains. | | Recorded. | Electrofishing carried out as a precaution prior to works to fill void. |

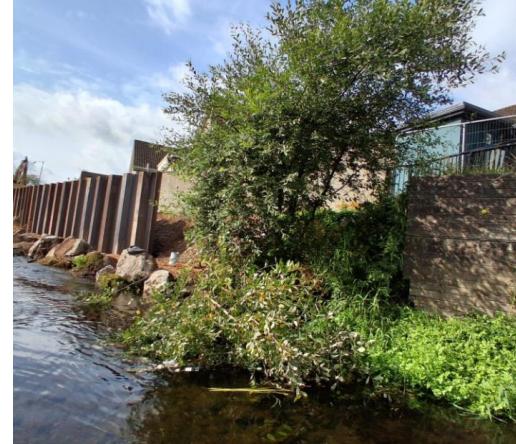
| Item number | Date | Comment | Image | ECoW Action/Recommendation | Sorensens's Action response |
|---|---|---|---|---|---|
| <b>8.13</b> | 07/08/2025 | Further clearance has been completed under Permit No. 028. | | Recorded. | Vegetation and trees surveyed prior to clearance. |

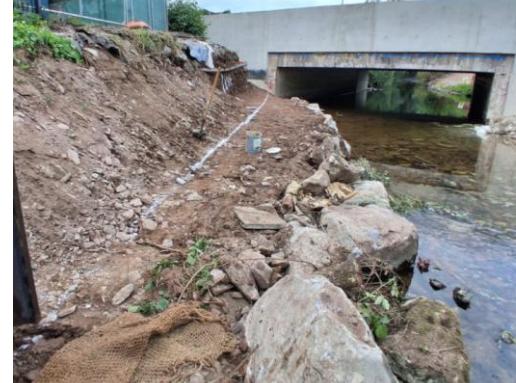
| Item number | Date | Comment | Image | ECoW Action/Recommendation | Sorensens's Action response |
|---|---|---|---|---|---|
| <b>8.14</b> | 07/08/2025 | Revetment wall at Bean and Leaf was demolished. – all works were contained to the dry embankment. | | Recorded. | No further action required. |

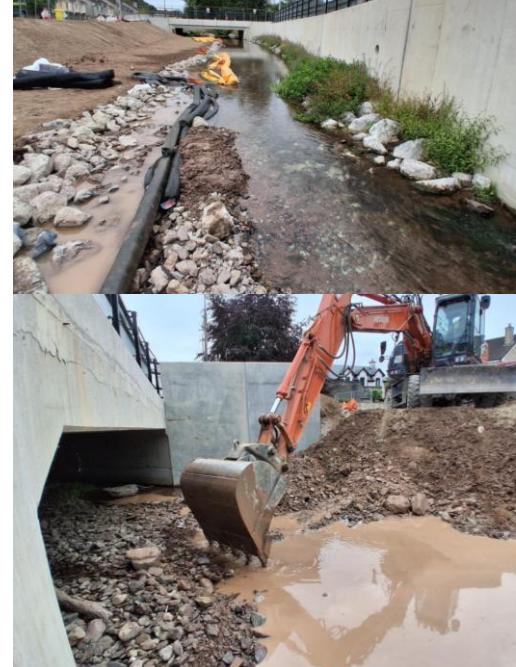
| Item number | Date | Comment | Image | ECoW Action/Recommendation | Sorensens's Action response |
|---|---|---|---|--|---|
| 8.15 | 08/08/2025 | Controlled release of silt took at CVV. | | Recorded. | Silt generated from works released gradually rather than all at the same time spreading out sediment load. |

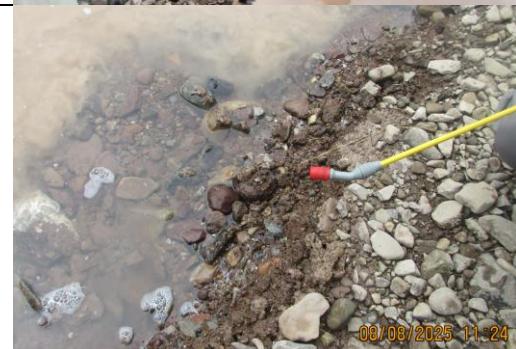
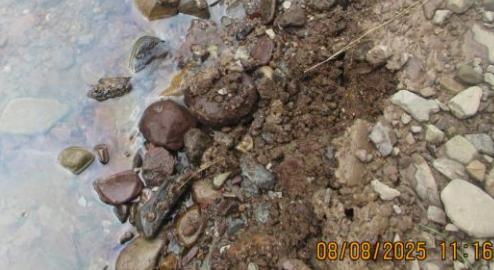
| Item number | Date | Comment | Image | ECoW Action/Recommendation | Sorensens's Action response |
|---|---|---|---|--|---|
| 8.16 | 08/08/2025 | <p>Hydrocarbon pollution was observed leaching from material within the overflow channel of the culvert at Brooklodge. The contamination was confined to an isolated pool immediately downstream where rock armour was being installed.</p> <p>Rapid and repeated</p> | | Investigated incident with site ecologist. | Pollution was short lived and source most likely attributed Brooklodge culvert installation in previous year. |

| Item number | Date | Comment | Image | ECoW Action/Recommendation | Sorensens's Action response |
|---|---|---|---|---|--|
| | | applications of Bioversal HC were carried out to treat the affected area. | | | |

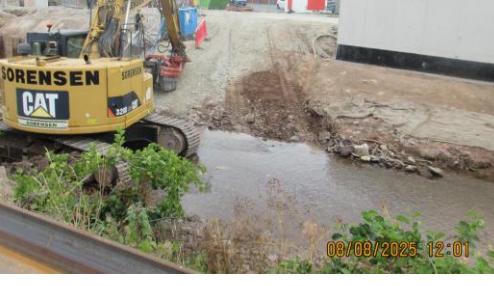
| Item number | Date | Comment | Image | ECoW Action/Recommendation | Sorensens's Action response |
|---|---|---|---|---|--|
| 8.17 | 08/08/2025 | The access ramp into the Glashaboy at Hazelwood requires maintenance to control erosion and runoff, as the stone layer on the lower half has been worn away during recent sheet piling works. | | Raised issue with site ecologist. | The access ramp into the Glashaboy River at Hazelwood is in daily use. Regular maintenance works involve placing a new layer of stone fill material on the ramp, as required. |

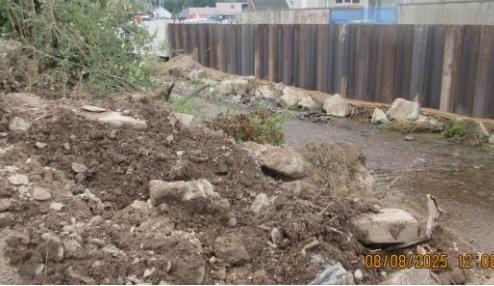
| Item number | Date | Comment | Image | ECoW Action/Recommendation | Sorensens's Action response |
|---|---|---|---|---|--|
| 8.18 | 08/08/2025 | Japanese knotweed (JKW) was identified on the Credit Union grounds, where material from the opposite riverbank has been temporarily stockpiled. | | Biosecurity measures will be required during any anticipated excavation works at this location. | Excavation works were carried out under supervision with biosecurity measures followed. Biosecurity measures were deployed during the removal works including the deployment of footwear facilities, cleaning down of buckets and tracks of the excavators, tyres and bodies of site vehicles. |

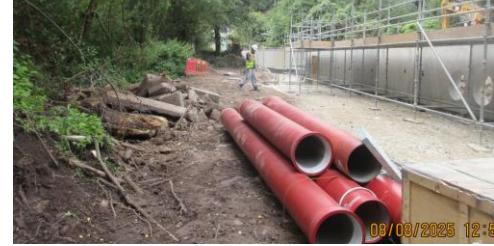
| Item number | Date | Comment | Image | ECoW Action/Recommendation | Sorensens's Action response |
|---|---|--|--|--|---|
| 8.19 | 08/08/2025 | The outlet path for the Area 4 pump station into the main channel will traverse areas affected by Japanese Knotweed (JKW) as well as zones of mature vegetation and trees. | | Implement biosecurity and measures to minimise impacts on the natural environment. | Biosecurity measures were followed. |

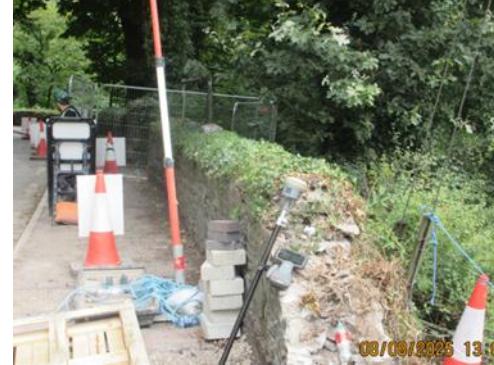
| Item number | Date | Comment | Image | ECoW Action/Recommendation | Sorensens's Action response |
|---|---|--|--|--|---|
| 8.20 | 08/08/2025 | Area 4 wall demolition and Demolition and subsequent works to take place adjacent to mature oak tree and invasive plant species Snow berry. | | Implement biosecurity measures. Demolition and subsequent works must be carried out with care to protect the oak tree, particularly its root system. | Works were carried out without harm to the oak tree either its roots or branches. Biosecurity measures were followed. |

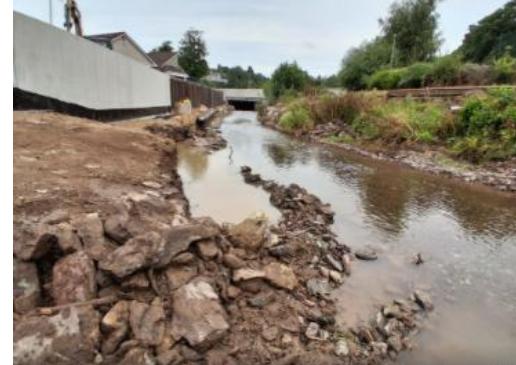
| Item number | Date | Comment | Image | ECoW Action/Recommendation | Sorensens's Action response |
|---|---|---|--|---|---|
| <b>8.21</b> | 11/08/2025 | Key for rock armouring being dug at Hazelwood Shopping Centre Bridge. | | Monitor NTU levels. Inspections and partial supervision. | Silt curtains were used downstream to stagger silt release into watercourse. NTU level were monitored through the works to manage siltation levels. |

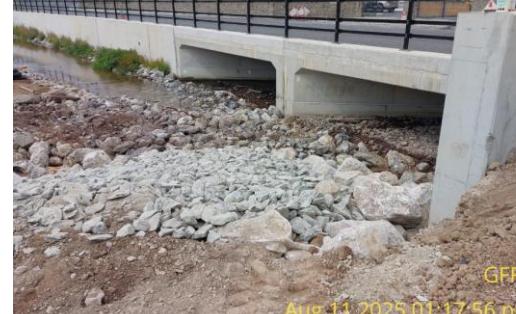
| Item number | Date | Comment | Image | ECoW Action/Recommendation | Sorensens's Action response |
|---|---|---|--|---|---|
| <b>8.22</b> | 11/08/2025 | The channel was dug across the downstream end of Brooklodge culvert to facilitate installation of rock armouring. | | Liaised with site ecologist. Inspections and partial supervision. | These works required the adjustment of the silt curtains. High spikes of NTU were recorded downstream however their duration was brief. Water was allowed to 'rest' through sporadic work and breaks. |

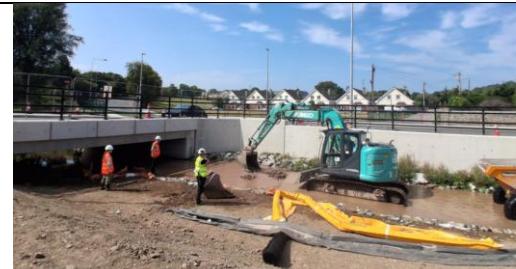
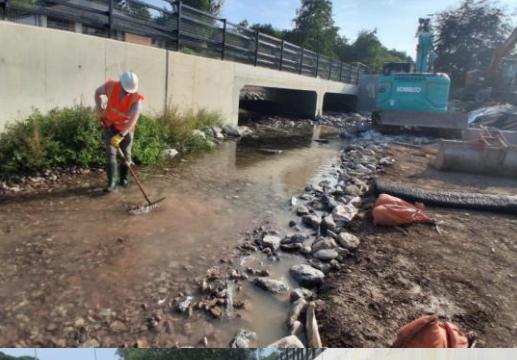
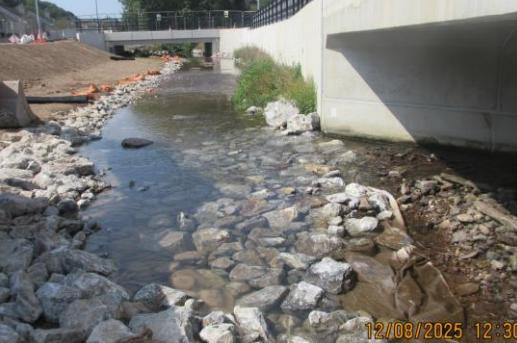
| Item number | Date | Comment | Image | ECoW Action/Recommendation | Sorensens's Action response |
|---|---|---|--|---|---|
| <b>8.23</b> | 11/08/2025 | Hydromorphology works were completed. Parr/ small adult trout in pool and some salmonid fry in the riffles were immediately observed. | | Supervised and guided works. | These works were part of a Change Order to provide some diversity to the river section for the benefit of fisheries species. |

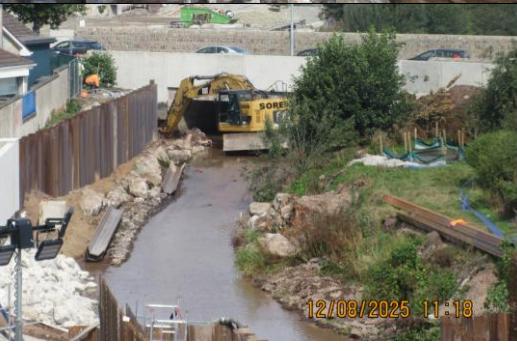
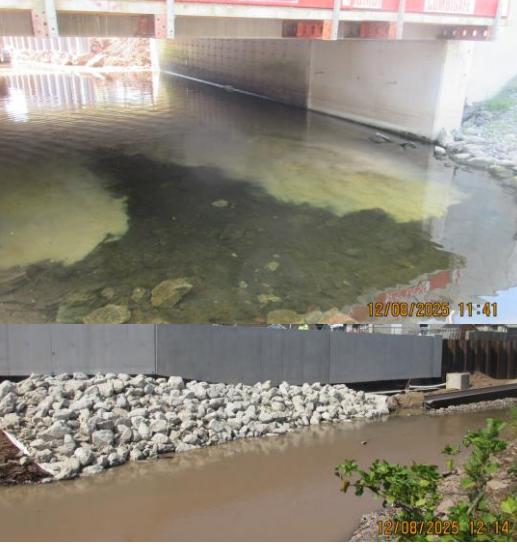
| Item number | Date | Comment | Image | ECoW Action/Recommendation | Sorensens's Action response |
|---|---|---|---|---|---|
| <b>8.24</b> | 12/08/2025 | <p>High NTU levels were recorded today due to several unforeseen factors:</p> <ol style="list-style-type: none"> <li>1. An unexpected bank collapse.</li> </ol> | | <p>Recorded and liaised with the site ecologist and site engineers accordingly.</p> | <p>Works carried out with ecological input. Silt curtains were unable to be deployed immediately around the works area due to the lack of space available. They were however deployed downstream. The release of silt from underneath the river</p> |

| Item number | Date | Comment | Image | ECoW Action/Recommendation | Sorensens's Action response |
|---|---|--|--|---|---|
| | | <p>2. Encountering a water main, which required additional excavation.</p> <p>3. Upstream of the works, pockets of silt beneath river gravels were unexpectedly released during nearby rock breaker operations which caused vibrations in the immediate area. The cause of this is uncertain but could be due to previous construction works in the area or natural marl deposits within the river bed, or a combination of the two.</p> | | | <p>gravels was sporadic and short in duration. The cause of this silt was possibly due to naturally occurring marl deposits under the riverbed.</p> <p>Note: Marl is a soft, crumbly soil or rock made of a mix of clay and lime, often found near rivers or lakes.</p> |

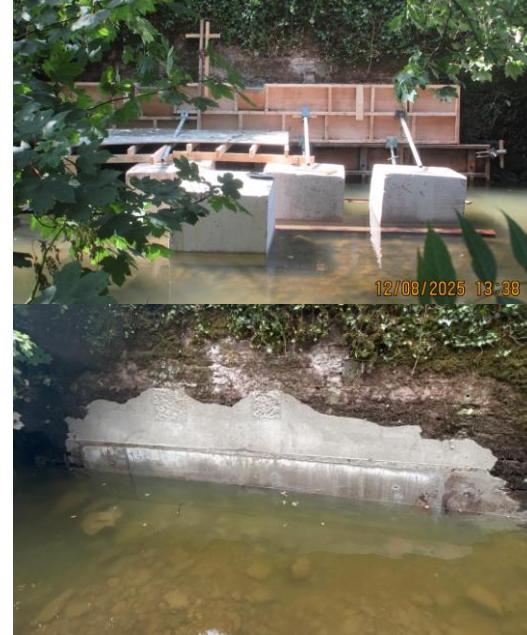
| Item number | Date | Comment | Image | ECoW Action/Recommendation | Sorensens's Action response |
|---|---|--|---|---|---|
| 8.25 | 12/08/2025 | <p>A section of the existing stone revetment wall along the Glashaboy River in Area 4 has been damaged and washed out creating a sizable void which is undermining the wall. This predates the scheme. Remediation works required.</p> | | <p>Liaised with site ecologist and site engineers regards the methodology and ecological mitigation measures required.</p> | <p>Works were carried out in line with ecological mitigations agreed on site which included E Fishing the void prior to works using, a water-based concrete and carrying out works at low tide.</p> |

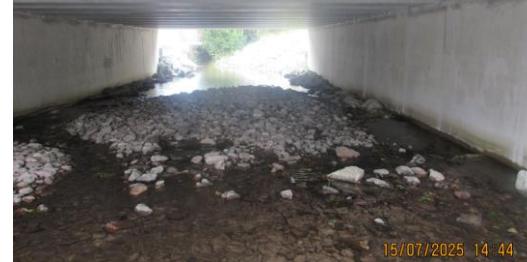
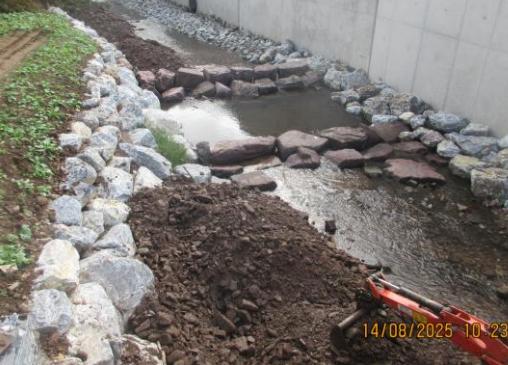
| Item number | Date | Comment | Image | ECoW Action/Recommendation | Sorensens's Action response |
|---|---|--|---|---|---|
| 8.26 | 12/08/2025 | <p>New Line – Removal of river material from within the structure. No upstream sondes were in place; however, there is a downstream sonde within the 100 m limit. Works began in dry conditions. The material was stockpiled at the upstream entrance, where it was repositioned</p> | | <p>These measures were implemented to counteract the accumulation of river material over the winter months before the installation of the step pools.</p> | <p>Works were carried out in a measured and gradual manner spaced out over a number of days which helped spread out silt generated from the works.</p> |

| Item number | Date | Comment | Image | ECoW Action/Recommendation | Sorensens's Action response |
|---|---|---|---|---|---|
| | | upstream around the two weir steps. | | | |

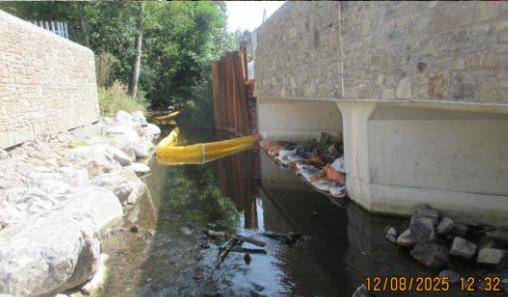
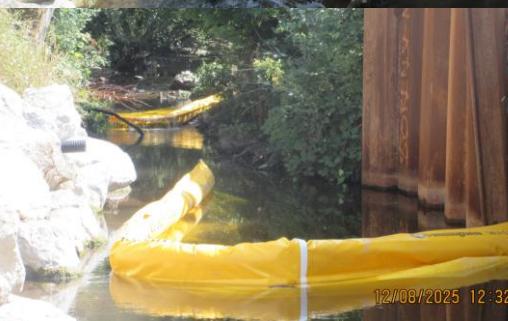
| Item number | Date | Comment | Image | ECoW Action/Recommendation | Sorensens's Action response |
|---|---|---|---|---|---|
| 8.27 | 12/08/2025 | Brooklodge culvert: Silt curtains were installed as part of silt control measures during the preparatory works to dam and overpump the Glenmore so works can be completed in the dry. | <br> | Oversaw works which involved the installation of Kelly blocks, bund and sump. | Works proceeded as planned and were carried out without complications. Some silt was generated when a sump was excavated directly into the riverbed, producing a flux of sediment that was mitigated by the two silt curtains positioned just downstream. |

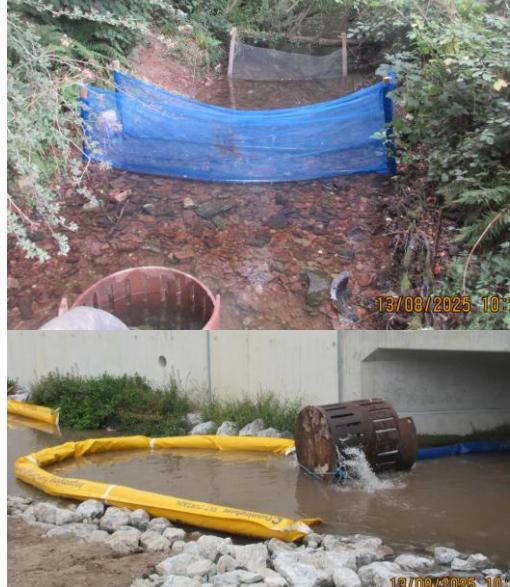
| Item number | Date | Comment | Image | ECoW Action/Recommendation | Sorensens's Action response |
|---|---|--|---|--|---|
| 8.28 | 13/08/2025 | Pumping commences at Brooklodge culvert. Fish nets were positioned upstream to prevent access into pump area and downstream with yellow silt curtain. Discharge is positioned in cage to prevent scouring of riffle gravels at same location. | | Fish nets were complimented by wire fence upstream to catch leaves and debris. Combination works well. | Appropriate measures are in place to prevent fish from entering the pump area. The condition of the protective fencing will require daily inspection, which the main contractor's site ecologist and environmental team are aware of and have agreed to. |

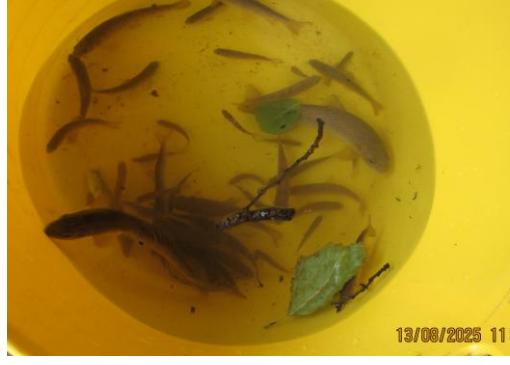
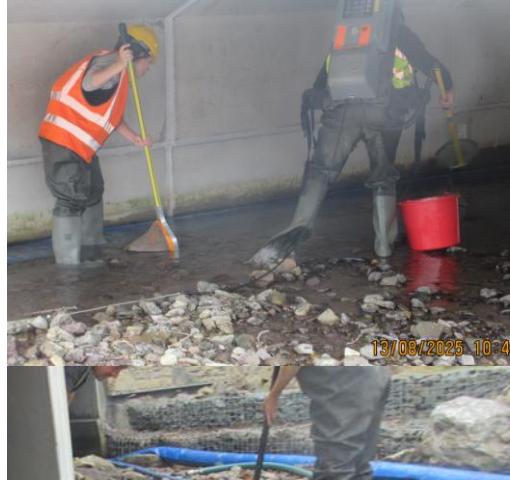
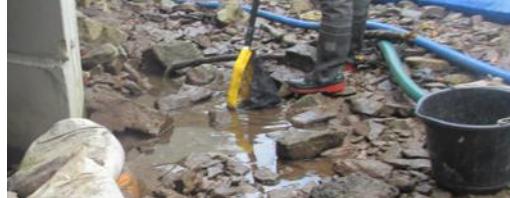
| Item number | Date | Comment | Image | ECoW Action/Recommendation | Sorensens's Action response |
|---|---|--|---|--|---|
| 8.29 | 13/08/2025 | Aquatic species were translocated today at Brooklodge to facilitate over-pumping for the installation of step pools, weir, and the flood defence wall. The translocation took place under ideal conditions, with a cool, overcast morning, and was carried out in full compliance with the relevant licence. All fish were | | Supervised electrofishing and assisted in the translocated from the elongated pool. | Significant efforts were made to capture all remaining fish species within the pool to ensure safe relocation. a significant number of fish, lamprey and eel were recovered from the pool. This included adult eels, juvenile lamprey, and a large number of trout. |

| Item number | Date | Comment | Image | ECoW Action/Recommendation | Sorensens's Action response |
|---|---|---|---|---|--|
| | | <p>measured prior to being released upstream of the works area for Inland Fisheries Ireland records.</p> <p>A large, elongated pool area became isolated from the river as a result of over pumping. Dewatering of this pool via a small two-inch pump was done under the supervision of the site ecologist. the pool was allowed to dry out gradually.</p> | | | <p>The Site Ecologist demonstrated consistent diligence and effective on-site management throughout the process.</p> |

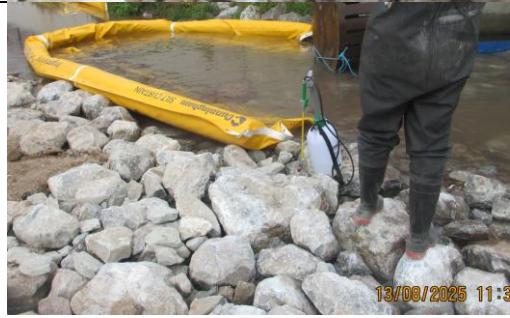
| Item number | Date | Comment | Image | ECoW Action/Recommendation | Sorensens's Action response |
|---|---|---|---|---|--|
| 8.30 | 13/08/2025 | <p>Bioversal was applied following the activation of the pump, which had caused a hydrocarbon sheen on the water surface. The silt curtains were temporarily opened and then reclosed to allow the treated river water to flush through the area.</p> | | Supervised works. | <p>Bioversal was applied repeatedly until the sheen no longer appeared.</p> |

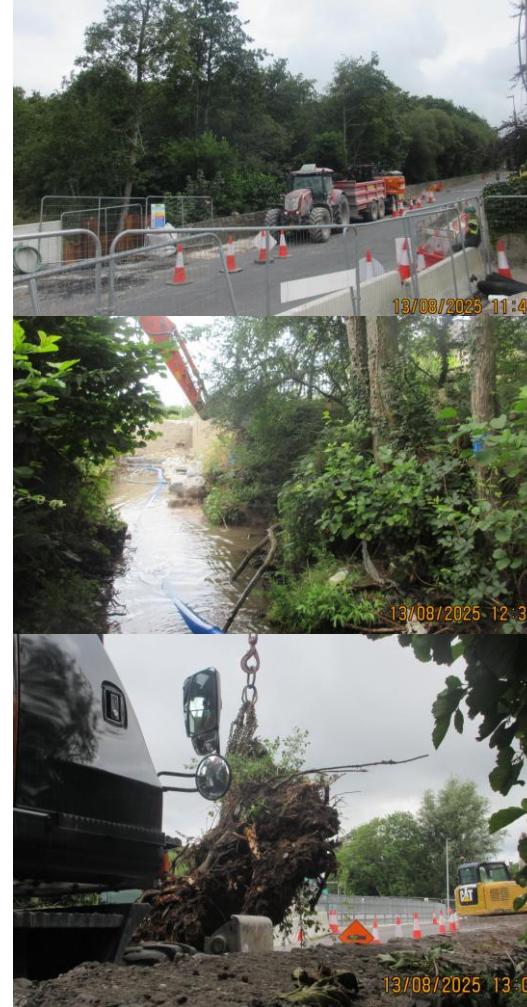
| Item number | Date | Comment | Image | ECoW Action/Recommendation | Sorensens's Action response |
|---|---|---|---|---|--|
| 8.31 | 13/08/2025 | <p>Brooklodge - Trees within the foot print the scheme were felled to complete the works per the design. The trees were inspected before felling of bird and bats. The trees, which had been undercut by the river, were felled by pushing them with the arm of the excavator into the adjacent wooded area. The trunks, roots, and attached soil were then cut to stump level and hauled by chain to the roadside for removal.</p> | | <p>Discussed with site ecologist prior to felling. Supervised felling and removal of trees.</p> | <p>The works were carried out under the supervision of the site ecologist who performed all necessary checks. A permit to clear vegetation was in place.</p> |

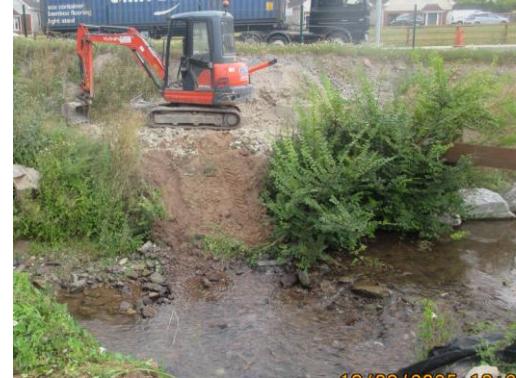
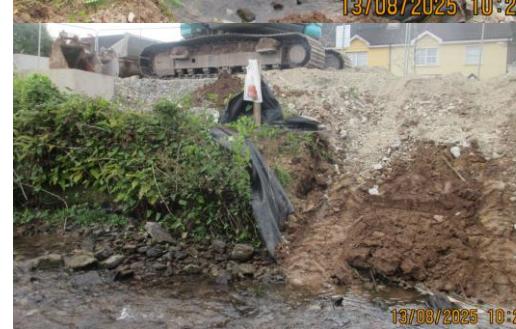
| Item number | Date | Comment | Image | ECoW Action/Recommendation | Sorensens's Action response |
|---|---|--|--|---|--|
| 8.32 | 13/08/2025 | <p>Downstream of Copper Valley Vue Rock armour placement and bank reggrading/reshaping works were undertaken downstream of the Copper Valley Vue structure.</p> <p>Silt control measures, including silt curtains and turbidity sondes, were in place for the duration of the works.</p> <p>Turbidity spikes were recorded intermittently; however, levels remained generally low and were effectively managed under a agreed stop–start operational approach to minimise sustained exceedances.</p> | | <p>Planned and supervised works in conjunction with site ecologist.</p> | <p>Works were carried out to best practise receiving supervision and monitoring of sondes by site ecologist.</p> |

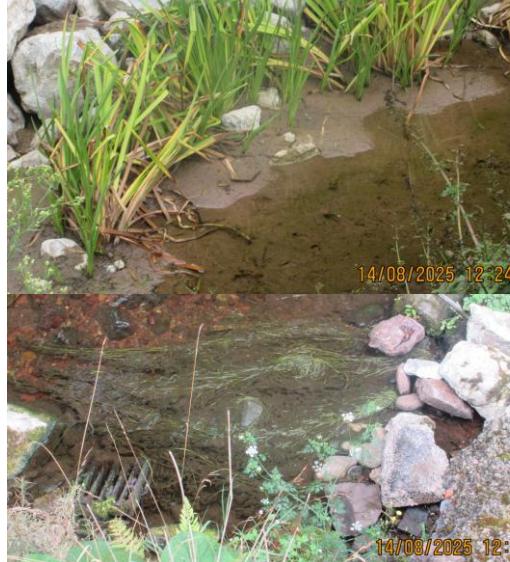
| Item number | Date | Comment | Image | ECoW Action/Recommendation | Sorensens's Action response |
|---|---|--|--|---|---|
| 8.33 | 14/08/2025 | <p>The Bur-reed is in good condition. While the original larger foliage has died back, numerous new shoots are emerging. If a silty area can be reinstated at Hazelwood, these plants could be returned at that time. Alternatively, waiting until late spring might be advisable to avoid potential winter wash-out. A split planting schedule between autumn and spring could also be considered.</p> <p>The translocated Ranunculus also appear to be in reasonable health. However, the silty moss present is probably algae associated with eutrophication.</p> | | <p>The status of aquatic plants at the translocation area, which had been relocated from Hazelwood prior to the commencement of in-stream works, was checked.</p> | <p>No action required.</p> |

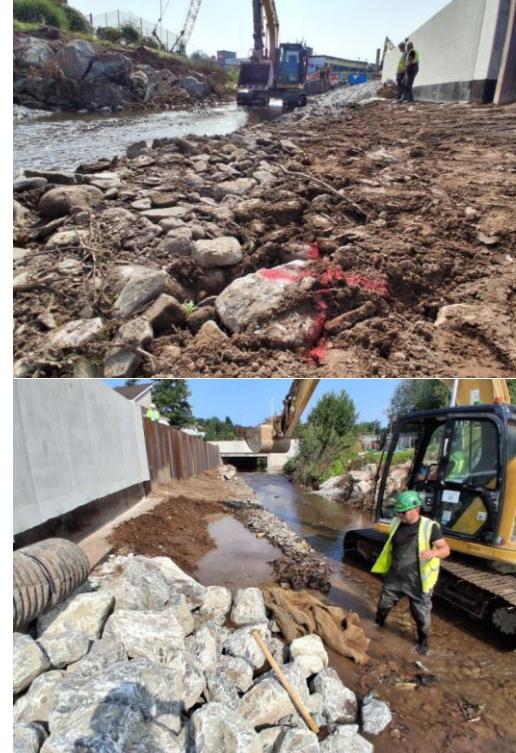
| Item number | Date | Comment | Image | ECoW Action/Recommendation | Sorensens's Action response |
|---|---|--|--|--|--|
| 8.34 | 15/08/2025 | Excavation of trench for rock armouring at Hazelwood Shopping Centre Bridge. | | Supervised works periodically and liaised with site ecologist and construction crew. | Coir mesh was placed to minimise the release of silt. The low river level allowed much of the works to be carried out from the semi-dry, which facilitated more effective silt management. |

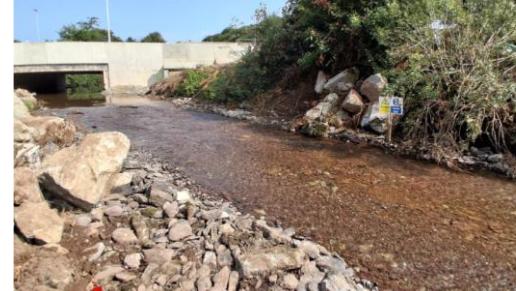
| Item number | Date | Comment | Image | ECoW Action/Recommendation | Sorensens's Action response |
|---|---|--|--|--|--|
| 8.35 | 15/08/2025 | Biosecurity signage in place at Hazelwood Shopping Centre Bridge. | | Raised biosecurity issue with site ecologist. | Signage is an effective measure; however, as best practice, signage and barriers should be installed before works commence in an area. |

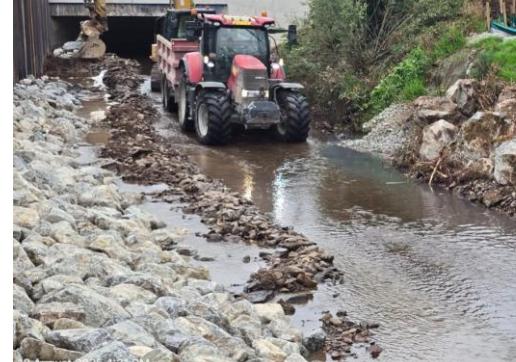
| Item number | Date | Comment | Image | ECoW Action/Recommendation | Sorensens's Action response |
|---|---|--|---|--|--|
| 8.36 | 18/08/2025 | Rock armouring works continued at Hazelwood. | | Monitored water parameters and supervised works periodically. Liaised with site ecologist and construction crew. | Due to lower river levels a bund was established between the excavation trench and the main flow. This allowed for less and more gradual realise of silt into the watercourse. |

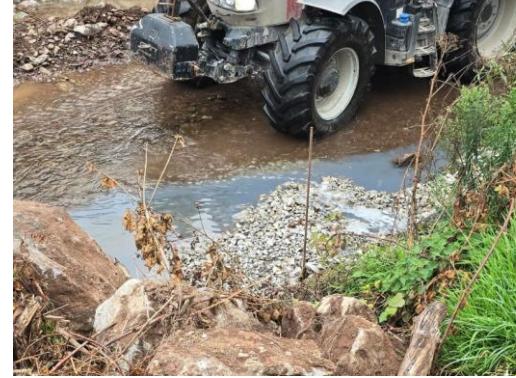
| Item number | Date | Comment | Image | ECoW Action/Recommendation | Sorensens's Action response |
|---|---|--|---|--|--|
| 8.37 | 18/08/2025 | Outfall below Hazelwood Bridge temporarily contaminated by cloudy grey with froth. Not too dissimilar to the colour of water where FOSROC is being applied to wall, but I don't see any evidence of a spillage so could be from somewhere else | | Notified site ecologist of observation and conducted a trace for source. | The site ecologist confirmed the discolouration at discharge was due to a GO washing out a bucket of the FOSROC being applied to walls. GOs reminded by SCE ecologist that this is not allowed - The duration and quantity were minor with no significant impacts. |

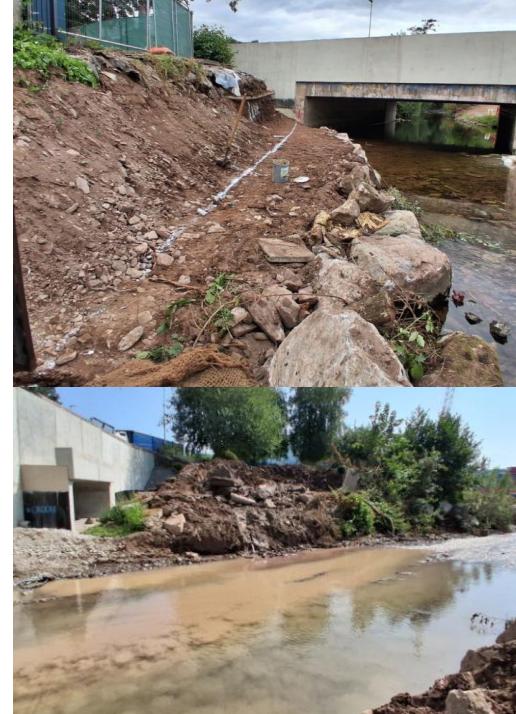
| Item number | Date | Comment | Image | ECoW Action/Recommendation | Sorensens's Action response |
|---|---|---|---|---|--|
| 8.38 | 18/08/2025 | Ground exposed from vegetation clearance and ground works along riverbank at Hazelwood in preparation for sheet piling. | | Recorded and discussed with site ecologist about silt mitigation methods. | Coir mesh and silt curtains to be placed one side while material on the opposite bank was removed. Dry conditions also helped to reduce potential run off. |

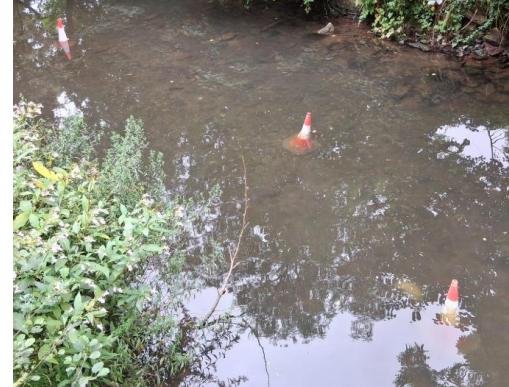
| Item number | Date | Comment | Image | ECoW Action/Recommendation | Sorensens's Action response |
|---|---|--|---|--|--|
| 8.39 | 19/08/2025 | Several traffic management cones were again observed in the river at Area 4. | | Recorded and alert site ecologist. | The cones were removed from the water. |

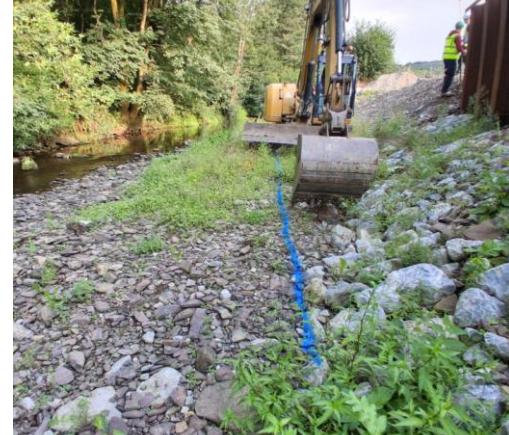
| Item number | Date | Comment | Image | ECoW Action/Recommendation | Sorensens's Action response |
|---|---|--|---|--|--|
| 8.40 | 21/08/2025 | Rock armouring at Sallybrook in the dry. | | Surveyed the area prior to works and supervised aspects of the construction. | The works were preceded by a walkover survey for Himalayan balsam. All plants encountered were uprooted and left to desiccate. The entire rock armour works was completed in the dry removing the need to silt mitigation. |

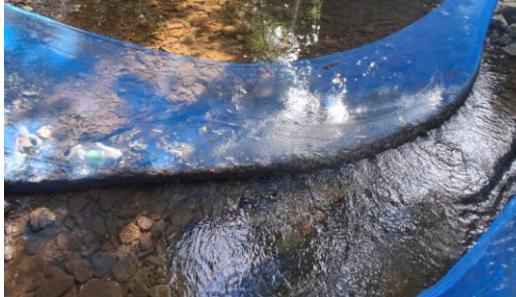
| Item number | Date | Comment | Image | ECoW Action/Recommendation | Sorensens's Action response |
|---|---|--|---|---|--|
| 8.41 | 21/08/2025 | Fish nets in place at Brooklodge culvert accumulating large quantity of leaves and light debris. | | Alerted site ecologist. | The fish curtains were cleaned and adjusted promptly. |

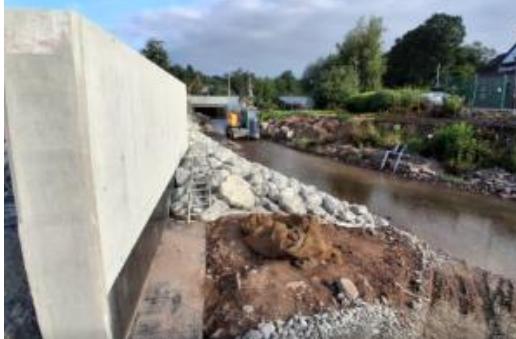
| Item number | Date | Comment | Image | ECoW Action/Recommendation | Sorensens's Action response |
|---|---|--|---|---|--|
| 8.42 | 21/08/2025 | Tracking instream at Hazelwood to complete steelworks for capping on the sheetpiles. | | Monitored works and parameters. | Sit generated was caused by silt deposited on riverbed during previous days rocks armour works being remobilised. Overall, silt was minor. |

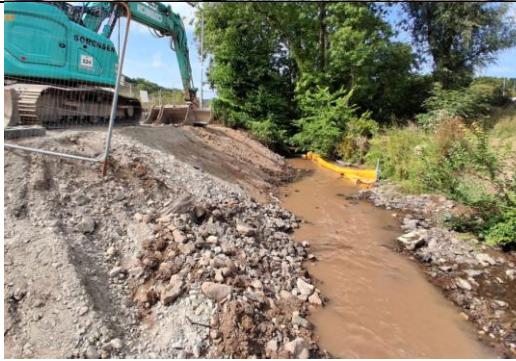
| Item number | Date | Comment | Image | ECoW Action/Recommendation | Sorensens's Action response |
|---|---|--|---|---|--|
| 8.43 | 21/08/2025 | Bank regrading and rock armour works at CVV generated large amounts of silt. | | Supervised some aspects of the works while monitoring the parameters. | The high spikes in silt levels were intermittent, caused by sporadic working. Breaks were also utilised to spread out silt loading. However, some siltation could not be fully avoided as the works had to be carried out in wet conditions within a restricted, narrow channel. |

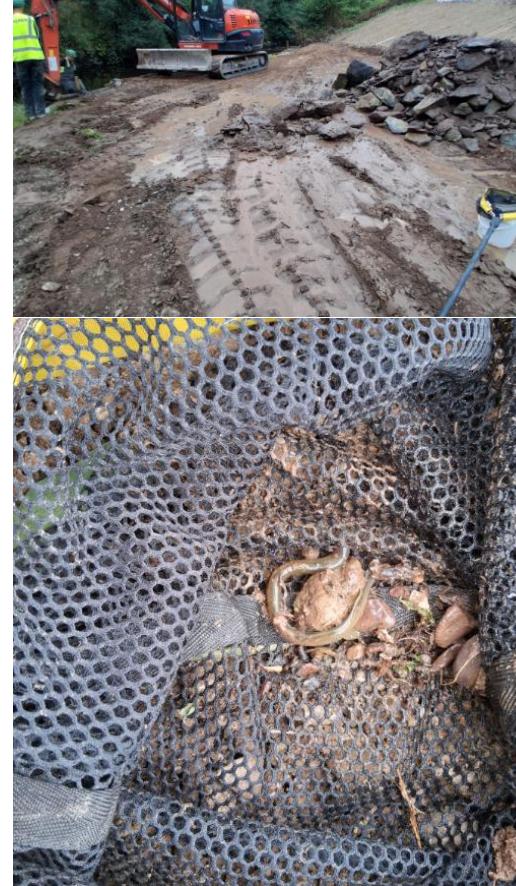
| Item number | Date | Comment | Image | ECoW Action/Recommendation | Sorensens's Action response |
|---|---|--|---|---|--|
| 8.44 | 22/08/2025 | Rock armour works directly upstream of the Hazel Road bridge requiring digging in the river margins. Since this is potential habitat for lamprey and eels, mitigation measures were required to reduce potential harm to aquatic life. | | Reviewed methodologies in consultation with the site ecologist. | The excavation along the river margins was carried out under the supervision of the site ecologist. Each bucket load of material was deposited and spread on the bank for visual inspection. Nets and buckets were used to capture and temporarily hold any species observed within the spoil. In total, 13 lamprey and 1 three-spined stickleback were rescued and subsequently translocated upstream of the works. |

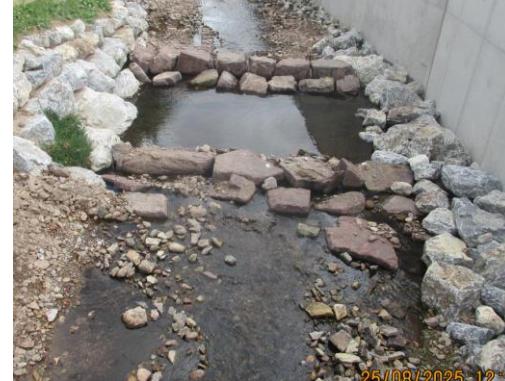
| Item number | Date | Comment | Image | ECoW Action/Recommendation | Sorensens's Action response |
|---|---|---|---|---|---|
| <b>8.45</b> | 25/08/2005 | Step pools installed at New Line were identified as possibly needing improvement to better facilitate fish passage. | <br><span data-bbox="1327 663 1473 684">25/08/2025 12:38</span> | Liaised with all relevant parties to work towards a compromise solution that aligned the scheme's objectives and fish passage requirements. | Subsequent design changes rectified this issue by lowering a flagstone on each weir alternately. In addition, a third weir was added to further reduce the height differences between the weirs and the upstream and downstream levels. |

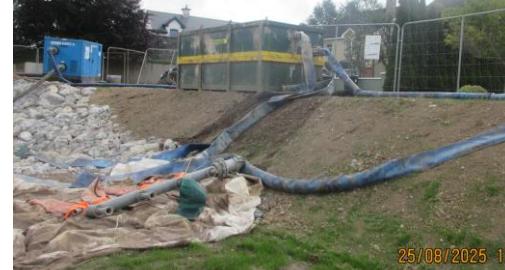
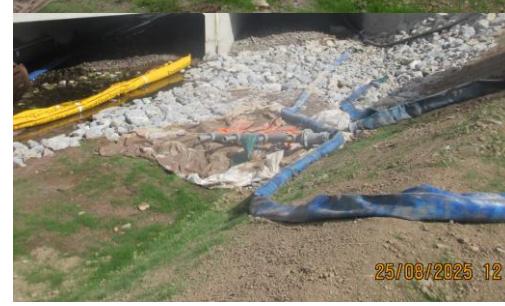
| Item number | Date | Comment | Image | ECoW Action/Recommendation | Sorensens's Action response |
|---|---|---|---|---|---|
| <b>8.46</b> | 25/08/2005 | Works continued at Brooklodge culvert to install flood walls. Pumping of ground water is required to keep excavations and works area dry. | <br><span data-bbox="1327 954 1473 975">25/08/2025 12:21</span><br><br><span data-bbox="1327 1240 1473 1260">25/08/2025 12:23</span> | Spoke with ground crew and foreman. Tanker was recommended. | A spike of >700 NTU was recorded. While this was very high, it was short in duration. The cause was intense digging in the dried-out riverbed upstream of the culvert. Over pumped water became extremely silty, and the system in place to manage silt was only partially effective. A tanker was deployed to empty the siltation tanks, which immediately improved the situation. |

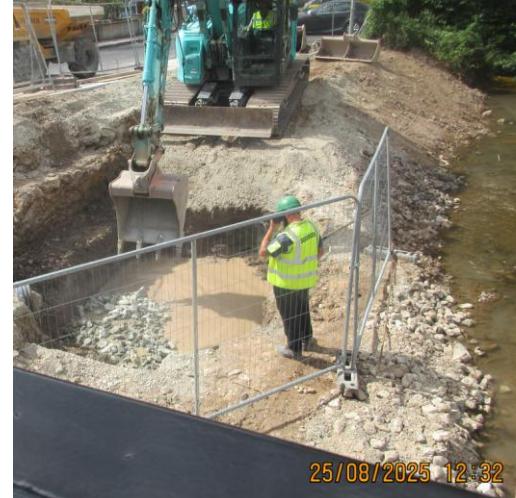
| Item number | Date | Comment | Image | ECoW Action/Recommendation | Sorensens's Action response |
|---|---|--|---|---|--|
| <b>8.47</b> | 25/08/2005 | <p>Copper Valley Vue (downstream)</p> <p>Excavation of headwall being carried out in the dry.</p> <p>Muddy water-filled excavations are being backfilled with stone during inspection.</p> | | Discussed with site ecologist and ground crew. | Excavation was backfilled avoiding the need to dewater on this occasion. |

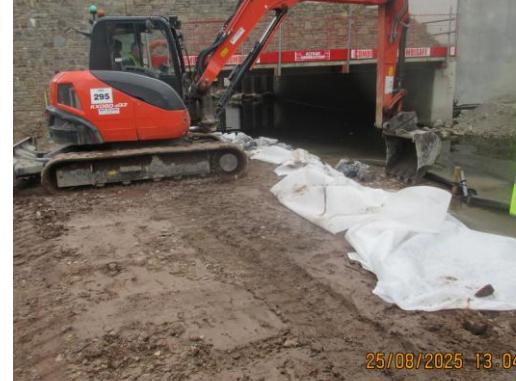
| Item number | Date | Comment | Image | ECoW Action/Recommendation | Sorensens's Action response |
|---|---|--|---|---|--|
| <b>8.48</b> | 25/08/2005 | Area 2 – upstream of Hazelwood Bridge. Rock armour works continued with silt controls in place. | | Reinstate disturbed areas to reduce bare ground exposure. | Site personnel were briefed on environmental sensitivities. Bank excavations were conducted with active eel and lamprey retrieval by the site ecologist. |

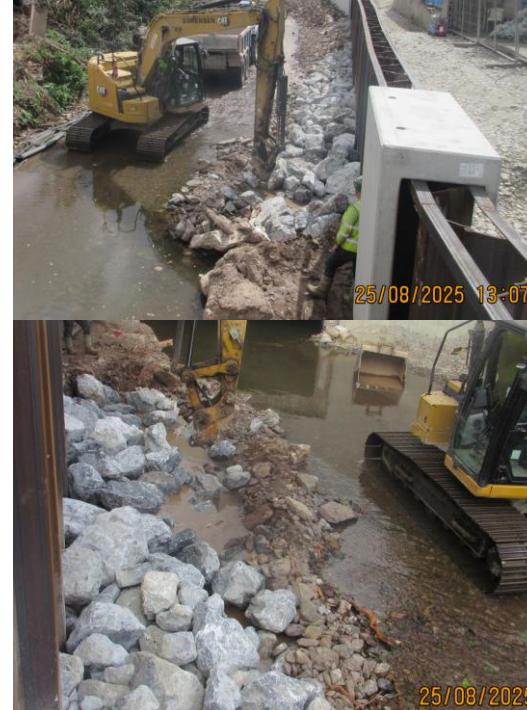
| Item number | Date | Comment | Image | ECoW Action/Recommendation | Sorensens's Action response |
|---|---|---|---|--|--|
| 8.49 | 25/08/2005 | <p>Hazelwood just downstream of Hazelwood Road bridge: Rock armour works taking place in semi-dry conditions. Low river levels allow bunding against the bank nearest the river to exclude flows. Only minimal excavation works were required for this section.</p> | | <p>Continue to monitor water quality sondes to confirm mitigation effectiveness.</p> | <p>Parameters were monitored throughout the works, with all levels remaining within acceptable ranges.</p> |

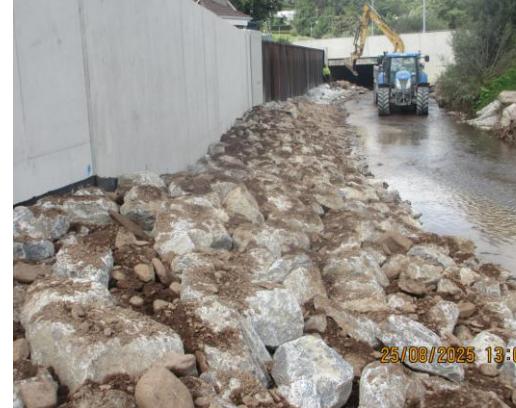
| Item number | Date | Comment | Image | ECoW Action/Recommendation | Sorensens's Action response |
|---|---|--|---|--|--|
| <b>8.50</b> | 25/08/2005 | <p>Hazelwood – Rock Armour Enhancement</p> <p>Sand and gravels have been added to the placed rock armour as a biodiversity enhancement measure. This approach is intended to accelerate natural colonisation and promote the establishment of native vegetation, helping the rock armour to green up more quickly and integrate with the surrounding riparian habitat.</p> | | <p>Liaised with site ecologist and site foreman to ensure these works were planned and implemented.</p> | <p>Works carried out in line with the Work Requirements. Biodiversity action will help natural regeneration and natural aesthetics of the site.</p> |

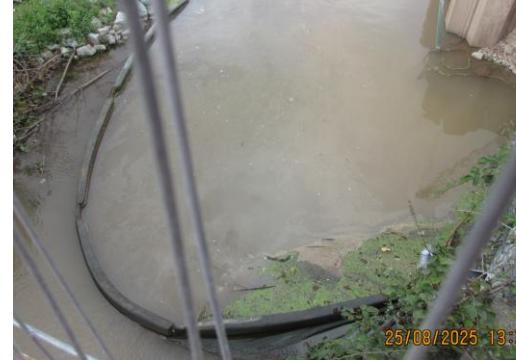
| Item number | Date | Comment | Image | ECoW Action/Recommendation | Sorensens's Action response |
|---|---|--|---|--|--|
| <b>8.51</b> | 25/08/2005 | <p>Hazelwood just upstream of temporary footbridge: Silt curtain holding a build-up of fines, as well as rubbish and water impurities not associated with the works.</p> | | <p>Periodic release of silt curtains recommended both terms of silt management and aesthetics of site.</p> | <p>Silt curtains were deployed in various numbers and positions through the Hazelwood instream works area. The curtains set up cross channel help to slow the release of silt downstream of the works allowing for greater dilution under controlled releases.</p> |

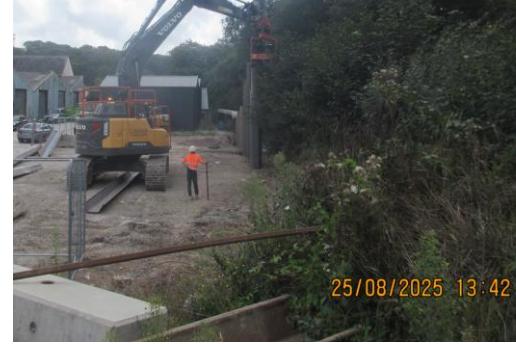
| Item number | Date | Comment | Image | ECoW Action/Recommendation | Sorensens's Action response |
|---|---|---|---|---|--|
| 8.52 | 25/08/2005 | Sheet Piling as part of a Change Order replacing flood embankment with sheet pile wall at Sallybrook. Piling conducted in the dry removing need for instream mitigations. Biosecurity was an issue as this is a JKW area. | <br><span data-bbox="1291 584 1477 605">25/08/2025 13:42</span> | Carry out works in line with biosecurity plan. | The works were undertaken following a JKW survey of the area. Excavations were kept to a minimum and carried out under the supervision and guidance of the site ecologist. No additional material was added into the holding cell. |

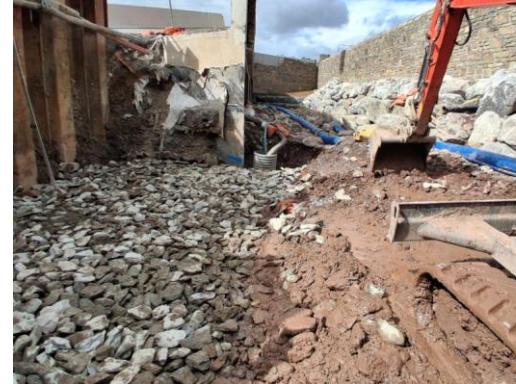
| Item number | Date | Comment | Image | ECoW Action/Recommendation | Sorensens's Action response |
|---|---|---|---|---|--|
| 8.53 | | Leanmix to be poured in the dry instream works area at Brooklodge Culvert | | Cure concrete fully before allowing re-wetting and check for possible seepage into dewatering area. | No immediate risks to waterway, however dewatering ongoing from the sump area. Sump in place was set at a deeper depth than the excavations receiving lean mix. Conditions were dry during the works. |

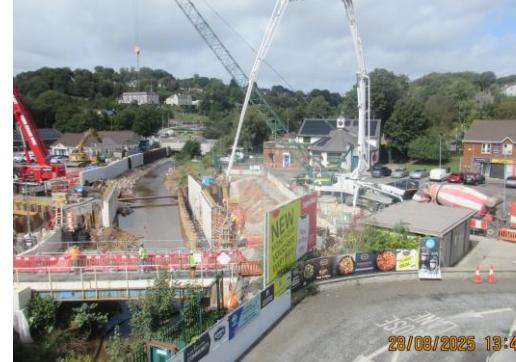
| Item number | Date | Comment | Image | ECoW Action/Recommendation | Sorensens's Action response |
|---|---|---|---|---|--|
| 8.54 | 28/08/2025 | Cement pouring at east abutment. | <br><span data-bbox="1343 632 1484 652">28/08/2025 13:43</span> | Supervised pouring periodically and liaises with ground crew. | No immediate risks to waterway, however dewatering ongoing from the abutment. However, no contact between cement and pumped water. |
