## Environmental Report August 2025

### Glashaboy Flood Relief Scheme

**Document code:** FFEC-GFRS-2025-008

*The following is the clients Ecological Clerk of Works (ECoW) monthly review of the Glashaboy River (Glanmire/Sallybrook) Drainage Scheme. It details observations made on site regarding environmental and ecological factors involved in the scheme. This formulates a monthly review to be submitted to the Environmental Monitoring Group (EMG).*

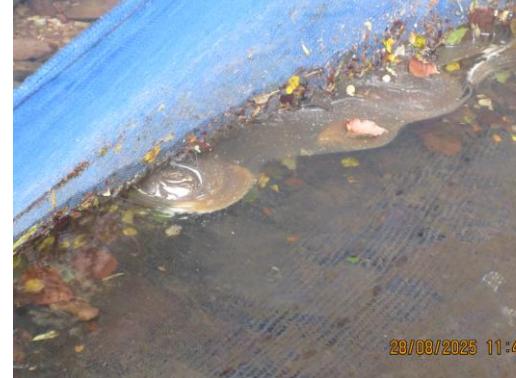
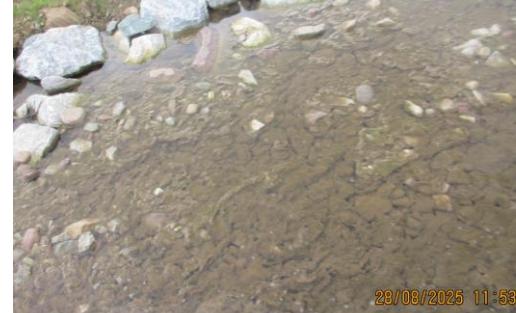
| Item number | Date | Comment | Image | ECoW Action/Recommendation | Sorensens's Action response |
|---|---|---|---|---|--|
| 8.55 | 28/08/2025 | Clear Signs of eutrophication at Copper Valley Vue from the rapid algae build up on clean rock armour and gravel installed only two weeks previous. Also, pooling of what looks like slurry run off at the fish nets just upstream. | <br><span data-bbox="1343 1017 1484 1038">28/08/2025 11:45</span><br><br><span data-bbox="1343 1362 1484 1383">28/08/2025 11:53</span> | Documented. | This river pollution originates outside the works and is not the responsibility of the contractor. |

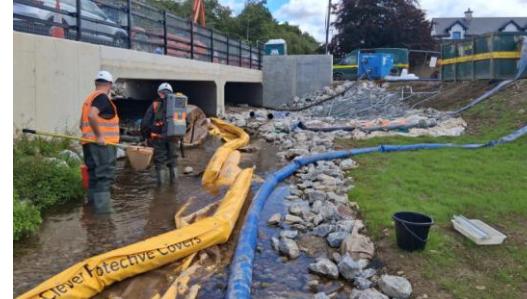
| Item number | Date | Comment | Image | ECoW Action/Recommendation | Sorensens's Action response |
|---|---|--|--|---|---|
| 8.56 | 29/8/2025 | Electro Fishing was conducting downstream of the Brooklodge culvert to facilitate works as the works area was extended downstream. | | Any fish found within the works area should be safely relocated under ecological supervision. | Good measures undertaken to prevent harm to fisheries species from the works. |
