## **Environmental Report March 2024**

### **Glashaboy Flood Relief Scheme**

**Document code:** FFEC-GFRS-2024-007

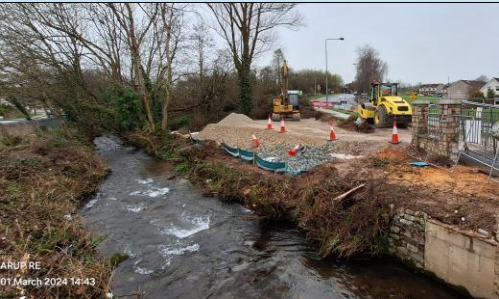
No.	Date	Comment	Image	ECoW Action/ Recommendation	Sorensen's action response
3.1	1/3/2024	Bare ground next to Glenmore River from enabling works.

A photograph showing a riverbank with exposed bare ground and construction equipment in the background. The river is flowing, and there are some trees and a fence in the distance. A timestamp in the bottom left corner reads 'ARUP RE 01 March 2024 14:43'.	Cover ground to prevent surface run off.	Exposed area received coir mesh a few days later. No heavy rain occurred within this time.

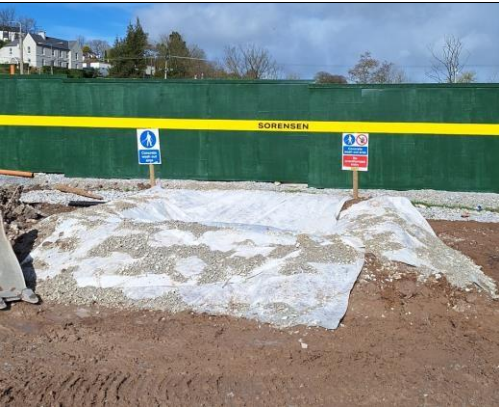
3.2	1/3/2024	Concrete wash out installed at Circus field.

A photograph of a concrete washout area. In the foreground, there is a pile of gravel covered with a white geotextile. Behind it is a green fence with a yellow stripe and the word 'SORENSEN' on it. There are also some signs and a blue sky in the background.	Requested procedure.	Site ecologist responded with the following: Plant and equipment requiring washing is brought to the concrete wash. It is power washed until clean, ensuring all wash water is caught in the basin. Wash water is allowed to percolate through the geotextile and gravel layers. Photos to follow.

Item No.	Issue	Action to be carried out
3.2	Concrete washout at Circus field.	Photos of procedure to be provided.
3.4	Grass seeding at Bleach hill.	Grass seeding to be carried out.

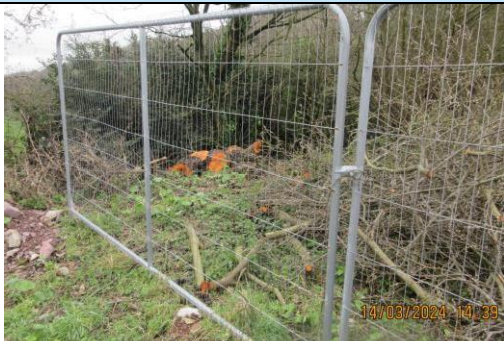
No.	Date	Comment	Image	ECoW Action/ Recommendation	Sorensen's action response
3.3	4/3/2024	Trees felled at Main Compound surveyed for nested birds.

Recorded.	Good practice as bird season is currently active. These trees were part of the originally site clearance designs but were overlooked during the clearance phase.
3.4	4/3/2024	Additional coir mesh added at Bleach hill as part of measures to manage surface runoff.

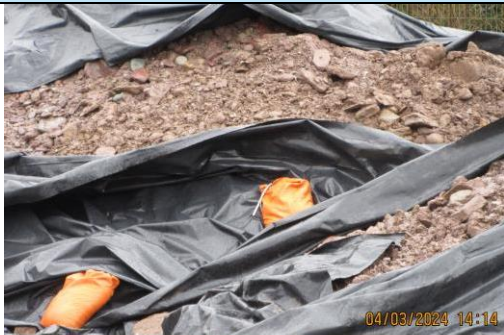
No.	Date	Comment	Image	ECoW Action/ Recommendation	Sorensen's action response
3.5	4/3/2024	Contaminated material exposed following strongwinds.

Recover material with plastic sheeting.	Material was recovered the following day.
3.6	4/3/2024	The JKW exclusion area adjacent to the stockpiling at Sallybrook Compound requires maintenance and/or improvement to prevent encroachment by plant, personnel, and stockpile materials.

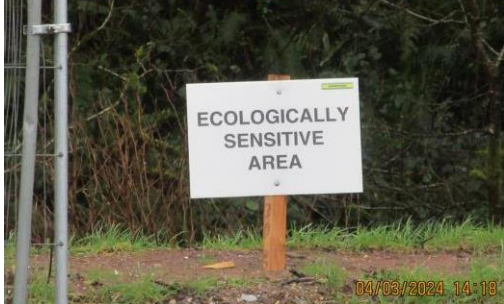
Address fencing issues at northern end of JKW exclusion zone.	Fencing was reestablished and received additional JKW signage.
3.7	4/3/2024	Signage installed in proximity to Holt N2.

Documented.	Good practice following recommendations by the otter specialist.

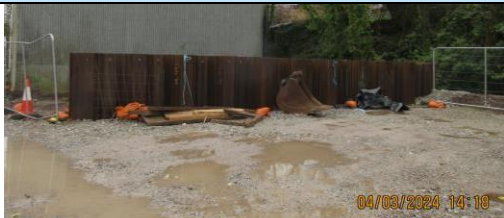
No.	Date	Comment	Image	ECOW Action/ Recommendation	Sorensen's action response
3.8	4/3/2024	Housekeeping at Sallybrook industrial estate.

Tidy up area and dispose of material accordingly.	This was rectified this month.
3.9	4/3/2024	Water from the attenuation channel discoloured today. However, the water in the main channel was rich brown in colour from the day's heavy rain.

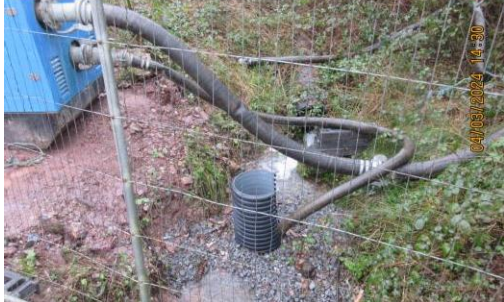
Continue to monitor and test accordingly.	Attenuation area discharge point was monitored by the site ecologist for turbidity.
3.10	4/3/2024	Pump being refueled within proximity to open surface drain in Area 1 in association with works at POD.

Discussed with site ecologist.	Refueled with hose from mobile tanker in addition to using spill tray and absorbent matting in case of a spill. Regularly inspected by personnel when refueling and the site ecologist.

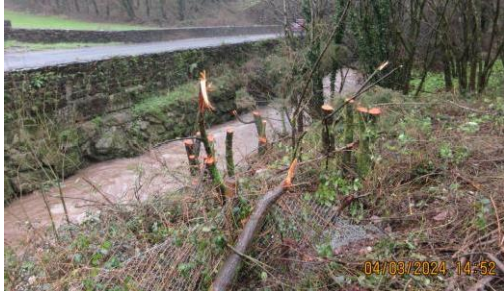
No.	Date	Comment	Image	ECOW Action/ Recommendation	Sorensen's action response
3.11	4/3/2024	Additional clearance at New Line as part of enabling works. This was granted approval by the EMG and will receive compensatory planting following completion of works.

Ensure replacement planting is carried out upon completion of works.	No further action required at this time.
3.12	4/3/2024	Silt fencing positively installed in associated with CopperValley Vue enabling works.

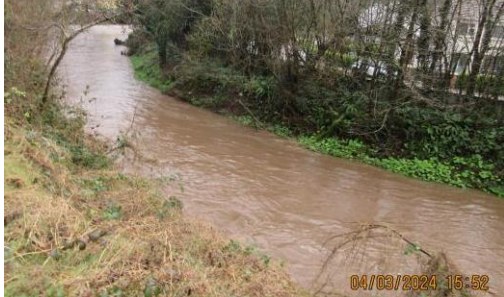
Maintain silt fencing for the duration of works in this area.	Fencing maintained throughout March.
3.13	4/3/2024	Monitoring for kingfisher ongoing throughout March by site ecologist.

Report any sightings of king fisher to ER.	Weekly reports submitted detailing daily morning time monitoring.

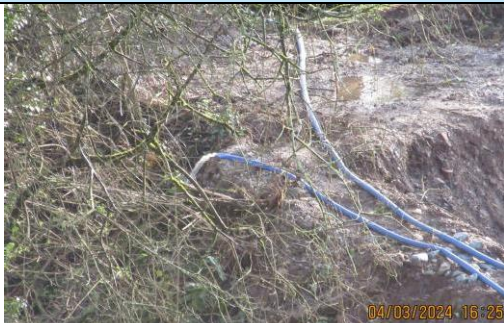
No.	Date	Comment	Image	ECOW Action/ Recommendation	Sorensen's action response
3.14	4/3/2024	Pumping from the funeral home works area into Glashaboy occurred without the silt bag attached, contrary to the Method Statement. However, it was observed that the water was clean.

Discussed with site ecologist.	Silt bag was fixed to the end of the hose the next day as the works site was closed due to a funeral. Water was pumped out overnight however discharge was clean as no excavations were carry out during this timeframe.

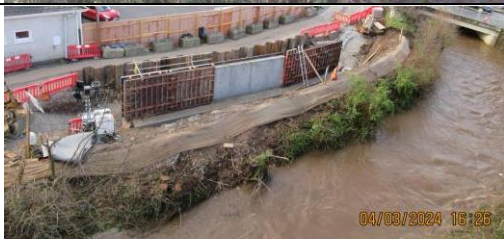
3.15	4/3/2024	Silt fencing is place along funeral home maintained throughout March as a precautionary measure.

Good practice of erosion control.	Erosion mesh in place throughout March.

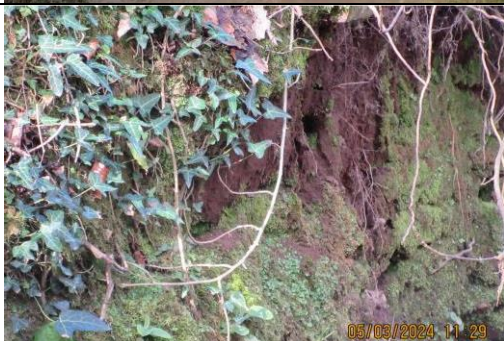
3.16	5/3/2024	An inspection by the ECOW was conducted at the Meadowbrook bank along the Glashaboy river to assess the potential kingfisher burrow for signs of nesting. No positive indicators of nesting were confirmed during the inspection.

Continue to monitor for king fisher as agreed with NPWS.	Monitoring forkingfisher conducted by the site ecologist throughout March and reported weekly.

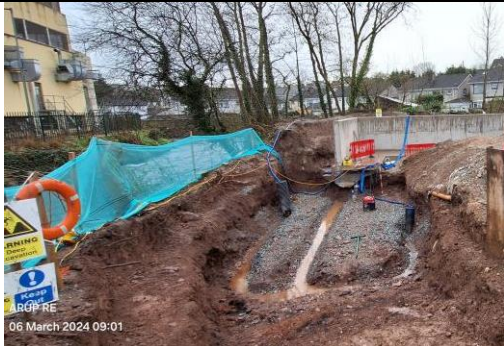
Documented.	No further action required.
3.19	6/3/2024	Over pumping continues from the works area at the funeral home. Good use of sumps and silt bags.

Good practice.	Maintained silt control standards throughout the month of March.

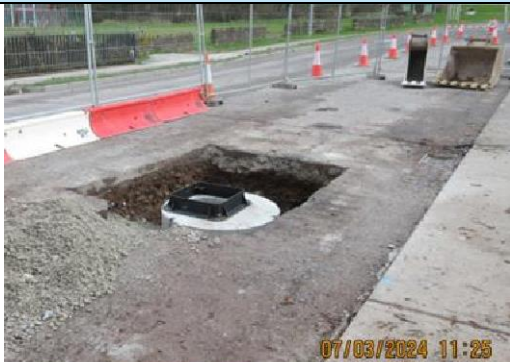
No.	Date	Comment	Image	ECoW Action/ Recommendation	Sorensen's action response
3.20	7/3/2024	A surface gully located on Hazelwood Rd, in front of cafe Bean & Leaf, which connects to the nearby Glashaboy river, received sediment-laden water from the works area earlier in the week during heavy rainfall.

3.20	A gully adjoining a works site on Hazelwood Road received sedimented runoff originating from the works following a heavy downpour.	Develop a protocol to safeguard gullies against potential sedimented surface water runoff originating from the works during rainfall.

Create a protocol to safeguard gullies against potential surface water runoff originating from the works prior to commencing works.	Procedure to be developed and deployed as needed.

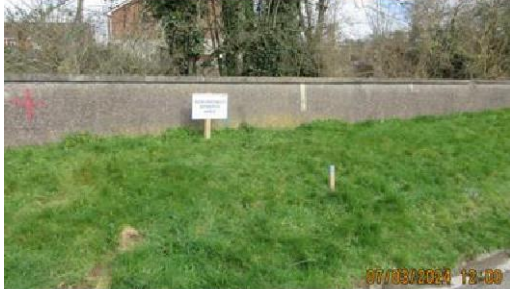
3.21	7/3/2024	Otter holts N6 C/D located opposite Meadowbrook estate have been provided with signage as recommended in Ross Macklin's latest report. Additionally, the area is scheduled to receive hoarding, as also per the recommendations. See Item 3.25.

Implemented best practices as advised by the otter specialist.	Signs were maintained throughout the month of March.

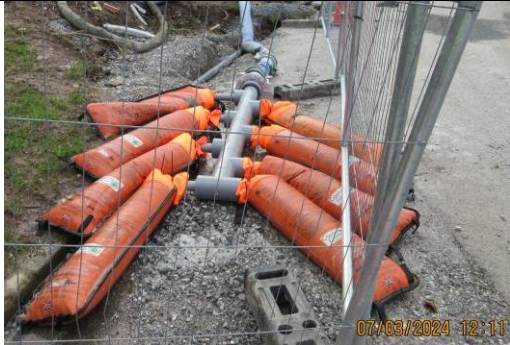
3.22	7/3/2024	The manifold system in operation at the pump station works area in Meadowbrook estate was observed to be discharging clean water into the nearby surface gully.

Positive condition at the time of inspection	Continued to monitor pumping throughout March.

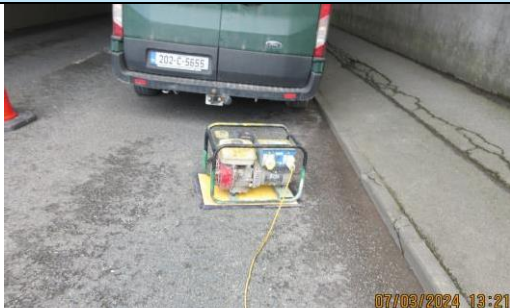
No.	Date	Comment	Image	ECow Action/ Recommendation	Sorensen's action response
3.23	7/3/2024	A generator in operation on New Line has been positioned on absorbent matting as a precautionary measure in case of any leaks.

This is good practice as there are surface drains nearby.	No action required.

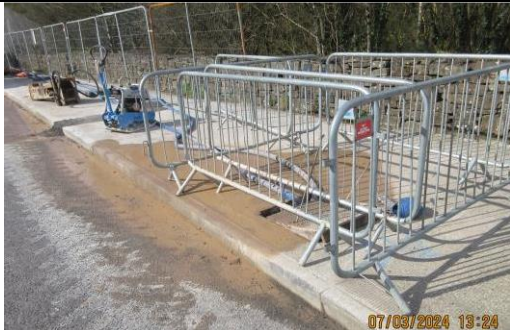
3.24	7/3/2024	Excavations on New Line Rd. are being pumped out, with the water heavily silted and directed into the foul system. A silt sock has been installed at the outlet of the hoses. Inquiries were made regarding alternative options explored, the duration of pumping works, the long-term plan for pumping and the current effectiveness of silt control measures.

Discussed with site ecologist.	Pumping was halted by the end of the day. Subsequent works in the area did not necessitate pumping, as there was no further groundwater ingress into the excavation works for the remainder of the month.

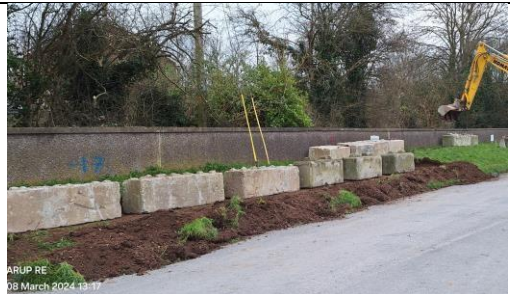
3.25	8/3/2024	Works commence on the installation of hoarding in proximity to other hols N6 C/D.

Complete hoarding works prior to permanent works in the area.	Hoarding was not completed before the end of March. However, no works were carried out in the area. Hoarding to be completed next month.

3.25	Hoarding to be completed at Meadowbrook.	Complete hoarding.
3.28	Extend erosion matting at Copper Valley Vue.	Extend erosion mesh.
3.33	Hoarding works not completed before the end of March.	Hoarding works to be completed prior to Sheet piling works commencing along this section of Meadowbrook estate.

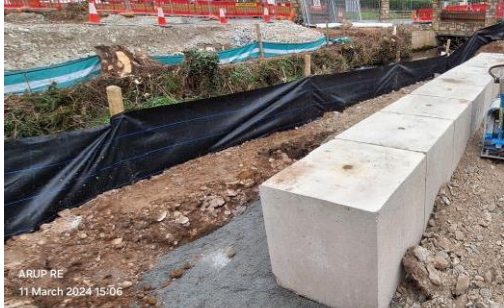
No.	Date	Comment	Image	ECow Action/ Recommendation	Sorensen's action response
3.26	11/3/2024	Silt fencing installed at Copper Valley Vue enabling works.

Good silt control measures.	Fencing was maintained throughout the month.
3.27	13/3/2024	Works along New Line were carried out without the need for additional pumping of ground water.

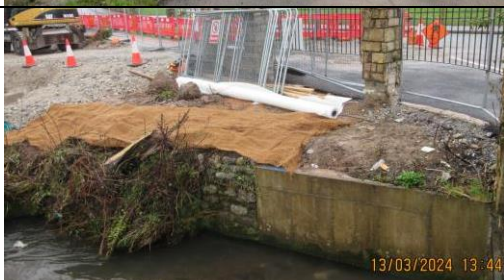
No action required.	Excavations were monitored daily for signs of ground water ingress for the duration of March.
3.28	13/3/2024	Erosion mesh was installed on exposed ground at Copper Valley Vue however the entire area exposed was not entirely covered with the mesh.

Extend mesh accordingly.	Mesh yet to be extended.

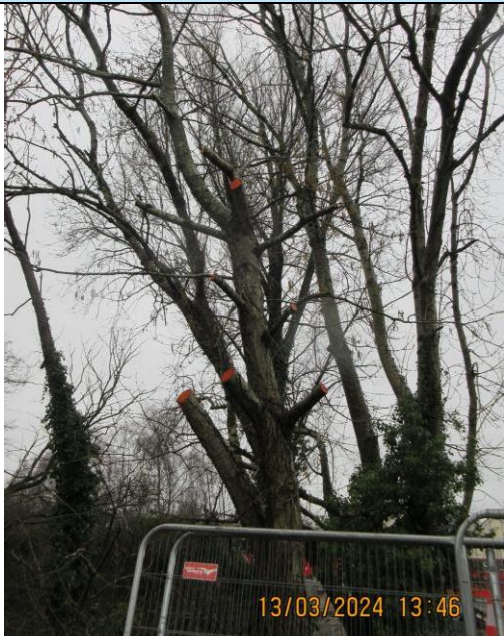
No.	Date	Comment	Image	ECoW Action/ Recommendation	Sorensen's action response
3.29	13/3/2024	Trees pruned at Copper Valley Vue as part of enabling works. Trees were surveyed for nesting birds by the site ecologist prior to pruning.

Good practice followed.	No further action required.
3.30	13/3/2024	Overpumping at Meadowbrook pump station is observed to be clean upon time of inspection.

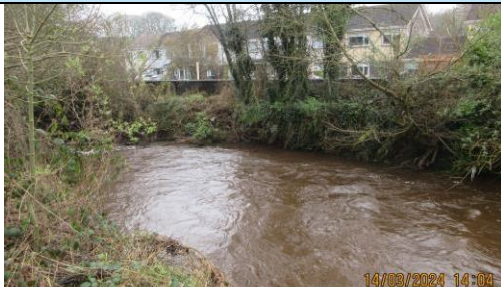
No.	Date	Comment	Image	ECow Action/ Recommendation	Sorensen's action response
3.31	14/3/2024	Monitoring for Kingfisher continued throughout March.

14/03/2024 14:04	Report any sightings of kingfisher.	Monitoring for KF carried out throughout the month and reported weekly.

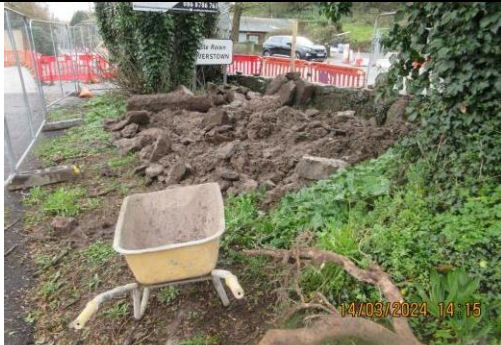
3.32	14/3/2024	The green area adjacent to the Springmount stream along the R639, which held value for pollinators, was covered with materials utilised by the masons for constructing the wall along the R639.

14/03/2024 14:15	Discussed with site ecologist.	Greenspace to be reinstated following the completion of works in the area.

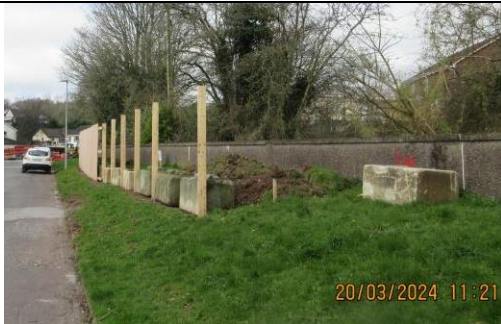
3.33	20/3/2024	Hoarding works at Meadowbrook halted for the remainder of the month.

20/03/2024 11:21	Complete hoarding works prior to permanent works in the area.	Hoarding was not completed before the end of March. However, no works were carried out in the area either. Hoarding to be completed next month.

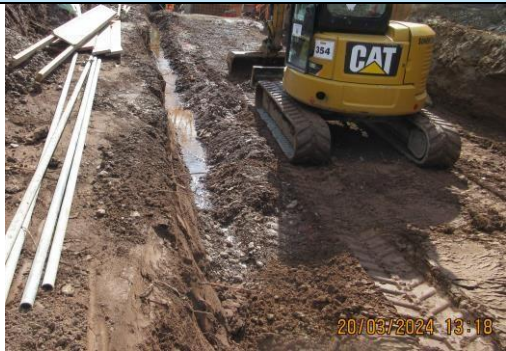
No.	Date	Comment	Image	ECoW Action/ Recommendation	Sorensen's action response
3.34	20/3/2024	A drainage system was installed within the funeral home works area to manage groundwater ingress. Water was directed via a drain and then channeled into the graveled sump area before being pumped out through silt bags into the main channel.

Documented.	Silt control measures successfully maintained throughout the month of March.

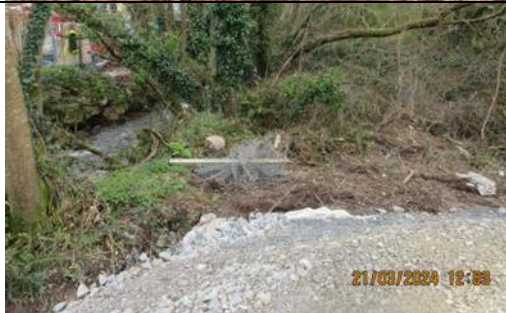
3.35	21/3/2024	There was a minor housekeeping issue observed at Copper Valley Vue where wire fencing and wooden posts were not properly removed.

Raised to site ecologist in Environmental Tour 009.	Issue has yet to be addressed.

3.35	Housing keeping at Copper Valley Vue.	Removed and dispose of materials.
3.36	Steel mesh on silt fencing at Copper Valley Vue.	Removed steel mesh.
2.37	Regarding an Item from February's audit, the proposal to install temporary diversions on the Glenmore River occurring from bridge and culvert works at New Line and Copper Valley Vue, Sorensen to consult Ross Macklin regarding otter passage.	Consult with otter specialist.

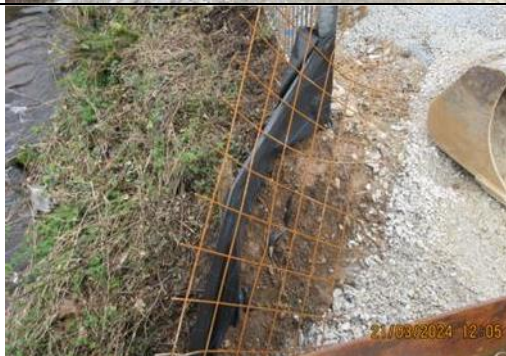
3.36	21/3/2024	There was a minor housekeeping issue observed at Copper Valley Vue with steel mesh currently stored on the silt fencing, which could potentially interfere with its effectiveness.

Raised to site ecologist in Environmental Tour 009.	Issue has yet to be addressed.

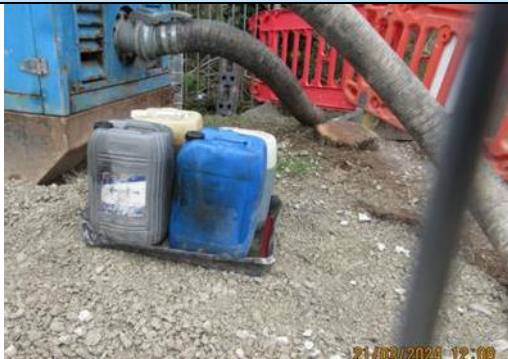
No.	Date	Comment	Image	ECoW Action/ Recommendation	Sorensen's action response
3.37	21/3/2024	Good storage of deleterious materials in proximity to Glenmore watercourse.

Positive observation documented.	No action required.
3.38	21/3/2024	Commencing on March 15th, water from the drainage works at Copper Valley Vue was pumped into the foul line. Plans are underway to develop contingency measures for implementing an alternative solution once the water from the works area becomes less turbid.

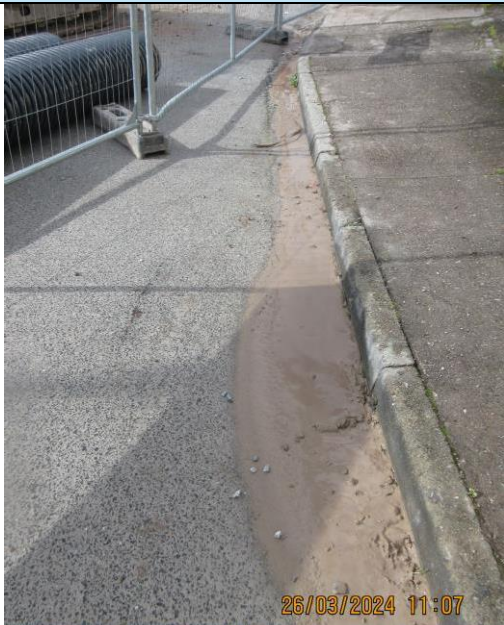
No.	Date	Comment	Image	ECow Action/ Recommendation	Sorensen's action response
3.39	26/3/2024	Meadowbrook pump station and adjacent manhole works area show signs of sediment having been pumped for the works area.

Discussed with site ecologist who was aware of the incident.	The pumping associated with the event was brief in duration. An extra silt sock was installed before the pumping resumed which was satisfactory. On March 28th, an alternative pumping system was implemented, utilising a manhole located within the westernmost eye of the John O' Callaghan Bridge. This pumping was being monitored by the Site Ecologist.
3.40	26/3/2024	New season growth of JKW observed growing in the temporary cell at Sallybrook.

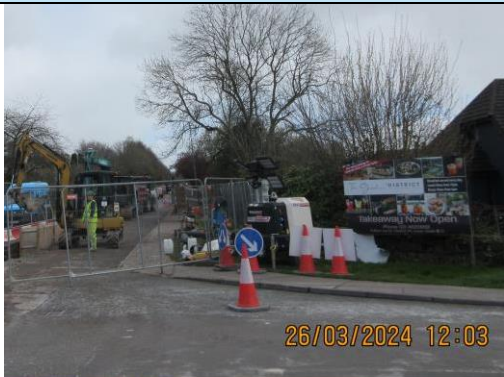
No.	Date	Comment	Image	ECOW Action/ Recommendation	Sorensen's action response
3.41	26/3/2024	Works continue along Hazelwood Road whilst avoiding harm to adjacent trees byroadside.

Documented.	Works regularly inspected by site ecologist.
3.42	26/3/2024	King fisher monitoring continued through March 2024, mainly by the site ecologist, and supplemented by the ECOW.

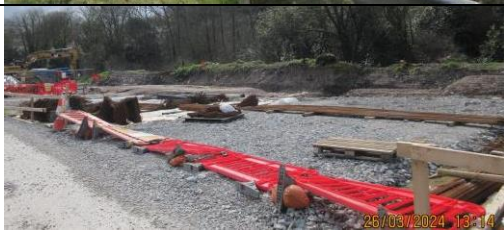
Details of monitoring was recorded.	Monitoring for KF carried out throughout March and reported weekly.
3.43	26/3/2024	A section of barriers at the Sallybrook JKW exclusion zone, that controls access into a stone covered storage area, was down upon inspection. No personnel were observed using the area at the time.

Discussed with site ecologist.	Fencing was reestablished the following day. Fencing safeguards are intentionally light as access is required frequently.
