## **Environmental Report February 2025**

Glashaboy Flood Relief Scheme

**Document code:** FFEC-GFRS-2025-002

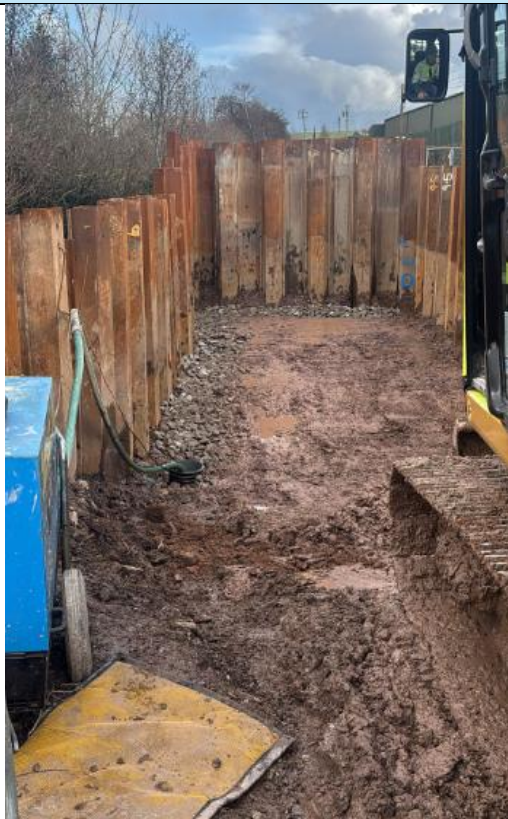
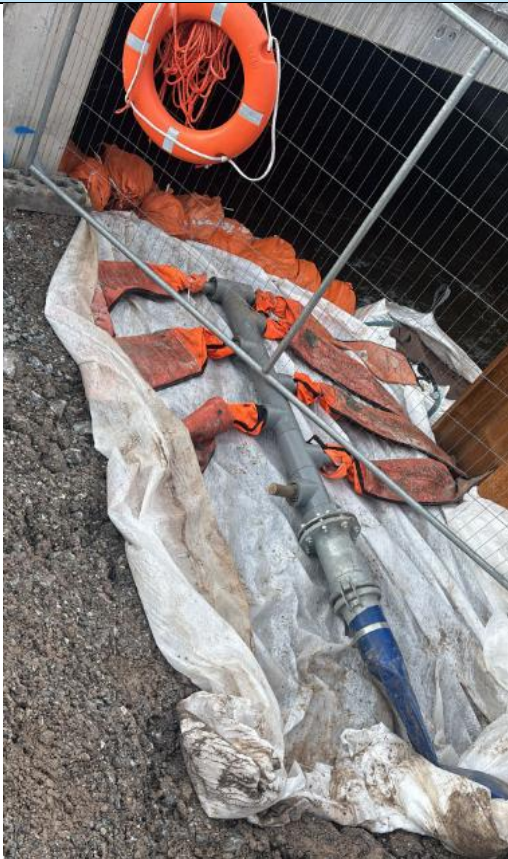
Item number	Date	Comment	Image	ECoW Action/Recommendation	Sorensens's Action response
2.1	04/02/2025	New Line: Works have commenced on the RC wall, with a cofferdam installed and excavations underway. Minor groundwater was encountered, which is being pumped out using a 2-inch pump. The dewatering plan includes a settlement tank and a manifold system positioned on terram. Dewatering plan also includes use of tanker to transport discharged water to attenuation area at Sallybrook.

Liaised with site ecologist about silt control measures for current pumping and future pumping at his location.	Silt mitigations measures installed correctly.

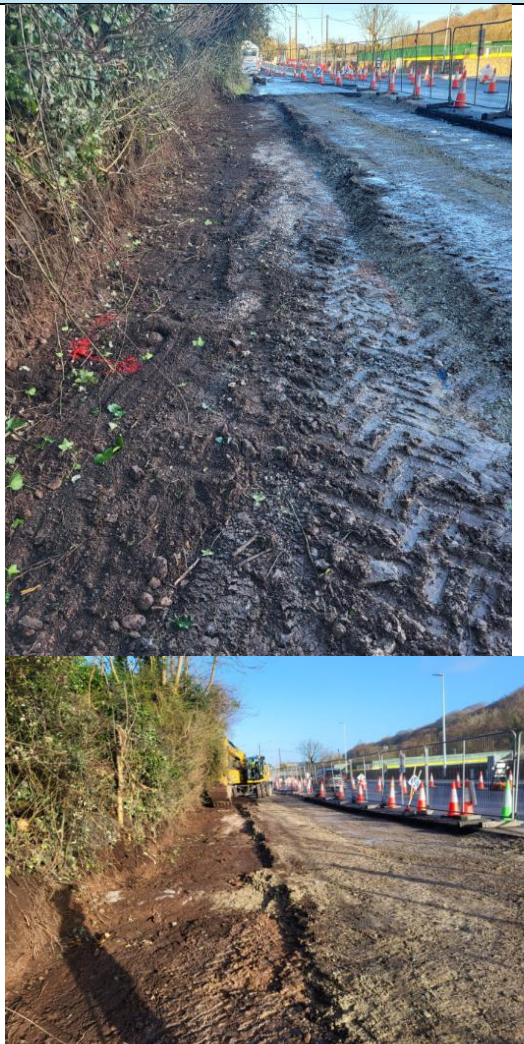
Item number	Date	Comment	Image	ECoW Action/Recommendation	Sorensens's Action response
2.2	04/02/2025	Works to widen the R639 required earth removal and minor vegetation removal consisting of verge side plants. No invasive were identified or reported.

Check for invasive plants as three-cornered garlic known to grow in some places locally.	Area was checked prior to works by site ecologist. No invasives plants were reported or identified.

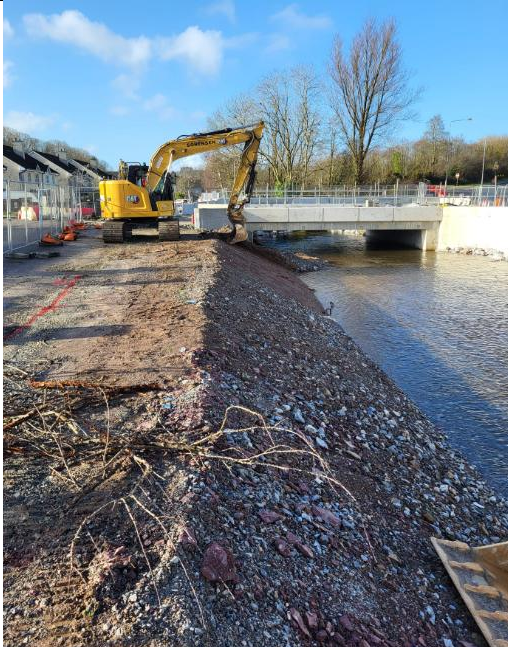
Item number	Date	Comment	Image	ECoW Action/Recommendation	Sorensens's Action response
2.3	05/02/2025	Grading works at Copper Valley Vue (CVV).

Follow up with coir mesh as erosion control.	Erosion control coir mesh installed where riverbank regrading was carried out. This is part of temporary works to control surface run off in the short term. During the open instream season this year, the bank will be regraded and erosion membrane added and seeded as part of the final design.
2.4	06/02/2025	Archaeology delay continues at Area 1 where pump station works are due to resume shortly.

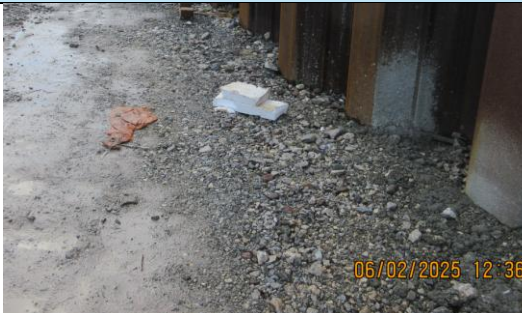
Item number	Date	Comment	Image	ECoW Action/Recommendation	Sorensens's Action response
2.5	06/02/2025	Housekeeping at Sallybrook, minor amount of waste present, empty sandbag and Styrofoam.

Raised housekeeping with site ecologist.	Waste was promptly cleaned up by the contractor following communication to site ecologist.
2.6	06/02/2025	At Sallybrook, the point of discharge for the tanker from New Line was inspected. It is bunded on three sides, with water allowed to percolate through the ground achieving effective attenuation of any silt present in discharged water.

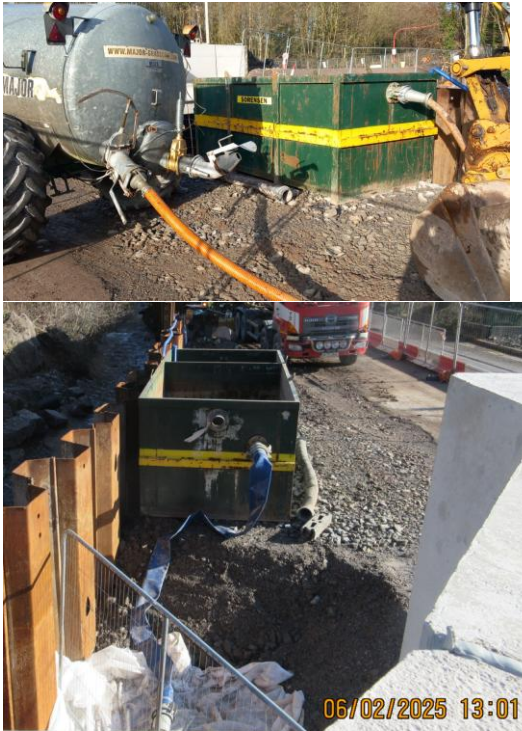
Item number	Date	Comment	Image	ECoW Action/Recommendation	Sorensens's Action response
2.7	06/02/2025	Pumping continues at New Line using settlement tank which is being tanked out to discharge location previously mentioned located at Sallybrook.

Inspected pumping set up and spoke with driver to confirm discharge location.	No further action is required other than maintaining the existing silt management setup.

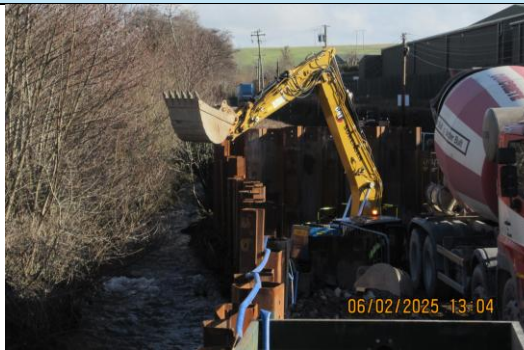
Item number	Date	Comment	Image	ECoW Action/Recommendation	Sorensens's Action response
2.8	06/02/2025	Excavator observed manoeuvring bucket of concrete above the water course. Obvious risks exist should cementitious material accidentally fall into the river.

Spoke with driver who demonstrated an understanding and awareness of about the environmental risks.	The driver was aware and demonstrated appropriate caution. The bucket was only half filled. And rotations were preformed slow and steadily. The returning bucket was positioned upwards. No concrete entered the watercourse. However, this was not best practise and will be avoided going forward.

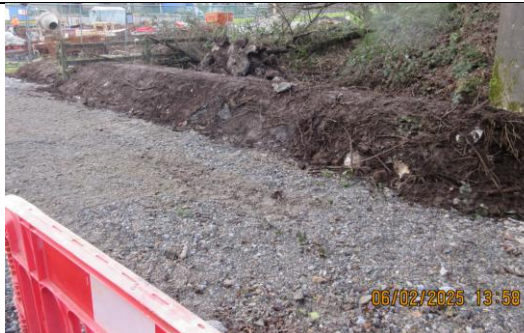
2.9	06/02/2025	At the M8 overpass at New Line, a berm was established at a wooded section to prevent encroachment from personal or plant.

This action was discussed with the site ecologist.	Bund installed following a request from the ECoW. Bund sufficient to address the issue of possible encroachment.

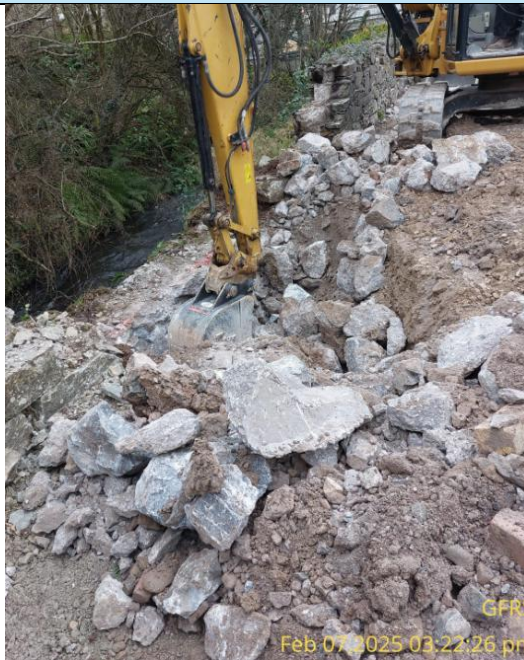
Item number	Date	Comment	Image	ECoW Action/Recommendation	Sorensens's Action response
2.10	07/02/2025	Works start at New Line to remove wall down to road level to enable RC wall construction. Risks off material entering watercourse.

Liaised with site ecologist about possible silt control measures.	The grounds crew and driver, especially, took care to prevent material from entering watercourses. The bucket moved from the wet side to the dry side, ensuring that all material remained on the dry side. The finished level left a step between the work area and the river created a deflector and container for possible run off.

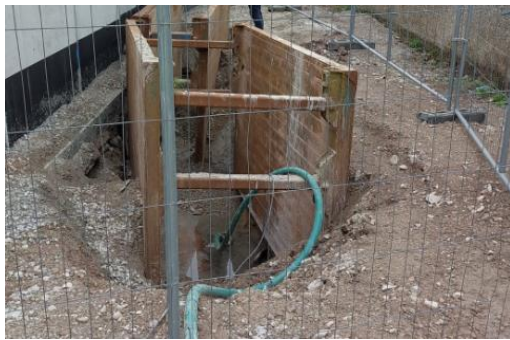
2.11	06/02/2025	Pumping commences at Hazelwood where a two-inch pump will be used to dewater open excavations while works continue. A permit to pump has been issued by the site ecologist.

Review Permit to Pump. All was in order.	Periodic monitoring was carried out for the duration of pumping at this location.

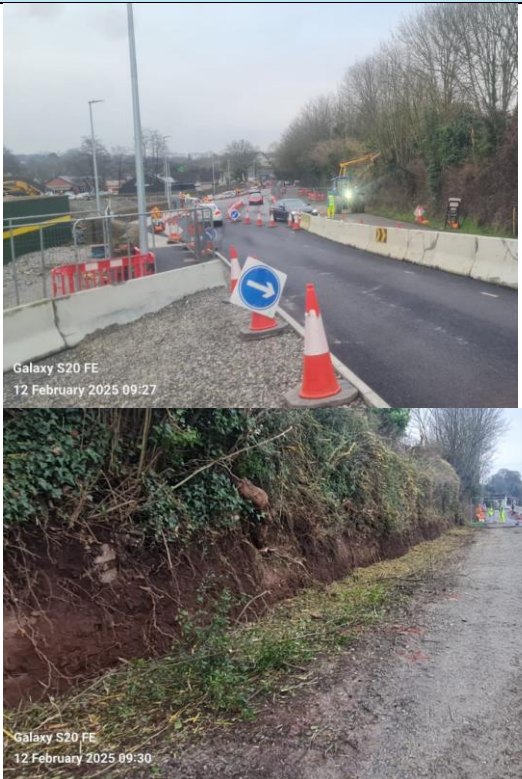
Item number	Date	Comment	Image	ECoW Action/Recommendation	Sorensens's Action response
2.12	06/02/2025	Works to widen the R639 required some minor hedge cutting.

If possible, carry out hedge cutting outside the bird nesting season.	The works were carried out efficiently and to a high standard outside the bird nesting season.

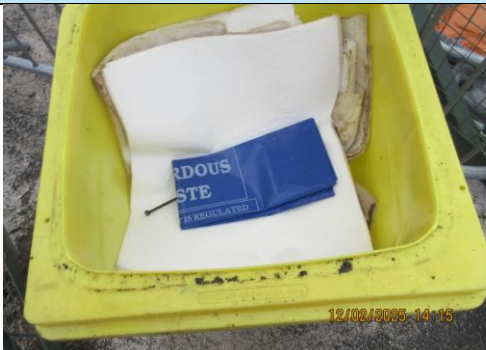
Item number	Date	Comment	Image	ECoW Action/Recommendation	Sorensens's Action response
2.13	12/02/2025	Spot checks of some spill kits on site showed they were well stocked with appropriate material inside.

Noted.	Spill kits continue to receive regular inspection and replenishment under the direction of the site ecologist in partnership with SCE's environmental unit.
2.14	12/02/2025	Trees to be removed at Meadowbrook estate to facilitate OPW weather station were inspected. These trees were overlooked as part of clearance works.

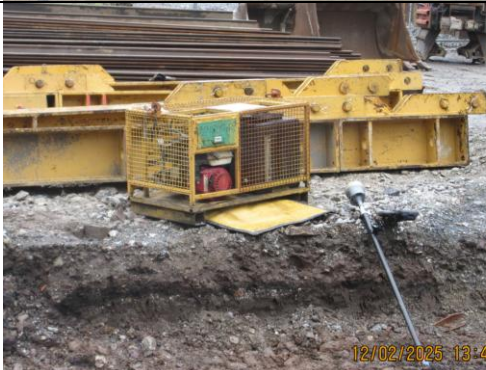
Remove before March 1 <sup>st</sup> .	Trees were inspected and removed prior to the bird nesting season. Trees were removed under the supervision of the site ecologist.
2.15	12/02/2025	Good use of spill matting with small generator in use at Area 1 Pump Station works area in case of a leak or spill event.

Noted.	No action required.

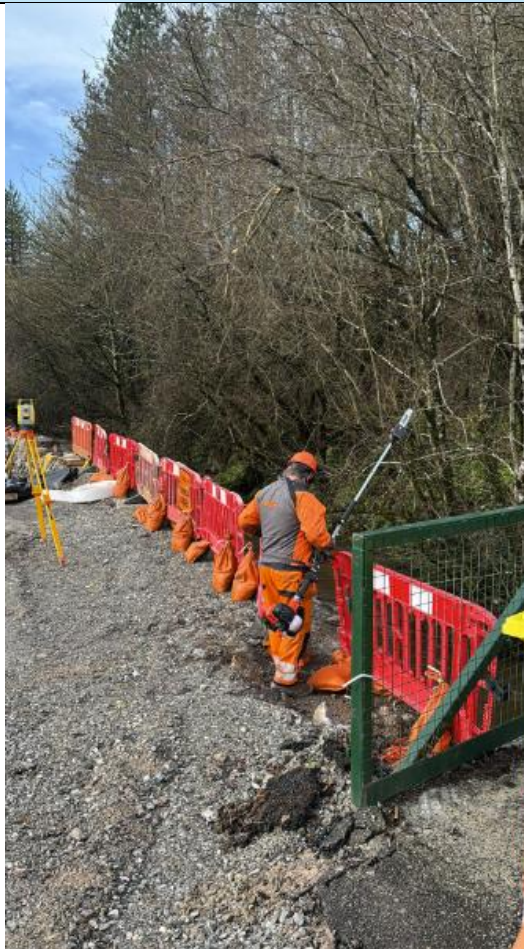
Item number	Date	Comment	Image	ECoW Action/Recommendation	Sorensens's Action response
2.16	14/02/2025	RC wall construction at New Line required delimbing of trees. Work carried out with a Permit to Clear Vegetation in place.

Liaised with the site ecologist regarding the works before they were carried out.	Permit to clear vegetation was issued to the ER team addressing all ecological concerns appropriately.

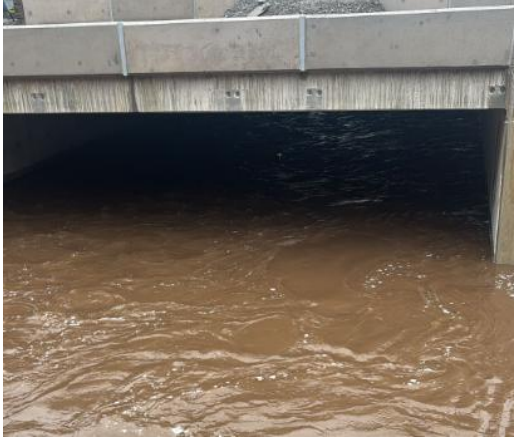
Item number	Date	Comment	Image	ECoW Action/Recommendation	Sorensens's Action response
2.17	14/02/2024	A yellow rainfall event affected all watercourses in Glanmire. No environmental issues occurred as a result.

The event was recorded, and preparations were discussed with the site ecologist prior to the arrival of heavy rainfall.	The entrance to the diversion pipe at New Line was exposed due to erosion. The entrance was subsequently blocked off.
2.18	14/02/2025	New Line: The former diversion pipe, which remains in place, has become uncovered, creating the possibility for fish to enter. There is a risk of fish becoming trapped, as the pipe is blocked at the other end.

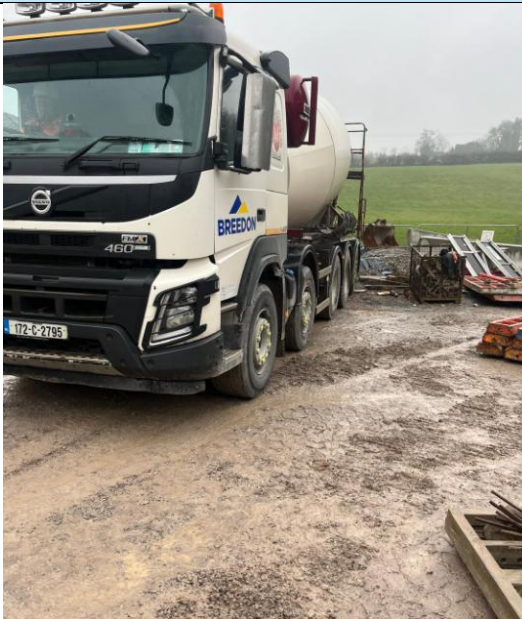
Item number	Date	Comment	Image	ECoW Action/Recommendation	Sorensens's Action response
2.19	14/02/2025	Concrete wash out being used at New Line

Continue to use concrete washout system for each pour at this location to manage concrete waste.	Concrete wash out wash used and maintained at this location.

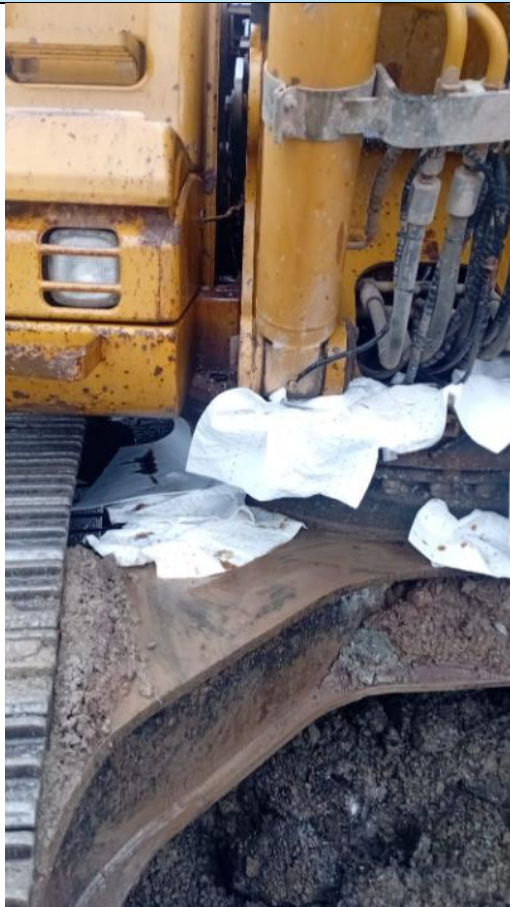
Item number	Date	Comment	Image	ECoW Action/Recommendation	Sorensens's Action response
2.20	14/02/2025	Hydraulic hose burst on excavator in Circus Field. Spill was promptly contained. No environmental impact occurred.

Discussed event with site ecologist.	Such an event is unavoidable on-site, even with regular vehicle inspections. What is important is that spill kits are readily available, and personnel are trained to respond promptly and effectively, which is exactly what occurred in this instance.

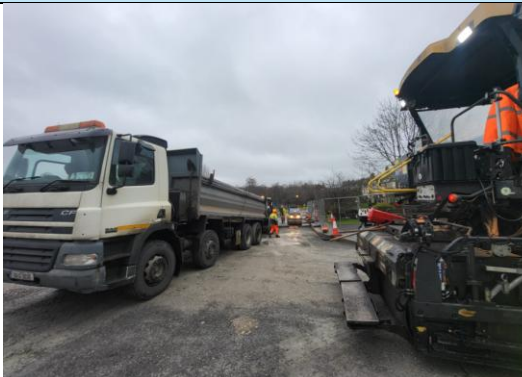
Item number	Date	Comment	Image	ECoW Action/Recommendation	Sorensens's Action response
2.21	18/02/2025	Road surfacing at CVV. Risks to storm water during wet conditions.

Recommended to implement measures to protect storm water gullies.	Measures were implemented to channel surface water into the stormwater gully, ensuring it does not come into contact with the freshly laid bituminous surface material.

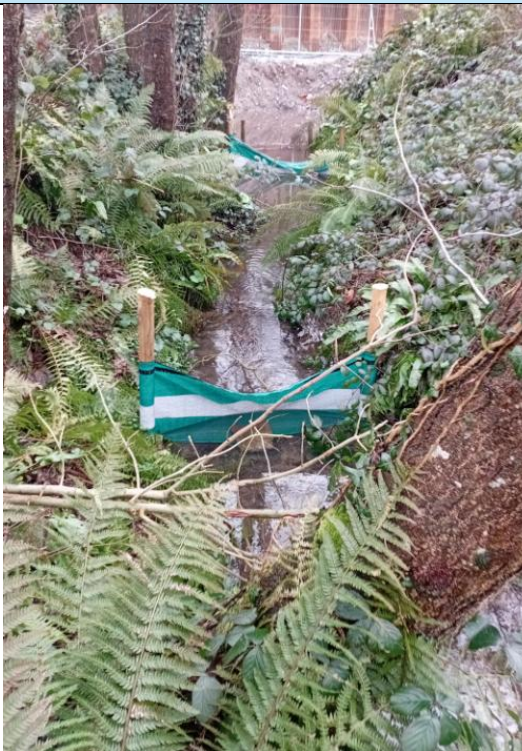
Item number	Date	Comment	Image	ECoW Action/Recommendation	Sorensens's Action response
2.22	18/02/2025	Preparatory works underway at Sallybrook to use nearby drain as an attenuation area for dewatering from pump station excavations.

Deploy a range of silt measures and ensure outlet pipe is not blocked prior to discharge into this area.	The silt management setup included silt fences, silt socks, a settlement tank, and gravel check dams. Pumping was periodically monitored, and NTU testing was conducted at a location agreed upon with the ECOW.
2.23	20/02/2025	Adjustments to rock armour at New Line required the temporary removal of silt mitigation measures coir mesh.

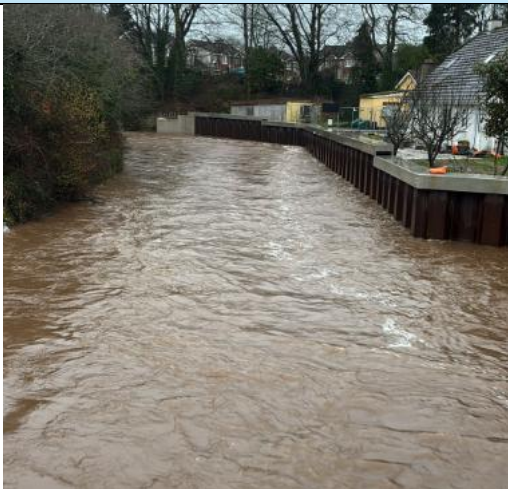
Item number	Date	Comment	Image	ECoW Action/Recommendation	Sorensens's Action response
2.24	21/02/2025	Elevated flows were observed in all Glashaboy and Glenmore rivers following heavy rainfall. No environmental issues were reported.

The event was recorded, and alerts were issued to the SCE environmental unit as a precaution.	Sand bags were reported as having been washed in the Glenmore channel which will be retrieved when safe to do so.

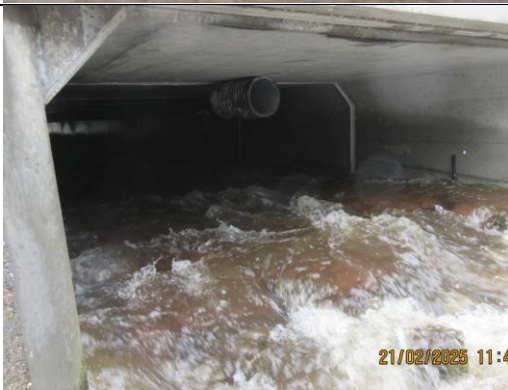
2.25	21/02/2025	The dipper nest, originally installed in the Cois na Gleann culvert as compensation for the loss of habitat during construction, was removed and reinstalled with modifications to enhance its height and provide better protection for potential dipper chicks that may use it.

Modifications made following ECOW observations to previous installation that posed risks to dipper chicks.	The chosen location is suitable; however, a temporary pedestrian bridge is located in close proximity and may influence uptake during the 2025 breeding season. Given the dimensions of both the culvert and the tube, including its height, there is very limited potential for it to become a snag point for debris. Larger debris is likely to accumulate at the culvert entrance, while smaller

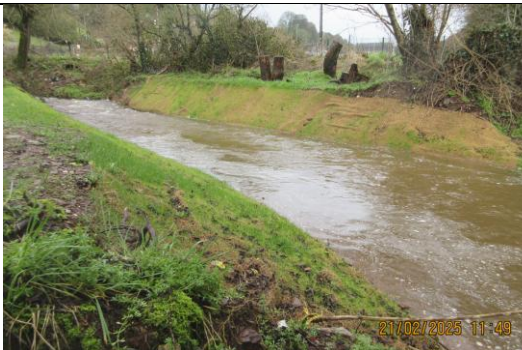
Item number	Date	Comment	Image	ECoW Action/Recommendation	Sorensens's Action response
					objects would be deflected to either side of the tube.
2.26	21/02/2025	A biodiversity initiative involving the removal of approximately 18 meters of concrete pipe to reconnect the CNG stream into the Glashboy River last September has been revisited. The progress of reinstatement looks promising with embankments greening up and riverbed properly gravelled up.

Noted	No action required.
2.27	21/02/2025	The dewatering setup at the Sallybrook pump station was inspected. The silt curtains were functioning effectively, and the silt sock had recently been replaced with an empty one. Additionally, the check dam contributed to filtration.

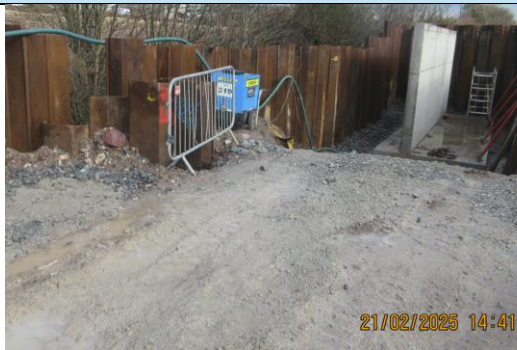
Item number	Date	Comment	Image	ECoW Action/Recommendation	Sorensens's Action response
2.28	21/02/2025	Concrete waste was observed at New Line with a possible route to the adjacent water course if heavy rains were to occur.

The area should be cleaned up immediately and access point sandbagged.	This was actioned promptly. No concrete waste entered the waterway. The area was scrapped with concrete wash deposited into the nearby concrete wash out receptor.
2.29	21/02/2025	Coir mesh reinstated at New Line.

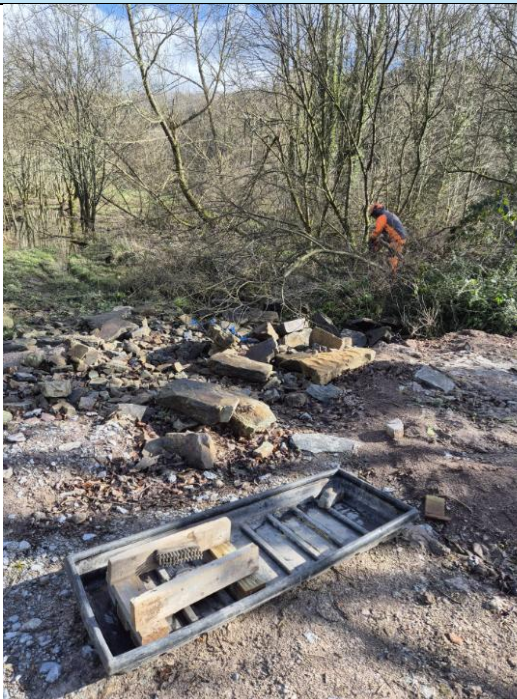
Item number	Date	Comment	Image	ECoW Action/Recommendation	Sorensens's Action response
2.30	25/02/2025	The vegetation clearance in Area 4 was conducted under the supervision of the site ecologist.

Discussed surveys required with the site ecologist prior which included a joint inspection together for ecological appraisal.	Japanese Knotweed (JKW) biosecurity measures were implemented, and the area was surveyed for mammals, birds, and frogs to ensure proper ecological possibilities were addressed.
2.31	26/02/2025	Concrete wash out at New Line when inspected was full.

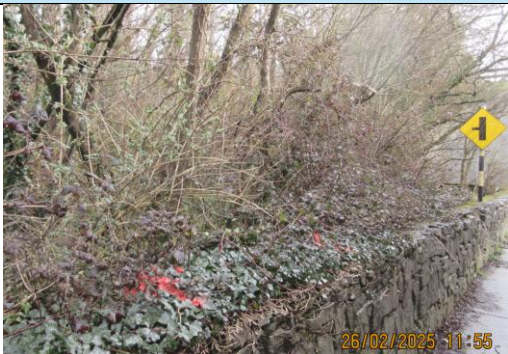
Item number	Date	Comment	Image	ECoW Action/Recommendation	Sorensens's Action response
2.32	26/02/2025	Enabling works to allow for wall repointing from Brooklodge culvert to New Line overpass required minor amount of tree limbs to be removed.  Permit to clear vegetation was in place (GFRS-PTCV-009)

Pre-inspection prior to delimbing. Invasives plant species were identified.	Repointing works did not occur this month.

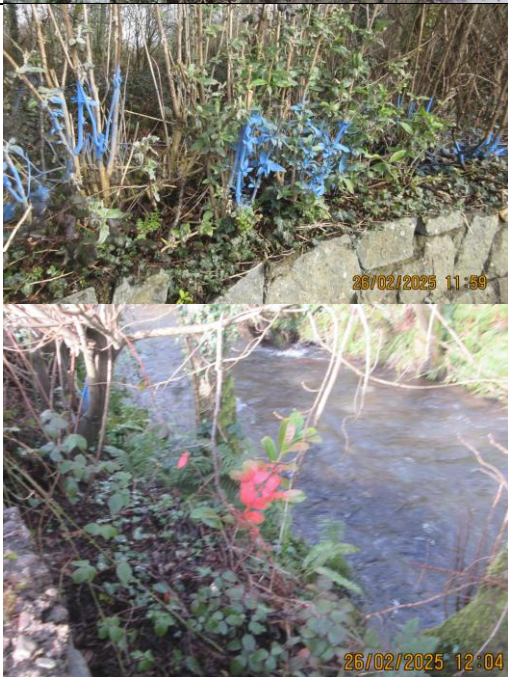
2.33	26/02/2025	At the same location previously mentioned, invasive plant species, including Buddleia and Cherry Laurel, were successfully removed following the use of effective biosecurity measures.

Liaised with site ecologist about biosecurity protocols.	Seed heads were removed from the Buddleia, and the single small Cherry Laurel plant was entirely grubbed out. All material was safely transported to the holding cell in Sallybrook for proper containment and disposal.

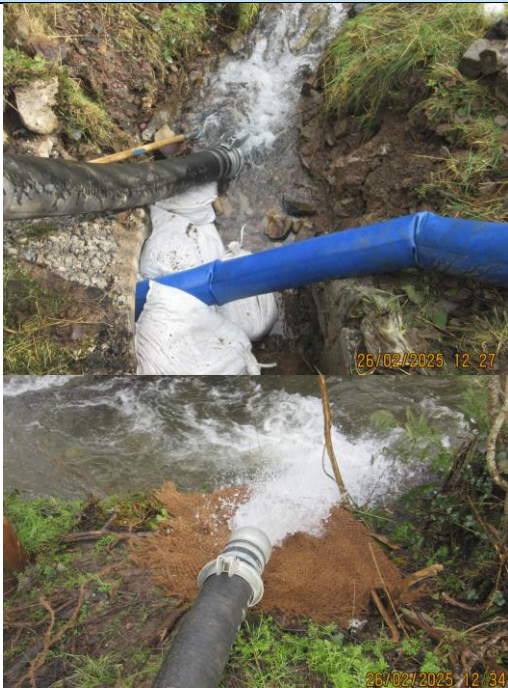
Item number	Date	Comment	Image	ECoW Action/Recommendation	Sorensens's Action response
2.34	26/02/2025	Over-pumping of the O'Connell Transport drainage line, which passes through the New Line RC wall works upstream of the bridge, was required. To prevent erosion and maintain bank stabilisation, coir mesh was positioned at the outflow.

Carry out periodic checks of coir mesh.	To prevent erosion and maintain bank stabilisation, coir mesh was positioned at the outflow.

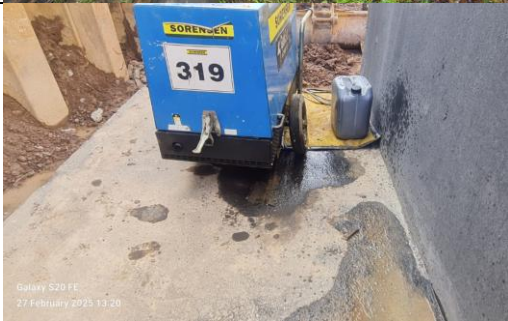
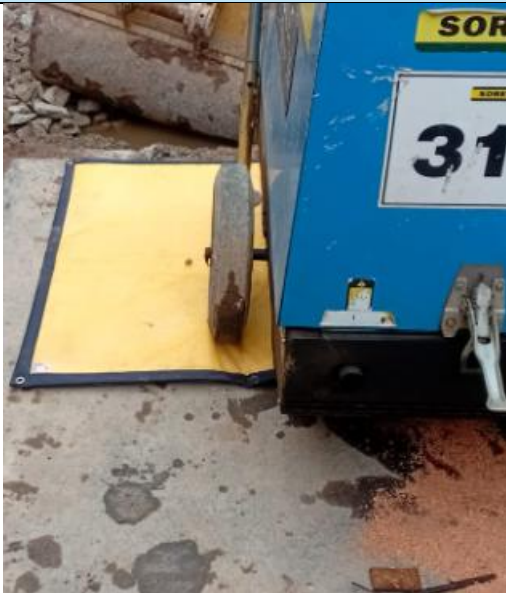
2.35	27/02/2025	Upon inspection at New Line it was observed what appeared to be a heavily leaking genny at New Line works area.

Liaised with site ecologist about the pollution risk of generator No.319 and requested it receives service before further use on site.	The generator showed no signs of leaking. However, in response to a small fuel spill, two absorbent pads were placed—one beneath the generator and another under the fuel can. The spill occurred during refuelling. To address this, a larger absorbent pad will be positioned underneath,

and granules will be applied to the spill zone for effective clean-up.
