Environmental Report February 2024

Glashaboy Flood Relief Scheme

Document code: FFEC-GFRS-2024-006

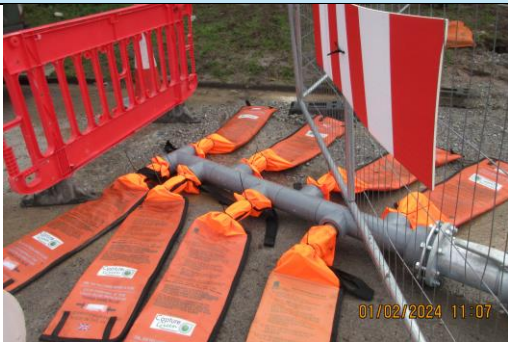
No.	Date	Comment	Image	ECow Action/Recommendation	Sorensens's Action response
1.	1/2/24	Good use of sediment control during pump station works at Meadowbrook with use of sump, settlement tank and manifold system that uses 8 silt bags simultaneously ensuring water pumped from works area into gully was clean when inspected.

A photograph showing a construction site with several orange silt bags placed in a line to create a sediment control barrier. Red plastic safety barriers are visible in the background. A timestamp '01/02/2024 11:07' is visible in the bottom right corner of the image.	Continued to monitor daily to ensure sediment control measures are maintained and consistent.	Continued to check to ensure water pumped from the works area enters the gully is not sedimented. Carry out hand test of turbidity as required.

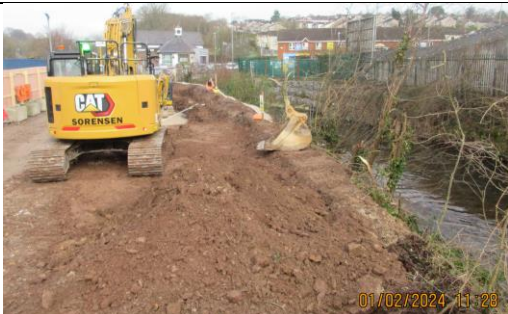
2.	1/2/24	Stock piling of excavation risings next to water course.

A photograph of a yellow CAT excavator with 'SORENSEN' written on its side, parked on a large pile of excavated earth. In the background, there is a body of water and some residential buildings. A timestamp '01/02/2024 13:28' is visible in the bottom right corner of the image.	Discussed with site ecologist	Stockpile was removed that day.

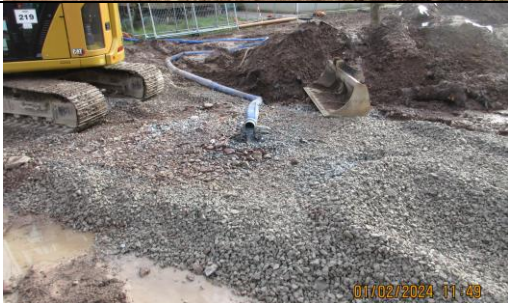
3.	1/2/24	Septic tank installation works at Sallybrook house was carried out with the following sediment control measures: filtration drain, silt fencing and selective timing of works to allow sediment to travel through attenuation area.

A photograph showing the installation of a septic tank. A large pile of dark soil is next to a gravel area where a pipe is being laid. A yellow excavator is partially visible on the left. A timestamp '01/02/2024 11:49' is visible in the bottom right corner of the image.	Continued to monitor to ensure sediment control measures are maintained and consistent.	Continued to follow sediment controls until works were complete.

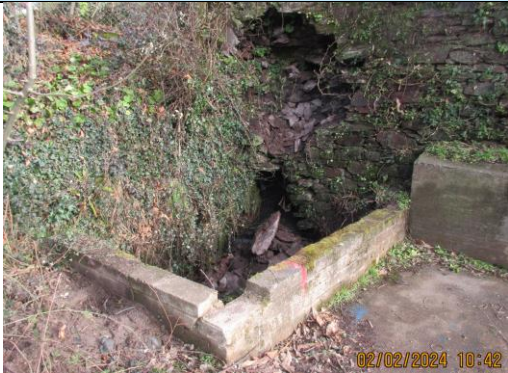
No.	Date	Comment	Image	ECoW Action/Recommendation	Sorensens's Action response
4.	2/2/24	Partial wall collapse at POD into outlet that runs into Sallybrook stream. No blockage was caused.

Documented.	The wall was later braced for the construction works on the surface water chamber.
5.	7/2/24	Erosion mesh in use at Funeral homework area adjacent to the Glashaboy river.

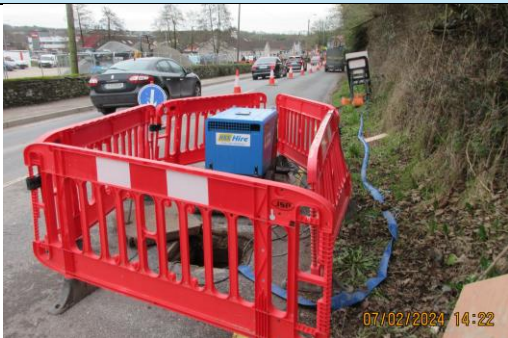
No.	Date	Comment	Image	ECoW Action/Recommendation	Sorensens's Action response
7.	7/2/24	R639 drainage works throughout February pumps water from works area back into previously installed drainage line.

Documented.	No action required.

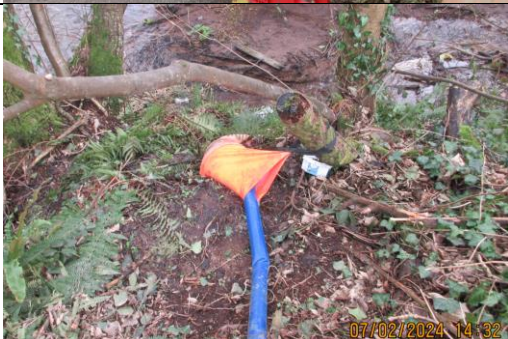
8.	7/2/24	Pumping of water from funeral home works area is satisfactory. Sumps in place, silt bags positioned at the end of lay flat. Vegetation on embankment also utilised for filtration.

Silt bag to be regular maintained to ensure optimal performance.	Silt bag regularly maintained by contractor's environmental champion with additional checks made by site ecologist.

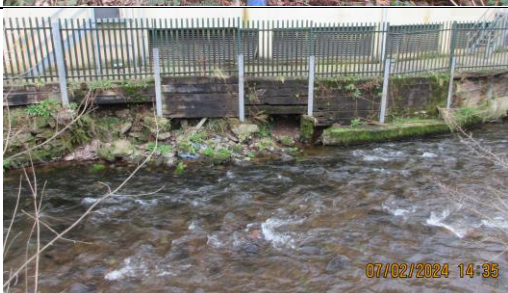
9.	7/2/24	Otter couch (C2) monitored throughout the month to ensure works don't negatively impact upon it. Signage required to alert personnel working in the area yet to be installed.

Continued to monitor couch while works continue. Erect signage as per Ross Macklin's recommendations	Sorensen to establish signage as per otter expert Ross Macklin's recommendations.

Item No.	Issue	Action to be carried out
9.	Otter signage at Funeral home for couch C2.	Erect signage.
15.	Mulched material in northern art of the JKW at Sallybrook requires special attention as material is unsuitable for the intended JKW burial at circus field (pending approval).	Sorensen to revert with plans to deal with mulched material.

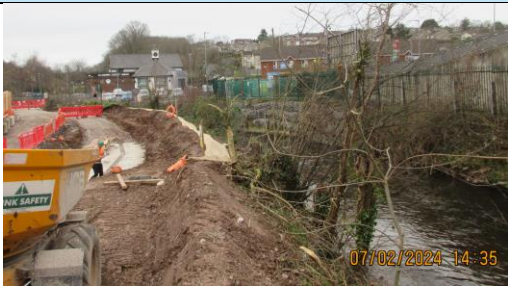
No.	Date	Comment	Image	ECoW Action/Recommendation	Sorensens's Action response
10.	7/2/24	Erosion mesh not deployed along this exposed section of the river embankment at the funeral home works area.

Discussed with site ecologist.	Erosion mesh was extended the following day.

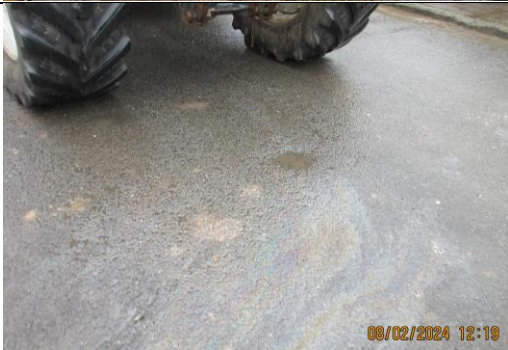
11.	8/2/24	Fuel spill at cul-de-sac of the Meadowbrook drainage works area.

Site ecologist on site at the time of discovery.	Oil booms were immediately deployed around two gullies. Investigation into the incident revealed the cause to be the overfilling of diesel by the tractor driver of Powers Group. The area was subsequently treated with Bioversal.

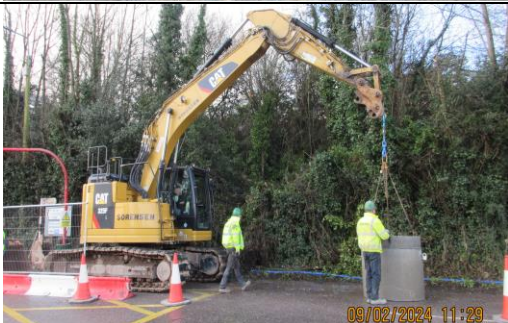
12.	9/2/24	Insufficient effort was made to prevent minor damage to vegetation during works along the R639 at the junction with Hazelwood Rd. The crew mentioned the need to manoeuvre inside (within the vegetation) to avoid traffic.

Discussed with site ecologist and personnel. Requested tree branches be avoided or if not possible to avoid, be delimbed with a chain saw.	Efforts were then made by the excavation driver to avoid vegetation which was successful.

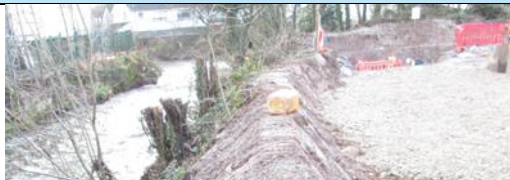
No.	Date	Comment	Image	ECoW Action/Recommendation	Sorensens's Action response
13.	9/2/24	Improper storage of empty containers poses a risk of them being blown into the main channel, potentially contributing to pollution.

Discussed with site ecologist.	The container was immediately relocated to a more appropriate storage location.

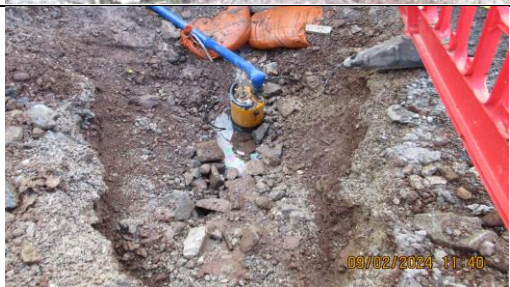
14.	9/2/24	Oil residue in works area being pumped out. Investigations revealed it was shutter oil (Forstrike). No spill kit on hand. No sump in place. However, the outlet to the lay flat was fitted with an oil and sediment filter.

Discussed with site ecologist.	Pumping was stopped. Oil boom installed. Investigation into cause was undertaken. A spill kit was later installed in this area.

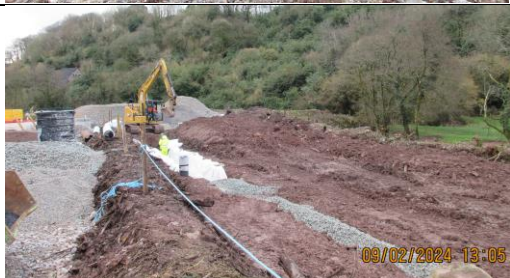
15.	9/2/24	Drainage works were carried out at the north end of Sallybrook in the JKW zone, with biosecurity protocols being adhered to. The mulch material generated from tree felling works in 2003 were moved to one side prior to excavations.

Discussed with JKW expert details concerning separation of mulched material.	Sorensen to revert with plans to deal with mulched material.

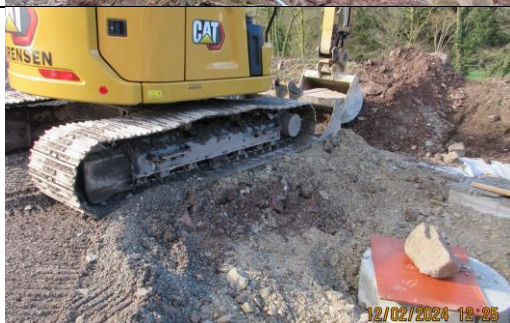
16.	12/2/24	Following drainage works in northern end of JKW zone, the excavator was cleaned down before being deployed elsewhere on site.

Documented.	No further action required.

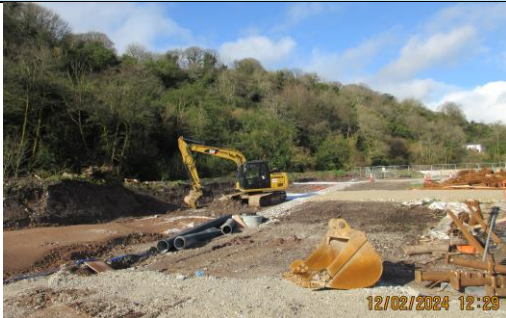
No.	Date	Comment	Image	ECoW Action/Recommendation	Sorensens's Action response
17.	12/2/24	Two access roads were installed at the Sallybrook JKW zone to enable embankment works. Terram and compacted stone were used to prevent ground disturbance from plant and personnel into the area.

Documented	Maintain biosecurity measures for the duration of works in this area.
18.	12/2/24	Trees removed at POD. Tree clearance was undertaken independent of works.

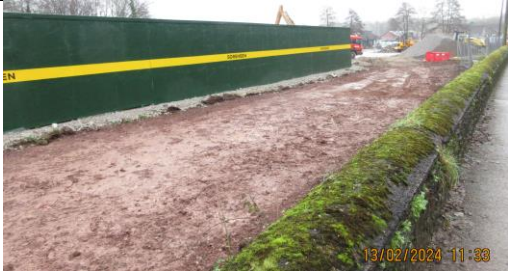
No.	Date	Comment	Image	ECoW Action/Recommendation	Sorensens's Action response
19.	13/2/24	Vegetation removal in front of main compound. Low ecological value. Clearance required to build wall as part of works.

Documented.	No action required.
20.	15/2/24	Housekeeping at Copper Valley Vue. Miscellaneous waste from emergency temporary works.

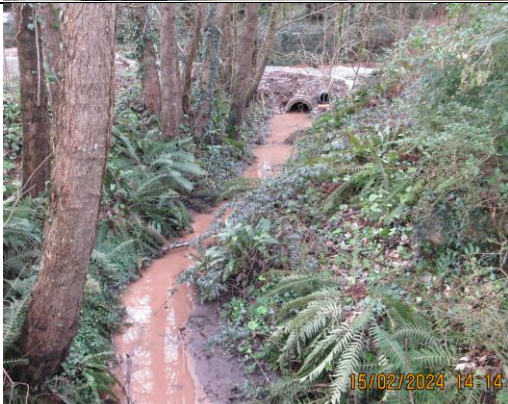
Discussed with site ecologist.	Housing keeping to be addressed.
21.	15/2/24	Sallybrook stream/drain sedimented from works in chamber works in POD. However, the outlet into the main channel, into which this stream/drain is connected via the attenuation channel, was clean.

Discussed with site ecologist.	IFI was consulted regarding these works, and no objections were raised concerning this low-value watercourse. Agreements were made not to dry out the stream during works, which was achieved during work here in February.

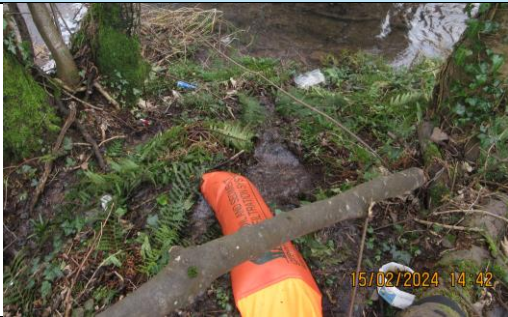
No.	Date	Comment	Image	ECow Action/Recommendation	Sorensens's Action response
22.	15/2/24	Pumping continued from the funeral home works area. Sump and silt bag in operation.

Discussed permit to pump with site ecologist.	Silt bag regularly maintained by environmental champion.

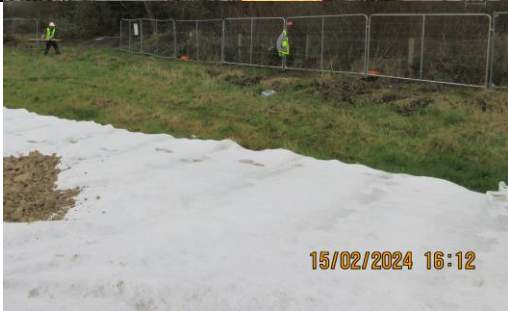
23.	15/2/24	Changes to otter holt buffer zone in Circus field where otter holt N6 is no longer active following a survey by otter expert Ross Macklin. Fence line moved back to vegetation along river.

Documented and discussed with site ecologist.	Ross Macklin's report confirmed that the otter holt was flooded and no longer active. Consequently, the conditions of the derogation license, which required maintaining a 20-meter buffer, are no longer applicable.

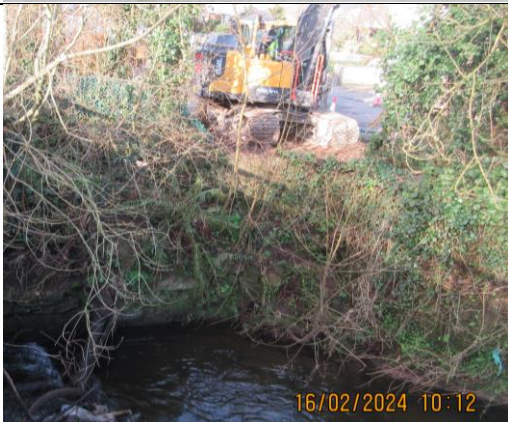
24.	16/2/24	Vegetation removal at Meadowbrook. No trees were removed by the excavator.

Documented and discussed with site ecologist.	No action required.

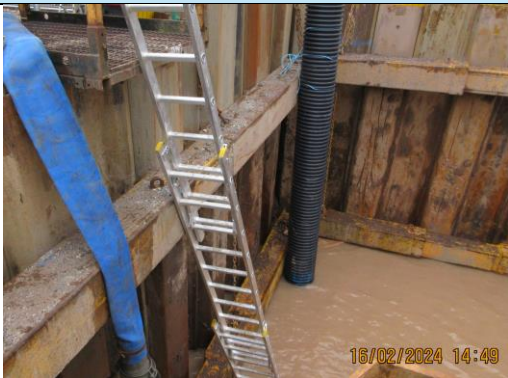
No.	Date	Comment	Image	ECoW Action/Recommendation	Sorensens's Action response
25.	16/2/24	Pump station works area at Meadowbrook used for filtration to control sediment from adjacent drainage line works.

Discussed with site ecologist.	Pump station was pumped out into manifold system before entering gully.
26.	16/2/24	Ivy covered trees at Copper Valley Vue required removal to facilitate enabling works – trees left in situ after cutting for bats.

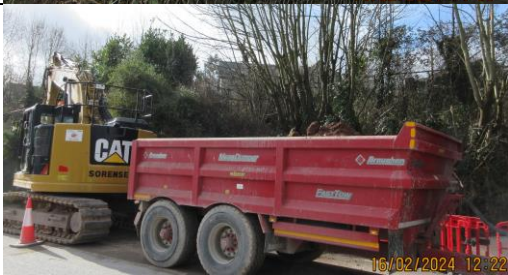
Documented.	No action required.
27.	16/2/24	The works along the R639 posed a potential threat to trees adjacent to the roadside due to the swinging motion of the excavator.

Discussed with site ecologist.	Additional banks person was put in position to guide driver of excavator as it manoeuvred the vehicles arm over an active roadway. The following day, trees were delimbed along the remainder of the route.

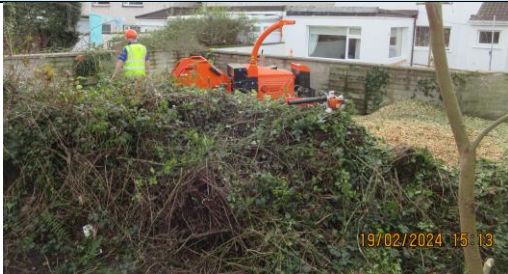
No.	Date	Comment	Image	ECoW Action/Recommendation	Sorensens's Action response
28.	19/2/24	Trees were removed as part of the design at Meadowbrook along Springmount stream to accommodate the proposed permanent sheet piling works.

Discussed with site ecologist.	Sub-contractors received toolbox talk regarding ivy covered trees and JKW.

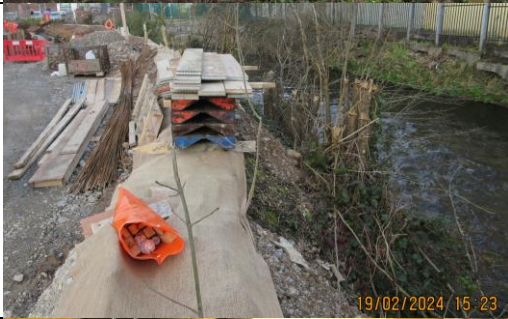
29.	19/2/24	At the Funeral home works area, there was excessive storage of materials on the river embankment and inappropriate stockpiling of excavation risings adjacent to main channel.

Discussed with site ecologist.	This was rectified within 24hrs.

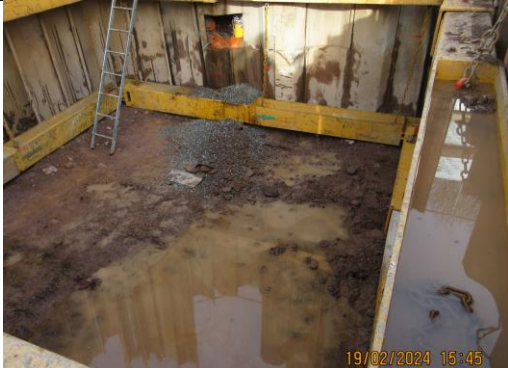
30.	19/2/24	Surface water chamber in POD sediment controls include pumping water further up the line into adjacent drain and over pumping around works using 2-inch pump. The volume of the stream/drain was impacted with a lowering of water levels although not to an great extent.

Discussed with site ecologist.	Continued to implement sediment controls and permit to pump system for duration to works.

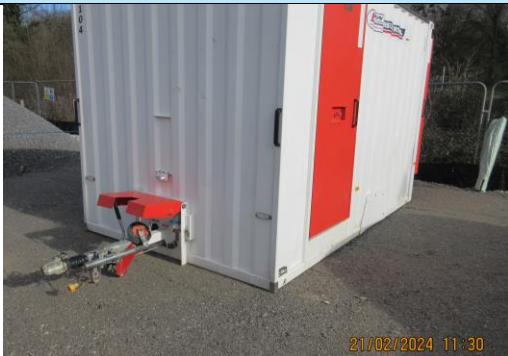
No.	Date	Comment	Image	ECoW Action/Recommendation	Sorensens's Action response
31.	21/2/24	Welfare facilities positioned in Circus field within the zone of flooding.

Discussed with site ecologist.	Welfare facilities are scheduled for removal.
32.	02/24	Corner of funeral home works area, monitored for JKW. Nothing was observed growing during the month.

31.	Welfare facilities positioned in Circus field within the zone of flooding.	Facilities to be removed outside flood impacted area.
33.	Housing keeping issue at green area near the Springmount stream along the R639, where waste materials from works are present.	To remove road equipment and waste materials from area.

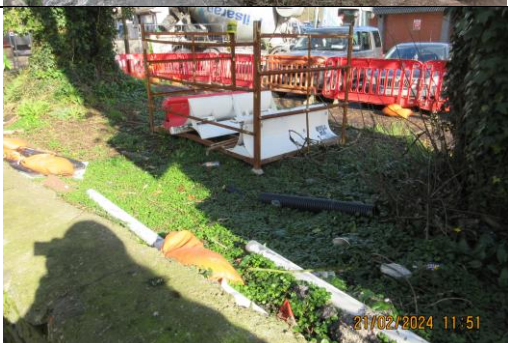
Liaised with site ecologist. Supervision by JKW expert required when excavations resume.	Area was monitored for JKW during the works. Excavations were undertaken under the supervision of JKW expert, Lisa Dolan.
33.	21/2/24	Housing keeping issue at green area near the Springmount stream along the R639, where waste materials from works are present. Also, storage of road equipment which is not ideal.

Alerted site ecologist during ET007.	To be rectified.

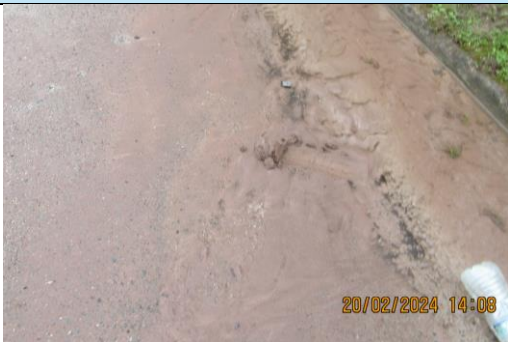
No.	Date	Comment	Image	ECoW Action/Recommendation	Sorensens's Action response
34.	21/2/24	At the Meadowbrook drainage works area, the ground around the gullies were layered with a layer of fine sediment. This suggested sedimented water was allowed to be pumped out of the works area without the proper sediment controls.

Reported to site ecologist who investigated the issue.	Investigation revealed a pump failure and the absence of fittings, leading to the suspension of the manifold system's use. As an alternative, a larger green silt bag was deployed, but it proved to be ineffective at capturing silt. Manifold system was reestablished the following day.
35.	22/2/24	Birch tree replaced at Bleach hill. The birch tree was removed during culvert works in 2023 that necessitated the additional removal of the birch tree to accommodate the works.

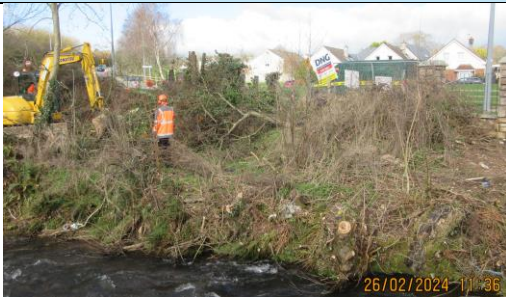
No.	Date	Comment	Image	ECoW Action/Recommendation	Sorensens's Action response
36.	26/2/24	Vegetation and tree removal carried out at the entrance to Copper Valley Vue estate as part of enabling works to install a bailey bridge.

Discussed with site ecologist. Recommended the use of silt fence along the banks of the Glenmore river.	Silt fencing was established.
37.	26/2/24	Trees and vegetation removed at New Line culvert as part of enabling works to install a river diversion around the existing culvert.

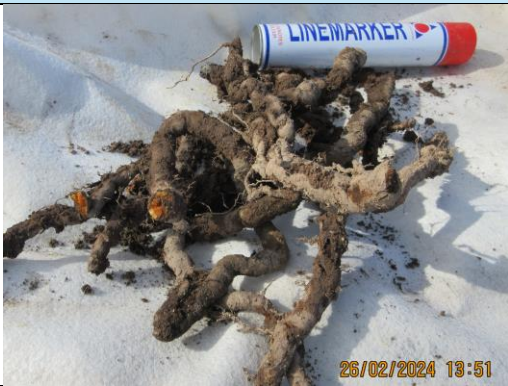
No.	Date	Comment	Image	ECoW Action/Recommendation	Sorensens's Action response
38.	26/2/24	Sallybrook JKW zone embankment works – Lisa Dolan on site to supervise works and ensure biosecurity measures are followed.

Supervision.	JKW rhizomes were marked with red spray paint on the ground. Engineer took GPS of each exposed rhizomes. Where possible rhizomes were then bagged up and deposited into the temporary storage area.

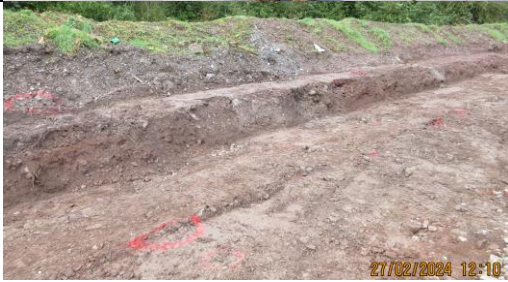
39.	27/2/24	Sallybrook JKW zone embankment works – Lisa Dolan on site to supervise works and ensure biosecurity measures are followed.

Documented	JKW rhizomes were marked with red spray paint on the ground. Engineer took GPS of each exposed rhizomes. Where possible rhizomes were then bagged up and deposited into the temporary storage area.

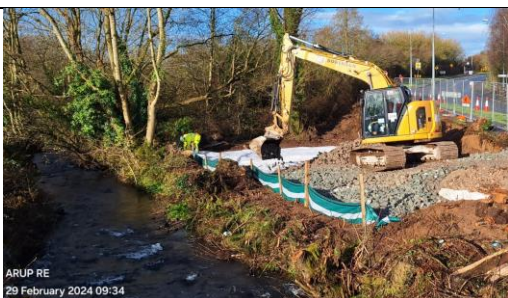
40.	28/2/24	At Copper Valley Vue enabling works, silt fencing installed along the banks of Glenmore for sediment control.

Discussed with site ecologist.	Silt fencing was installed. Tree roots were left in place where possible along the bank of the river.

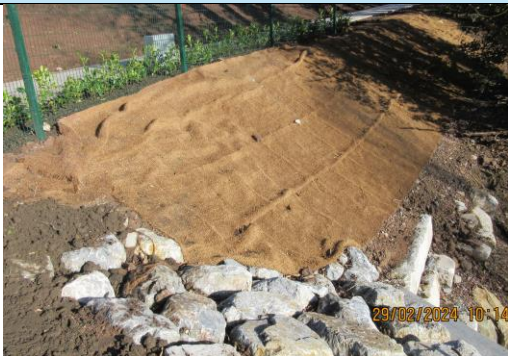
No.	Date	Comment	Image	ECoW Action/Recommendation	Sorensens's Action response
41.	29/2/24	Top soiling carried out at Bleach Hill. It is not obvious that the ground underneath the mesh received topsoil. Topsoil not yet grass-seeded. MAR 120 submitted by contractor regarding type of seed.

Discussed with site ecologist.	Site ecologist to confirm that ground under erosion mesh has been top soiled. Site ecologist to revert with date of grass seeding following the approval of MAR 120.
42.	29/2/24	Contaminated material exposed.

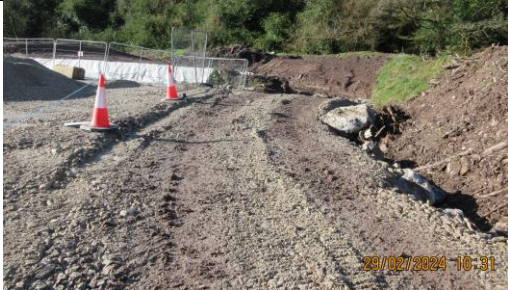
No.	Date	Comment	Image	ECoW Action/Recommendation	Sorensens's Action response
44.	29/2/24	Lack of demarcation and gap in fencing at the JKW area at Sallybrook where the temporary storage area is connected to the north of the JKW zone.

Improve demarcation and fencing.	Signage to be improved and fencing secured.
45.	29/2/24	Excavations at the funeral home have recommenced under the supervision of Lisa Dolan, considering the area's Japanese Knotweed (JKW) potential as indicated in the design drawings.

42.	Contaminated material exposed.	Recover to prevent run off.
44.	Lack of demarcation and gap in fencing at the JKW area at Sallybrook where the temporary storage area is connected to the north of the JKW zone.	Signage to be improved and fencing secured.
