Environmental Report October 2025

Glashaboy Flood Relief Scheme

Document code: FFEC-GFRS-2025-010

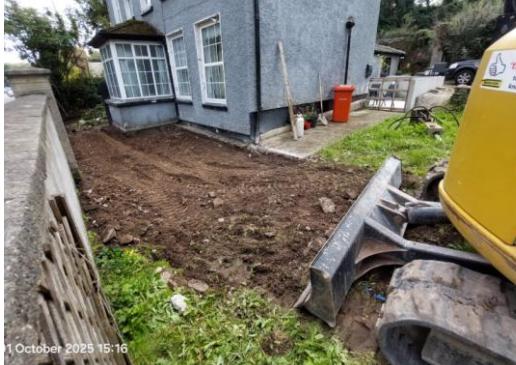
Item number	Date	Comment	Image	ECoW Action/Recommendation	Sorensens's Action response
10.1	01/10/2025	Works commenced within a private garden adjacent to Springmount culvert to complete the remaining drainage installation. A mature tree and the presence of invasive species were noted within the works area.

Discussed works methodology and environmental aspects with site ecologist.	The works were carried out while minimising disturbance of tree roots while installing the necessary drainage line. Invasive species were addressed during the works. See Item 10.6.

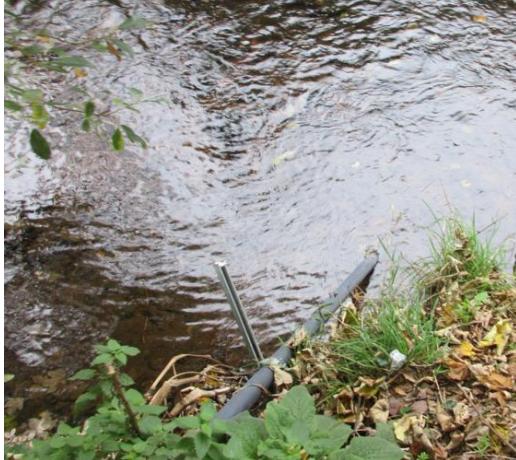
10.2	01/10/2025	Capital Water Systems Ltd. (CWSL) were retained to monitor water quality parameters during the extension period. A technical issue was reported with the upstream Hazelwood sondes.

Monitored the sondes transmissions via the online application during instream works.	CWSL were onsite promptly to resolve the technical issue. Services were not impacted. CWSL services continued until all instream works were completed successfully.

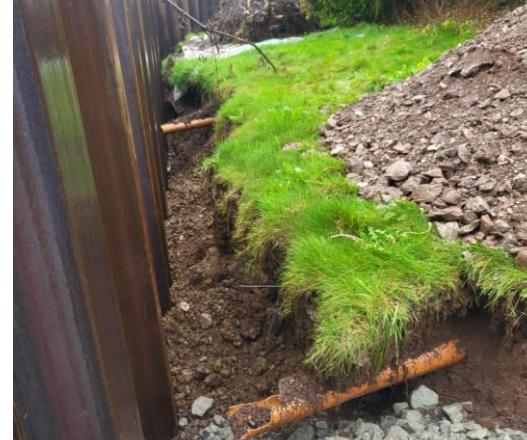
Item number	Date	Comment	Image	ECoW Action/Recommendation	Sorensens's Action response
10.3	02/10/2025	Works at the Credit Union in Hazelwood involved ground works on dry side of the sheet piles, including the excavation of material and tree roots within a Japanese Knotweed area.

Carry out works in line with the biosecurity management plan which outlines all steps and protocols to prevent spread of JKW.	Works were carried out under the supervision of the site ecologist and in line with the Biosecurity management plan.

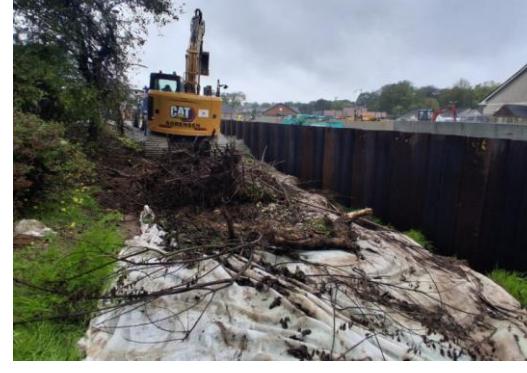
10.4	03/10/2025	Tree stumps recovered from the Japanese knotweed (JKW) exclusion zone at the Credit Union site, which had been temporarily stored on terram sheeting, were transported to the Temporary Holding Facility in Sallybrook.

Carry out works in line with the biosecurity management plan which outlines all steps and protocols to prevent spread of JKW.	Good application of biosecurity measures throughout the ground work operations at this location.

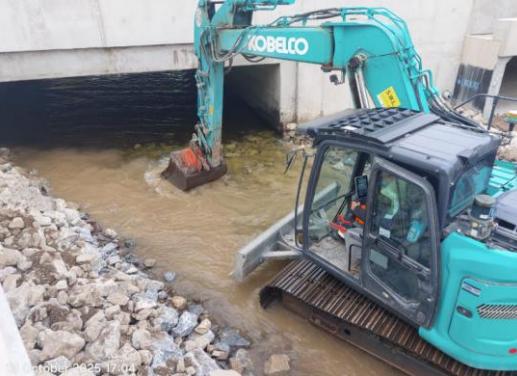
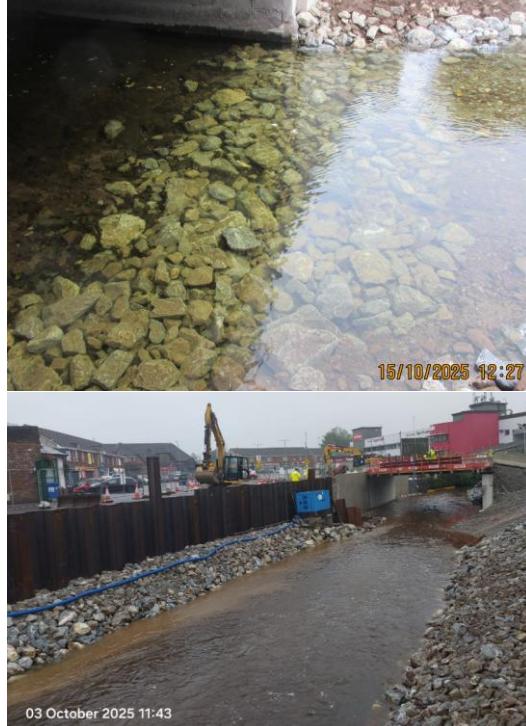
10.5	03/10/2025	<p>Installation of rock armour along the downstream face of the Hazelwood Road Bridge required localised excavation into the riverbed, resulting in temporary sediment disturbance. Some sedimentation was unavoidable.</p>

<p>The NTU parameter was monitored via the downstream sondes and communication made with site crews.</p>	<p>The duration of works was limited. Turbidity spikes were short-lived. Overall, the activity was undertaken in an acceptable manner and was necessary to facilitate the implementation of the approved design.</p>

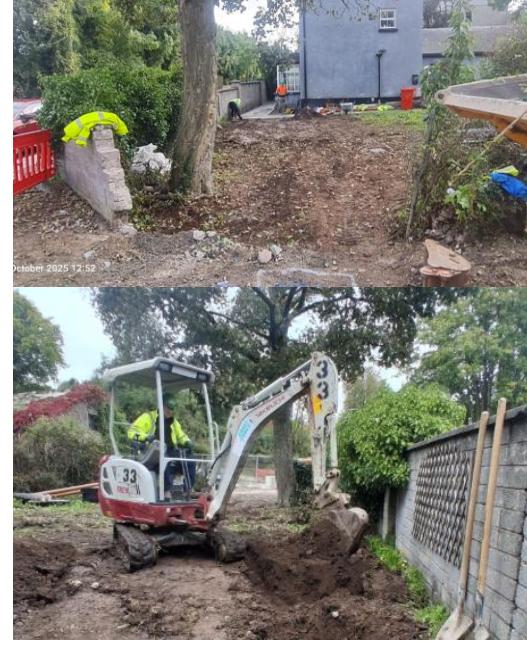
10.6	06/10/2025	<p>Works on the filter drain at Springmount culvert were being carried out under ecological supervision due to the presence of Spanish bluebell (<i>Hyacinthoides hispanica</i>) – a plant species listed under the Third Schedule of S.I. No. 477/2011 (European Communities (Birds and Natural Habitats) Regulations 2011) and/or the Union List of Invasive Alien Species under Regulation (EU) 1143/2014.</p>

<p>Discussed works methodology and environmental aspects with site ecologist in advance of works.</p>	<p>Spanish bluebell bulbs were recovered at the Springmount site and relocated to the temporary Holding Facility in Sallybrook.</p>

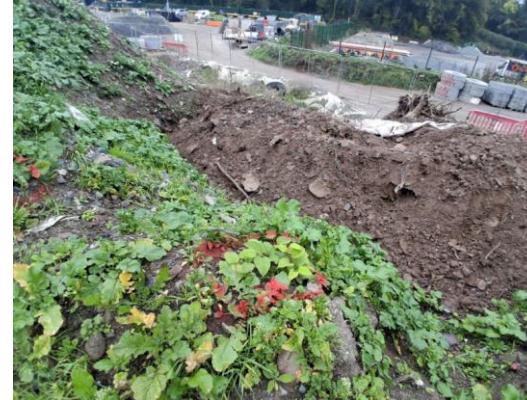
10.7	07/10/2025	A survey was carried out in the Temporary Holding Facility in Sallybrook. All visible and confirmed invasive plants species, in particular, Japanese knotweed, were marked with spray paint for later treatment.

A photograph showing a patch of Japanese knotweed plants growing in a disturbed area of soil. The plants are green with large, heart-shaped leaves. Some of the plants have red spray paint markings on them, likely indicating they have been identified for treatment. The background shows a construction site with a road and some buildings.	Carry out works in line with the biosecurity management plan which outlines all steps and protocols to prevent spread of JKW.	Invasive plant species JKW were treated with a chemical herbicide during dry conditions, when application success is improved.

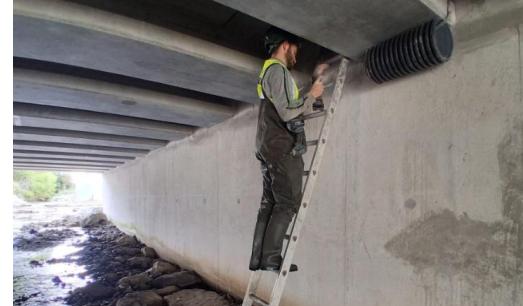
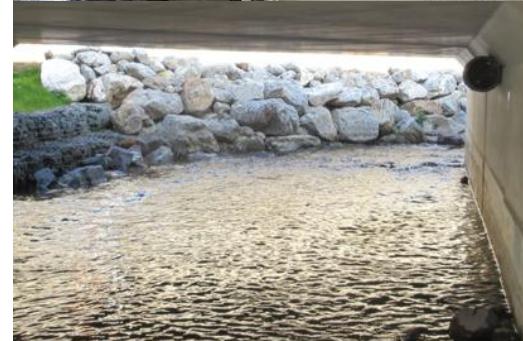
10.8	10/10/2025	Dipper nest tubes were installed on various structures within the scheme.

Discussed actions and locations with site ecologist.	<p>The artificial dipper nests were installed as a positive biodiversity enhancement measure.</p> <p>The dipper tubes were installed by the site ecologist in consultation with the National Parks and Wildlife Service area ranger. The locations and design were agreed and were based on a proven and successful design used in the Duhallow LIFE project.</p>

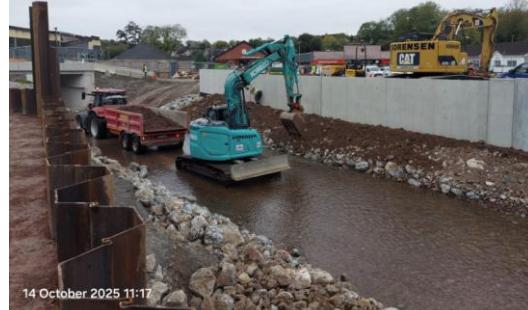
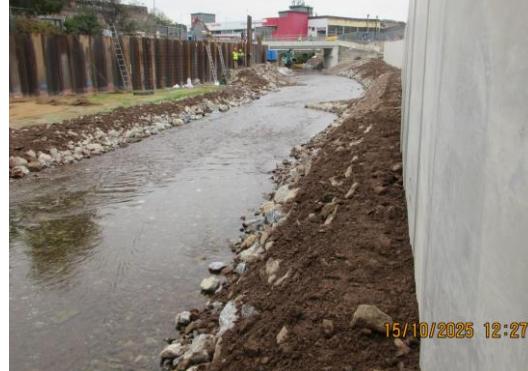
10.9	13/10/2025	Gravels were placed on rock armour at Hazelwood.

Liaised with grounds crew to ensure all rock armour received gravels.	This action will accelerate the greening up of the rock armour, providing more medium for naturally deposited seeds to begin colonisation.

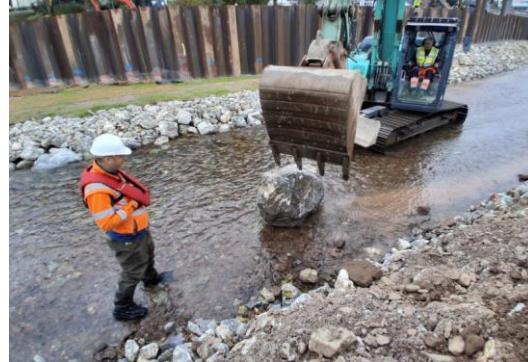
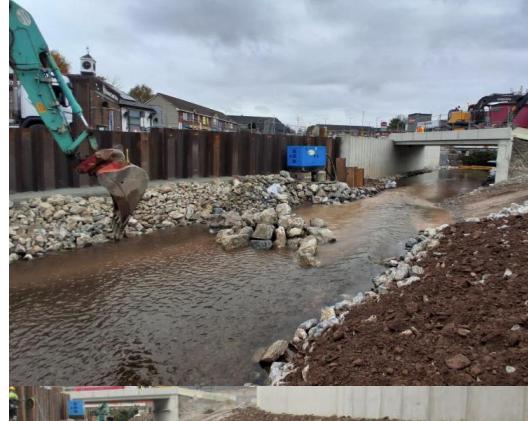
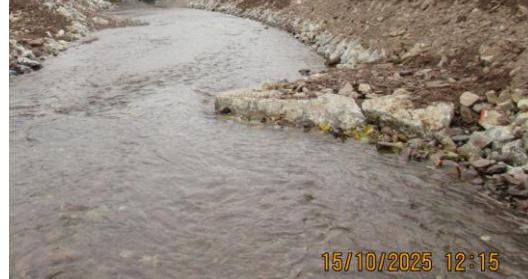
Item number	Date	Comment	Image	ECoW Action/Recommendation	Sorensens's Action response
10.10	14/10/2025	<p>Installation of two alternating deflectors between Hazelwood Road Bridge and the new Hazelwood Shopping Centre Bridge.</p> <p>This section of the river has been straightened and lost the heterogeneity of flow habitats as part of instream works 2025 to install the two flood defence walls and construct new bridge as part the approved flood defence scheme.</p> <p>To restore some immediate habitat diversity and encourage river sinuosity, two flow deflectors were installed.</p>

Designed and supervised works in consultation with site ecologist and grounds crew.	<p>The deflector was installed at per the agreed design change.</p> <p>The deflector had an immediate positive effect of diversifying the flow within this stretch of river.</p>

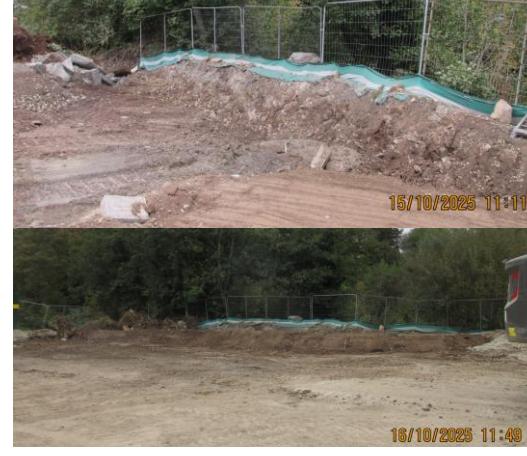
Item number	Date	Comment	Image	ECoW Action/Recommendation	Sorensens's Action response
10.11	15/10/2025	<p>Preparation works have commenced at the Circus Field stockpile site, where the permanent cell for the burial of invasive plant species and contaminated material has been agreed. Initial earthworks were encroaching upon the root zones of the riverside trees, all of which are to be retained.</p>

<p>Establish a root protection zone without delay. Spoke with Forman and driver.</p>	<p>No more earthworks took place on this day. The next day an earth bund was established and root protection zone designated.</p>

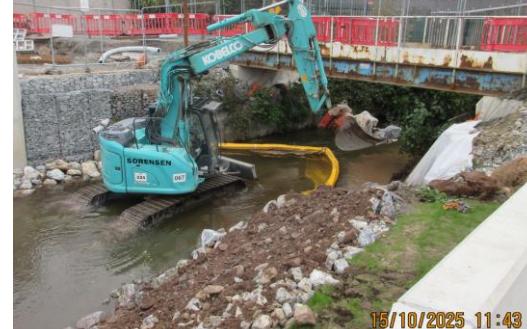
10.12	15/10/2025	<p>Rock armour works were carried out downstream of the headwall at Hazelwood. Unfortunately, a section of an alder tree had to be removed to facilitate the works. Seeding of the rock armour with gravel was also undertaken.</p>

<p>Works were partially supervised and monitored remotely throughout the works.</p>	<p>Works were carried out professionally with all tracking kept to a minimum. Silt control measures were in place for the during of the works.</p>

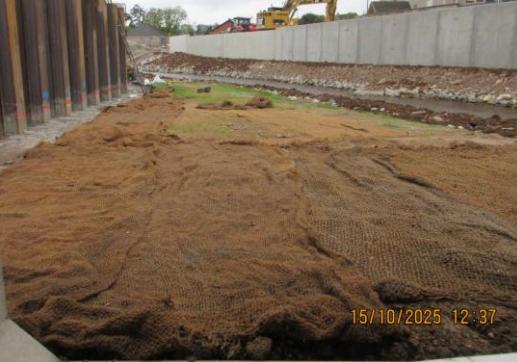
10.13	15/10/2025	<p>Additional coir mesh was installed downstream of the Hazelwood Road bridge overflow culvert to act as a matting layer over the soil while vegetation becomes established.</p>

<p>Discuss ongoing works at this location with site ecologist and foreman regarding silt control measures.</p>	<p>Works carried out to minimise mobilisation of silt into the adjacent watercourse.</p>

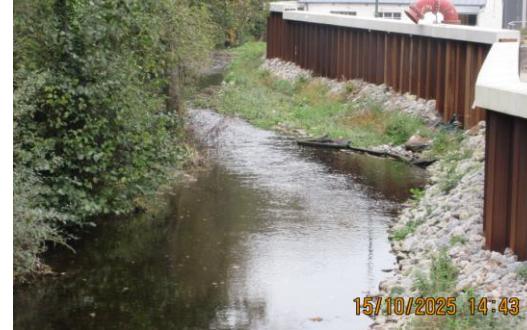
Item number	Date	Comment	Image	ECoW Action/Recommendation	Sorensens's Action response
10.14	15/10/2025	A silt curtain remains in place in the river at Sallybrook. In-stream silt control measures should be removed when they are no longer required. Although the curtain is not causing notable environmental harm, best practice would be to remove it.

15/10/2025 14:43	Informed site ecologist who organised its removal.	The silt curtain was removed within a few days of notifying the site ecologist.

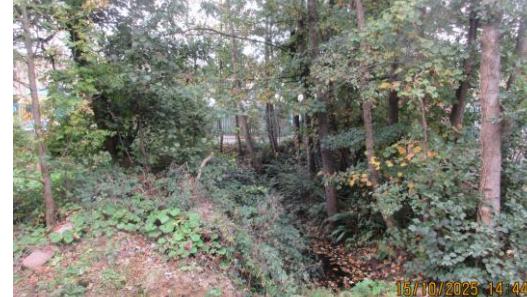
10.15	15/10/2025	Sallybrook House swale requires additional works to control hydrocarbons that are present.

15/10/2025 14:44	Works should be carried out to minimise impact on nearby trees and control invasive plant species.	Works are still being planned with environmental measures in place to protect nearby trees in the area and safeguard against invasive plants.

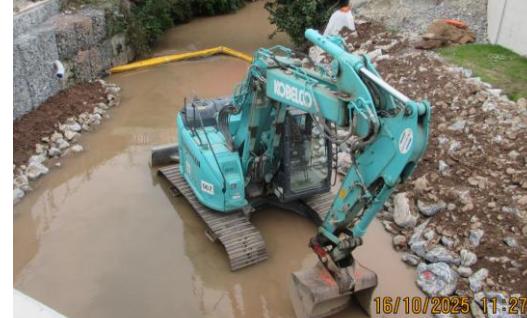
10.16	16/10/2025	Adding river gravels to rock armour continuing at Hazelwood today.

16/10/2025 11:27	Works were supervised.	Works were carried out professionally while keeping tracking in the river to a minimum. Silt control measures were in place during of the works. Siltation was intermittent and low in overall quantities.

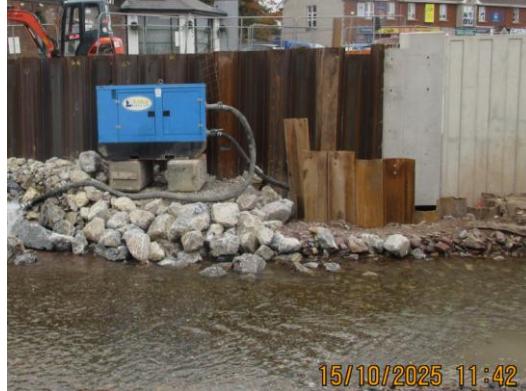
10.17	16/10/2025	Sheetpiles around the remaining cofferdam at Hazelwood Shopping Centre Bridge were removed which required an excavator with the movax attachment to work from within the river.

A photograph showing a blue generator unit with a black hose connected to it, situated on a rocky riverbank. Behind the generator is a vertical sheetpile wall. The timestamp '15/10/2025 11:42' is in the bottom right corner of the image.	Works were partially supervised and river parameters monitored throughout the works.	Sheet pile removal was carried out successfully with minimum disturbance to the river and minor siltation.

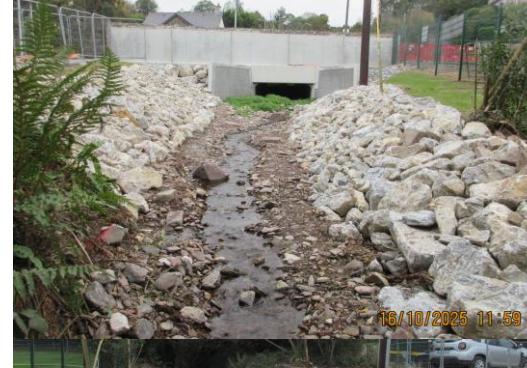
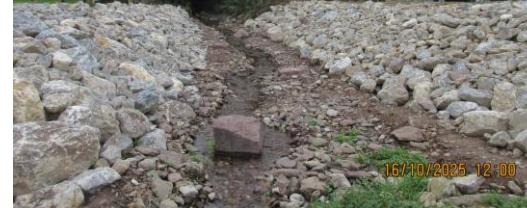
10.18	16/10/2025	It was noted during a site inspection that rock around at Cois na Gleann (CNG) has not received river gravels.

Discussed with ground crew and foreman.	Gravels to be added in November. These are works that can be carried out from the dry without need to enter or disturb the CNG stream.

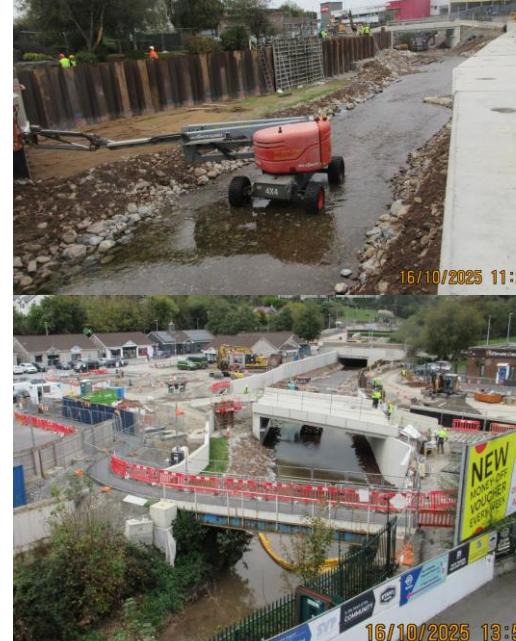
Item number	Date	Comment	Image	ECoW Action/Recommendation	Sorensens's Action response
10.19	16/10/2025	Formwork on the Credit Union side is continuing in the dry. A mobile elevated work platform (MEWP) was positioned in the river to facilitate surface finishing on the concrete face new overflow culvert. Temporary sheet piles were also removed. Rock armour continues to be covered with river gravels.

16/10/2025 11:20 16/10/2025 13:53	Monitored the sondes transmissions via the online workspace.	Works were carried out with minimal disturbance to the river.
10.20	17/10/2025	The coir mesh positioned immediately downstream of the overflow culvert at Hazelwood requires staking to secure it in place.

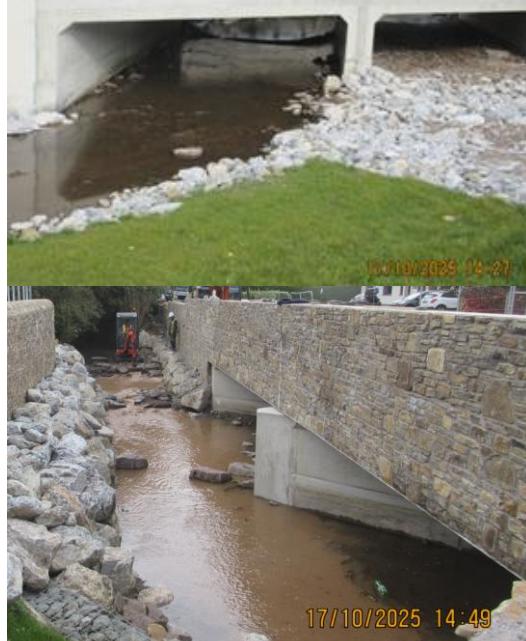
Item number	Date	Comment	Image	ECoW Action/Recommendation	Sorensens's Action response
10.21	17/10/2025	Works on the Brooklodge steps were carried out today. A silt curtain was in place. The activities generate some unavoidable silt but were short in duration. The works are necessary to improve fish passage.

Discussed works with site ecologist and grounds crew.	The works were carried out in accordance with the design changes. The works were completed prior to the end of the in-stream extension. Some siltation occurred during the works but was minor in extent overall. Fish passage has now been significantly improved at this location.

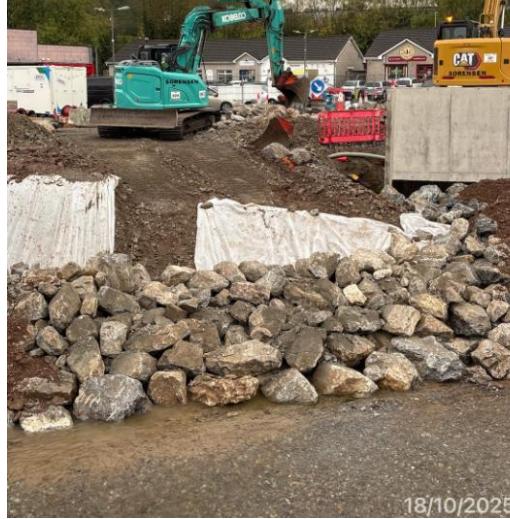
Item number	Date	Comment	Image	ECoW Action/Recommendation	Sorensens's Action response
10.22	18/10/2025	<p>The slipway was removed at Hazelwood and rock armour placement carried out as instream works at this location are now completed. The remaining wall that connects to the new Shopping Centre Bridge can now be completed.</p>

18/10/2025	<p>Monitored the sondes transmissions via the online workspace and kept in communication with ground crew and site ecologist.</p>	<p>Works were carried out from the dry with minimal disturbance to the river environment.</p>

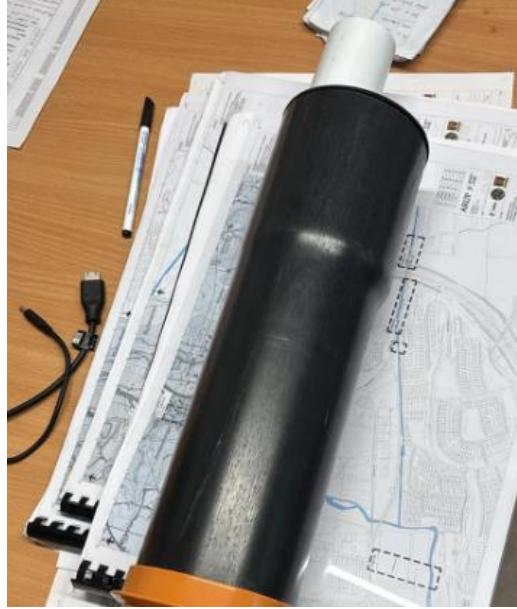
Item number	Date	Comment	Image	ECoW Action/Recommendation	Sorensens's Action response
10.23	20/10/2025	Artificial sand martin chambers have been designed and assembled for their installation at Hazelwood within the Credit Union flood defence wall concrete capping.

Liaised and consulted with all parties to finalise the design and oversee its implementation on site.	The NPWS were consulted by the site ecologist who have approved the Sand martin tubes design and placement.
10.24	23/10/2025	The first set of sand martin tubes were positioned and concrete poured.

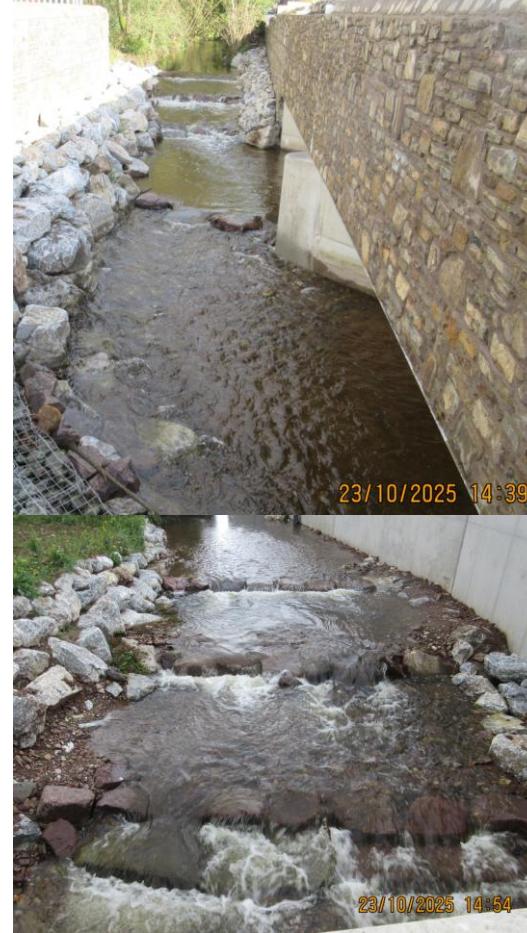
Item number	Date	Comment	Image	ECoW Action/Recommendation	Sorensens's Action response
10.25	23/10/2025	Checks were carried out on the New Line steps and Brooklodge steps regarding the previous fish passage issue.

Preformed inspections.	Both steps arrangements appear significantly improved with clear formation of low flow channels at graduated heights which are ideal for fish passage up and down stream.

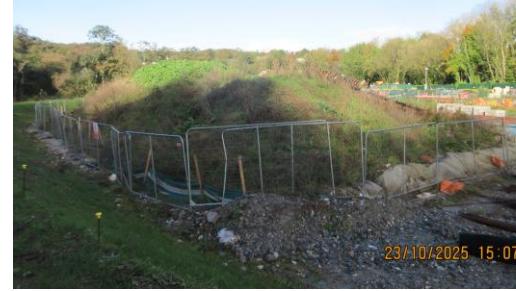
Item number	Date	Comment	Image	ECoW Action/Recommendation	Sorensens's Action response
10.26	23/10/2025	The temporary holding cell at Sallybrook was inspected as it is planned in November 2025 to be relocated to Circus Field for its final burial in consultation with NPWS.

Carry out relocation and burial of all material in line with RAMS: Area 2 – Invasive Alien Plant Species (IAPS) Onsite Burial Cell.	Plans are ongoing with a detailed Method statement having been submitted. The root barrier has yet to be approved. Works are expected to commence next month.

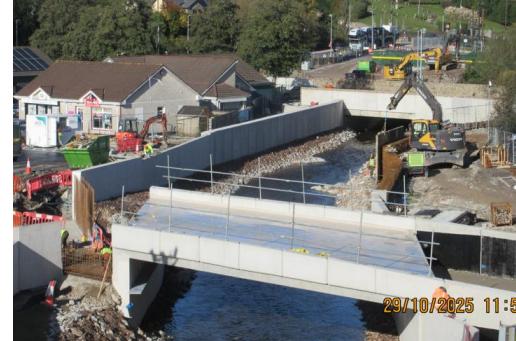
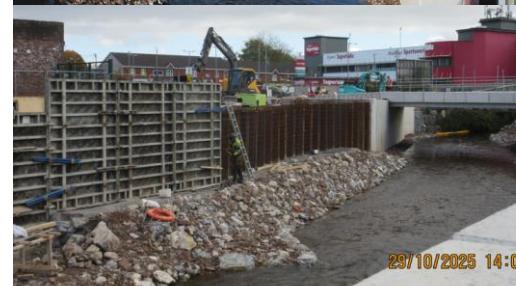
10.27	29/10/2025	Form work is ongoing along the Credit Union side of Hazelwood. This involves the installation of a concrete front on the permanent sheet pile wall. Works are being carried out in the dry outside the river.

Carried out site inspections and ongoing monitoring.	Works are being carried out professionally with regard to the river environment.

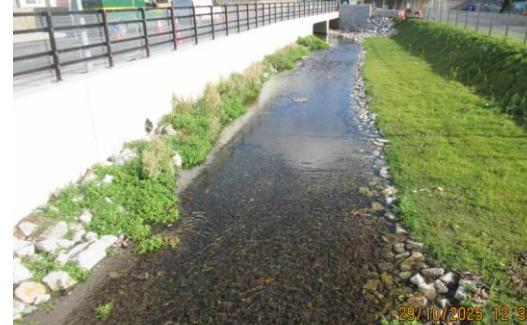
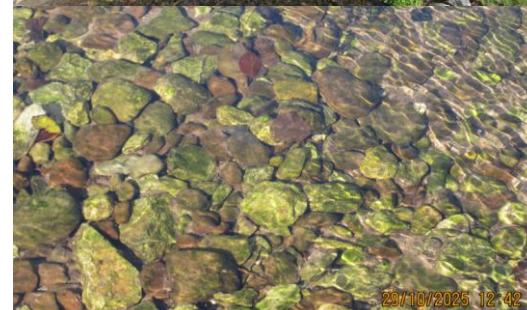
Item number	Date	Comment	Image	ECoW Action/Recommendation	Sorensens's Action response
10.28	29/10/2025	<p>Gravels were added to the stretch of river between Brooklodge Culvert and the Copper Valley Bridge. These gravels will hopefully be utilised by spawning trout during the upcoming spawning season, which typically occurs from November to December. The silt that initially covered the gravels following the in-stream works has been washed away by increased water flows during October.</p>

Carried out inspections.	Works in this area are substantially completed. Ongoing monitoring will take place over the winter months to evaluate the developing river conditions.

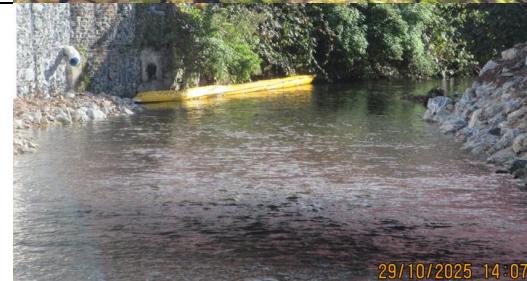
10.29	29/10/2025	<p>A silt curtain remains in place downstream of the Hazelwood pedestrian bridge. Instream works are now complete. This silt curtain should now be removed.</p>

Raised to site ecologist who organised its removal.	The silt curtain will be removed when river conditions allow the works to be carried out safely.
