Monthly Site Environmental Audit

Glanmire Flood Relief Scheme

28/08/2023 To 27/09/23

Details			
Project:		Glanmire Flood Relief Scheme	
Auditor:	Tim Field	Audit Period:	September
Locations Audited: All site.

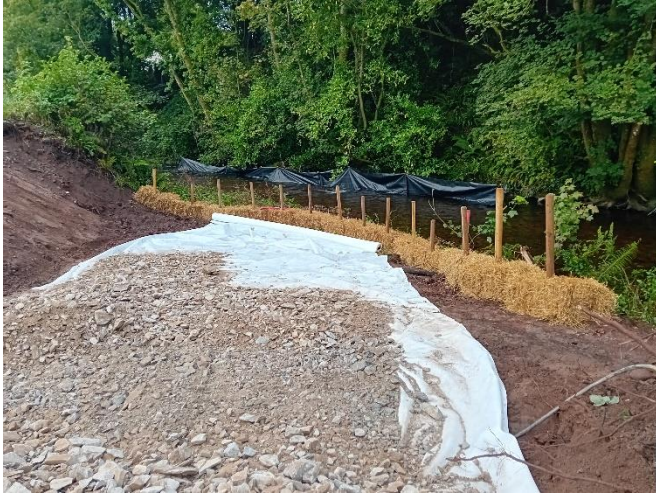
Photo 1

Works have now commenced in the mainstream of the River. Access ramp into river was constructed. Kelly blocks were put into the river at the foot of the ramp to create an area of slack water at the foot of the ramp. This allowed to the suspended solids generated by our works entering into the river be controlled and dispersed gradually.

Silt mitigation at river access point – demarcation of otter holt

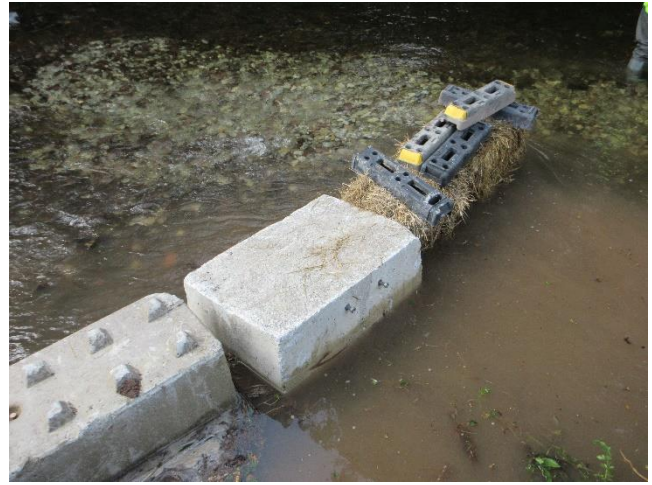
Photo 2

Silt netting has been placed in the water prior to works commencing. It was found that the flow of water is too great to create an effective effect to slow down or remove the silt from the water.

Silt mitigation measures instream at piling works

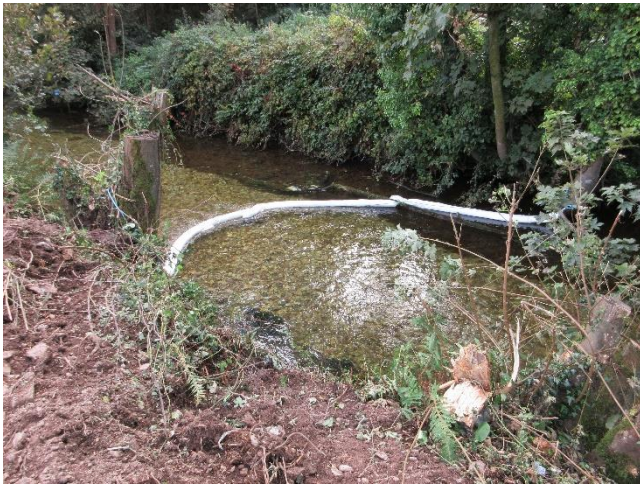
Photo 3

Marine oil booms have been placed in areas where mechanical works are occurring alongside the river channel, these will be deployed in the event of a spill. These booms will be removed prior to any weather events to reduce the risk of them being washed away.

Oil boom below works area

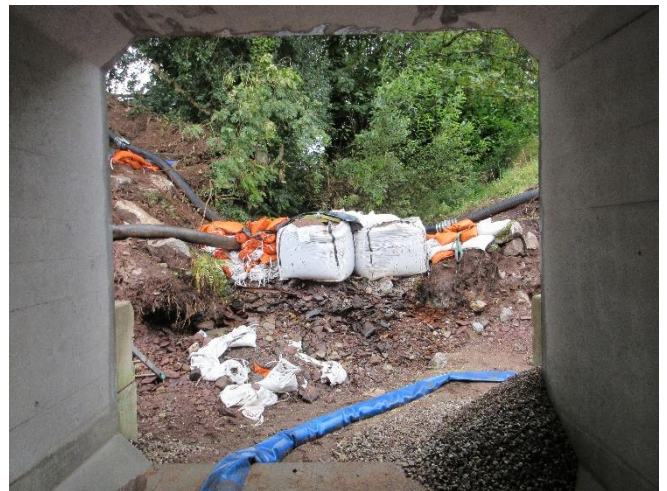
Photo 4

Bleach hill culvert works are progressing. The contractor is witnessing issues with the water table/ volume of water the needs to be managed. 4 no Pumps have been installed to manage the over-pumping for the works. Meeting with fisheries on site occurred on the 31st. Works were assessed with the officer and agreed that no electrofishing was required for these culverts. Ground water within the 'dry section' of culvert was pumped into a settlement chamber and a silt controlling measure before being removed for discharge over ground.

Dam at Bleach hill culvert

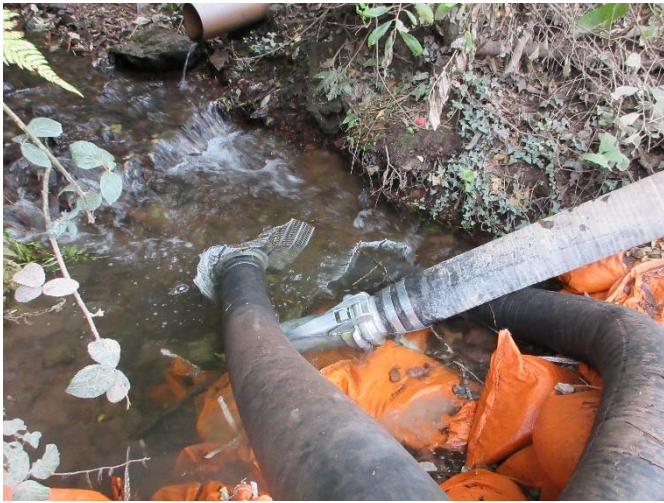
Photo 5

Fish guards on Abstraction pumps

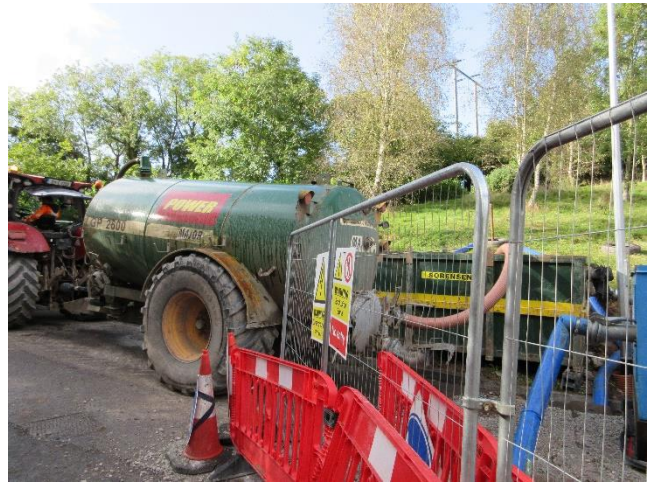
Photo 6

Removal of silted water

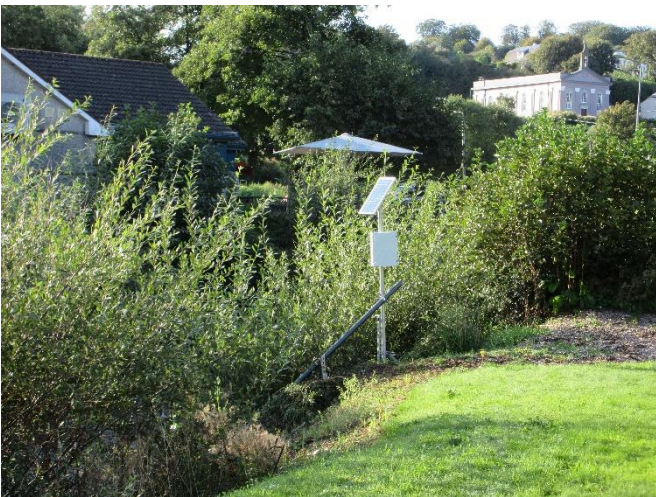
Photo 7

Water Sonds have been placed into the River to record water quality as per Appendix 1/28 of the works specification. Sonds installed on 7/9/23 and on W/C 18/9/23

Water monitoring Sonde located by Glanmire Credit Union

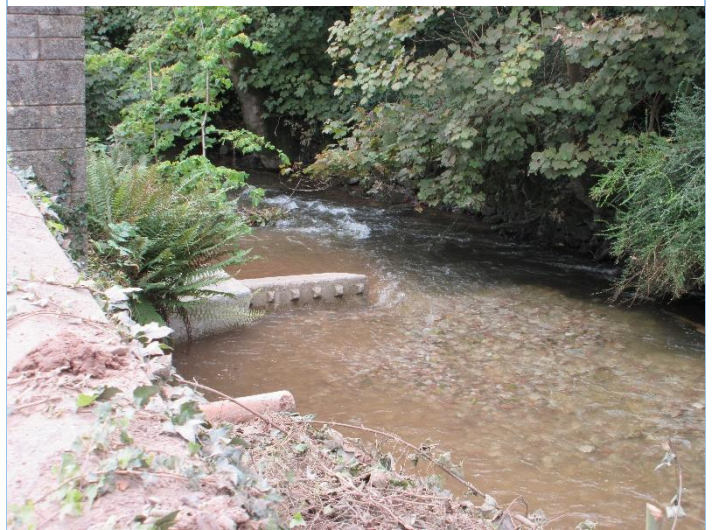
Photo 8

Silt control measures instream

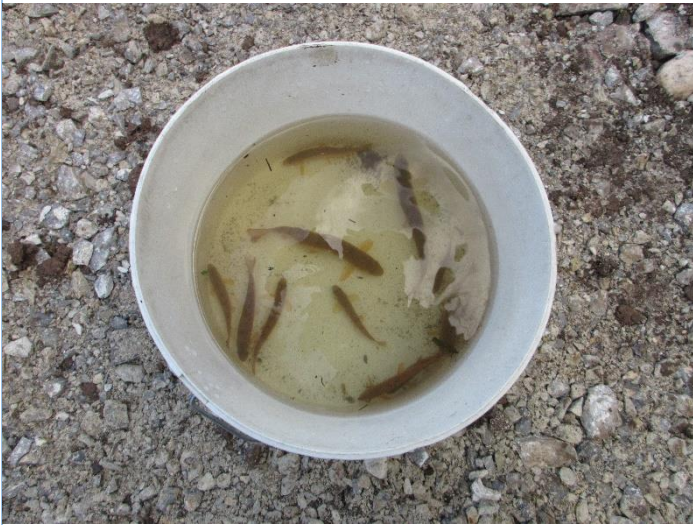
Photo 9

Electrofishing was carried out by an officer of Inland Fisheries Ireland on the 21st of the month. A number of fish, including juvenile trout and eel, were successfully translocated.

Successfully translocated fish post-electrofishing by IFI Officer

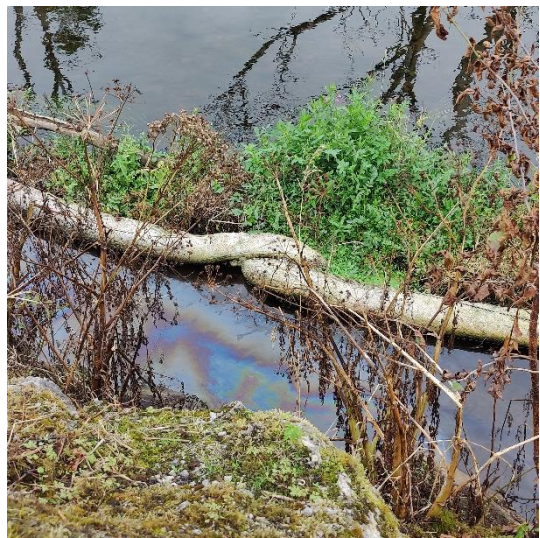
Photo 10

Area of concern has been raised in the sluice at the back of Grandons car garage where oil contamination is impacting the river. Containment measures are in place, however , oil contamination continues to impact the river daily.

Further potential contamination has been observed in Grandons car park. Oil sheen observed on the water surface. Samples taken and awaiting test results. Likely to be removed as waste from the project.

Oil slick visible at Grandons

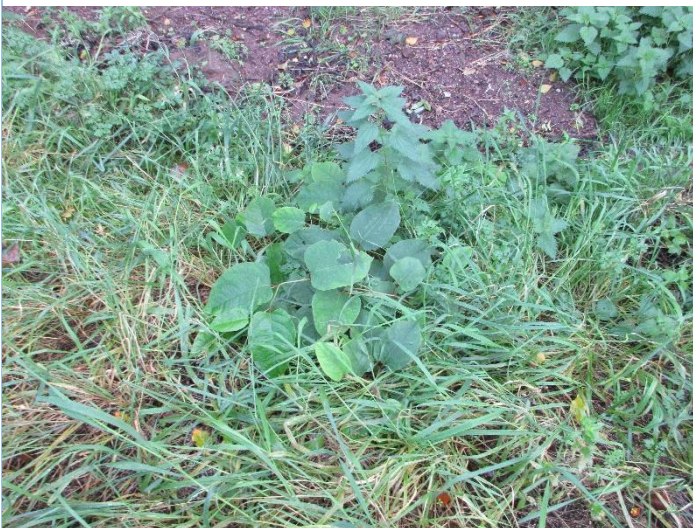
Photo 11

IAPS: Surveys were completed by Knotweed Solutions in July for Area 1 and September for Areas 2, 3 and 4. Multiple stands of knotweed were identified in Areas 1 and 2. A number of Himalayan Balsam plants were also identified in Area 2 and 4 as well as multiple non-Third schedule species in all areas.

Newly identified JKW stand – Area 2

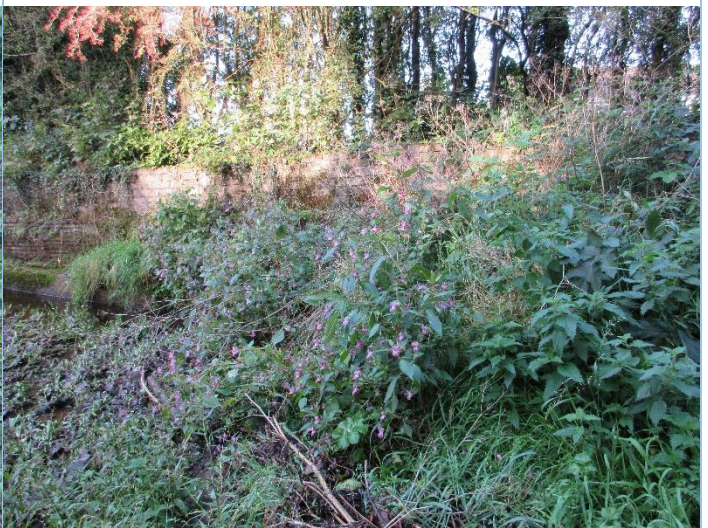
Photo 12

Newly identified Himalayan Balsam – Area 2

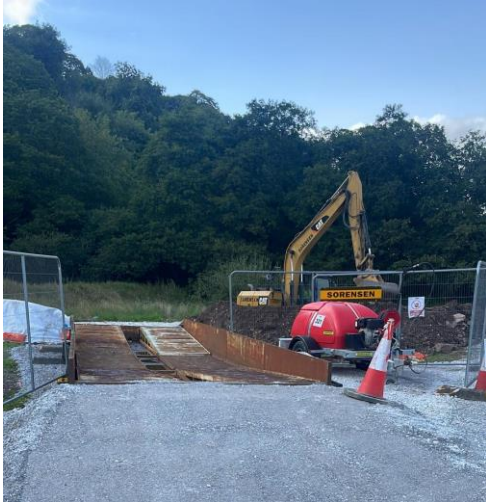
Photo 13

Wheelwash in place as per biosecurity measures

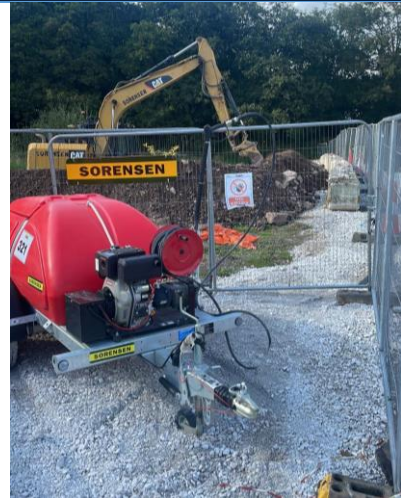
Photo 14

Jet wash in place for washing down of plant at the jet wash

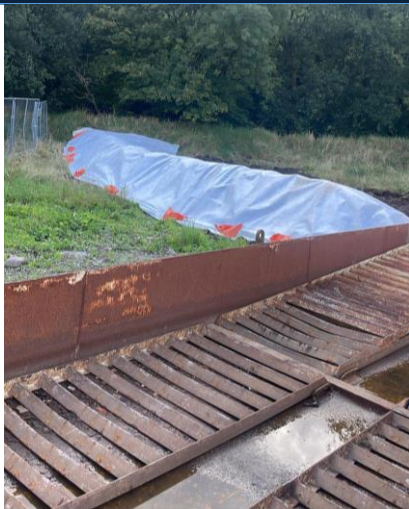
Photo 15

Terram in place along the bund for the knotweed set down area.

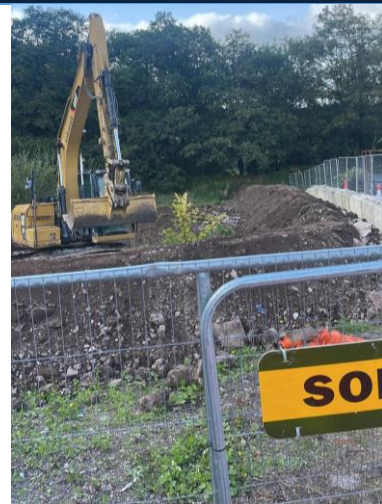
Photo 16

Bund (flood protection) in place for knotweed set down area.
