## Monthly Site Environmental Audit

## Glanmire Flood Relief Scheme

01/10/24 To 25/10/24

## ENVIRONMENTAL AUDIT

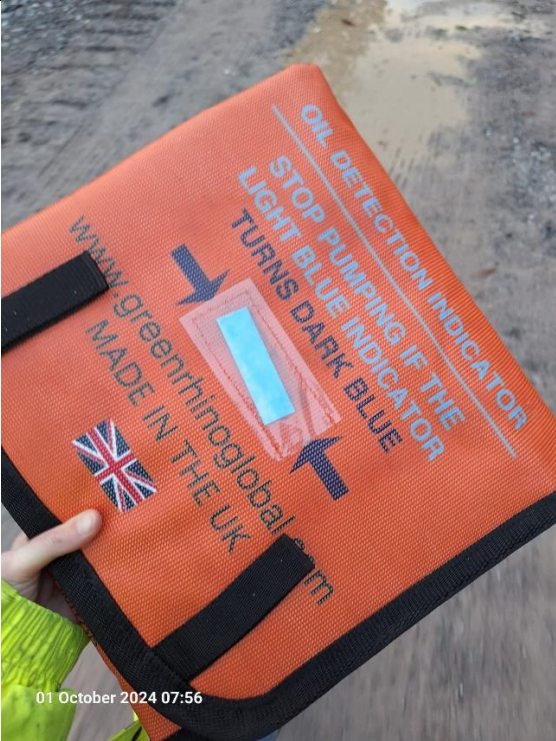
Figure 1			Figure 2

- Pumping system at Eurofins site monitored, oil pads, booms and oil absorbent silt socks replaced as required.
- Eurofins site monitored for seepage of contamination into the river – oil booms deployed at outfall 1/OF8 as a precautionary measure.
- Pumping activity stopped at Meadowbrook (01/10/24) due to unsatisfactory levels of silt. System adjusted and pumping re-commenced 02/10/24.
- Otter Holt Camera Monitoring: No Otter sightings at N2, C2, N6C and N6D.
  - Other mammalian sightings: **N2** – cat 5<sup>th</sup> Oct.

<b>Caption 1</b>			<b>Caption 2</b>		
Oil absorbent silt sock with indicator sheet which indicates when the sock has reached absorbency capacity.			Settlement tank, oil filter manifold system and absorbent booms and pads at Eurofins.

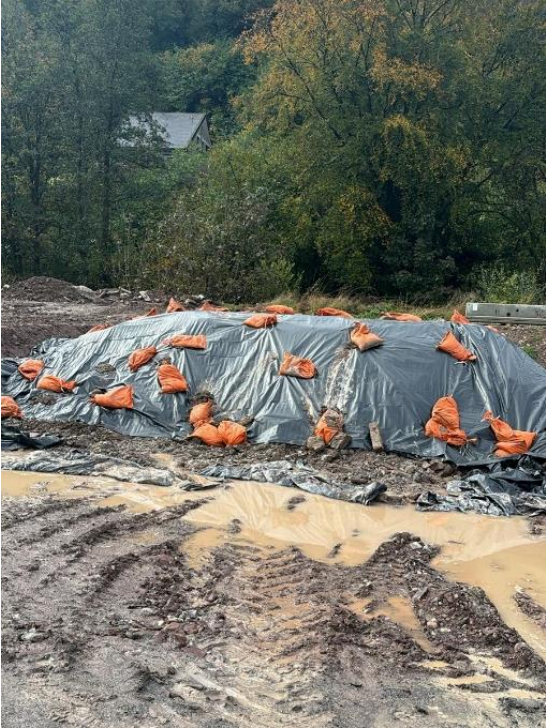
Figure 3			Figure 4

- Stockpiled material from Eurofins excavation relocated to a lined and bunded area in Sallybrook compound. Sampling completed by OCM 14/10/24.
- Area 1 embankment works undertaken with the supervision of Lisa Dolan, JK Specialist.
- Otter Holt Camera Monitoring: No Otter sightings at N2, C2, N6C and N6D.
  - Other mammalian sightings: **N2** – cat 19<sup>th</sup> Oct.

- Results of testing on Eurofins excavated material received 22/10/24 – material classified as hazardous, containing <0.001% asbestos.
- Area 1 wheel-wash pumped out into the knotweed cell ahead of status yellow rainfall event, to prevent overtopping and the potential spread of J. knotweed rhizomes.
- Otter Holt Camera Monitoring: No Otter sightings at N2, C2, N6C and N6D.
  - Other mammalian sightings: **N6C** – cat 21<sup>st</sup> Oct; **N6D** – dog 24<sup>th</sup> Oct.

<b>Caption 3</b>			<b>Caption 4</b>		
Material excavated from Eurofins stockpiled in a sealed and bunded area of Sallybrook compound for testing.			Oil absorbent granules deployed near Copper Valley Vue in response to a hydraulic hose burst. Area also treated with Bioversal HC.

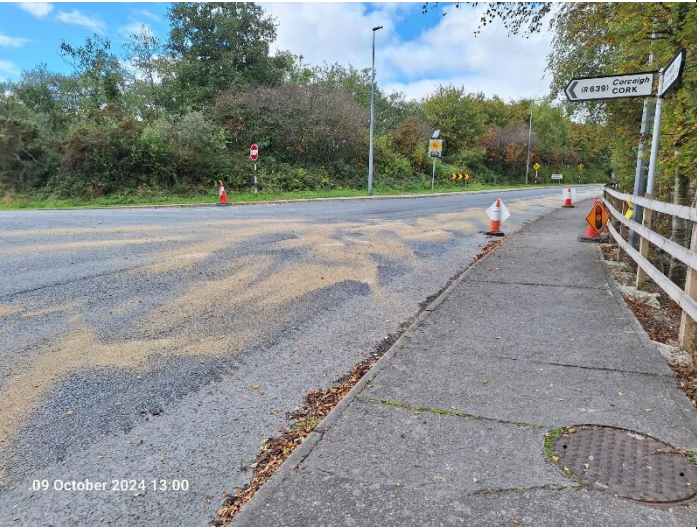
- Hydraulic hose burst near Copper Valley Vue (09/10/24) during dry conditions. No gullies impacted. Bioversal HC and oil absorbent granules used on the affected road surface. Area swept by hand and used granules placed in hazardous waste bags for disposal.
- Pumping no longer required at Eurofins site. Oil absorbent manifold system removed, and area treated with Bioversal HC.
- Otter Holt Camera Monitoring: No Otter sightings at N2, C2 and N6C.
  - Other mammalian sightings: **N6C** – cat 8<sup>th</sup> Oct, fox 13<sup>th</sup> Oct.

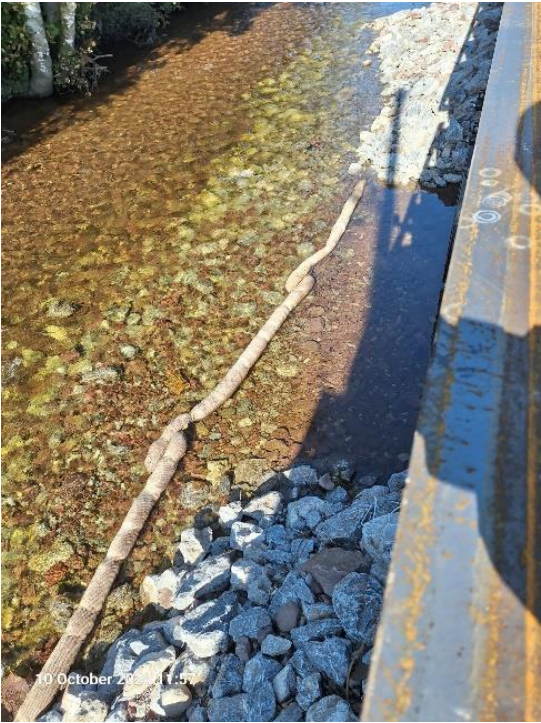
Figure 5			Figure 6

<b>Caption 5</b>			<b>Caption 6</b>		
Oil absorbent booms in place at the outfall of 1/OF8 (Eurofins) as a precautionary measure due to the presence of hydrocarbons in the ground water at Eurofins.			Housekeeping required sitewide – raised during Environmental Tour 019.

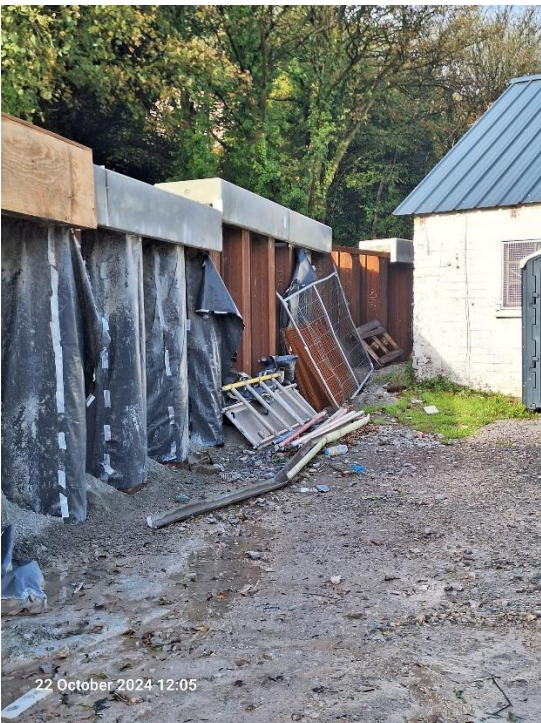
- Environmental Tour 019 (22/10/24) – Main findings: Housekeeping required sitewide. Grass seeding to be completed at Riverstown Bridge. Continued monitoring of the Eurofins site required.

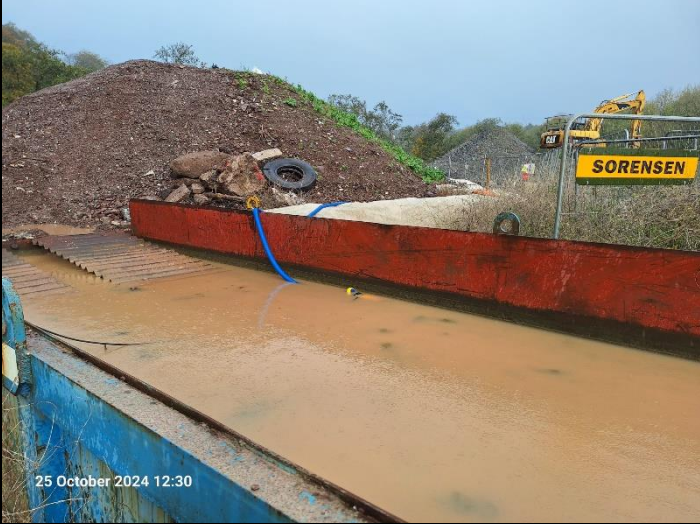
Figure 7			Figure 8

<b>Caption 7</b>			<b>Caption 8</b>		
Japanese knotweed area wheel-wash pumped out into the containment cell ahead of status yellow rain warning.
