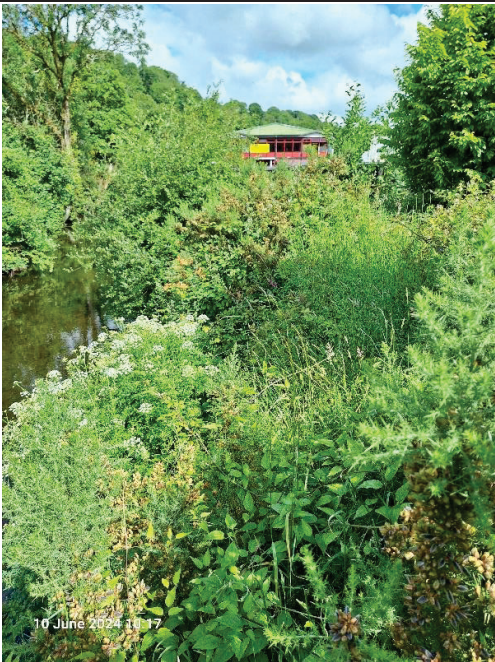
<b>Caption 5</b>			<b>Caption 6</b>		
Vegetated area surveyed for nesting birds and IAPS – Area 2 Grandons/Evcare Gym.			Vegetated area surveyed for nesting birds – Area 2 Grandons/Evcare Gym.

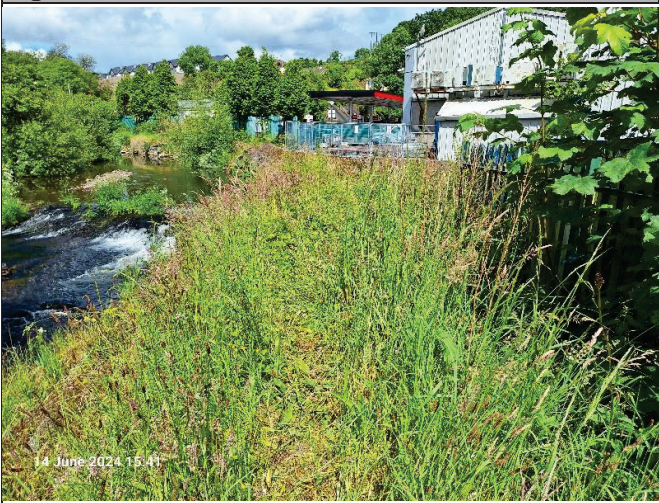
<b>Caption 7</b>			<b>Caption 8</b>		
Vegetated area surveyed for IAPS and nesting birds – Area 2 Grandons			Vegetated area surveyed for IAPS and nesting birds – Area 2 Grandons

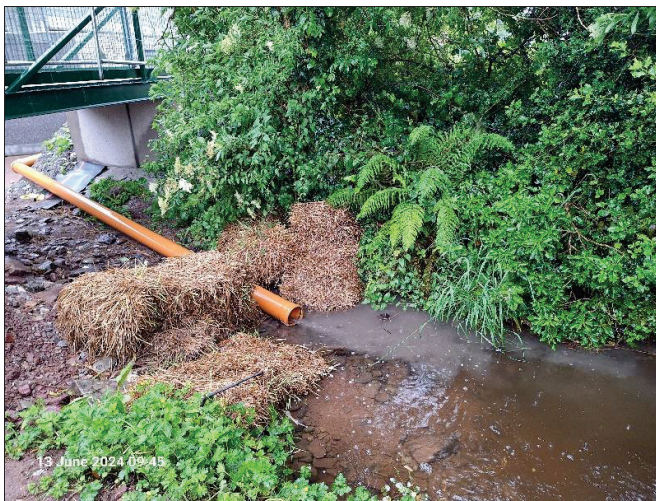
<b>Caption 9</b>		
Silt contamination coming from road gullies during rainfall event - Area 2 Cois na Gleann

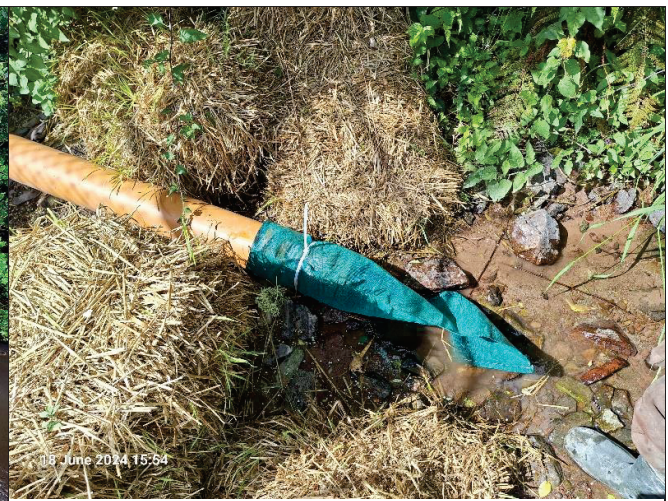
<b>Caption 10</b>		
Silt sock installed on outfall pipe of road gullys - Area 2 Cois na Gleann

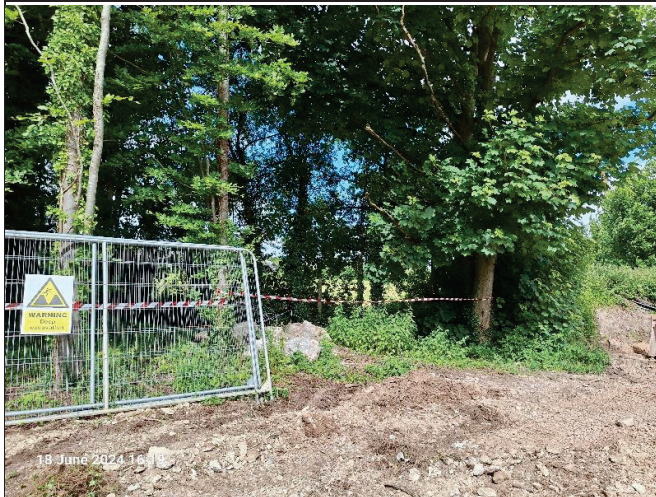
<b>Caption 11</b>		
Hazard tape installed around trees to be protected and upheld - Area 3 New Line.

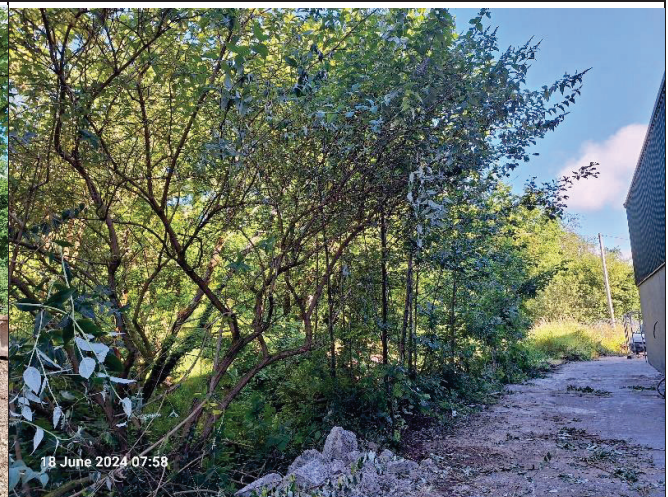
<b>Caption 12</b>		
Trees surveyed for nesting birds prior to felling - Area 1 Grandons.

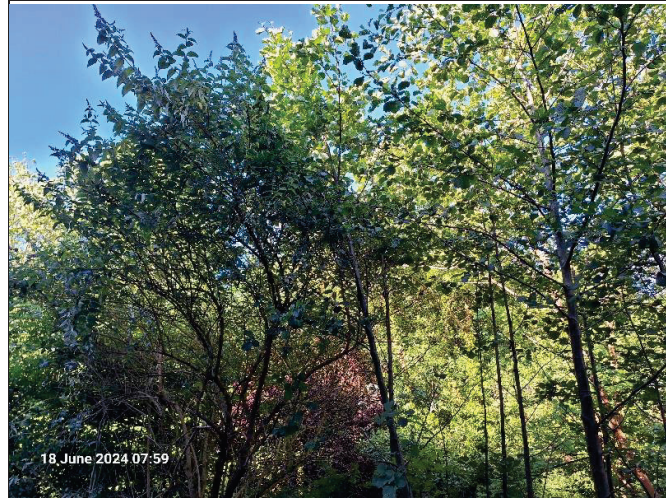
<b>Caption 13</b> Trees surveyed for nesting birds prior to felling – Area 1 Grandons.	<b>Caption 14</b> Hazard tape and signage erected around ne J. knotweed stand – Area 1 Grandons.

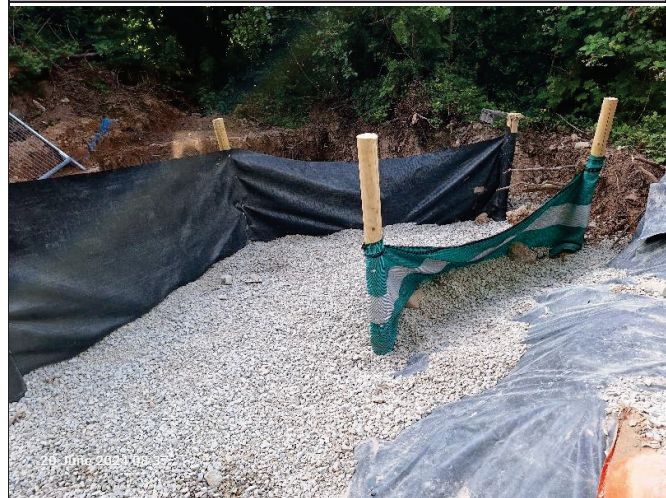
<b>Caption 15</b> Silt mitigation installed Area 3 New Line in anticipation of meeting ground water during excavations	<b>Caption 16</b> Silt mitigation installed Area 3 New Line in anticipation of meeting ground water during excavations
