Environmental Report October 2023

Glashaboy Flood Relief Scheme

Document code: FFEC-GFRS-2023-002

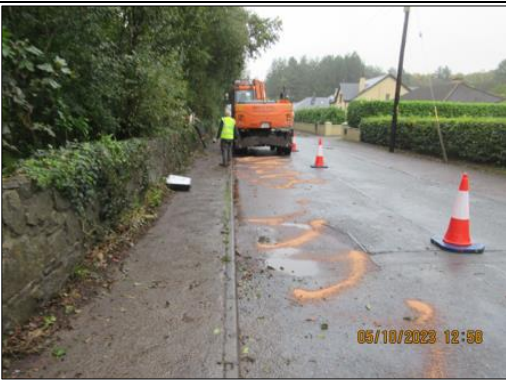
4	3/10/2023	Sub-contractor did not utilize any ground protection measures when working in O'Callaghans park causing compaction and damage to amenity grassland.	 	Documented.	Area was graded the next day. Compaction later evidenced following flood event by pooling in same area.
5	4/10/2023	Temporary sheet pile area being use as attenuation area from the adjacent drainage works-site. Holes in sheet piles leaking sediment rich water into main channel.	 	Discussed with ground crew. Informed site ecologist.	Sorensen installed sandbags and positioned in front of sheet pile holes to block water escaping through.
6	5/10/2023	Brust hose leads to oil spill on Newline Rd.

Discussed with site ecologist and sub-contractors.	Sorensen responded by applying absorbent granules to the oil on the road, an oil boom positioned on the drain and using a road sweeper to collect the contaminated granules.

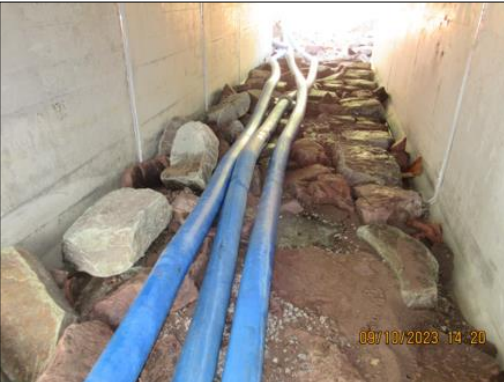
7	9/10/2023	Flag stones inserted into Bleach hill culvert high on one side.

Discussed with site foreman.	Flag stones lowered on high side.
8	9/10/2023	Plastimul used for culvert should be kept in a dry area.

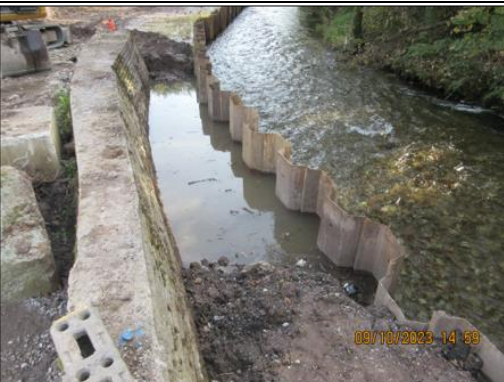
Discussed with site ecologist.	This was acknowledged by Sorensen's personnel and placed in a more appropriate position.
9	9/10/2023	Suggested spoil should be dug out to check for protected species eel/lamprey by spreading out.

Discussed with site ecologist.	Spoil was checked for eel and lamprey species by site ecologist prior to infilling.

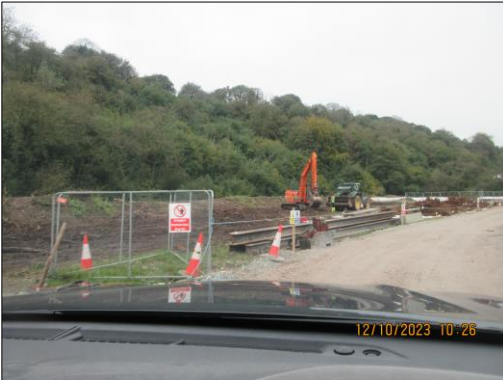
13	12/10/2023	Mulching of tree felling branches into JKW area.

- Does not mention that the tree mulching of branches, from the tree felling works in the JKW exclusion at Sallybrook, has now created additional contaminated material within this area. This mulched material was filled into the archaeology trench and tracked into the general area.

Later raised via email to site ecologist and project manager via email.	Sorensen yet to respond.
14	12/10/2023	The over-pumping of water from the stream at Bleach Hill throughout the construction process has resulted in the erosion of the downstream bank.

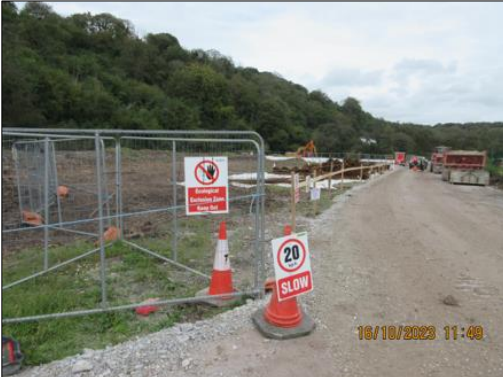
Discussed with site ecologist.	Site ecologist agreed to monitor over winter period to determine if corrective measures are required.
15	16/10/2023	Sallybrook JKW exclusion area has received increased signage and fencing.

Documented.	This is a corrective action by Sorensen in response to last month's Audit that raised this issue.

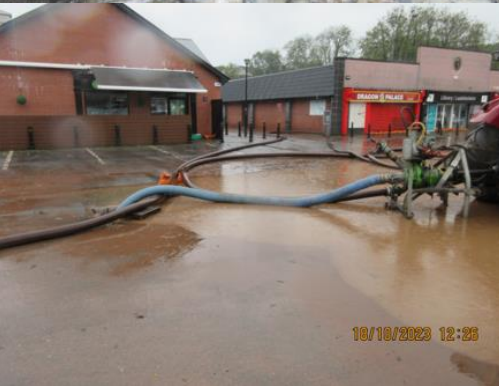
19	17/10/2023	Surface water runoff from works area at Bleach hill into drain leading into stream – no preventive action in place to minimize silt entering stream.	 	Documented. Informed site ecologist.	Sorensen took the corrective action of installing a sediment barrier around the drain to prevent any further access of sediment into the stream.
20	18/10/2023	Sorensen help to prevent flooding of businesses at Sallybrook.

Documented.	No action required.
21	19/10/2023	Stockpiling of flood material by Council at Circus Field. Otter fencing not maintained.	 	Discussed with site ecologist.	Haras panels were installed around the holt to demarcate the area and prevent any accidental stockpiling within the otter holt buffer zone.

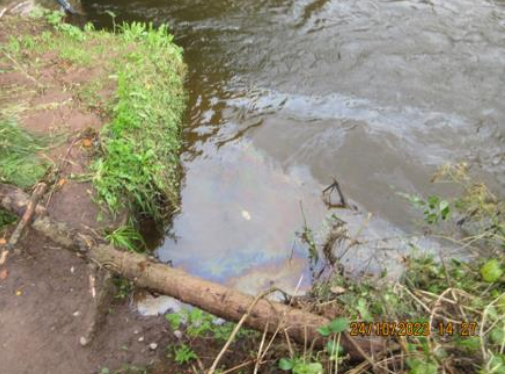
22	24/10/2023	Oil slick at riverstown bridge investigated.

Source could not be determined. Works upriver of this site investigated for possible connection but none was observed.	No action required.
23	24/10/2023	Heras panels being stored within otter N6 exclusion zone at Circus field.	 	Discussed with site ecologist.	Heras panels were removed.
24	25/10/2023	Change Order to alter bund at Sallybrook.
