E Flow Monitoring Survey Report

Blackpool Culvert Flow Survey 2014/2015

Blackpool Culvert Flow and Level Survey 2014 / 2015 – General Report

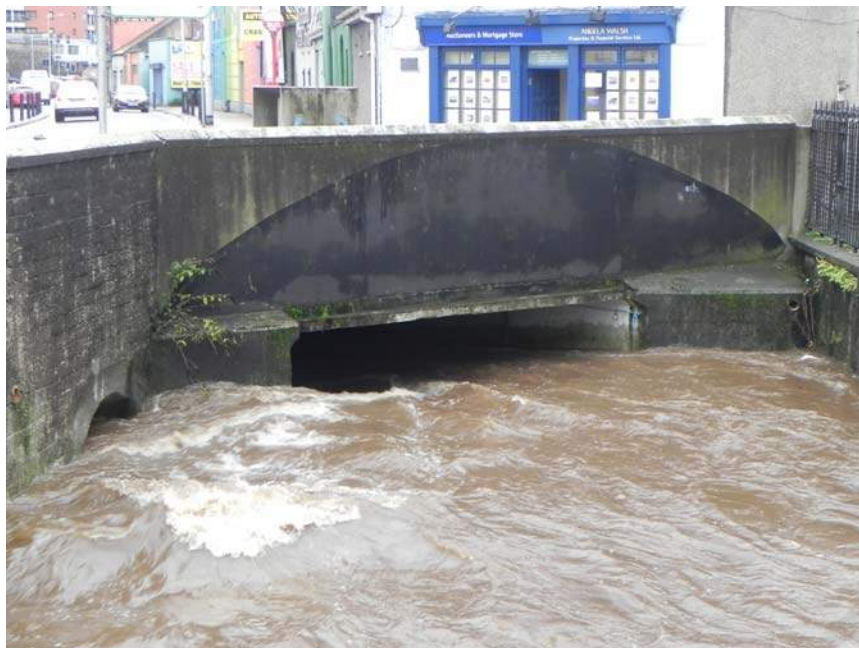
Fig 1: Entrance to Culvert at Blackpool Church after Rain Event

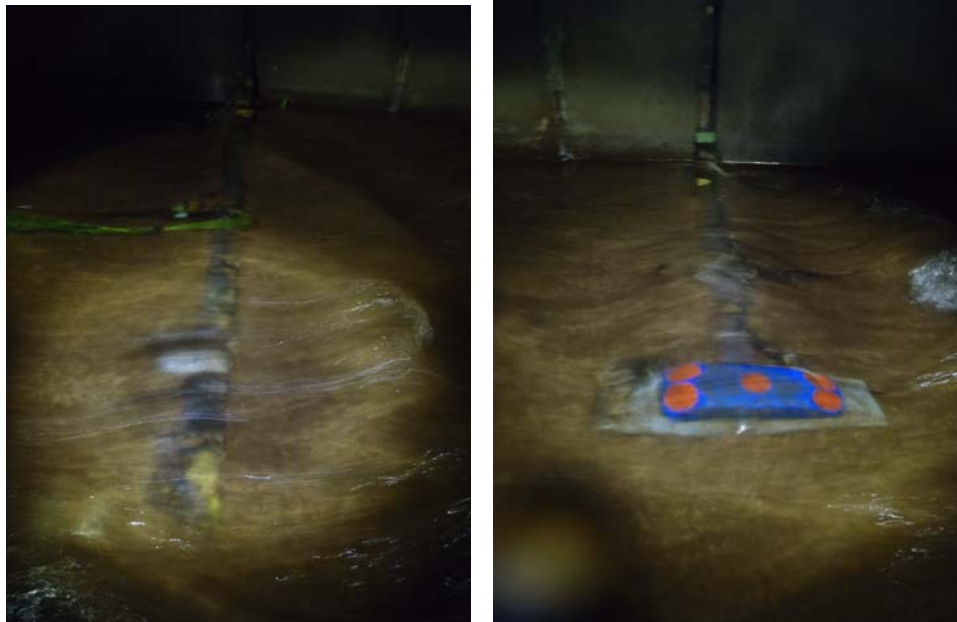
A strange phenomenon was witnessed at all the sites from time to time. This was the intermittent occurrence of a wave effect in the locations of the probe. In fact these waves were evident periodically throughout the culvert and seemed to move location. Why this seemed strange, was that on certain occasions the level at the probe could seem quite static, but on other occasions, at more or less the same flow conditions, a wave would be present. Sometime these waves were upstream of the probe, sometimes over the probe, and other times seemed to sweep across the channel. Initially we assumed the probe installations might be causing these waves, however it was very hard to pin point exactly why this wave would be present on one occasion and not another, when the conditions seemed similar. It did occur more when the levels were slightly higher, (e.g water levels of 0.15m at FM1 and FM4). It proved difficult to take accurate level and velocity measurements when these waves were present. It was not uncommon to have a water level varying between 0.13 and 0.17 m

Fig 24: Wave effect evident at FM1 2150 AV and ADFM probes.

for example, which has the potential to introduce a large error. It was decided due to this issue that in general, unless a probe was being moved or replaced, that we would record all data and only offset the levels subsequently if several measurements confirmed a correction was required.

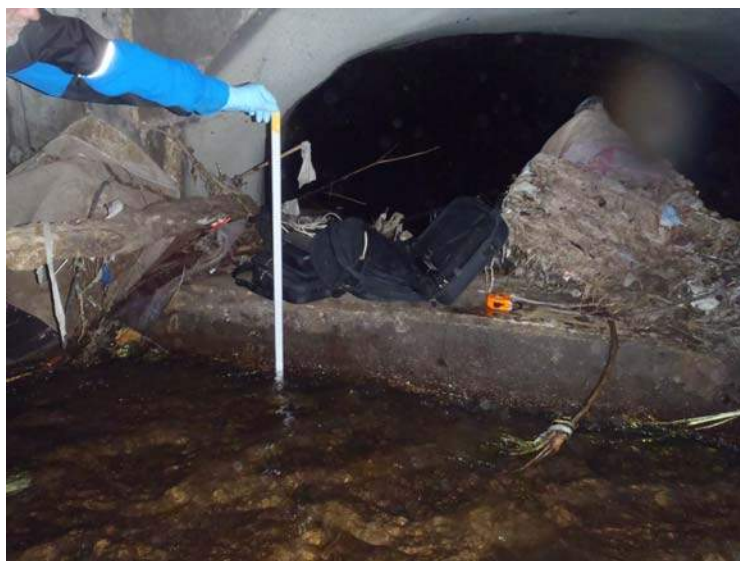
Fig 35: Concrete wall at entrance to old brewery culvert (FM2).

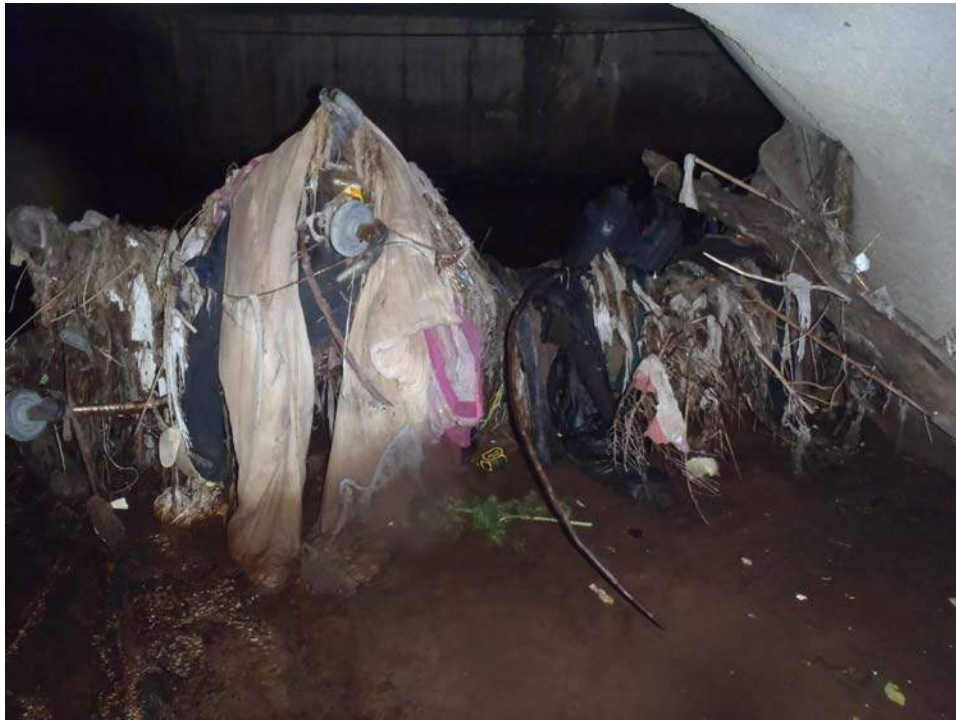
The wall trapped debris as can be clearly seen from Fig 36 below. This debris included household rubbish that must have been dumped into the River Bride and had flowed to this point. However it was noted from monitoring the debris and sediment at the bifurcation, that it was the basically the same debris there at all stages. There were no new large items of debris specifically noted from visit to visit before its removal.

Fig 36: Debris trapped on wall at entrance to old brewery culvert (FM2).

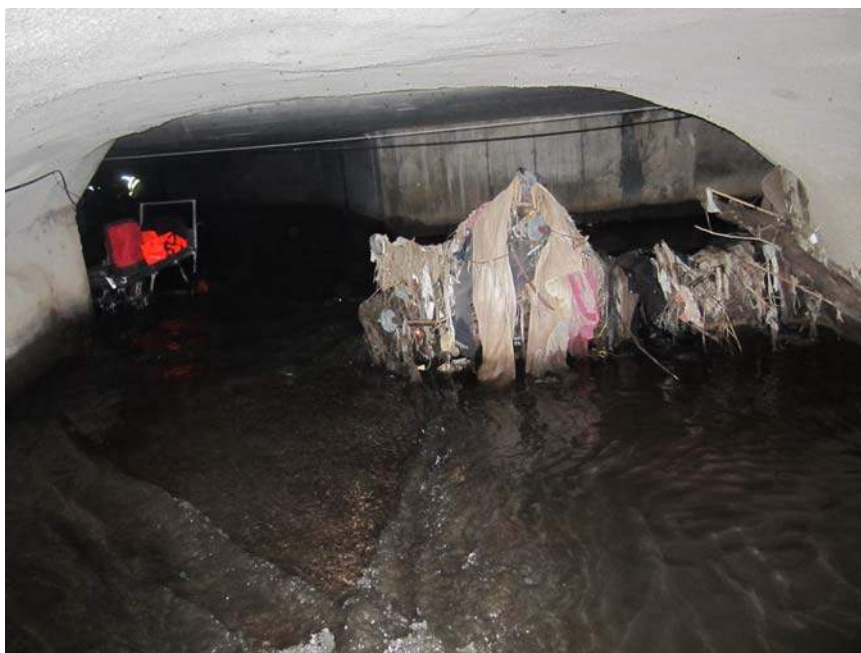
Fig 37: Debris trapped on wall at entrance to old brewery culvert (FM2) looking back from FM2 probe.

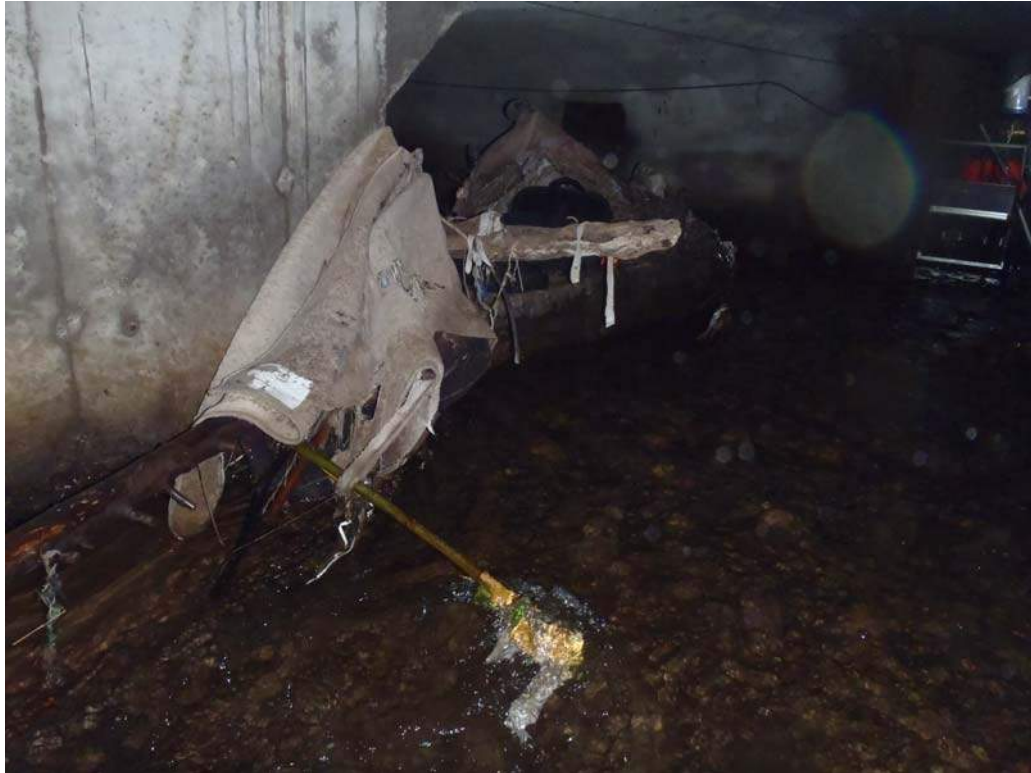
Fig 38: Debris trapped on wall at entrance to old brewery culvert (FM2) looking from cross section in bifurcation.

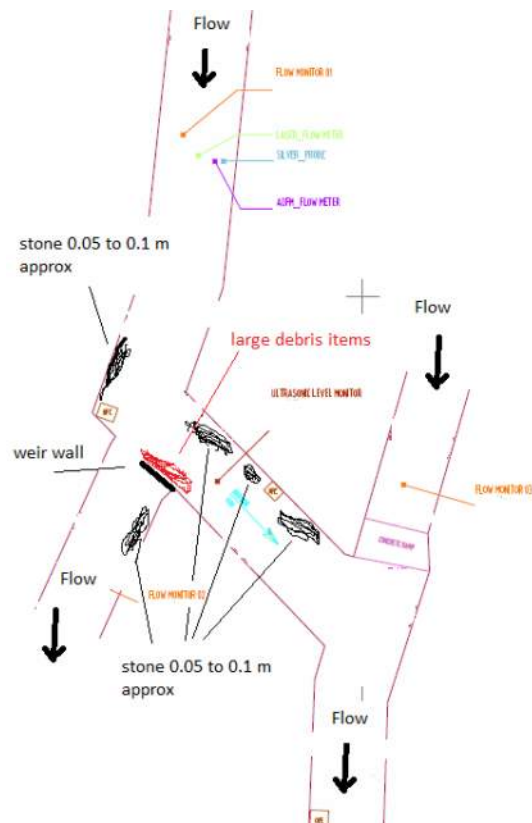
Unlike the new culverts, (at FM1, FM3, and FM4), which have level concrete floors; FM2 has a natural earth floor. Water channels from side to side at certain parts of the channel, resulting in accumulation of stones at various points along the channel. This is similar to conditions found in any natural stream.

Fig 39: Location of stone and sediment at bifurcation

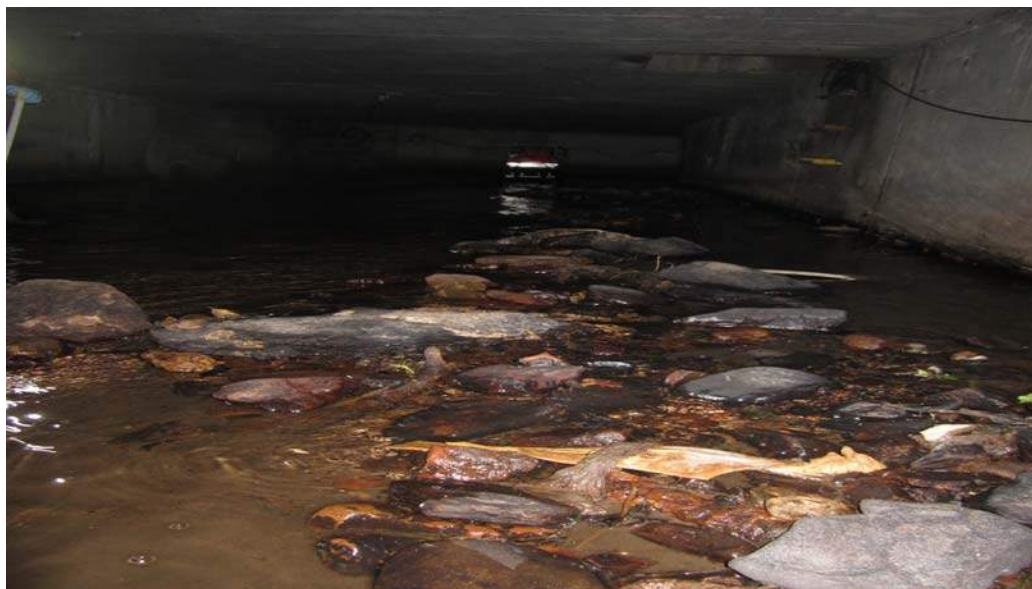
Fig 40 below looks back from the Limerick Road FM3/FM4 side towards the Watercourse Road FM1/FM2 culvert across the bifurcation when levels were very low. The low water levels show clearly the stone accumulation predominantly at the north wall side of the cross section. Some of the larger items stones seen in this photograph were cleared, presumably at the same time the wall was removed.

Fig 40: Stone accumulation in cross section at bifurcation during low levels:

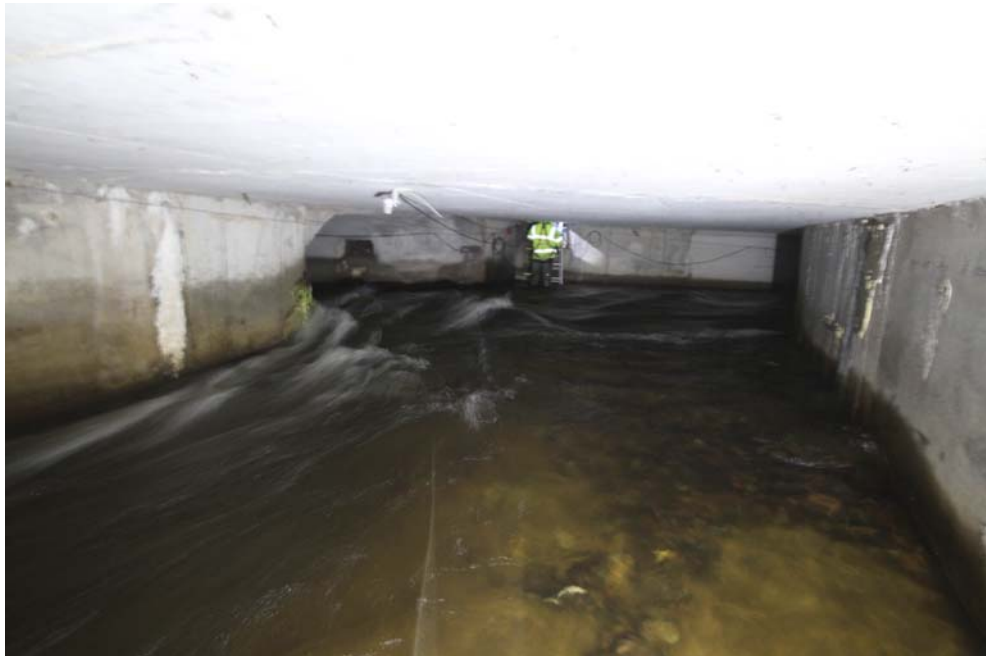
Fig 41 taken during high flow conditions in November shows there is still a relatively small accumulation of stones on the north end wall side of the bifurcation cross section. Flow is predominantly on the south end wall side only.

Fig 41: Stone accumulation in cross section at bifurcation during High Flows in November:

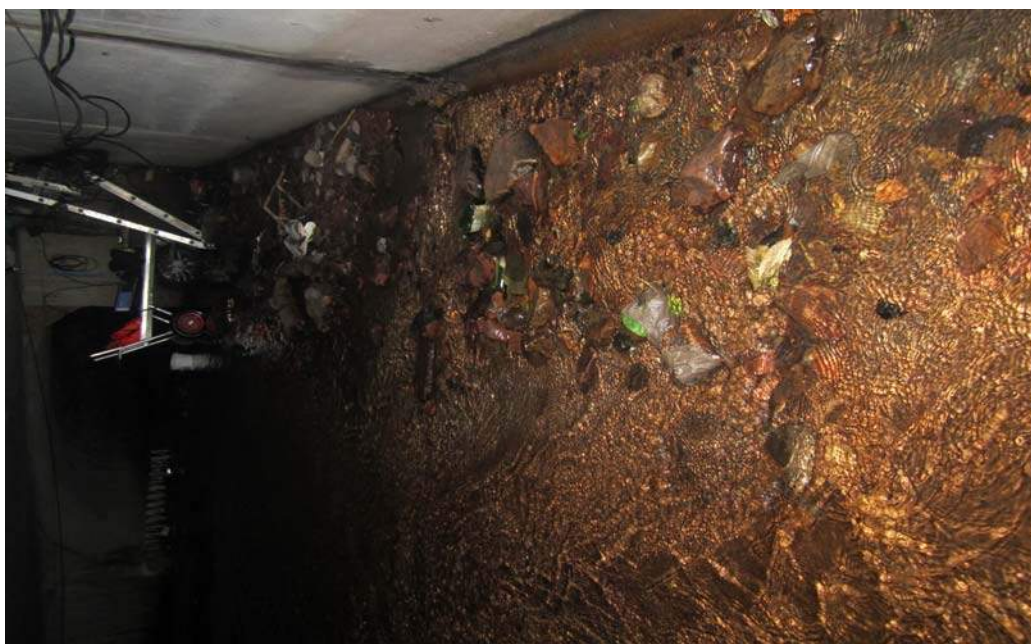
Fig 42 shows an accumulation of stones along the FM1 channel just before the entrance to the old Brewery Culvert, (FM2). The trolley and ladder in the background are part of our survey equipment.

Fig 42: Stones at FM1 location before entrance to brewery channel, (FM2):

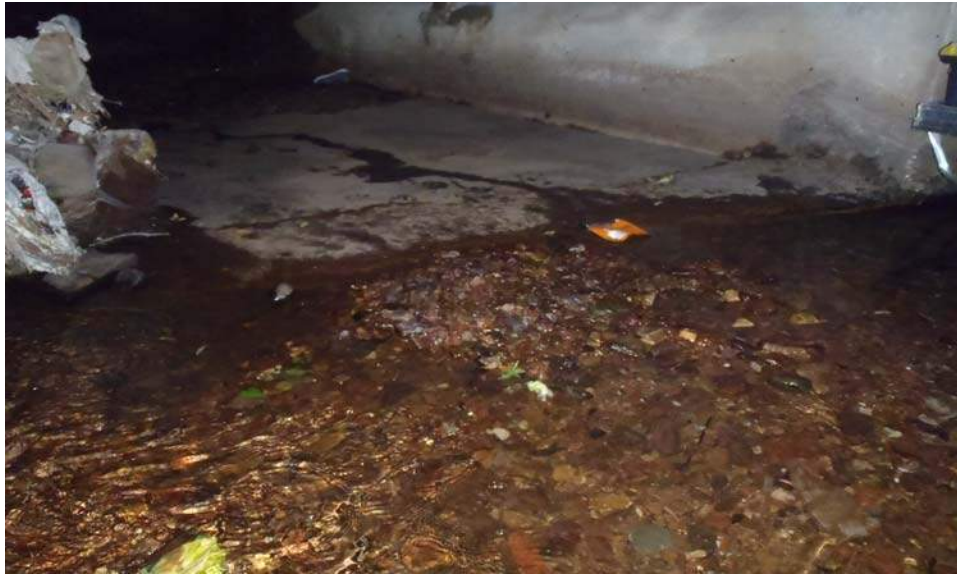
By August levels within the culvert were very low with almost no flow, (level of 0.02m (4.46 M OD), entering Old Brewery Culvert FM2. Most of the flow at this point did seem to cross the bifurcation from FM1 to Limerick Road Culvert FM4.

Fig 43: Location to brewery channel, (FM2), In August shows almost no flow entering:

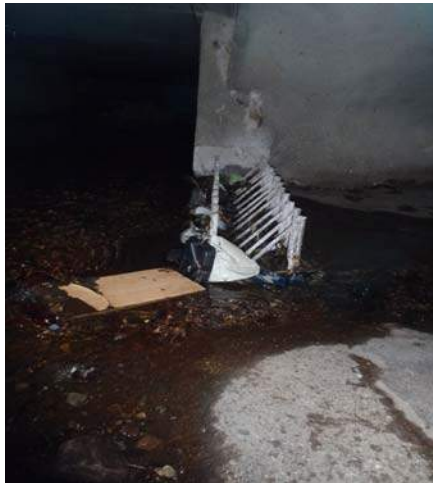
Fig 45: Reinforcement structure left after wall removed

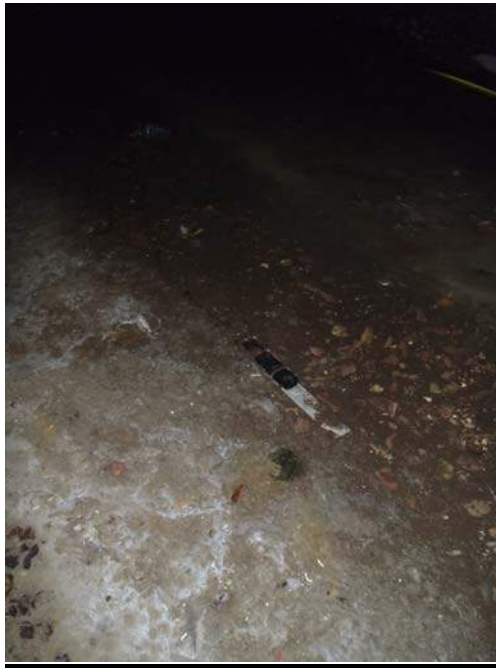
Fig 46 shows the 2150 AV probe in FM2 old brewery channel. Almost no flow was noted in this culvert at this time during dry conditions.

Fig 46: AV probe in old brewery channel, (FM2).

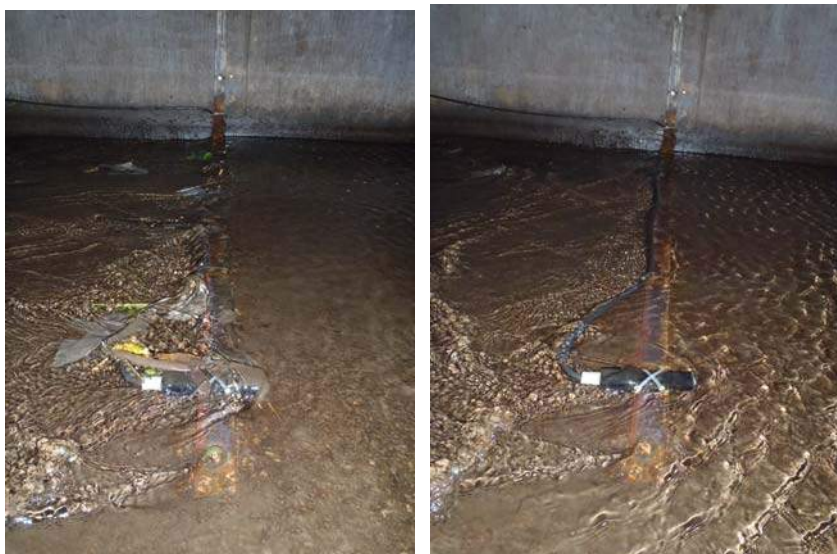
Fig 47 shows FM3 AV probe before and after cleaning during summer conditions

Fig 47: FM3 AV Probe before and after cleaning during low water levels

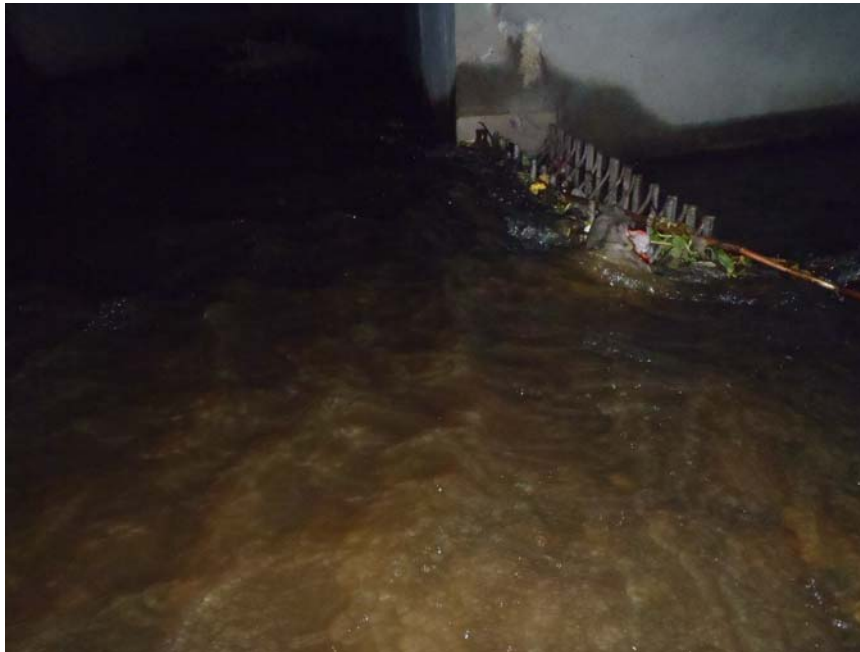
In October water levels started to rise again. Fig 53 below taken on the 8th October, shows how debris had accumulated on the remained reinforcement structure of the removed wall. This was having some effect on flow distributions at this stage. In fact flow conditions appeared similar to those observed back in April and May before the wall was removed.

Fig 53: fouling on reinforcement structure in October:

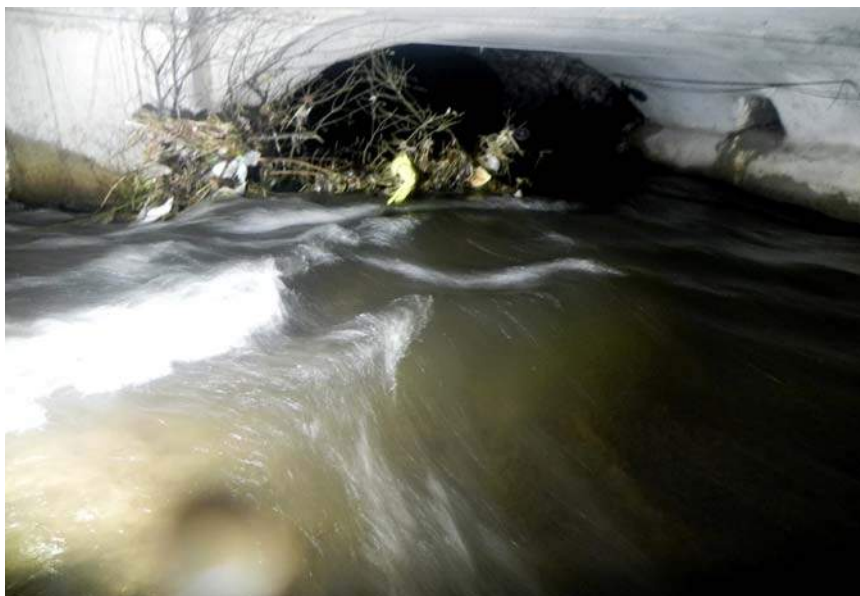
After a heavy rain event in January 2015 we can see a standing wave at the bifurcation at the side of the entrance to the old Brewery Culvert, (FM2), as seen in Fig 54. The debris trapped on the remained reinforcement structure, where the wall was originally, would appear to be contributing to this. Despite this, a considerable percentage of the flow can be seen entering the old brewery channel during these higher flows. This is the most recent or last photograph at this important location, taken during high flow conditions, during the survey.

Fig 54: Standing wave at entrance to brewery channel ,(FM2) on 16th November after recent heavy rain events.

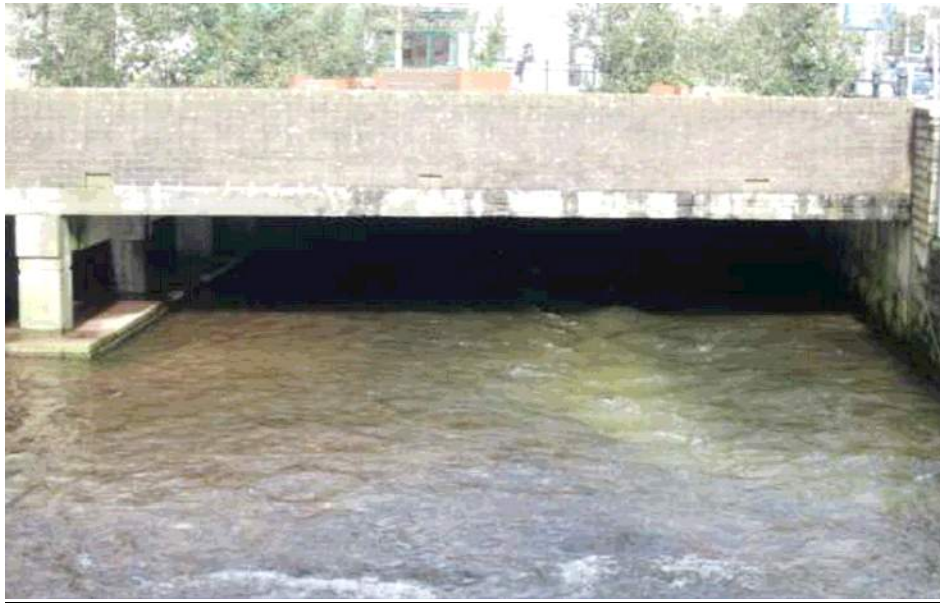
Fig 55: bridge at Blackpool Church before cleaning

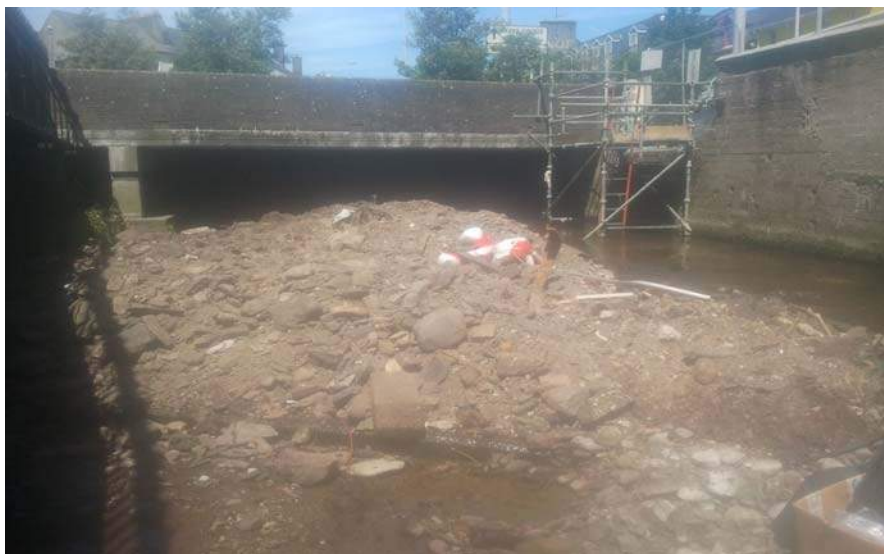
A large amount of stone, silt and rubbish was removed from under the bridge and surrounding areas by Cork City Council, starting in June 2014. Fig 56 taken on the 12th June shows the extent of this work.

Fig 56: bridge at Blackpool Church during cleaning works

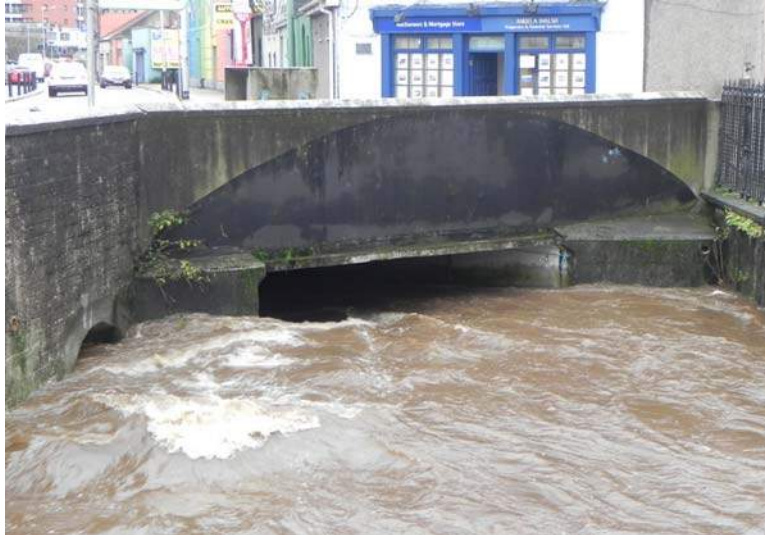
Fig 59 taken shortly after the rain event on 14th November, below shows the conditions at the entrance of the culvert after the highest recorded rain event. This is reported on further in section 10.1

Fig 59: Entry to culvert at Blackpool Church after rain event on the 14th November

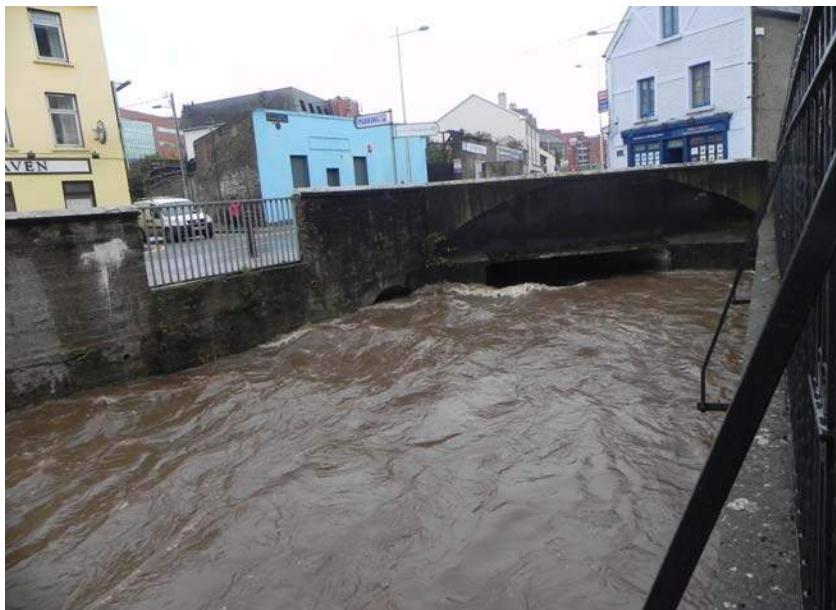
Fig 60: Conditions at Blackpool Church after rain event on the 14th November

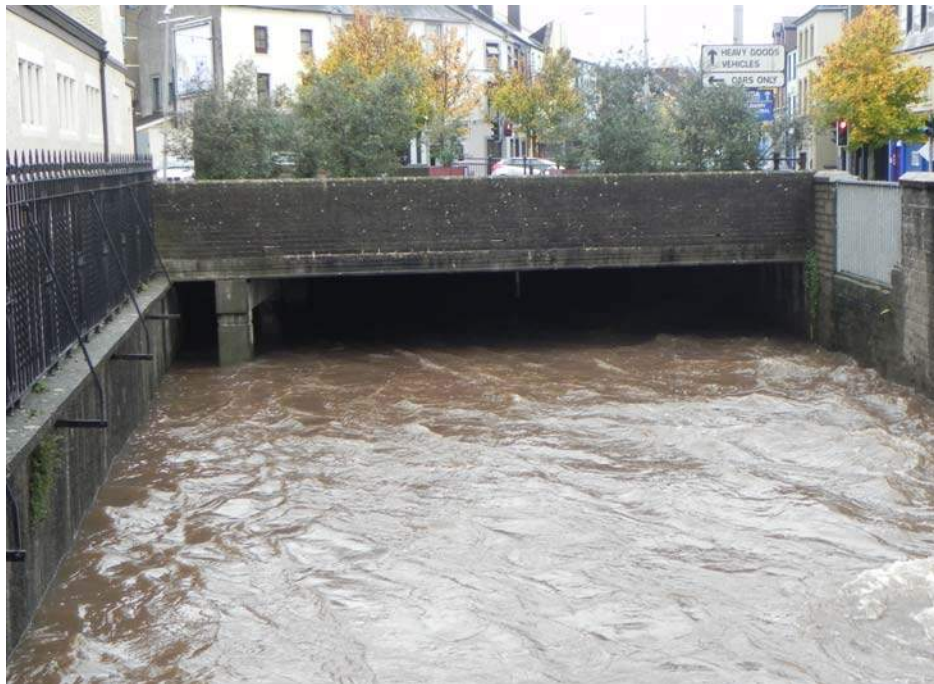
Fig 61: Bridge at Blackpool Church after rain event on the 14th November

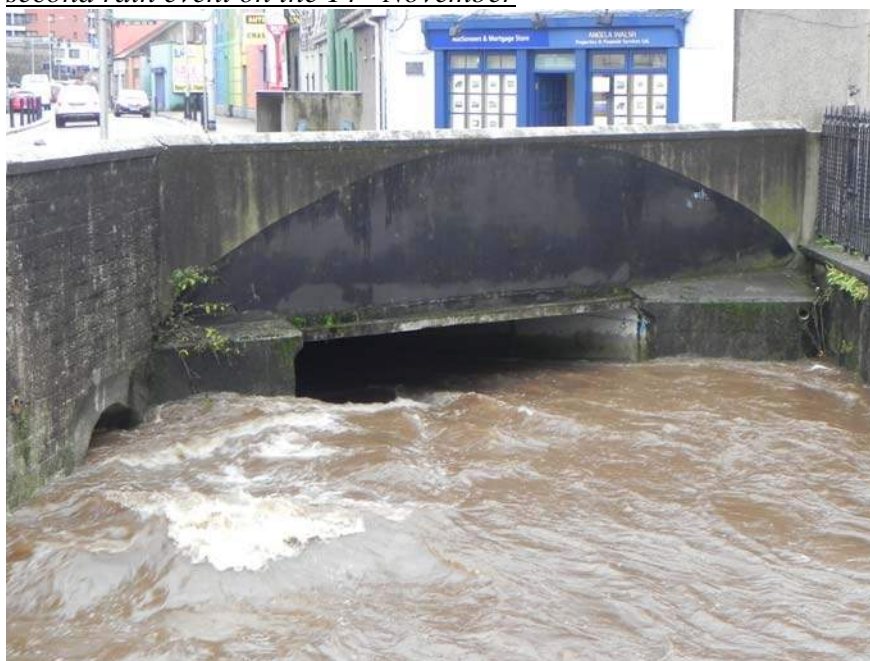
Fig 73: High Flow at the Culvert Entrance at Blackpool Church the morning after second rain event on the 14th November

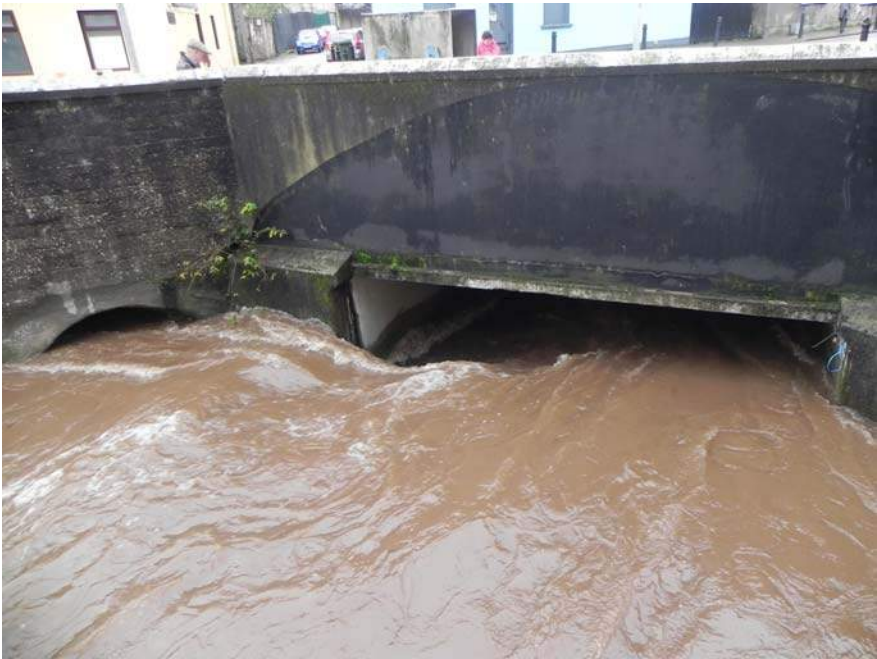
Levels recorded as high as 0.8 m, (6.99 M OD), on the level gauge under the bridge at the church which is the highest recorded since monitoring started last March. In Fig 73 above, the photograph was taken at 10 am approx on the 14th Nov, when the levels logged under the bridge at this time would have decreased back to 0.4 m, (6.59 M OD). Thus we can assume the level at the entrance during the previous 14th Nov peak of 0.75 m, (6.94 M OD), logged 4 hours prior to this could have been noticeably higher. There is a standing wave noted on left side of channel in Fig 74.

Fig 74: Standing wave at left side of culvert Channel
