3.5 Area 3 North – Cork Rd Bridge to N25

Area 3 includes Midleton Town Centre, southern side of IDL site, the Baby Walk, People’s Park, areas adjacent to Dungourney River and Bailick Road. The area is at risk of fluvial flooding from the Owenacurra and the Dungourney, as well as tidal flooding.

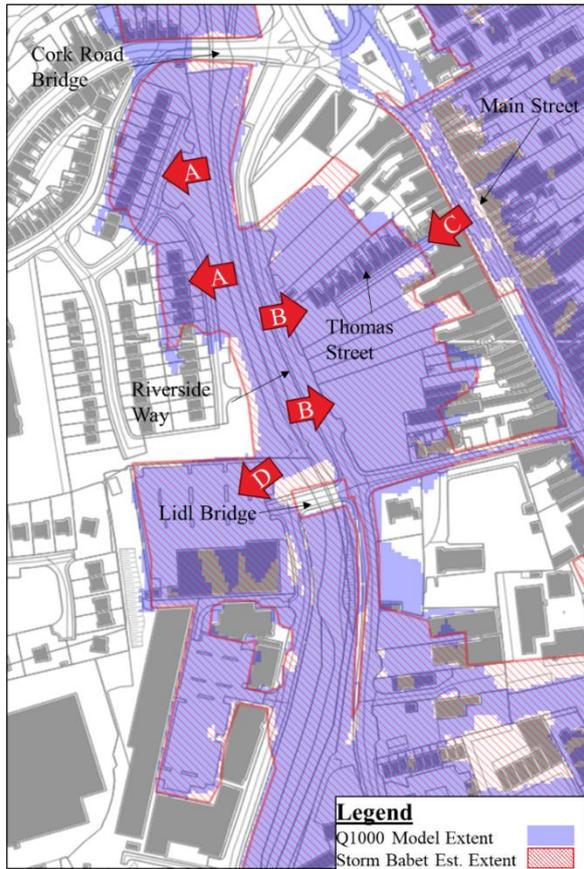
Figure 47: Cork Bridge/ Lidl Bridge: Existing Flood Mechanisms

There are a number of mechanisms of flooding in the area from the Cork Road Bridge to the Lidl Bridge on the Owenacurra. This area includes a number of large commercial properties including Lidl (Waters Edge) and businesses accessed from Riverside Way as well as residential properties (Woodlands Estate, Thomas Street). The mechanisms of flooding detailed below correspond to the arrows in Figure 47.

- A. Water overtops the right bank of the Owenacurra at the Woodlands estate for the relatively lower return period events;
- B. Thomas Street is inundated due to water getting out of channel on the left bank of the Owenacurra. This mechanism also inundates Riverside Way and the carparks/ commercial properties in this area.
- C. Thomas Street is also at risk of flooding from overland flow from Main Street.
- D. Upstream of the Lidl Bridge water gets out of bank on the right bank of the Owenacurra. Properties within the Waters Edge commercial development are at risk from this mechanism (Lidl, McDonalds, Aldi etc)

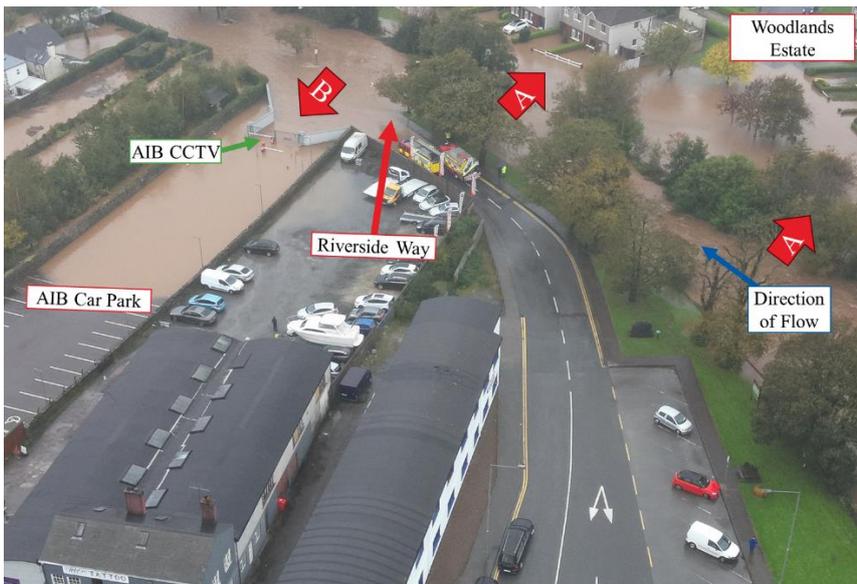
Figure 48: Flooding of Woodlands Estate and Riverside Way

All the mechanisms of flooding in this area as detailed in the hydraulics report and as noted above occurred during Storm Babet. We have been able to determine this by reference to the aerial imagery as supplied by the Guileen Coast Guard (Figure 48) and observations from our site visits. Wrack marks recorded in the days after the flood event were also compared against Lidar data in order to confirm the flood extents in the Woodlands Estate and Thomas Street Area. We note that there was good validation between the wrack mark data and the Q1000 model water levels in these two areas.

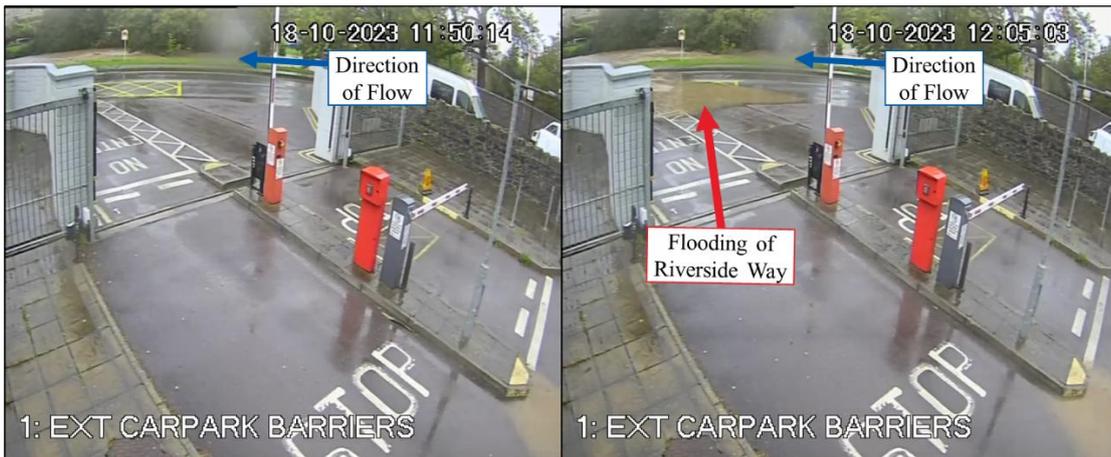
Figure 50: Flooding of Riverside Way between 11.50am and 12.05pm

Stills of CCTV footage from the AIB Carpark camera (refer to Figure 48 for the location and direction of camera) show water getting out of bank and starting to flood Riverside Way at circa 12.00pm. These stills, which are time stamped, are presented in Figure 50.

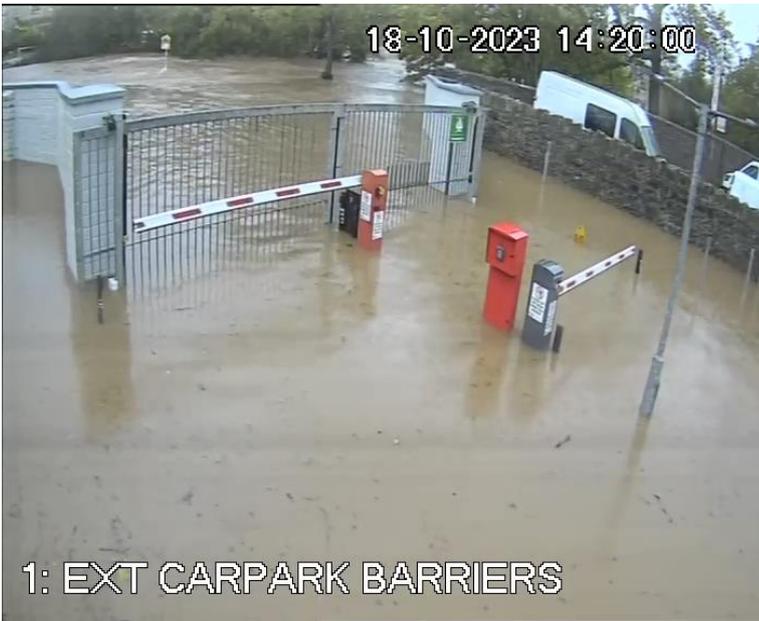
Figure 51: Flooding of Riverside Way between at estimated peak (2.20pm)

From inspection of the full CCTV footage, the peak of the flood event in this area occurred at circa 2.20pm in this area. Figure 51 presents a still of the CCTV footage shows the extent of the flooding at this time. The peak of the flow on the Dungourney is discussed in Section 3.5.6.

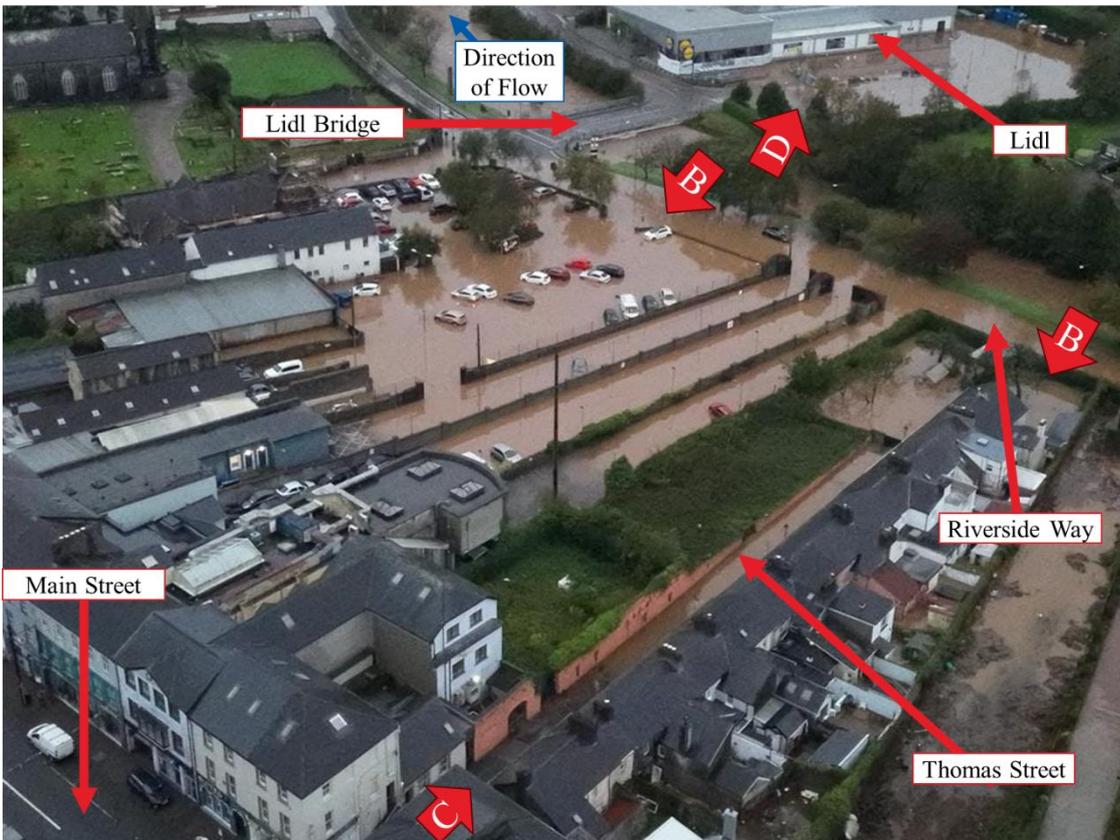
Figure 52: Flooding of Riverside Way, Thomas Street and Lidl

Figure 52 presents an aerial image of Thomas Street and the Lidl development inundated after the peak of the event. It can be seen that the Lidl bridge is not surcharged in the image. Drone footage taken from earlier in the event and therefore closer to the peak, does however show that the Lidl Bridge was in fact surcharged by the event but not overtopped. It's estimated that water levels upstream of the bridge were circa 4.0mOD at the peak which is almost equivalent to the Q1000 model max water level of 3.95mOD.

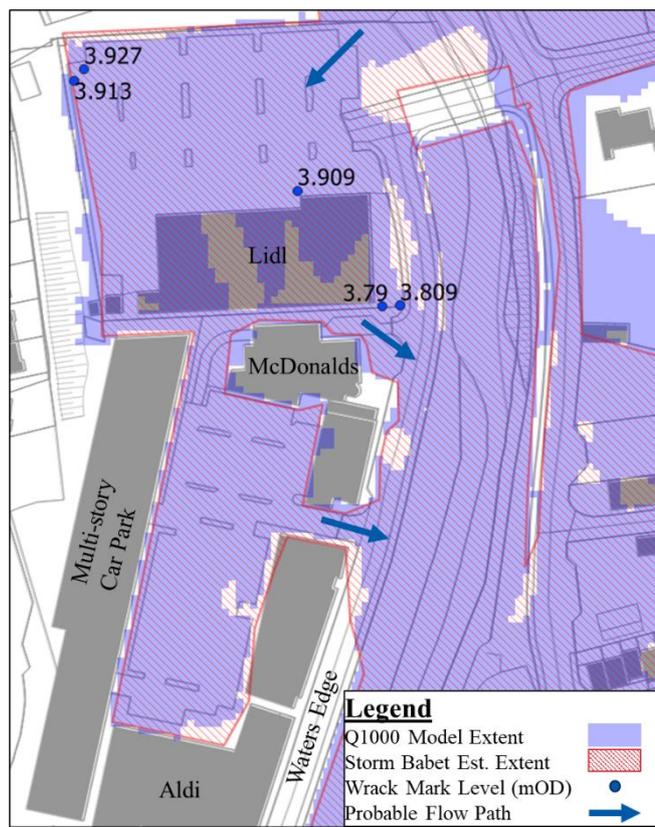
Figure 53: Waters Edge Development: Wrack Marks Levels (mOD) and estimated direction of flow

Wrack marks recorded in the Waters Edge commercial development are presented in Figure 53. All the levels are circa 100mm higher than the modelled Q1000 maximum water levels in this area. It is noted that the model has a T5 downstream tidal boundary which coincides with the peak of the fluvial hydrograph which suggests that the Q1000 modelled water levels would in fact be lower if the model was run with a tidal boundary equivalent to the recorded tide during Storm Babet.

Based on an inspection of the various datasets, we do not believe that water overtopped the right bank of the Owenacurra downstream of the Lidl Bridge during Storm Babet and that the inundation of the car park between the Aldi and McDonalds was a result of overland flow which originated from upstream of the Lidl bridge. The likely flow paths in this area are also presented in Figure 53.

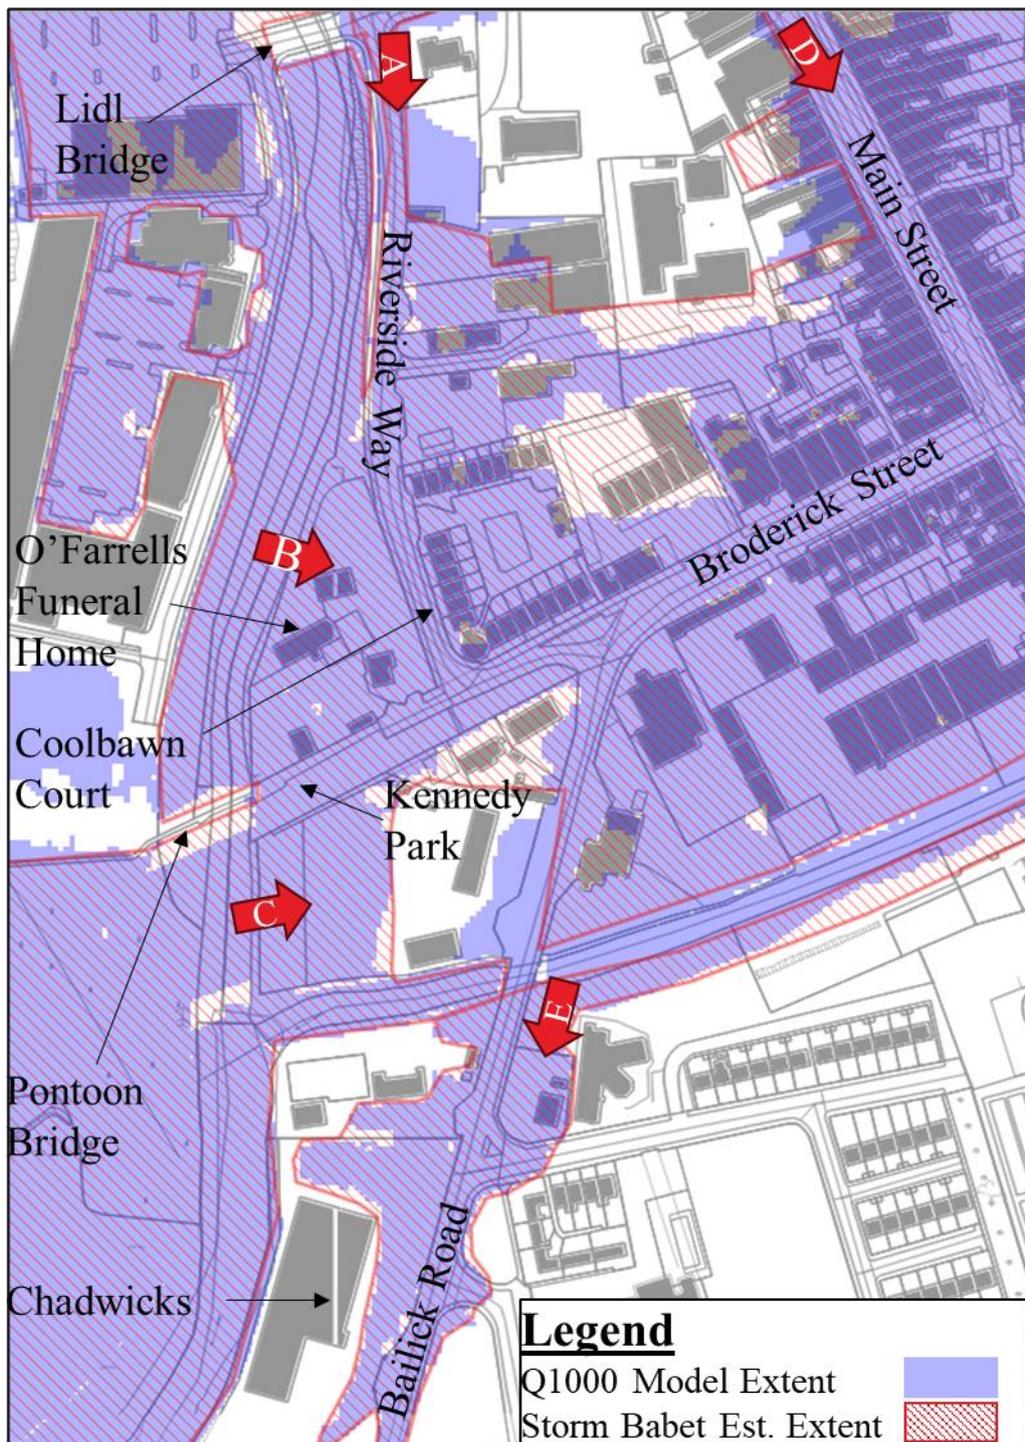
Figure 54: Lidl Bridge to Chadwick's: Existing Flood Mechanisms

There are a number of mechanisms of flooding in the area between Lidl Bridge and Chadwicks. This area includes a large number of commercial and residential properties in the vicinity of Kennedy Park. The mechanisms listed below correspond to the arrows in Figure 54.

- A. As discussed in Section 3.5.1, water overtops the left bank upstream of the Lidl Bridge and travels South along Riverside Way towards Coolbawn Court
- B. Water also gets out of bank along the left bank via O'Farrell's Funeral Home upstream of Pontoon Bridge
- C. Downstream of Pontoon Bridge the left bank is overtopped which leads to flooding of the ESB Site
- D. As discussed in further in Section 3.5.3, overland flow from Upper Main Street also leads to flooding in this area.

E. The Dungourney overtops the left bank around the Bailick Road Bridge and also results in flooding of the Bailick Road adjacent to Chadwicks Hardware store.

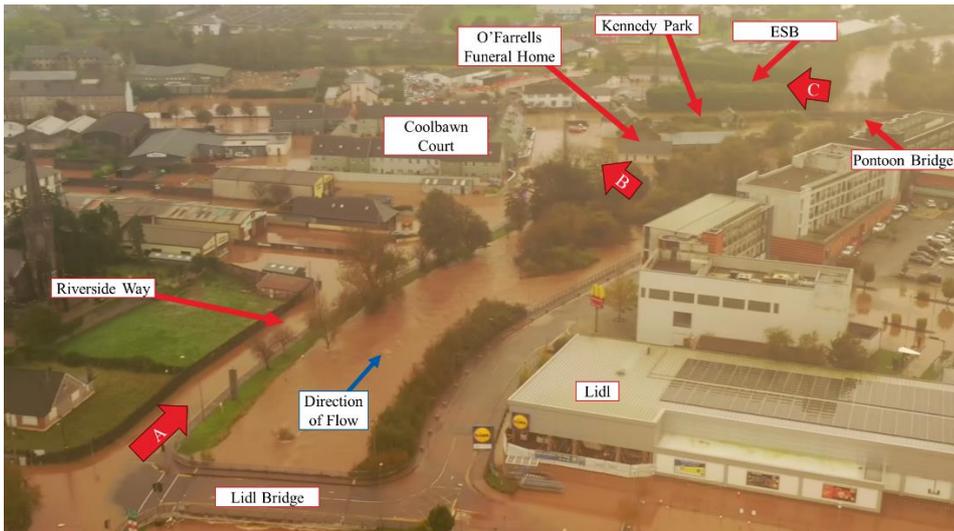
Figure 55: Flooding of Riverside Way and the Coolbawn Court/ Kennedy Park area

Figure 55 presents a still image of the drone footage which was uploaded to social media and shows Riverside Way and the Coolbawn Court/ Kennedy Park area inundated by the event close to the peak.

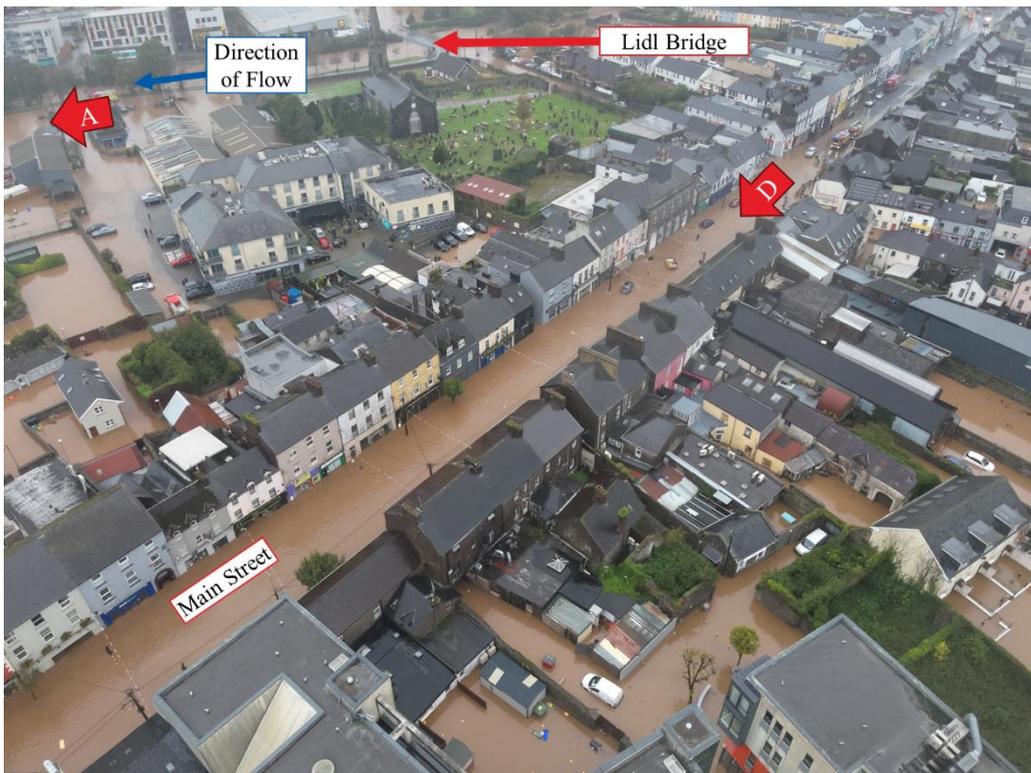
Figure 56: Flooding of Main Street

Figure 56 presents an aerial image from the Guileen Coast Guard which shows extensive flooding of Main Street. The flooding to the East of Main Street was overland flow coming the Drury's Avenue direction (refer to Section 3.5.3).

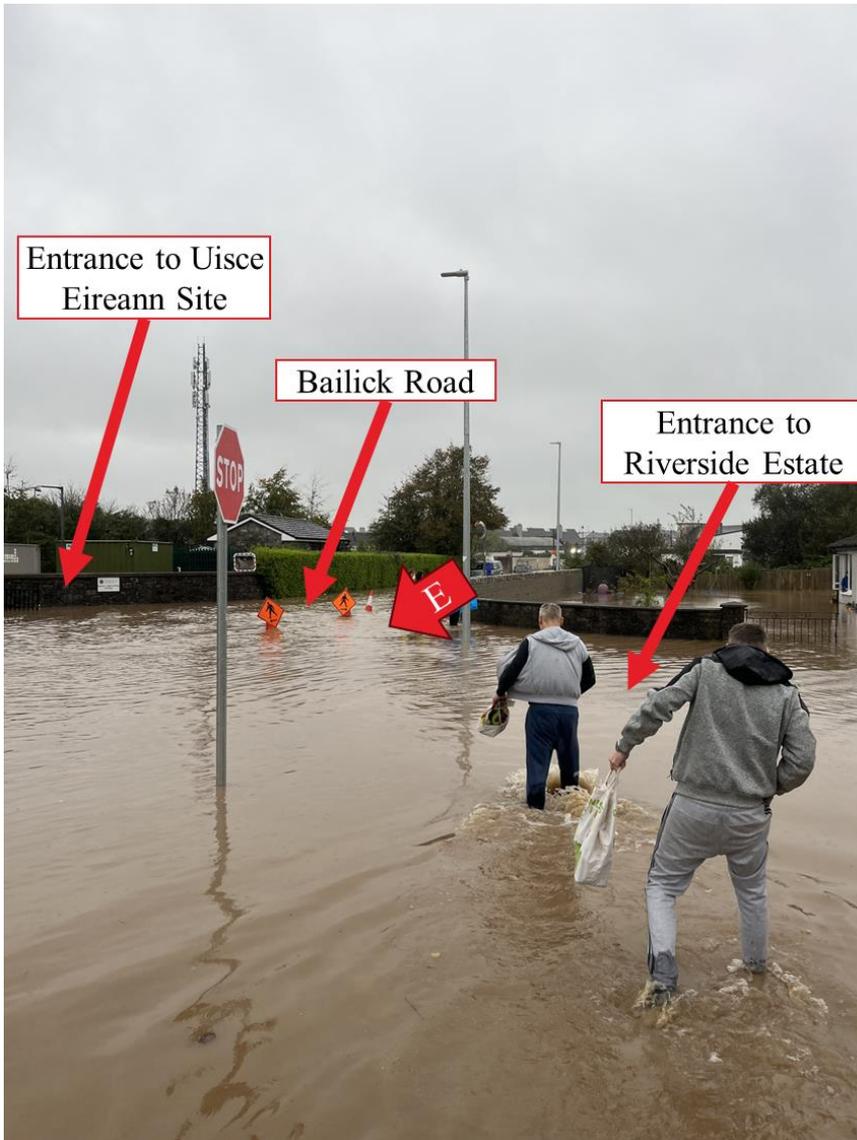
Figure 57: Flooding of Bailick Road South of the Dungourney

Figure 57 presents an image taken at 3.50pm on the day of the flood event and shows flooding of Bailick Road South of the Dungourney. We note that only one residential property was inundated in this area. The commercial properties on Bailick Road (i.e. Chadwicks and the Uisce Eireann sites) were not inundated but we note that entrances to the sites were, as these are at a lower elevations than the buildings.

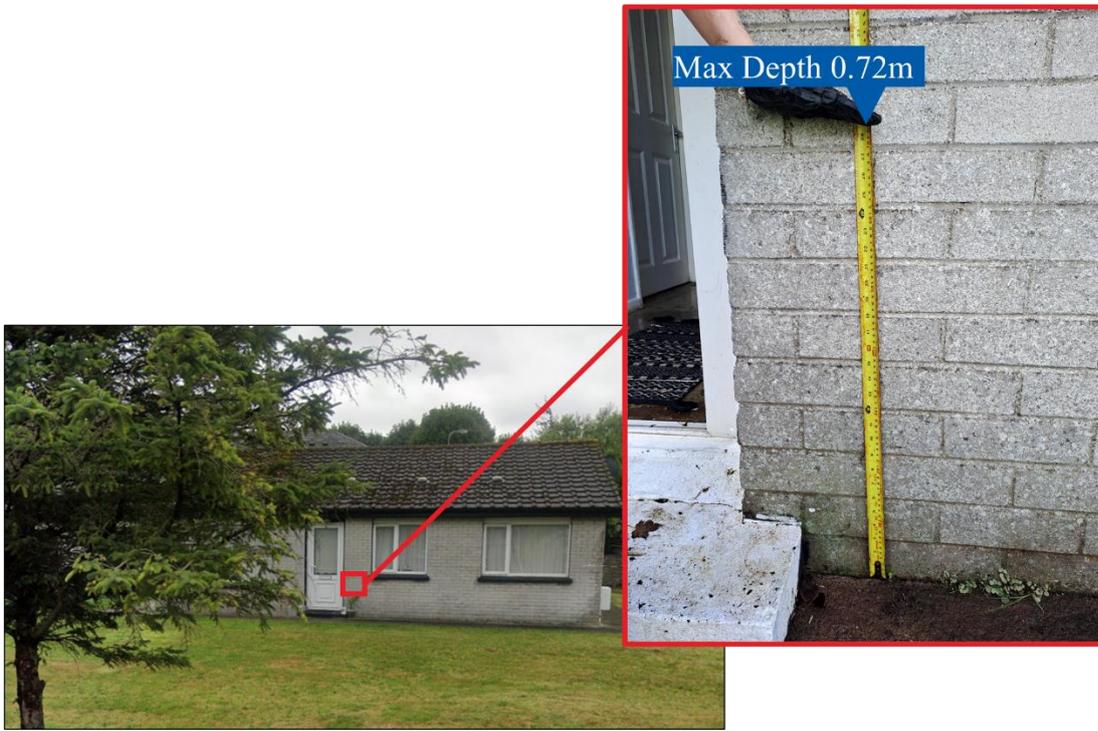
Figure 58: Estimated Depth of Flooding at the Residential Property Opposite Chadwick's

An estimation of flood depth from a local resident was recorded by Office of Public Work (OPW) Staff in the days after the event the residential property opposite Chadwicks. It was estimated that the water depth at this location was circa 0.72m as shown in Figure 58.

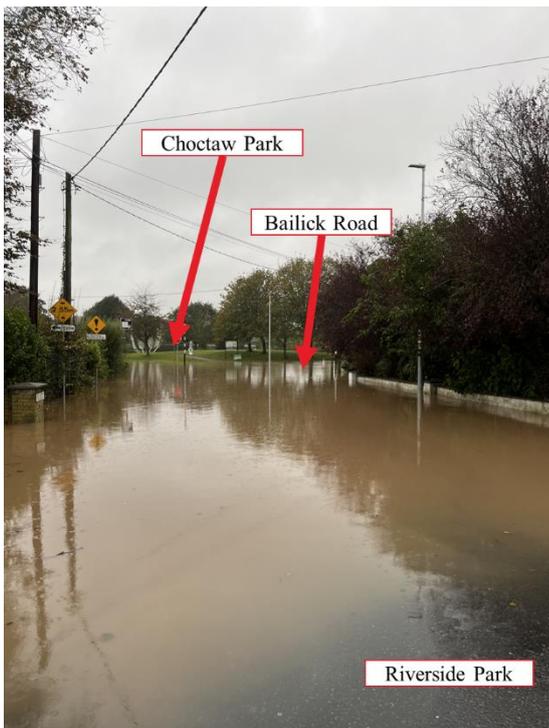
Figure 59: Flooding of Bailick Road/ Riverside Park adjacent to Choctaw Park

Flood water travelled south along the Bailick Road until it entered the estuary via two locations. These locations were Choctaw Park immediately North of N25 bridge and the existing boat ramp South of the N25. There were no reports of any properties south of Chadwicks being inundated during the event. Figure 59 presents another photograph (taken at 3.40pm) of the flood extent along the Bailick Road adjacent to the Choctaw Park.

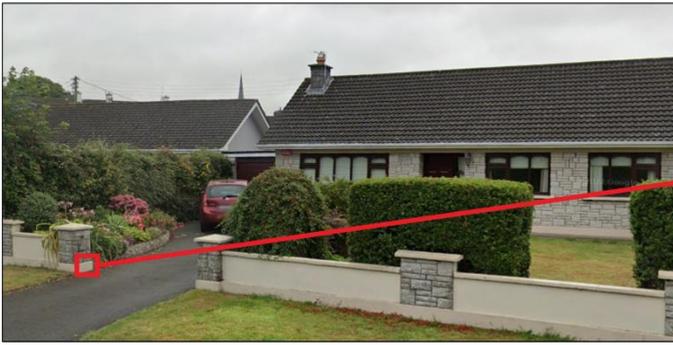
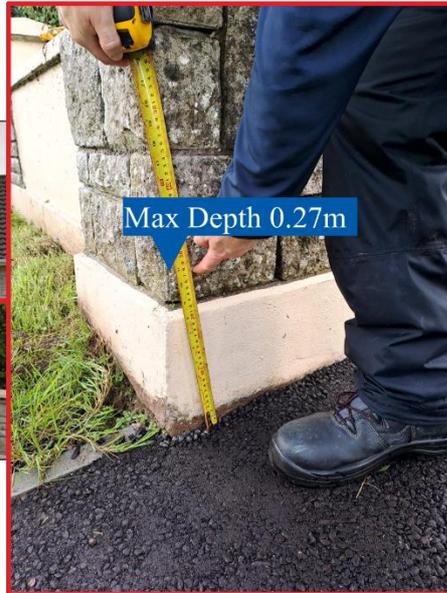
Figure 60: Wrack Mark at Nunsville, Riverside Park, Bailick Road

A wrack mark was recorded by OPW Staff in the days after the event at Nunsville, Riverside Park along the Bailick Road. It was estimated that the water depth at this location was circa 0.27m as shown in Figure 60.

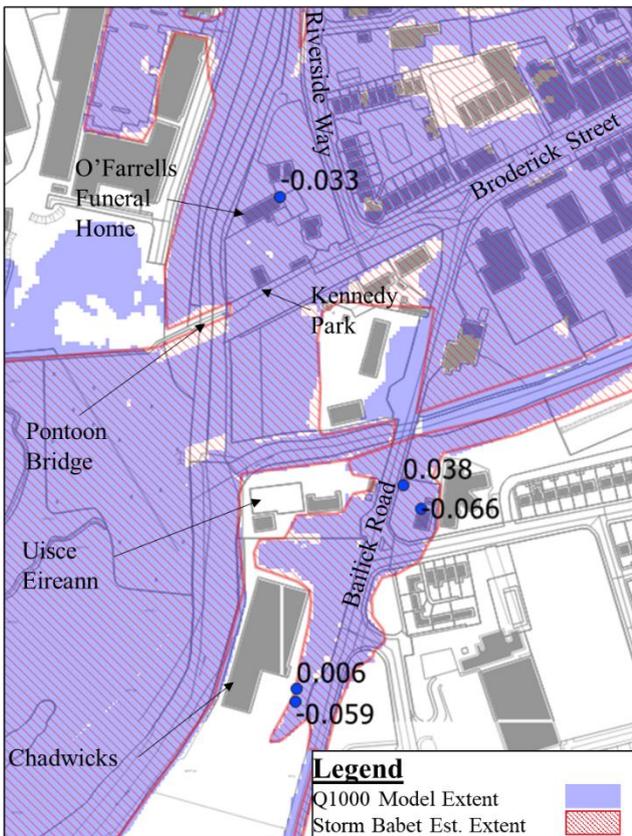
Figure 61: Riverside Way to Chadwicks: Wrack Marks vs Q1000 Modelled Levels (m)

Figure 61 presents the modelled existing scenario Q1000 maximum flood extent in blue and the Storm Babet estimated extent in red hatch for this area. The delta between the surveyed wrack marks and the modelled Q1000 max water levels is also shown. It is evident from inspection of the delta values that the wrack marks and modelled Q1000 water levels are in close agreement despite the different tidal conditions in the model and during the actual event.

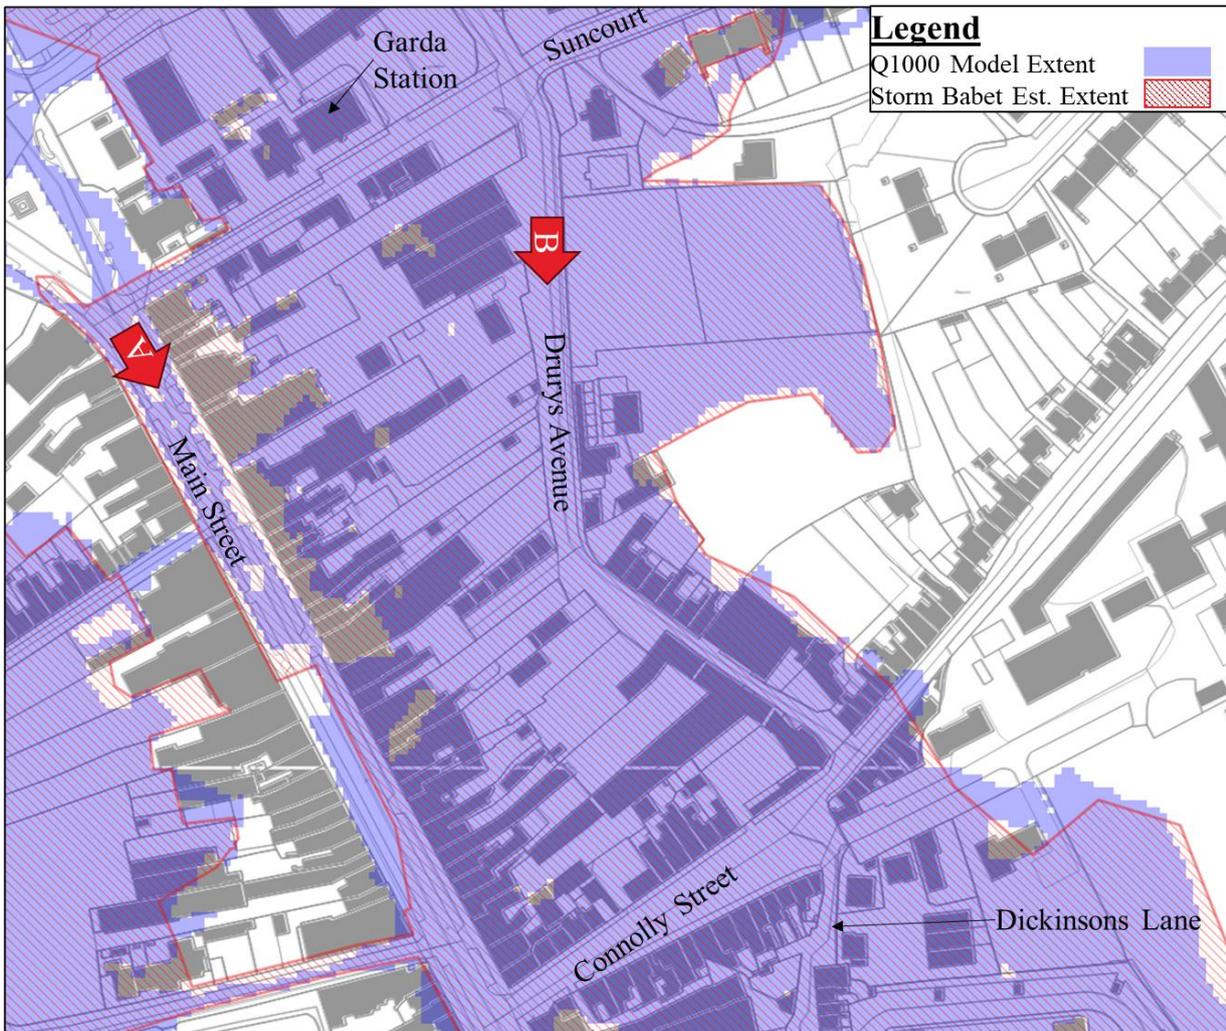
Figure 62: Upper Main Street/ Drury's Avenue: Existing Flood Mechanisms

There are two mechanisms of flooding in this area both of which are detailed below and correspond to the arrows in Figure 62.

- A. Overland flow from the area to the North via the top of Main Street (discussed in Section 3.4.7)
- B. Overland flow from the area to the North via Drury's Avenue (discussed in Section 3.4.7)

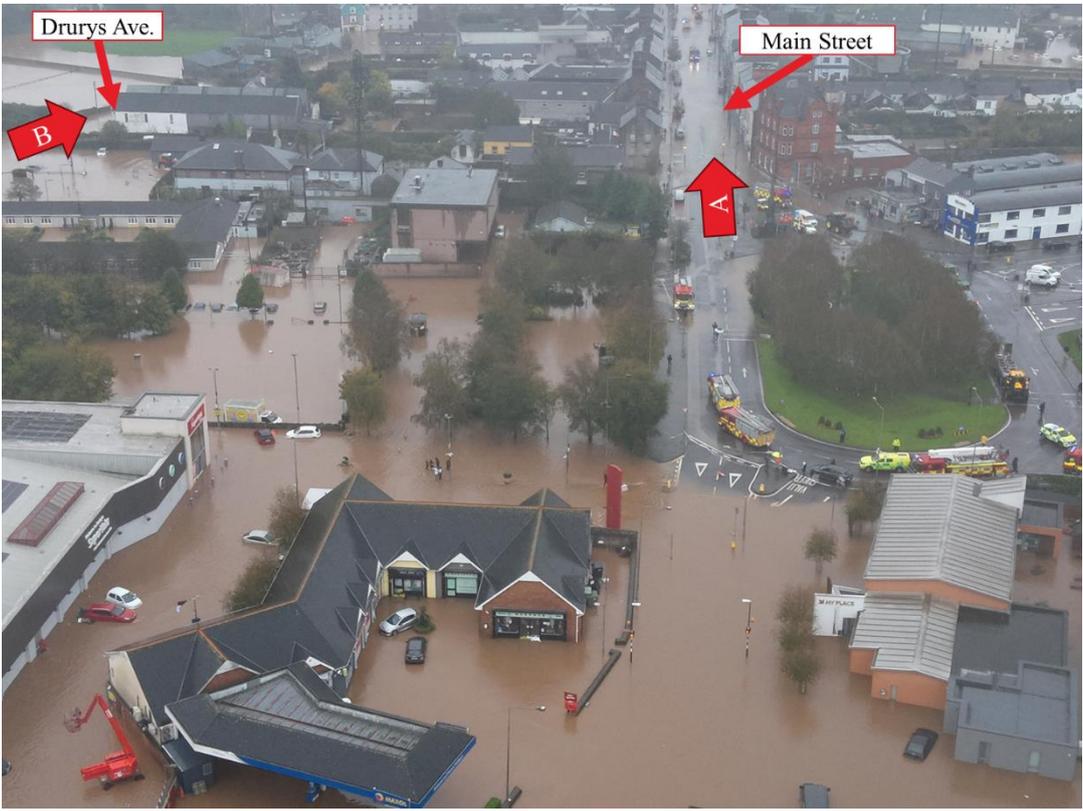
Figure 63: Flooding of Upper Main Street

Figure 63 presents an aerial image of the upper end of Main Street from which it can be seen that the upper end of the street is flooded to shallow depths due to overland flow from the Towns Park area.

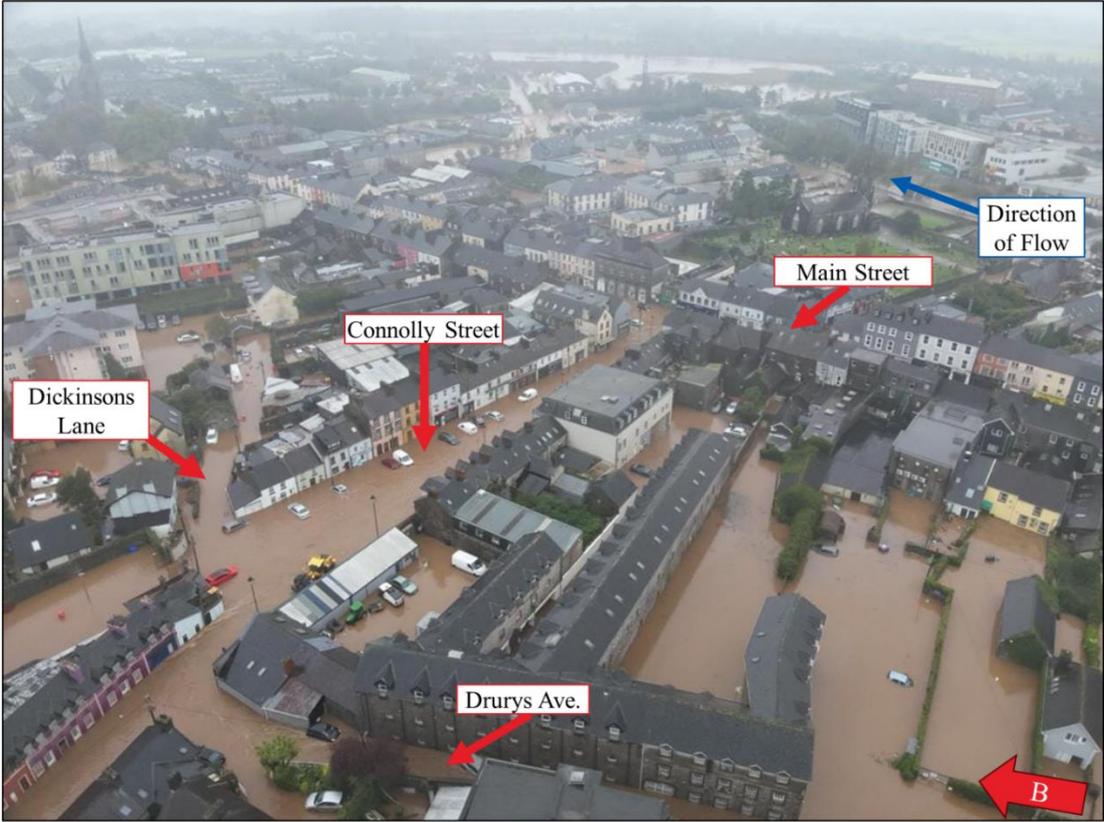
Figure 64: Flooding of Drury’s Avenue/ Connolly Street.

Figure 64 presents aerial imagery at the lower end of Drury’s Avenue/ Connolly Street from which it can be seen that the entire area is inundated.

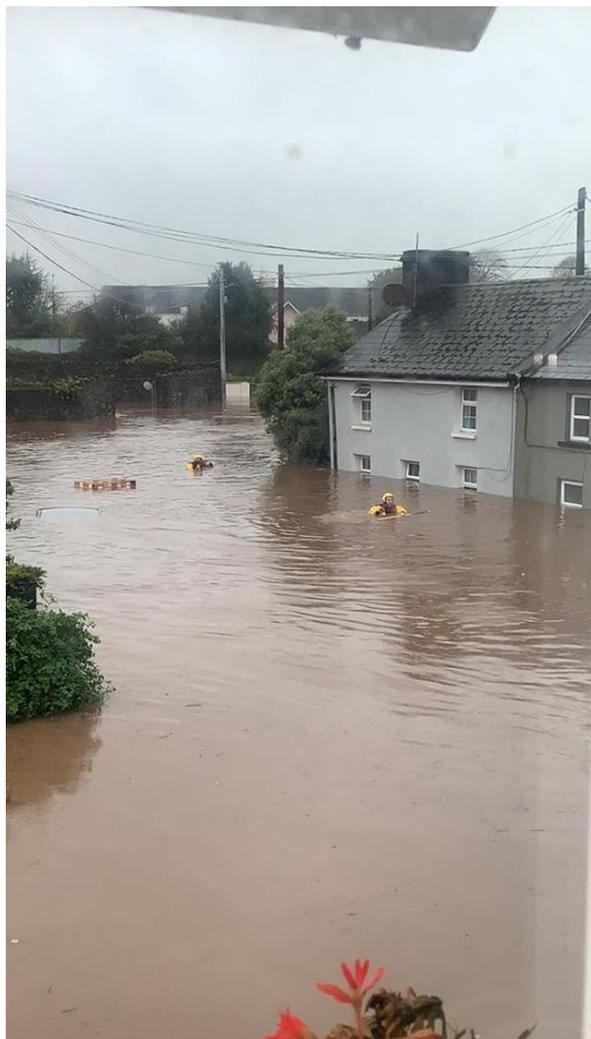
Figure 65: Water depths: Drury's Avenue (adjacent to An Stor)

A picture shared on social media and which is reproduced below in Figure 65 shows that the flood depths along Drury's Avenue, adjacent to An Stor were very significant and well in excess of 1.4m. We note that flood depths of this magnitude are circa 0.5m higher than the Q1000 model maximum flood depth in this area.

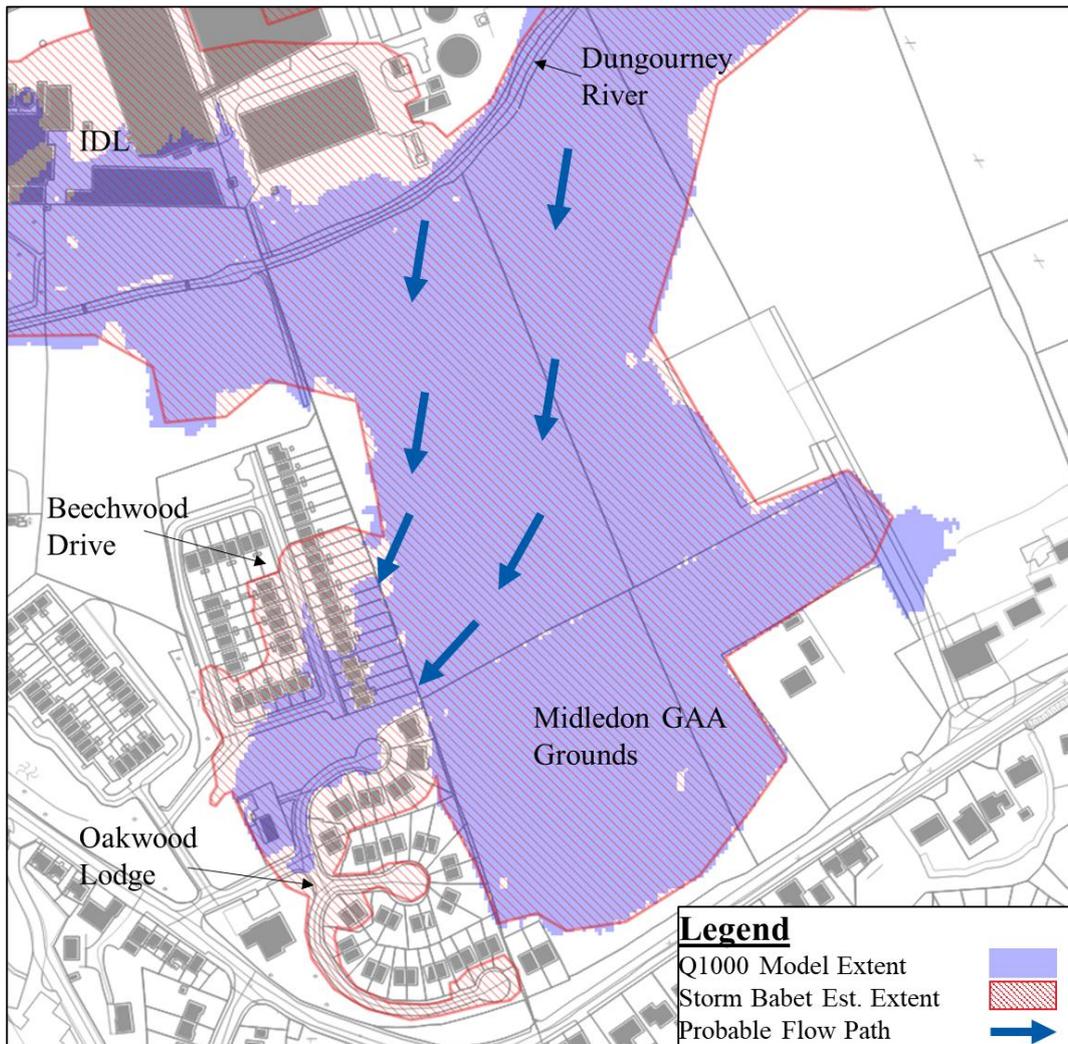
Figure 66: Beechwood/ Oakwood Estate: Existing Flood Mechanisms

The primary mechanism of flooding in the Beechwood and Oakwood Estate is from overland flow entering the rear of the estate. This water originates from overtopping of the left bank of the Dungourney and flows across the GAA pitches before reaching the estate. This mechanism of flooding is indicated in Figure 66.

As part of the GAA grounds redevelopment works it is understood that an informal earthen embankment was placed parallel to the rear wall of the Beechwood and Oakwood Estates. However, there is a gap of circa 15m in this embankment between the South of Beechwood Drive and the North of Oakwood Lodge. It is likely that the majority of flood water entered the estates at this location.

A significant number of wrack marks were recorded on this area and were used to generate the maximum flood extent from the Lidar data as shown in Figure 66. This extent was then cross referenced with the anecdotal data on the flood extent and depths which were observed in the estates during the event.

From comparison of the Q1000 model extent and the Storm Babet observed extent it is clear the modelled Q1000 extent is considerably less than the observed extent of flooding within the Beechwood/ Oakwood estates. This may be due to the flow from the Dungourney catchment during the event being in excess of the Q1000 design flow, i.e. Storm Babet may have approximated to an event in excess of the Q1000 event on the Dungourney. Alternatively, the model in this area may not be representative of what is on the ground and may therefore underestimate water levels for extreme events in the area. This may be related to recent changes in the floodplain elevations associated with the development of the GAA pitches or it may be a function of the roughness in channel and on the floodplain. Further assessment of the design hydrology and hydraulic model will be carried in order to investigate the representation of Storm Babet by the model.

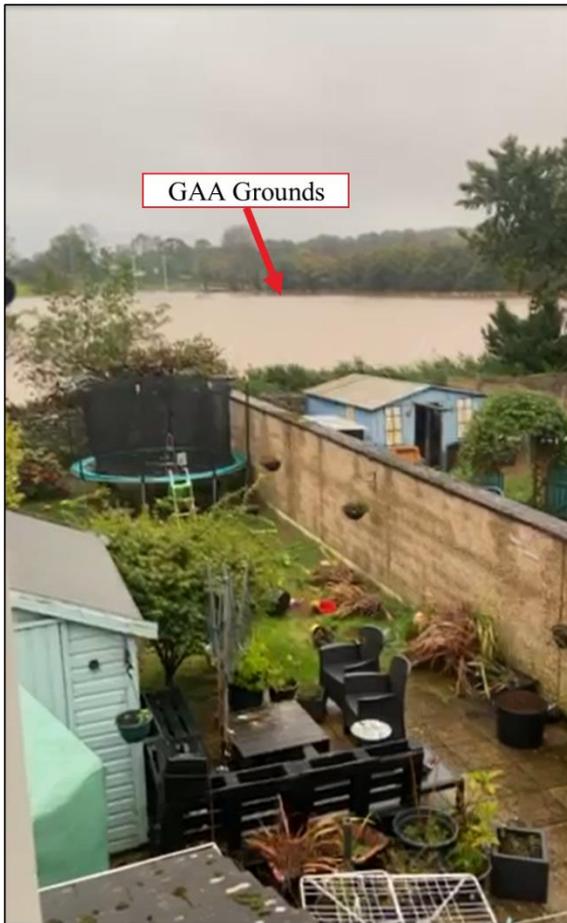
Figure 67: Flooding of the GAA Grounds to the Rear of Beechwood

A still of a video taken by a Beechwood resident and shared with the Project Team is shown in Figure 67 below, it shows the GAA Grounds inundated. It is noted that the permitted GAA development required no reduction in floodplain storage, therefore if this was constructed as permitted it should not result in an increase in flood levels.

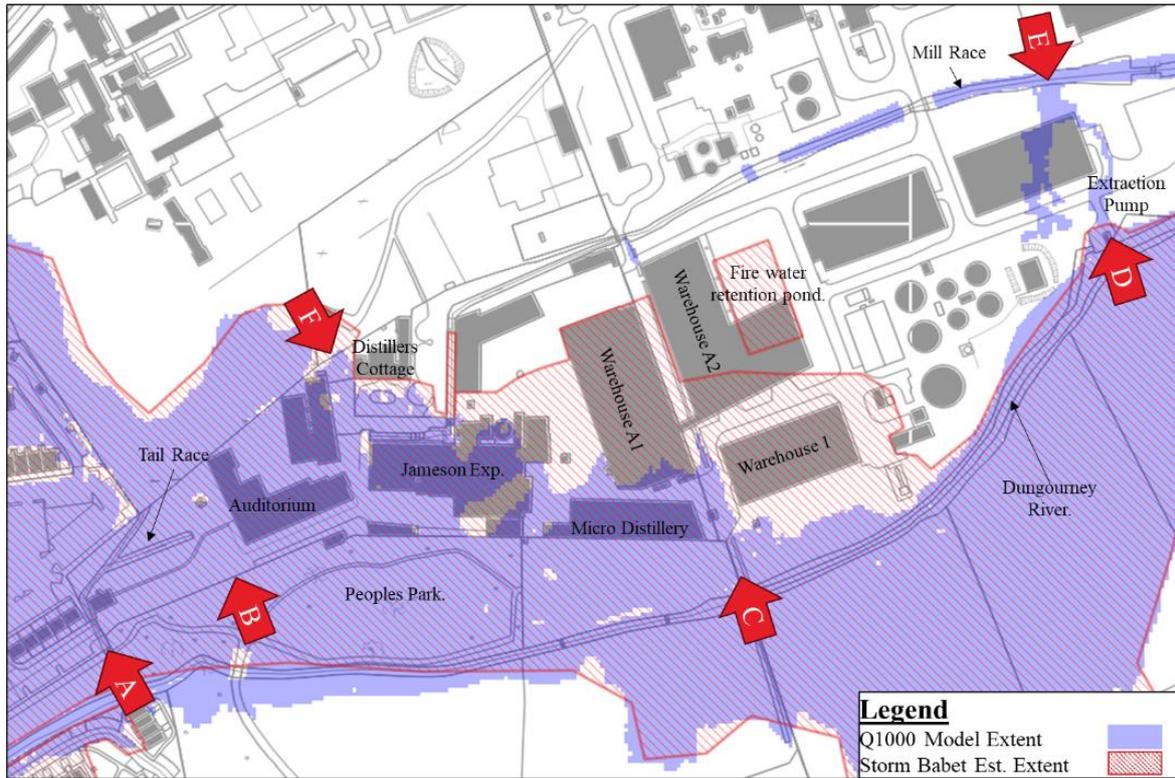
Figure 68: Irish Distillers: Existing Flood Mechanisms

The Irish Distillers Site (which includes The Jameson Experience) is at risk from a number of mechanisms of flooding from the Dungourney as listed below and as sketched in Figure 68:

- A. Fluvial water from the Dungourney backs up the culvert under the Distillery entrance resulting in flooding around the tail race.
- B. Water overtops the right bank of the Dungourney flooding the site from the South. It is noted that that the perimeter wall between the IDL Site and the People's Park has been removed from the hydraulic model for events beyond the Q50 event.
- C. The main source of flooding to the IDL site is fluvial water from the Dungourney backing up the culvert and also overtopping the existing bund spill level.
- D. The right bank of the Dungourney overtops resulting in fluvial flooding at the extraction pump.
- E. Water overtops the left bank of the Mill Race and travels South before entering the Dungourney.

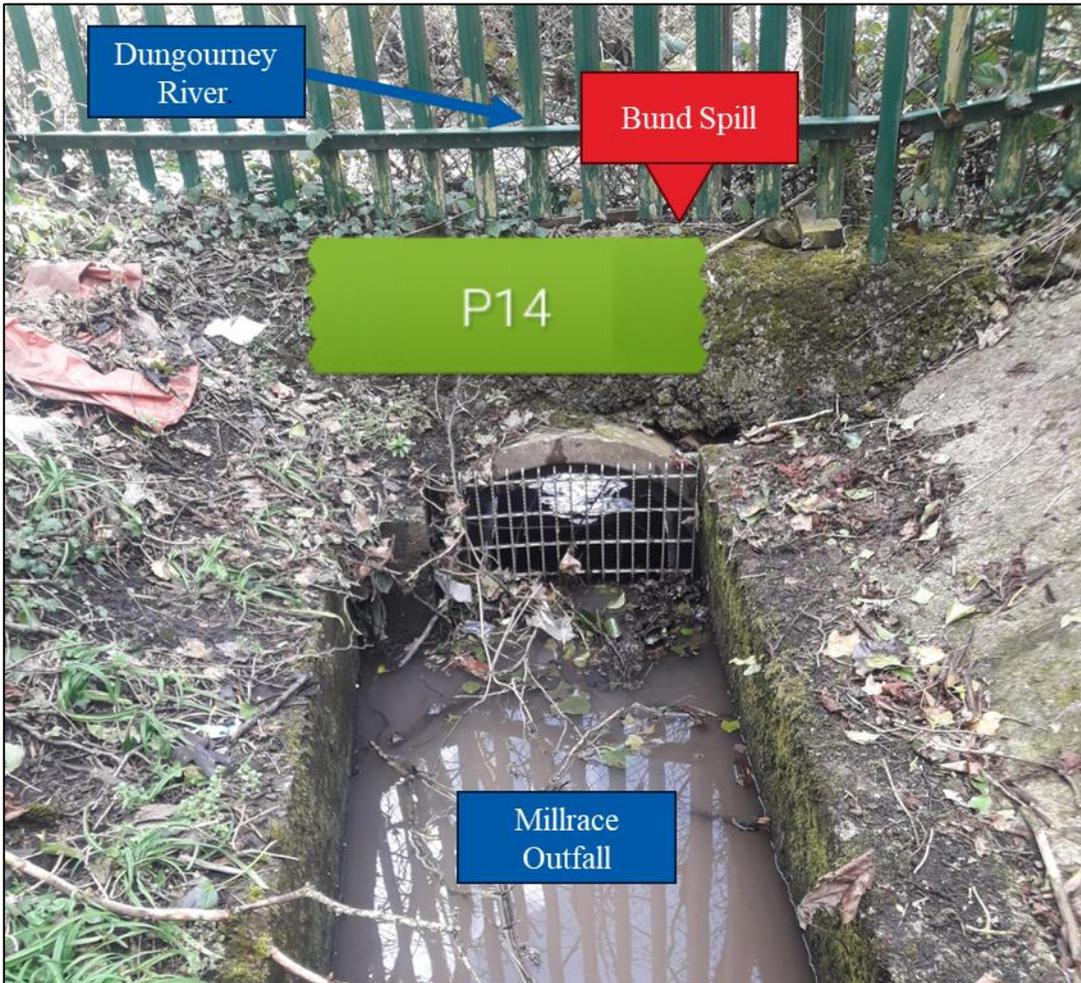
Figure 69: Millrace outlet to Dungourney

The main volume of water entering the site was from fluvial water backing up the culvert and over topping of the bund spill level close to the micro distillery. An image of the outfall and spill is shown in Figure 69.

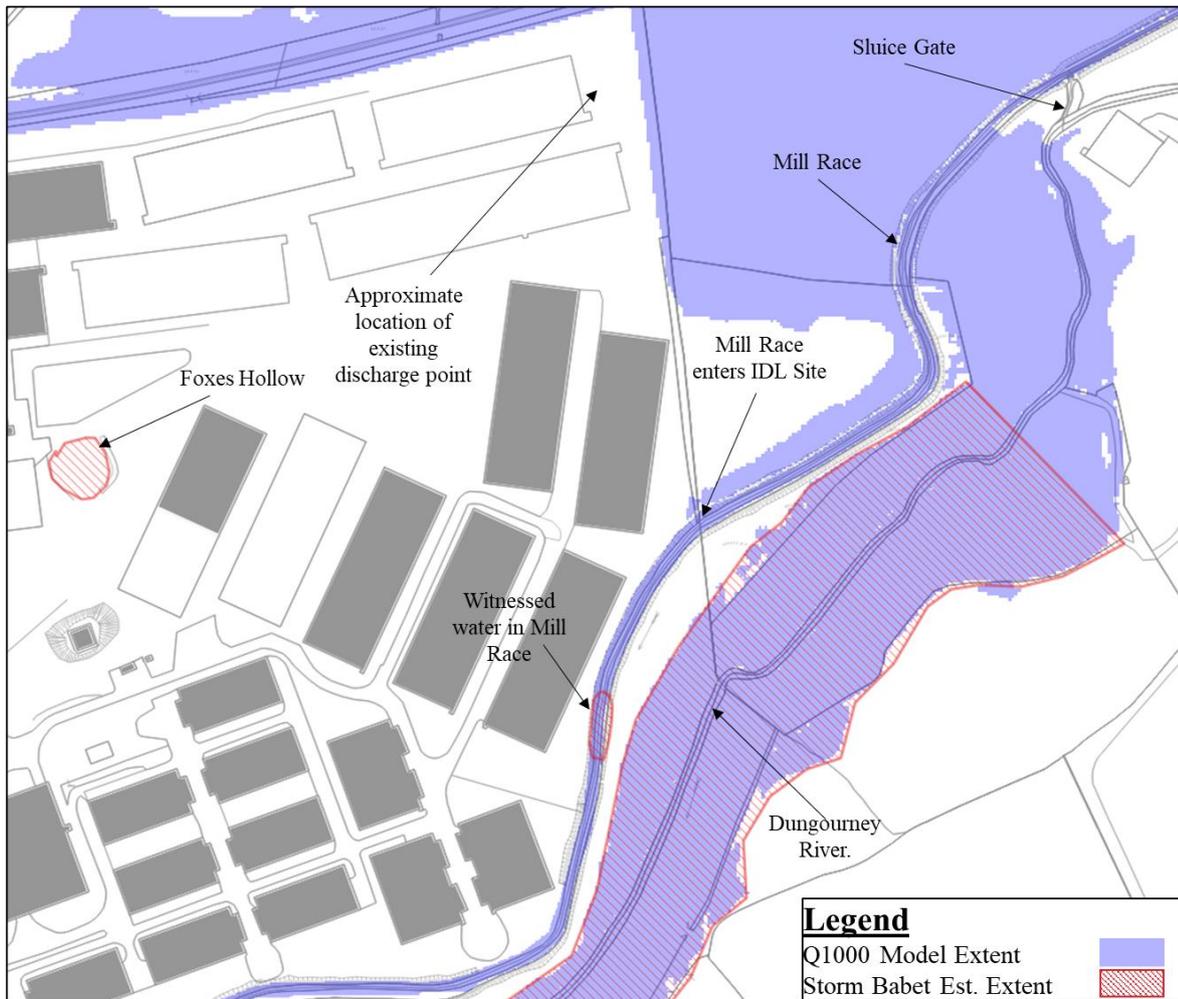
Figure 70: Irish Distillers Upstream: Modelled vs Observed Storm Babet Flood Extent

The model assumes the existing sluice gate upstream on the millrace fails and therefore the millrace takes water from the Dungourney and is active. During the Q1000 model scenario the left bank overtops but this mechanism was not observed during Storm Babet as the millrace was only wet with direct rainfall.
