3.5 Area 3 North – Cork Rd Bridge to N25

Area 3 includes Midleton Town Centre, southern side of IDL site, the Baby Walk, People’s Park, areas adjacent to Dungourney River and Bailick Road. The area is at risk of fluvial flooding from the Owenacurra and the Dungourney, as well as tidal flooding.

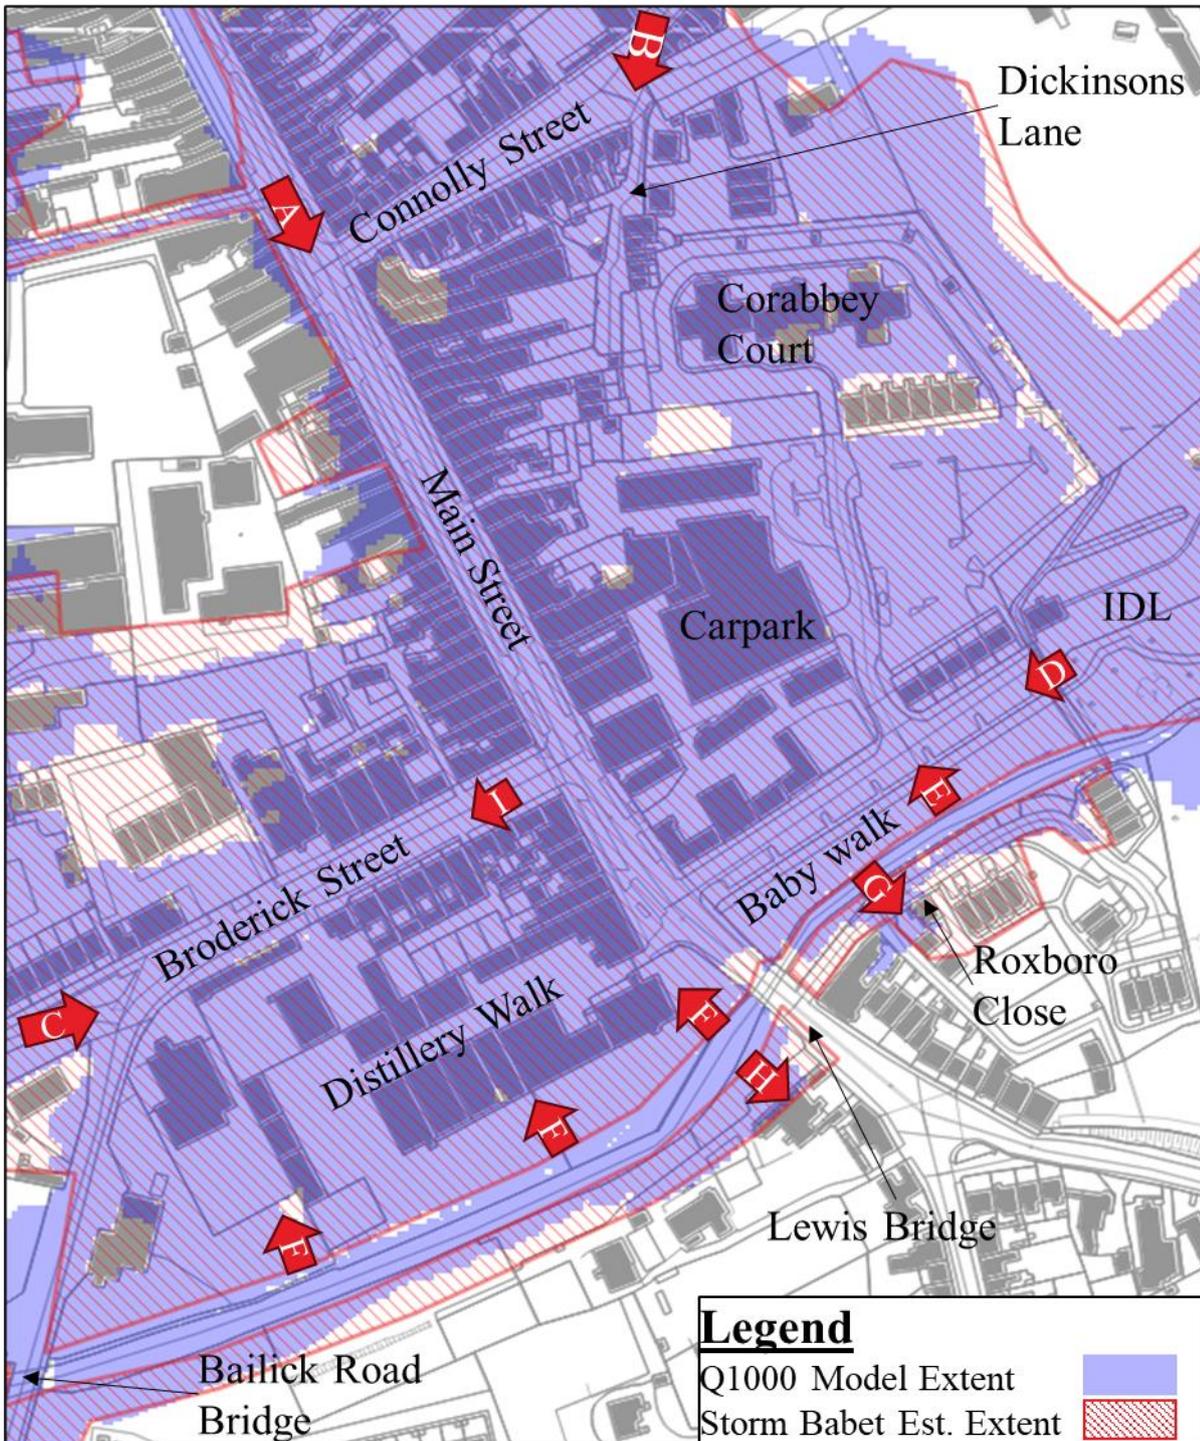
Figure 71: Lower Main Street/ The Babys Walk: Existing Flood Mechanisms

The main area of the town in the vicinity of The Baby's Walk and Lower Main Street is at risk from a number of mechanisms of flooding from the Dungourney and the Owenacurra. The mechanisms of flooding in the hydraulic model detailed below correspond to the arrows in Figure 71.

- A. For the large return period events, flood risk in the vicinity of Main Street is partly due to overland flow from the Owenacurra River as detailed in Section 3.5.3. The threshold of flooding of this flow path is the Q1000 event in the hydraulic model;

- B. There is also a risk of overland flow from Drury's Avenue which travels South and inundates Connolly Street/ Dickinson's Lane as detailed in Section 3.5.3. The threshold of flooding of flooding of this flow path in the hydraulic model is the Q100 event.

- C. Overland flow from the Owenacurra via Kennedy Park and Broderick Street travels East as detailed in Section 3.5.2.
- D. The Baby's Walk is flooded from the East due to overland flow from the IDL/ People's Park as discussed in Section 3.5.5.

- E. The Baby's Walk area is directly flooded from the Dungourney due to over topping of the right bank of the river. The threshold of flooding for fluvial flooding is the Q5 event.

- F. The Distillery Walk / Cuddigan's Yard area downstream of Lewis Bridge is also directly flooded from the Dungourney due to over topping of the right bank during the Q1000 event.

- G. Water overtops the Dungourney left bank upstream of Lewis Bridge and floods the Roxboro Close Area in the modelled Q1000 event.
- H. On the left bank downstream of Lewis Bridge water gets out of channel in the Q1000 model event.

- I. Broderick Street is also flooded from flow coming down Main Street

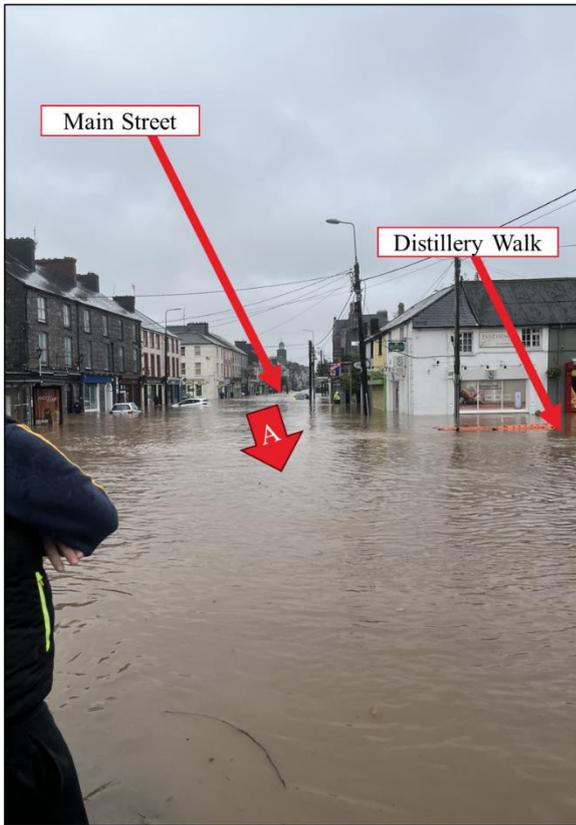
Figure 72: Flooding of Lower Main Street

Figure 72 shows flooding of Lower Main Street at 2.11pm on the day of the event. Wracks marks taken at the Three shop at the end of Main Street were circa 3.8mOD which is 300mm above the modelled Q1000 modelled water level at this location (i.e. 3.5mOD).

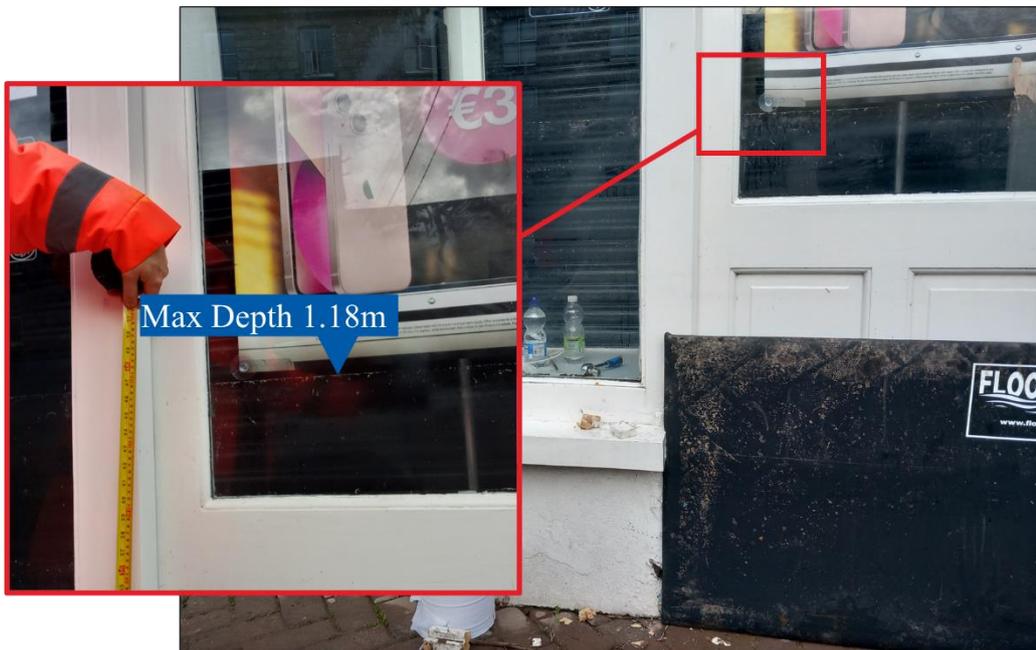
Figure 73: Wrack Mark at Three Shop

A wrack mark was also recorded by Arup at the front door of the Three shop, the maximum depth of flooding at this location was circa 1.18m as shown in Figure 73.

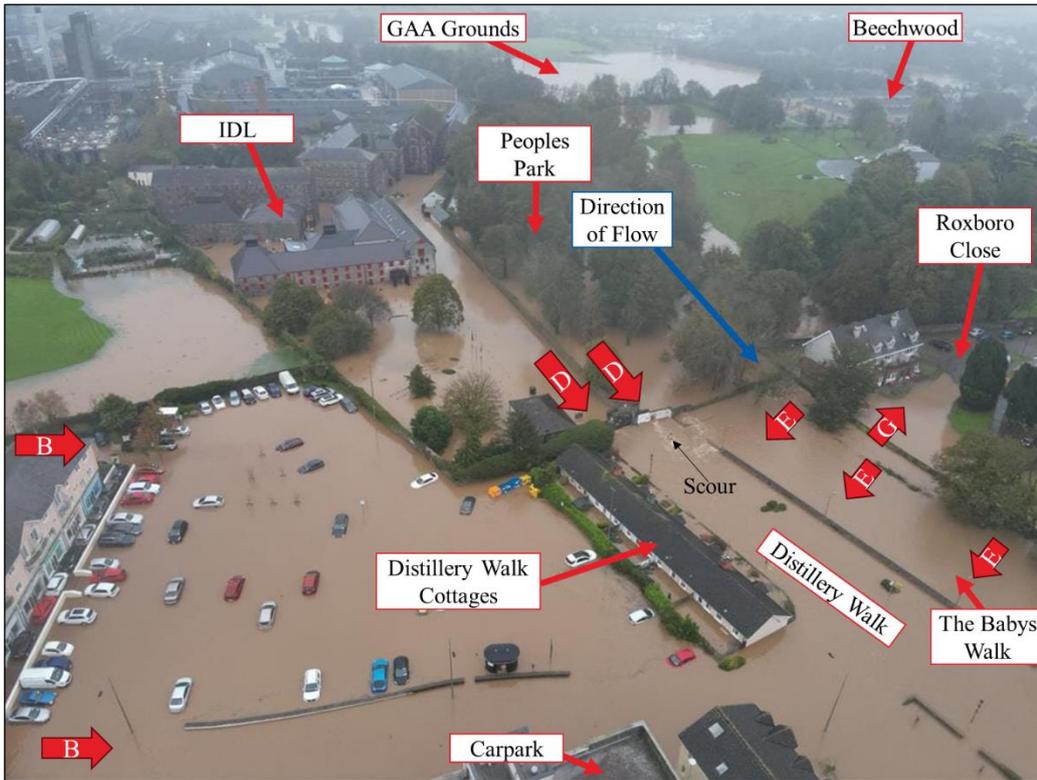
Figure 74: Flooding of IDL, Peoples Park and The Babys Walk

Figure 74 was provided by the Guileen Coast Guard shows the extent and active mechanisms of flooding in the IDL, People's Park and The Babys Walk area. Water flooded the rear of the Distillery Walk Cottages via the Corabbey Court development (Mechanism B), through the IDL entrance and the gap in the wall connecting People's Part to Distillery Walk (Mechanism D) and directly from the Dungourney (Mechanism E). The flood mechanism resulting in inundation of Roxboro Close can also be seen in Figure 74 (Mechanism G).

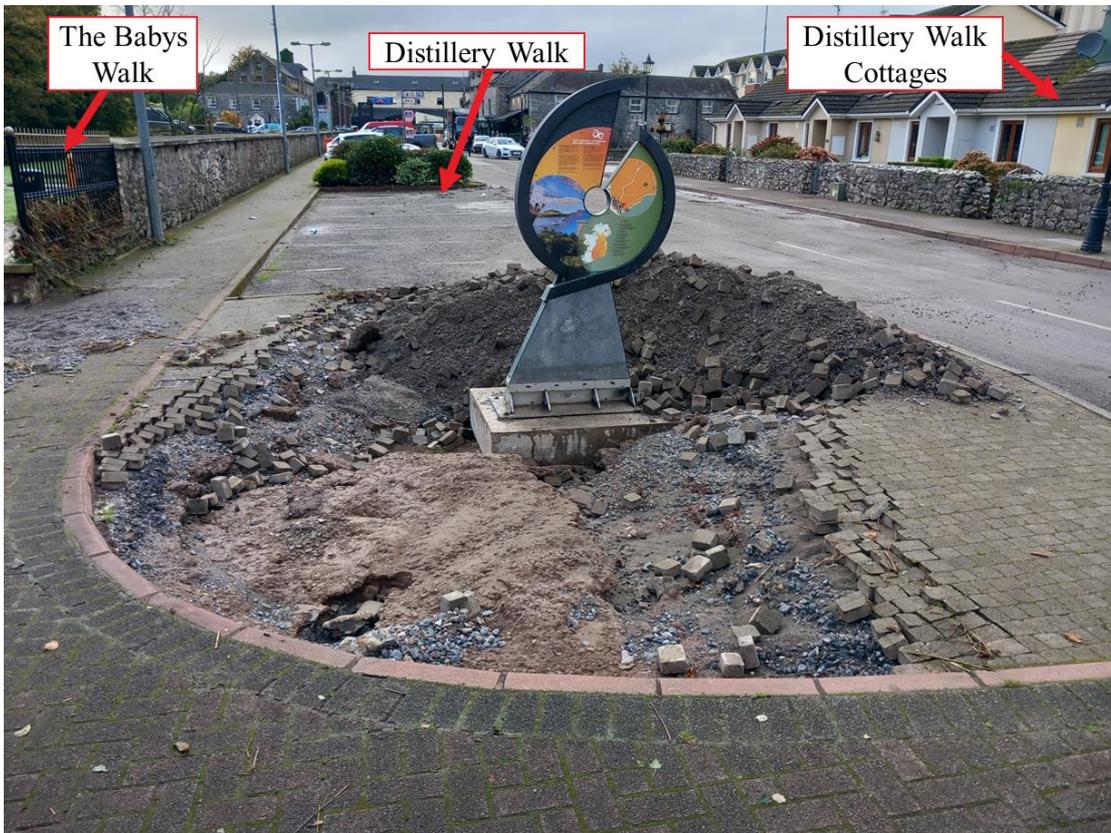
Figure 75: Scour Damage at Distillery Walk

The gap in the wall connecting People’s Park and Distillery Walk squeezed the flow and resulted in very high velocities which led to significant scouring of a section of footpath as shown in Figure 75.

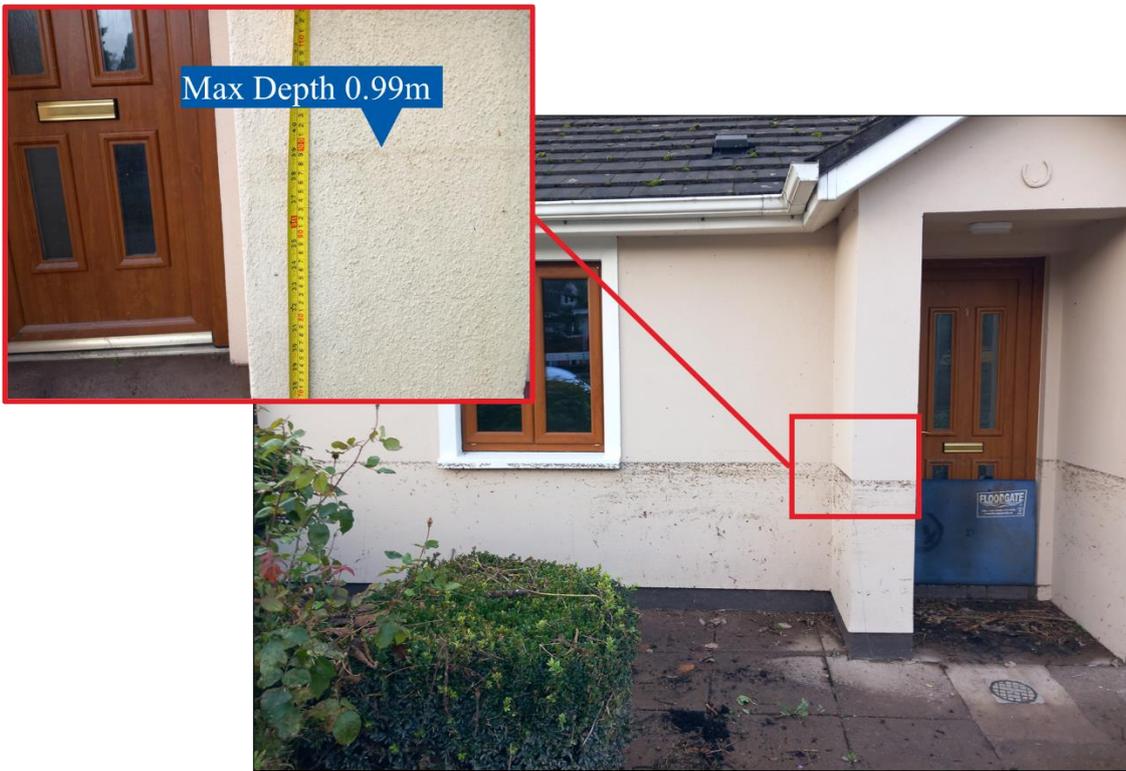
Figure 76: Wrack Mark at Distillery Walk Cottages

A wrack mark was also recorded by Arup at the Distillery Walk Cottages, the maximum depth of flooding at this location was circa 0.99m as shown in Figure 76.

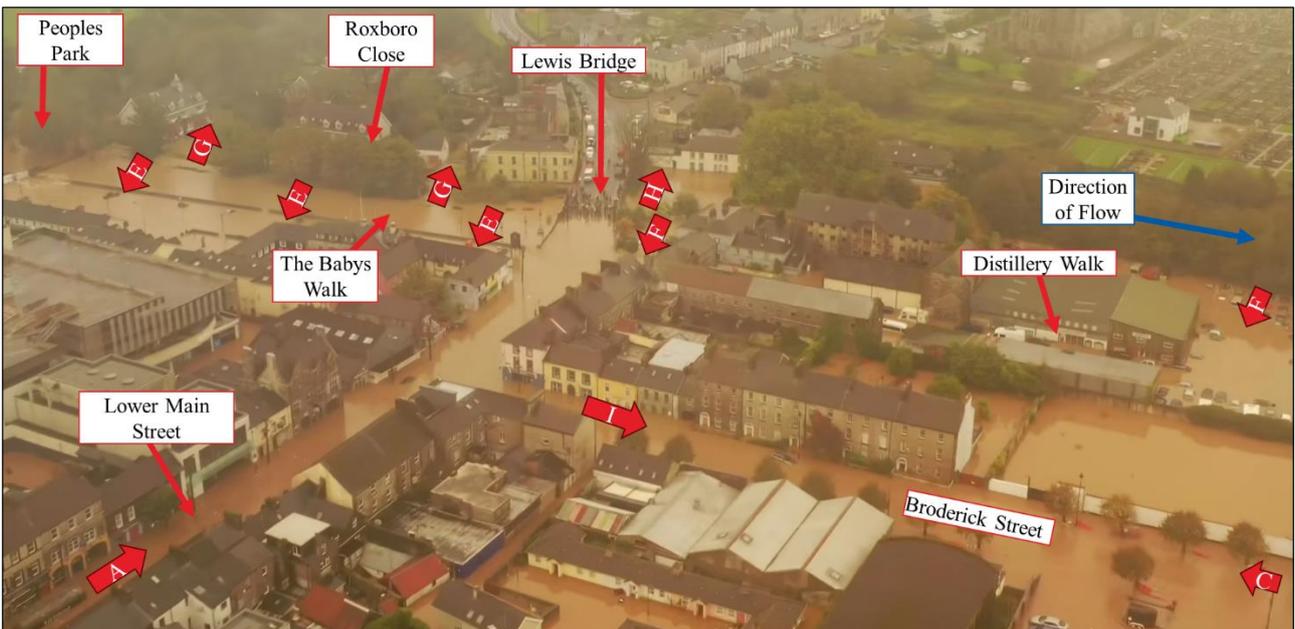
Figure 77: Flooding of Lower Main Street, The Baby's Walk and Broderick Street

Figure 77 presents a still of drone footage taken just after the peak of the flood event and uploaded to social media. It shows flooding of Lower Main Street, The Baby's Walk and Roxboro Close as discussed above. It also shows the flood extent of the right and left bank downstream of Lewis Bridge (Mechanism F and H respectively). Figure 76 illustrates the flooding Broderick Street, the source of which is believed to be from Kennedy Park in the direction of Main Street (Mechanism C) initially and then later in the event from Lower Main Street in the direction of Kennedy Park (Mechanism I). It is noted that the Owenacurra was also overtopped in this location such that water on Broderick Street was in effect a meeting point of two separate overland flow routes.

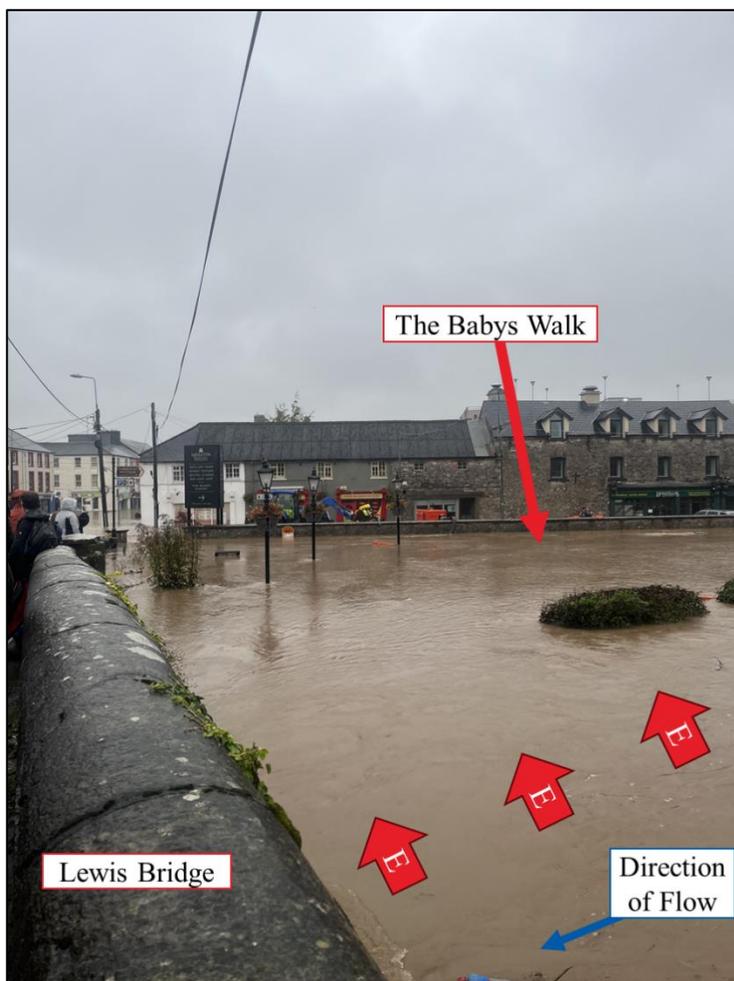
Figure 78: Flooding of The Babys Walk

Figure 78 was taken at 3.06pm on the day of the event from Lewis Bridge in the direction of The Babys Walk. Based on water levels from other images it is estimated that this was the time of the peak of the flood in this area. It is estimated that the peak water level in The Baby's Walk was circa 3.6mOD which is circa 100mm higher than the modelled Q1000 model water level (i.e. 3.5mOD).

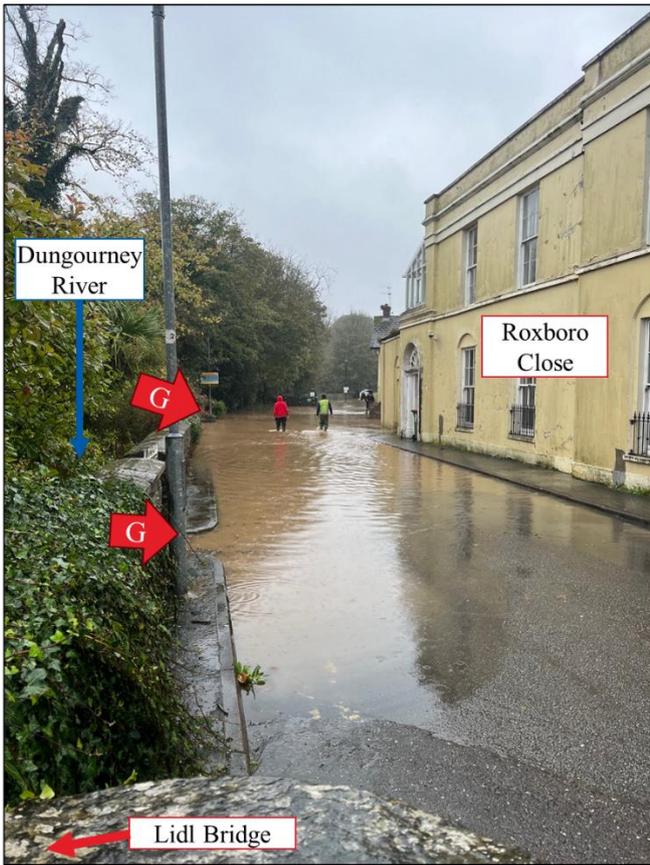
Figure 79: Flooding of Roxboro Close

This is notably higher than the Q1000 model water level in this area was circa which is 3.7mOD, i.e. the maximum water level during Storm Babet is circa 350mm higher than the modelled Q1000 water level.

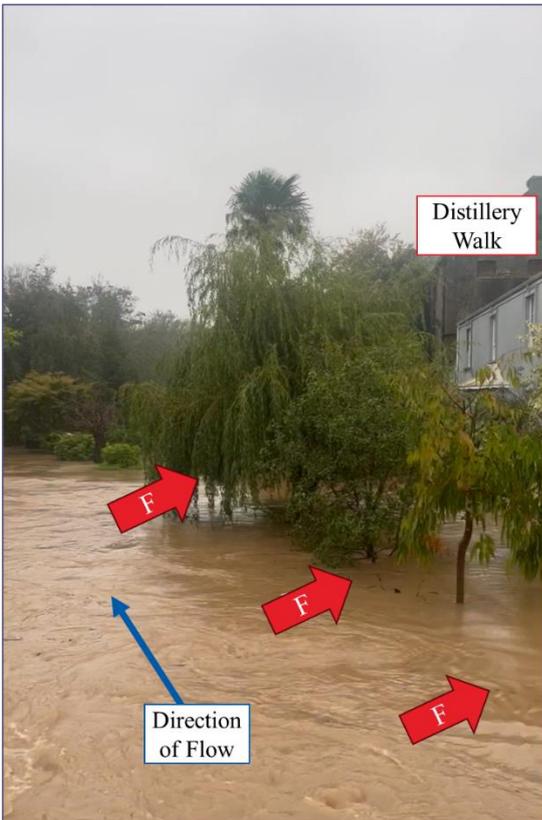
Figure 80: Flooding of Right Bank Downstream of Lewis Bridge

Figure 80 is a still of a video and shows the mechanism of flooding on the right bank downstream of the Lewis Bridge (Mechanism F). No wrack marks were recorded after the event at this location however based on topographical survey data it is estimated that the flood level in this area was circa 3.6mOD which is 300mm higher than the Q1000 modelled level of 3.3mOD.

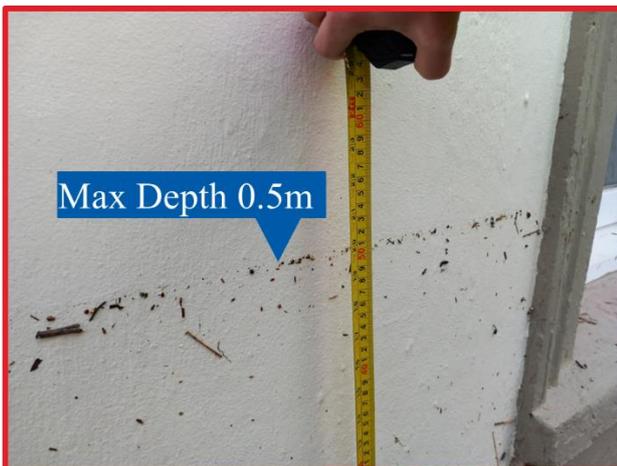
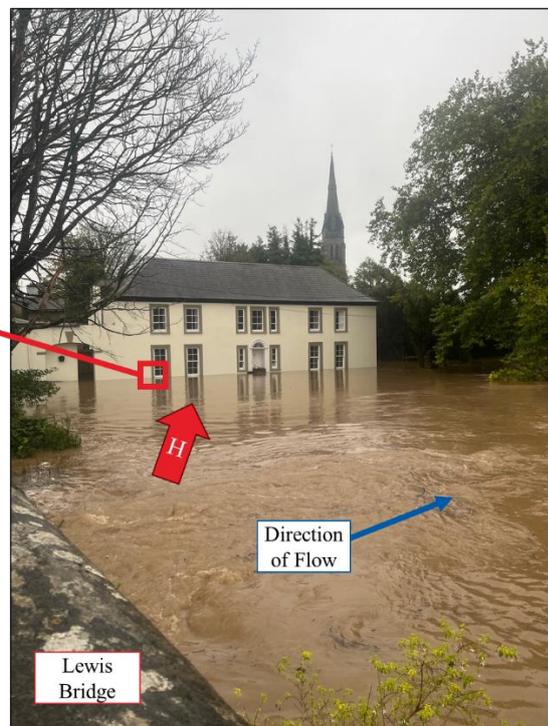
Figure 81: Flooding of Left Bank Downstream of Lewis Bridge

Figure 81 was taken at 3.02pm on the day of the event and shows the mechanism of flooding on the left bank downstream of the Lewis Bridge (Mechanism H). Based on topographical survey data, it is estimated the flood level in this area was circa 3.6mOD which is also 300mm above the modelled Q1000 water level of circa 3.3/3.35mOD in this area. A wrack mark was also recorded by Arup at this location, the maximum depth of flooding was circa 0.50m as shown in Figure 81.

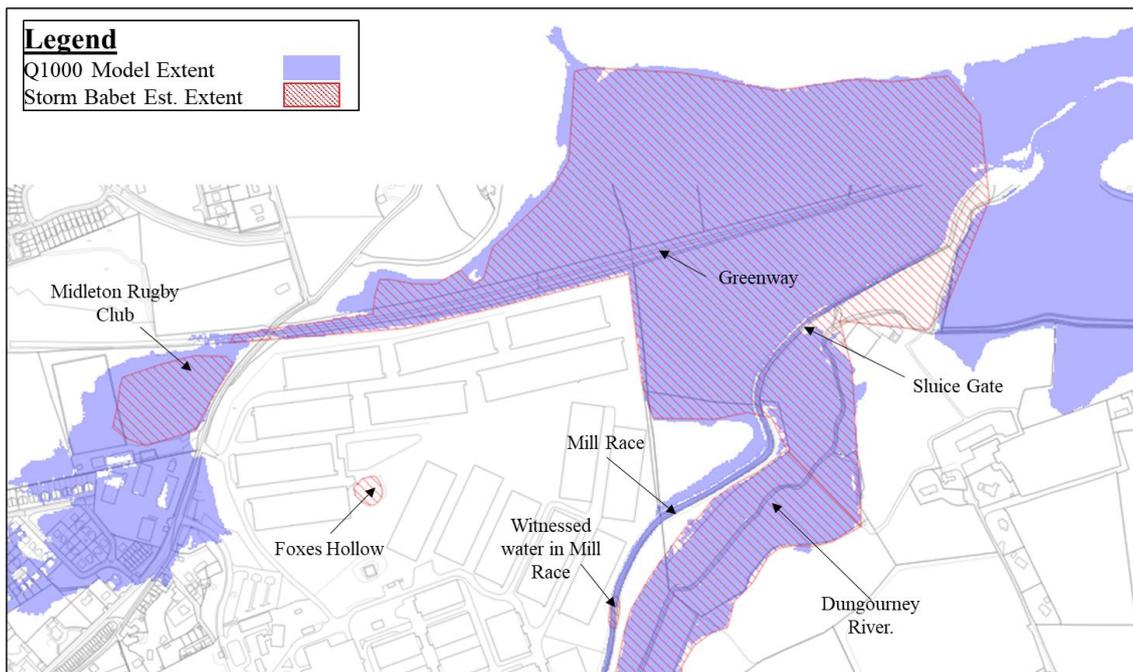
Figure 84: Area 4: Modelled vs Observed Storm Babet Flood Extent

There were no reports of properties flooding from groundwater/ fluvial sources in this area during Storm Babet. The Green Way, Midleton Rugby Club and agricultural lands to the East of the IDL Site were flooded. The estimated flood extent from Storm Babet is presented in Figure 84.

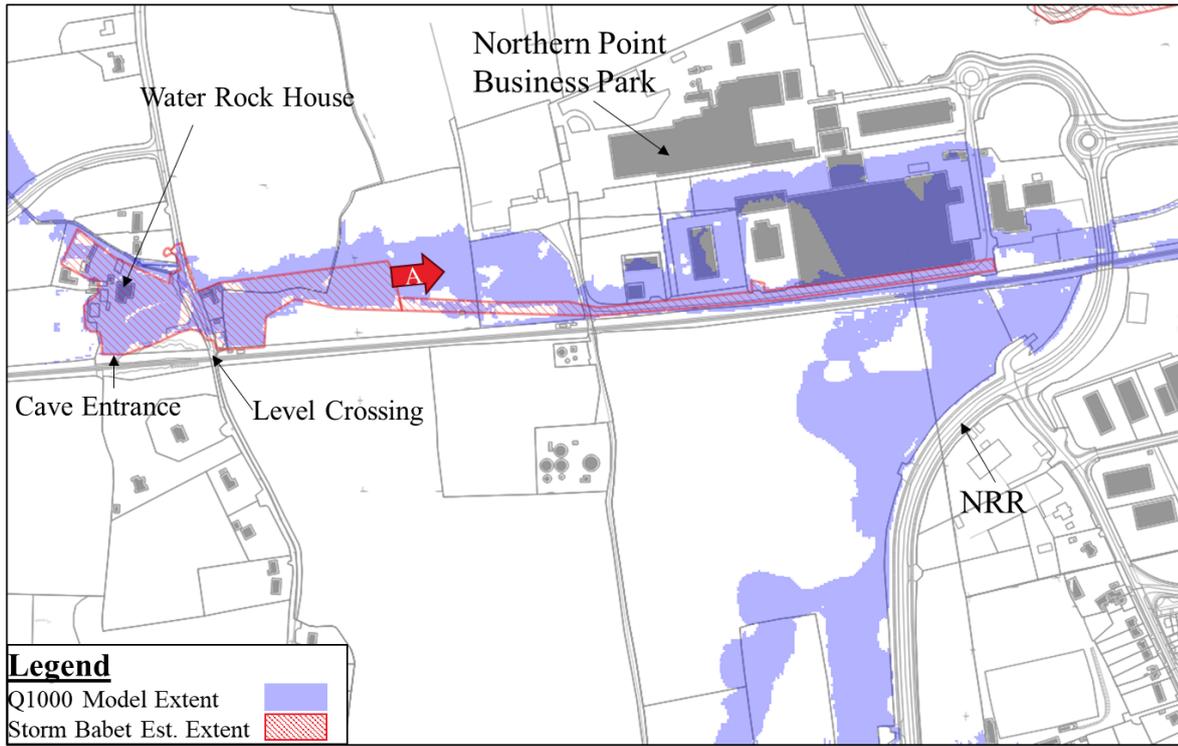
Figure 86: Water Rock Upstream of Cave System: Existing Flood Mechanism

The Q100 event inundates Water Rock House and overtops the local access road. A number of residential properties adjacent to the road are inundated as a consequence. There is a sufficient head of water over the road to cause a significant volume of water to flow east beyond the residential properties and fall towards the Owenacurra, this mechanism of flooding is presented in Figure 86 using the “A” arrow.

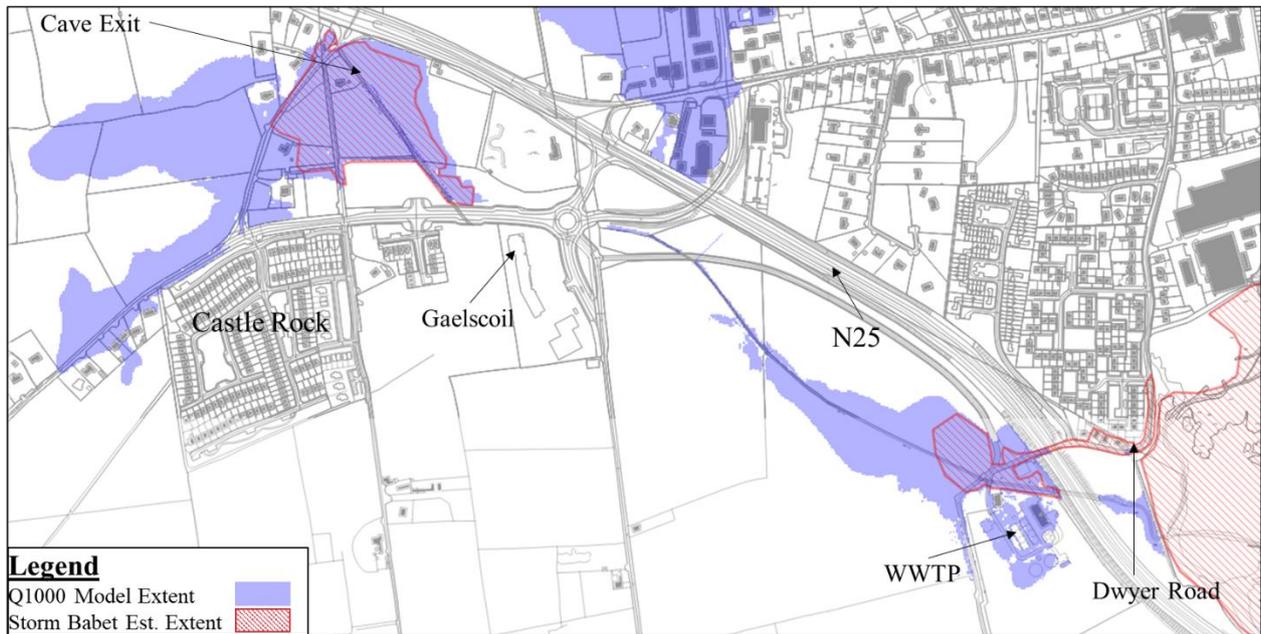
Figure 87: Water Rock Downstream of Cave System: Existing Flood Mechanism

A number of properties downstream of the cave system are also at risk from fluvial flooding. The WwTP is also at risk.

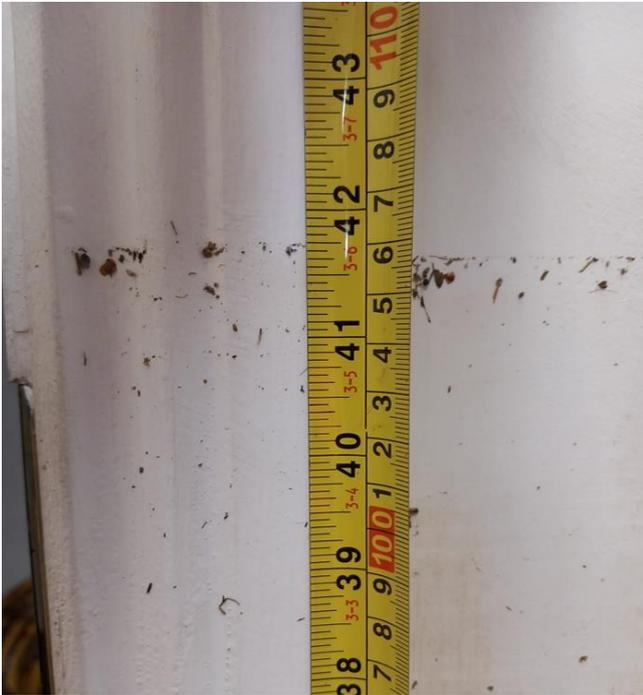
Figure 88: Wrack Mark at Water Rock House

Wrack marks recorded at Water Rock House by Arup following the event suggest the depth of flooding in the property was 1.06m (Figure 88), the finished floor level of this property is 10.19mOD therefore the estimated max flood level is circa 11.25mOD. The modelled Q1000 water level at this location is 11.15mOD, i.e. 100mm lower than the observed level.

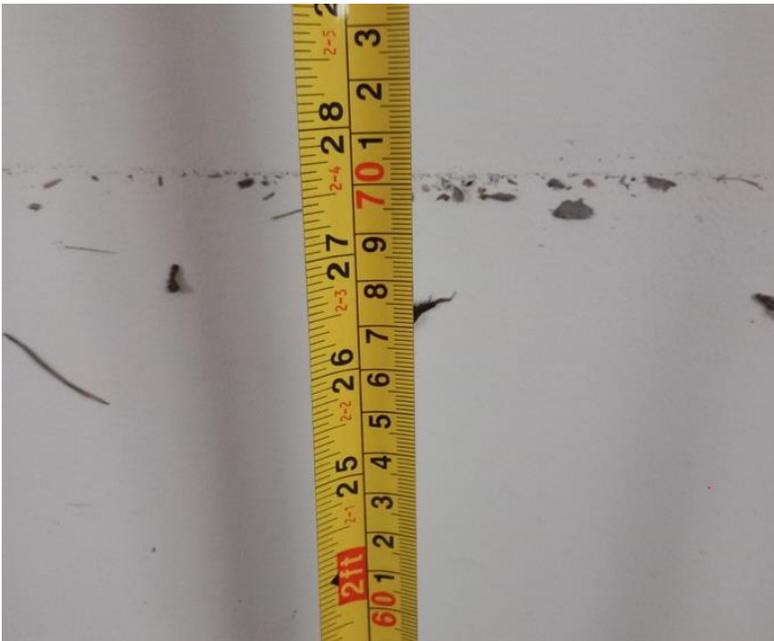
Figure 89: Wrack Mark at Bungalow opposite Water Rock House

Wrack marks recorded at the bungalow opposite Water Rock House by Arup following the event suggest the depth of flooding in the property was 0.7m (Figure 89). As the finished floor level of this property is 10.66mOD the estimated maximum flood level is circa 11.36mOD which is circa 200mm above the modelled Q1000 water level at this location (11.13mOD).

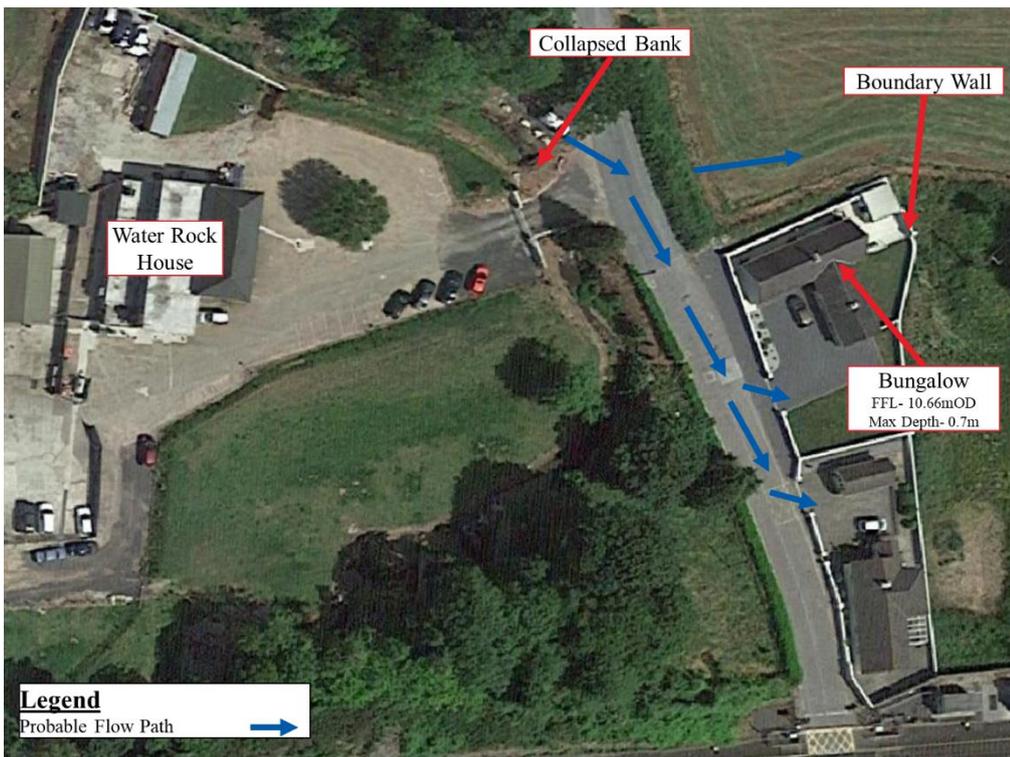
Figure 90: Probable flow path leading to flooding of Water Rock Bungalows

The probable flow path and the boundary walls are outlined in Figure 90. Furthermore, during the flood event the channel banks directly upstream of the culvert passing under the Water Rock House access road collapsed. (Figure 91)

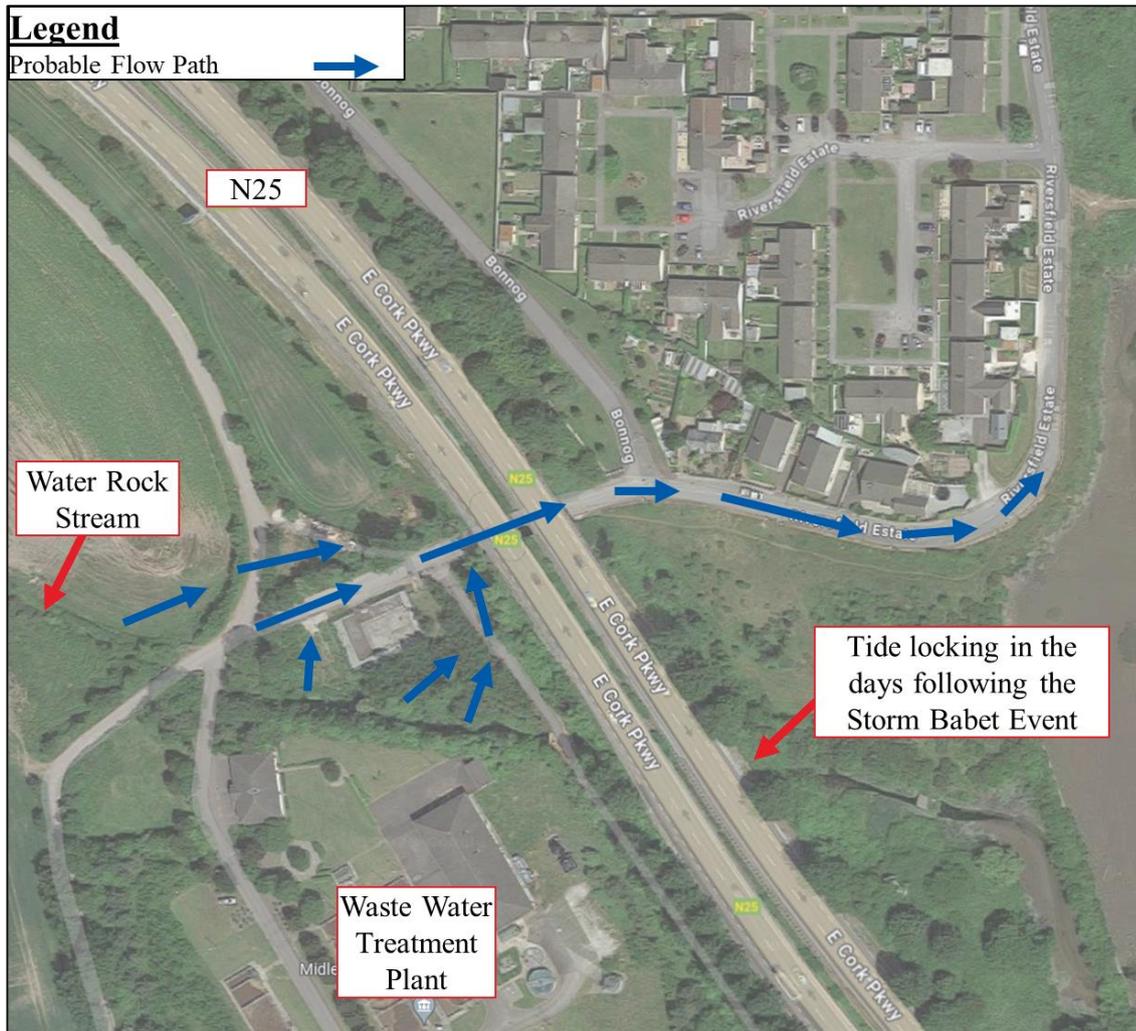
Figure 92: Probable Flow Path Flooding Riversfield Estate

There were reports of flooding at Dwyer’s Road/ Riversfield Estate on the 18th October and again on the evening of the 19th October. The probable flow path resulting in flooding of Riversfield Estate is shown in Figure 92. It is believed the source of the flooding on the 19th was due to tide locking of the Water Rock Stream outfall. The water levels in the stream were still elevated due to discharge from the cave system upstream hence there was little additional capacity in the channel available to store water which could not be discharged at high tide. It is noted that the same mechanism of flooding was witnessed circa 10 days later, over the last weekend in October.

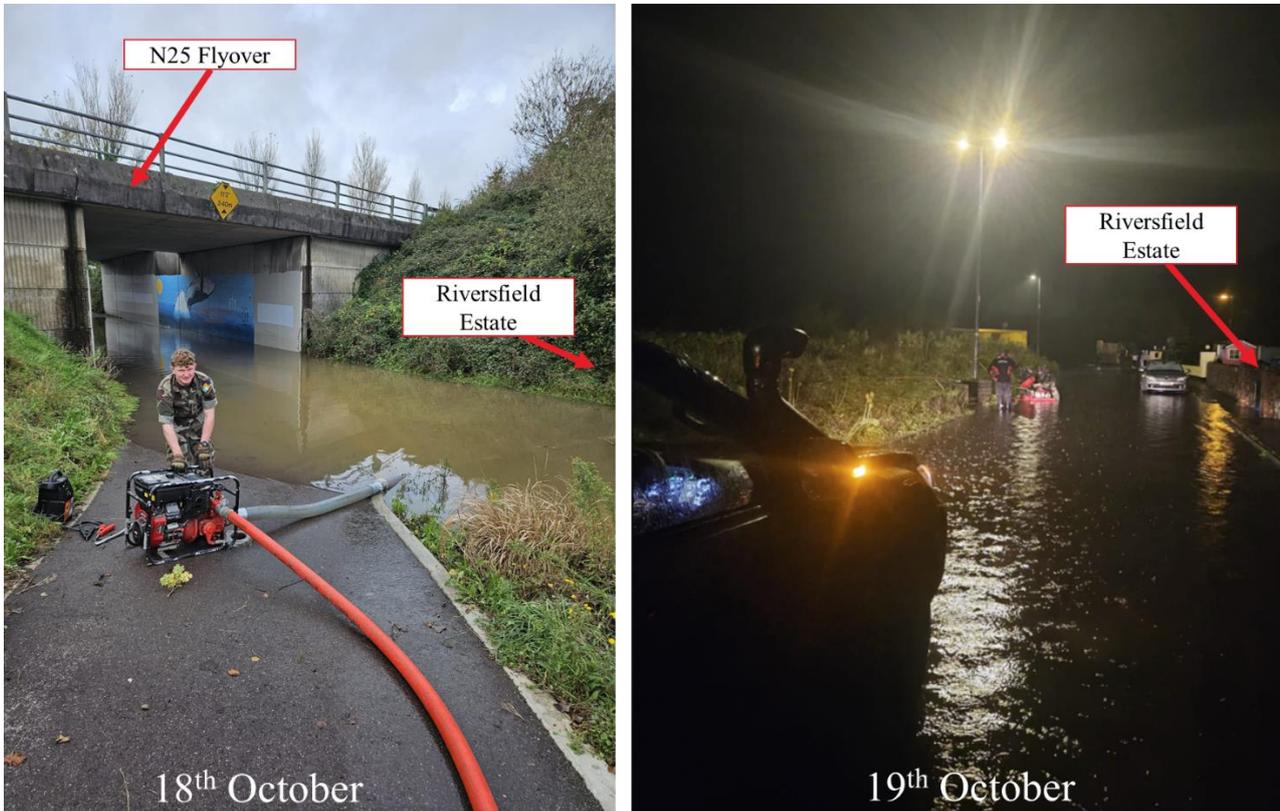
Figure 93: Flooding of Dwyer's Road/ Riversfield Estate Area

Images shared on social media for this area are presented in Figure 93 below. Based on inspection of water levels and available topographical survey data it is believed that 3 residential properties flooded in the Riversfield Estate area.

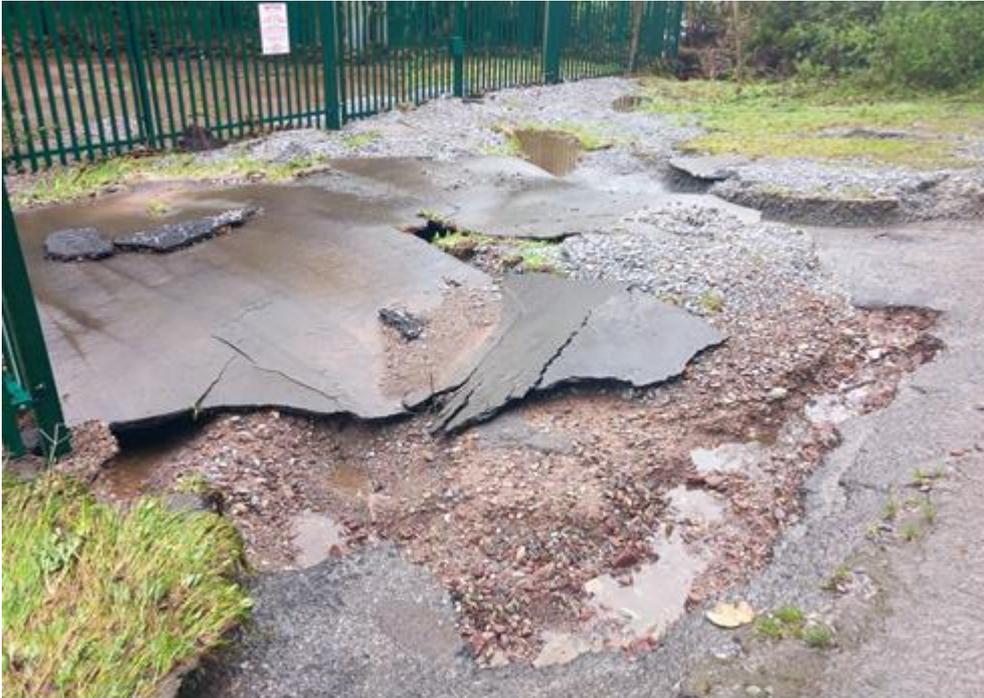
Figure 94: Damage to Road at Ballyedmond Gauge

The area in the vicinity of the gauge at Ballyedmond was very significantly flooded during Storm Babet. There was also significant damage to the local infrastructure: a number of local roads and the parking area in front of the site were all damaged during the event (Figure 94). The boundary wall in front of the site was also knocked during the event (Figure 95).
